# MARJORIE RUSSELL RESEARCH CENTER SITE

2351 Arrowhead Drive  
Carson City, Nevada 89701

**Site Number: 9852**  
**STATE OF NEVADA PUBLIC WORKS DIVISION**  
**FACILITY CONDITION ANALYSIS**

Report distributed in December 2021

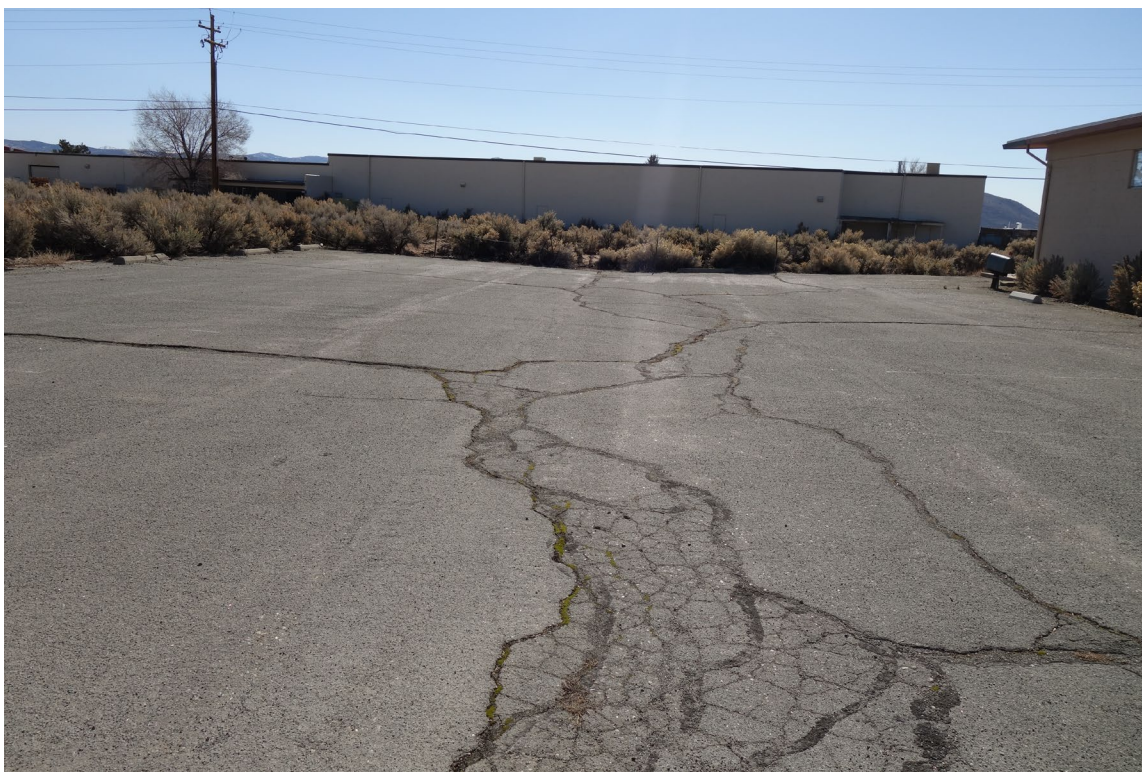
The existing asphalt concrete paving is in poor shape. There are large cracks and areas of alligating and is showing signs of failure. This project would provide for the removal and replacement of AC paving. Also included is PC concrete ADA accessible parking, striping, signage and wheel stops. 30,000 square feet was used to generate this estimate. This project should be implemented within the next 2 - 3 years.

Marjorie Russell Research Center Site – FCA Site #9852  
Description: Paving Replacement Needed.

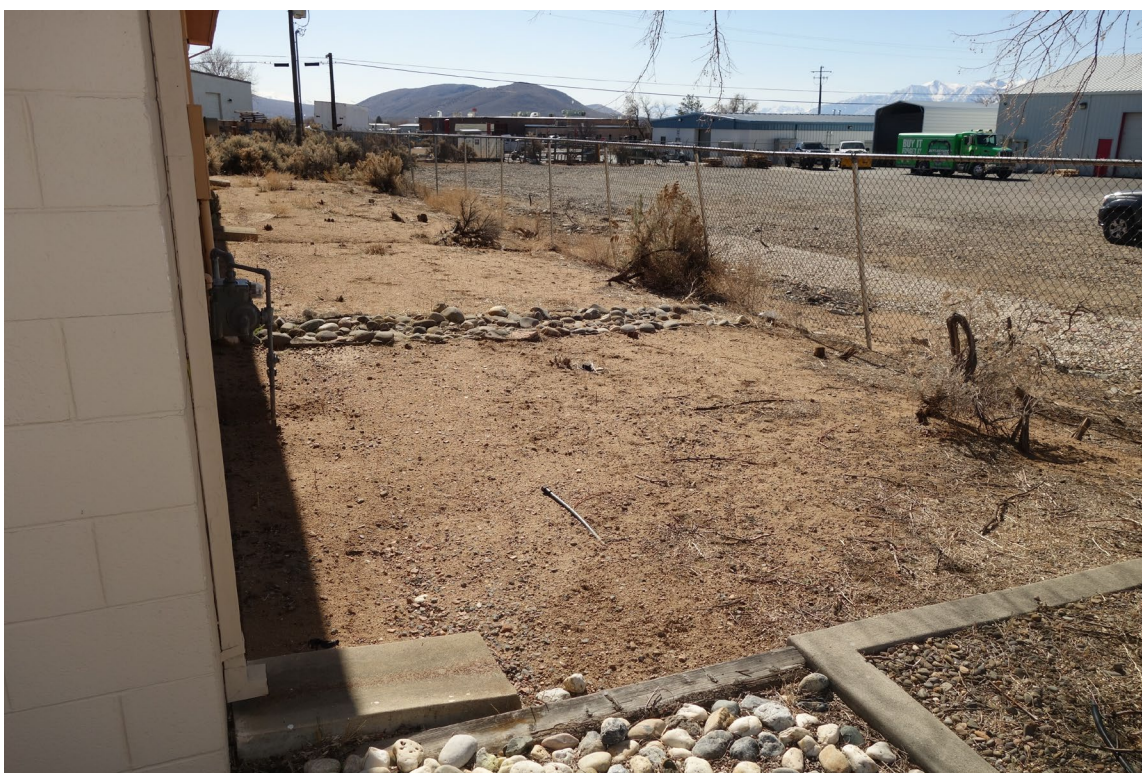
The west side of the building has some areas in need of drainage improvements where the roof drainage down spouts terminate at grade. This project would provide for down spout extensions to a gravel drywell capable of handling runoff from rain and snow melt.

Marjorie Russell Research Center Site – FCA Site #9852  
Description: Drainage / Landscape Improvements Needed.

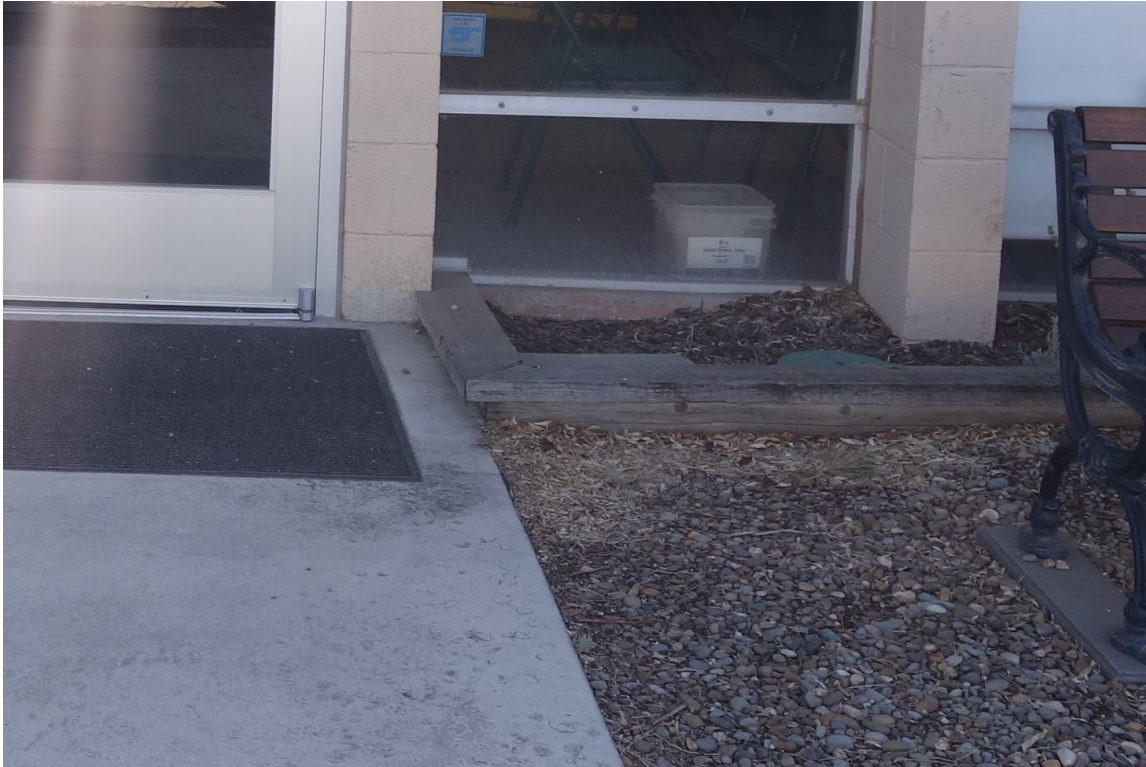
This building has planters across the front of the building that extend up onto the exterior wall. This practice promotes water infiltration through the side of the building and has been known to cause mold growth along the exterior walls of buildings. This project recommends that the planters be removed as soon as feasible and replaced with xeriscaping. This project or a portion there of was previously recommended in the FCA report dated 02/12/2003, 03/01/2006 and 02/28/2013. It has been amended accordingly to reflect conditions observed during the most recent survey date of 02/26/2021.

Marjorie Russell Research Center – FCA Building #0208  
Description: Planter Removal Recommended.

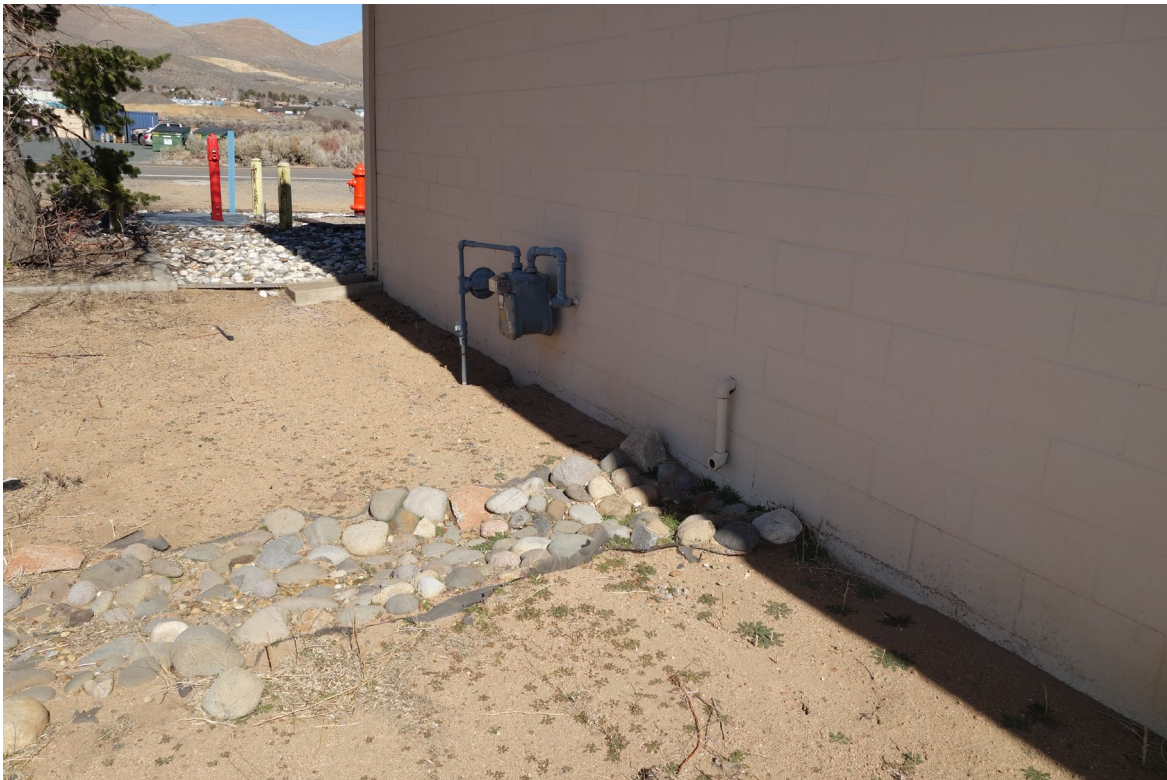
Agreements reached between the Nevada Risk Management Office and the State of Nevada's Insurance Underwriter require Seismic Gas Shutoff Valves (SGSV's) on all gas services to all State buildings. This project would install a SGSV to the gas line serving the building. This project or a portion there of was previously recommended in the FCA report dated 03/01/2006 and 02/28/2013. It has been amended accordingly to reflect conditions observed during the most recent survey date of 02/26/2021.

Marjorie Russell Research Center – FCA Building #0208  
Description: Seismic Gas Isolation Valve Needed.

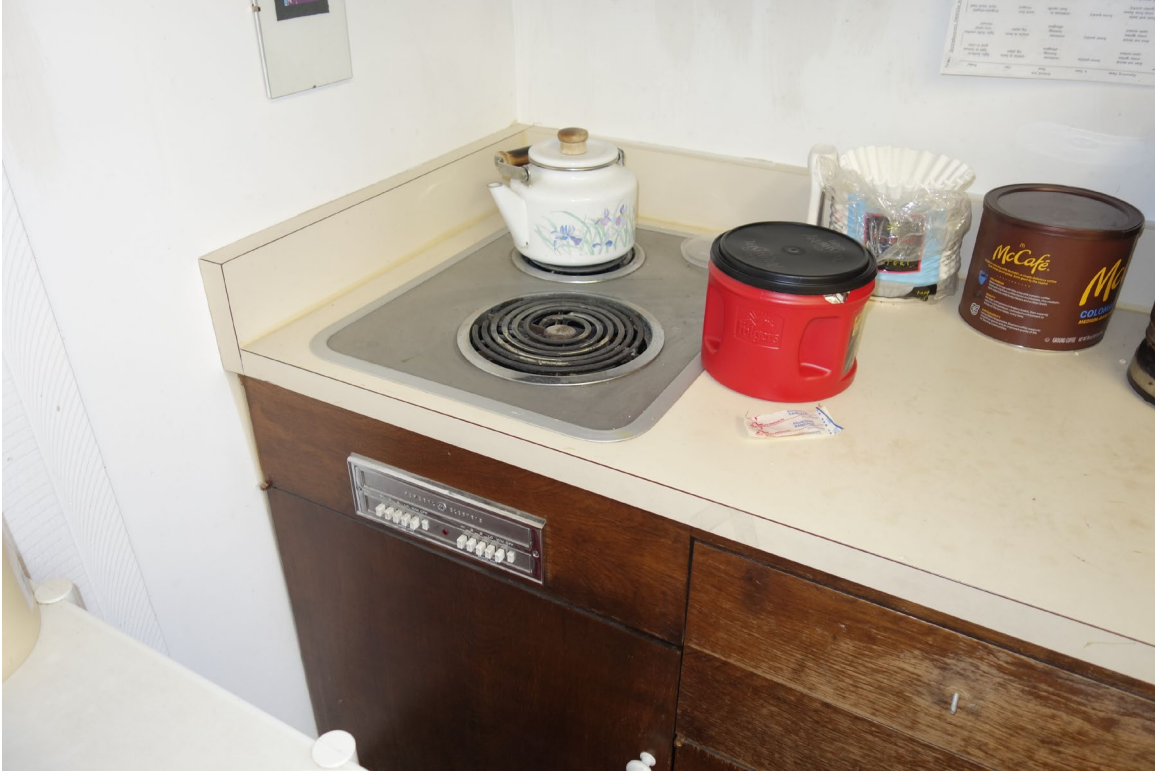
The kitchenette and associated cabinets in the employee break room are original to the building. The quality of construction and installation were inadequate for the high usage at this facility, and the cabinets and countertops are delaminating and failing. This project recommends the replacement of the existing kitchen countertops, cabinets, and associated equipment with heavy duty, quality components. The cabinets should be finished inside and outside with a melamine or similar finish which encapsulates the door, frame, and shelving. The countertops should be constructed of a highly durable product, such as stainless steel, over a moisture resistant underlayment to minimize swelling and damage from water exposure. ADA compliance according to NRS 338.180, IBC - 2018, ICC/ANSI A117.1 and the most current version of the ADA Standards for Accessible Design should be incorporated into the design such as providing an accessible sink. This estimate includes removal and disposal of the existing materials. This project should be implemented concurrently with the EXHAUST HOOD INSTALLATION project.

The building contains an electric stove top in the kitchen area. The 2018 Uniform Mechanical code requires an exhaust hood to be installed. This project would provide for the purchase and installation of exhaust hood including the required ducting to the exterior of building.

Marjorie Russell Research Center – FCA Building #0208  
Description: Breakroom Remodel and Exhaust Ventilation Recommended.

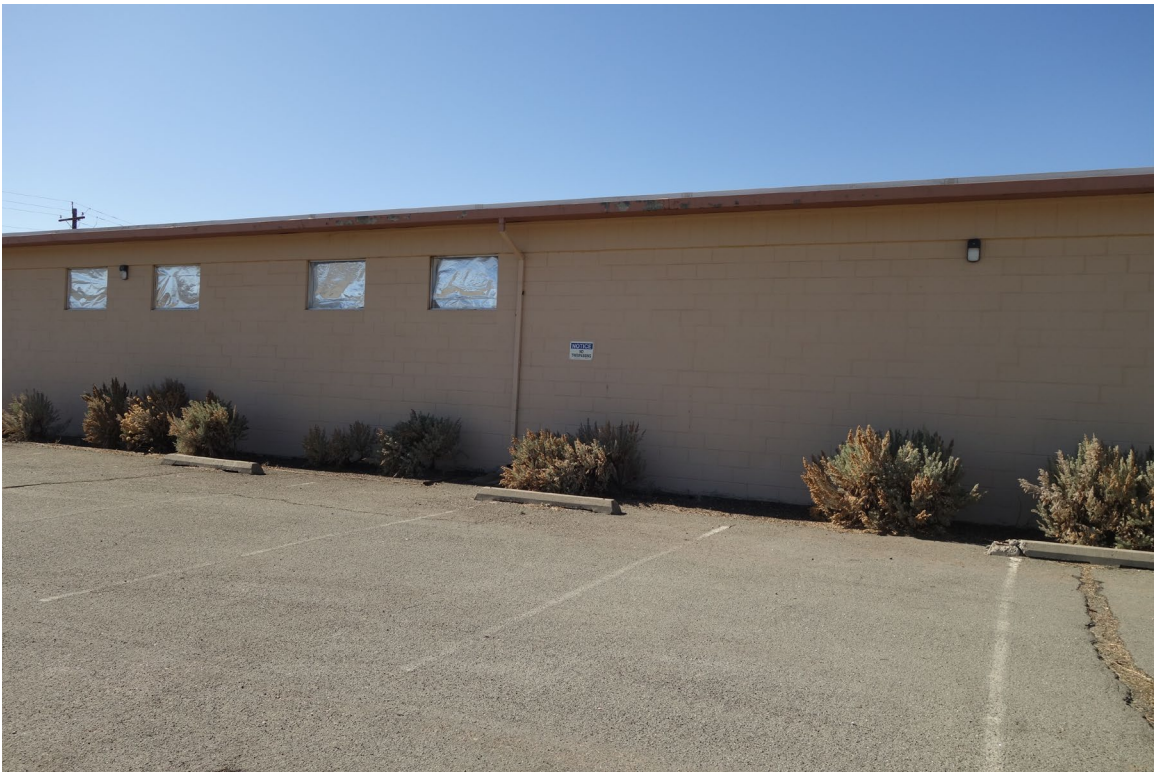
The building is constructed of concrete masonry units (CMU) with no insulation. The windows are original to the building, and of single pane construction. Buildings of this type are not energy efficient. This project recommends adding an exterior insulation and finish system (EIFS) over the CMU, replacing the storefront window systems and doors with a dual pane insulated storefront window system and removing and replacing the windows in the rear of the building. This work will make the building more energy efficient.

Marjorie Russell Research Center – FCA Building #0208  
Description: Exterior Insulation & Finish (EIFS) & Window Replacement Needed.

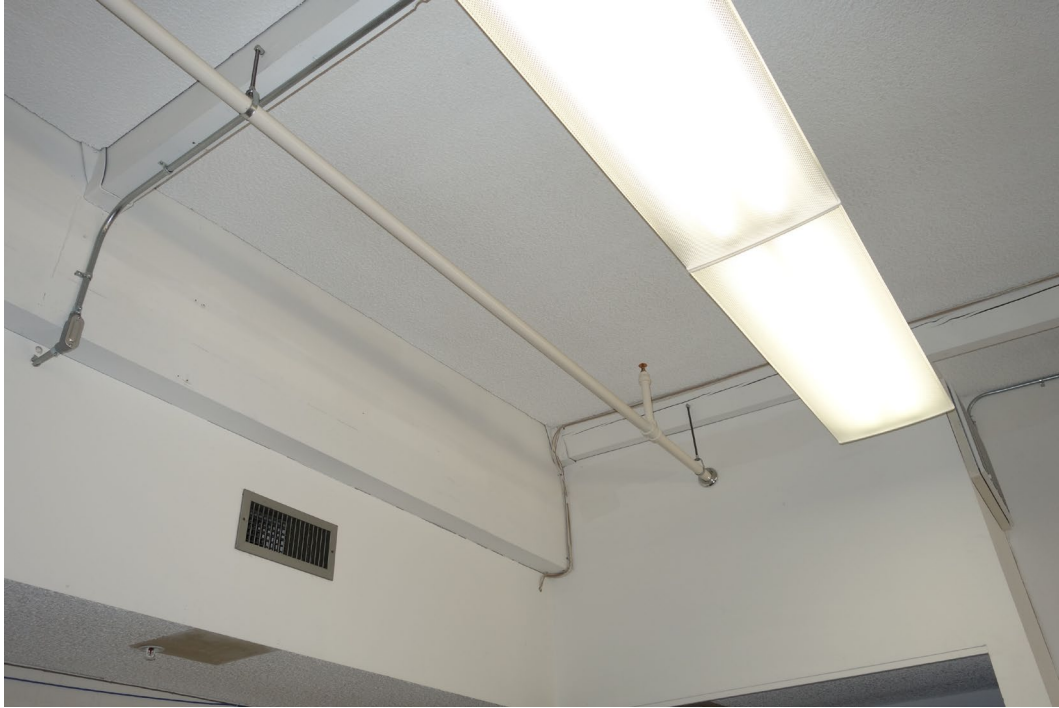
The existing lighting fixtures are the older fluorescent type and are not energy efficient. This project will upgrade fixtures to higher efficiency units with a longer life cycle. 5,000K LED lamps, without the ballasts are suggested, and new tombstones (if needed). Occupancy sensors will be installed in low occupancy areas for additional savings. Electrical wiring upgrades are not included in this estimate.

Marjorie Russell Research Center – FCA Building #0208  
Description: Interior LED Lighting Upgrade Recommended.

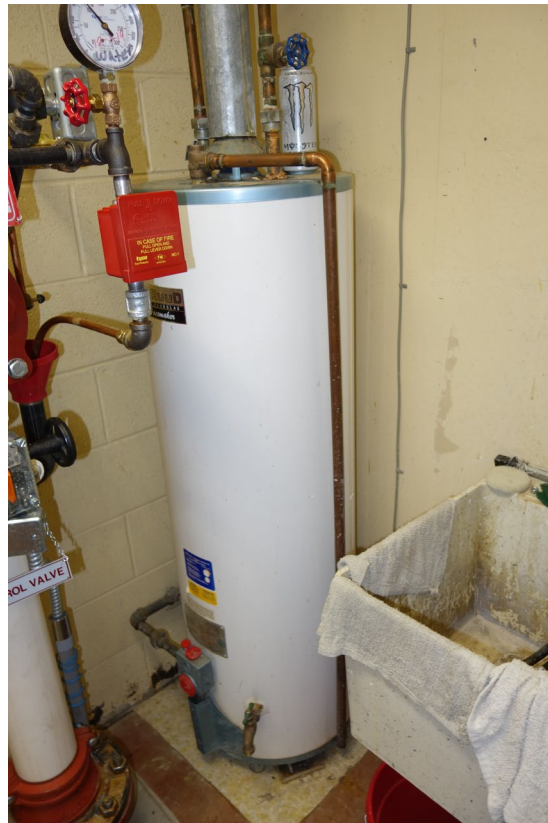
The water heater tank is showing signs of wear and deterioration. It appears this appliance is original to the building and has reached the end of its expected life. This project would provide for the purchase and installation of a new 75 gallon gas fired water heater tank including seismic bracing and drain pan. Removal and disposal of the existing tank is included in this estimate.

Marjorie Russell Research Center – FCA Building #0208  
Description: Water Heater Replacement Recommended.
