STATE OF NEVADA
STATE PUBLIC WORKS DIVISION

FACILITY CONDITION ASSESSMENT REPORT FOR:

DEPT OF EMPLOYMENT, TRAINING AND REHABILITATION
EMPLOYMENT SECURITY DIVISION

SITE #: 9853 STATE ADMIN OFFICE SITE
500 E 3RD ST
CARSON CITY, NV 89701-4722

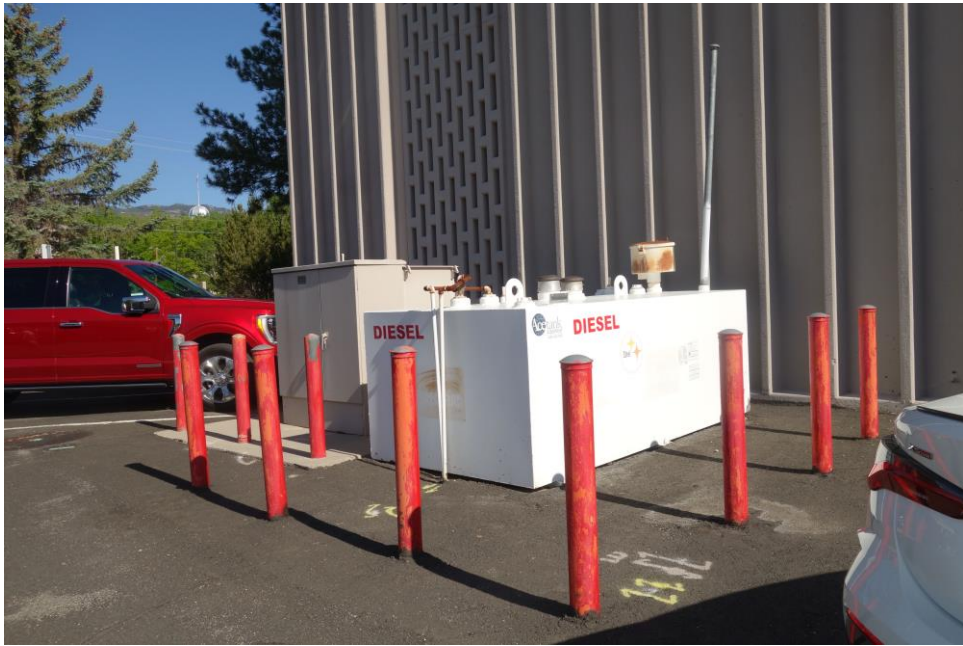
PRIORITY	3 - Four to Ten Years	
PROJECT #	9853ENV1 - ENVIRONMENTAL	STATUS	9/4/2024	NEW

REMOVAL OF ABANDONED EQUIPMENT

QUANTITY	UNITS	TOTAL	SF COST
A legacy backup generator and associated support equipment have been abandoned in place. The generator is located in the basement and the diesel fuel tank is located in the south parking lot. All of the equipment including the transfer switch have remained in place since the current generator was installed in 2012. All associated equipment should be removed to eliminate unnecessary environmental hazards such as engine coolants, batteries and diesel fuel.	1	Package	\$20,000.00	-

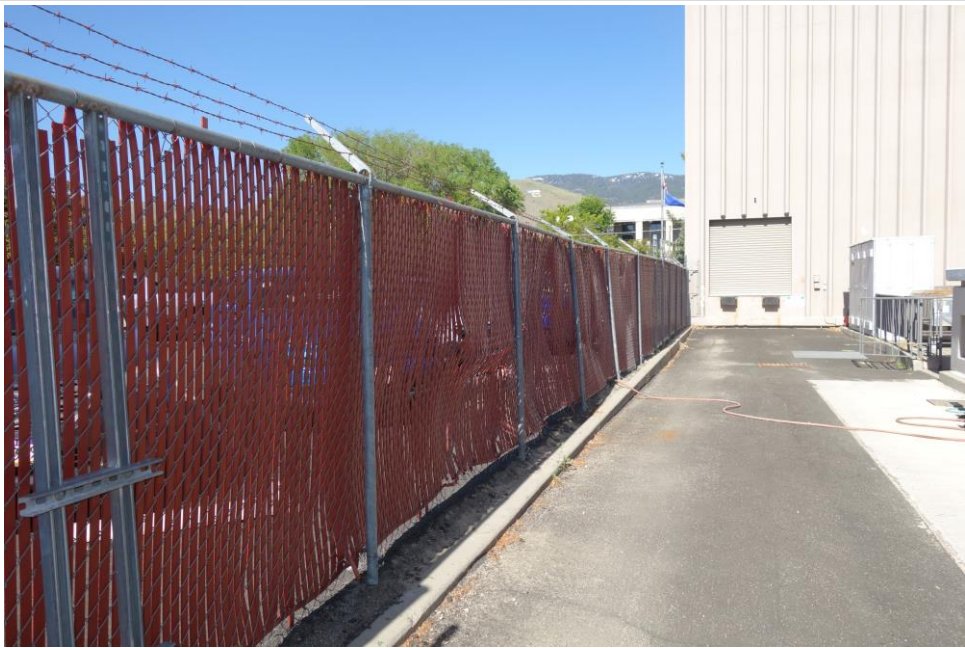
PRIORITY	3 - Four to Ten Years	
PROJECT #	9853SEC1 - SECURITY	STATUS	9/4/2024	NEW

SECURITY FENCING REPLACEMENT

QUANTITY	UNITS	TOTAL	SF COST
The perimeter security fencing protecting the loading dock is damaged. Possibly due to vehicle parking on the outside. This project recommends the replacement of the fencing and installation of wheel stops for the parking spaces located outside of the fence.	100	Linear Foot	\$10,000.00	-

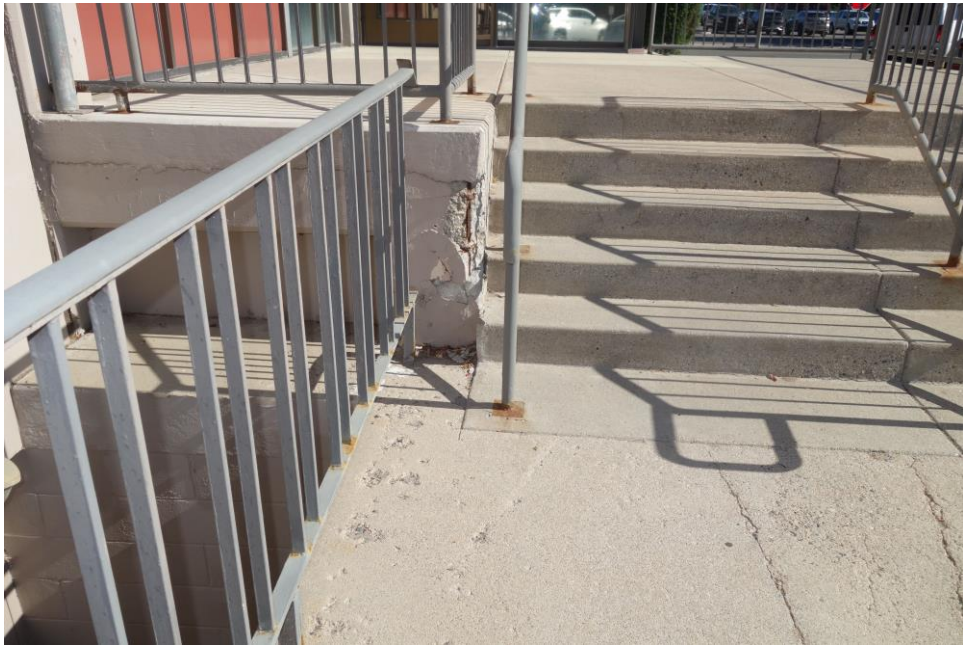
PRIORITY	3 - Four to Ten Years	
PROJECT #	9853SIT2 - SITE ISSUES	STATUS	9/4/2024	NEW

CONCRETE REPLACEMENT

QUANTITY	UNITS	TOTAL	SF COST
The concrete flatwork and stairs on the east side of the building are starting to fail. Vertical rebar is exposed at the stairs leading to the 1st floor east entrance. This project recommends a complete replacement of the stair landing, stairs and vertical concrete elements supporting the 1st floor entry landing.	1000	Square Foot	\$50,000.00	-

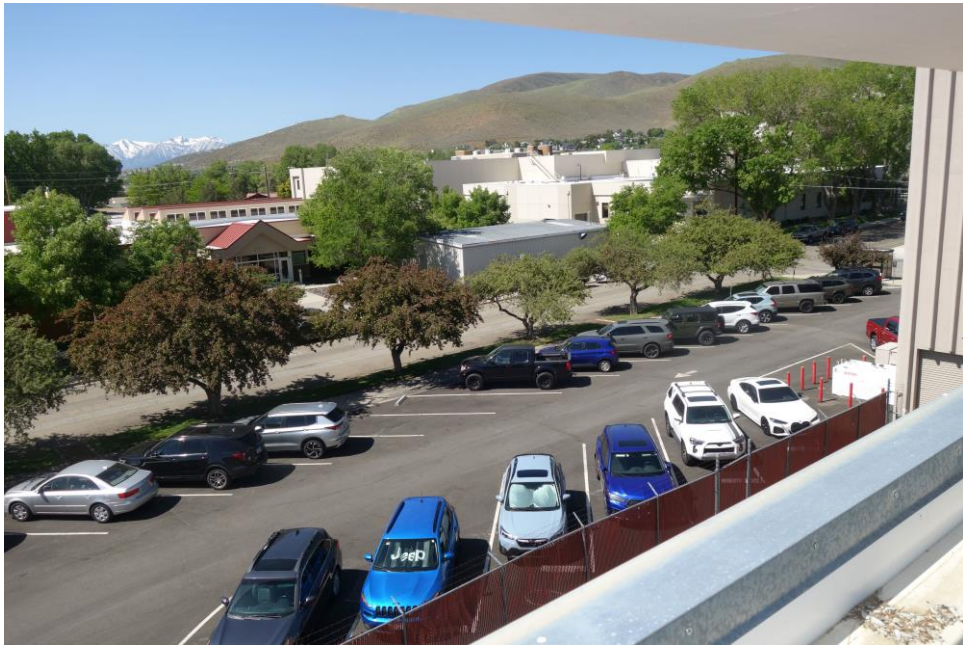
PRIORITY	3 - Four to Ten Years	
PROJECT #	9853SIT3 - SITE ISSUES	STATUS	9/4/2024	NEW

CRACK SEAL AND SLURRY SEAL

QUANTITY	UNITS	TOTAL	SF COST
The condition of the parking lot pavement was in the fair condition. It is important to maintain the asphalt concrete paving on the site. This project would provide for minor crack filling and sealing of the paving site wide including access roads, parking areas and driving test areas. Striping is included in this estimate. This project should be scheduled on a 5 year cyclical basis to maintain the integrity of the paving and prevent premature failure. 20,000 square feet of asphalt area was used to generate this estimate.	20000	Square Foot	\$21,600.00	-

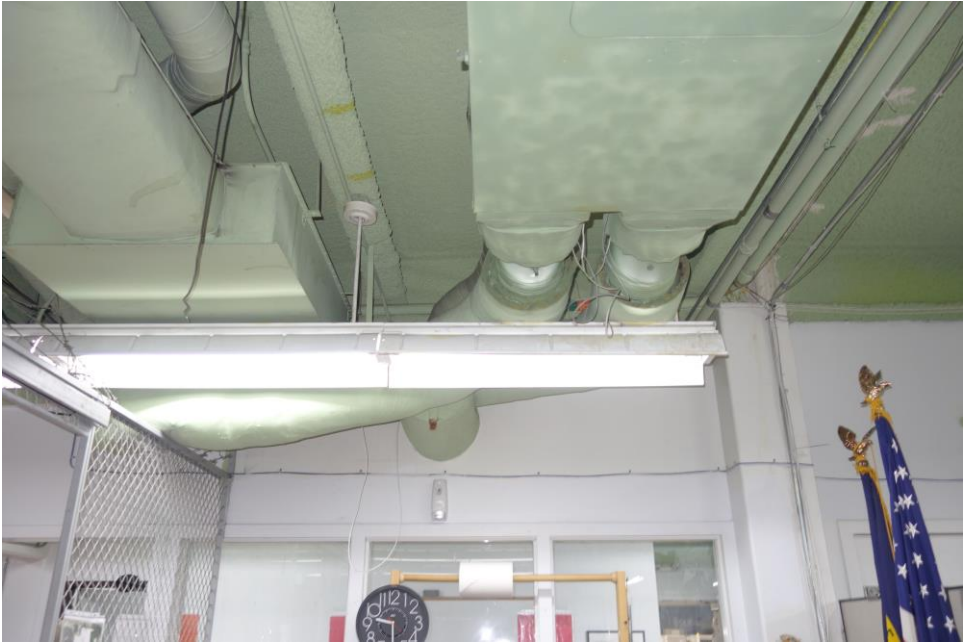
PROJECT #		0398ENV1 - ENVIRONMENTAL	PRIORITY	1 - Immediate to Two Years	
			STATUS	8/29/2024	NEW

ASBESTOS SURVEY

QUANTITY	UNITS	TOTAL	SF COST
<p>The building was constructed in 1960 and is known to contain asbestos containing materials (ACM) on the steel beam fire protection. The nature and extent of ACM is unknown. Due to the age of the building and extent of the recommended renovation, the entire building needs to be surveyed to identify all sources of ACM and other common hazards. The cost of abatement will be determined from the results of the survey and not included in this project.</p>	1	Package	\$20,000.00	\$ 1.00

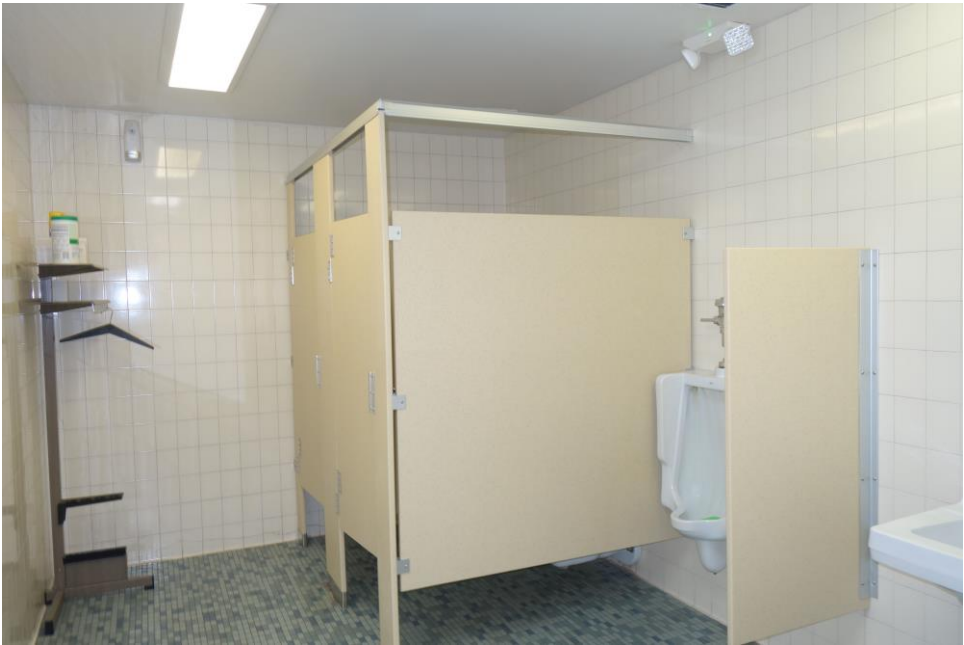
PRIORITY	3 - Four to Ten Years	
PROJECT #	0398ADA1 - ADA	STATUS	8/29/2024	NEW

BUILDING ADA IMPROVEMENTS

QUANTITY	UNITS	TOTAL	SF COST
<p>There is one accessible unisex restroom near the lobby on the first floor. The main restrooms on each floor are not ADA compliant and the building is lacking ADA compliant signage. This project recommends that the restrooms on each floor be refurbished in compliance with current accessible standards. This project would provide for restroom modifications including needed wall changes, new fixtures, and a sign package for the entire facility. The 2018 IBC, ICC/ANSI A117.1 - 2009, NRS 338.180 and the most current version of the ADA Standards For Accessible Design were used as a reference for this project.</p>	6	Each	\$300,000.00	\$ 10.00

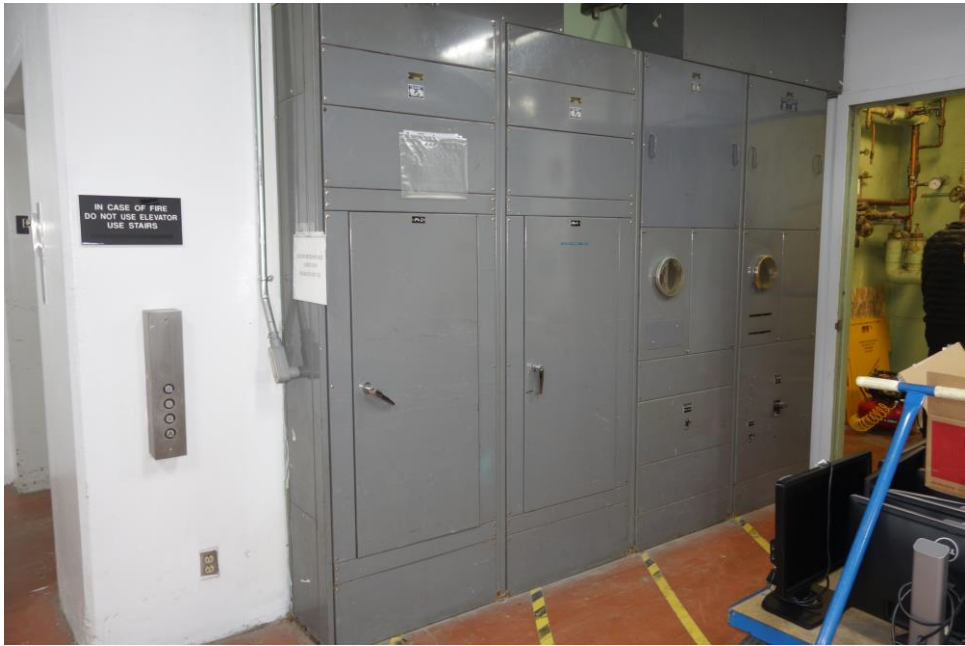
PRIORITY	3 - Four to Ten Years	
PROJECT #	0398ELE1 - ELECTRICAL	STATUS	8/29/2024	NEW

ELECTRICAL INFRASTRUCTURE REPLACEMENT

QUANTITY	UNITS	TOTAL	SF COST
This building is over 60 years old and the electrical system is not compliant with NFPA 70e. A complete replacement is recommended. In addition, interior lighting and lighting controls need replacement. This project would provide funding to replace the electrical system, lighting and communication systems. Electrical coordination and Arc Flash studies are also included in this project.	1	Package	\$3,103,700.00	\$ 100.00

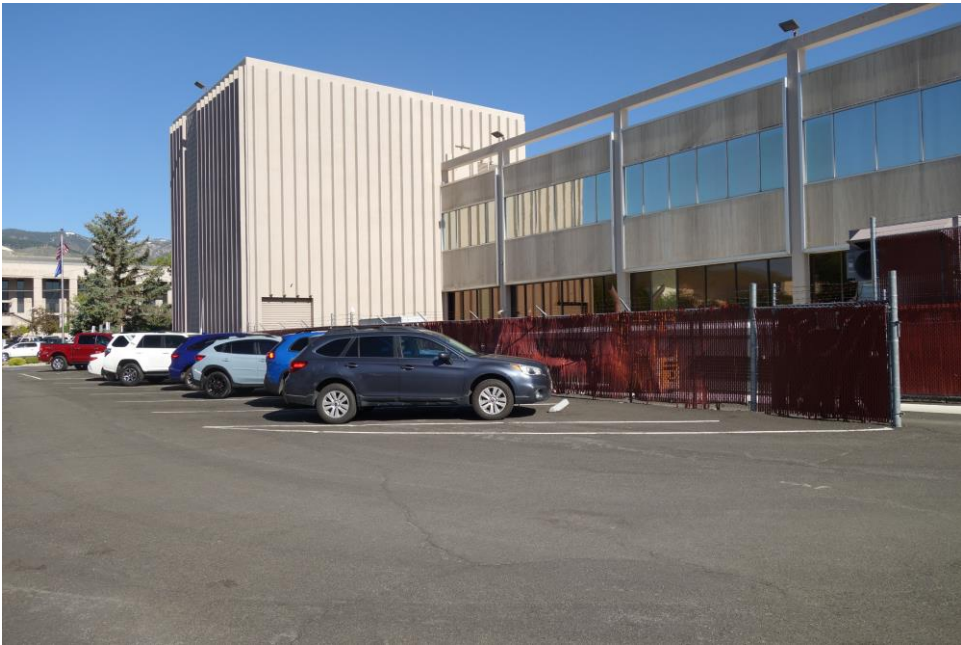
PRIORITY	3 - Four to Ten Years	
PROJECT #	0398EXT5 - BUILDING EXTERIOR	STATUS	4/23/2024	IN PROGRESS

TREATMENT OF EXTERIOR FINISHES

QUANTITY	UNITS	TOTAL	SF COST
It is important to maintain the finish, weather resistance and appearance of the building. This project includes items to protect the exterior building envelope other than the roof, including painting, staining, or other applied finishes, and sealant and gaskets in and around windows, flashing, fixtures, and other penetrations to maintain the building in good, weather tight condition.	30920	Square Foot	\$61,800.00	\$ 2.00

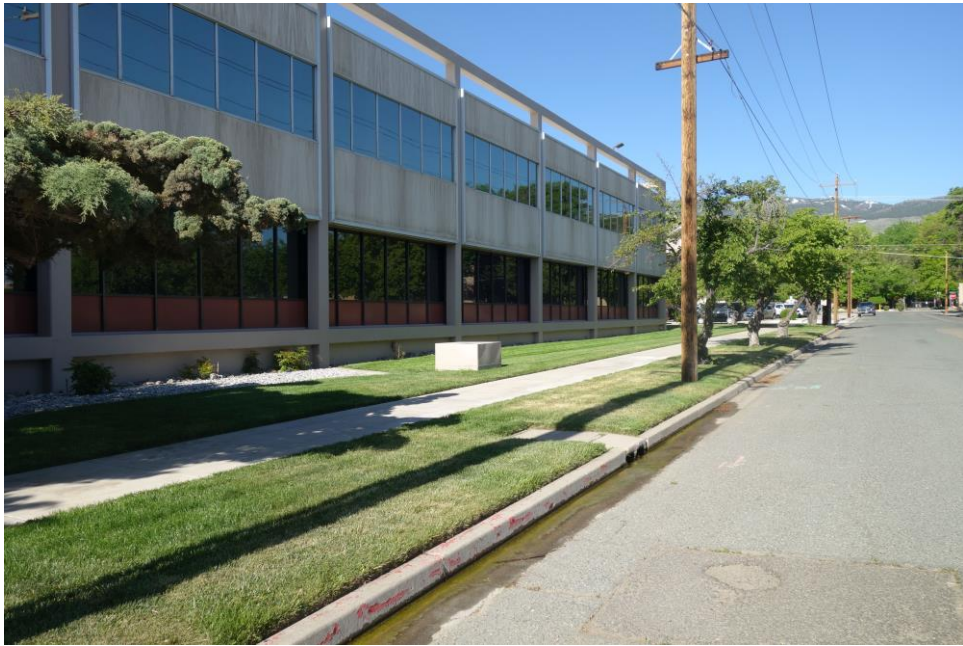
PRIORITY	3 - Four to Ten Years	
PROJECT #	0398EXT6 - BUILDING EXTERIOR	STATUS	9/3/2024	NEW

WINDOW REPLACEMENT

QUANTITY	UNITS	TOTAL	SF COST
The second floor windows are a single pane storefront system that are not thermally efficient. The first floor glazing is original and reaching the end of its useful life. This project recommends the replacement of glazing systems on both floors to create a high efficiency modern building exterior.	1728	Square Foot	\$850,000.00	\$ 27.00

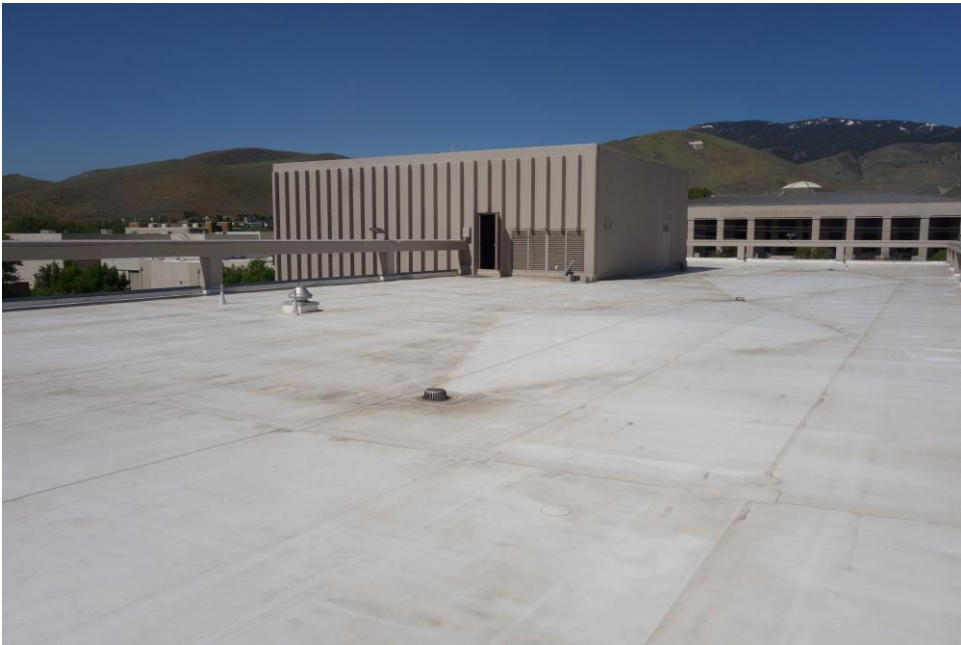
PRIORITY	3 - Four to Ten Years	
PROJECT #	0398EXT7 - BUILDING EXTERIOR	STATUS	9/4/2024	NEW

ROOF REPLACEMENT

QUANTITY	UNITS	TOTAL	SF COST
The roof on this building was in fair condition at the time of the survey. The statewide roofing program has set the useful life of an average roof at 20 - 25 years. The roof warranty expires during that time frame. Temperature fluctuations throughout the year, consistent wind which blows sand and dirt on to the roof membrane, and constant exposure to the sun are contributing factors to wear and deterioration. The current roofing system was installed in 2001 with a 15 year warranty. Based on the expected roofing lifespan, it is recommended that this building be re-roofed in the next 4 - 6 years to be consistent with the roofing program.	11000	Square Foot	\$242,000.00	\$ 8.00

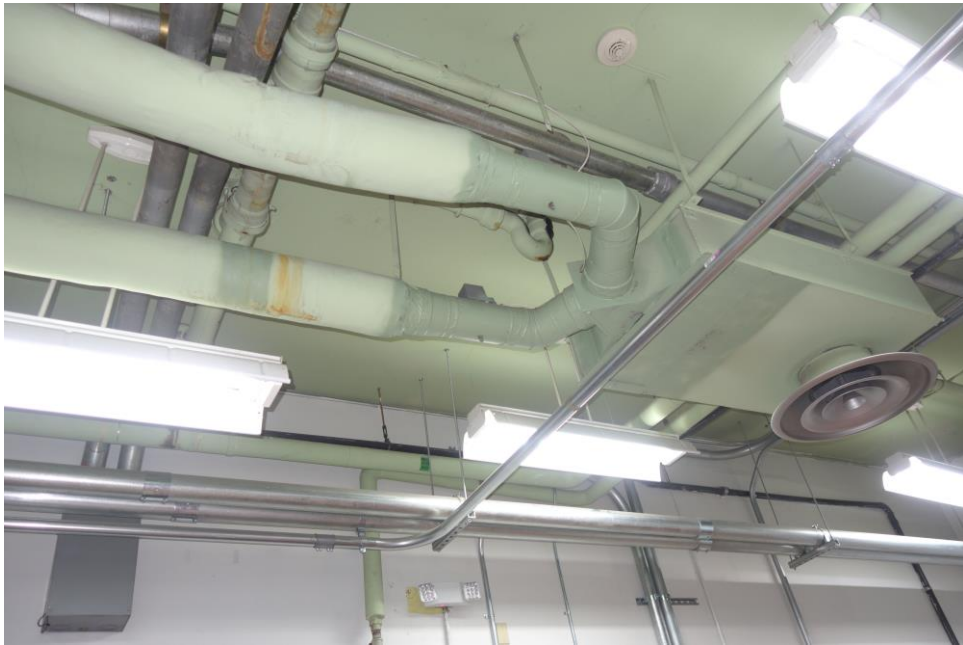
PRIORITY	3 - Four to Ten Years	
PROJECT #	0398HVA1 - HVAC	STATUS	8/29/2024	NEW

HVAC REPLACEMENT

QUANTITY	UNITS	TOTAL	SF COST
The building is equipped with a dual duct central heating and air conditioning system that is original to the building and approaching 65 years of operation. The control system is a mix of digital and pneumatic. The central plant equipment has been replaced, however, the air handling systems (including the heating and cooling coils) and all air distribution are original. A complete replacement of the air distribution system and upgrading the HVAC control system to direct digital controls (DDC) is recommended.	30920	Square Foot	\$2,763,500.00	\$ 89.00

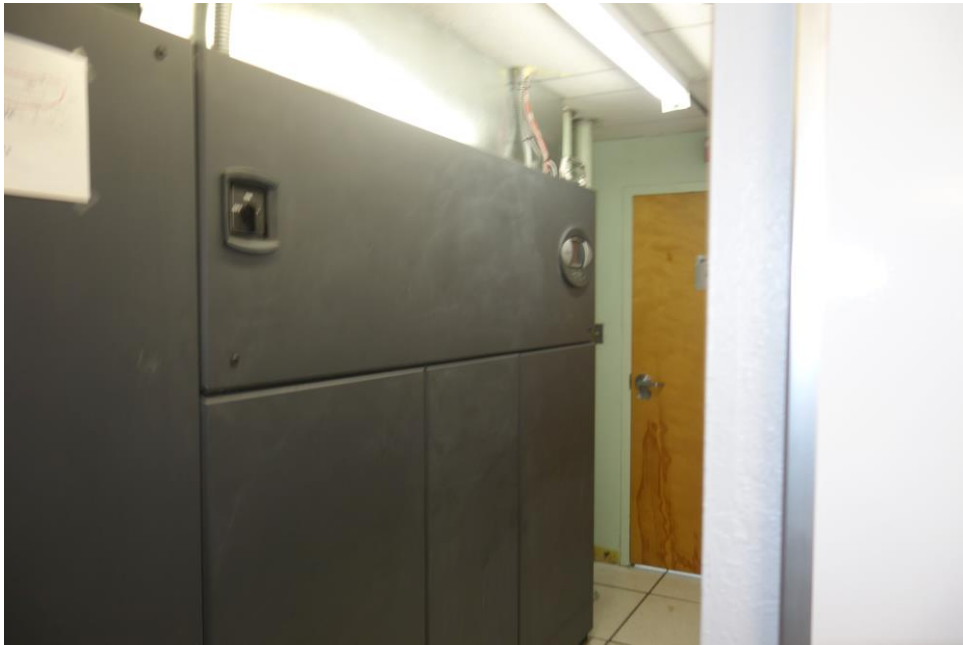
PRIORITY	3 - Four to Ten Years	
PROJECT #	0398HVA2 - HVAC	STATUS	9/3/2024	NEW

COMPUTER ROOM HVAC REPLACEMENT

QUANTITY	UNITS	TOTAL	SF COST
The computer room HVAC system was replaced in 2007. Typical life cycle for mechanical systems is 20 - 25 years. This project recommends a complete replacement of the HVAC systems including the piping in the next 6 - 8 years.	400	Square Foot	\$413,200.00	\$ 13.00

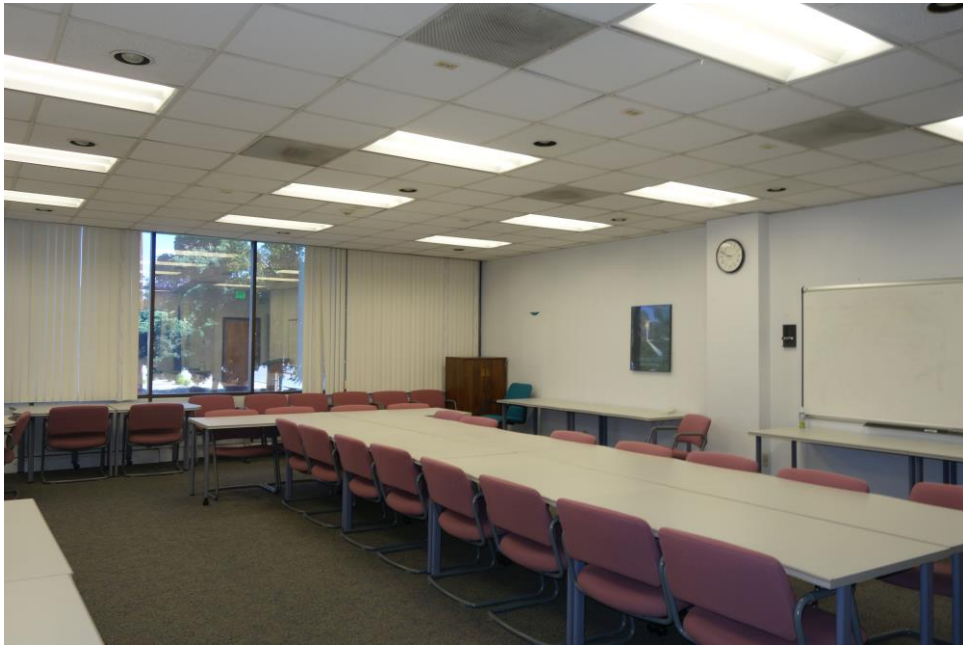
PROJECT #		0398INT5 - BUILDING INTERIOR	PRIORITY	3 - Four to Ten Years	
			STATUS	8/29/2024	NEW

CEILING GRID & TILE REPLACEMENT

QUANTITY	UNITS	TOTAL	SF COST
Much of the ceiling grid and tile in the facility is old and needs replacement. In addition, prior to the recommended demolition of the HVAC distribution, plumbing and electrical systems, the existing ceiling grid and tile must be removed and replaced once the infrastructure work is complete. This project includes miscellaneous repairs of interior walls, demolition and replacement of the ceiling grid.	30920	Square Foot	\$711,200.00	\$ 23.00

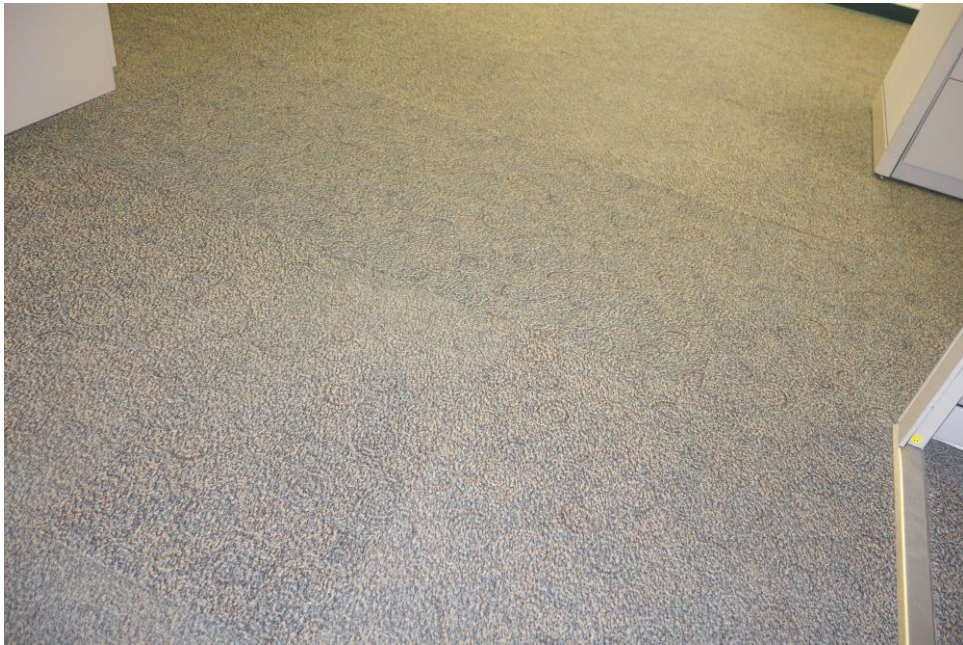
PRIORITY	3 - Four to Ten Years	
PROJECT #	0398INT6 - BUILDING INTERIOR	STATUS	8/29/2024	NEW

FLOORING REPLACEMENT

QUANTITY	UNITS	TOTAL	SF COST
Due to the recommended demolition of the HVAC and electrical systems, the existing flooring must be removed and replaced. This project provides for demolition, miscellaneous floor repairs, and replacement of all flooring.	30920	Square Foot	\$494,700.00	\$ 16.00

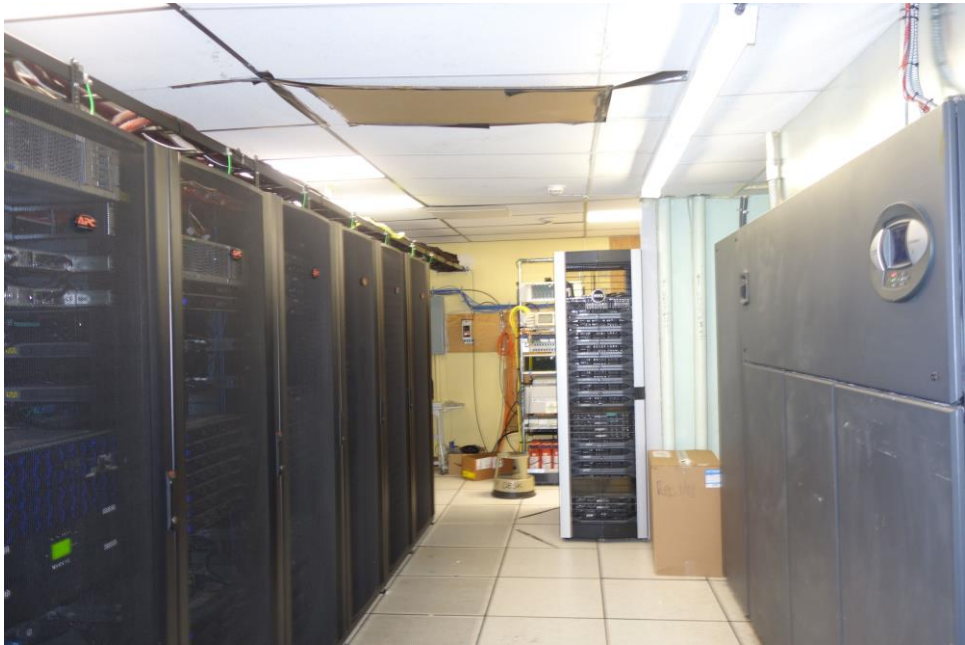
PRIORITY	3 - Four to Ten Years	
PROJECT #	0398INT7 - BUILDING INTERIOR	STATUS	9/3/2024	NEW

COMPUTER ROOM REFURBISHMENT

QUANTITY	UNITS	TOTAL	SF COST
The interior finishes of the computer room was in poor condition. Ceiling tiles were missing or broken, wall finishes were faded and wire management in need of cleanup. Additionally, a critical element of efficient server cooling is air management via the perforated floor tile. Other than the perforated floor tiles, it is recommended that all raised floor tile penetrations be sealed and damaged floor tiles be replaced to ensure that all air flow is directed to the intake of the computer servers.	400	Square Foot	\$40,000.00	\$ 1.00

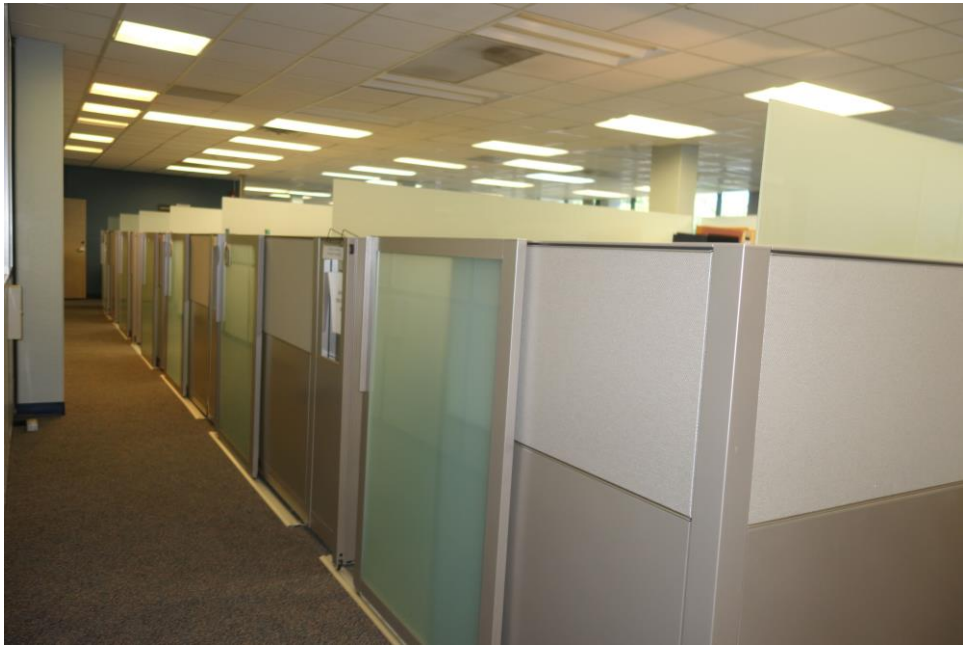
PRIORITY	3 - Four to Ten Years	
PROJECT #	0398INT8 - BUILDING INTERIOR	STATUS	9/3/2024	NEW

INTERIOR FINISHES

QUANTITY	UNITS	TOTAL	SF COST
The interior finishes were in fair condition. It is recommended the interior walls and ceilings be painted in the next 6 -8 years. All surfaces should be repaired and prepped prior to painting. For durability in wet areas, an epoxy-based paint should be used. Building maintenance should be scheduled on a cyclical basis to maintain the integrity of the structure.	30920	Square Foot	\$309,200.00	\$ 10.00

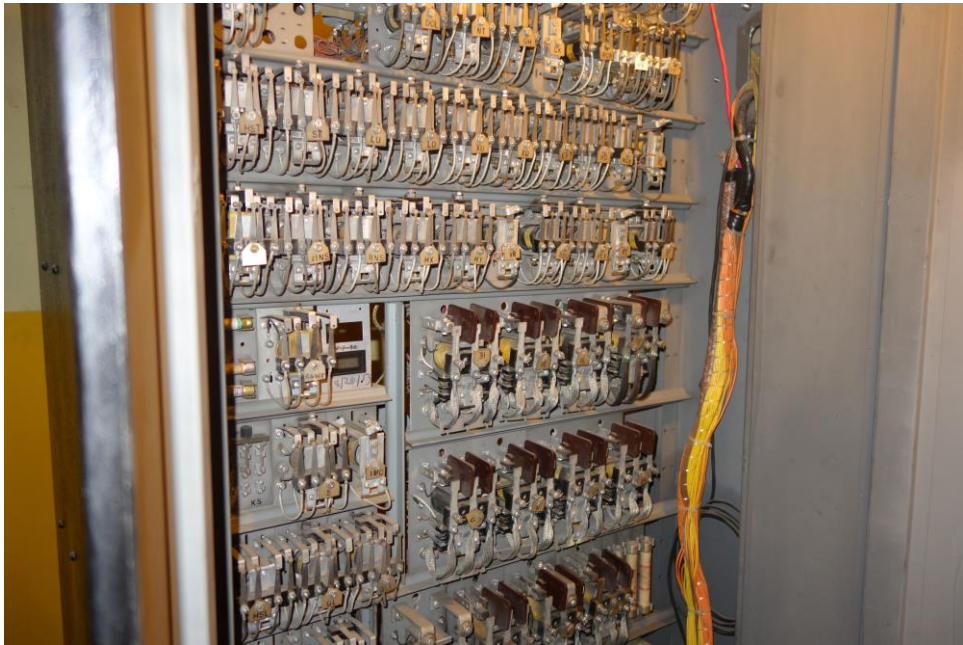
PRIORITY	3 - Four to Ten Years	
PROJECT #	0398INT9 - BUILDING INTERIOR	STATUS	9/10/2024	NEW

ELEVATOR REFURBISHMENT

QUANTITY	UNITS	TOTAL	SF COST
The elevator is original to the building and appears to be well maintained. However, the elevator does not appear to be in compliance with current safety regulations and replacement controls and other components are very difficult to purchase. This project recommends a complete refurbishment of the elevator and controls to bring the system up to current standards.	1	Package	\$630,000.00	\$ 20.00

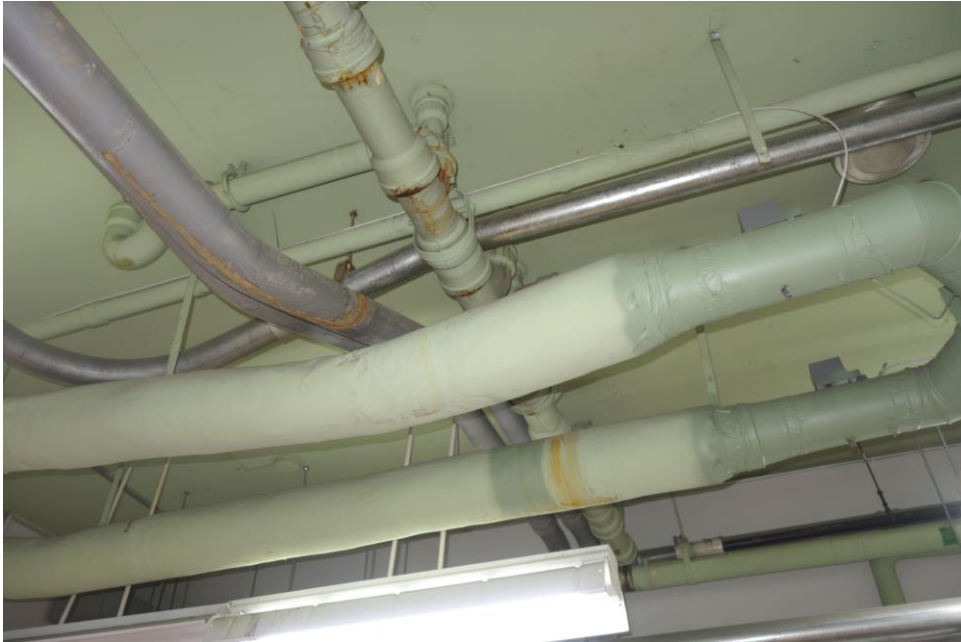
PROJECT #	0398PLM2 - PLUMBING	PRIORITY	3 - Four to Ten Years
		STATUS	9/3/2024 NEW

PLUMBING REPLACEMENT

QUANTITY	UNITS	TOTAL	SF COST
The building plumbing system is original to the building approaching 65 years of age. The waste and vent system is cast iron hub connected system with visible exterior corrosion. The domestic water piping is a mix of copper and galvanized. This project recommends extensive testing of the plumbing and waste systems to determine the remaining life span. The estimated cost of replacing the entire system is included in this estimate.	1	Package	\$787,700.00	\$ 25.00

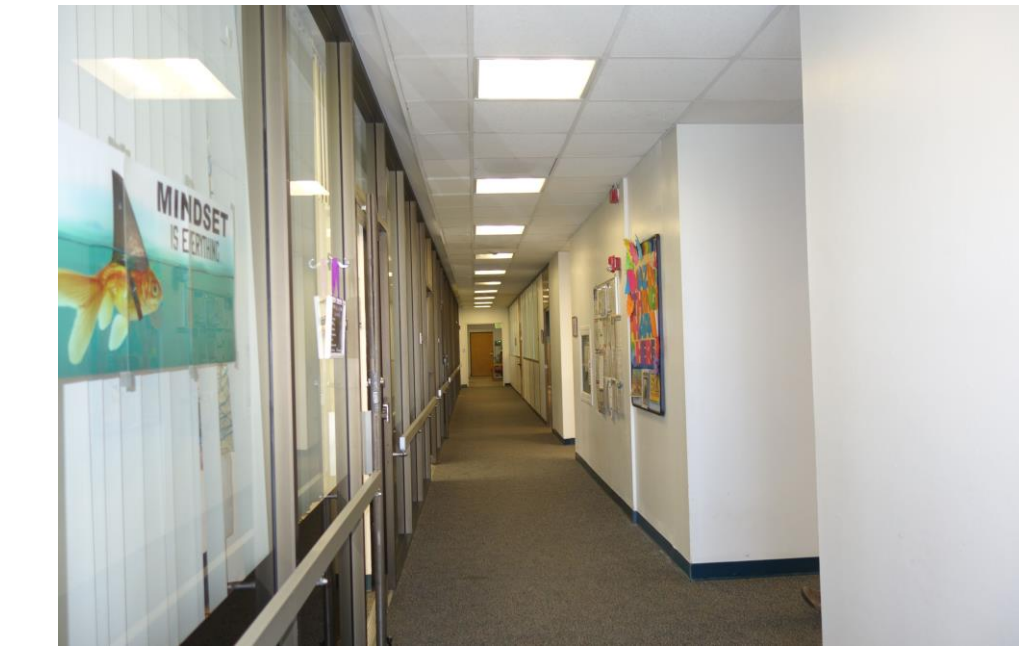
PROJECT #	0398SFT2 - SAFETY ISSUES	PRIORITY	3 - Four to Ten Years
		STATUS	8/29/2024 NEW

FIRE SPRINKLER INSTALLATION

QUANTITY	UNITS	TOTAL	SF COST
This building exceeds 24,000 square feet on all floors. Pursuant to the Nevada State Fire Marshal Regulation, NAC 477.915 1.(c)(1) states, that every building owned or occupied by the state regardless of occupancy having a floor area greater than 12,000 square feet on any floor or 24,000 square feet on all floors or is an "R" occupancy, must have sprinklers installed when the building is remodeled or an addition is proposed. This project would provide funding for the installation of a fire sprinkler system and backflow prevention when the building is remodeled including the basement and 3rd floor mezzanine.	30920	Square Foot	\$834,800.00	\$ 27.00
