State of Nevada  
Department of Administration  
Enterprise Information Technology Services  
Facility Condition Analysis

# **DATA CENTER SITE**

575 East 3rd Street  
Carson City, Nevada 89701

**Site Number: 9855**  
**STATE OF NEVADA PUBLIC WORKS DIVISION**  
**FACILITY CONDITION ANALYSIS**

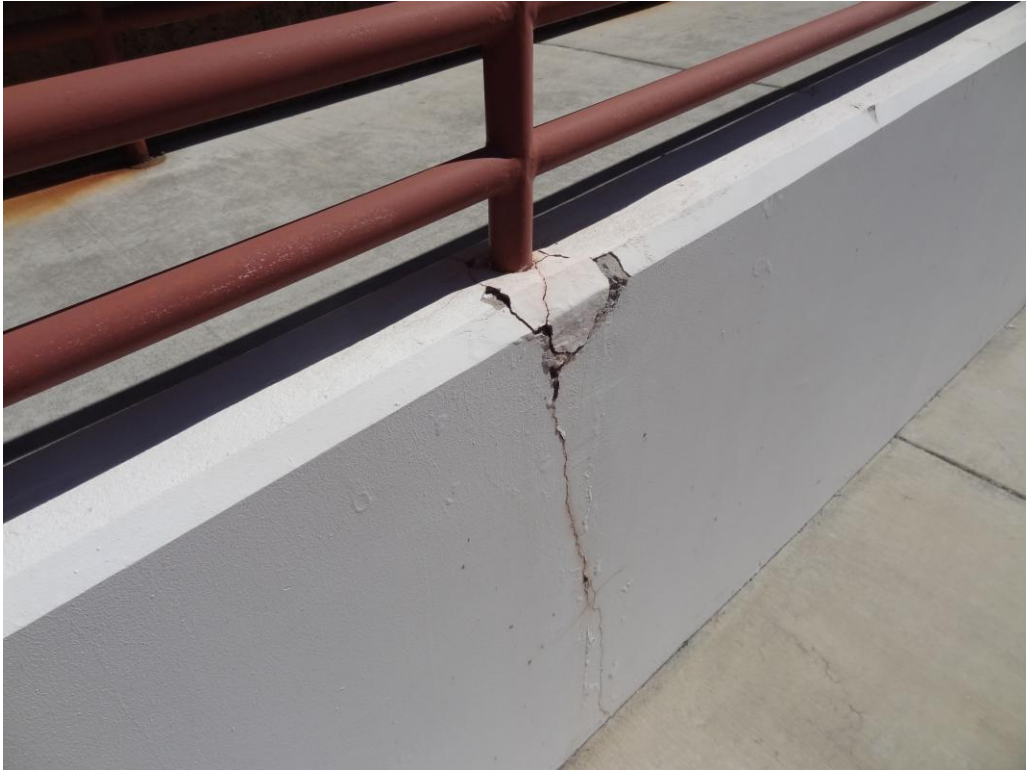
Data Center Site – FCA Site #9855  
Description: Damaged concrete at exterior ramp.

In order to comply with current Americans with Disabilities Act (ADA) requirements, modifications will be necessary for the ADA ramp and stairs on the south side of the building. The standards for a ramp require a 36" clear space. Currently, the handrails encroach on this clearance and reduce the clear space to less than 32". The concrete on the stairs and the ramp is deteriorating. Spalling and cracking have occurred. Exposure to the elements is a contributing factor. This project recommends modifying the steel handrails to comply with ADA guidelines, repairing the concrete on the ramp, and replacing the concrete stairs. The 2012 IBC, ICC/ANSI A117.1 - 2009, NRS 338.180 and the most current version of the ADA Standards For Accessible Design were used as a reference for this project.

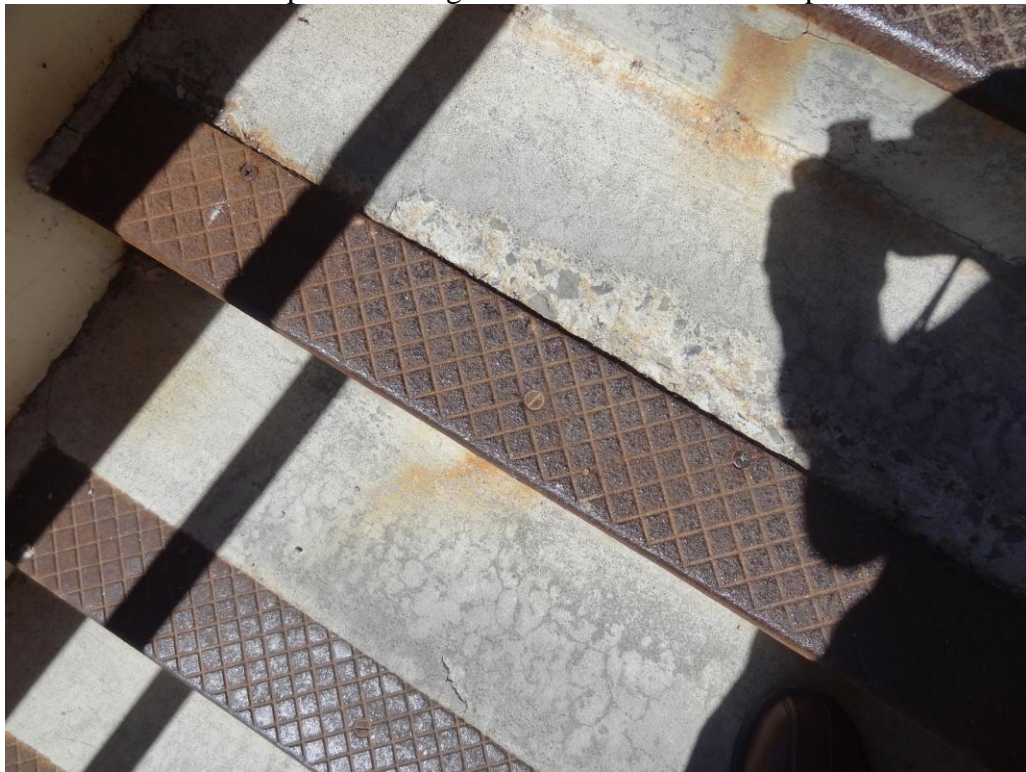
Data Center Site – FCA Site #9855  
Description: Concrete on exterior stairs has deteriorated.

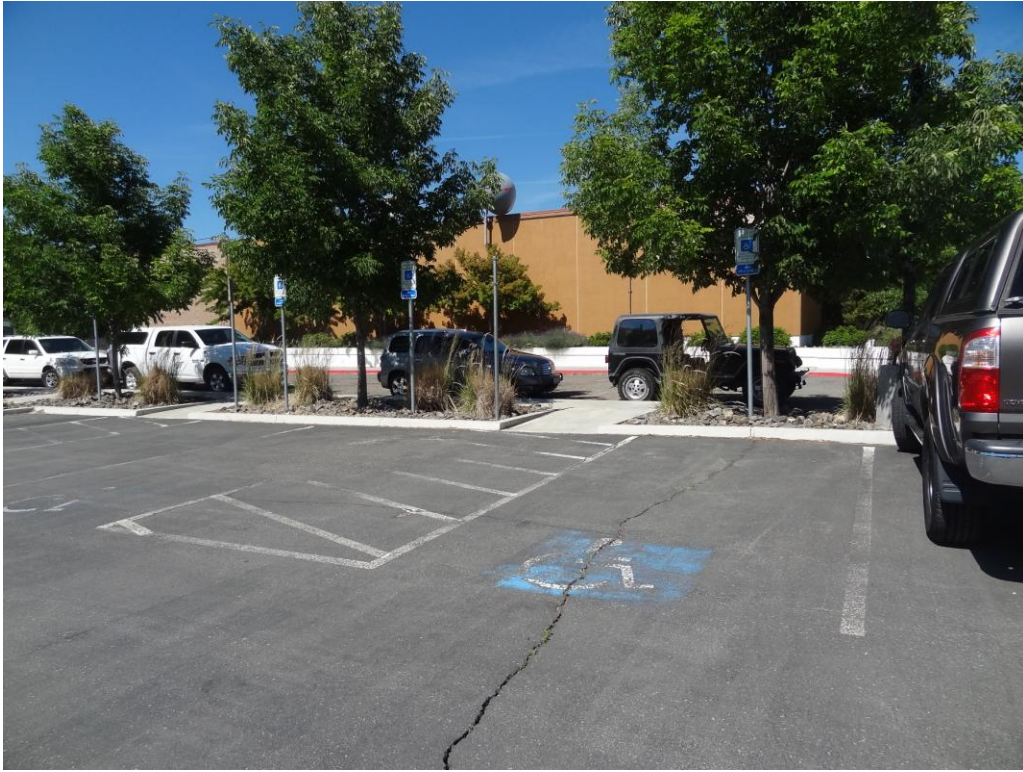
Description: ADA parking missing signage at loading zone and has faded striping.

The Americans with Disabilities Act (ADA) provides for accessibility to sites and services for people with physical limitations. The ADA parking area and passenger loading area are missing proper signage and striping to comply with ADA requirements. There is a missing "No Parking" sign at the ADA parking area and the striping has faded. This project would provide for striping, purchase and installation of the sign, and any other necessary upgrades to the parking area. The 2012 IBC, ICC/ANSI A117.1 - 2009, NRS 338.180 and the most current version of the ADA Standards For Accessible Design were used as a reference for this project.

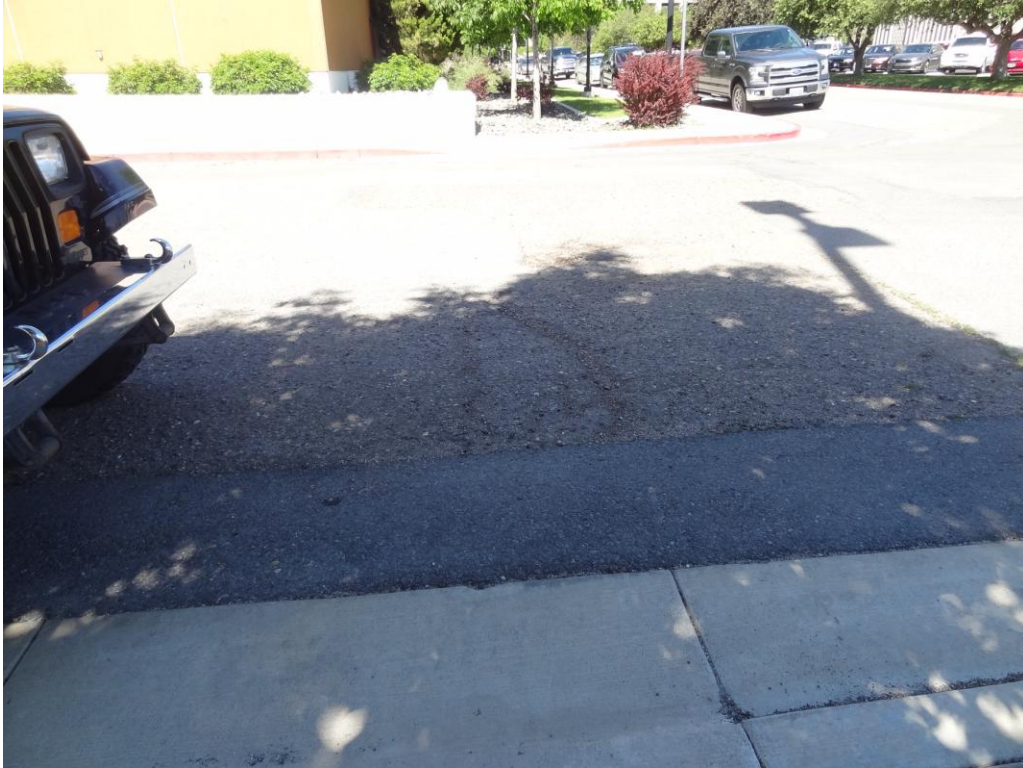
The Data Center site is located on the corner of East Third Street and South Valley Street in Carson City. There is a large paved parking area to the east with ADA compliant parking spaces. The ADA route of travel to the building is interrupted by East Fourth Street which has non-compliant slopes and potholes. The site is served by city water with backflow prevention, city sewer, natural gas, and electrical service.

Description: ADA path of travel across street is non-compliant.

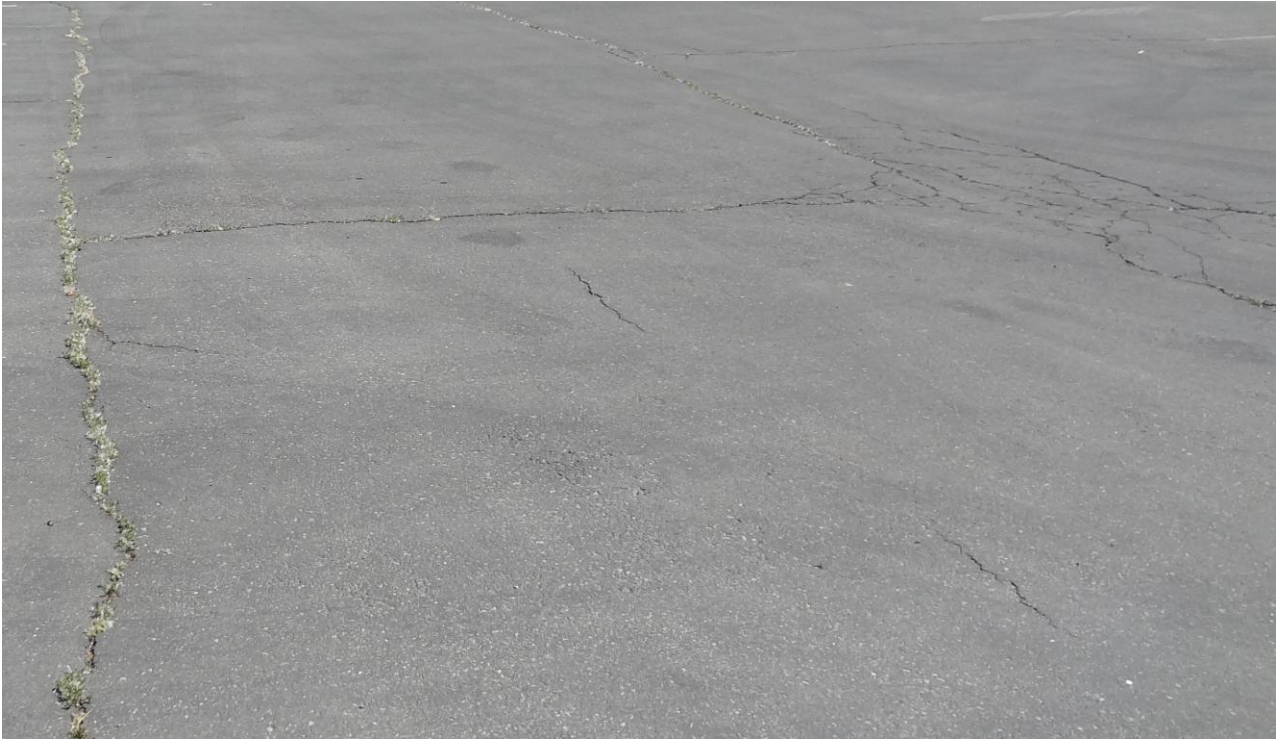
Data Center Site – FCA Site #9855  
Description: Asphalt paving is cracked and alligatored.

It is important to maintain the asphalt paving on the site. This project would provide for minor crack filling and striping of the parking lot. This project should be scheduled within 2-3 years to maintain the integrity of the paving and prevent premature failure.

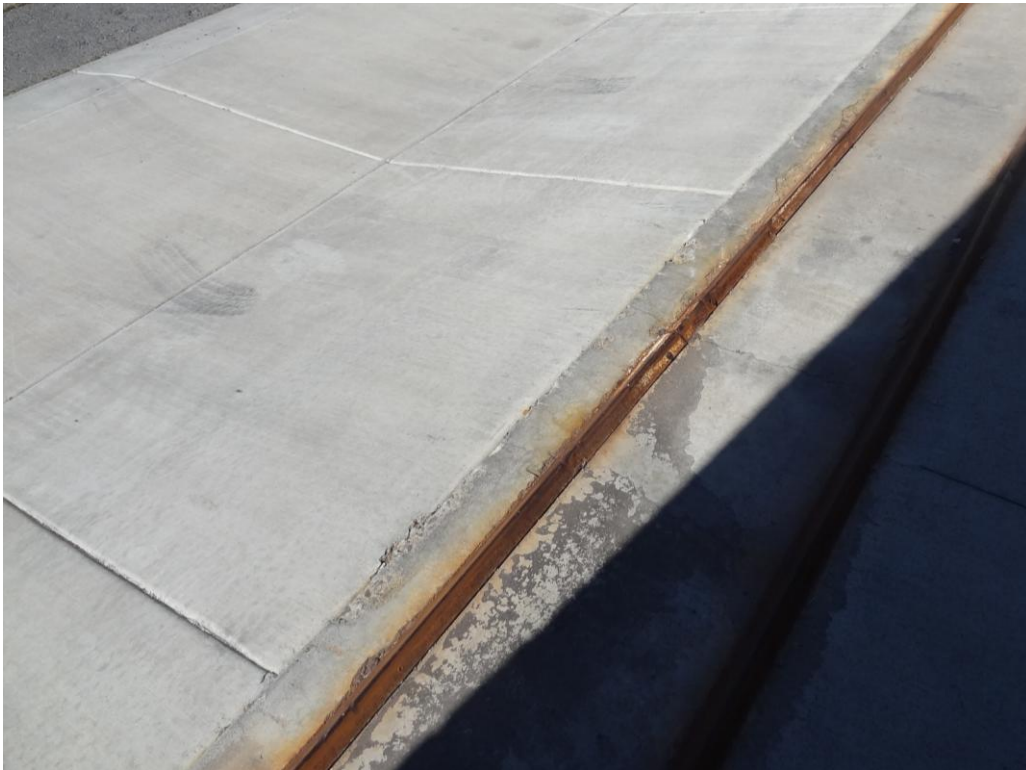
The concrete apron leading up to the loading dock is dysfunctional in its current configuration. The slope from the sidewalk to the gate is too steep causing vehicles to scrape bumpers and hitches on it. When trucks pull up to the dock, they are too high and there is no dock leveler. There is not enough space for most trucks to turn and back up in the street adjacent to the loading area. These issues have caused many delivery companies to refuse to use the ramp requiring the staff to unload in the street. It is recommended to procure engineering services to re-design the approach to the loading dock to ensure a functional system. This project would provide for the removal and disposal of the concrete from the sidewalk to the loading dock, re-grading and installing a total of 1,000 square feet of new concrete, removing and re-installing the automatic gate, and installing a new dock leveler.

Data Center Site – FCA Site #9855  
Description: Extreme slope on approach to loading dock.

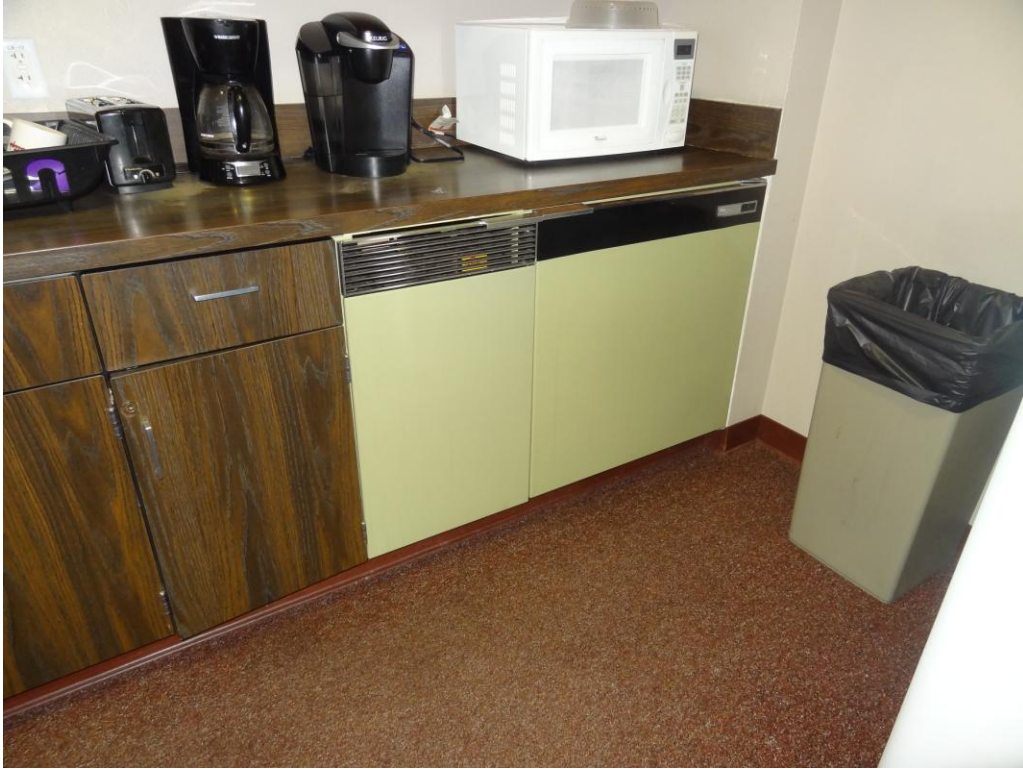
One of the break rooms in the building dates back to the original construction in 1970. The quality of construction and installation were inadequate for the high usage at this facility, and the cabinets and countertops are delaminating and failing. This project recommends the replacement of the existing countertops, cabinets, and associated equipment with heavy duty, quality components. The cabinets should be finished inside and outside with a melamine or similar finish which encapsulates the door, frame, and shelving. The countertops should be constructed of a highly durable product, such as stainless steel, over a moisture resistant underlayment to minimize swelling and damage from water exposure. ADA compliance according to NRS 338.180, IBC - 2012, ICC/ANSI A117.1 - 2009 and the most current version of the ADA Standards for Accessible Design should be incorporated into the design such as providing an accessible sink. This estimate includes removal and disposal of the existing materials.

Data Center – FCA Building #0393  
Description: Original employee break room.

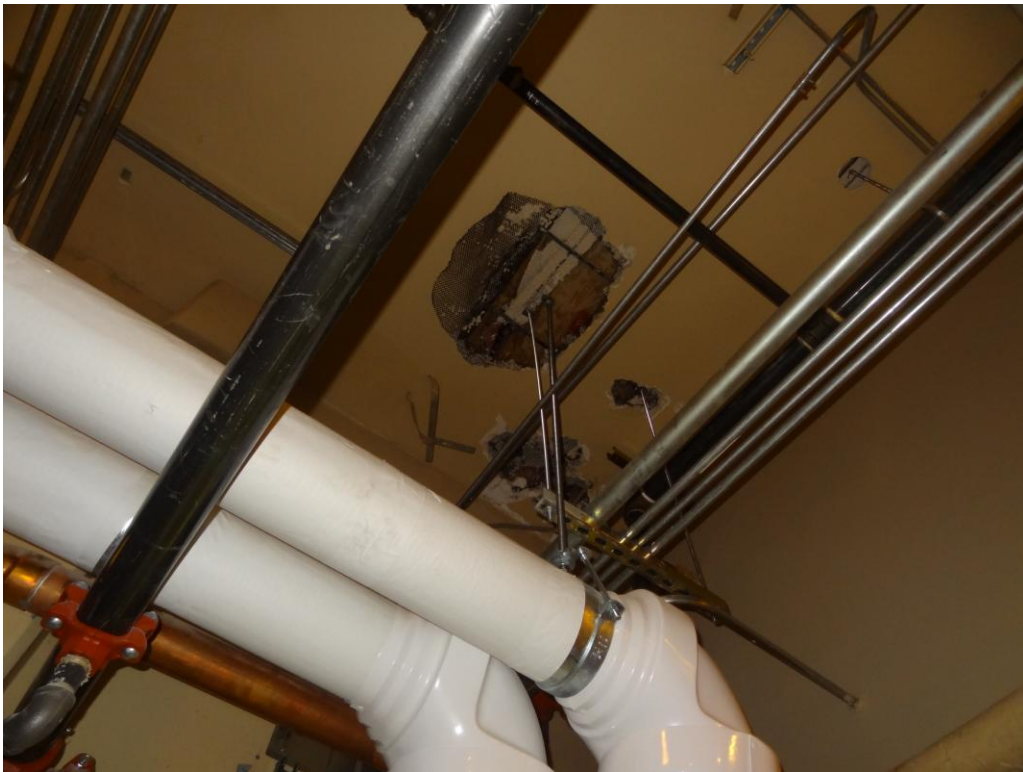
Data Center – FCA Building #0393  
Description: Fire-rated ceiling in Mechanical Room is damaged.

There are voids in the lath and plaster ceiling in the mechanical room that need to be repaired. This project recommends patch and repair of all holes in the ceiling.

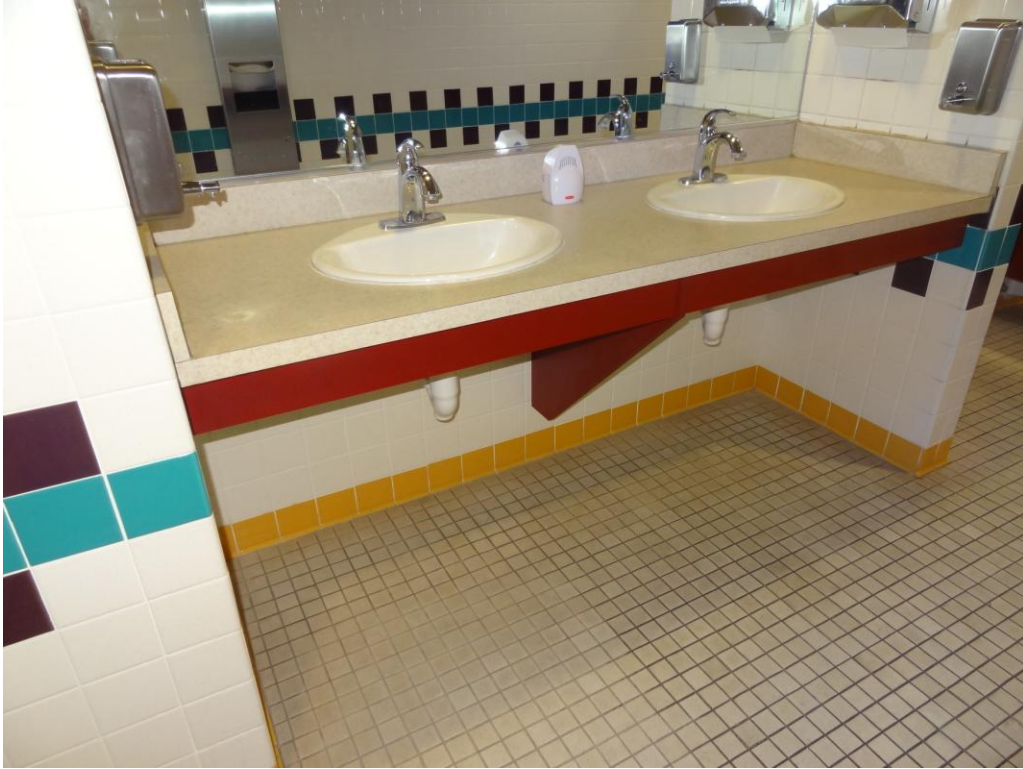
Data Center – FCA Building #0393  
Description: 2"x 2" original floor tile in restrooms.

The 2"x2" floor tiles in the restrooms are reaching the end of their useful life. It is recommended that the flooring be replaced. This project would provide for removal and disposal of the existing flooring and installation of new 12"x12" tiles within the next 2-3 years.

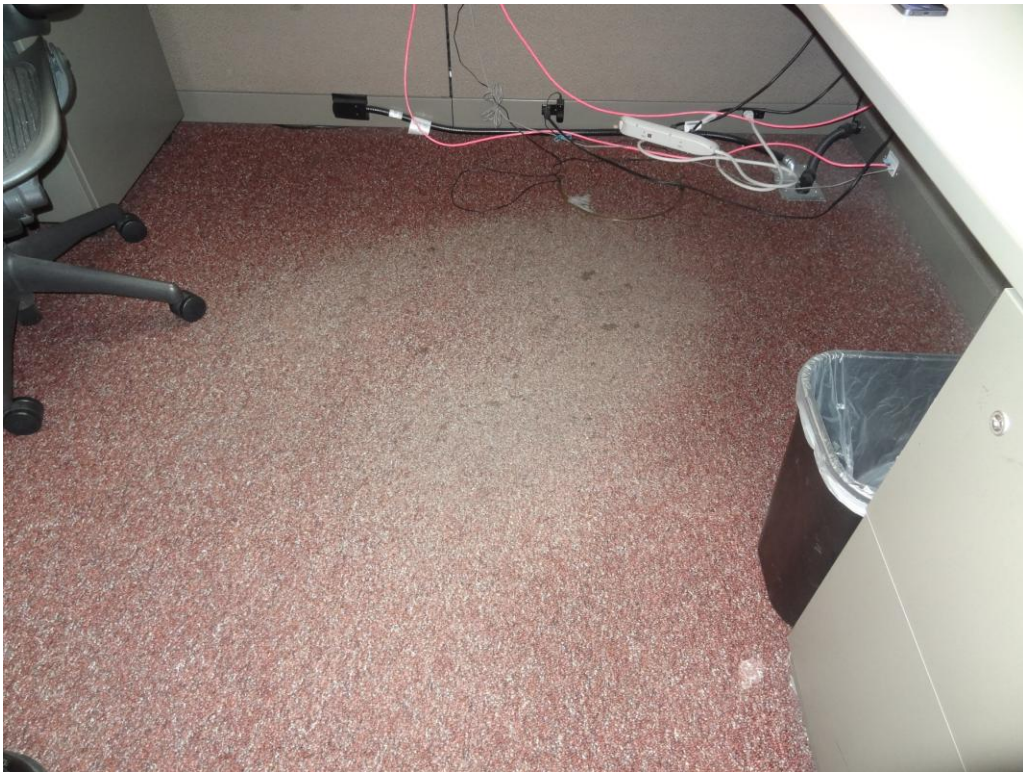
Data Center – FCA Building #0393  
Description: Typical condition of carpet.

The carpet in the building is showing signs of extreme wear and should be scheduled for replacement. It is recommended that the carpet be replaced with heavy duty commercial grade carpet in the next 2-3 years.

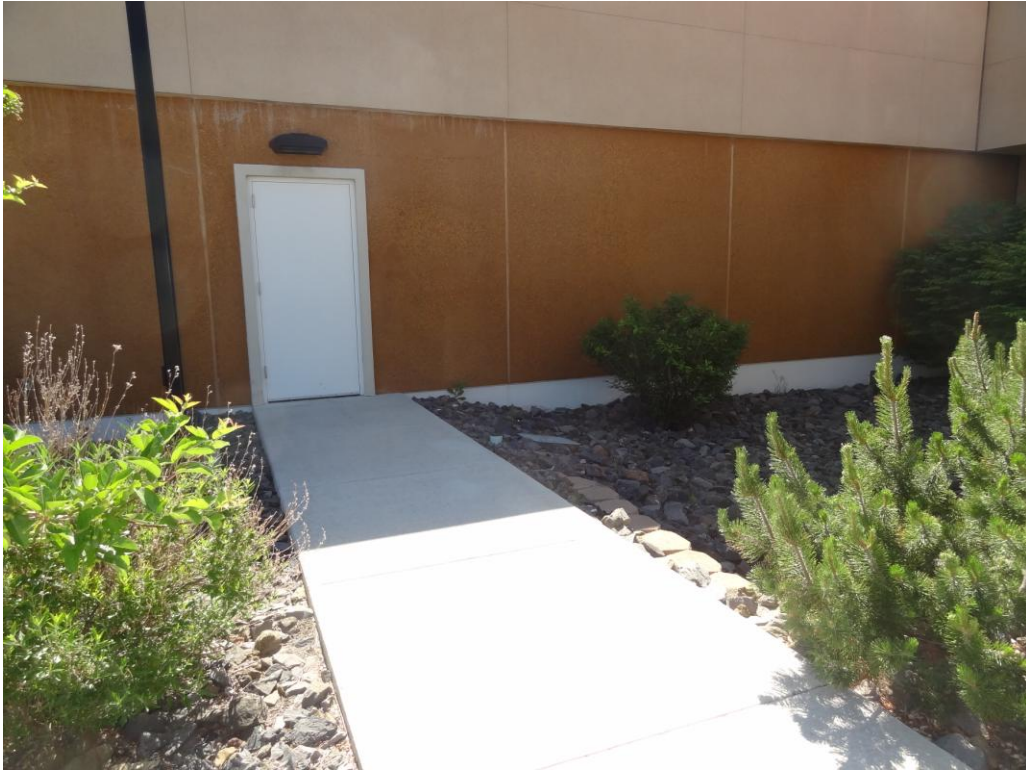
Data Center – FCA Building #0393  
Description: Exterior finishes.

It is important to maintain the finish, weather resistance, and appearance of the building. This project would provide funding to protect the exterior of the building excluding the roof. Included in the cost are cleaning and sealing the concrete wall panels, brick and masonry, and caulking of the windows, flashing, fixtures, and all other penetrations. It is recommended that the building be sealed and caulked in the next 5-7 years and that this project be scheduled on a cyclical basis to maintain the integrity of the structure.
