STATE OF NEVADA STATE PUBLIC WORKS DIVISION

FACILITY CONDITION ASSESSMENT REPORT FOR:

OFFICE OF THE GOVERNOR
ENTERPRISE INFORMATION TECHNOLOGY SERVICES

SITE #: 9855 DATA CENTER SITE
575 E. THIRD STREET
CARSON CITY, NV 89701-

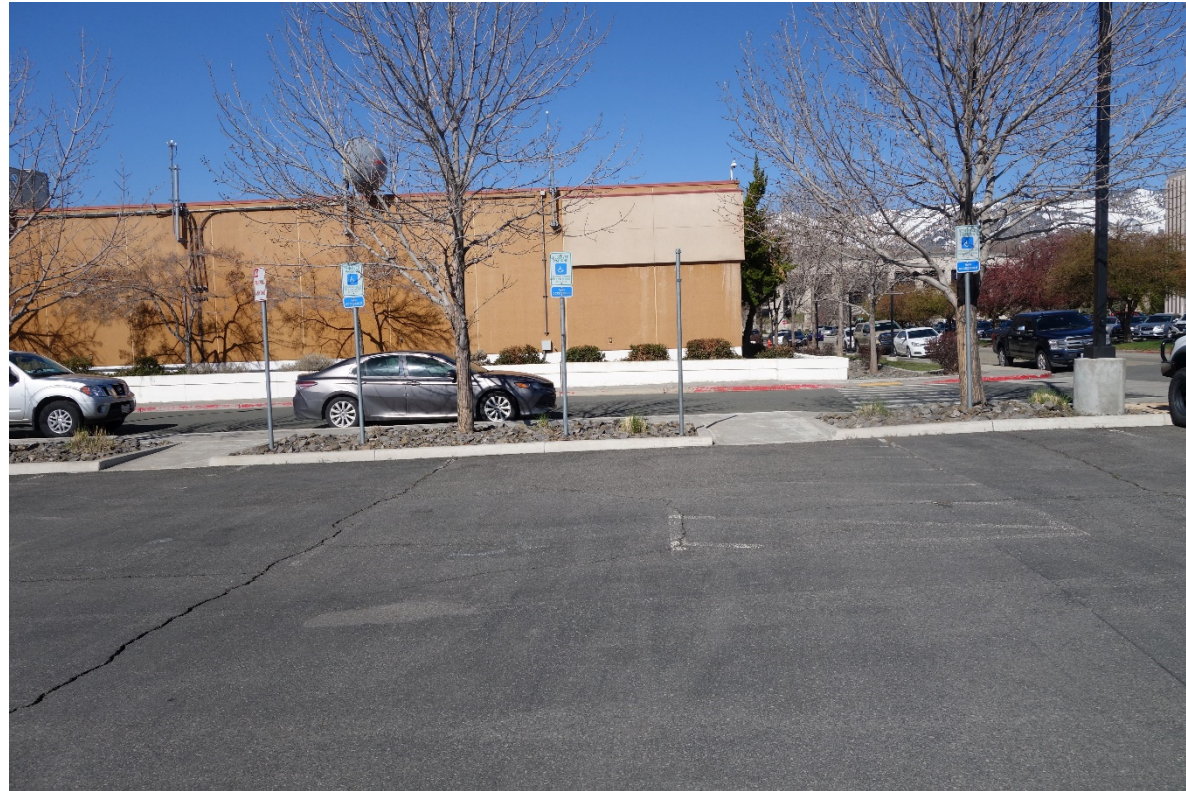
CRACK FILL & SEAL ASPHALT PAVING

It is important to maintain the asphalt paving on the site. This project would provide for minor crack filling and striping of the parking lot. This project should be scheduled within 2-3 years to maintain the integrity of the paving and prevent premature failure. This project should be implemented concurrently with the ADA SIGNAGE & STRIPING project. This project or a portion thereof was previously recommended in the FCA report dated 06/01/2013. It has been amended accordingly

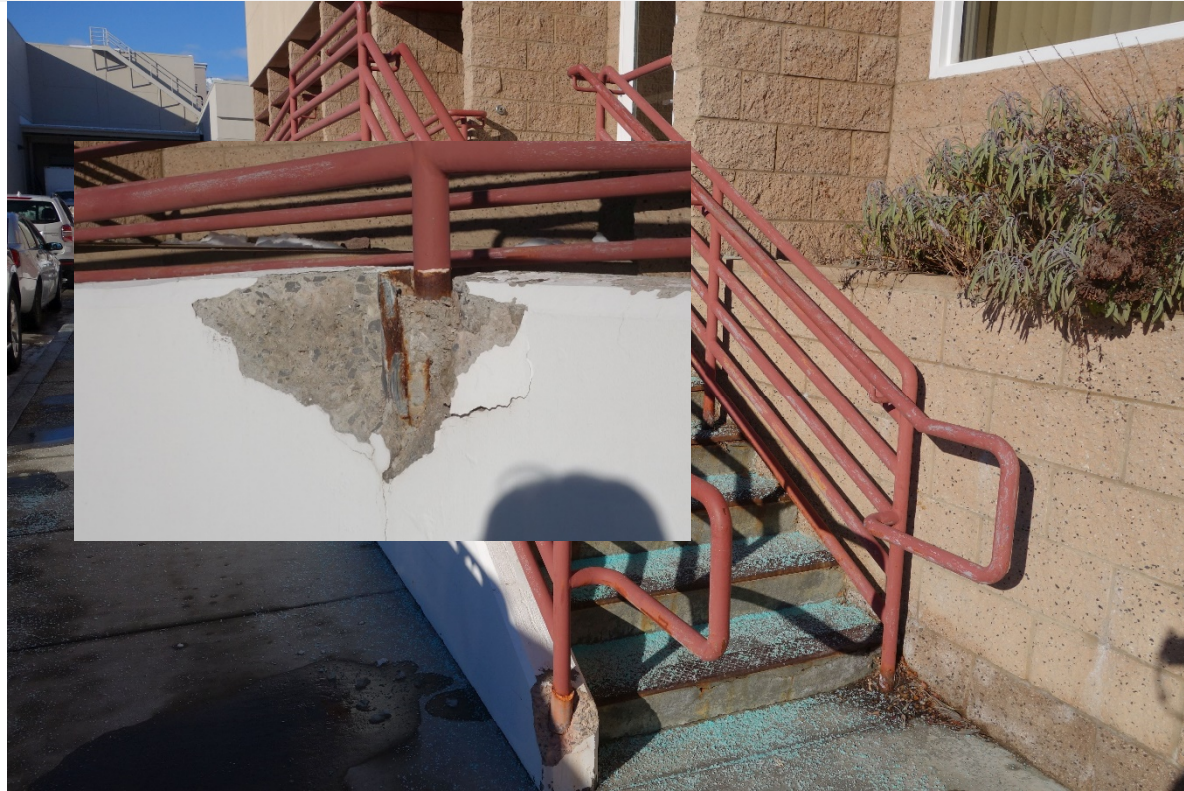
ADA RAMP MODIFICATIONS

In order to comply with current Americans with Disabilities Act (ADA) requirements, modifications will be necessary for the ADA ramp and stairs on the south side of the building. The standards for a ramp require a 36" clear space. Currently, the handrails encroach on this clearance and reduce the clear space to less than 32". The concrete on the stairs and the ramp is deteriorating. Spalling and cracking have occurred. Exposure to the elements is a contributing factor. This project recommends demolition and replacement of the ramp, handrails and stairs.

The 2018 IBC, ICC/ANSI A117.1 - 2009, NRS 338.180 and the most current version of the ADA Standards for Accessible Design were used as a reference for this project. This project or a portion thereof was previously recommended in the FCA report dated 06/01/2013. It has been amended accordingly to reflect conditions observed during the most recent survey date of 12/13/2022.

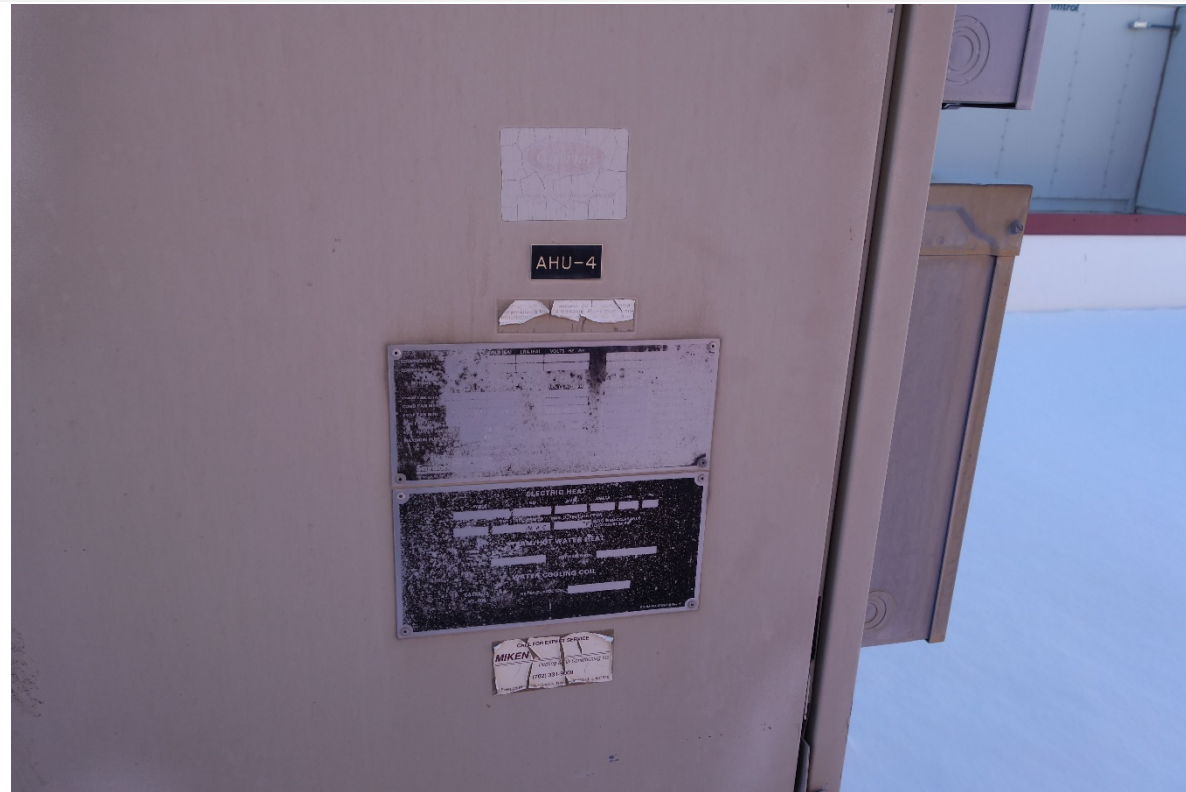
AIR HANDLER REPLACEMENT

The current backup air handling unit (AHU-4) serving the computer room was installed in 1990 under CIP 89-11. The air handling unit is beyond its useful life. If this unit fails in operation as the backup, the server room would become hot and could lead to server failures and potential loss of critical data. It is recommended to install a new backup air conditioning system. This project would provide for the purchase and installation of a new air conditioning unit, to

include all required modifications and connections to the utilities. This project or a portion thereof was previously recommended in the FCA report dated 06/01/2016. It has been amended accordingly to reflect conditions observed during the most recent survey date of 12/13/2022.

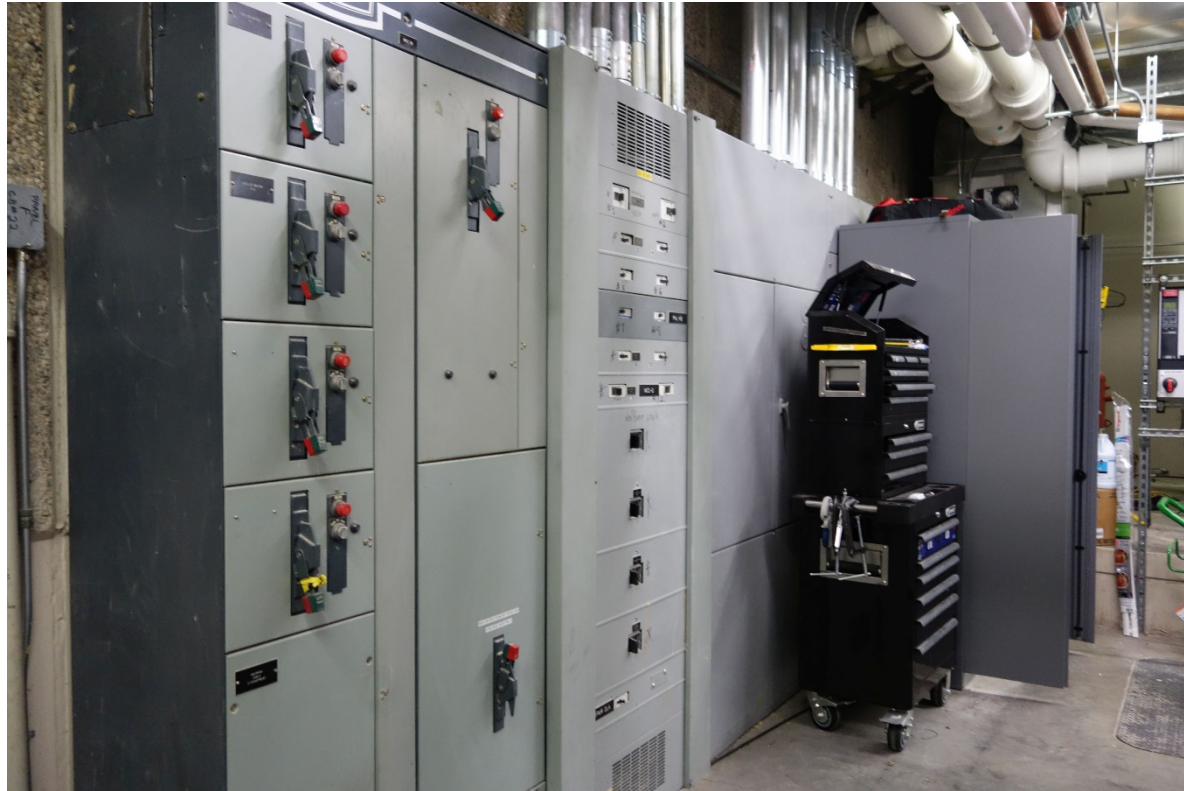
ARC FLASH and ELECTRICAL COORDINATION STUDY

Arc flash and electrical breaker coordination studies have not been performed or it has been more than 5 years since the last coordination study. Safety requirements for maintenance personnel and the latest electrical code require coordination studies to be verified and performed every 5 years, along with arc flash labeling on all electrical panels. This project will perform the required coordination study, evaluation, adjustments and labeling for the building's electrical distribution system.

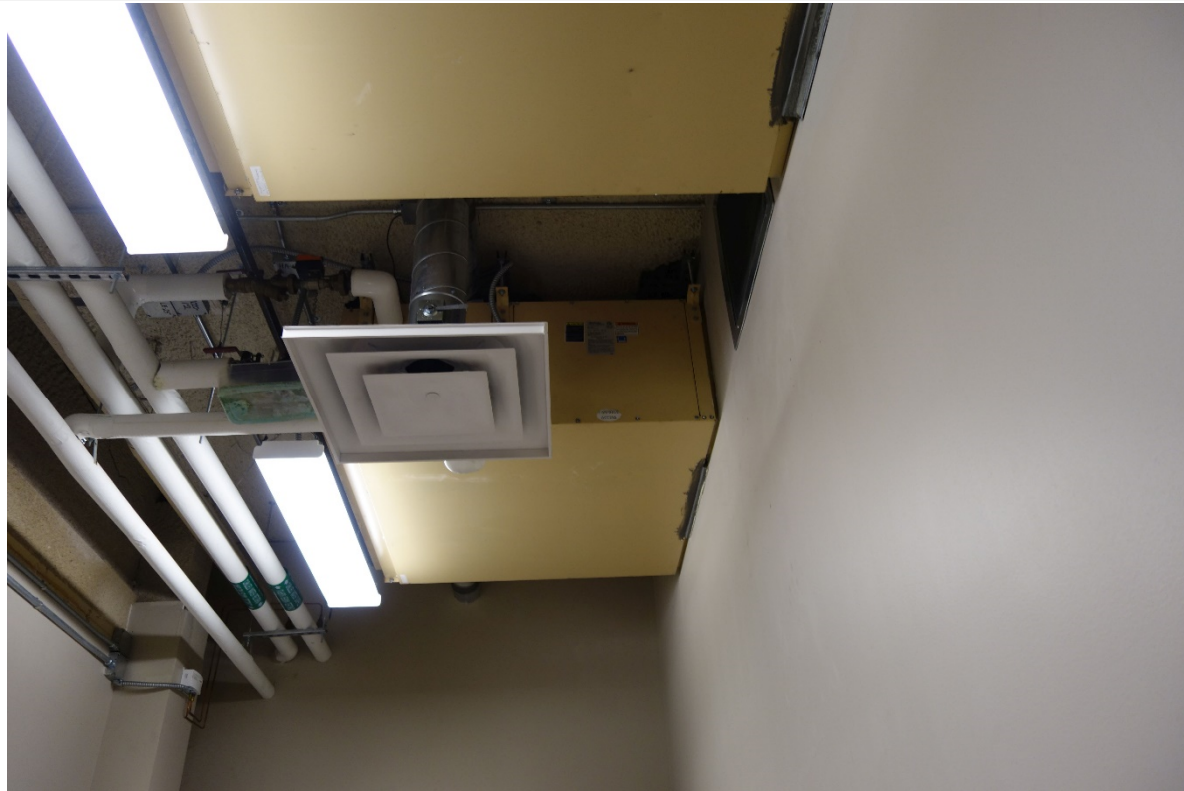
FAN COIL REPLACEMENT

There are two fan coil units (FCU 1a & 1b) which condition the Communications Room appear to be original to the building. The current cooling demand exceeds the capacity of these two units and should be replaced. This project would fund the purchase and installation of new fan coil units and include all required modifications and connections to utilities.

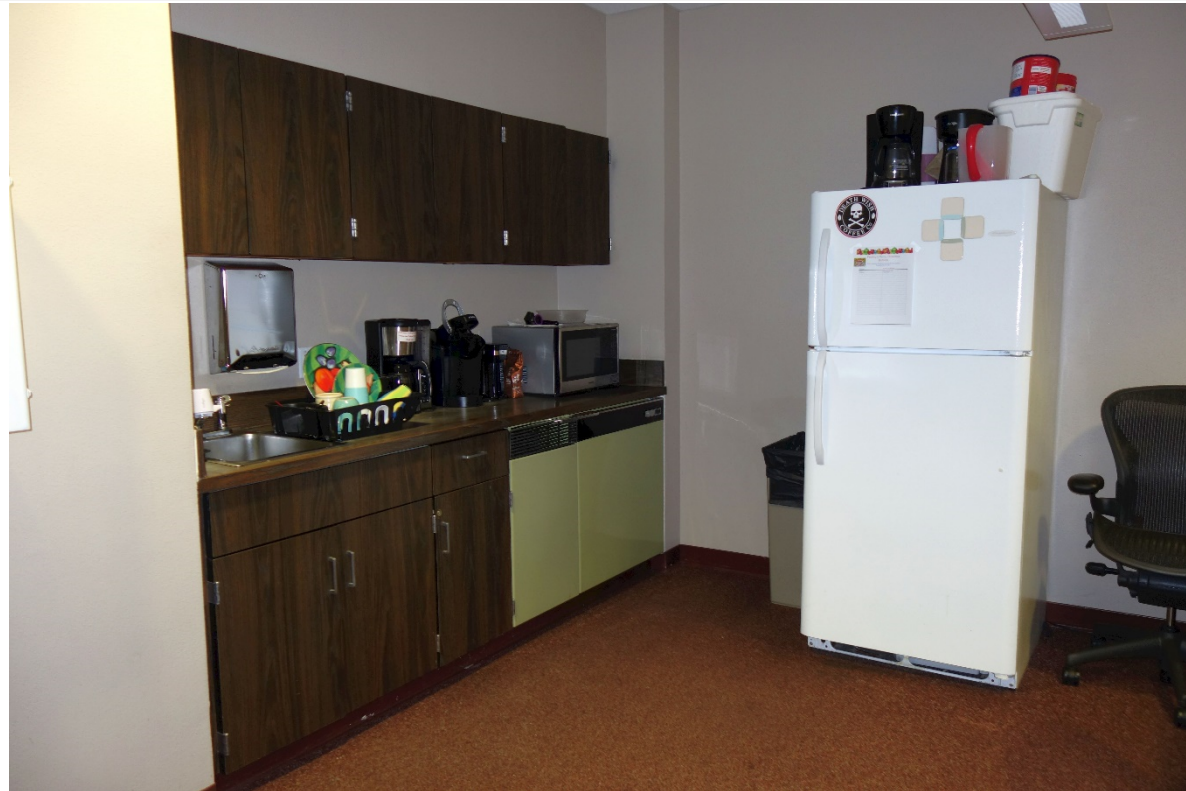
BREAK ROOM REMODEL

The break room in the original building dates back to the original construction in 1970. The quality of construction and installation were inadequate for the high usage at this facility, and the cabinets and countertops are delaminating and failing. This project recommends the replacement of the existing countertops, cabinets, and associated equipment with heavy duty, quality components. The cabinets should be finished inside and outside with a melamine or similar finish which encapsulates the door, frame, and shelving. The countertops should be constructed of a highly durable product, such as stainless steel, over a moisture resistant underlayment to minimize

swelling and damage from water exposure. ADA compliance according to NRS 338.180, IBC - 2018, ICC/ANSI A117.1 - 2009 and the most current version of the ADA Standards for Accessible Design should be incorporated into the design such as providing an accessible sink. This estimate includes removal and disposal of the existing materials. This project or a portion thereof was previously recommended in the FCA report dated 06/01/2016. It has been amended accordingly to reflect conditions observed during the most recent survey date of 12/13/2022.

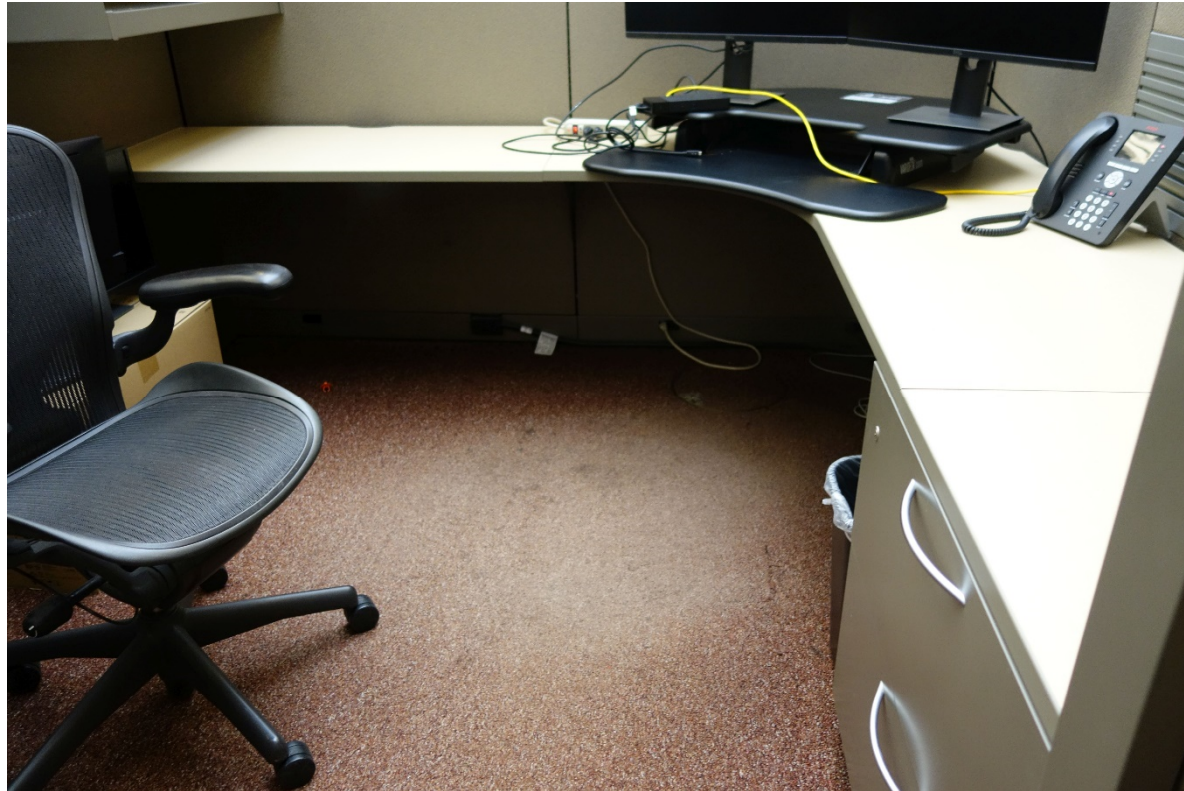
CARPET REPLACEMENT

The carpet in the building is showing signs of extreme wear and should be scheduled for replacement. It is recommended that the carpet be replaced with heavy duty commercial grade carpet in the next 2 - 3 years. This project or a portion thereof was previously recommended in the FCA report dated 06/01/2016. It has been amended accordingly to reflect conditions observed during the most recent survey date of 12/13/2022.

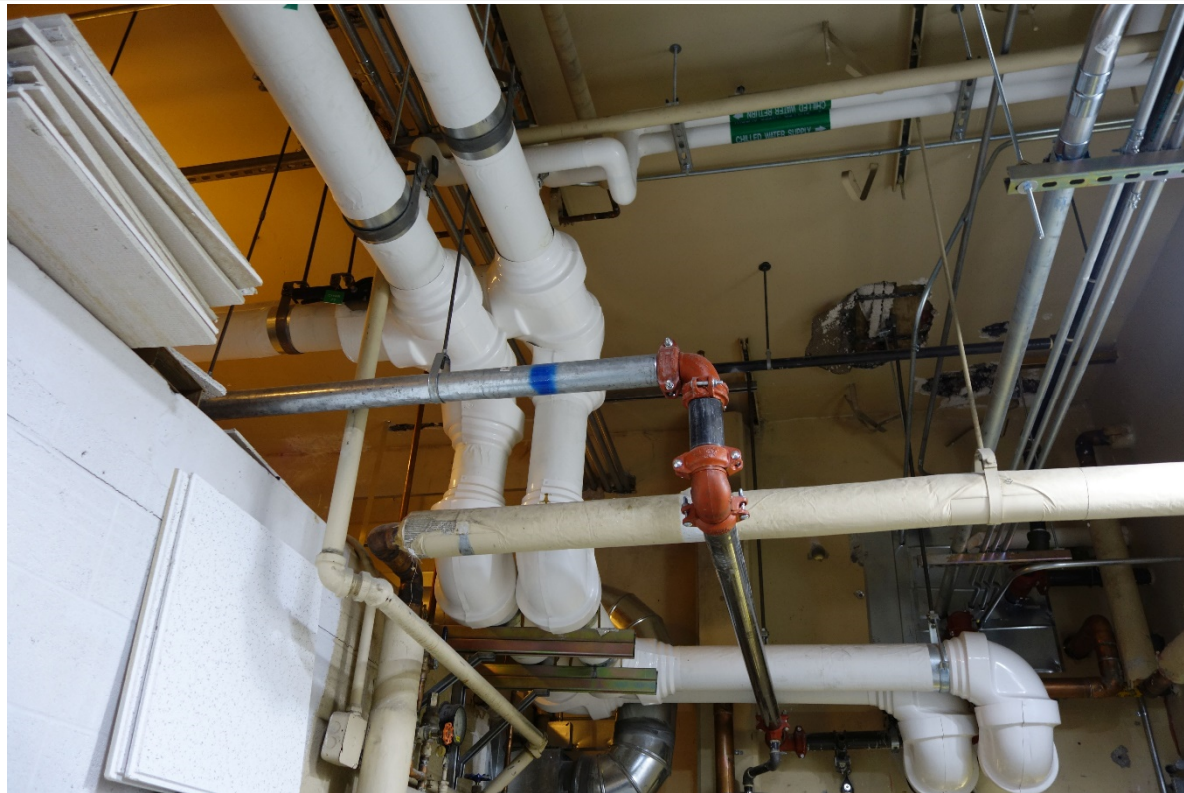
CEILING REPAIRS

There are voids in the gypsum board ceiling in the mechanical room that need to be repaired. This project recommends patching and repair of all holes in the ceiling.

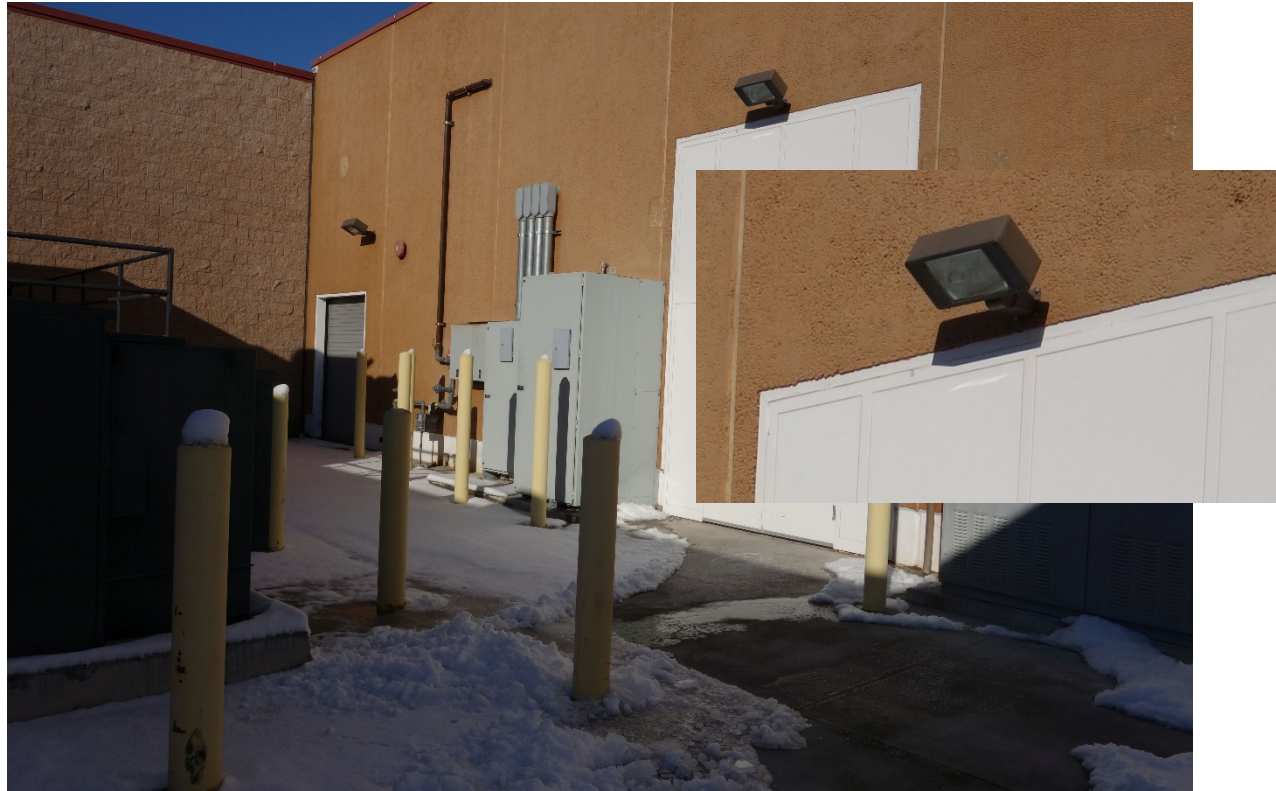
EXTERIOR LIGHTING REPLACEMENT

The building has perimeter lighting on the exterior of the building. The light fixtures are metal halide and not energy efficient. This project would provide for the replacement of the 8 exterior wall pack light fixtures with new LED light fixtures, using existing wiring. This project or a portion thereof was previously recommended in the FCA report dated 06/01/2016. It has been amended accordingly to reflect conditions observed during the most recent survey date of 12/13/2022.

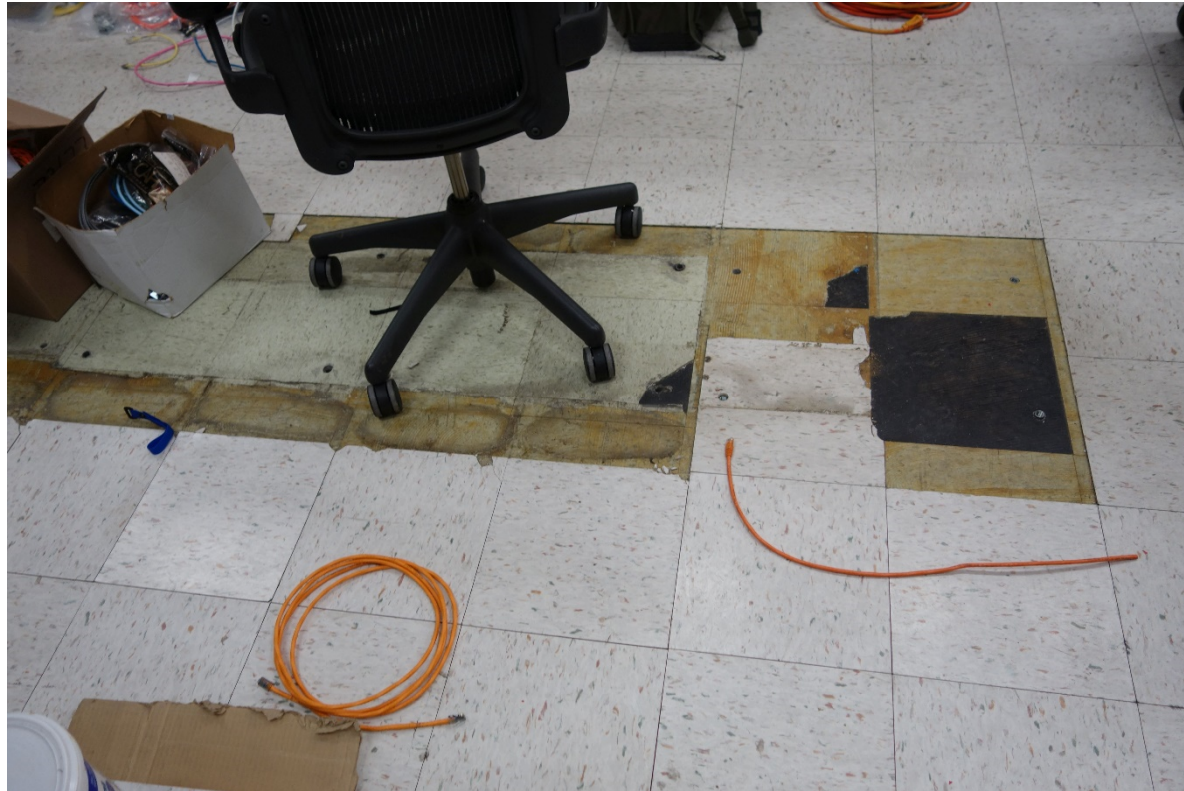
FLOORING REPLACEMENT

The VCT (vinyl composite tile) flooring in the Communications Equipment Room is damaged and has reached the end of its useful life. It is recommended that the VCT flooring be replaced. This project would provide for removal and disposal of the VCT and installation of new 12x12 VCT with a 6" base. Testing for asbestos containing materials (ACM) is included in this estimate.

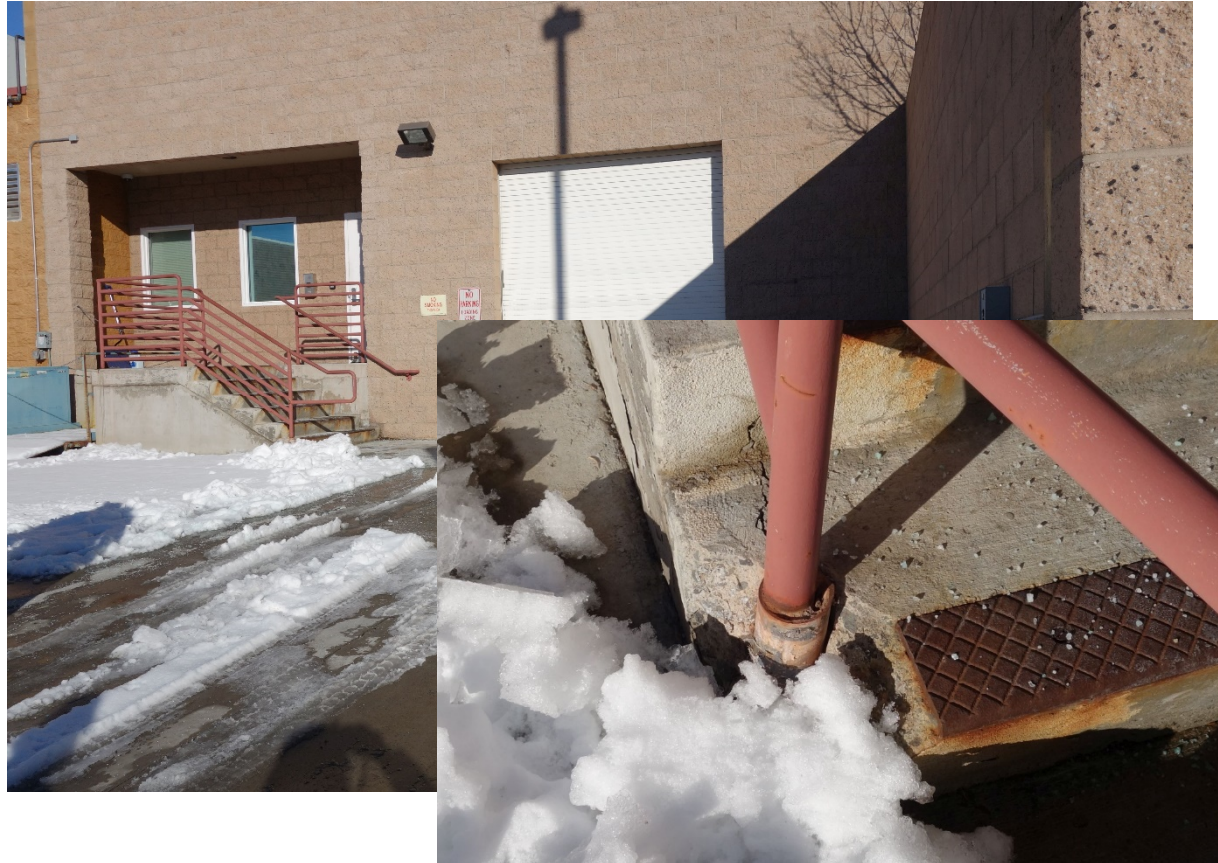
LOADING DOCK IMPROVEMENTS

The existing concrete stairs at the loading dock are failing. The concrete base supporting the guard and handrails has mostly failed leaving the rails unsupported. In addition, the ground dock lift is beyond its useful life. This project would fund the removal and replacement of the stairs, guard rails and dock lift.

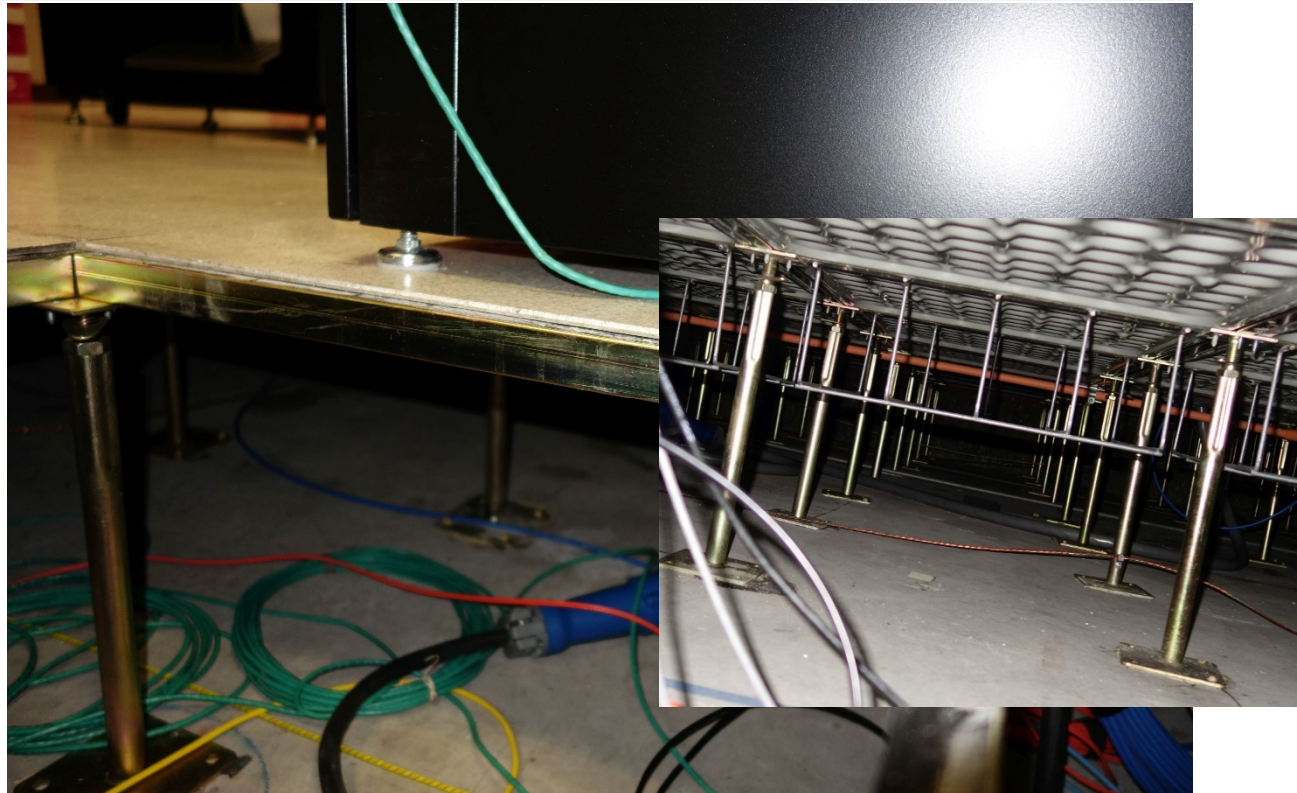
SEISMIC RETROFIT SERVER RAISED FLOOR

A visual survey of the structure supporting the computer server room floor indicates a lack of seismic bracing, both for the floor and the server racks. Lack of bracing increases the risk of data loss and a sustained outage resulting from a strong seismic event. This project would fund the replacement of the server room raised floor with a seismic rated floor. The project scope includes temporary server rack support, working in an occupied facility and phasing construction. Alternatively, a retrofit of the existing floor may be possible, reducing the substantial investment while meeting the seismic requirements. It is recommended that this option be investigated.

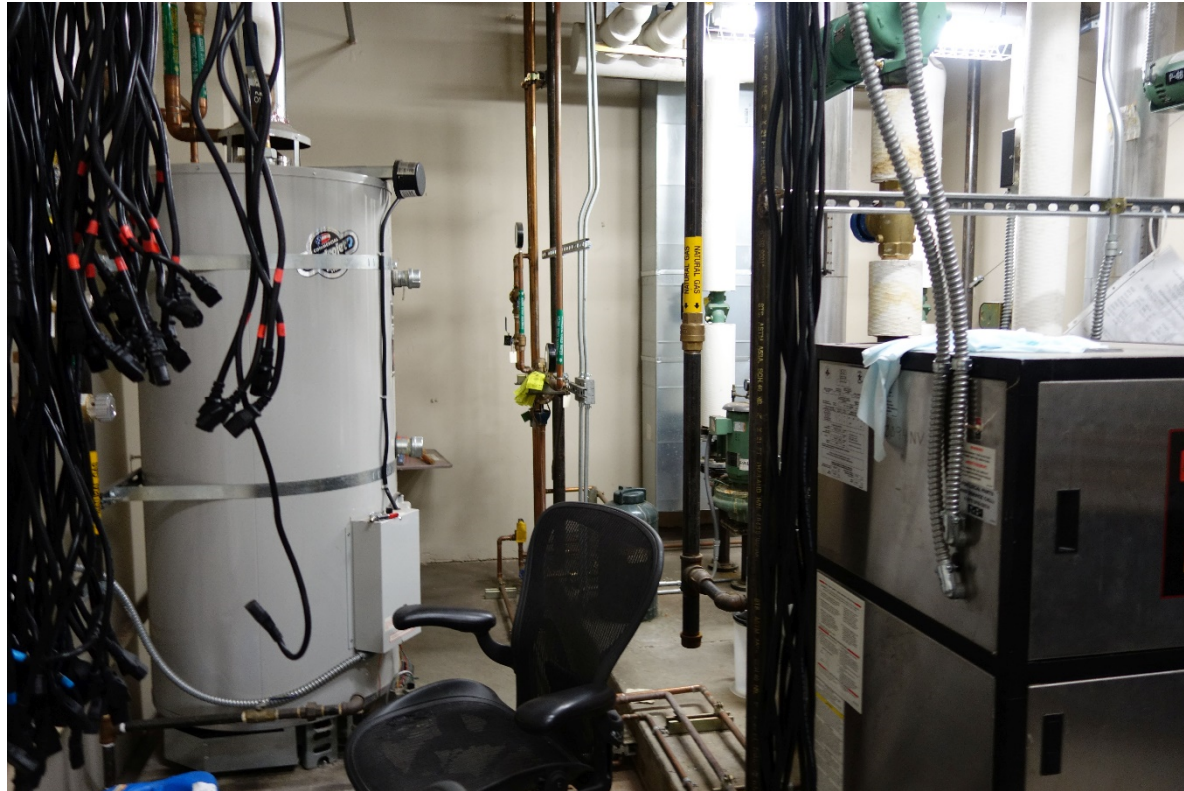
WATER HEATER REPLACEMENT

There is a 75-gallon gas-fired water heater in the building. The average life span of a water heater is eight to ten years. The water heater was installed in 2006. With the passage of time and constant use, this unit is showing signs of wear and should be scheduled for replacement in the next 2 - 3 years. It is recommended that a new gas-fired water heater be installed. Removal and disposal of the existing equipment is included in this estimate. This project or a portion thereof was previously recommended in the FCA report dated 06/01/2016. It has been amended accordingly to reflect conditions observed during the most recent survey date of 12/13/2022.

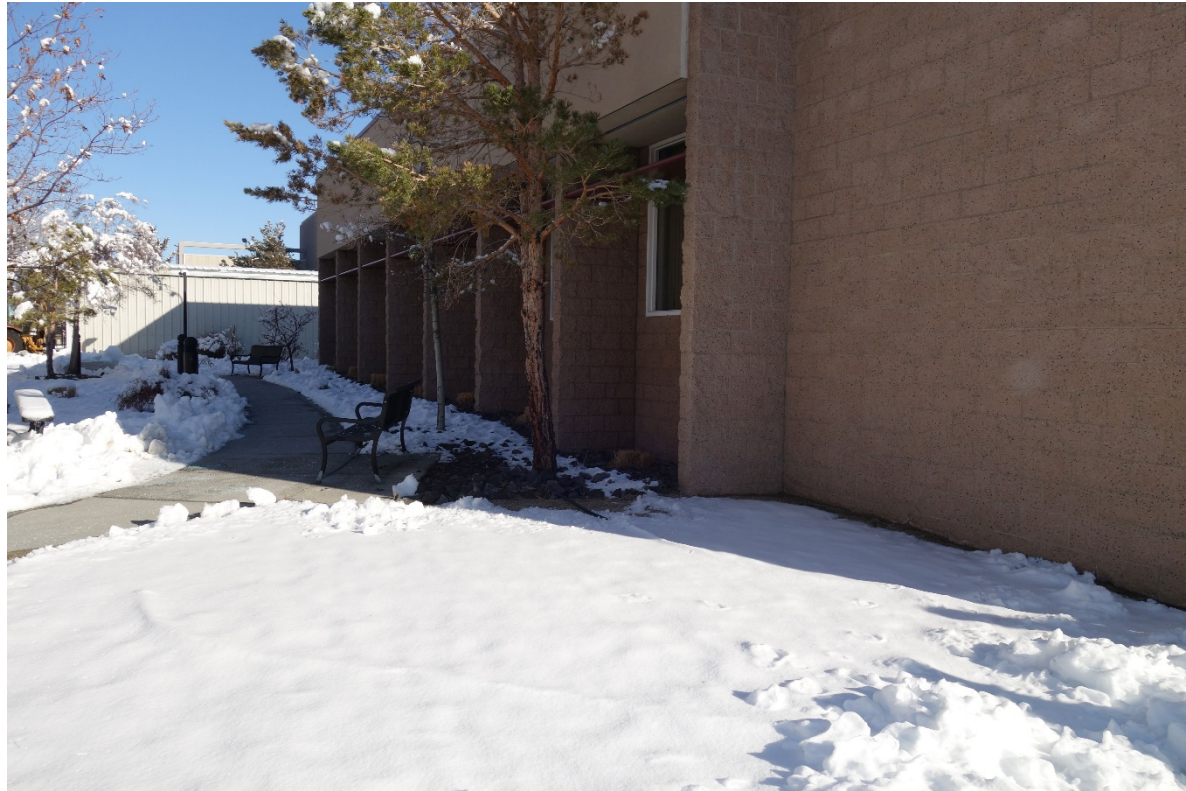
EXTERIOR FINISHES

The exterior finishes were in good condition. It is important to maintain the finish, weather resistance, and appearance of the building. This project would provide funding to protect the exterior of the building excluding the roof. Included in the cost are cleaning and sealing the concrete wall panels, brick and masonry, and caulking of the windows, flashing, fixtures, and all other penetrations. It is recommended that the building be sealed and caulked in the next 6 - 8 years and that this project be scheduled on a cyclical basis to maintain the integrity of the structure.

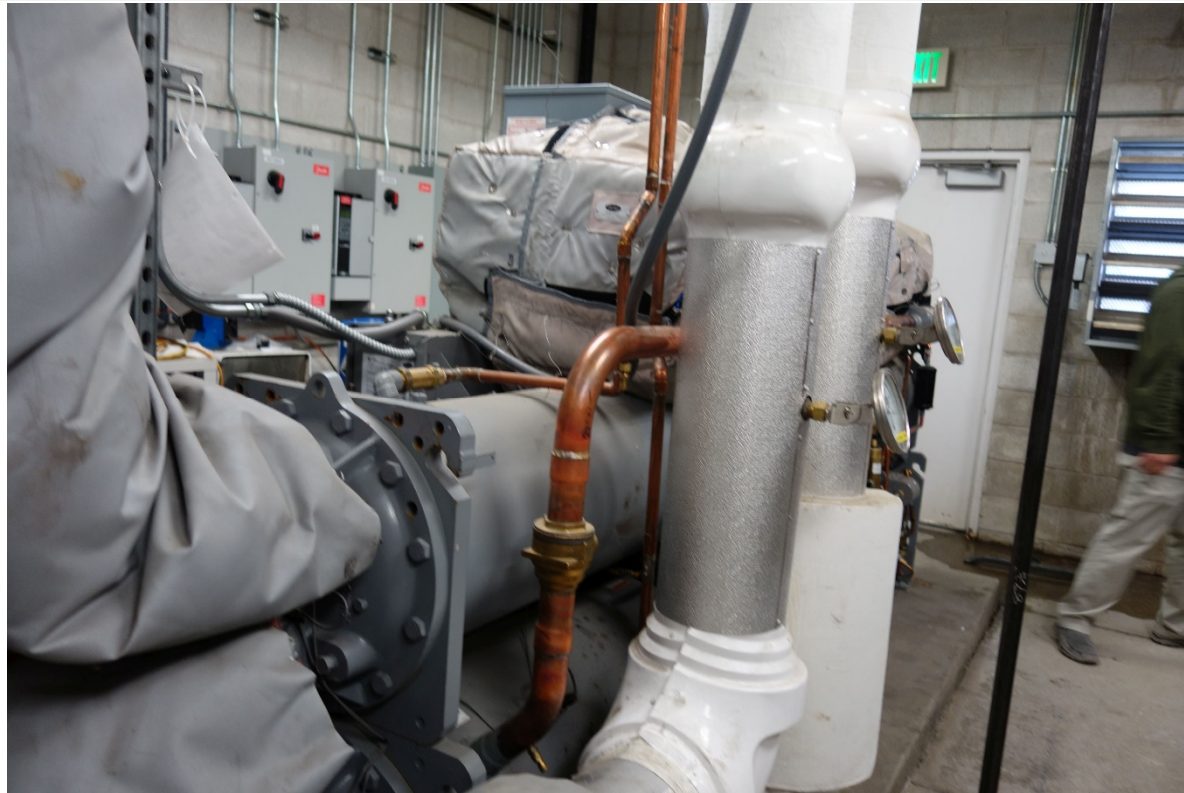
HVAC SYSTEM REPLACEMENT

The HVAC system in the building was mostly replaced in 2006 and will be reaching the end of its useful life in the next 8 - 10 years and should be planned for replacement.

This project would fund the replacement of the HVAC systems in the building including chillers, cooling tower, boilers, chilled & hot water piping, temperature controls and cleaning the existing duct work and grilles. This project includes removal and disposal of all equipment and materials and the

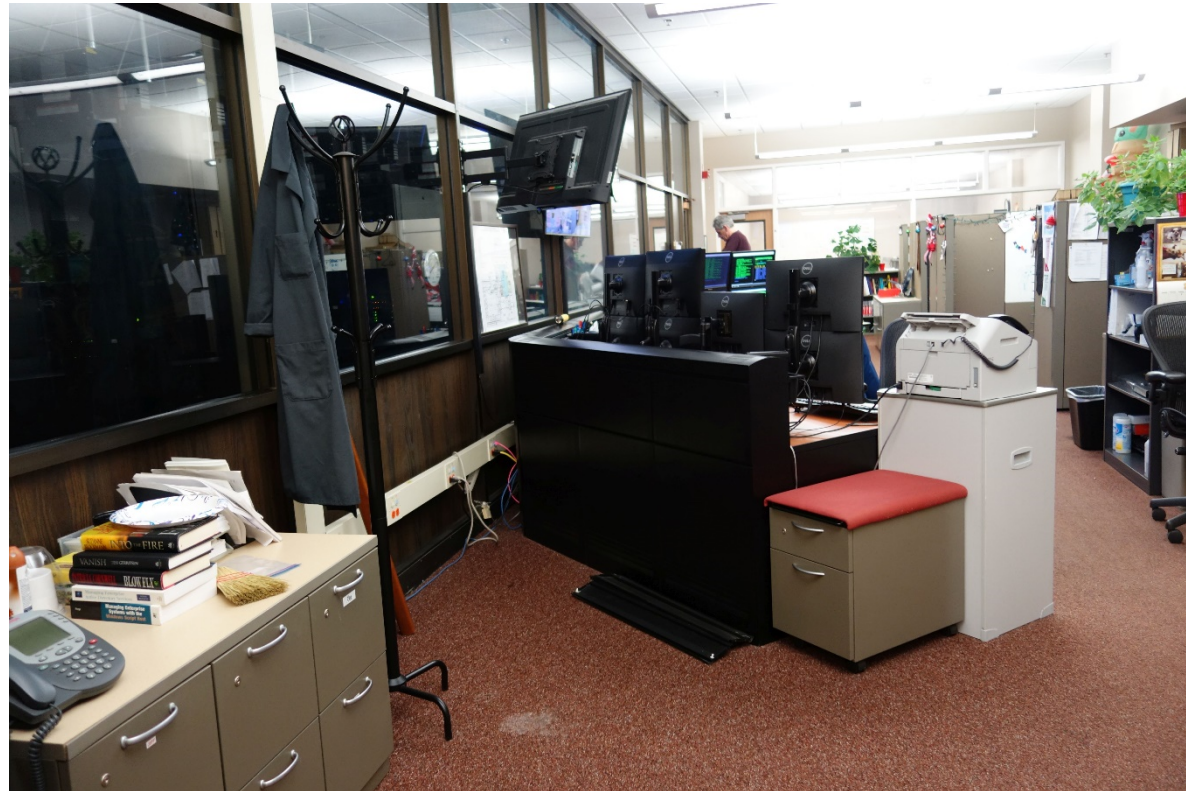
INTERIOR FINISHES

The interior finishes are in fair condition. It is recommended to paint the interior walls and ceilings at least once in the next 4 - 6 years and that this project be scheduled on a cyclical basis to maintain the integrity of the structure. Prior to painting, all surfaces should be repaired and adequately prepared to receive the coating. An epoxy-based paint should be utilized in wet areas for durability.

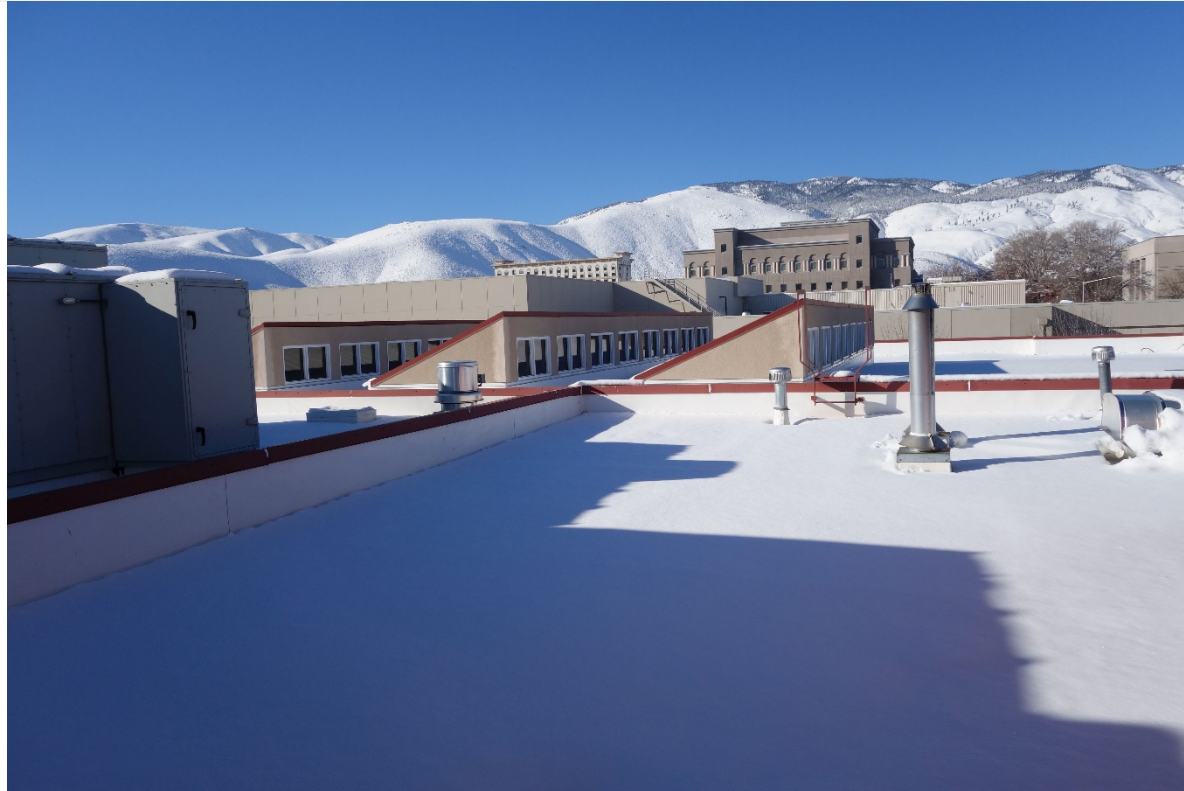
ROOF REPLACEMENT

The roof on this building was in fair condition at the time of the survey. The statewide roofing program has set the useful life of an average roof at 20 - 25 years. Typically, the roof warranty expires in 20 years. The temperature fluctuations throughout the year, consistent wind which blows sand and dirt on to the roof membrane, and constant exposure to the sun are contributing factors to wear and deterioration. The current roofing system was installed in 2003. It is recommended that this building be re-roofed in the next 4 - 6 years to be consistent with the roofing program and the

end of the warranty period. This project or a portion thereof was previously recommended in the FCA report dated 06/01/2016. It has been amended accordingly to reflect conditions observed during the most recent survey date of 12/13/2022.
