# NEVADA HISTORICAL SOCIETY SITE

**Site Number: 9856**

**STATE OF NEVADA PUBLIC WORKS DIVISION  
FACILITY CONDITION ANALYSIS**

SPWD Facility Condition Analysis - 0401

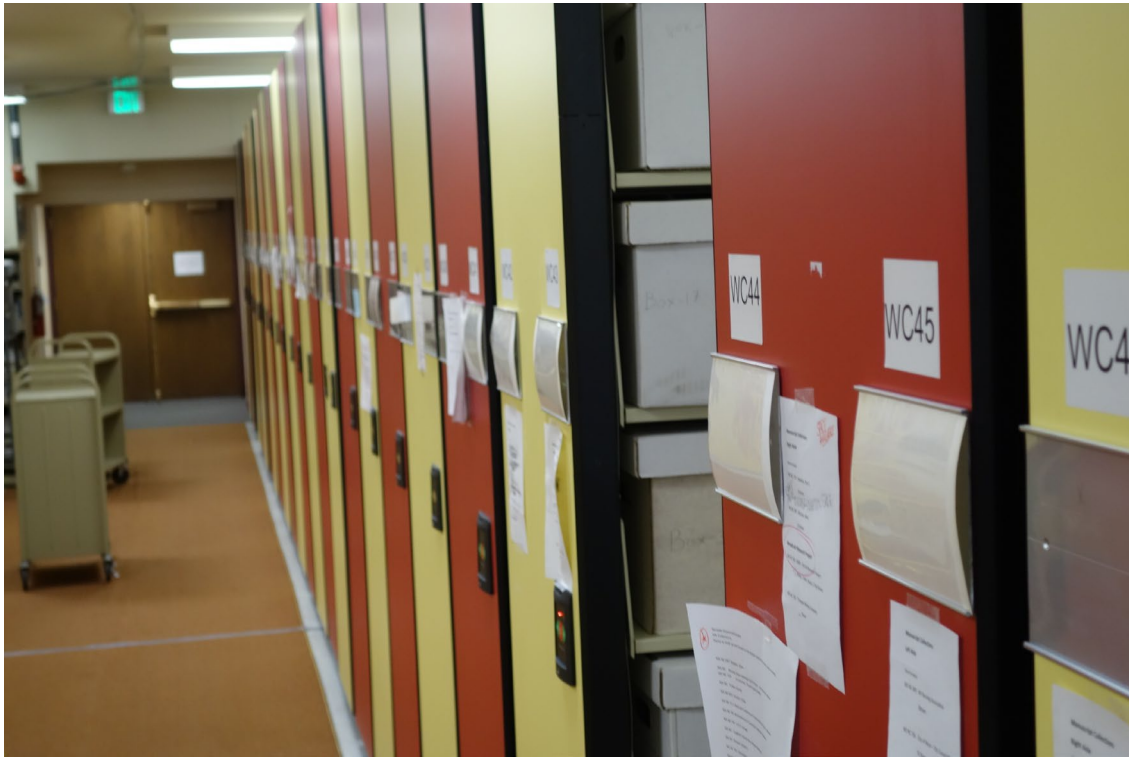
The existing high density storage system in the archive area is not functioning properly and is a safety hazard. The electrical and mechanical elements of the system are aged, compromising the safety of the staff and volunteers. The system has a safety feature which prevents the shelves from moving when a person is in the aisle. The electronics and sensors for this safety feature are failing and pose a very dangerous situation for a person working in the aisles. There are also shelves at the ends of the system that do not open fully. It is recommended to refurbish the entire storage system. The estimate includes removal and disposal of existing electrical and mechanical parts and purchase and installation of new parts to restore the system to a safe and fully functioning system.

Nevada Historical Society - Building #0401  
Description: High Density Storage System Repairs Needed.

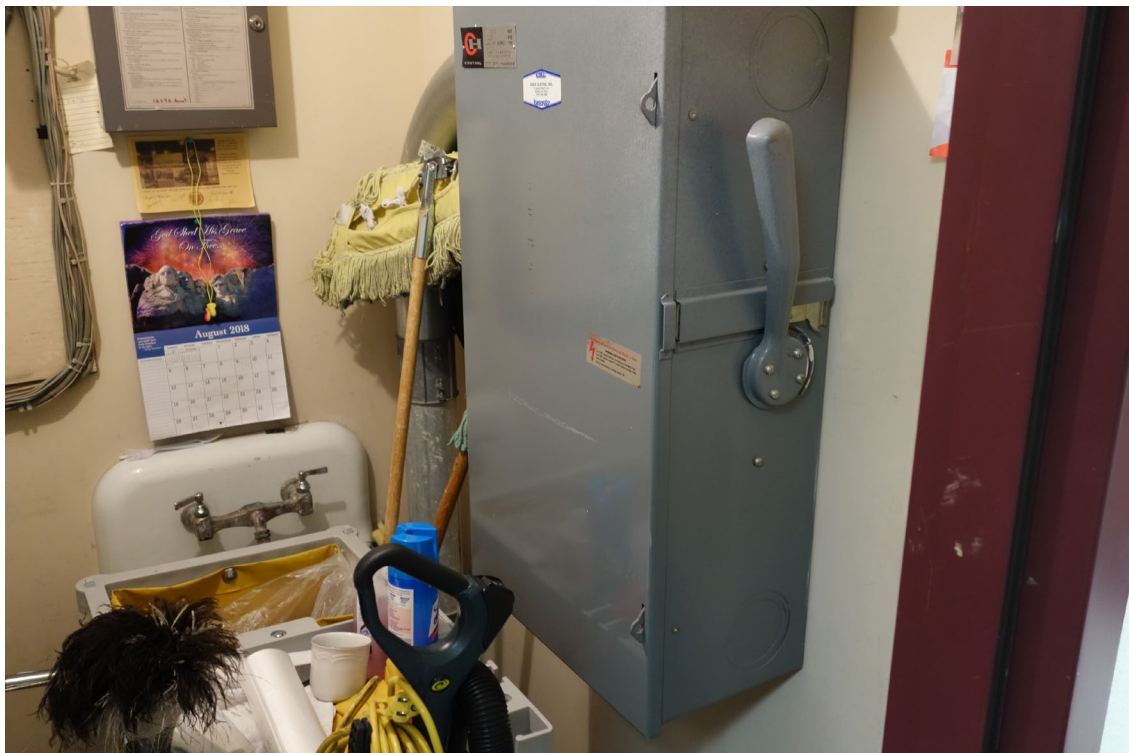
There are electrical panels in the building which do not have proper clear floor space around them. The 2018 IFC section 605.3 states that, "A working space of not less than 30 inches in width, 36 inches in depth and 78 inches in height shall be provided in front of electrical service equipment. Where the electrical service equipment is wider than 30 inches, the working space shall not be less than the width of the equipment. No storage of any materials shall be located within the designated working space." This project would provide funds to relocate the janitors equipment and other items currently blocking the working space.

Nevada Historical Society - Building #0401  
Description: Clearance at Electrical Equipment Required.

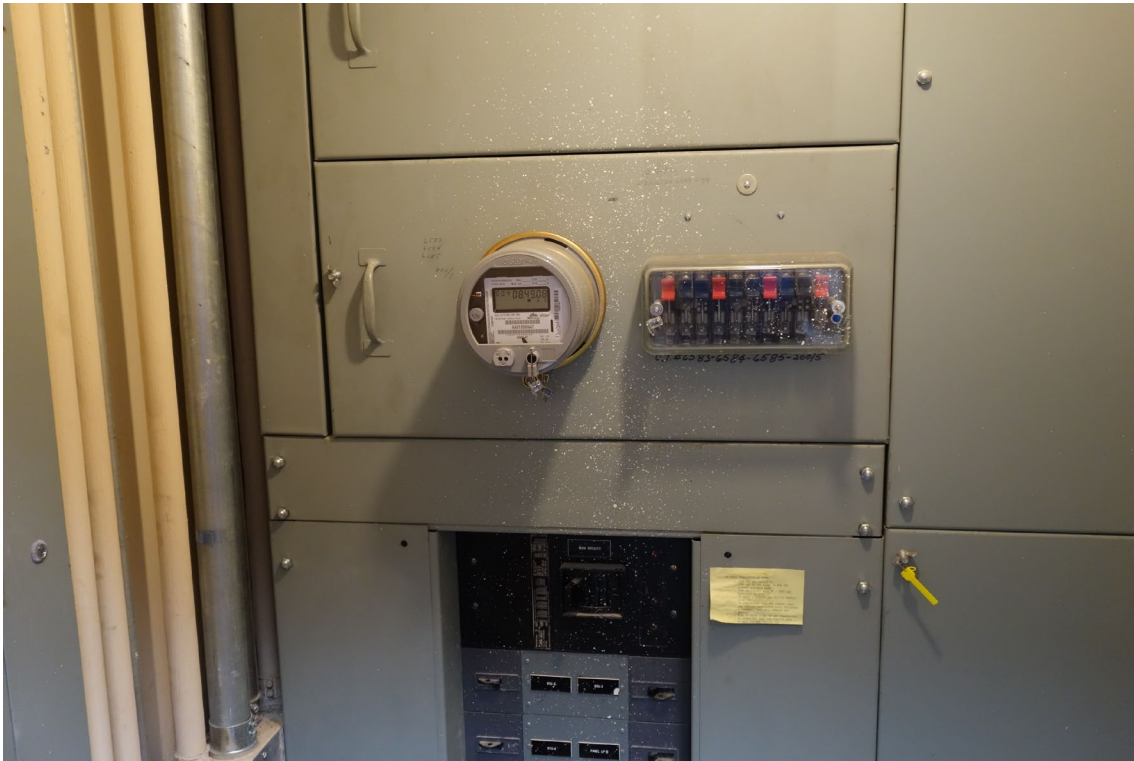
This building is over 50 years old and the electrical system has reached the end of its useful life. There are also conflicts having electrical equipment clearances, and wet locations (janitor sink) in close proximity. Additionally, it was constructed before the requirements for NEC 70e electrical Arc Flash Assessments. As a consequence, the original subpanels, distribution boards and breakers are not labeled with available fault current (AIC Rating). In order to comply with the NEC 70e requirements, it is recommended that the original electrical equipment be replaced with new to facilitate the required Breaker Coordination and Arc Flash studies. Additionally, this project funds relocating the janitor functions to a newly created space. Removal and disposal of the existing equipment is included in this project.

Nevada Historical Society - Building #0401  
Description: Electrical Upgrade Recommended.

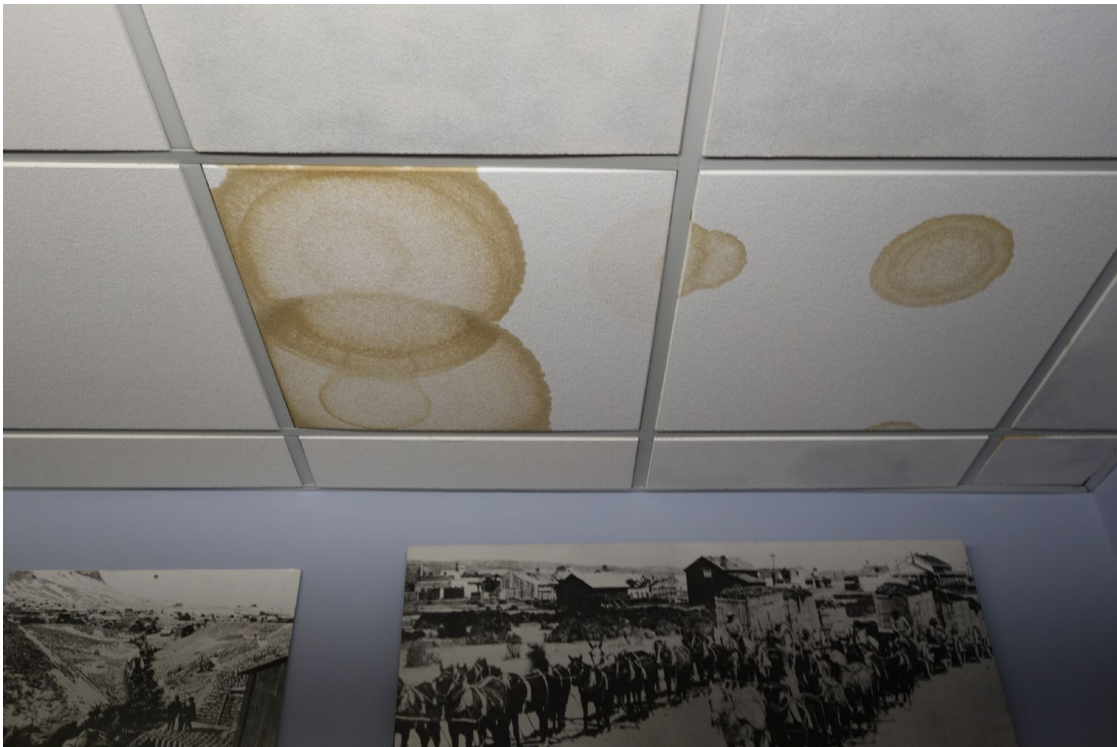
A portion of the ceiling in the building is covered with acoustical ceiling tiles. The ceiling tiles are damaged and stained and some are coming loose from the substrate. This project would provide for the replacement of the ceiling tiles. Removal and disposal of the existing tiles is included in this estimate. Additional costs would be required if there is asbestos in the tiles or adhesive.

Nevada Historical Society - Building #0401  
Description: Ceiling Tile Replacement Needed.

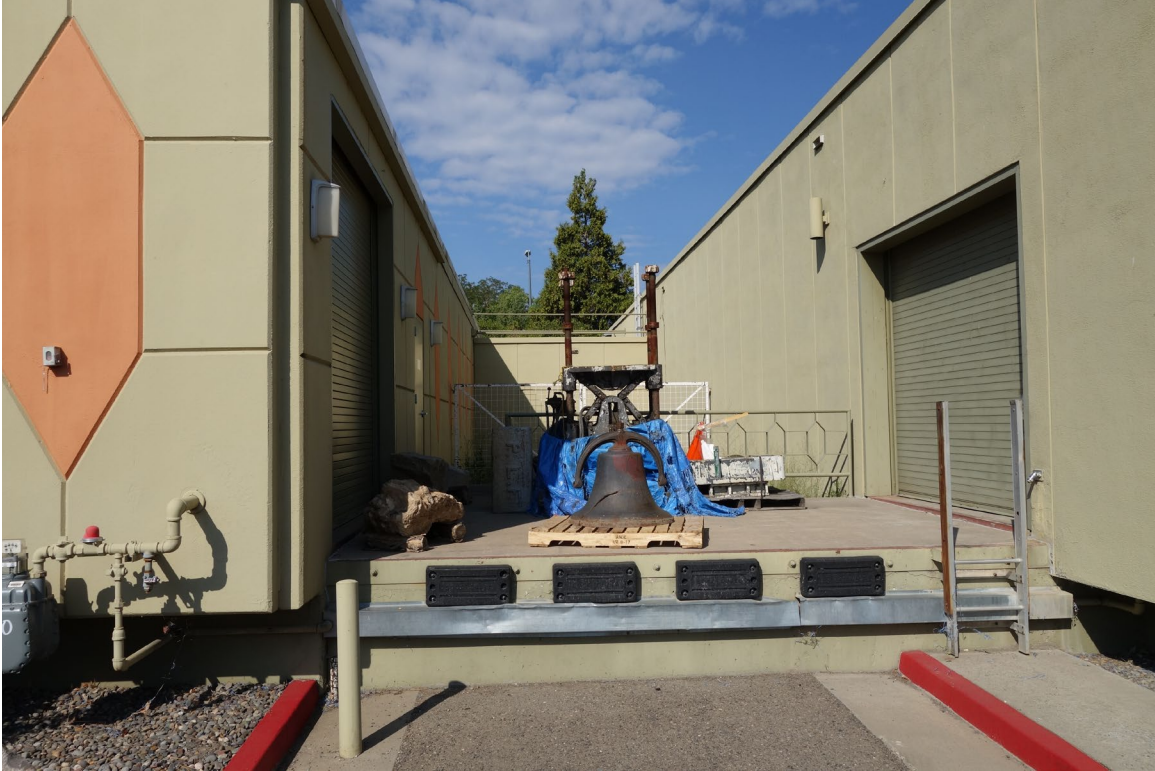
The building mounted wall pack lights at the main entrance and the loading dock appear to be original to the building. These fixtures have High Pressure Sodium (HPS) lamps and are less efficient. This project would provide for the replacement of the existing wall pack fixtures with LED wall packs using the existing wiring.

Nevada Historical Society - Building #0401  
Description: Exterior Wall Lighting Upgrade Recommended.

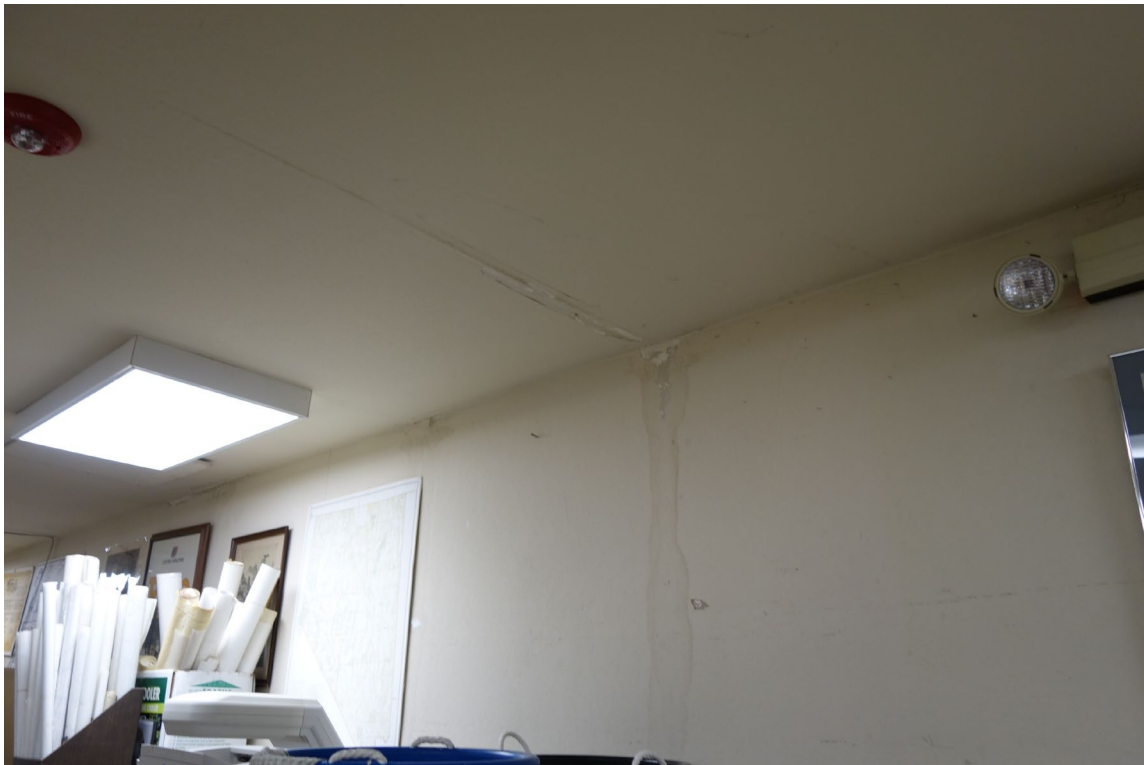
Water leaks and moisture has damaged the gypsum board in the Archive Storage area. The water damage was caused by previous roof leaks. This project recommends removing any damaged gypsum board, and replacing it and re-finishes the gypsum board seams.

Nevada Historical Society - Building #0401  
Description: Gypsum Board Repairs Needed.

This project should be implemented concurrently with the ROOF REPLACEMENT and INTERIOR FINISHES projects.

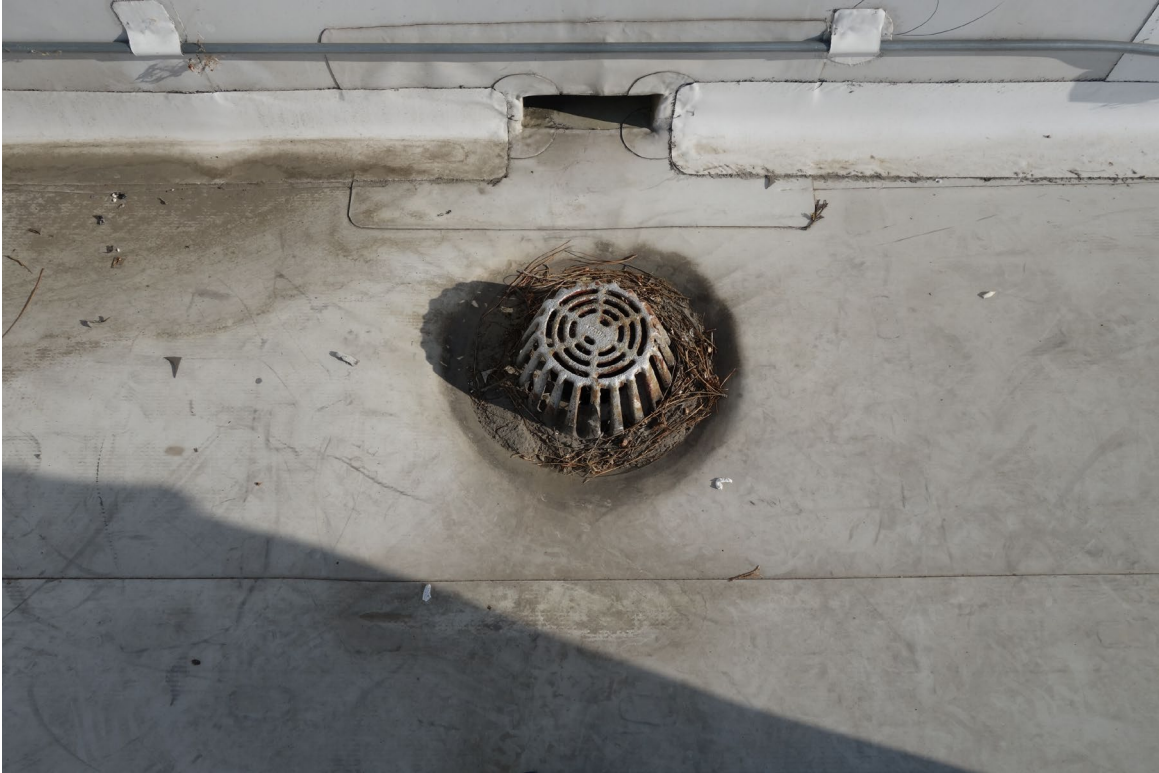
The roof on this building was in fair condition at the time of the survey. The statewide roofing program has set the useful life of an average roof at 20 years. The roof warranty expires at the end of the same time frame. The temperature fluctuations throughout the year, consistent wind which blows sand and dirt on to the roof membrane, and constant exposure to the sun are contributing factors to wear and deterioration. The current roofing system was installed in 2004 with a 15 year warranty. It is recommended that this building be re-roofed in the next 2 - 3 years to be consistent with the roofing program and the end of the warranty period.

Nevada Historical Society - Building #0401  
Description: Roof Replacement Recommended.

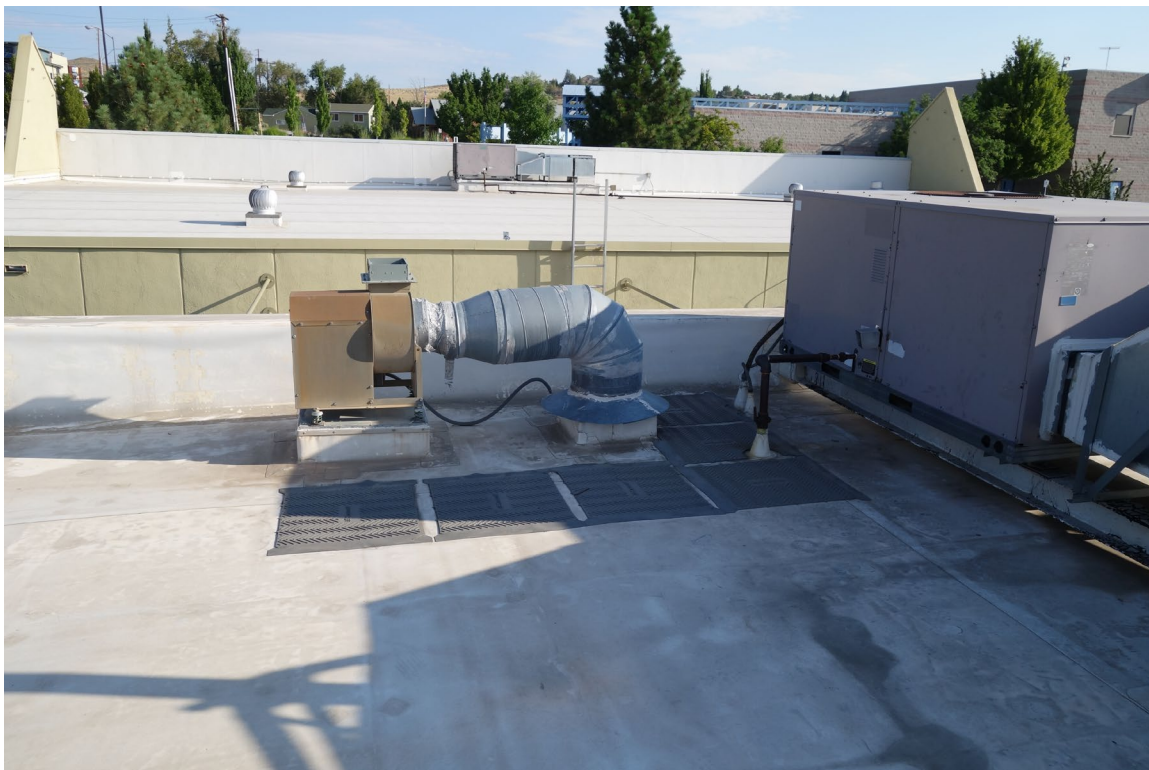
The five HVAC roof top units were installed in 1997. They are not energy efficient and have reached the end of their expected and useful life. The R-22 refrigerant in the cooling system is no longer EPA compliant and its production is mandated to be phased out completely by January 1, 2020. This project would provide for installation of five new HVAC packaged units and cleaning of the existing duct work and grilles. This project includes removal and disposal of the existing equipment, including utility exhaust fan and all required connections to utilities.

Nevada Historical Society - Building #0401  
Description: HVAC Equipment Replacement Recommended.
