State of Nevada
Department of Cultural Affairs
Division of Museums and History
Nevada Historical Society
Facility Condition Analysis

NEVADA HISTORICAL SOCIETY

Site Number: 9856
STATE OF NEVADA PUBLIC WORKS BOARD
FACILITY CONDITION ANALYSIS

Report Printed in March 2011

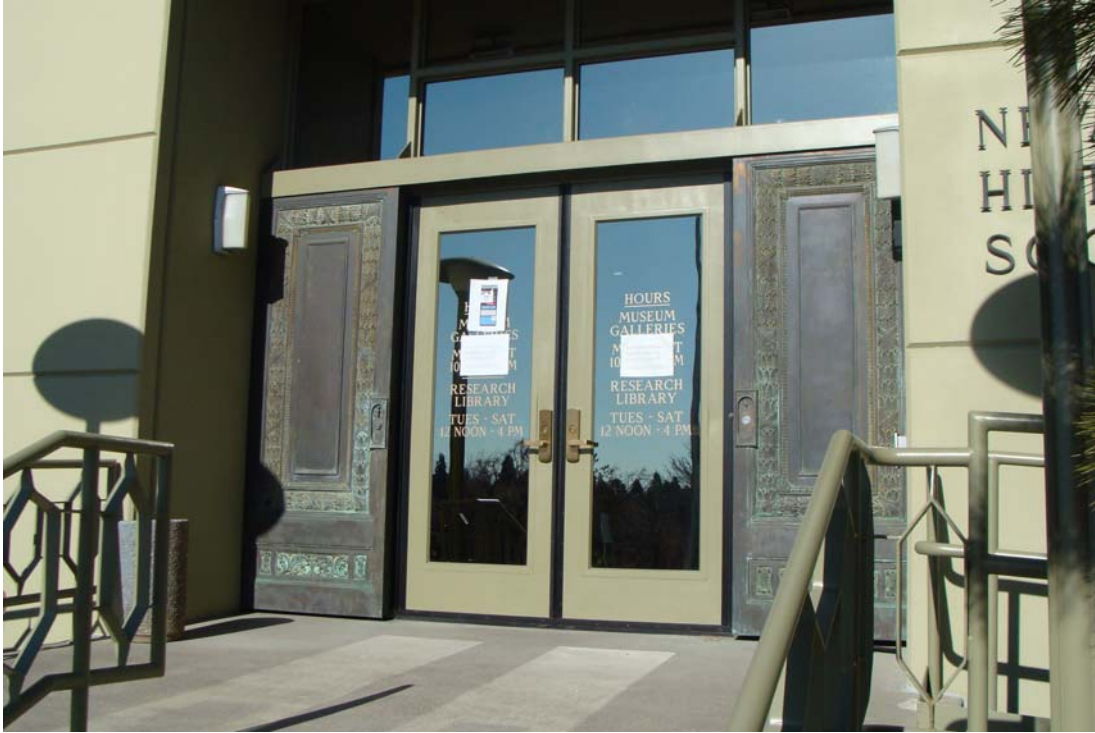
Nevada Historical Society - Building #0401
Description: Public entrance / exterior landing.

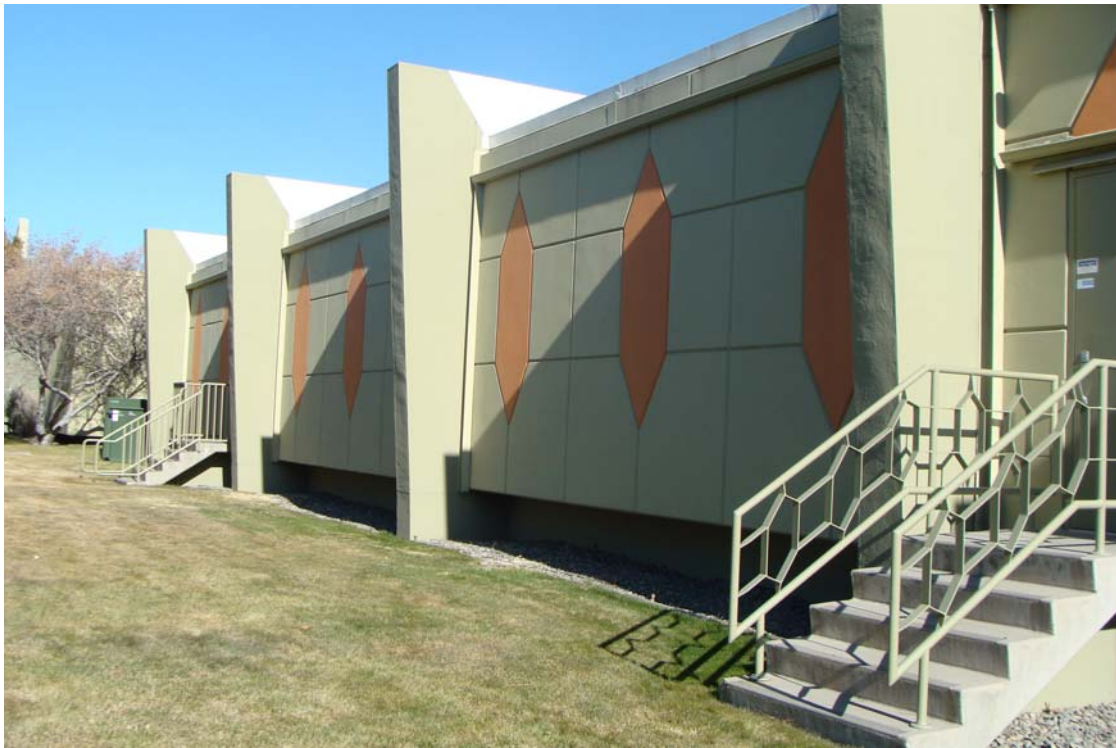
There are a total of five exterior stairways coming out of the building, not including the one at the south side main entrance. Four of these stairways do not have a bottom landing. This does not comply with 2006 IBC Section 1009.4 which describes the requirements for landings at stairways including that the width and length of the landing shall not be less than the width of the stairway. The fifth stairway has a bottom landing that slopes towards the stairway and the building. This landing is on the east entrance and creates a situation where water pools up and freezes creating a slipping hazard. This project addresses installing four new landings designed to current code and removing and replacing the landing at the east entrance.

Nevada Historical Society - Building #0401
Description: Exit stairs in need of a landing.

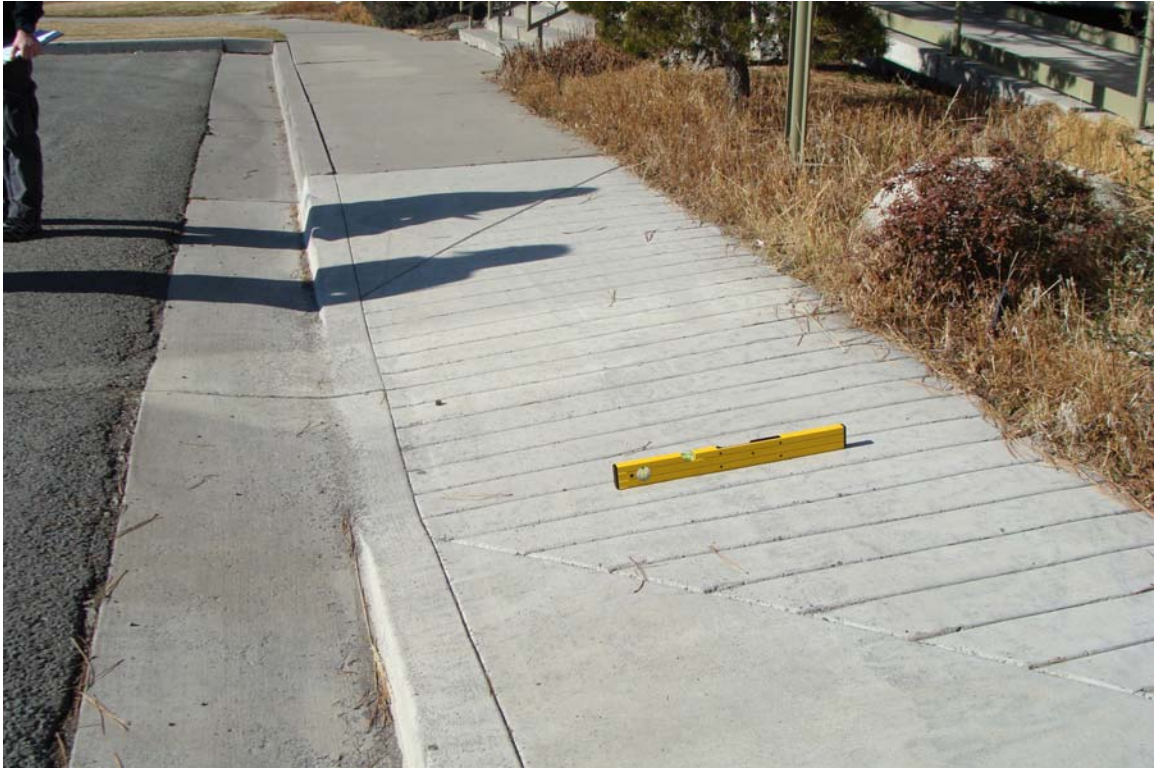
The Americans with Disabilities Act (ADA) provides for accessibility to sites and services for people with physical and mental limitations. There are numerous areas between the sidewalk and the main entry doors that do not comply with ADA guidelines. The sidewalks, stairway and entry landing are not compliant and should be scheduled for repairs. Due to the slope at the entry landing, the adjacent ramps will require modifications to meet the new elevation of the landing. The stairway will need to be completely rebuilt. If the handrails are re-used, proper returns will need to be retrofitted onto them. Directional signage from the parking spaces to the entry should be included as well. The 2006 IBC, ICC/ANSI A117.1 - 2003 and the most current version of the Americans with Disabilities Act Accessible Guidelines (ADAAG) were used as a reference for this project.

Nevada Historical Society - Building #0401
Description: ADA accessible route non compliant.

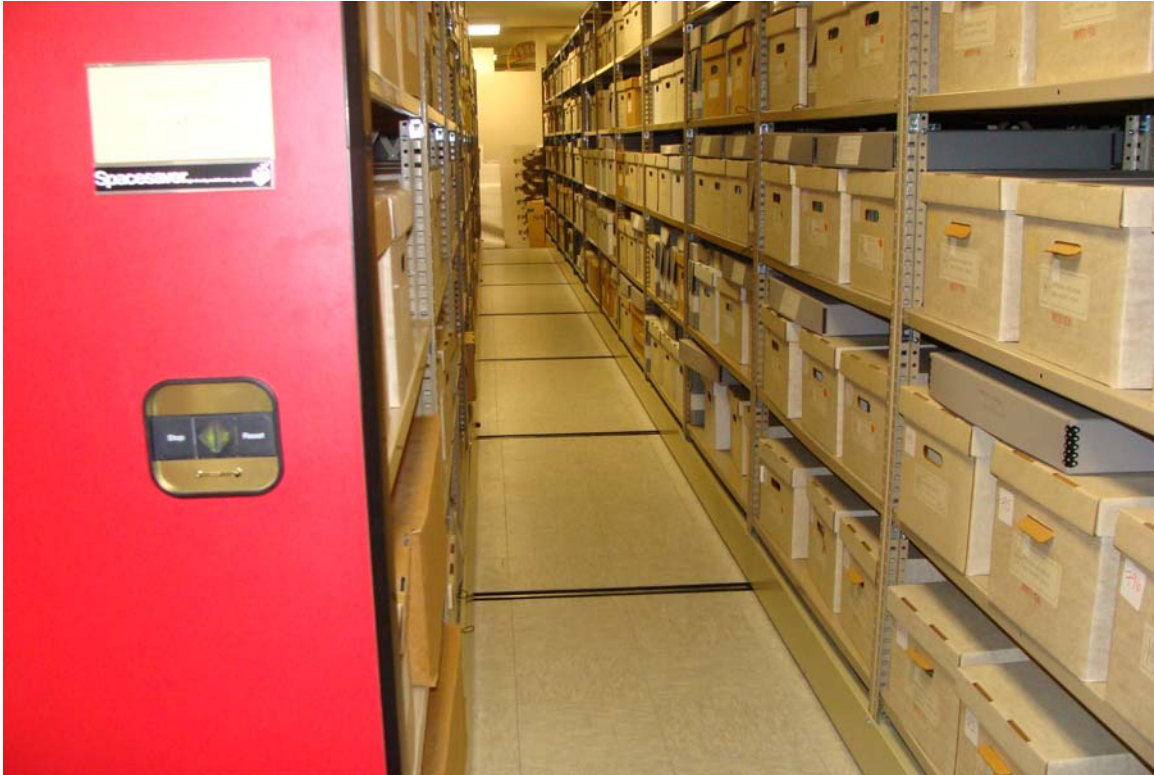
Nevada Historical Society - Building #0401
Description: Storage racks.

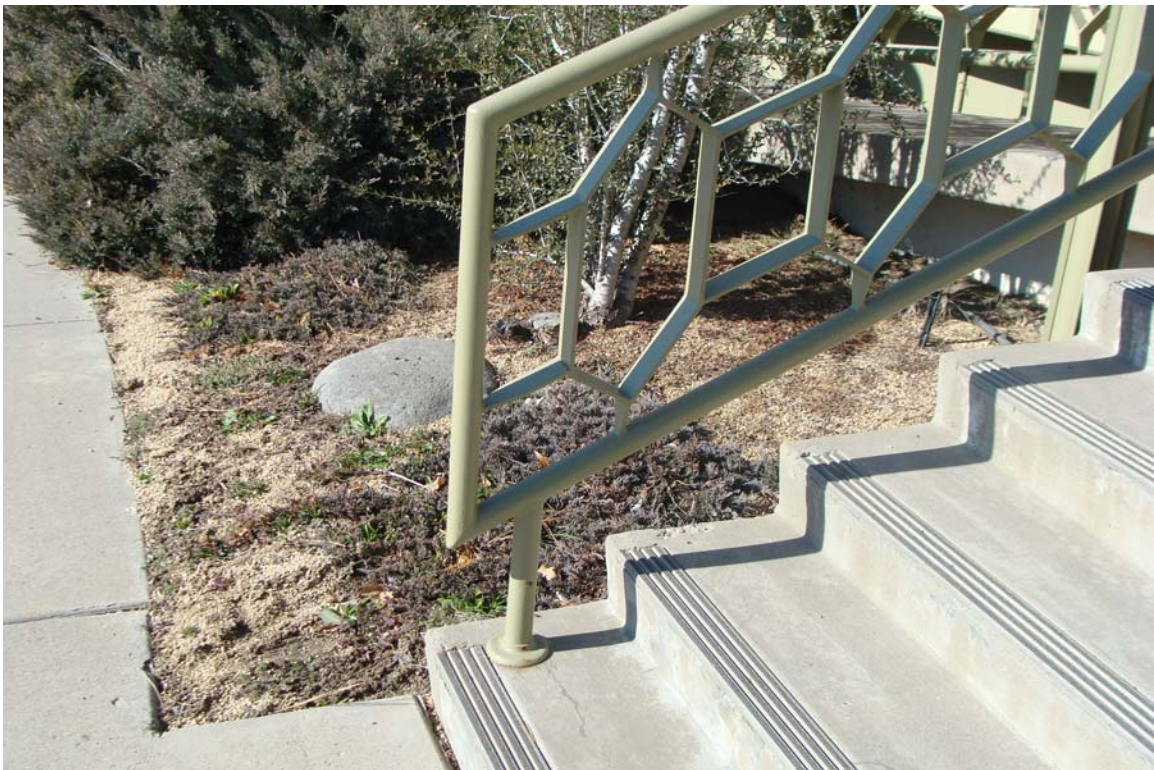
Nevada Historical Society - Building #0401
Description: Non compliant stairs and handrails.
