NEVADA EARLY INTERVENTION SERVICES

2667 Enterprise Road
Reno, Nevada 89511

Site Number: 9859

**STATE OF NEVADA PUBLIC WORKS DIVISION
FACILITY CONDITION ANALYSIS**

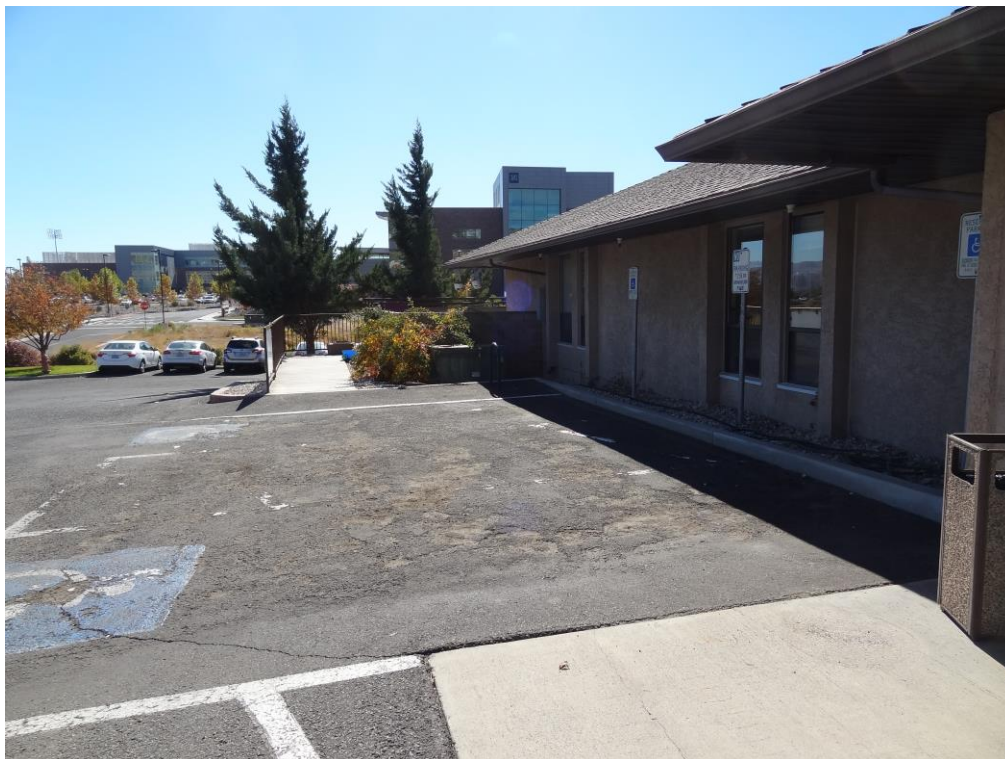
The ADA provides for accessibility to sites and services for people with physical limitations. The existing ADA parking spaces have reached the end of their useful life due to pavement deterioration. Based on the total number of parking spaces at this facility, 4 concrete parking spaces are necessary to comply with ADA requirements. This project would provide for 4 concrete ADA parking spaces and walkways to the existing sidewalk. This will require regrading, installing concrete, striping, signage and any other necessary upgrades. The 2018 IBC, ICC/ANSI A117.1, NRS 338.180 and the most current version of the ADA Standards for Accessible Design were used as a reference for this project.

Nevada Early Intervention Services Site - Site #9859
Description: ADA Accessible Parking Upgrade Needed.

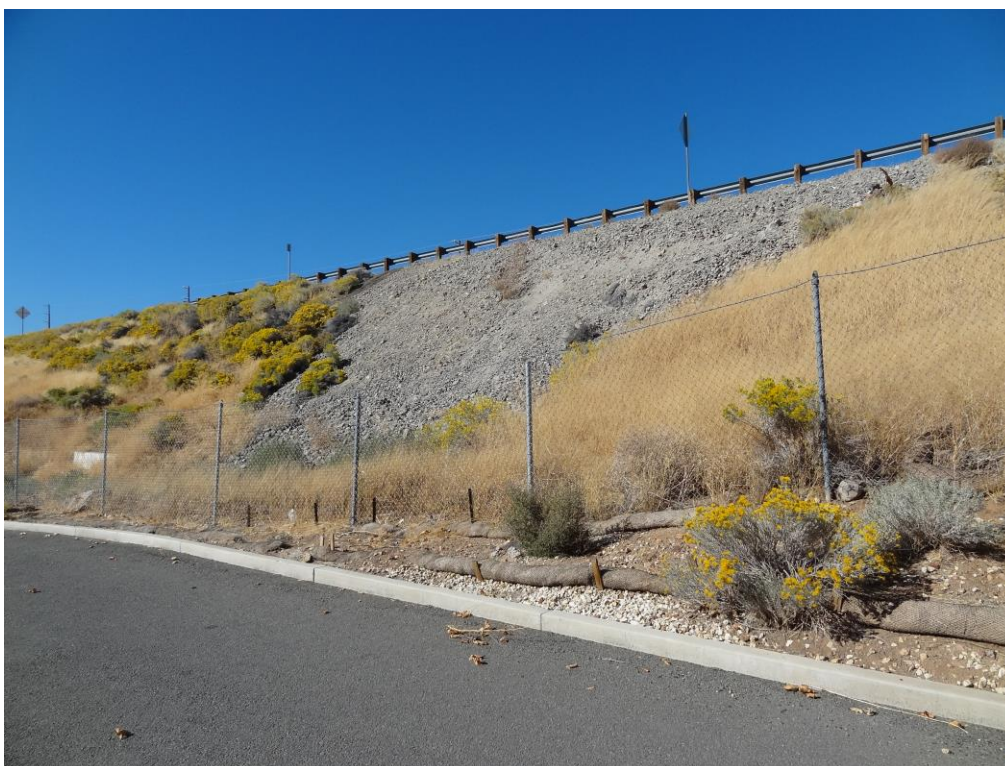
On the north side of the building, the dirt bank between the building and McCarran Blvd is eroding considerably. The runoff from McCarran Blvd is exacerbating an already poorly designed drainage area. The dirt bank has spilled over the curb into the access road. There have been several minor improvements accomplished to control the situation, but it is apparent that a major improvement must happen to protect the road, parking and the building from permanent damage. This project recommends installing a retaining wall near the curb to provide proper drainage and erosion control. The estimate is based on a 300 foot long, 4'-0" high reinforced concrete masonry unit retaining wall. This project or a portion thereof was previously recommended in the FCA report dated 05/19/2011. It has been amended accordingly to reflect conditions observed during the most recent survey date of 10/24/2017.

Nevada Early Intervention Services Site - Site #9859
Description: Additional Erosion Control Needed.

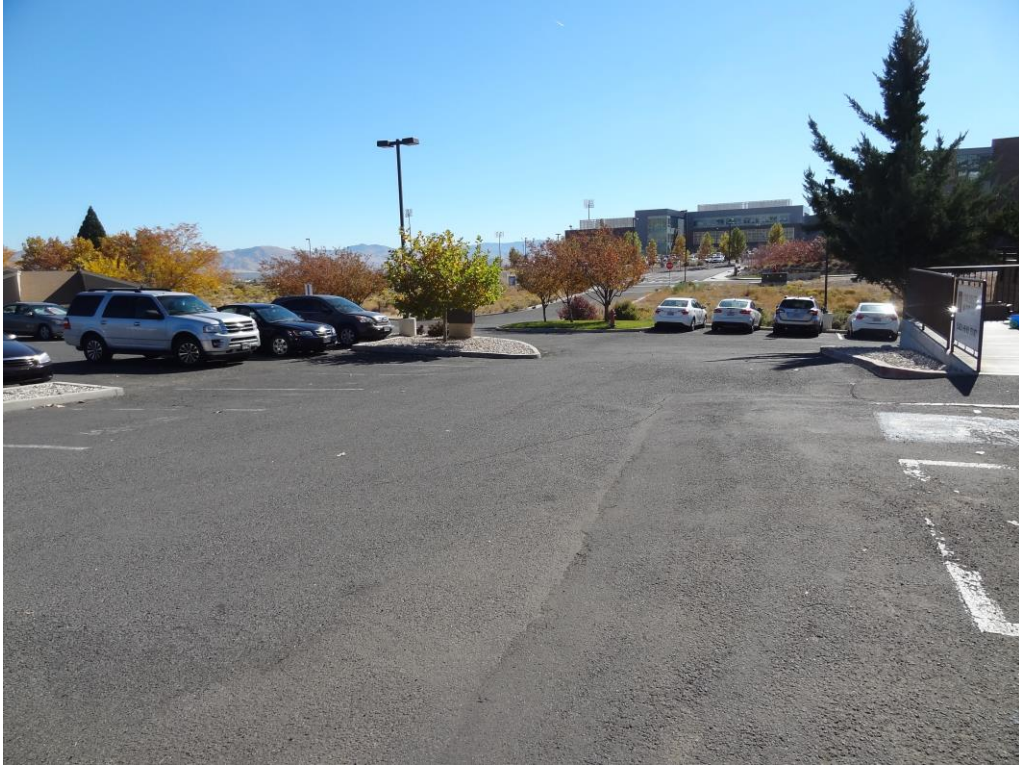
Nevada Early Intervention Services Site - Site #9859
Description: Slurry Seal & Striping Needed.

It is important to maintain the asphalt concrete paving on the site. This project would provide for minor crack filling and slurry sealing of the paving site wide including access roads and parking areas. Striping is included in this estimate. This project should be scheduled on a 5 year cyclical basis to maintain the integrity of the paving and prevent premature failure. 60,000 square feet of asphalt area was used to generate this estimate.

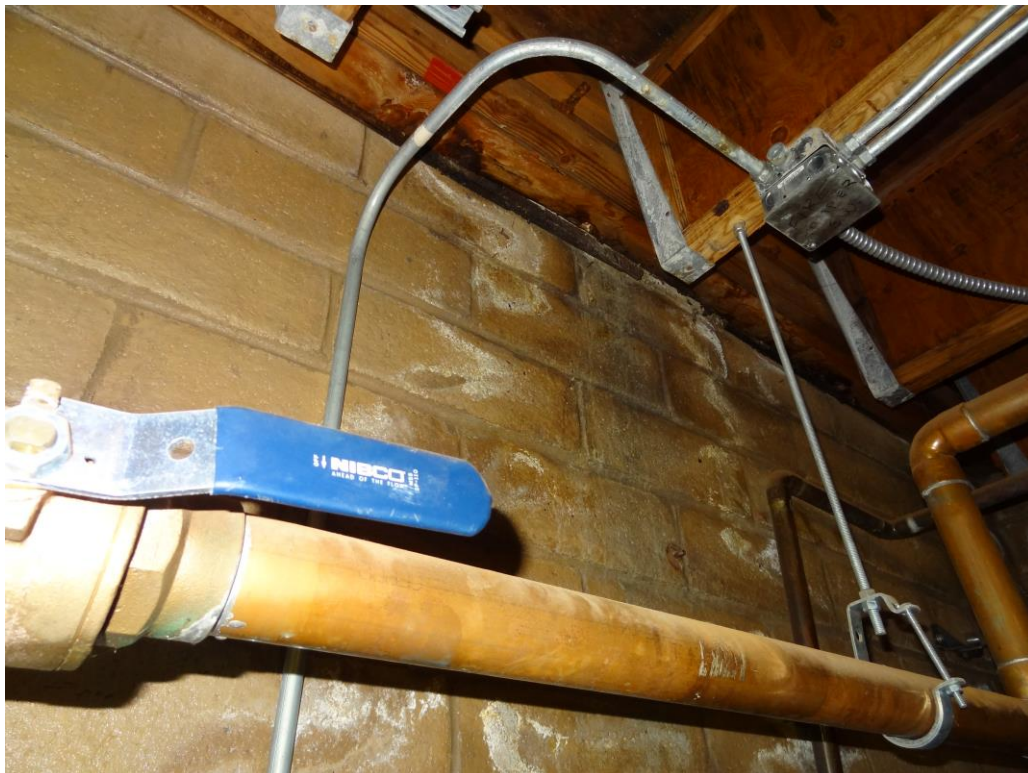
The south facing exterior wall experiences water weeping through it during inclement weather. The water infiltration can be seen on the interior of the brick masonry wall and the most extensive weeping occurs directly below the roof scuppers. This project provides for waterproofing the exterior wall and decks by applying sealant and caulking and extending the roof scuppers and deck scuppers to grade rather than draining down the sides of the walls.

Nevada Early Intervention Services - Building #0515
Description: Evidence of Water Leaks – Waterproofing Upgrades.

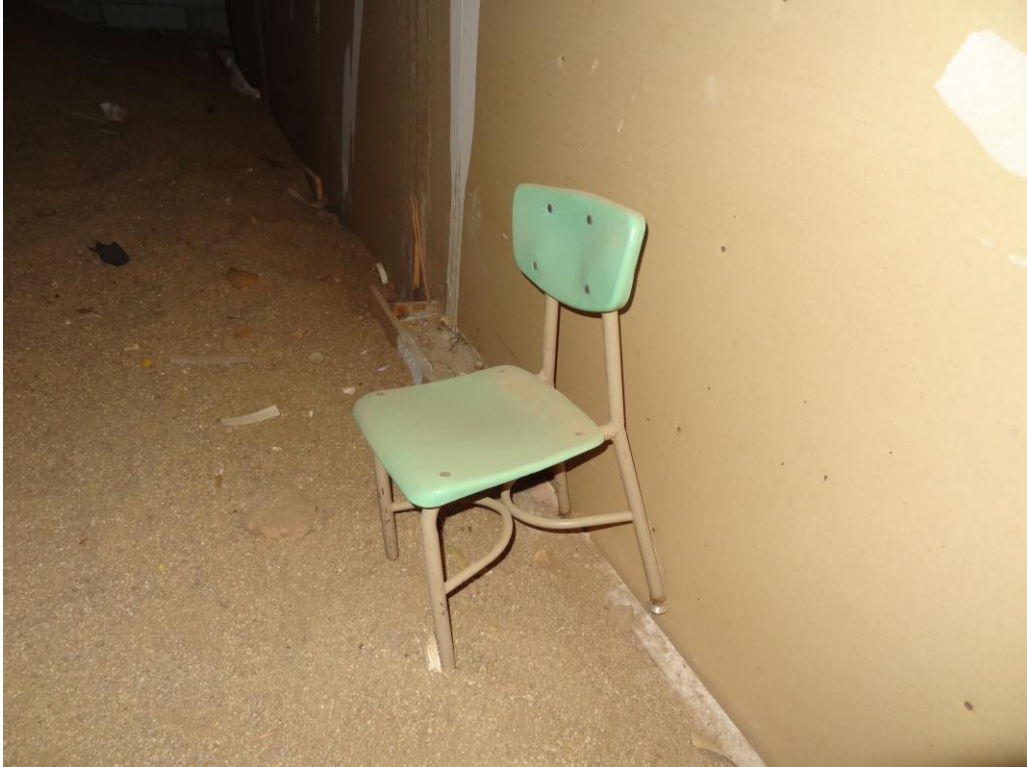
There are locations in the crawlspace where soils are in contact with wood and gypsum board materials. 2018 IBC Section 2304.12 Protection Against Decay and Termites requires a minimum of 8" clearance between the earth and wood structural members. This project provides for the removal of excess soils and to provide the required soil clearances.

Nevada Early Intervention Services - Building #0515
Description: Regrade Crawlspace Needed .

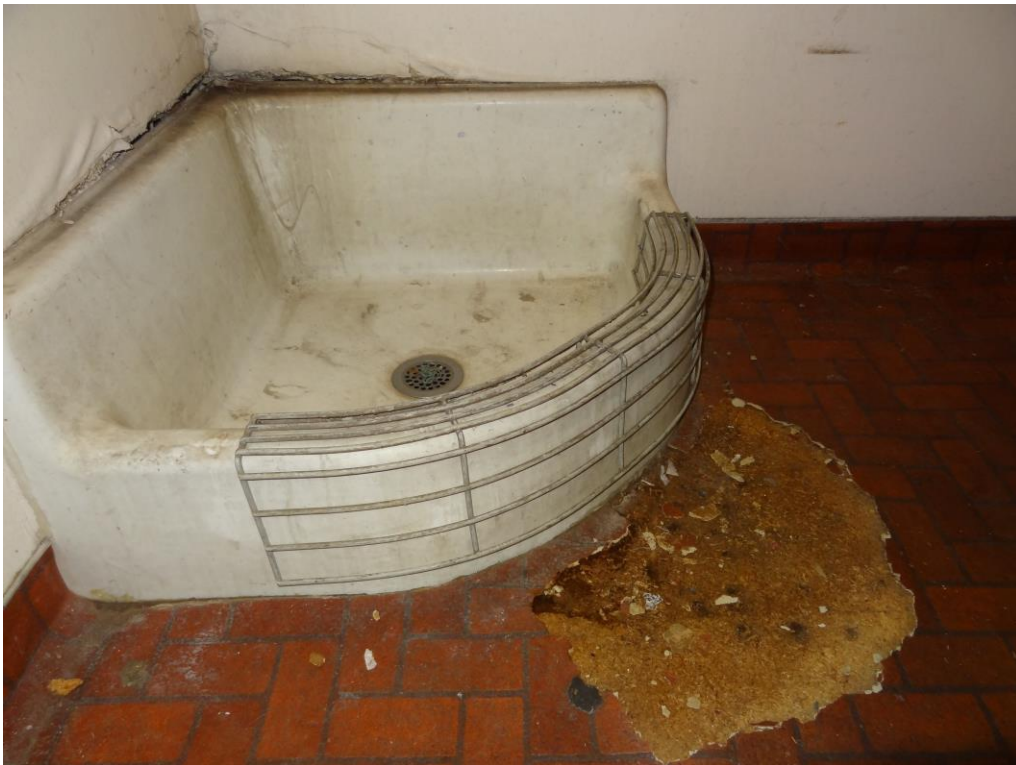
The mop sink in the Janitor Closet is mounted adjacent to gypsum board and is showing signs of water damage. This project would provide fiberglass reinforced panels (FRP) to be installed on the walls adjacent to the mop sink. The FRP shall extend two feet beyond the edge of the sink and a minimum of 54" above the floor finish. This project or a portion thereof was previously recommended in the FCA report dated 05/19/2011. It has been amended accordingly to reflect conditions observed during the most recent survey date of 10/24/2017.

Nevada Early Intervention Services - Building #0515
Description: Janitors Closet Repairs.

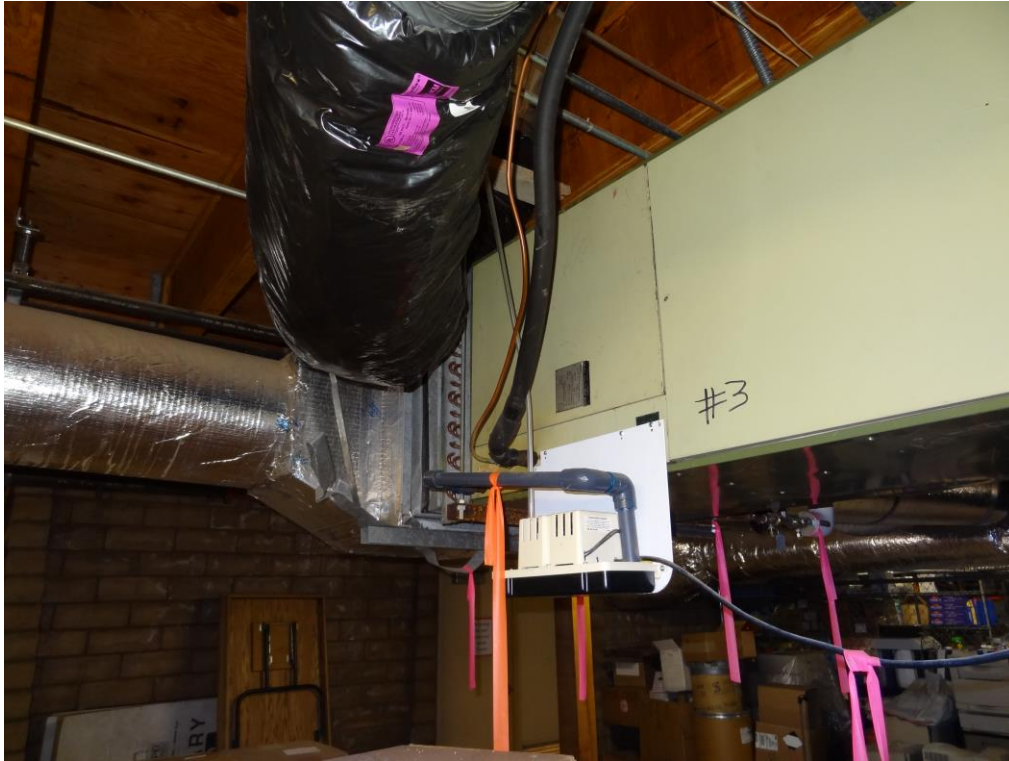
The HVAC system is original to the building and should be scheduled for replacement. It is not energy efficient and has reached the end of its expected and useful life. The R-22 refrigerant in the cooling system is no longer EPA compliant and its production is mandated to be phased out completely by January 1, 2020. This project would provide for installation of a new HVAC system, replacing the fiberglass and flexible ducting and cleaning of the duct work and grilles. This project includes removal and disposal of the existing HVAC system and all required connections to utilities.

Nevada Early Intervention Services - Building #0515
Description: HVAC Replacement.

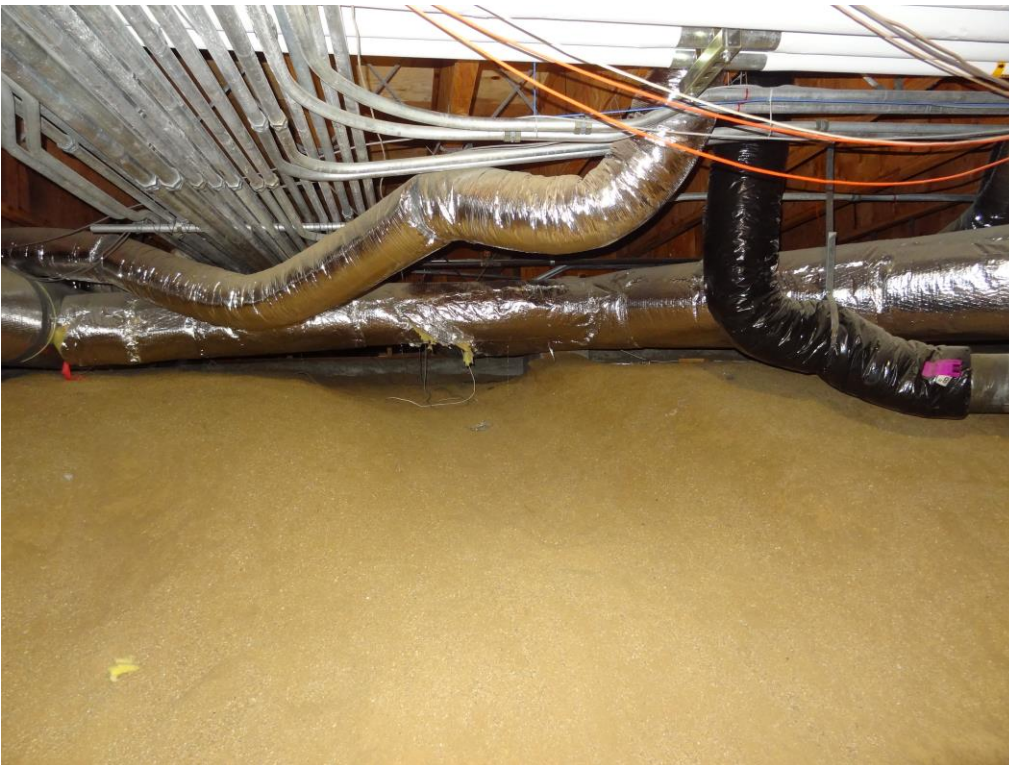
Nevada Early Intervention Services - Building #0515
Description: Fiberglass & Flex Replacement Needed.
