Department of Health & Human Services
Division of Child & Family Services
Nevada Early Intervention Services
Facility Condition Analysis

NEVADA EARLY INTERVENTION SERVICES

Site Number: 9859

**STATE OF NEVADA PUBLIC WORKS DIVISION
FACILITY CONDITION ANALYSIS**

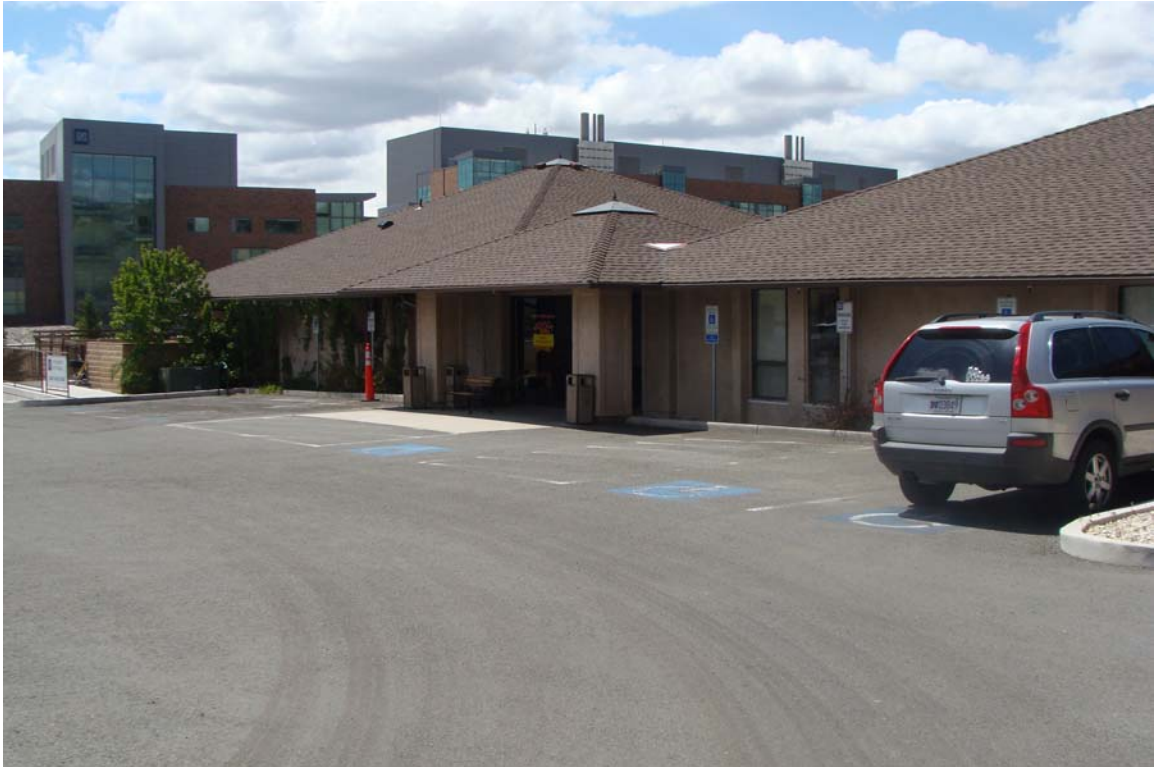
Nevada Early Intervention Services Site - Site #9859
Description: ADA accessible parking at building entrance.

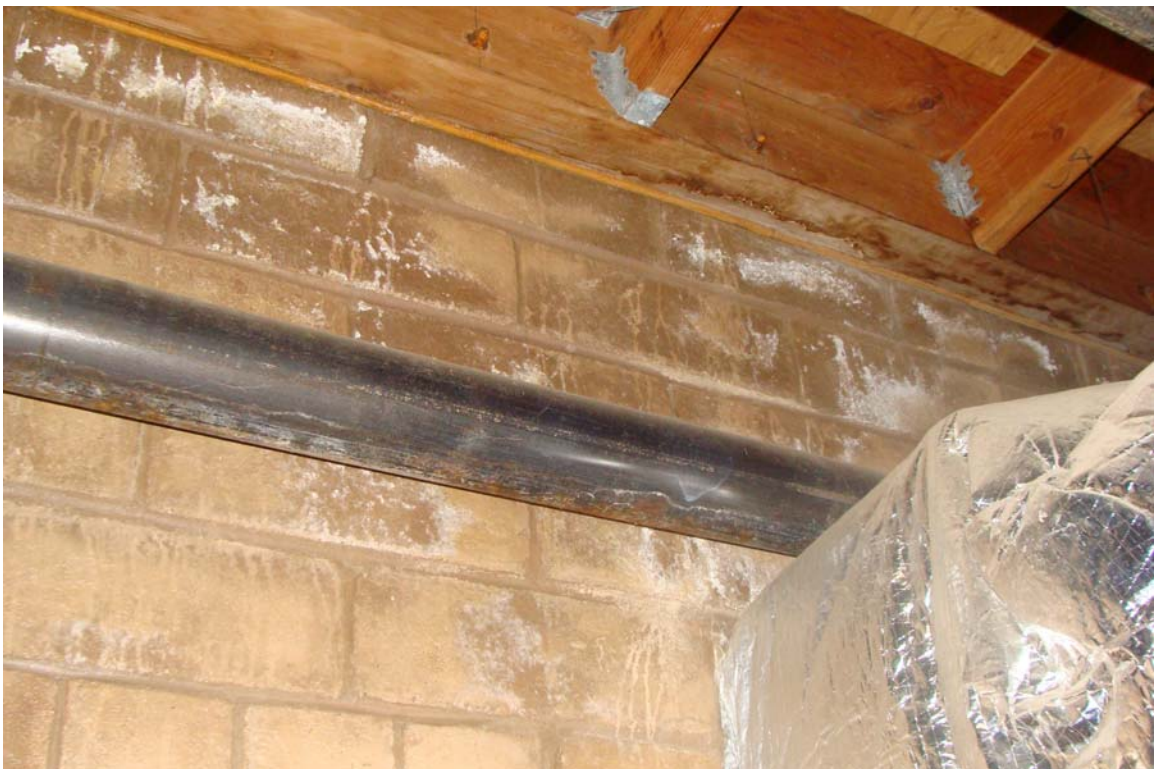
The south facing exterior wall experiences water weeping through it during inclement weather. The water infiltration can be seen on the interior of the brick masonry wall and the most extensive weeping occurs directly below the roof scuppers. This project provides for waterproofing the exterior wall and decks by applying sealant and caulking and extending the roof scuppers and deck scuppers to grade rather than draining down the sides of the walls.

Nevada Early Intervention Services - Building #0515
Description: Evidence of water leaks.

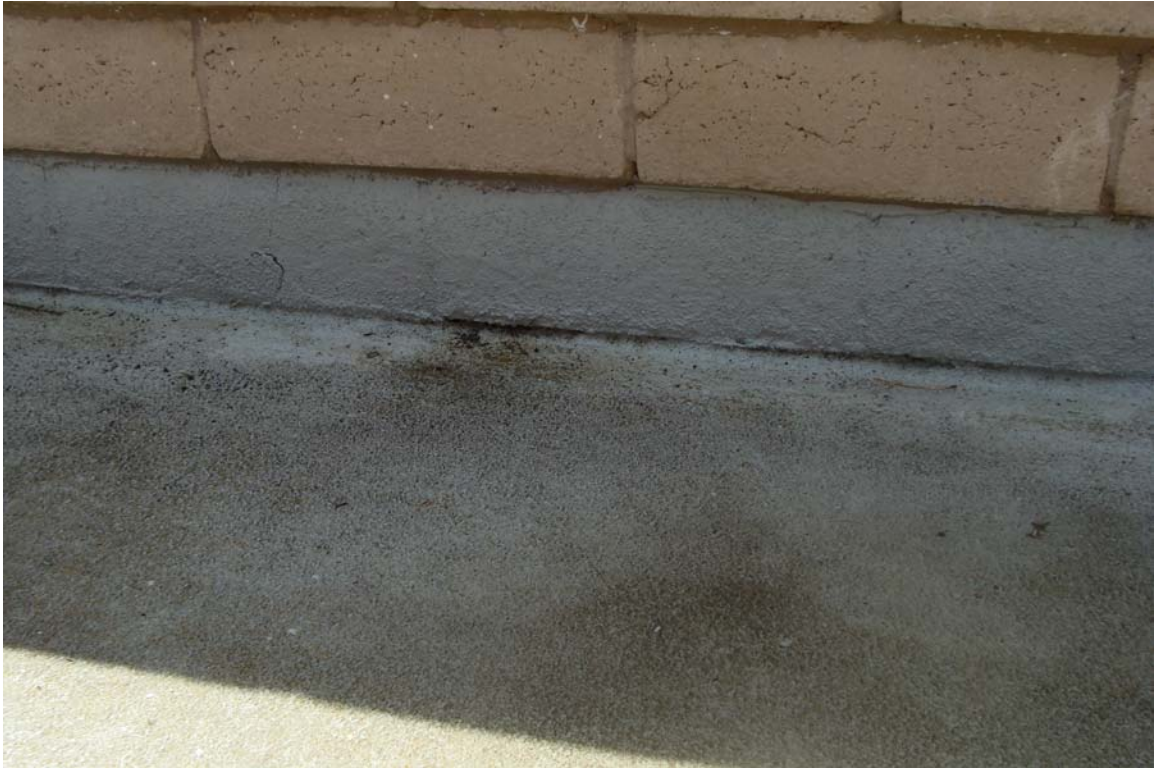
Nevada Early Intervention Services - Building #0515
Description: Area of possible water infiltration at exterior deck.

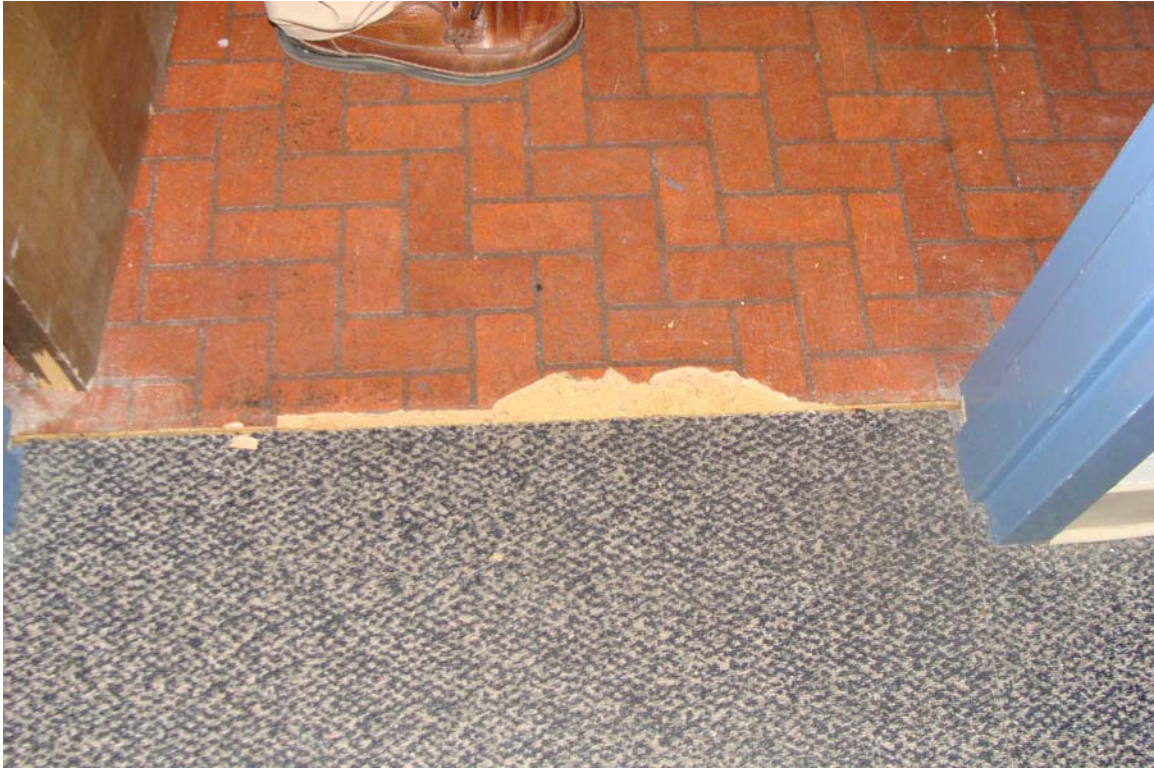
Nevada Early Intervention Services - Building #0515
Description: Typical worn flooring in original area of building.

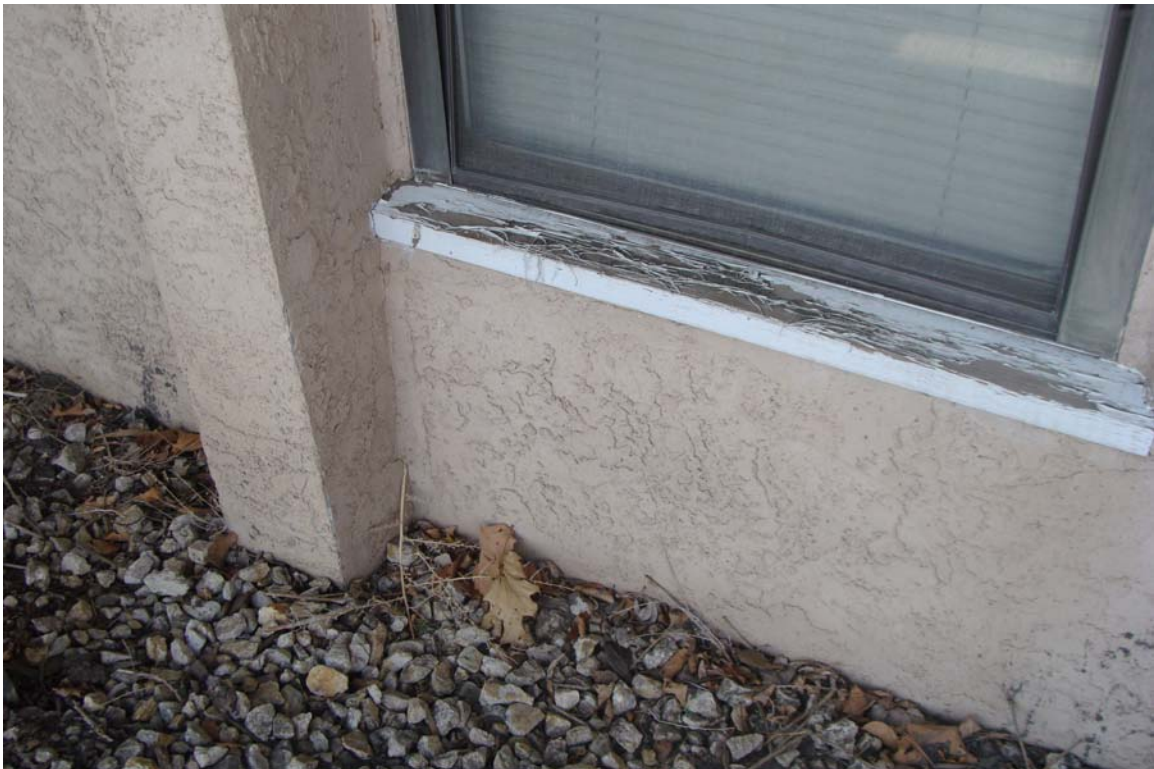
Nevada Early Intervention Services - Building #0515
Description: Window trim in need of paint.

It is important to maintain the finish, weather resistance and appearance of the building. This project would provide funding to protect the exterior of the building excluding the roof. Included in the cost is power washing the entire building, priming and painting the stucco and trim and caulking of the windows, flashing, fixtures and all other penetrations. It is recommended that the building be painted in the next 3-4 years and that this project be scheduled on a cyclical basis to maintain the integrity of the structure.
