State of Nevada
Department of Administration
Division of Buildings & Grounds
Blasdel Office Building
Facility Condition Analysis

BLASDEL OFFICE BUILDING

209 East Musser Street
Carson City, Nevada 89701

Site Number: 9960
STATE OF NEVADA PUBLIC WORKS BOARD
FACILITY CONDITION ANALYSIS

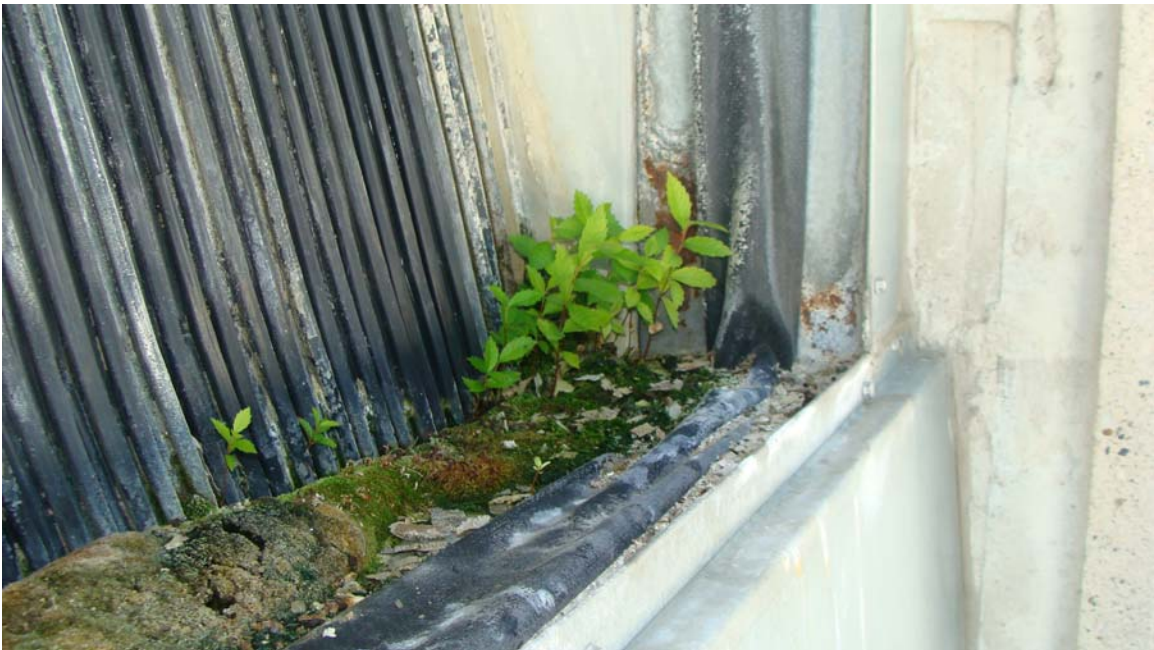
Blasdel Office Building - Building #0200
Description: Plant growth at cooling tower exhaust.

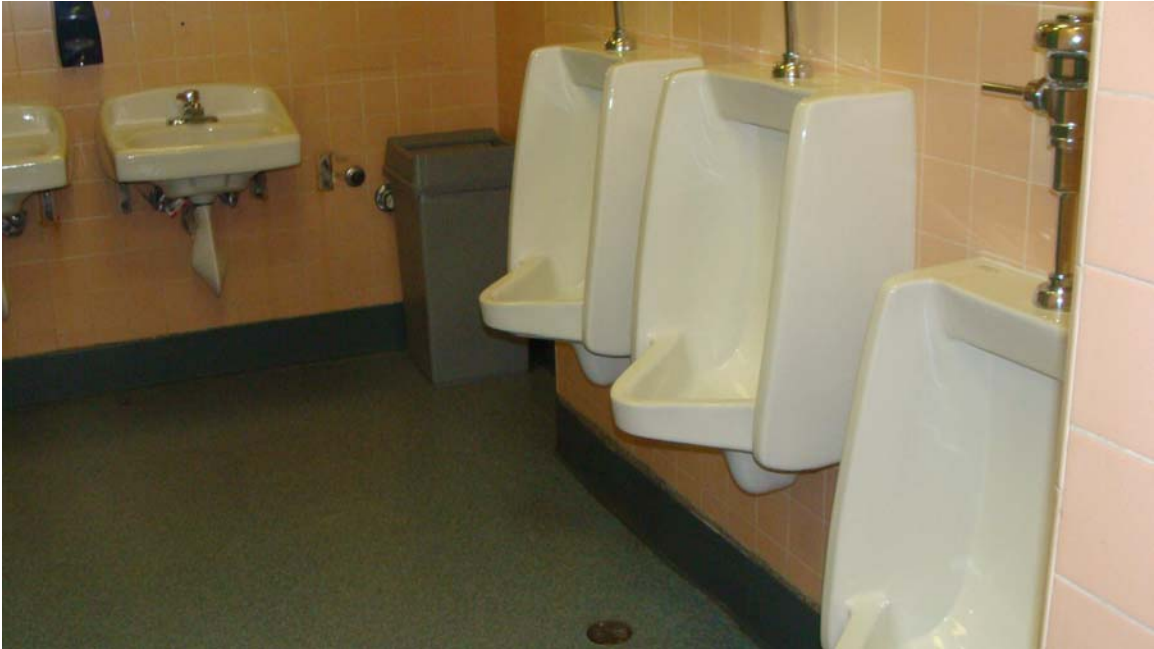
The Men's and Women's designated ADA restrooms on the first floor do not fully meet the Americans with Disabilities Act (ADA) requirements. The restrooms on the second and third floors should be remodeled to comply with the ADA as well. A complete retrofit is necessary on all four restrooms on the second and third levels including new partitions, water closets, urinals, lavatories, faucets, handles and any other necessary fixtures and finishes and minor modifications to the first floor designated ADA restrooms. This project would provide funding to bring all of the restrooms into ADA compliance. NRS 338.180, IBC - 2006, ICC/ANSI A117.1 - 2003 and Americans with Disabilities Act Accessibility Guidelines (ADAAG) - 2003 were referenced for this project.

Blasdel Office Building - Building #0200
Description: Men's restroom in need of ADA upgrades.
