State of Nevada
Department of Administration
Public Works Division / Buildings & Grounds Section

CARSON CITY STATE OFFICES SITE

Site Number: 9864
STATE OF NEVADA PUBLIC WORKS DIVISION
FACILITY CONDITION ANALYSIS

Report distributed in November 2021

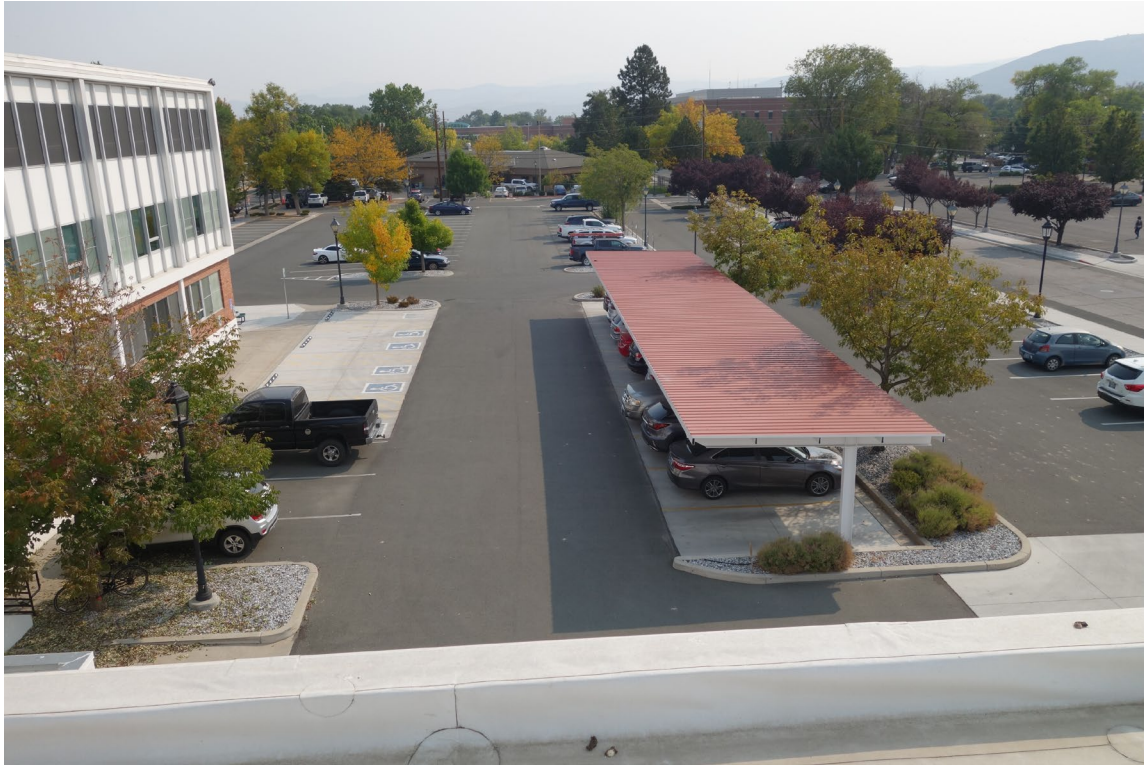
Carson City State Offices Site - Site #9864, Building #3110
 Description: Site Parking, New Paving East Parking, and Carport.

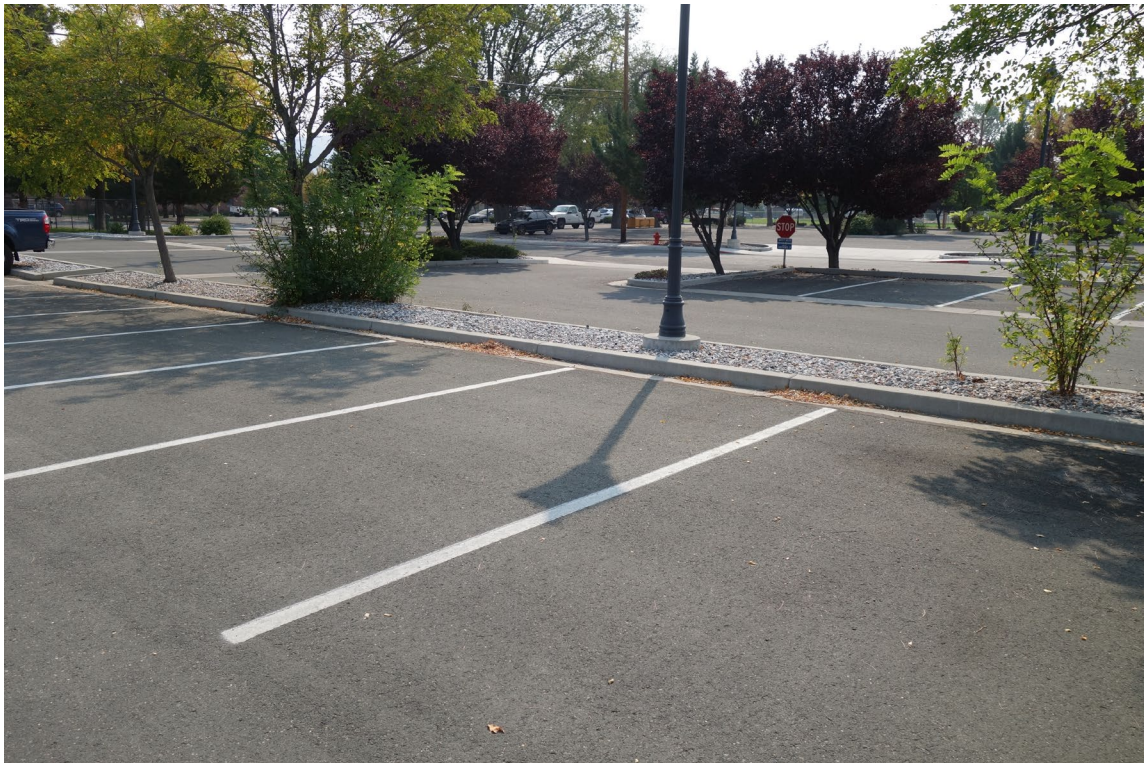
Carson City State Offices Site - Site #9864
 Description: Site Parking New Paving.

It is important to maintain the asphalt concrete paving on the site. This project would provide for minor crack filling and sealing of the paving site wide including access roads, parking areas, and the maintenance yard. Striping is included in this estimate. This project should be scheduled on a 5 year cyclical basis to maintain the integrity of the paving and prevent premature failure. 30,000 square feet of asphalt area were used to generate this estimate.

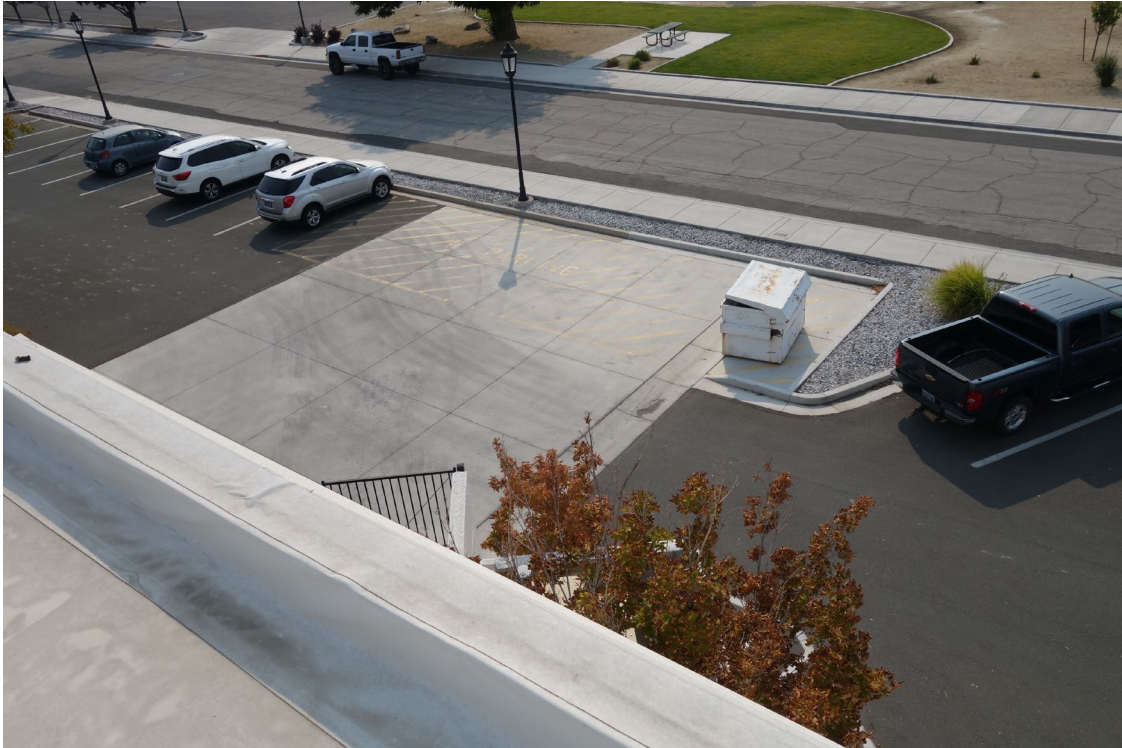
Carson City State Offices Site - Site #9864
Description: Dumpster Area Concrete Paving.

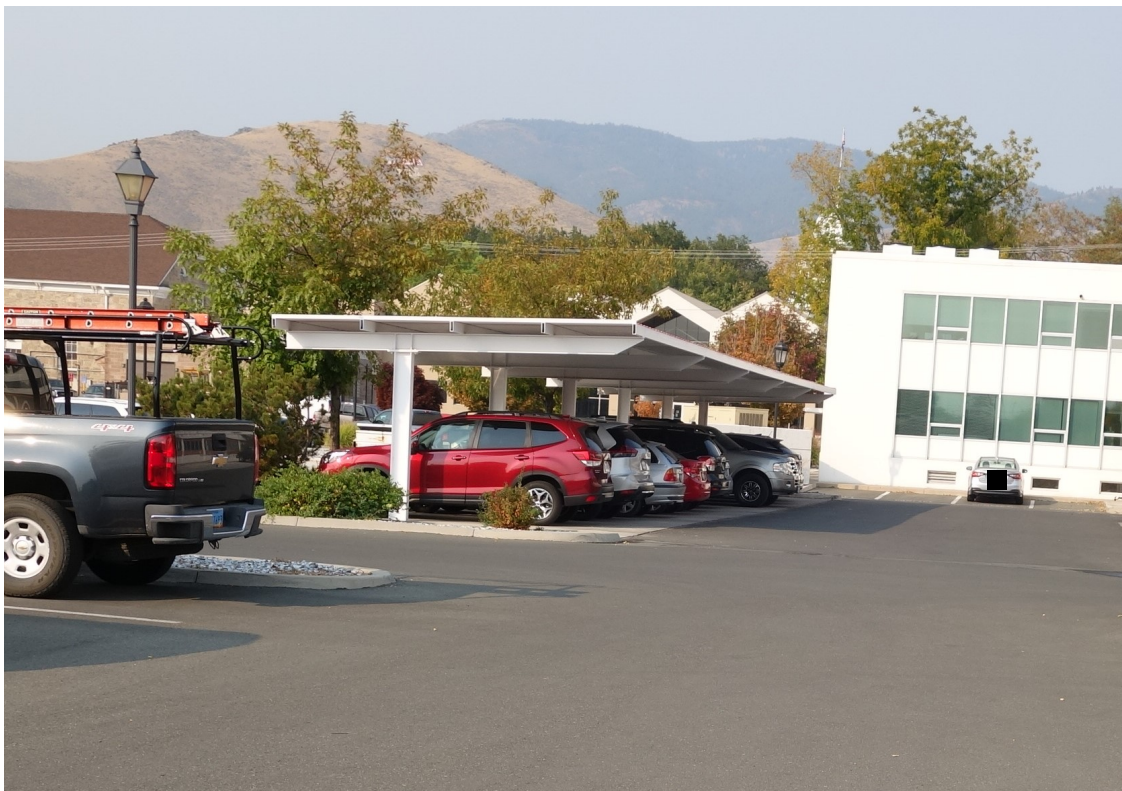
Carson City State Offices Site - Building #3110
Description: View of Carport.

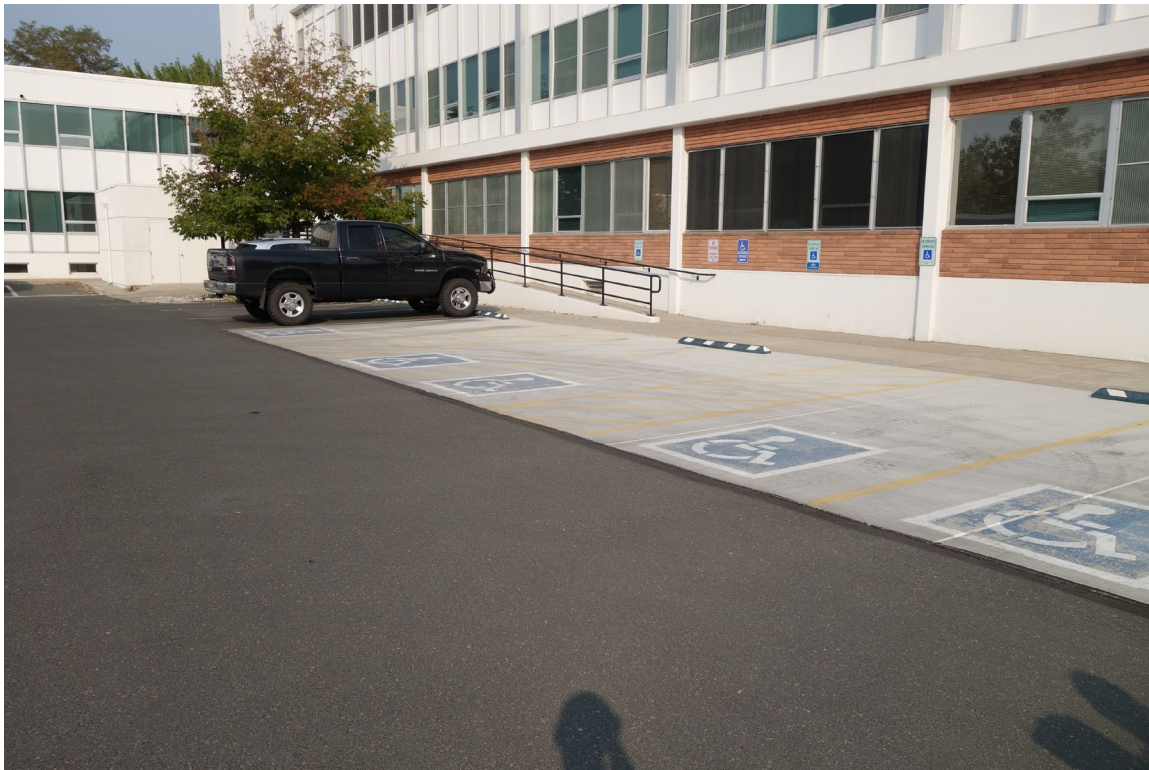
Carson City State Offices Building - Building #0397
Description: View of Concrete ADA Parking.

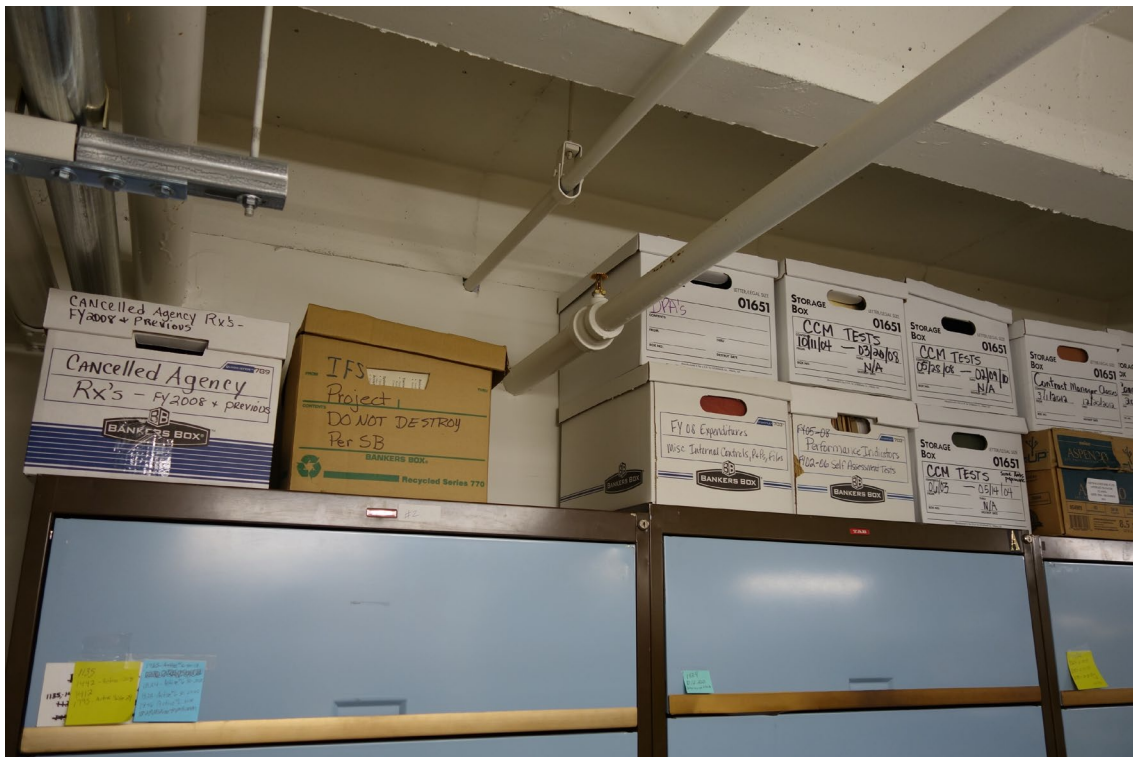
The upright sprinkler heads do not appear to have the correct clearance to obstructions as required by NFPA 13 as referenced in 2018 IFC Section 903.3.1. It is recommended that 18" of clearance be provided to combustibles; however, there are exceptions to this requirement and consultation with the AHJ (Authority Having Jurisdiction, in this case State Fire Marshal) is recommended. This project would fund the purchase of additional storage cabinets and relay out of the storage area to accommodate the required fire sprinkler clearance.

Carson City State Offices Building - Building #0397
Description: Fire Sprinkler Head Obstruction.

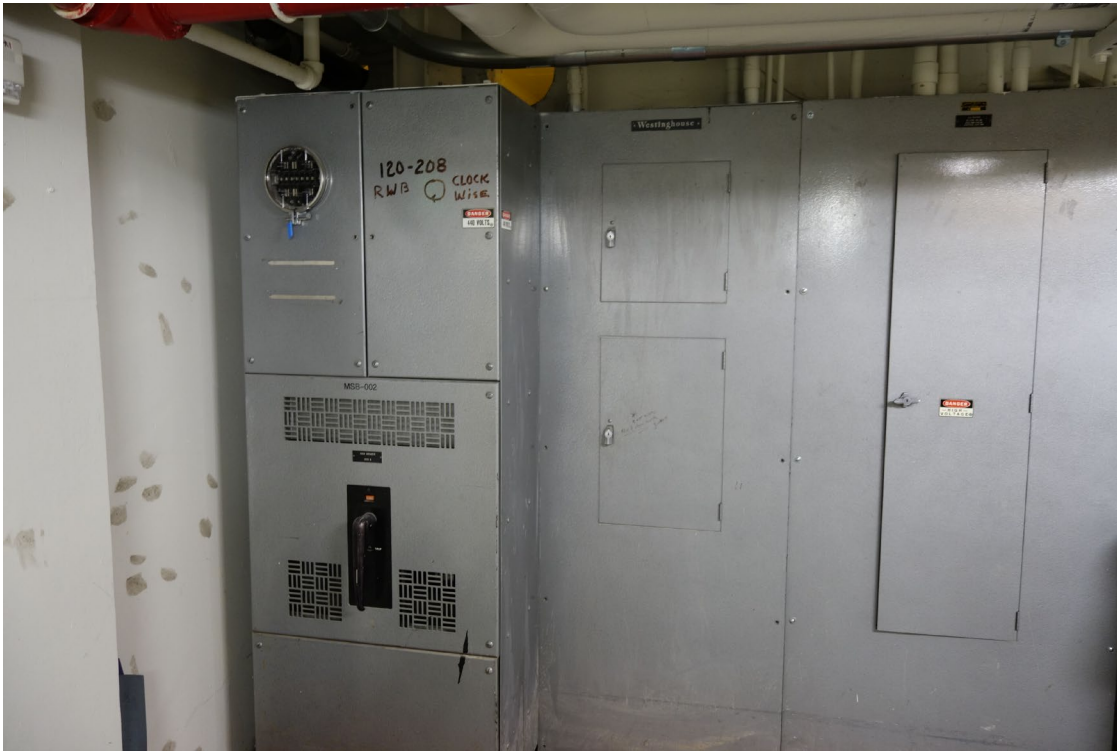
At the time of the survey, it was noted that the electrical service entrance switchgear has been replaced. However, some distribution boards in the basement appear to be original to the construction of the building. It is recommended that an electrical coordination and arc flash study be performed to ensure electrical safety. Electrical hardware infrastructure upgrades have not been included in this estimate.

Carson City State Offices Building - Building #0397
Description: Electrical Arc Flash & Coordination Study Needed.

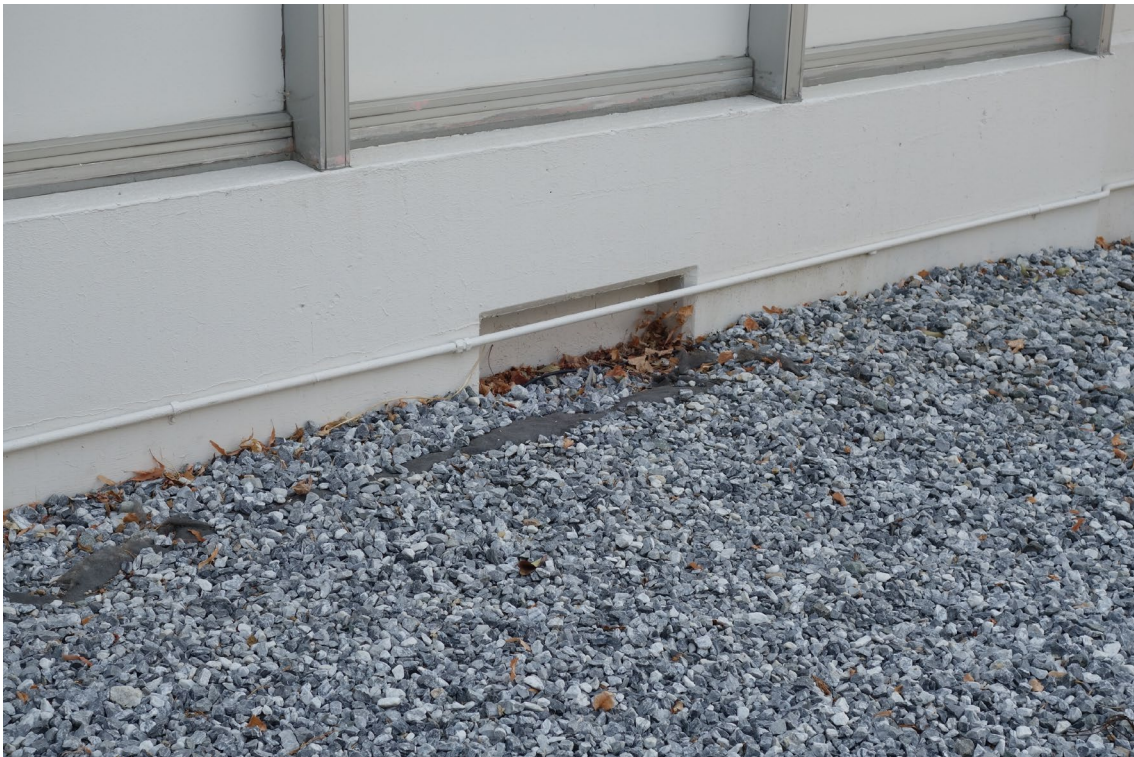
The grade on the west side of the building does not slope away from the building effectively which could allow water to infiltrate the basement window openings. This project would create positive flow away from the building by regrading and reinstallation of landscaping as needed.

Carson City State Offices Building - Building #0397
Description: Building Drainage Upgrade, West Side.

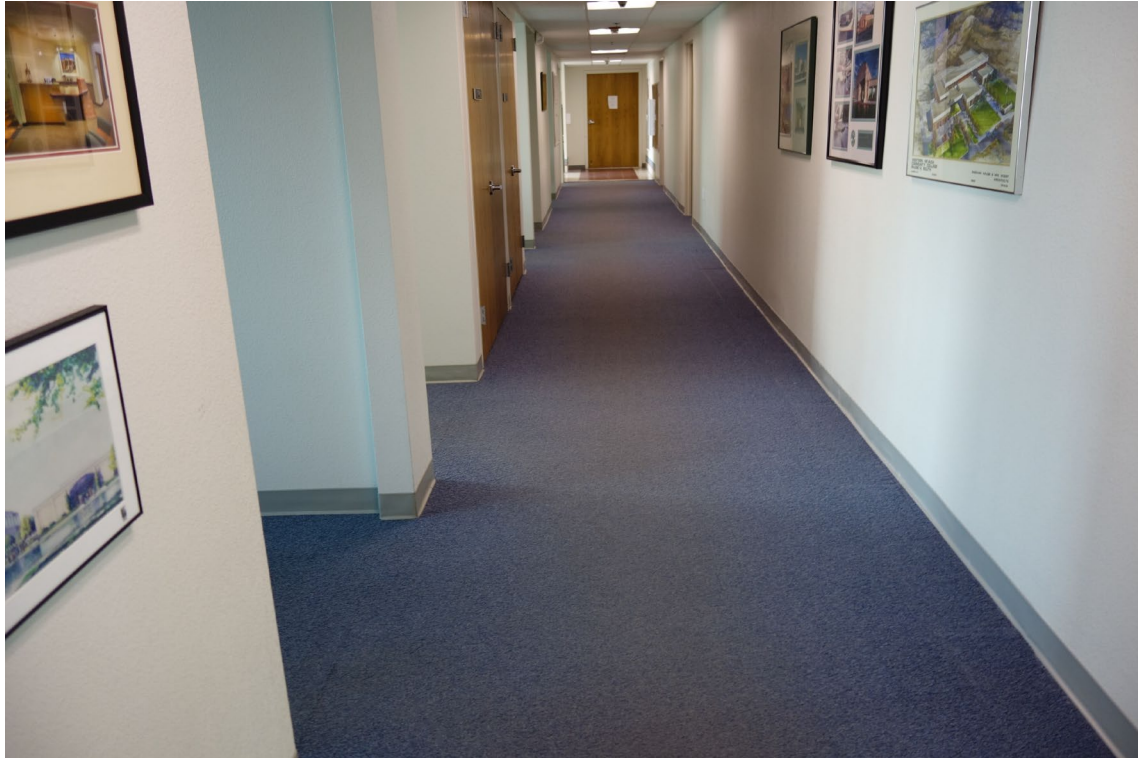
Carson City State Offices Building - Building #0397
Description: Ground Floor, View of Interior.

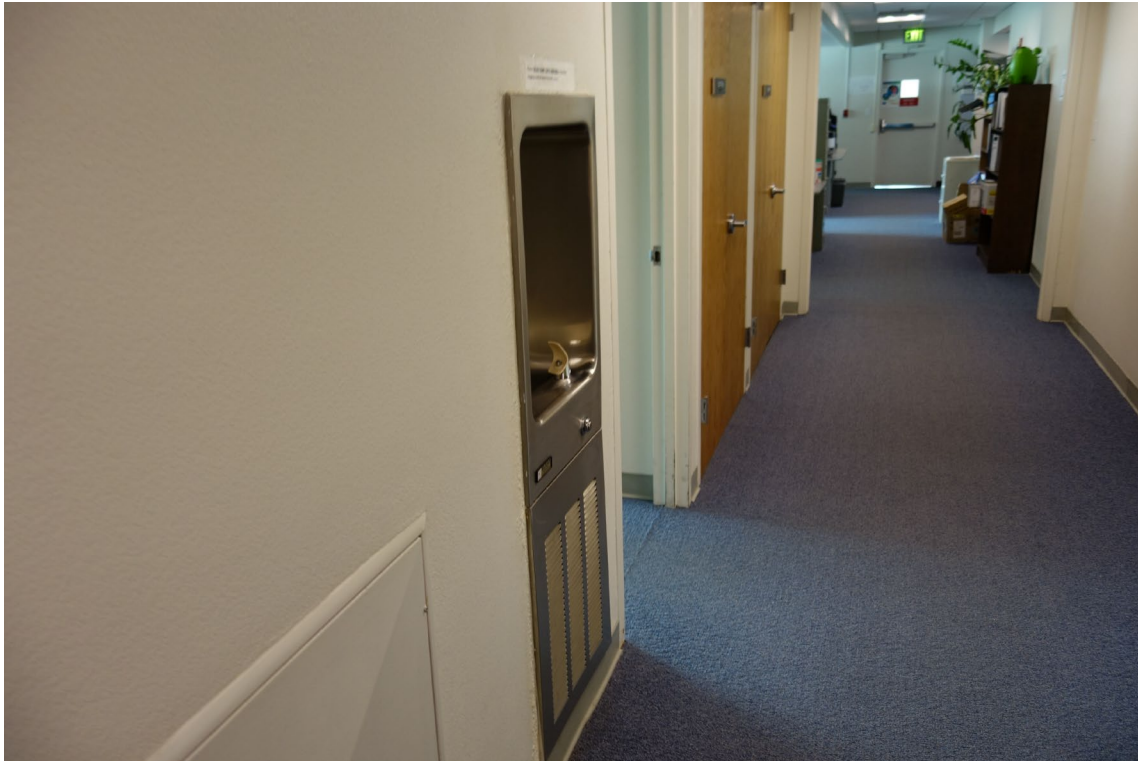
Carson City State Offices Building - Building #0397
Description: 2nd Floor, View of Interior.

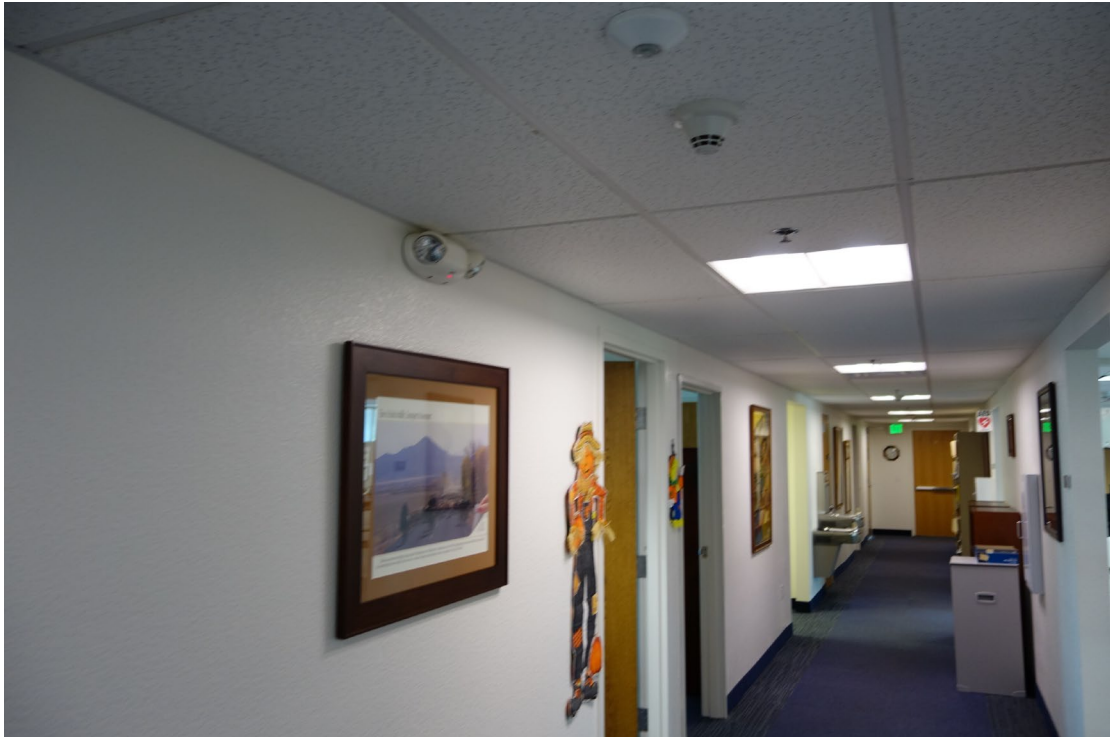
Carson City State Offices Building - Building #0397
Description: 3rd Floor, View of Interior.

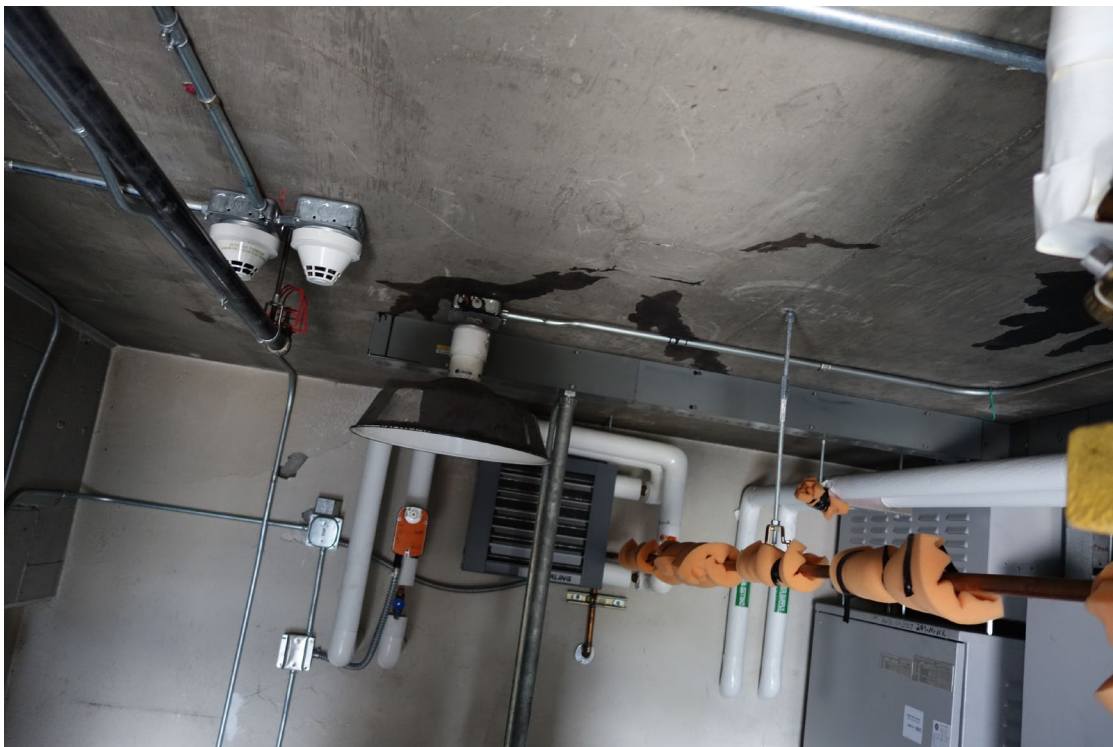
Roof leaks are evident on the ceiling of the 4th floor penthouse mechanical room need to be repaired. This project will fund the investigation and repair of the single ply roofing system.

Carson City State Offices Building - Building #0397
Description: 4th Floor, Roof Leak Repairs.
