NORTH DECATUR DMV SITE

7170 North Decatur Road
Las Vegas, Nevada 89131

Site Number: 9869
STATE OF NEVADA PUBLIC WORKS DIVISION
FACILITY CONDITION ANALYSIS

Report distributed in October 2021

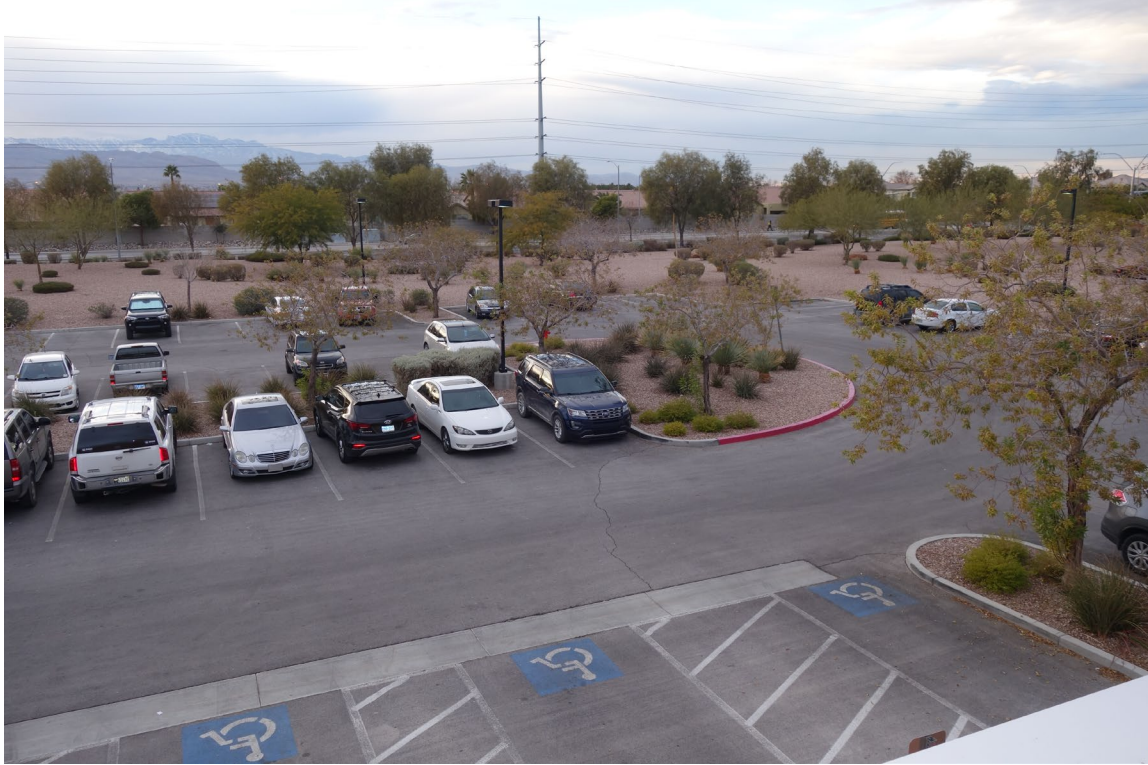
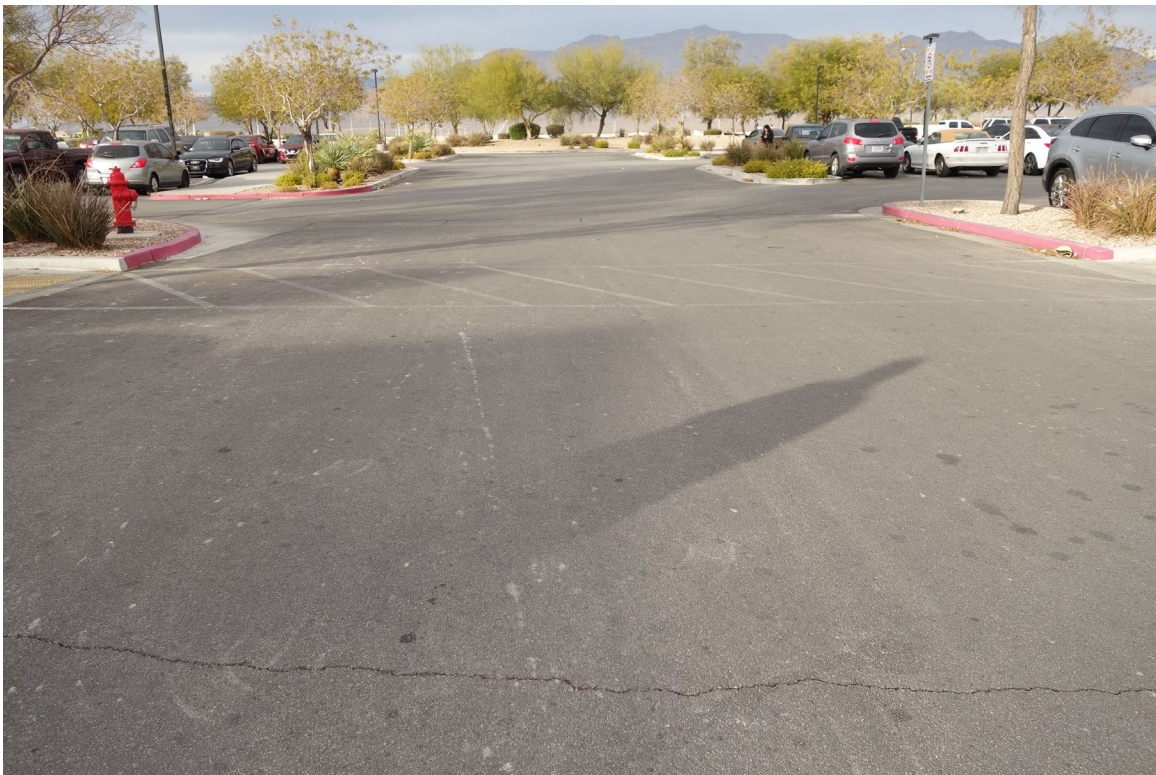
North Decatur DMV Site - Site #9869
Description: View of the North Parking Area.

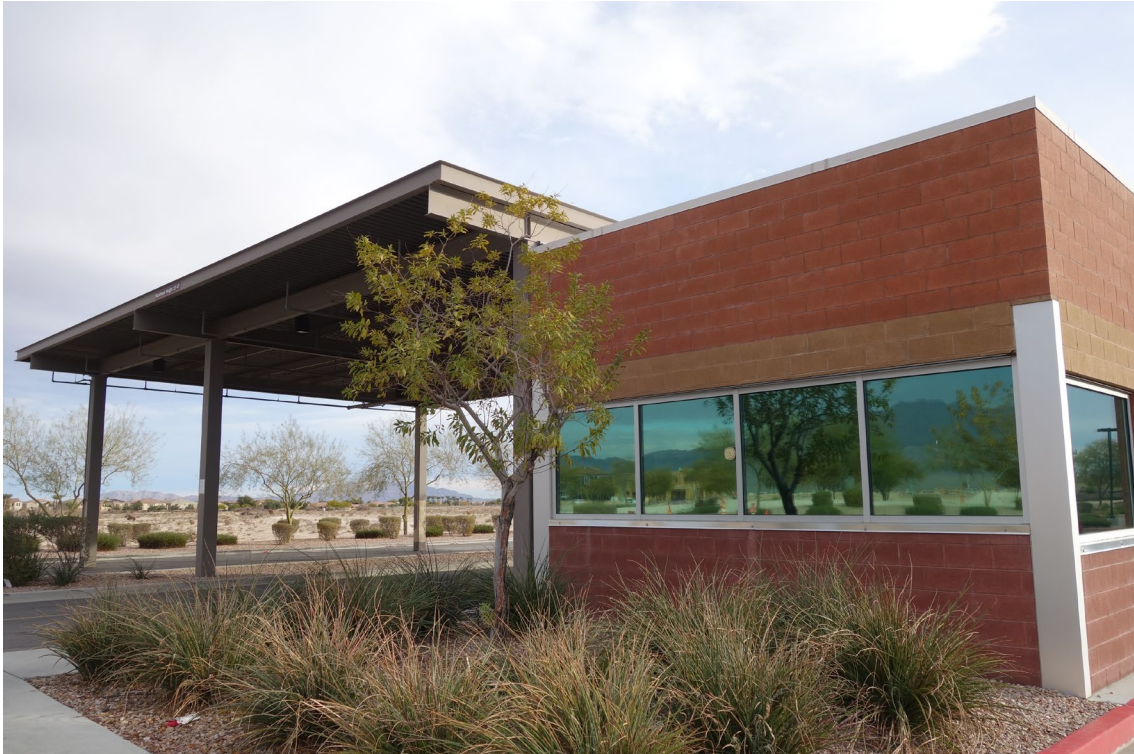
The exterior finishes were in fair condition. It is important to maintain the finish, weather resistance and appearance of the building. This project would provide funding to protect the exterior of the building excluding the roof. Included in the cost is cleaning and sealing the concrete masonry units and caulking of the windows, flashing, fixtures and all other penetrations. It is recommended that the building finishes are addressed in the next 2-3 years and that this project be scheduled on a cyclical basis to maintain the integrity of the structure.

DMV Inspection Station - Building #2454
Description: Exterior of the Building.

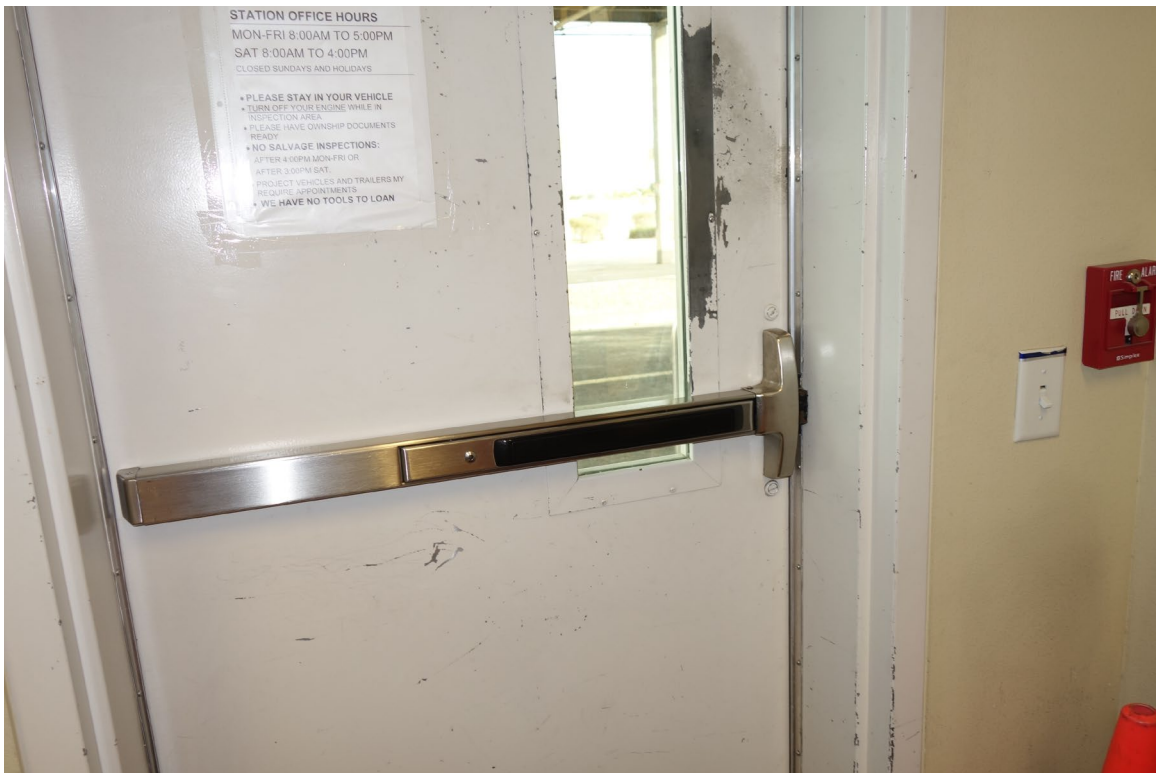
The interior finishes are in fair condition, however some metal doors and door frames are in need of repainting. It is recommended that the interior walls and ceilings be painted at least once in the next 5 - 7 years and that this project be scheduled on a cyclical basis to maintain the integrity of the structure. Prior to painting, all surfaces should be repaired and prepped. An epoxy-based paint should be utilized in wet areas for durability.

DMV Inspection Station - Building #2454
Description: Interior Finishes Around Metal Doors.

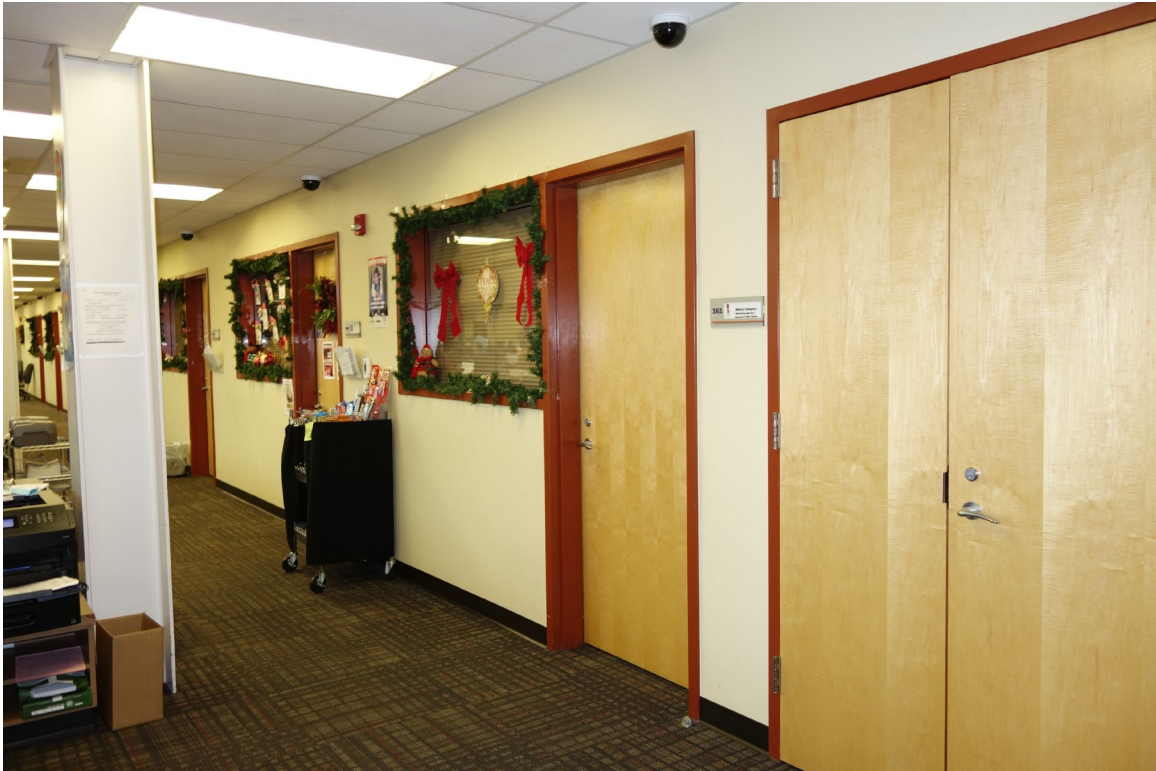
The interior finishes are in fair condition, however some metal doors and door frames are in need of repainting. It is recommended that the interior walls and ceilings be painted at least once in the next 4 -6 years and that this project be scheduled on a cyclical basis to maintain the integrity of the structure. Prior to painting, all surfaces should be repaired and prepped. An epoxy-based paint should be utilized in wet areas for durability.

North Decatur DMV Services Center - Building #2453
Description: View of the Interior Finishes.

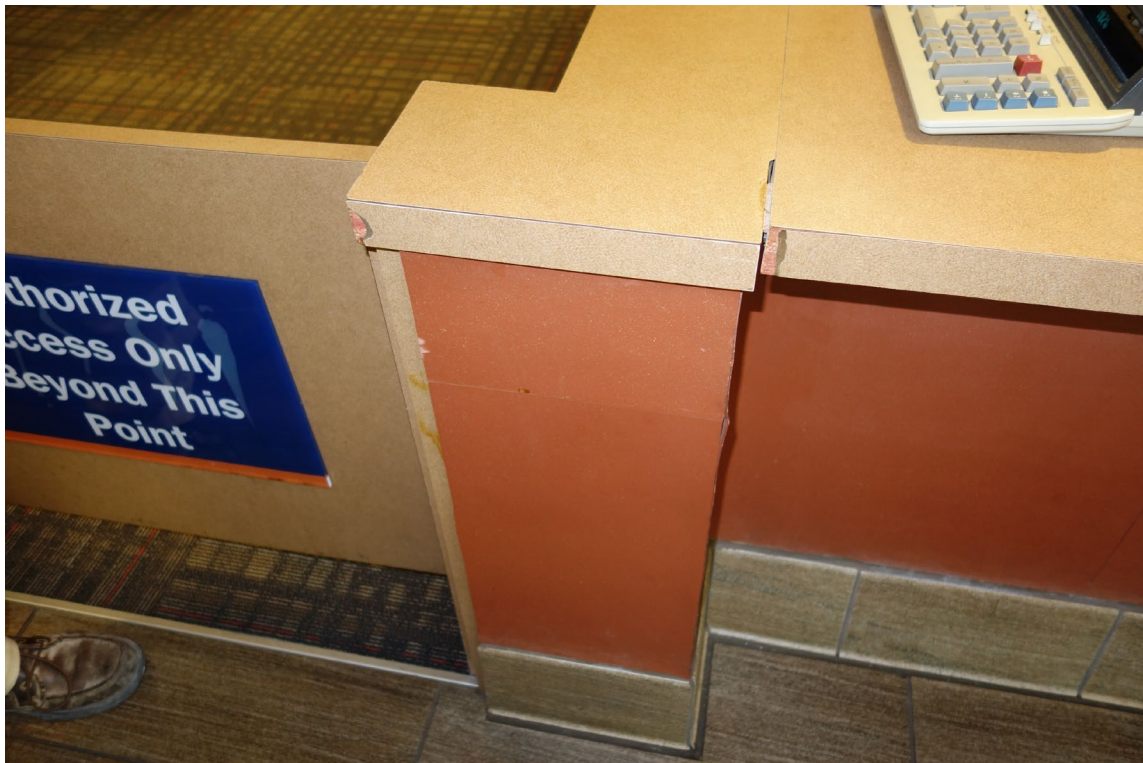
The built-in Customer Service counters and cabinetry are original to the building. The quality of construction and installation was inadequate for the high usage at this facility, and the cabinets and countertops are delaminating and failing. This project recommends the replacement of the existing countertops, cabinets, and associated equipment with heavy duty, quality components. The cabinets should be finished inside and outside with a melamine or similar finish which encapsulates the door, frame, and shelving. ADA compliance according to NRS 338.180, IBC - 2018, ICC/ANSI A117.1 and the most current version of the ADA Standards for Accessible Design should be incorporated into the design such as providing an accessible sink. 100 linear feet of casework was used for this estimate. This estimate includes removal and disposal of the existing materials.

North Decatur DMV Services Center - Building #2453
Description: Customer Service Counters & Casework Upgrade.

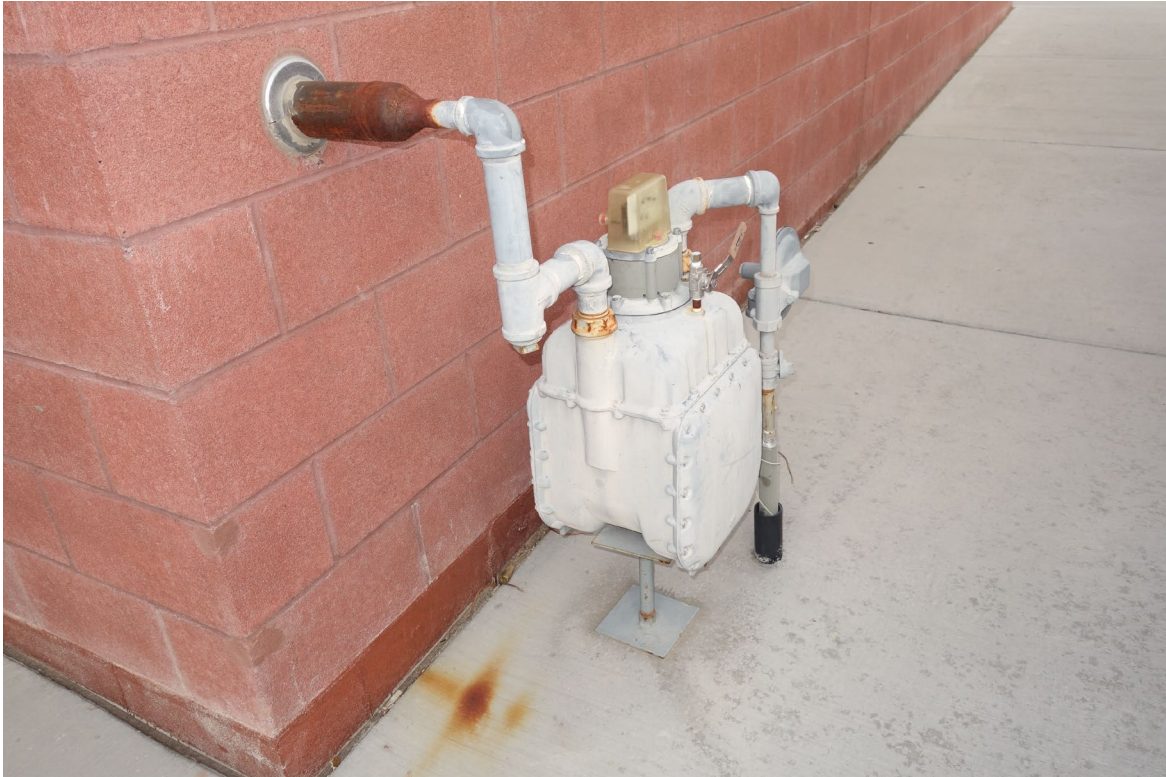
North Decatur DMV Services Center - Building #2453
Description: Seismic Gas Shut-Off Valve Needed.

This project would provide for the installation of a seismic gas shut-off valve on the main gas service piping prior to entering the building. This estimate is based on the manufacturer Pacific Seismic Products or approved equal, equipped with the optional Model MS remote monitoring switch (to be interfaced with the direct digital control system and/or with an audible alarm). The gas piping immediately adjacent to the seismic gas valve shall be secured to the building utilizing unistrut channel bracing.

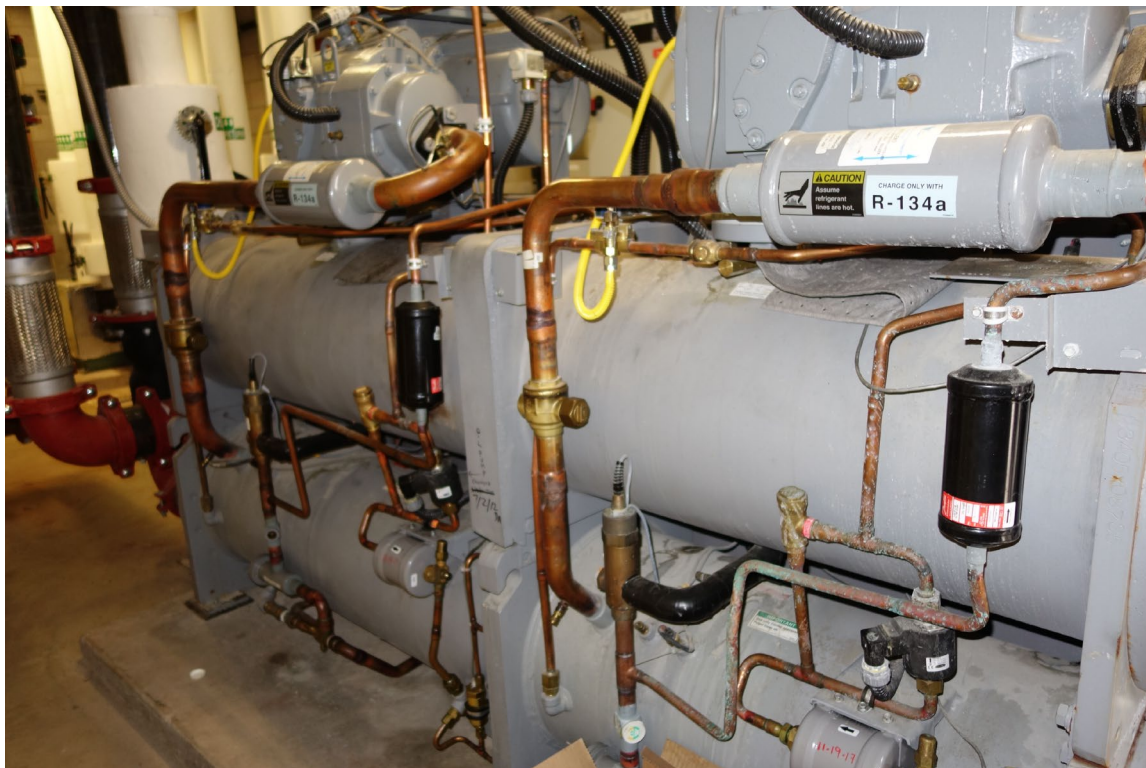
The existing HVAC system was installed in 2006 with the installation of new boilers, chiller, pumps, air handlers, and fan coils. All of this equipment is reaching the end of its useful life and scheduled for replacement in the next 5 - 7 years. This project would provide for replacing the existing equipment with new, high efficiency equipment and cleaning the existing duct work and grilles. This project includes removal and disposal of the existing HVAC units and all required connections to utilities.

North Decatur DMV Services Center - Building #2453
Description: HVAC Central Plant Equipment Nearing End of Useful Life.
