NEVADA STATE MUSEUM INDIAN HILLS SITE

Site Number: 9874
STATE OF NEVADA PUBLIC WORKS DIVISION
FACILITY CONDITION ANALYSIS

Report distributed in December 2021

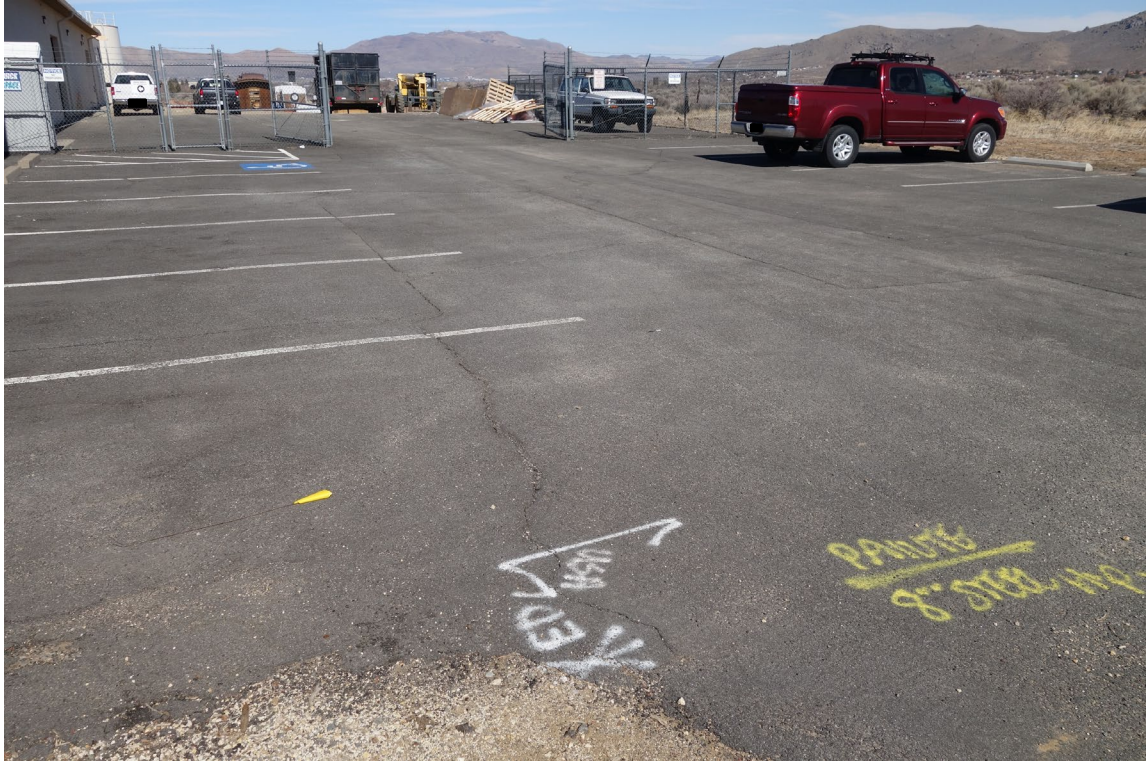
Nevada State Museum Indian Hills Site – FCA Site #9874
Description: Asphalt Crack Fill & Slurry Seal Recommended.

It is important to maintain the asphalt concrete paving on the site. This project would provide for minor crack filling and sealing of the paving site wide including access roads, parking areas and driving test areas. Striping is included in this estimate. This project should be scheduled on a 5 year cyclical basis to maintain the integrity of the paving and prevent premature failure. 35,000 square feet of asphalt area was used to generate this estimate.

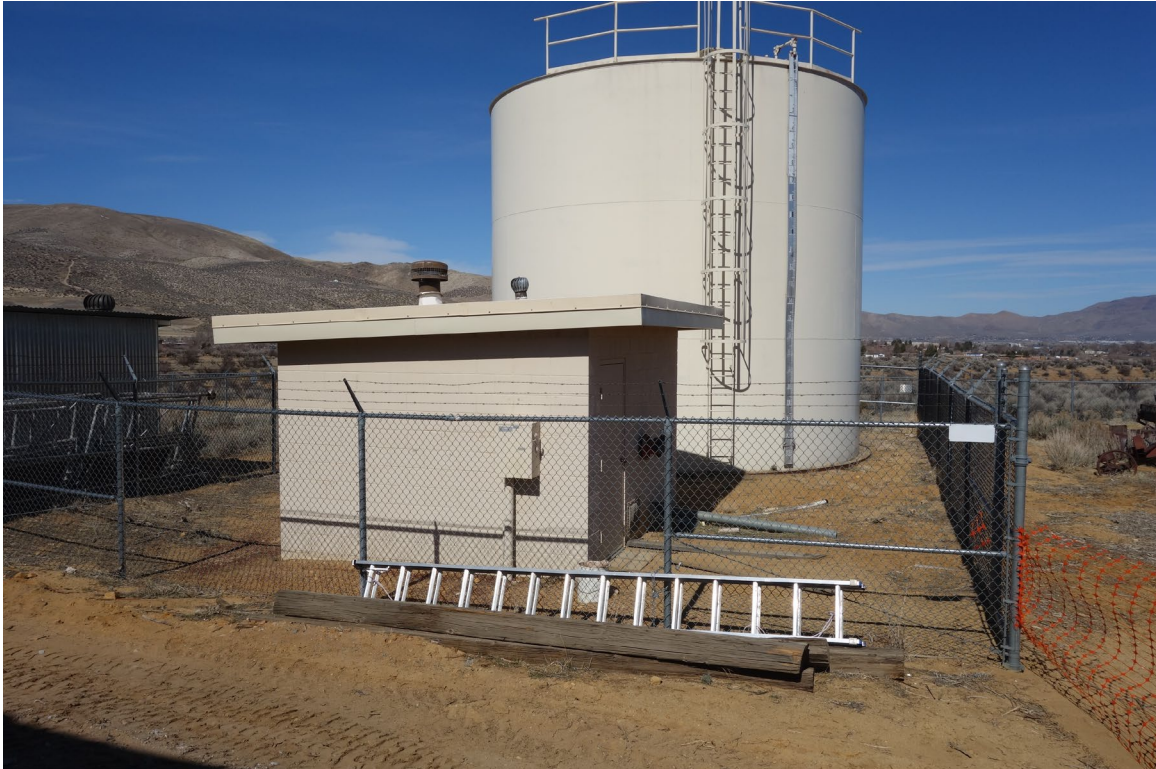
The exterior finish was in fair condition with some touch-up needed in some areas in the next 2 - 3 years. It is important to maintain the finish, weather resistance and appearance of the tank. This project recommends work to protect the exterior tank envelope, including sand blasting, painting, staining, or other applied finishes and other penetrations to maintain the tank in good, weather tight condition. This project should be performed on a cyclical basis.

Indian Hills Water Tower – FCA Building #2563
Description: Exterior of the Water Storage Tank.

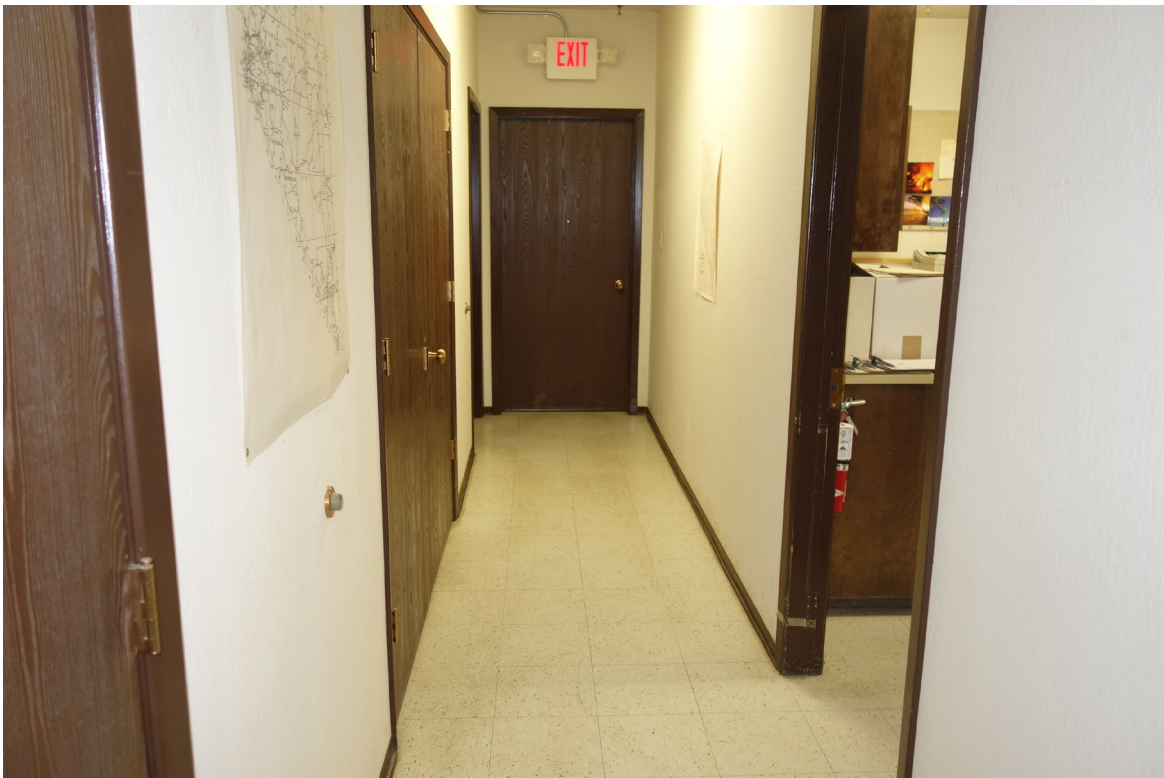
The existing doors in this facility have locking knob-type door hardware. The locks on the doors are sticking and do not operate properly. This project would provide for the purchase and installation of locking lever action door handles to be placed on all the doors in the building. The 2012 IBC, ICC/ANSI A117.1 - 2009, NRS 338.180 and the most current version of the ADA Standards For Accessible Design were used as a reference for this project.

Indian Hills Warehouse – FCA Building #0860
Description: Accessible Door Hardware Needed

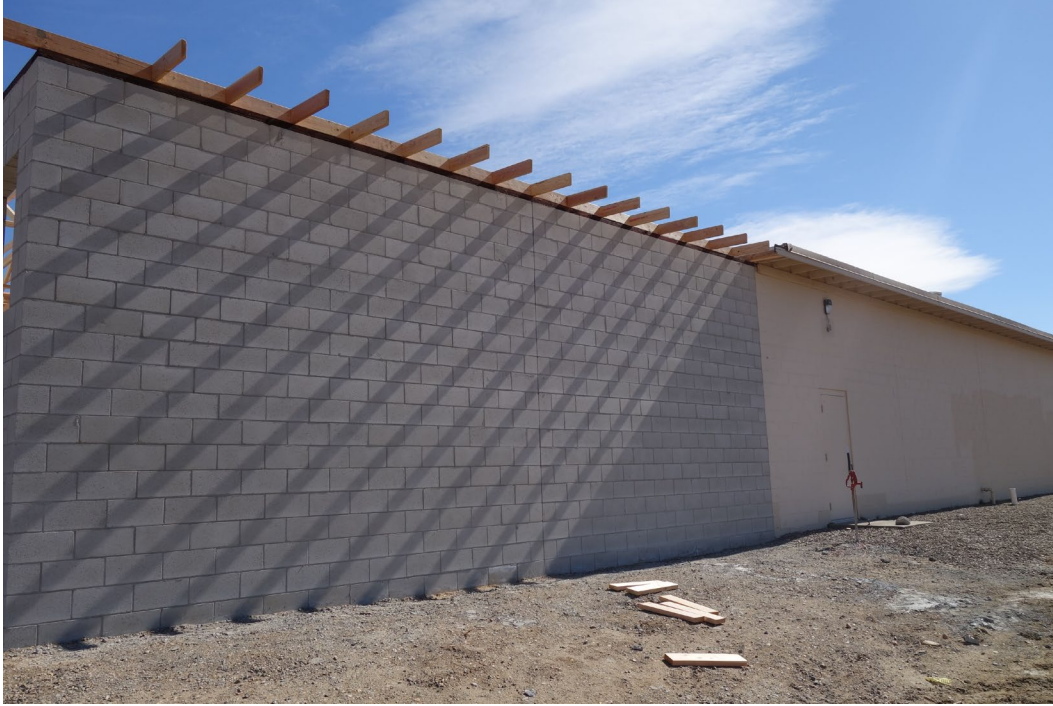
The building is constructed of concrete masonry units (CMU) with no insulation. Buildings of this type are not energy efficient. This project would provide for the purchase and installation an exterior insulating finish system (EIFS) over the CMU including the addition. This work will make the building more energy efficient and should concur at the same time the HVAC renovation occurs.

Indian Hills Warehouse – FCA Building #0860
Description: Exterior Insulation & Finish System (EIFS) Needed.

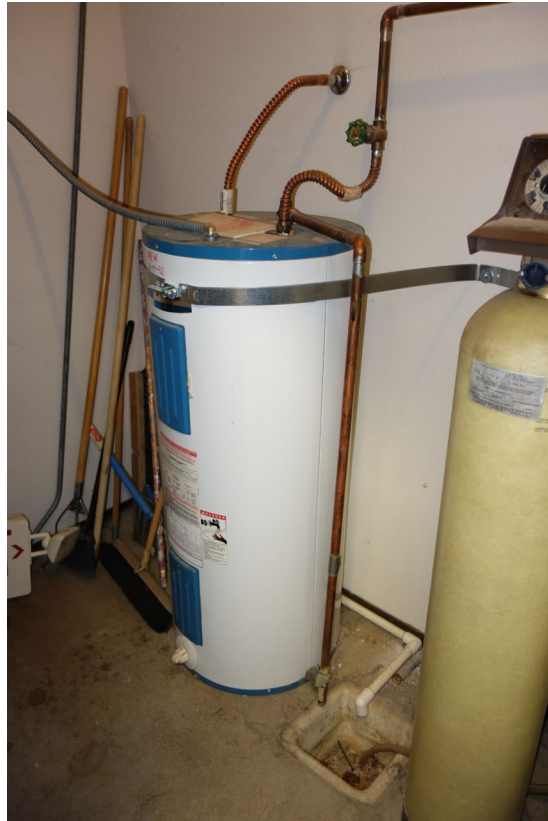
There is a 50 gallon electric water heater in the building. The average life span of a water heater is eight to ten years. With the passage of time and constant use, this unit is showing signs of wear and should be scheduled for replacement in the next 2 - 3 years. It is recommended that a new electric water heater be installed including a drip pan and seismic bracing. Removal and disposal of the existing equipment is included in this estimate.

Indian Hills Warehouse – FCA Building #0860
Description: Water Heater Replacement Needed.

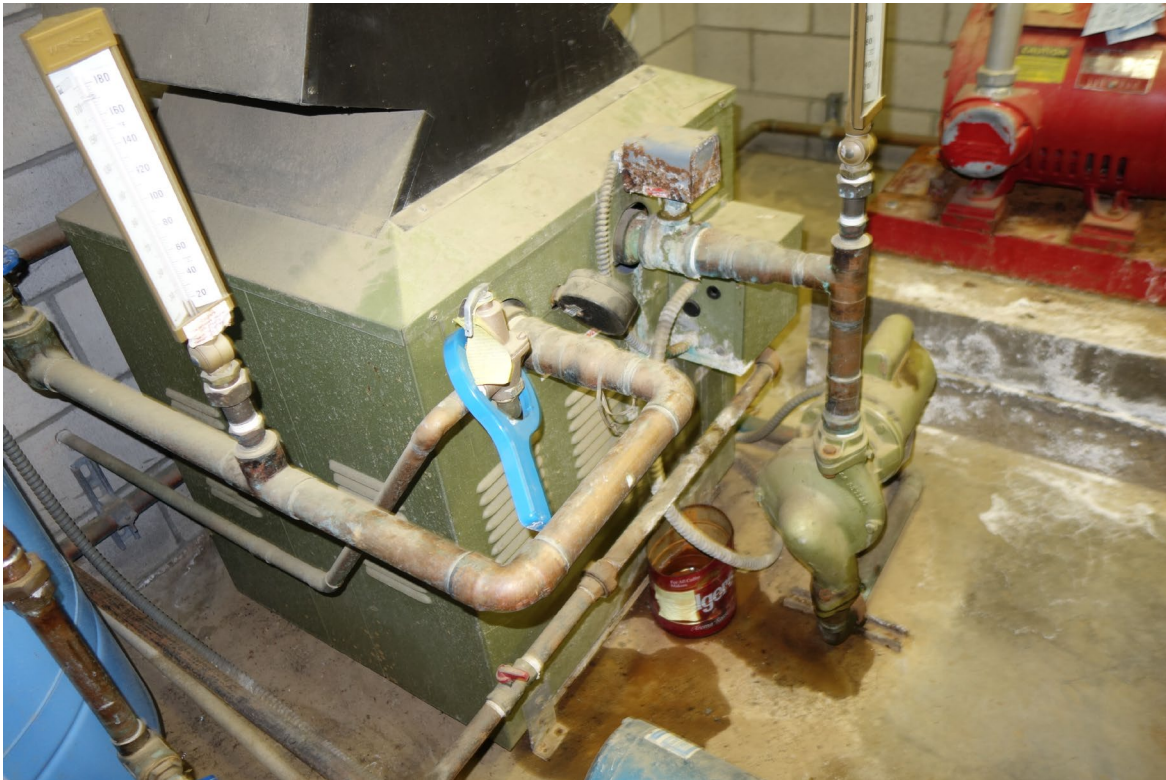
A boiler located in the building is no longer in use. It leaks water on the floor and creates unsanitary conditions promoting mold growth. This project will remove the boiler and associated piping, cap water lines and remove the vent through roof.

Indian Hills Pump House – FCA Building #0859
Description: Abandoned Boiler Removal Needed.
