GALLAGHER FISH HATCHERY

Site Number: 9881
STATE OF NEVADA PUBLIC WORKS DIVISION
FACILITY CONDITION ANALYSIS

Report distributed in January 2022

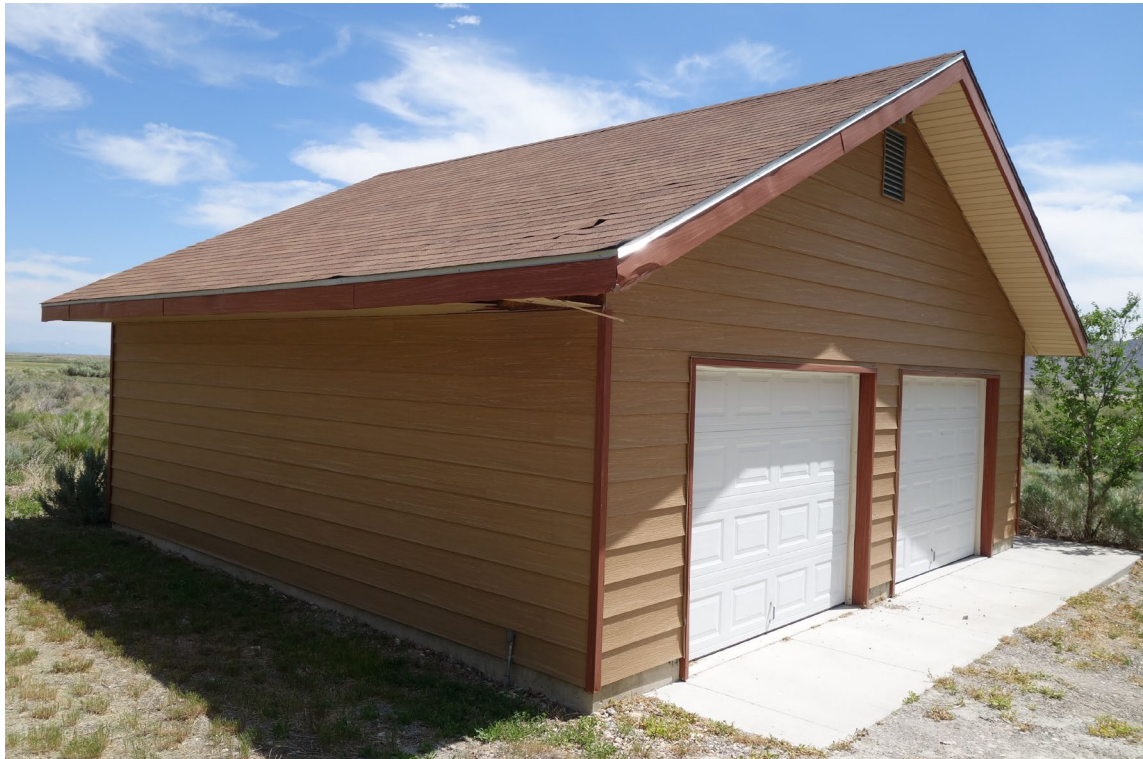
The southwest corner of the roof has been structurally damaged. The asphalt shingles are rippled and the fascia and soffit are severely damaged. The project would fund the removal of the shingles in this area, inspect and repair any trusses and roof sheathing, and replace the damaged fascia, cladding, and soffit.

Residence #2 Garage – FCA Building #3146
Description: Structural Repairs Project.

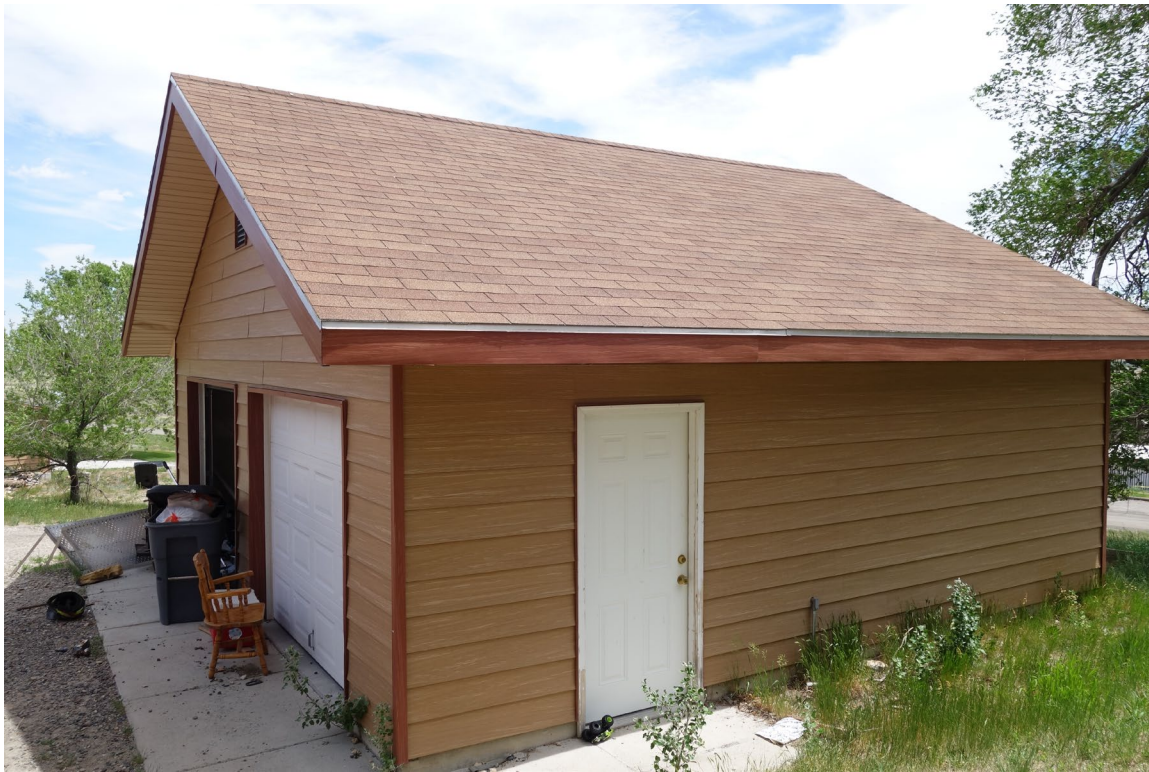
The exterior finishes are in good condition. It is important to maintain the finish, weather resistance, and appearance of the building. This project would provide funding to protect the exterior of the building excluding the roof. Included in the cost is cleaning the vinyl siding and caulking of the window, flashing, fixtures and all other penetrations. It is recommended that the building be cleaned and caulked in the next 8 - 9 years and that this project is scheduled on a cyclical basis to maintain the integrity of the structure.

Residence #1 Garage – FCA Building #3145
Description: Exterior of the Building.

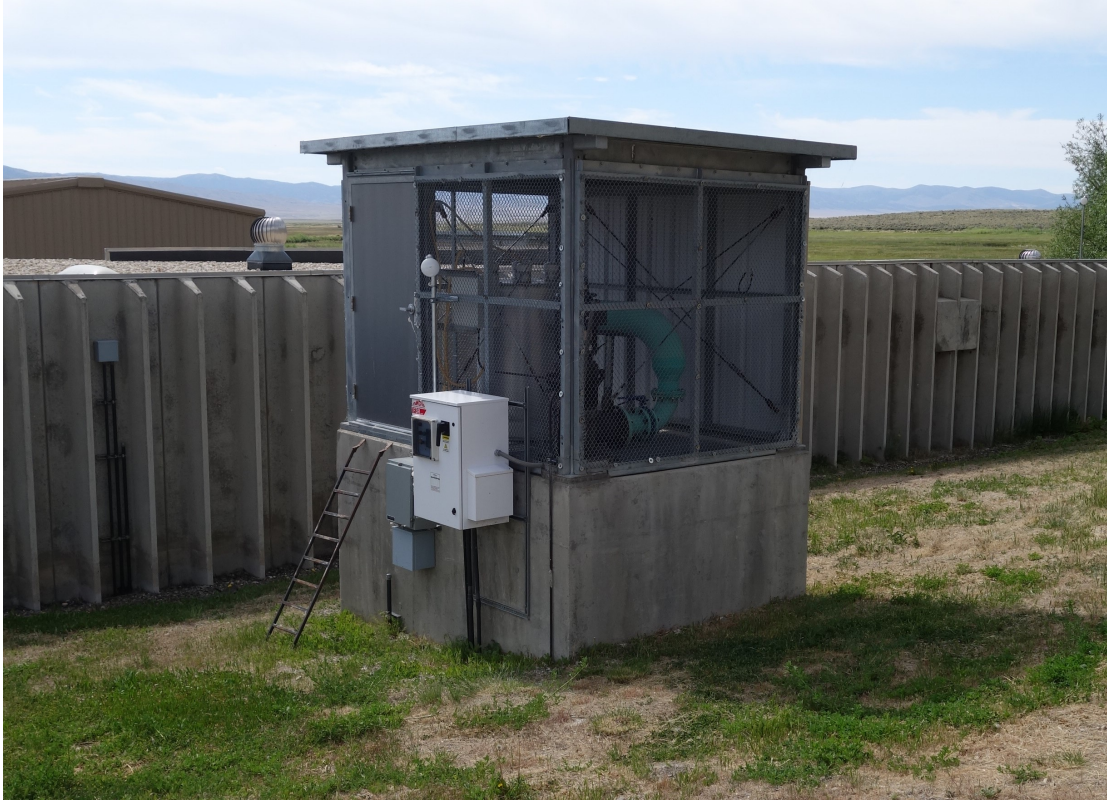
The exterior finishes are in good condition. It is important to maintain the finish, weather resistance, and appearance of the building. This project would provide funding to protect the exterior of the building excluding the roof. Included in the cost is the caulking and sealing of the flashing, fixtures and all other penetrations. It is recommended that the building be caulked and sealed in the next 8 - 9 years and that this project be scheduled on a cyclical basis to maintain the integrity of the structure.

Control Box #1 – FCA Building #3143
Description: Exterior of the Building.

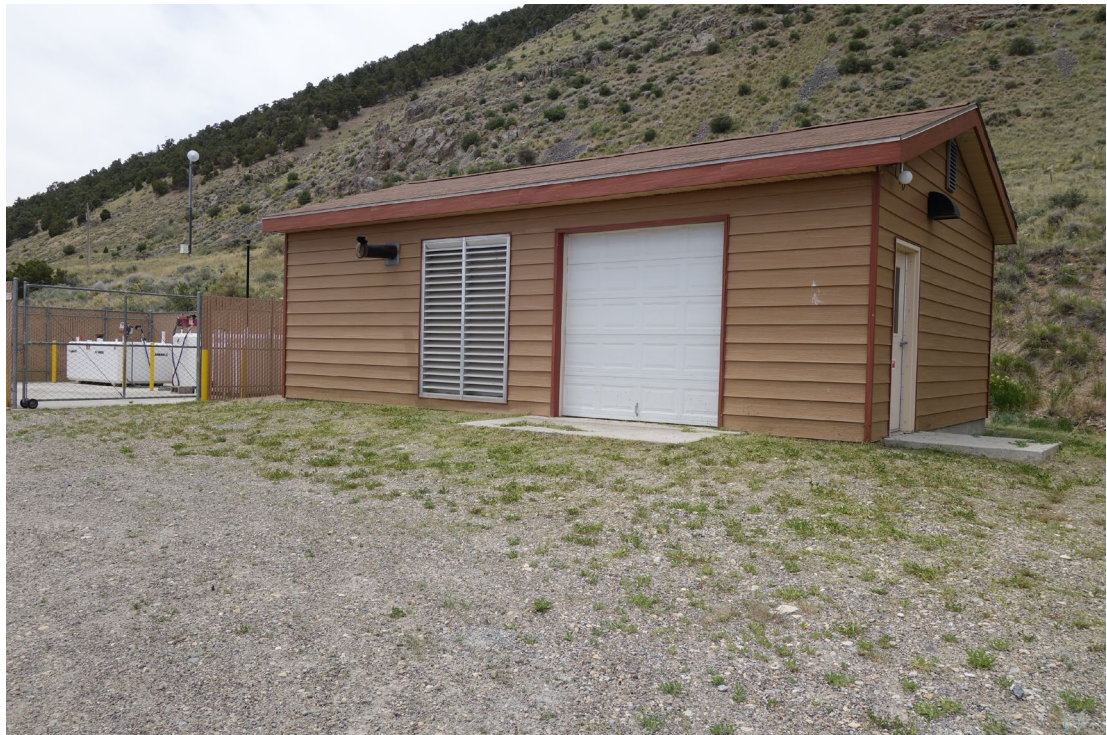
The exterior finishes are in good condition. It is important to maintain the finish, weather resistance, and appearance of the building. This project would provide funding to protect the exterior of the building excluding the roof. Included in the cost is cleaning the vinyl siding and caulking of the flashing, fixtures and all other penetrations. It is recommended that the building be cleaned and caulked in the next 8 - 9 years and that this project is scheduled on a cyclical basis to maintain the integrity of the structure.

Emergency Generator Building – FCA Building #3142
Description: Exterior of the Building.

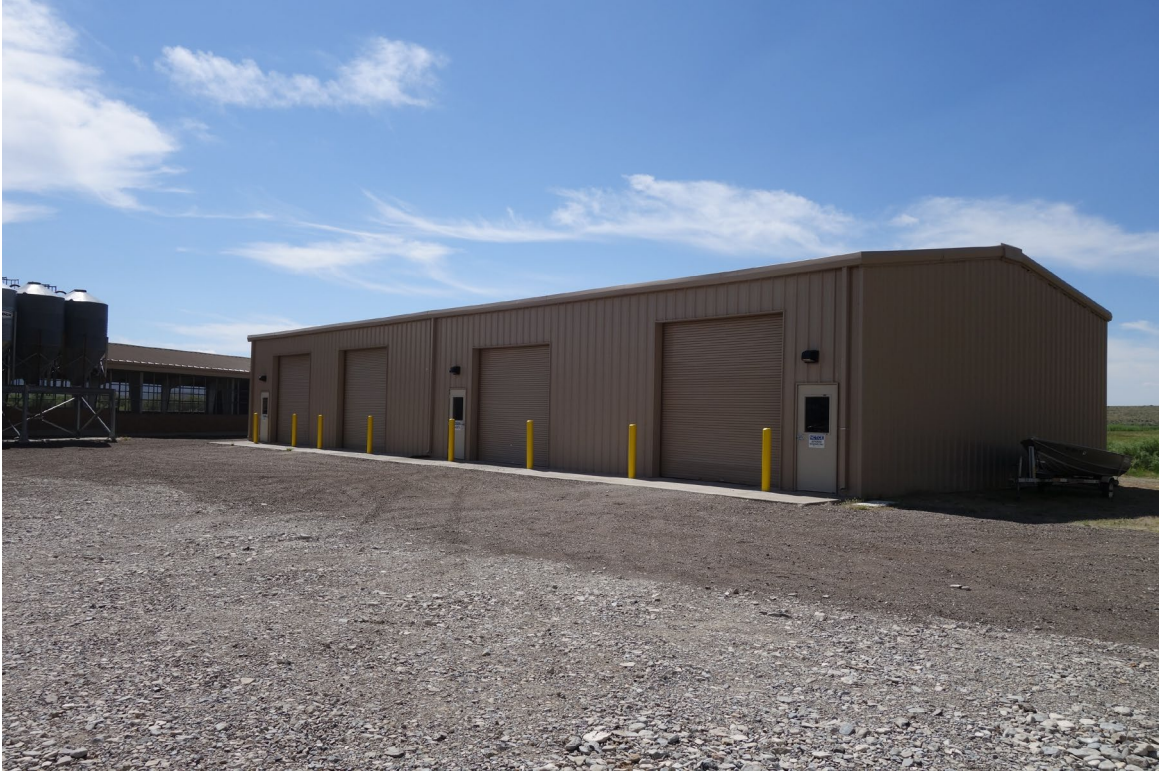
The exterior finishes are in good condition. It is important to maintain the finish, weather resistance, and appearance of the building. This project would provide funding to protect the exterior of the building excluding the roof. Included in the cost is the caulking and sealing of the flashing, fixtures and all other penetrations. It is recommended that the building be caulked and sealed in the next 8 - 9 years and that this project be scheduled on a cyclical basis to maintain the integrity of the structure.

Vehicle Storage Building – FCA Building #3141
Description: Exterior of the Building.

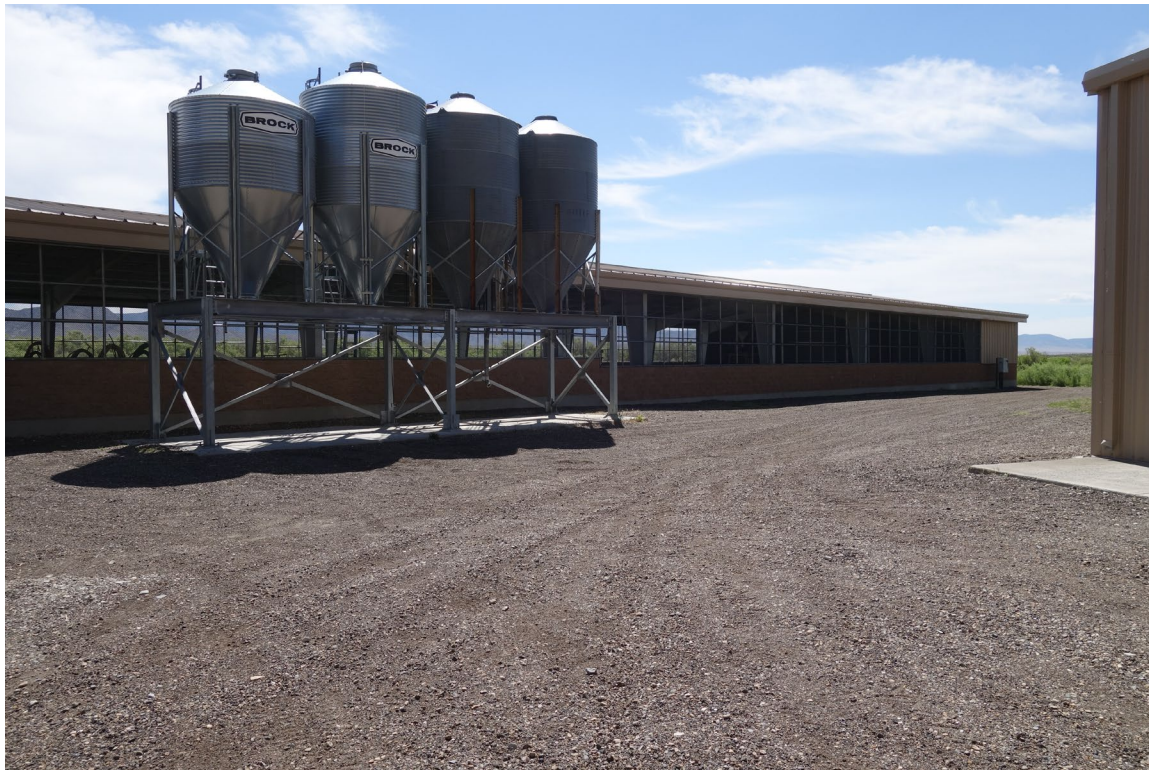
The exterior finishes are in good condition. It is important to maintain the finish, weather resistance, and appearance of the building. This project would provide funding to protect the exterior of the building excluding the roof. Included in the cost is the caulking and sealing of the flashing, fixtures and all other penetrations. It is recommended that the building be caulked and sealed in the next 8 - 9 years and that this project be scheduled on a cyclical basis to maintain the integrity of the structure.

Rearing Building – FCA Building #3140
Description: Exterior of the Building.

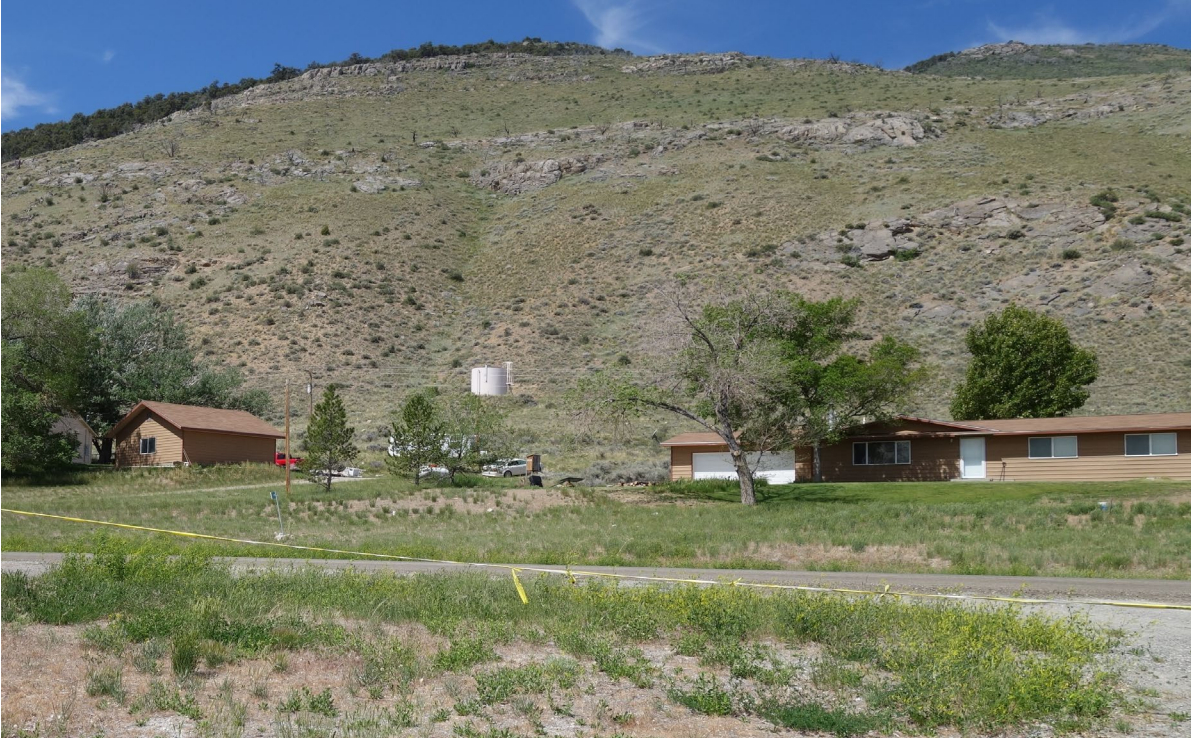
Water Tank – FCA Building #3139

The exterior finishes are in good condition. It is important to maintain the finish, weather resistance, and appearance of the water tank. This project would provide for the painting of the water tank and caulking of the joints to maintain it in a good, weather tight condition. It is recommended that this project be implemented in the next 8 - 9 years and is recommended on a cyclical basis based on environmental conditions.

Description: View of the Tank with Residences #1 & #2 in the Foreground.

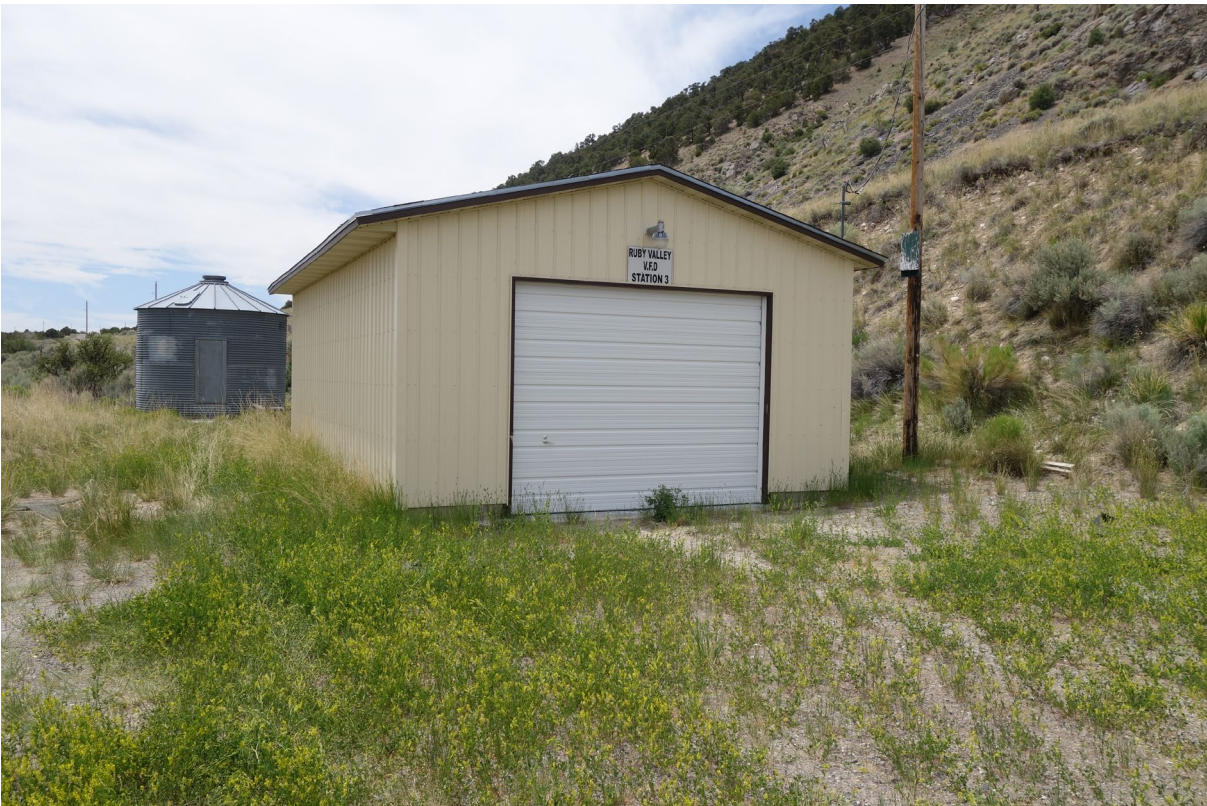
NDF Fire Truck Garage – FCA Building #2543

The exterior finishes are in good condition. It is important to maintain the finish, weather resistance, and appearance of the building. This project would provide funding to protect the exterior of the building excluding the roof. Included in the cost is the caulking and sealing of the flashing, fixtures and all other penetrations. It is recommended that the building be caulked and sealed in the next 8 - 9 years and that this project be scheduled on a cyclical basis to maintain the integrity of the structure.

Description: Exterior of the Building.

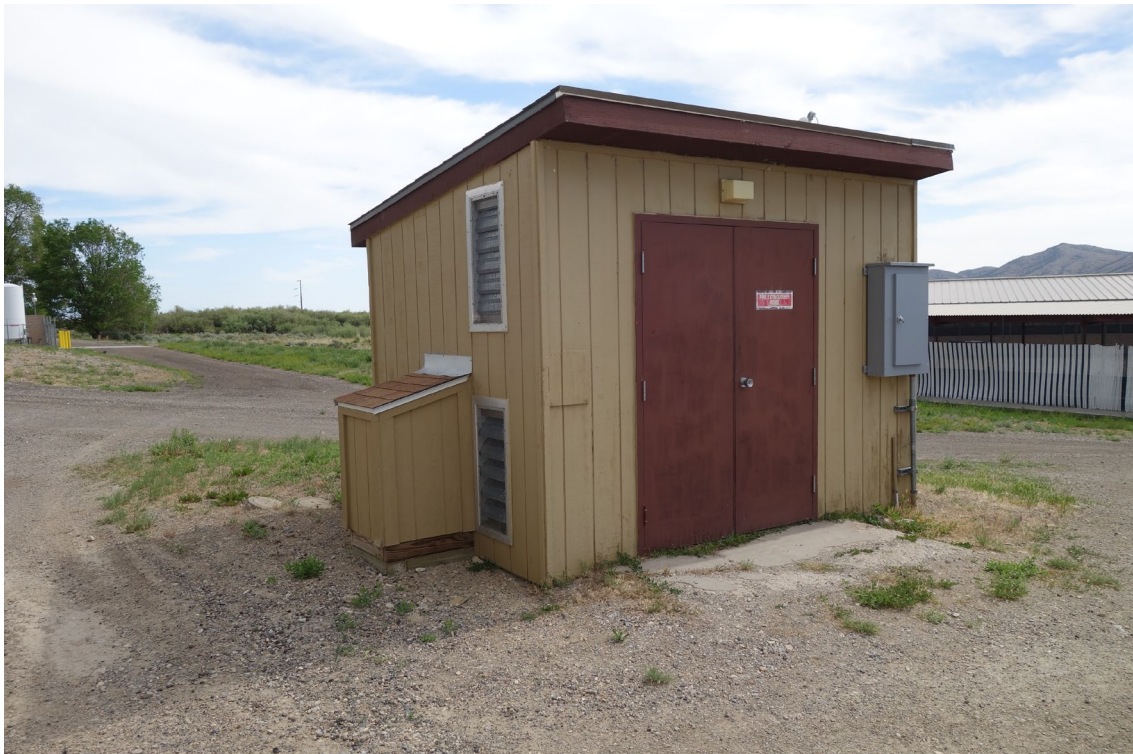
The exterior finishes are in fair condition. It is important to maintain the finish, weather resistance, and appearance of the building. This project would provide funding to protect the exterior of the building excluding the roof. Included in the cost is sanding, priming and painting, and caulking of the flashing, fixtures and all other penetrations. It is recommended that the building be painted in the next 4 - 5 years and that this project be scheduled on a cyclical basis to maintain the integrity of the structure.

Domestic Pump House – FCA Building #0939
Description: Exterior of the Building.

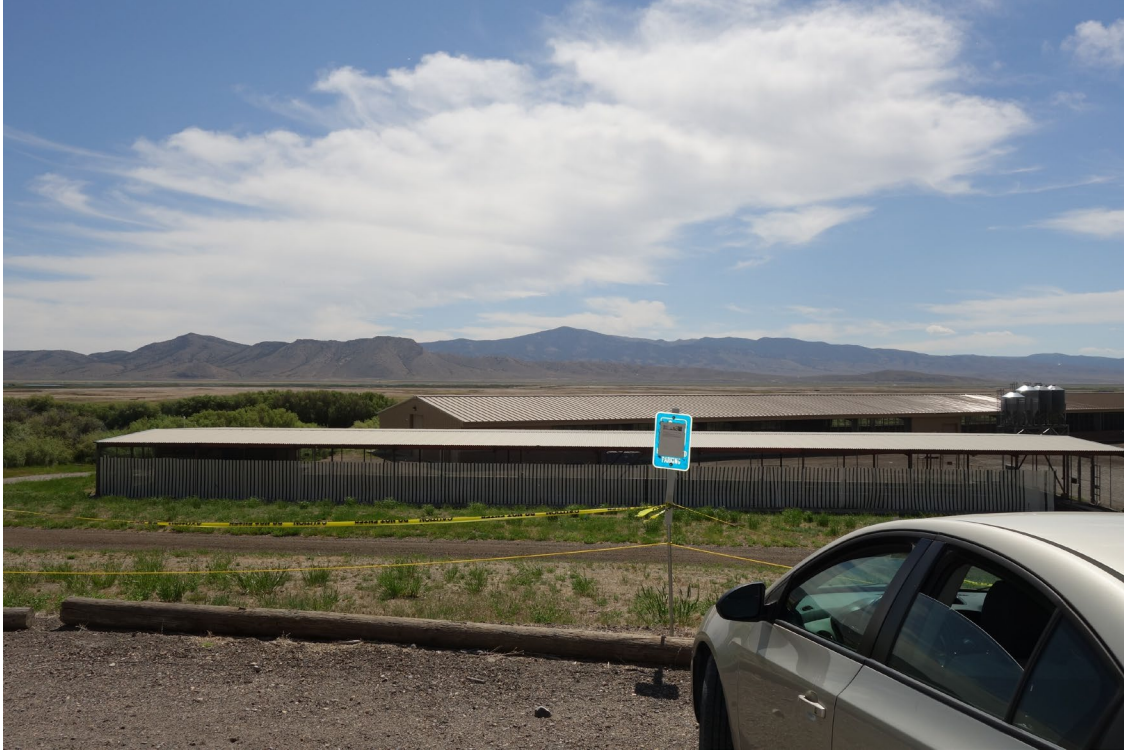
The painted finishes are in poor condition with paint flaking off columns and potentially landing in the fish raceways. It is important to maintain the finish, weather resistance, and appearance of the structure. This project would provide for painting of the structure in 2 - 3 years and it is recommended that this project be scheduled on a cyclical basis to maintain the integrity of the structure.

Gallagher Fish Hatchery Shade Shelter #1 – FCA Building #0936
Description: Exterior of the Structure.

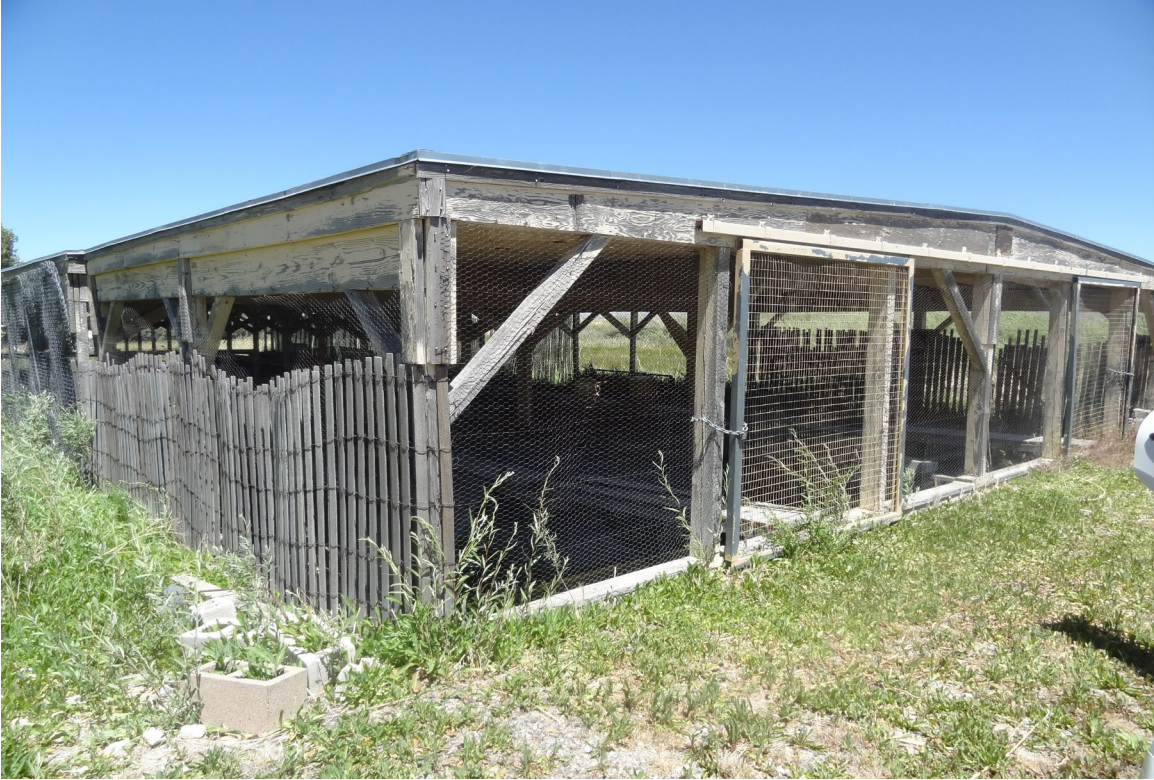
The Gallagher Fish Hatchery Shade Shelter North is located approximately 1 mile north of the main Hatchery site. The wood post and beam structure with concrete raceways is in poor condition. The facility is no longer in use.

The structure is dilapidated, deteriorating, and is over 50 years of age. It is no longer in use. This project would provide funding for the demolition and disposal of the structure.

Gallagher Fish Hatchery Shade Shelter North – FCA Building #0935
Description: 2012 Photo - Demolish Structure Project Recommended.

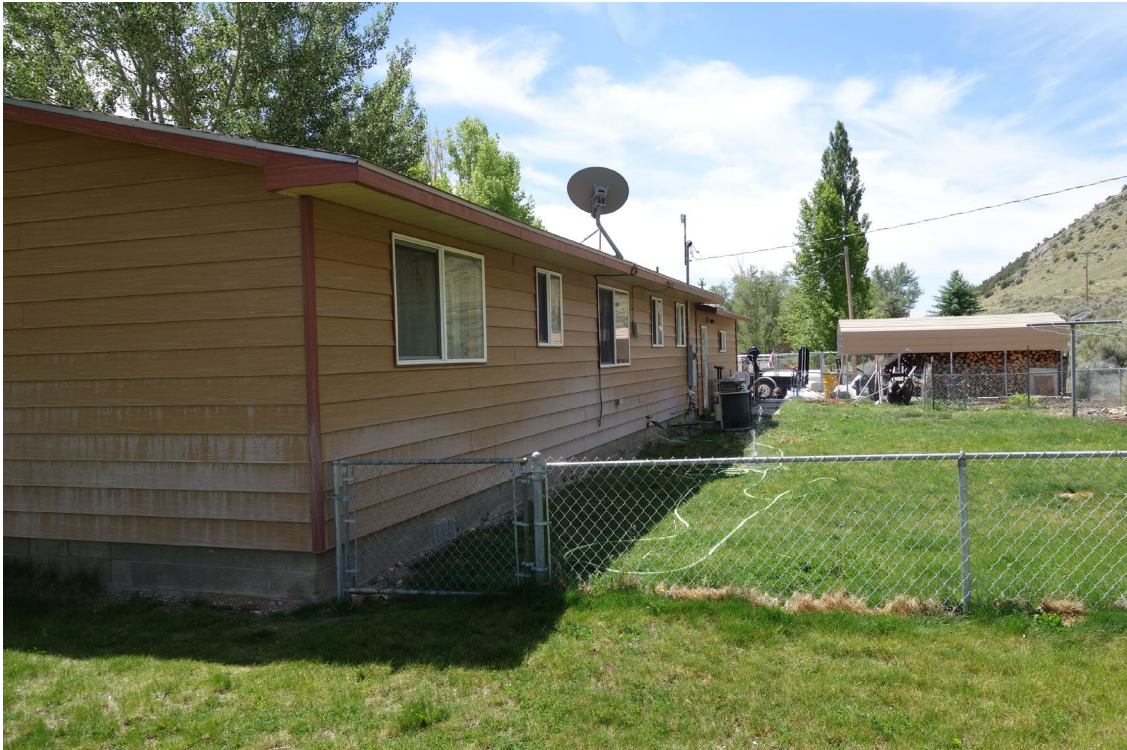
The exterior finishes are in poor condition. It is important to maintain the finish, weather resistance, and appearance of the building. This project would provide funding to protect the exterior of the building excluding the roof. Included in the cost is cleaning the vinyl siding and caulking of the windows, flashing, fixtures and all other penetrations. It is recommended that the building be cleaned and caulked in the next 2 - 3 years and that this project is scheduled on a cyclical basis to maintain the integrity of the structure.

Gallagher Fish Hatchery Residence #6 – FCA Building #0934
Description: Exterior Finishes of the Building.

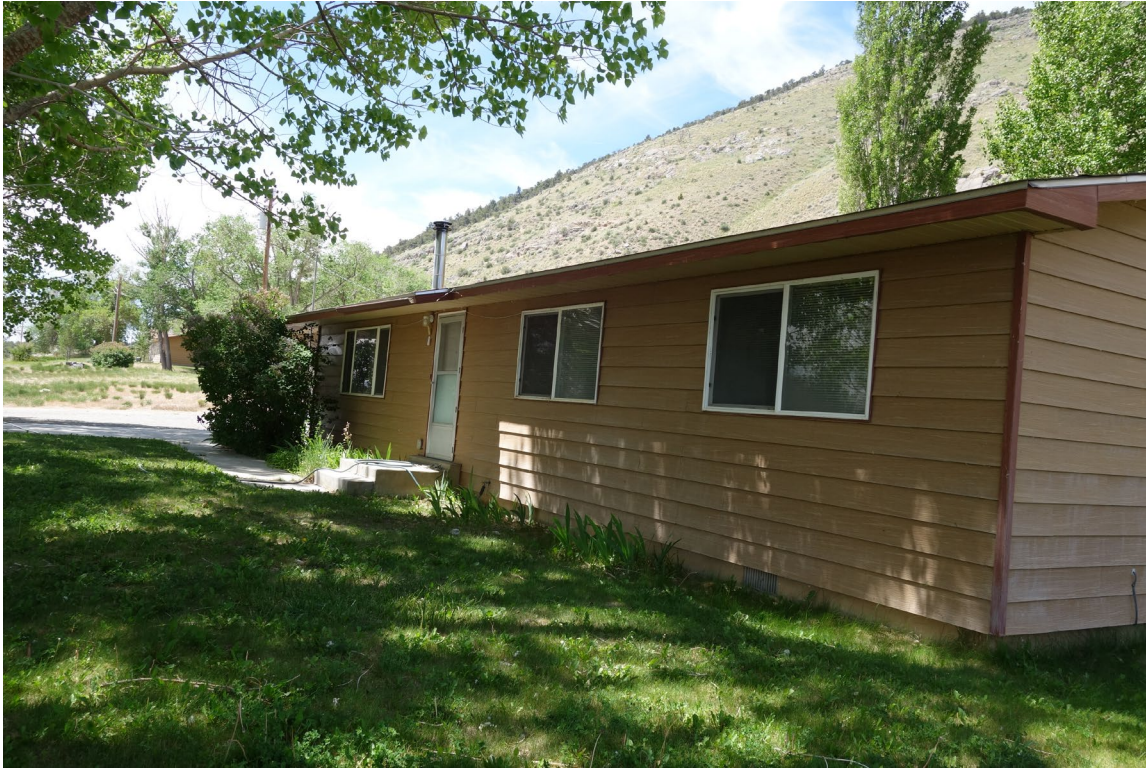
The exterior finishes are in fair condition. It is important to maintain the finish, weather resistance, and appearance of the building. This project would provide funding to protect the exterior of the building excluding the roof. Included in the cost is cleaning the vinyl siding and caulking of the windows, flashing, fixtures and all other penetrations. It is recommended that the building be cleaned and caulked in the next 4 - 5 years and that this project is scheduled on a cyclical basis to maintain the integrity of the structure.

Gallagher Fish Hatchery Residence #5 – FCA Building #0933
Description: Exterior of the Building.
