State of Nevada
Department of Wildlife
Facility Condition Analysis

SPRING CREEK REARING STATION

**STATE OF NEVADA PUBLIC WORKS DIVISION
FACILITY CONDITION ANALYSIS**

Report distributed in January, 2018

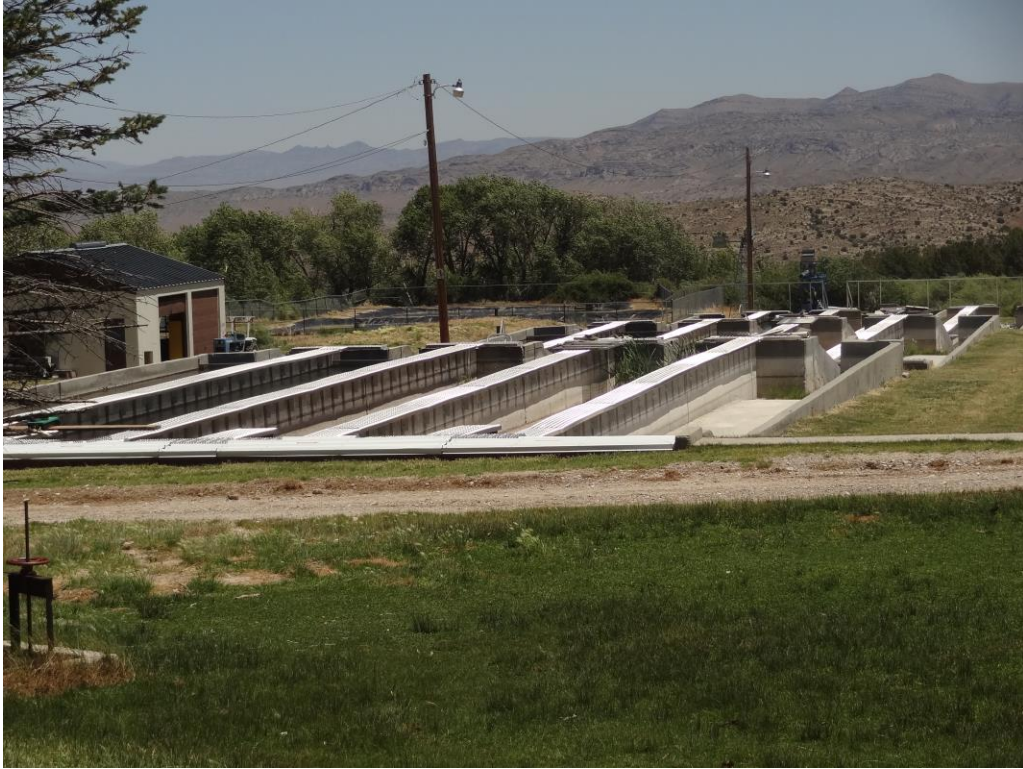
The 19 fish raceways receive water from both Spring Creek and Snake Creek. The water flows through the raceways and eventually flows back into Snake Creek. At times during the summer months and during droughts, the water from the creeks are unable to meet demands. This project recommends drilling a new well and installing new pumping equipment to serve the water demands of the site. Estimates are based on a maximum of 300 feet of drilling.

Spring Creek Fish Rearing Station Site - Site #9882
Description: Raceways.

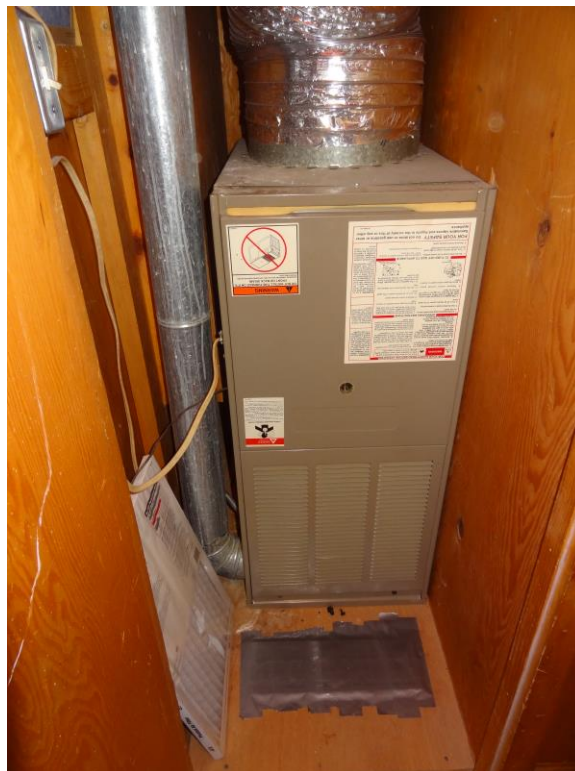
S.C. Rearing Station Residence #1 North - Building #0664
Description: HVAC equipment replacement needed.

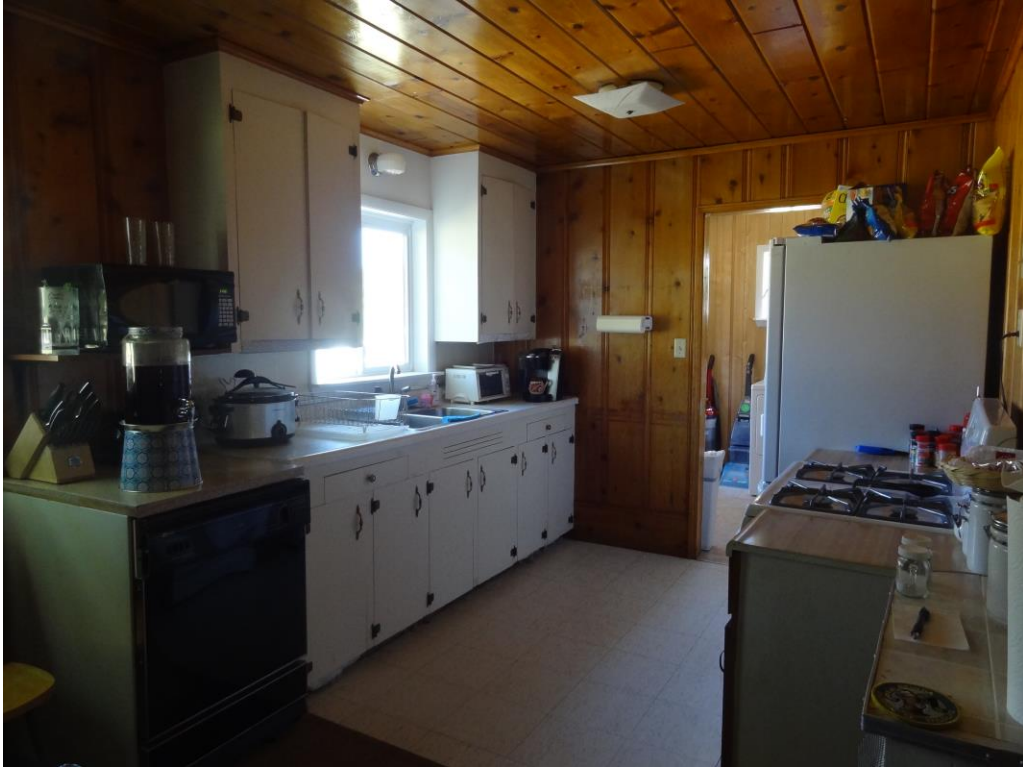
S.C. Rearing Station Residence #1 North - Building #0664
Description: Interior remodel needed.

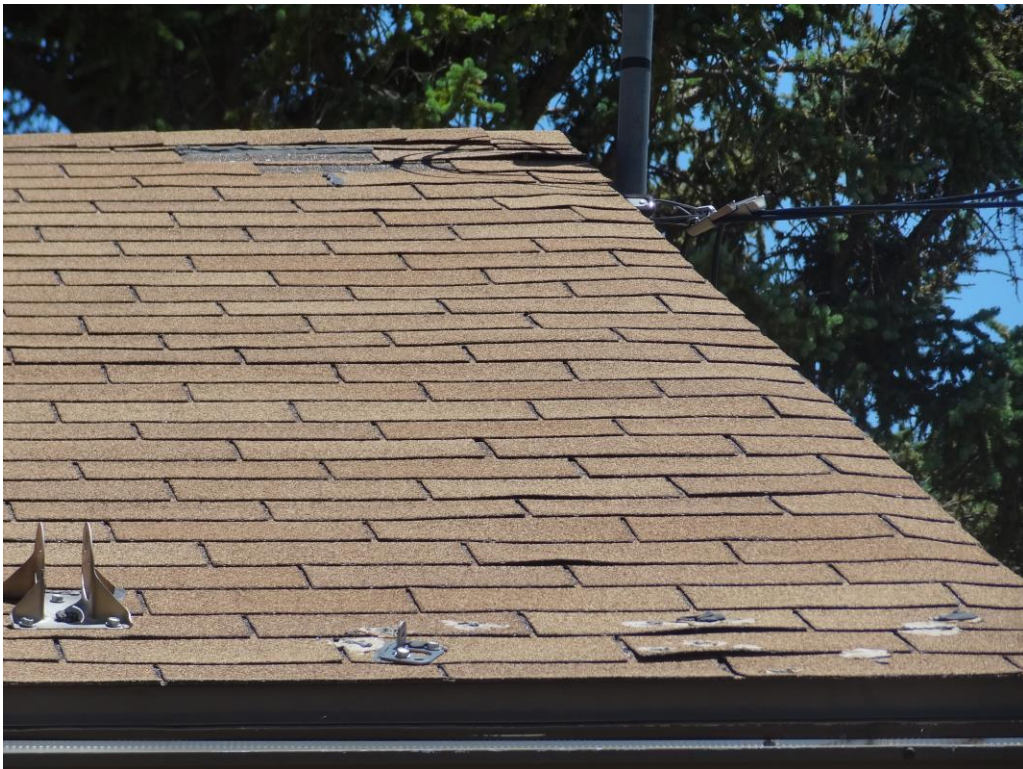
The asphalt composition shingle roof on this building was in poor condition at the time of the survey. It is recommended that this building be re-roofed in the next 2-3 years with a new 50 year asphalt composition roofing shingle and new underlayment. This estimate includes removal and disposal of the old roofing.

S.C. Rearing Station Residence #2 South - Building #0947
Description: Roof replacement needed.

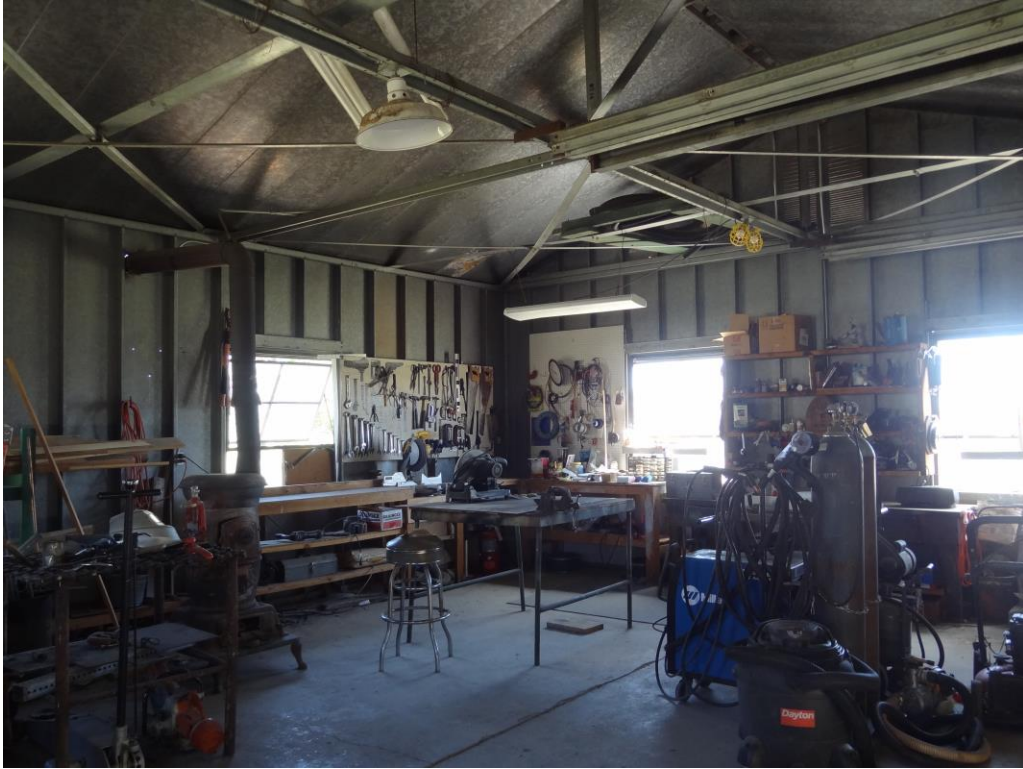
S.C. Rearing Station Storage/Shop - Building #0665
Description: Insulation needed.

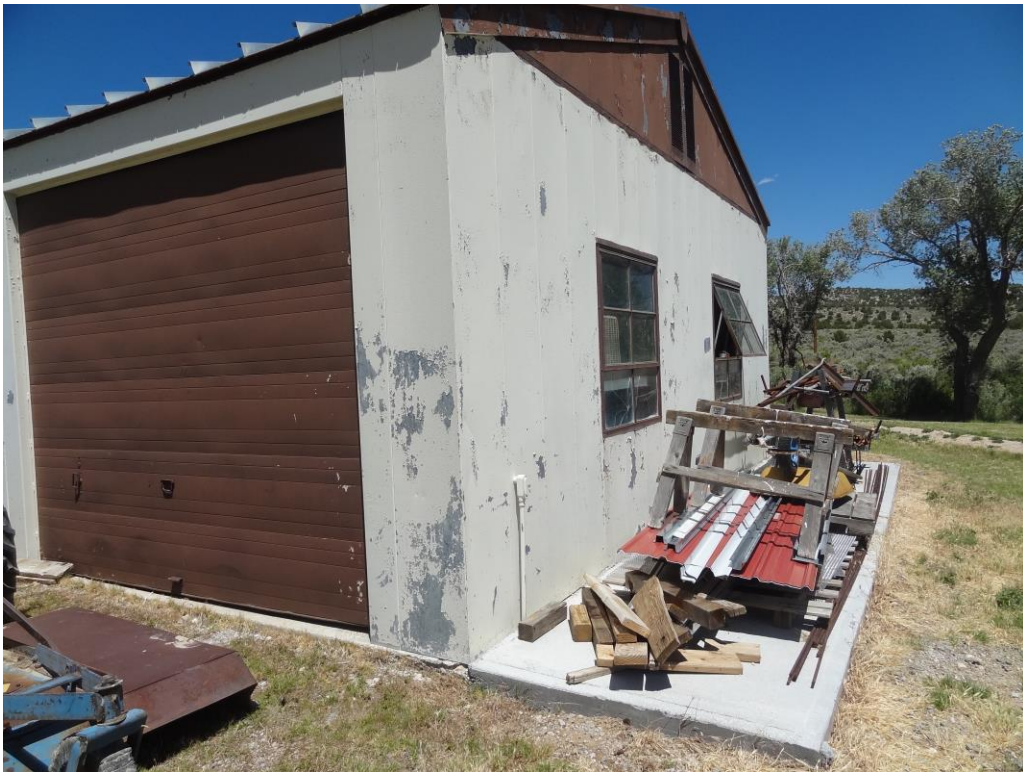
The windows are original, single pane construction in metal frames. These older windows are drafty and not energy efficient. This project recommends replacing the windows with dual pane, higher efficiency units. This estimate is for the replacement of 6 units. Removal and disposal of the existing windows is included in this estimate.

S.C. Rearing Station Storage/Shop - Building #0665
Description: Window replacement needed.

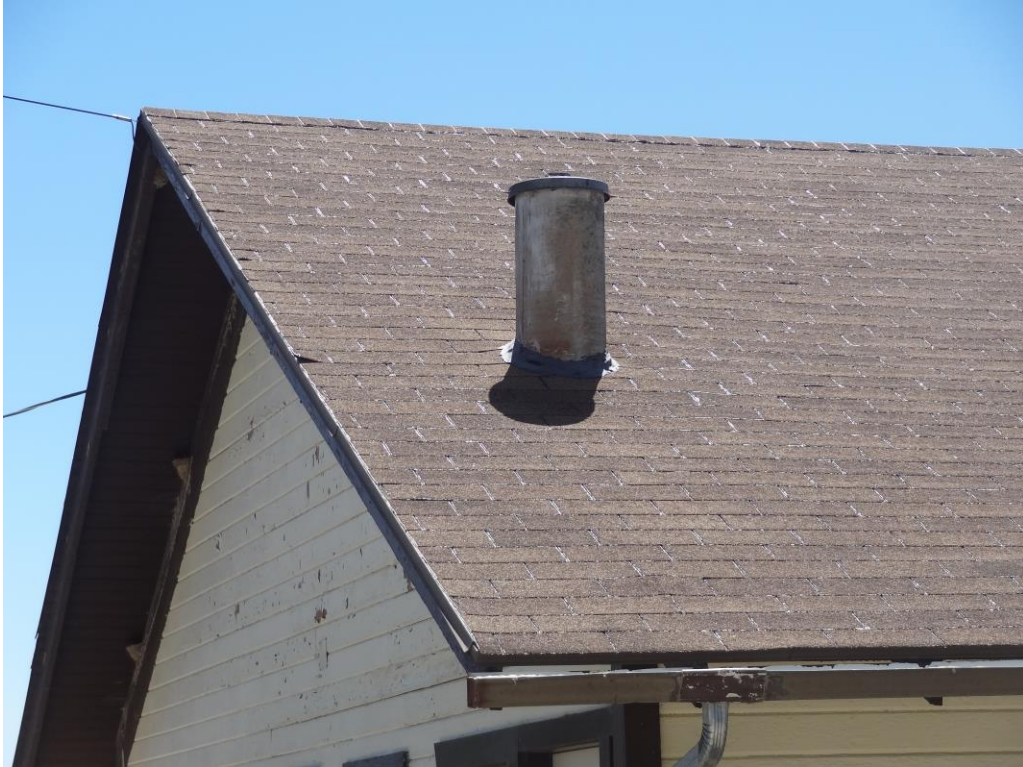
The asphalt composition shingle roof on this building was in poor condition at the time of the survey. It is recommended that this building be re-roofed in the next 2-3 years with a new 50 year asphalt composition roofing shingle and new underlayment. This estimate includes removal and disposal of the old roofing.

S.C. Rearing Station Office & Garage - Building #0666
Description: Roofing replacement needed.

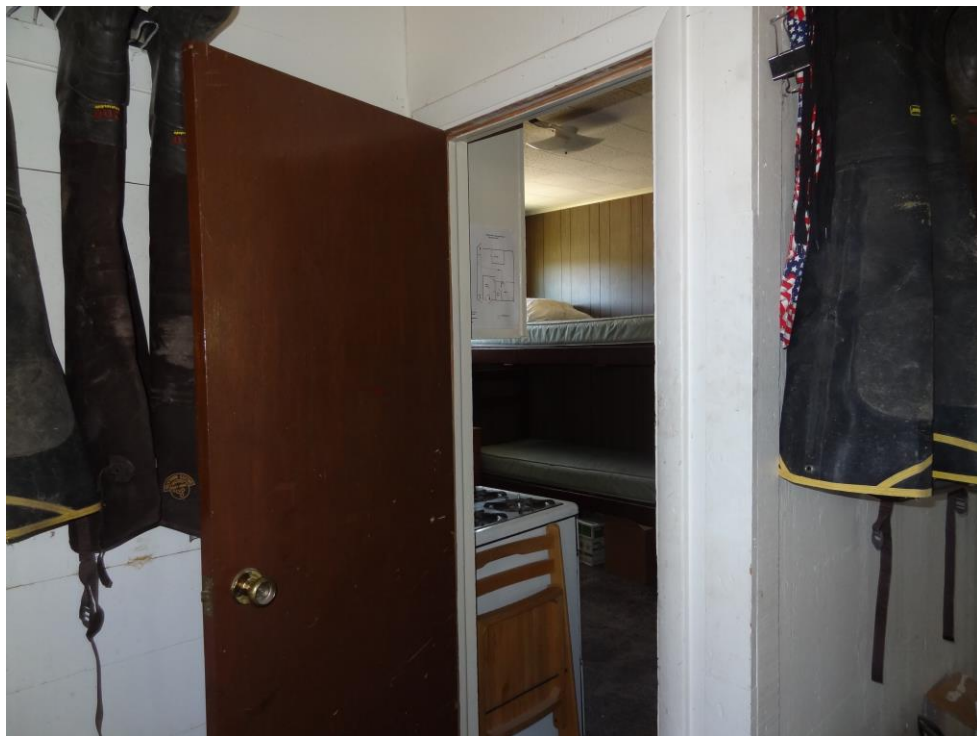
S.C. Rearing Station Office & Garage - Building #0666
Description: Smoke/ carbon monoxide alarm installation needed.

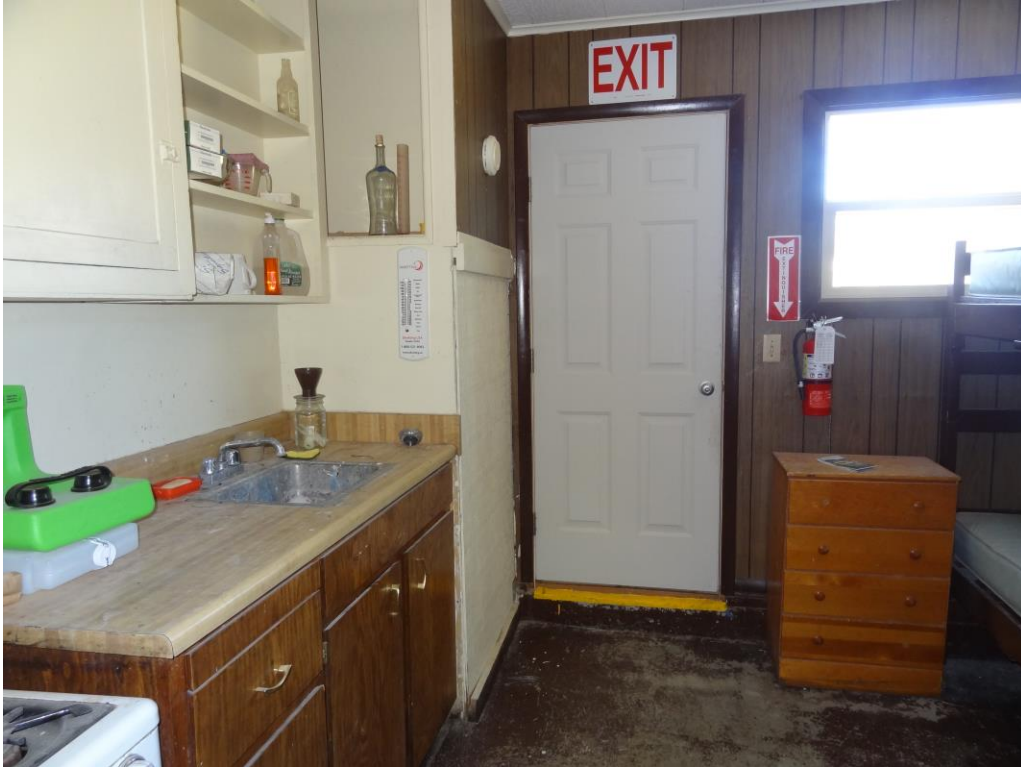
S.C. Rearing Station Office & Garage - Building #0666
Description: Exit sign and egress lighting installation needed.

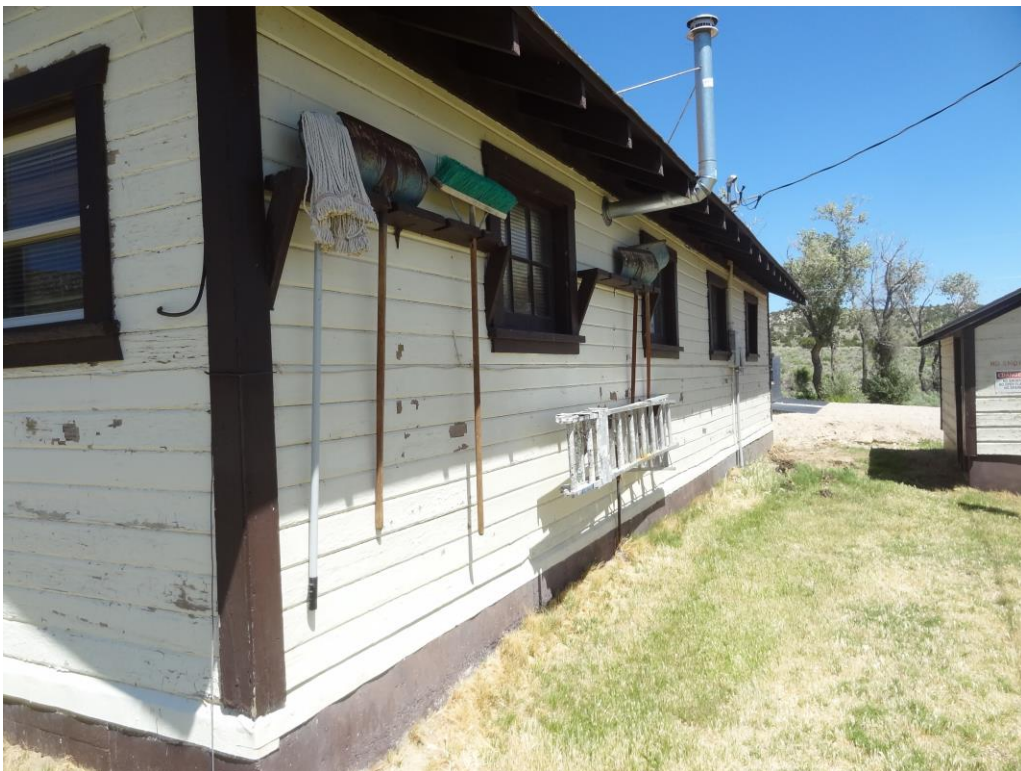
The flue on this building has an improper support strap, is too close to combustibles and doesn't have the proper clearances. The heater flue, the support strap and the distances of the flue to the fascia do not comply with IFGC 2012, IBC 2012, IMC 2012 chapter 8, chimneys and vents or the Manufacturers Specification for installation instructions. It is recommended that all flues throughout the building be installed per the manufacturers specifications IFGC 2012, IBC 2012 and IMC 2012.

S.C. Rearing Station Office & Garage - Building #0666
Description: Flue repairs needed.

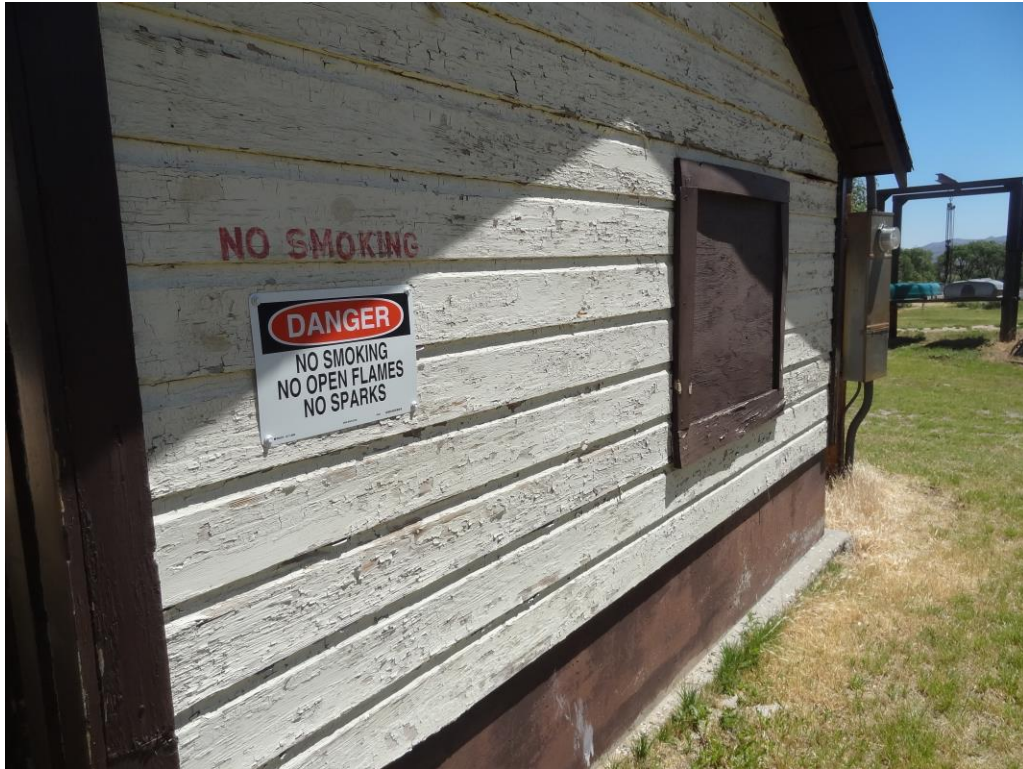
It is important to maintain the finish, weather resistance and appearance of the building. This project would provide funding to protect the exterior of the building excluding the roof. Included in the cost is sanding, priming, painting and caulking of the windows, flashing, fixtures and all other penetrations. It is recommended that the building be painted in the next 2-3 years and that this project be scheduled on a cyclical basis to maintain the integrity of the structure.

S.C. Rearing Station Shed #1 - Building #0948
Description: Exterior finishes needed.

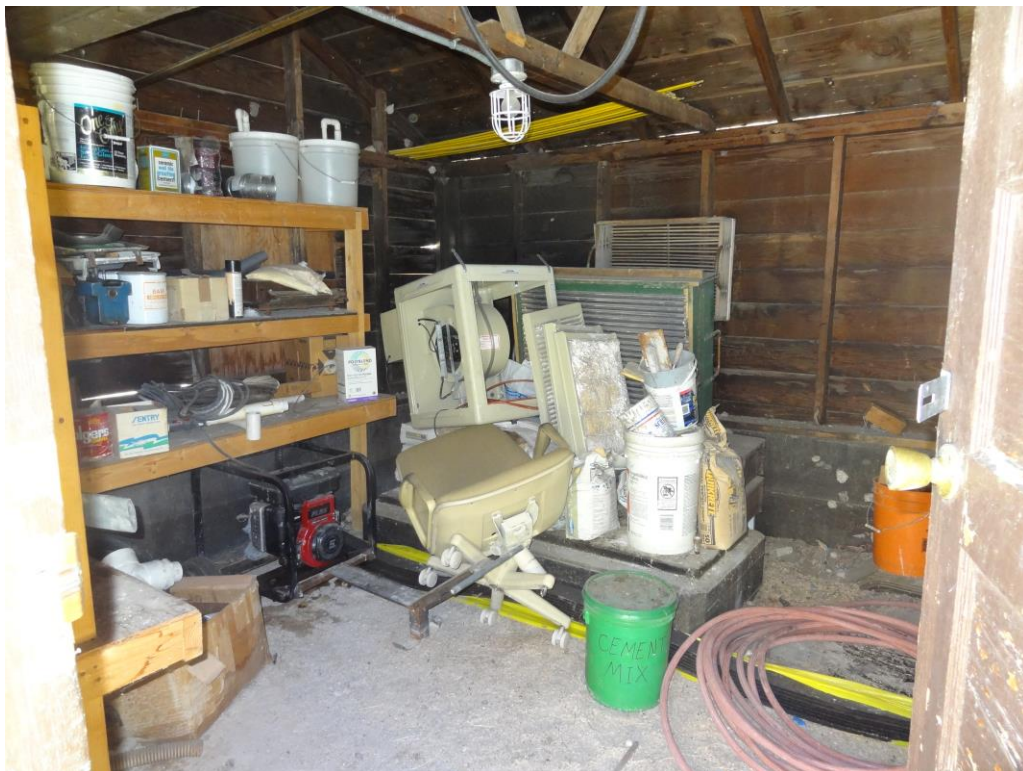
S.C. Rearing Station Shed #1 - Building #0948
Description: Concrete foundation needed.
