RYE PATCH STATE RECREATION AREA

Site Number: 9883
STATE OF NEVADA PUBLIC WORKS DIVISION
FACILITY CONDITION ANALYSIS

Report distributed in January 2022

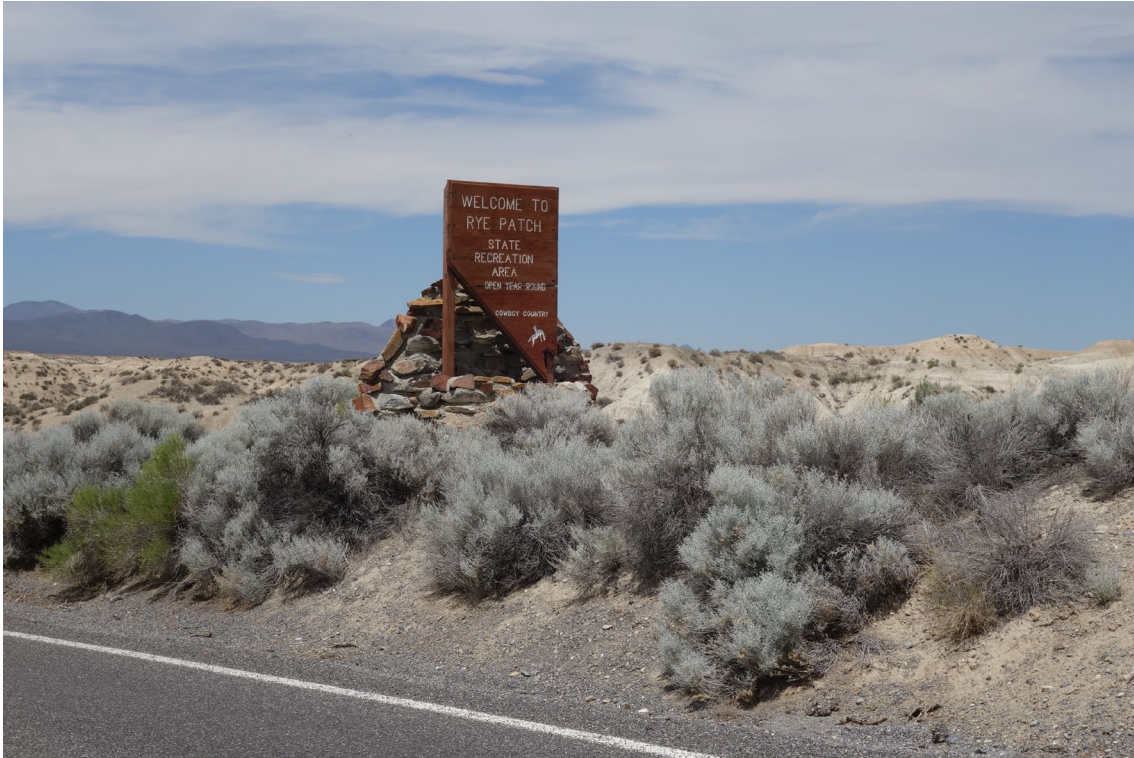
Rye Patch SRA - FCA Site #9883
Description: View at Park Entry.

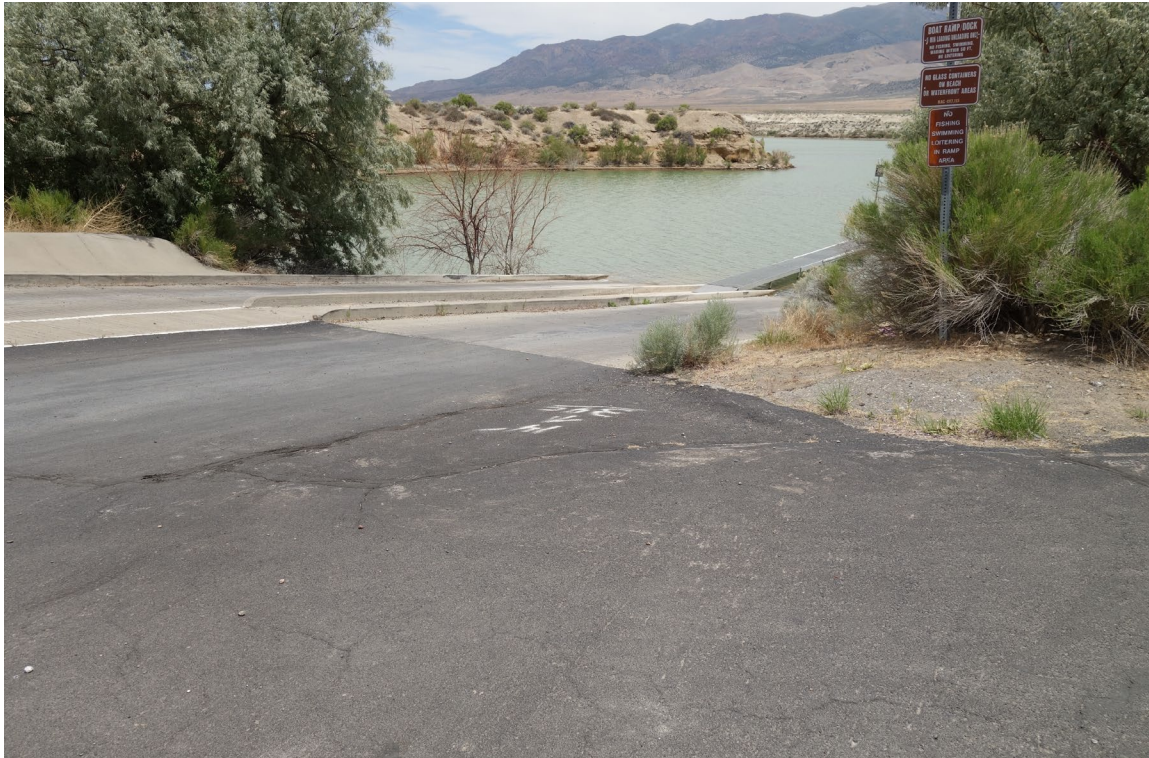
Rye Patch SRA - FCA Site #9883
Description: View of Boat Ramp Area.

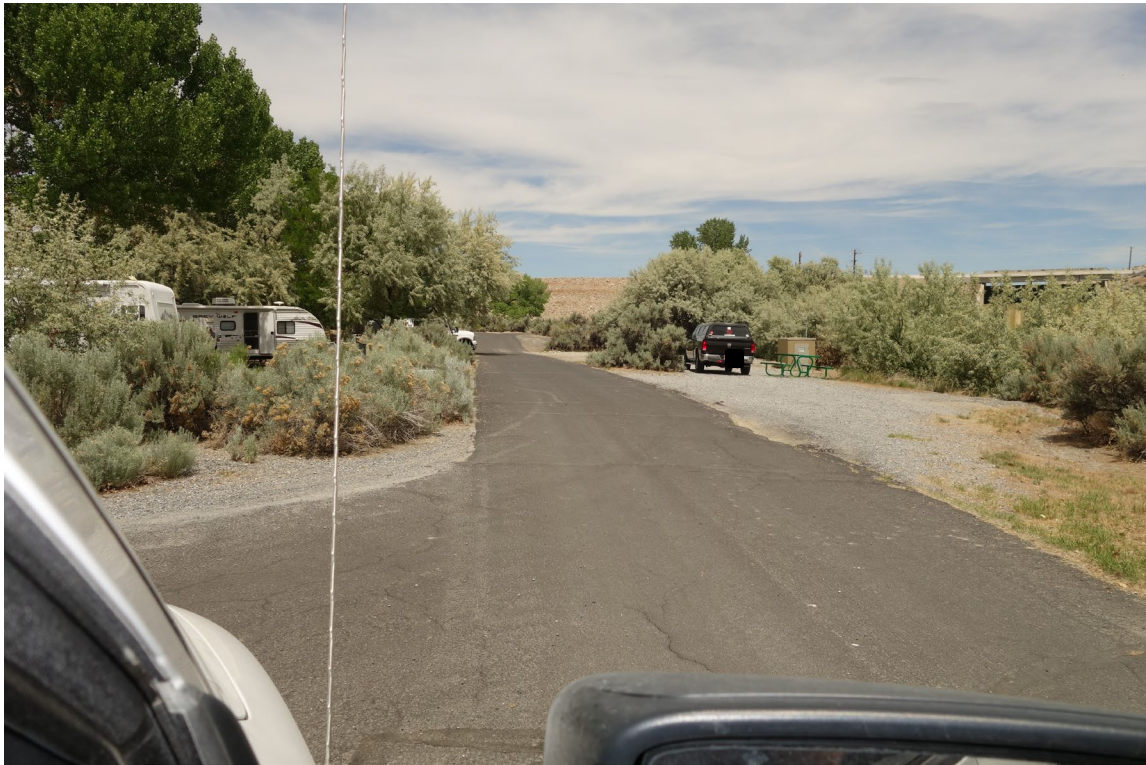
Rye Patch SRA - FCA Site #9883
Description: View of Lower Campground.

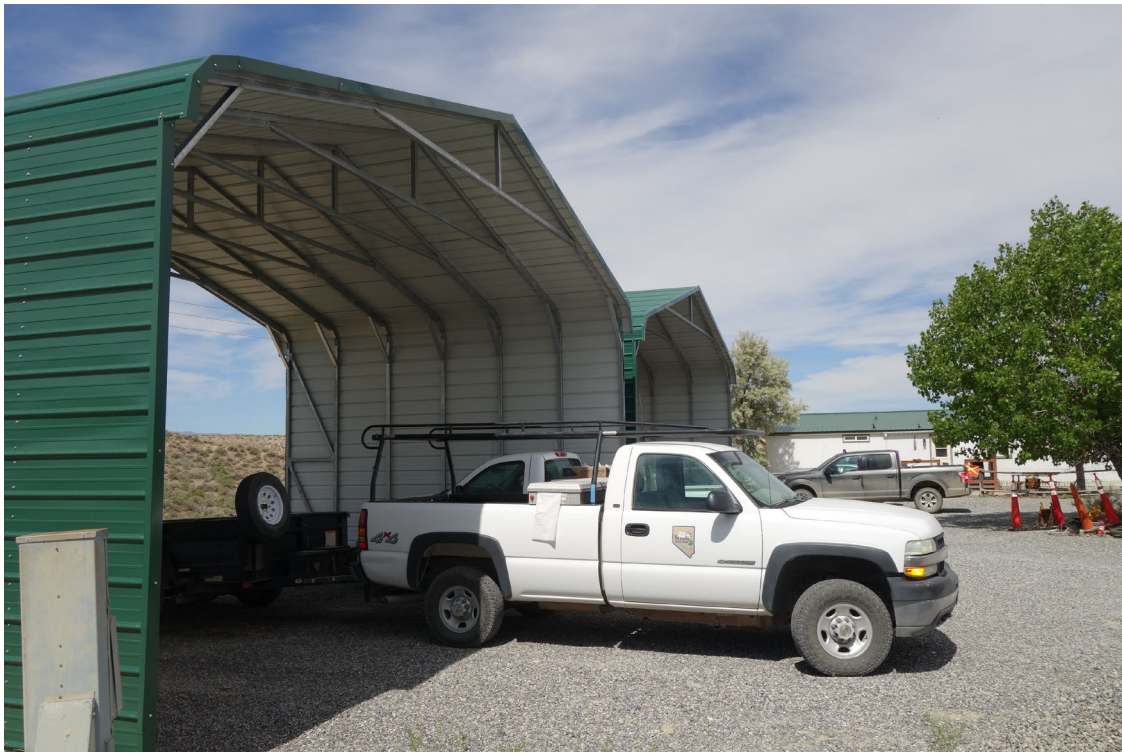
Rye Patch SRA - FCA Buildings #4046 & #4047
Description: Vehicle Shade Structures #1 & #2.

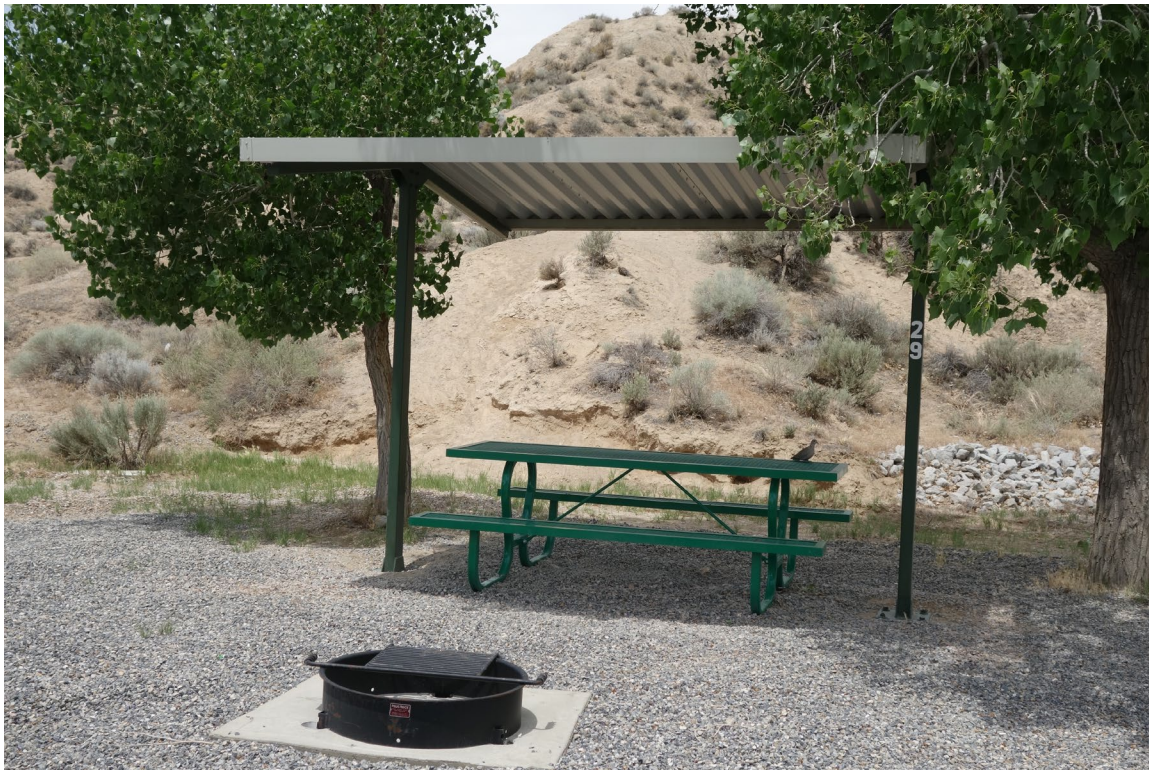
The exterior finishes of the shade ramadas are all in good condition. There are 29 steel shade ramadas in different locations throughout the site which are either 144 s.f., 264 s.f. or 400 s.f. for a total of 9,272 square feet. It is important to maintain the finish, weather resistance and appearance of the structures. This project would provide for painting of the structures and it is recommended that this project be scheduled on a cyclical basis to maintain the integrity of the structures.

Rye Patch SRA - FCA Buildings #3119 thru #3138
Description: Typical Boat Ramp Area Shade Ramadas.

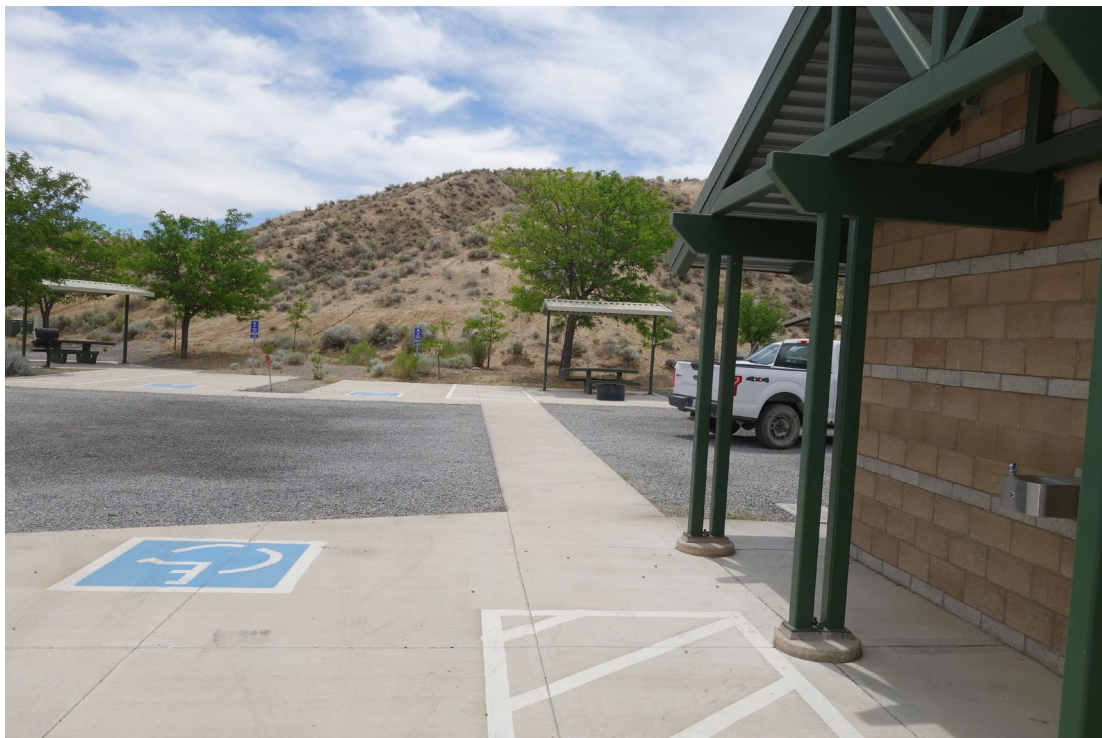
Rye Patch SRA - FCA Buildings #3119 thru #3138
Description: Boat Ramp Area Two Accessible Shade Ramadas.

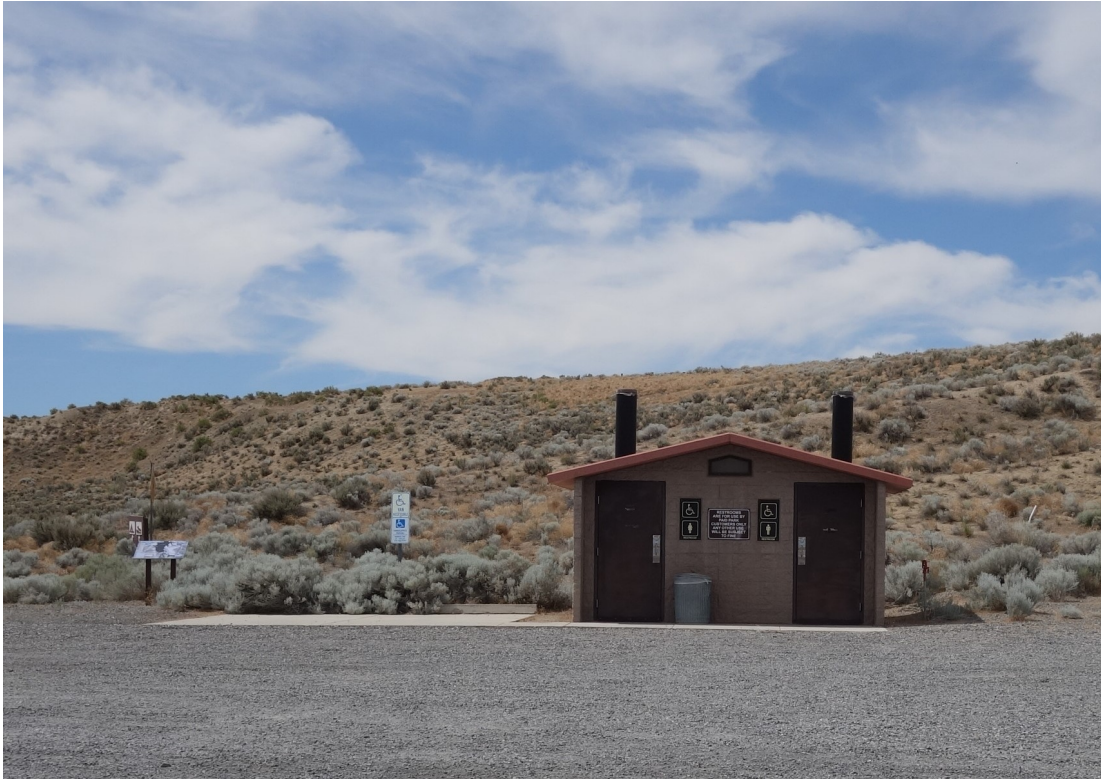
The exterior finishes are in good condition. It is important to maintain the finish, weather resistance, and appearance of the building. This project would provide funding to protect the interior and exterior of the building. Included in the cost are cleaning and sealing the precast concrete, and caulking of the windows, flashing, fixtures and all other penetrations. An epoxy paint is recommended on the interior precast concrete. It is recommended that the building be sealed and caulked in the next 8 - 9 years and that this project be scheduled on a cyclical basis to maintain the integrity of the structure.

The interior finishes are in good condition; however, since this is a public restroom a shorter cycle between re-finishing is recommended. It is recommended to power wash the interior walls and ceilings, and replace the Fiberglass Reinforced Panels where necessary at least once in the next 4 - 5 years and that this project be scheduled on a cyclical basis to maintain the integrity of the structure.

Rye Patch SRA - FCA Building #3118
Description: Group Use Comfort Station - Accessible.

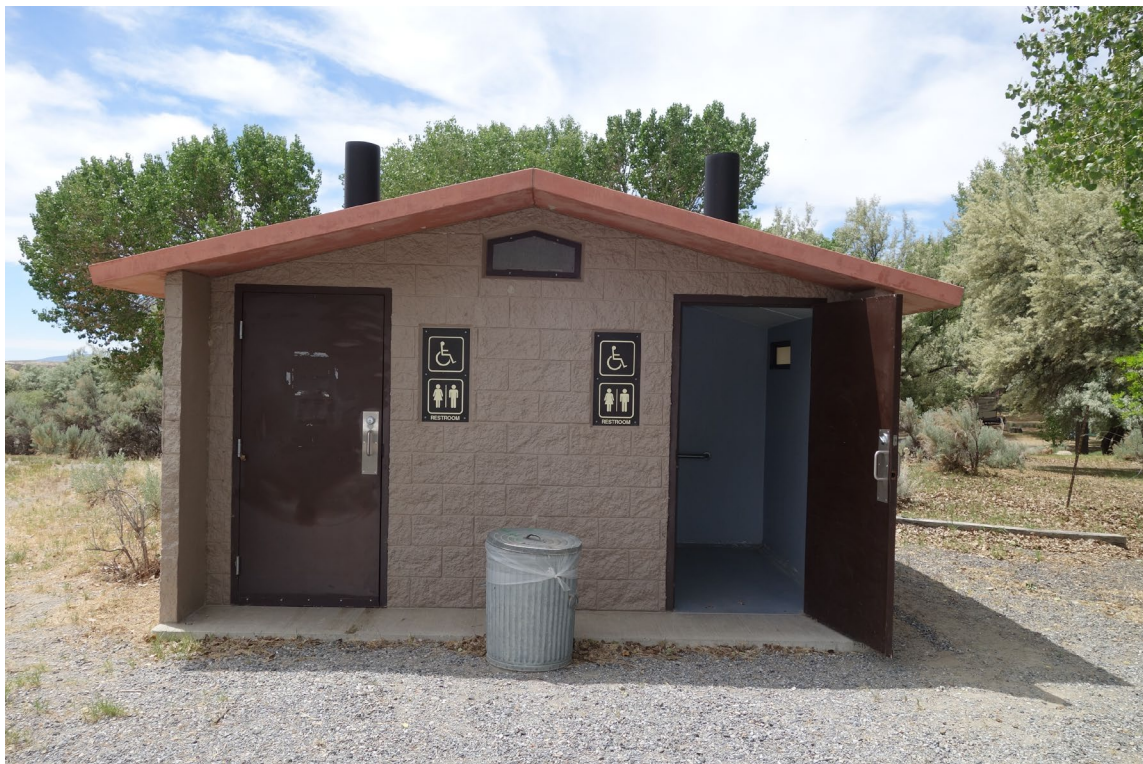
The exterior finishes are in good condition. It is important to maintain the finish, weather resistance, and appearance of the building. This project would provide funding to protect the interior and exterior of the building. Included in the cost are cleaning and sealing the precast concrete, and caulking of the windows, flashing, fixtures and all other penetrations. An epoxy paint is recommended on the interior precast concrete. It is recommended that the building be sealed and caulked in the next 8 - 9 years and that this project be scheduled on a cyclical basis to maintain the integrity of the structure.

The interior finishes are in good condition; however, since this is a public restroom a shorter cycle between re-finishing is recommended. It is recommended to power wash the interior walls and ceilings, and replace the Fiberglass Reinforced Panels where necessary at least once in the next 4 - 5 years and that this project be scheduled on a cyclical basis to maintain the integrity of the structure.

Rye Patch SRA - FCA Building #3117
Description: Lower Campground Comfort Station.

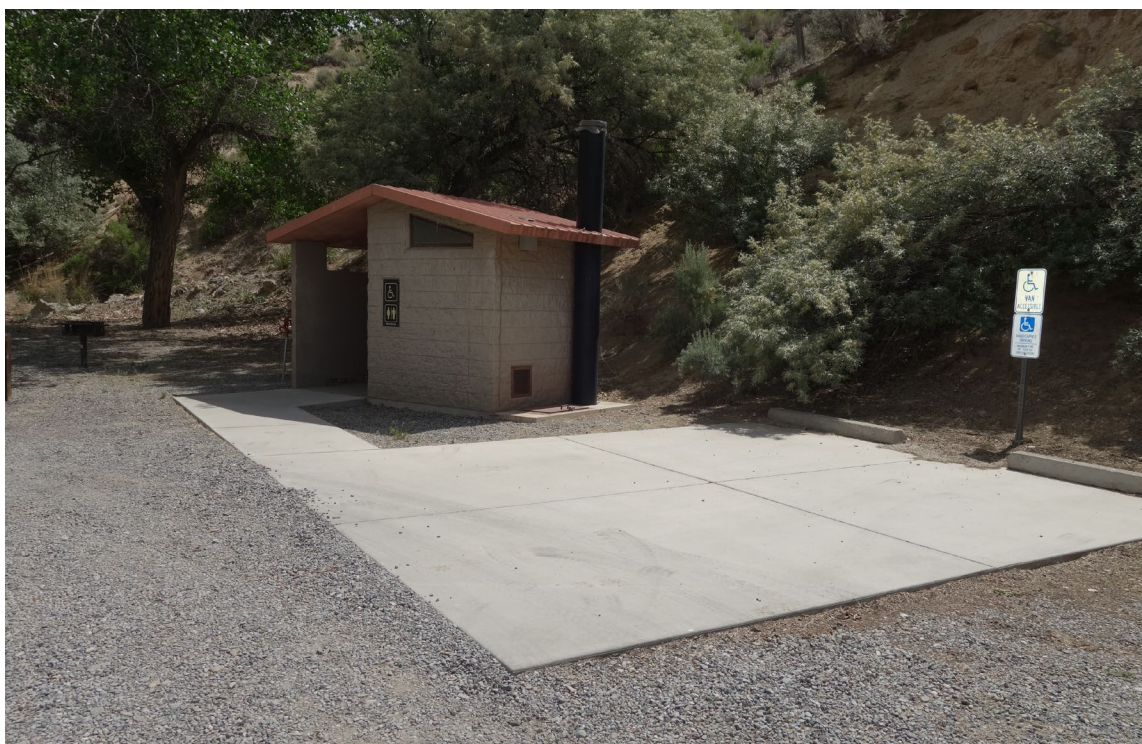
The exterior finishes are in good condition. It is important to maintain the finish, weather resistance, and appearance of the building. This project would provide funding to protect the interior and exterior of the building. Included in the cost are cleaning and sealing the precast concrete, and caulking of the windows, flashing, fixtures and all other penetrations. An epoxy paint is recommended on the interior precast concrete. It is recommended that the building be sealed and caulked in the next 8 - 9 years and that this project be scheduled on a cyclical basis to maintain the integrity of the structure.

The interior finishes are in good condition; however, since this is a public restroom a shorter cycle between re-finishing is recommended. It is recommended to power wash the interior walls and ceilings, and replace the Fiberglass Reinforced Panels where necessary at least once in the next 4 - 5 years and that this project be scheduled on a cyclical basis to maintain the integrity of the structure.

Rye Patch SRA - FCA Building #3116
Description: Day Use Comfort Station - Accessible.

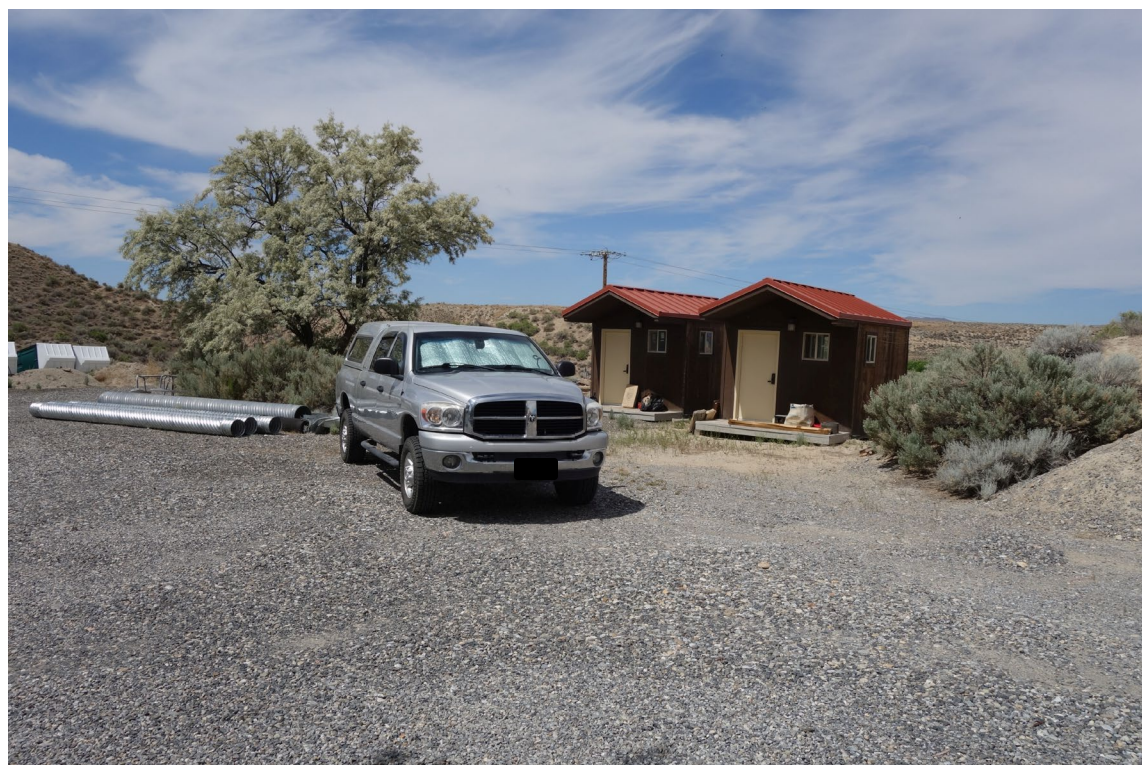
The exterior finishes are in poor condition. It is important to maintain the finish, weather resistance, and appearance of the building. This project would provide funding to protect the exterior of the building excluding the roof. Included in the cost is sanding, priming and painting, and caulking of the windows, flashing, fixtures and all other penetrations. It is recommended that the building be painted in the next 2 - 3 years and that this project be scheduled on a cyclical basis to maintain the integrity of the structure.

The interior finishes are in fair condition. It is recommended that the interior walls and ceilings be painted at least once in the next 4 - 5 years and that this project be scheduled on a cyclical basis to maintain the integrity of the structure. Prior to painting, all surfaces should be repaired and prepped.

Rye Patch SRA - FCA Buildings #3114 & #3115
Description: Cabin #1 & Cabin #2.

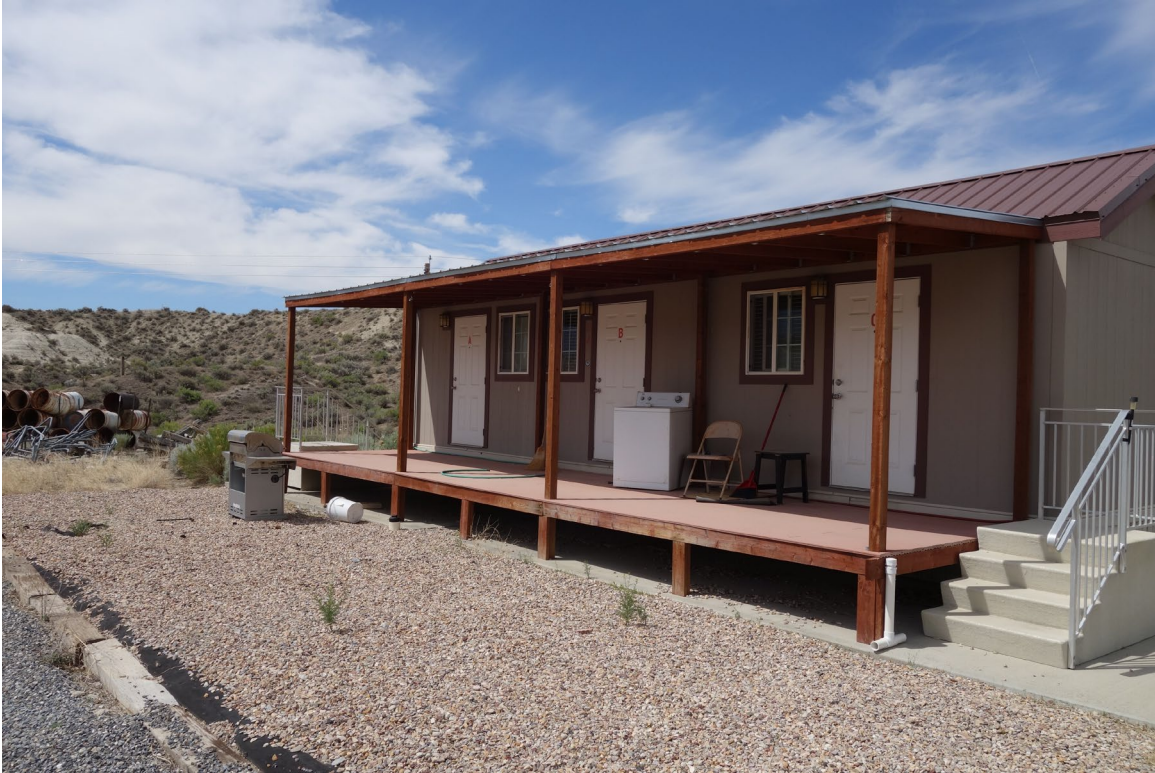
The exterior finishes are in good condition. It is important to maintain the finish, weather resistance, and appearance of the building. This project would provide funding to protect the exterior of the building excluding the roof. Included in the cost is sanding, priming and painting, and caulking of the flashing, fixtures and all other penetrations. It is recommended that the building be painted in the next 8 - 9 years and that this project be scheduled on a cyclical basis to maintain the integrity of the structure.

The interior finishes are in good condition. It is recommended that the interior walls and ceilings be painted at least once in the next 8 - 9 years and that this project be scheduled on a cyclical basis to maintain the integrity of the structure. Prior to painting, all surfaces should be repaired and prepped. An epoxy-based paint should be utilized in wet areas for durability.

Rye Patch SRA - FCA Building #2754
Description: Man Camp Trailer Door Landings and Guardrail Projects.

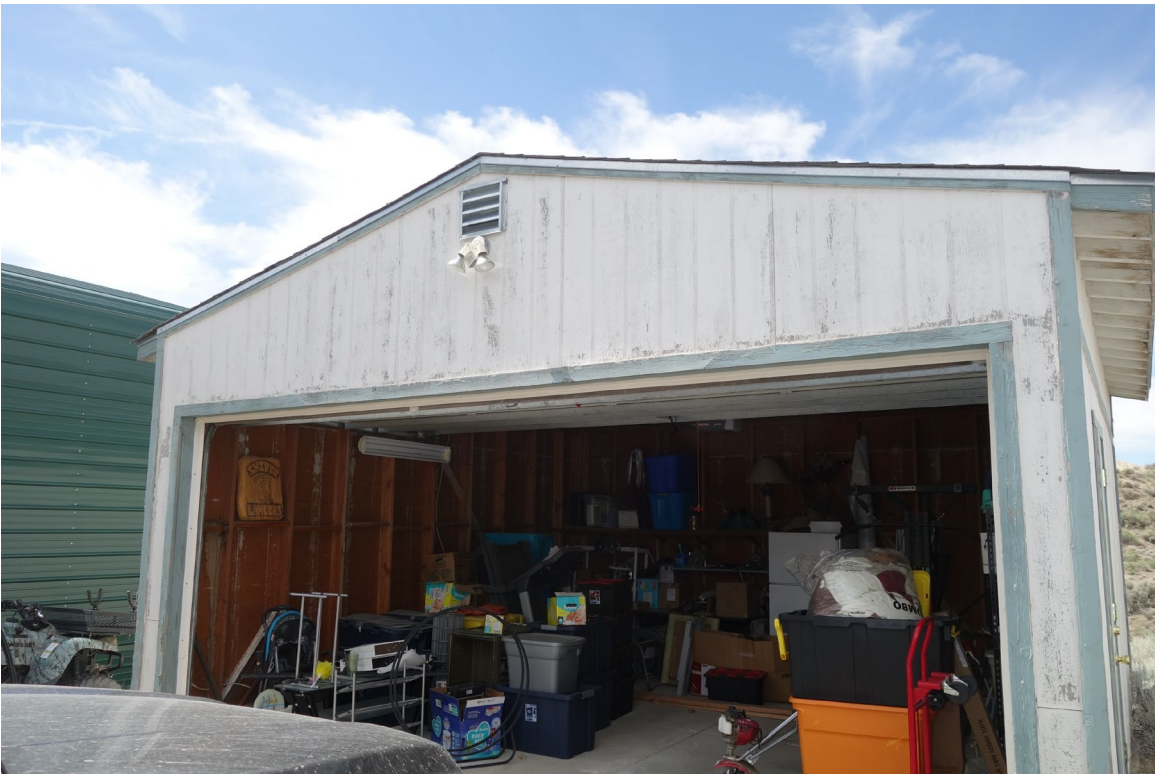
The exterior finishes are in poor condition. It is important to maintain the finish, weather resistance, and appearance of the building. This project would provide funding to protect the exterior of the building excluding the roof. Included in the cost is sanding, priming and painting, and caulking of the flashing, fixtures and all other penetrations. It is recommended that the building be painted in the next 2 - 3 years and that this project be scheduled on a cyclical basis to maintain the integrity of the structure.

The asphalt composition shingle roof on this building was in poor condition at the time of the survey. It is recommended that this building be re-roofed in the next 2 - 3 years with a new 50 year asphalt composition shingle roof and new underlayments. This estimate includes removal and disposal of the old roof.

Rye Patch SRA - FCA Building #2532
Description: Residence #1 Garage.

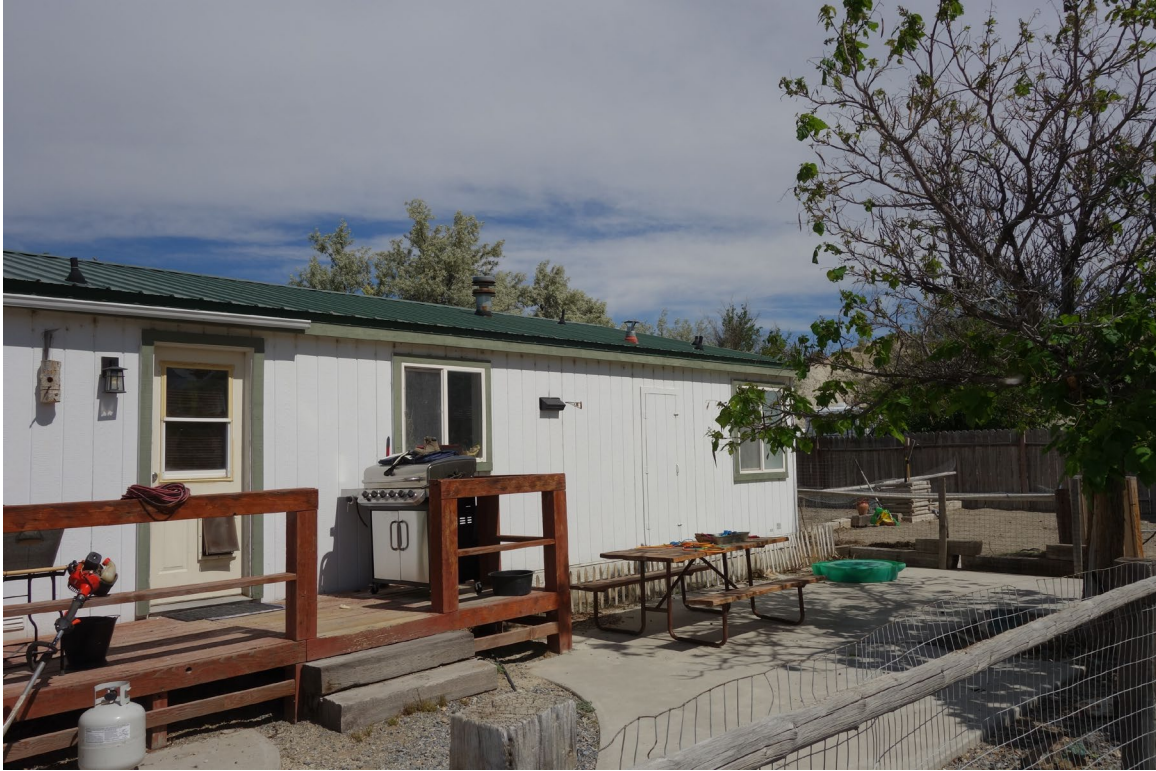
This building is lacking a carbon monoxide detection system. 2018 IRC R315, IFC 2018 Section 1103.9 (Carbon Monoxide Detection for Existing Buildings) define requirements in Dwelling Units and Sleeping Units (Group I & R Occupancies) for buildings containing fuel-burning appliances. The carbon monoxide alarms shall be listed as complying with UL 2034 and be installed and maintained in accordance with NFPA 720 and the manufacturer's instructions. This project would provide funding for the purchase and installation of carbon monoxide alarms in accordance with this code.

The exterior finishes are in poor condition, especially the finishes on the front and rear decks. It is important to maintain the finish, weather resistance, and appearance of the building. This project would provide funding to protect the exterior of the building excluding the roof. Included in the cost is sanding, priming and painting, and caulking of the windows, flashing, fixtures and all other penetrations. It is recommended that the building be painted in the next 2 - 3 years and that this project be scheduled on a cyclical basis to maintain the integrity of the structure.

The interior finishes are in good condition. It is recommended that the interior walls and ceilings be painted at least once in the next 8 - 9 years and that this project be scheduled on a cyclical basis to maintain the integrity of the structure. Prior to painting, all surfaces should be repaired and prepped. An epoxy-based paint should be utilized in wet areas for durability.

There is a 40 gallon propane-fired water heater in the building. The average life span of a water heater is eight to ten years. With the passage of time and constant use, this unit is showing signs of wear and should be scheduled for replacement in the next 7-8 years. It is recommended that a new propane-fired water heater be installed. Removal and disposal of the existing equipment is included in this estimate.

Rye Patch SRA - FCA Building #1309
Description: Residence #1.

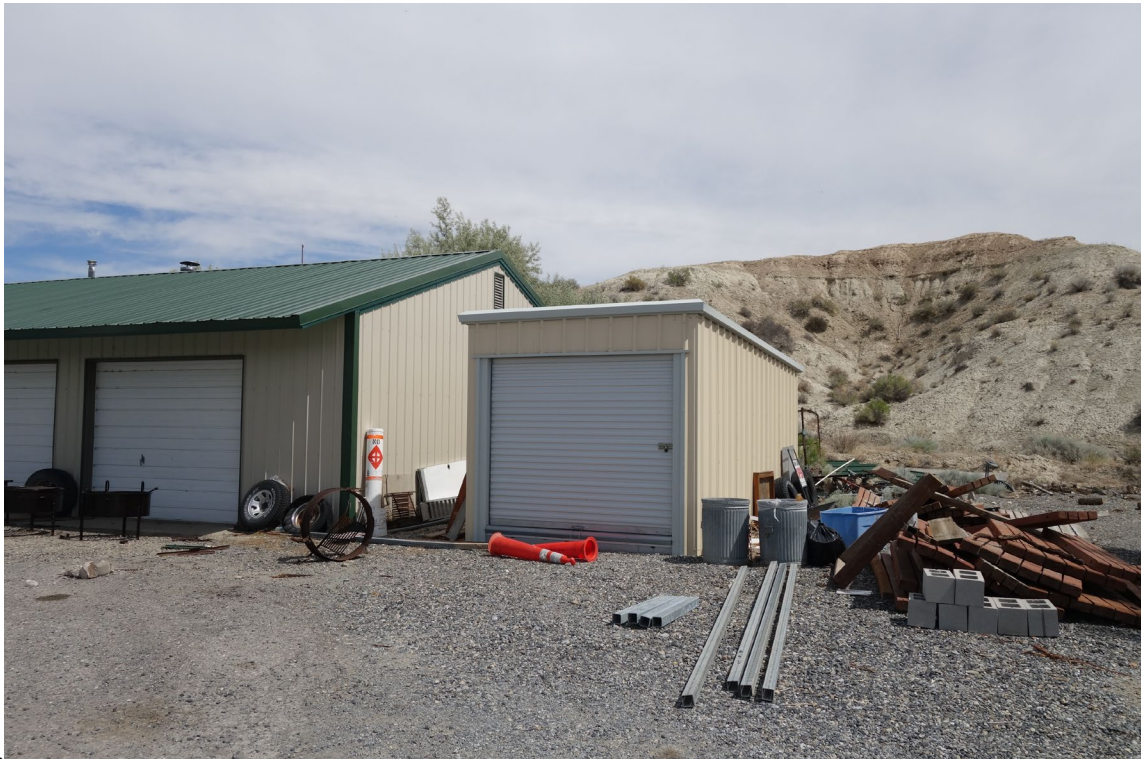
Rye Patch SRA - FCA Building #1308
Description: Storage Building #1.

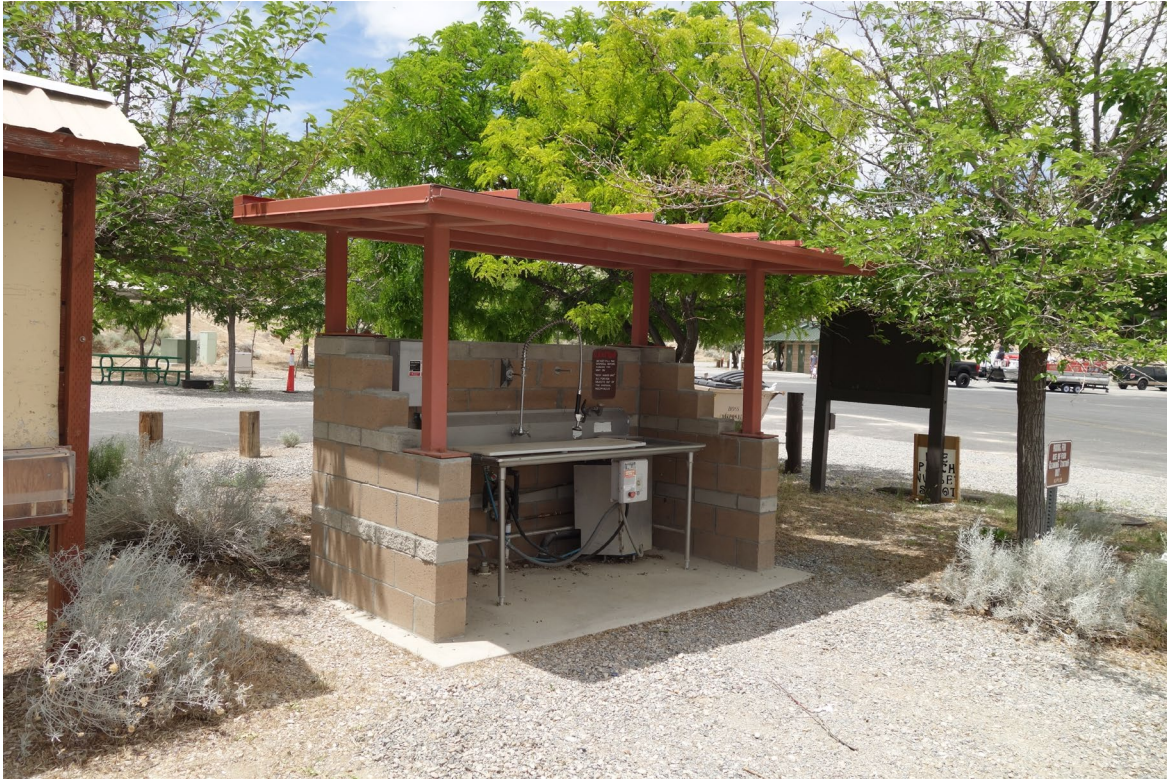
The exterior finishes are in fair condition. It is important to maintain the finish, weather resistance, and appearance of the structure. This project would provide funding to protect the exterior of the building excluding the roof. Included in the cost are cleaning and sealing the concrete masonry units, and painting the steel framing. It is recommended that the building be sealed and painted in the next 4 - 5 years and that this project be scheduled on a cyclical basis to maintain the integrity of the structure.

Rye Patch SRA - FCA Building #1307
Description: Fish Cleaning Station.

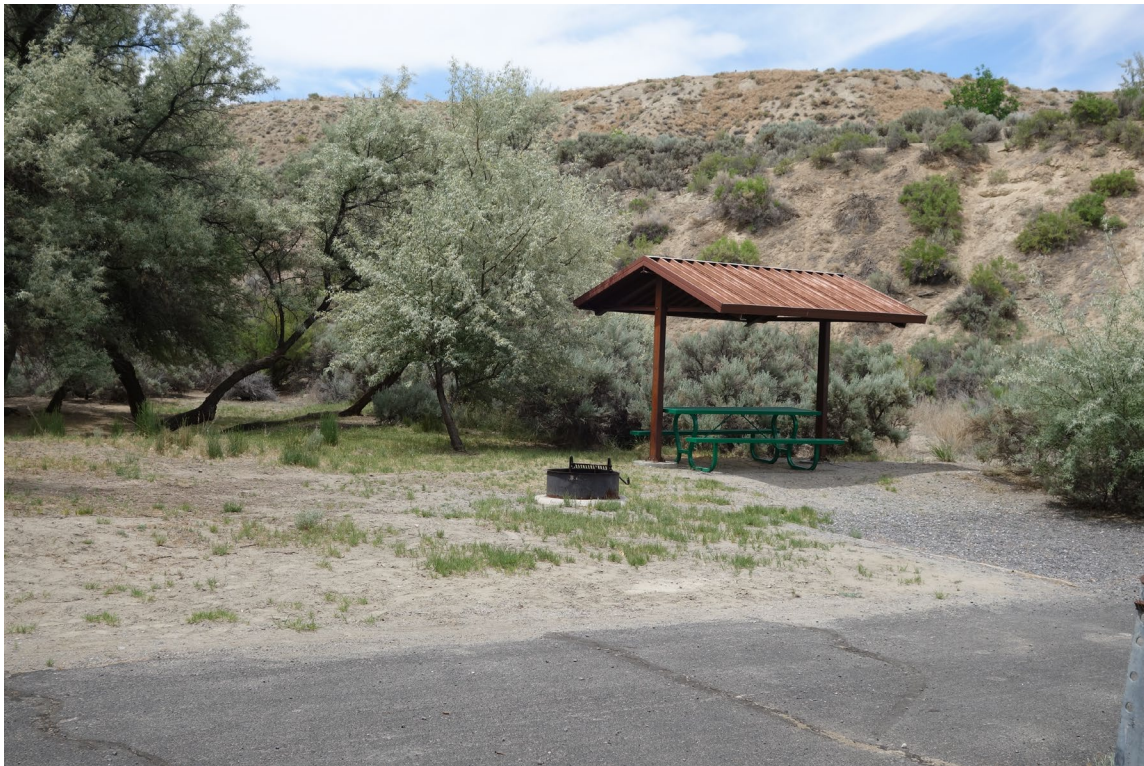
Rye Patch SRA - FCA Buildings #1300 thru #1303
Description: Typical Lower Campground Shade Ramadas.

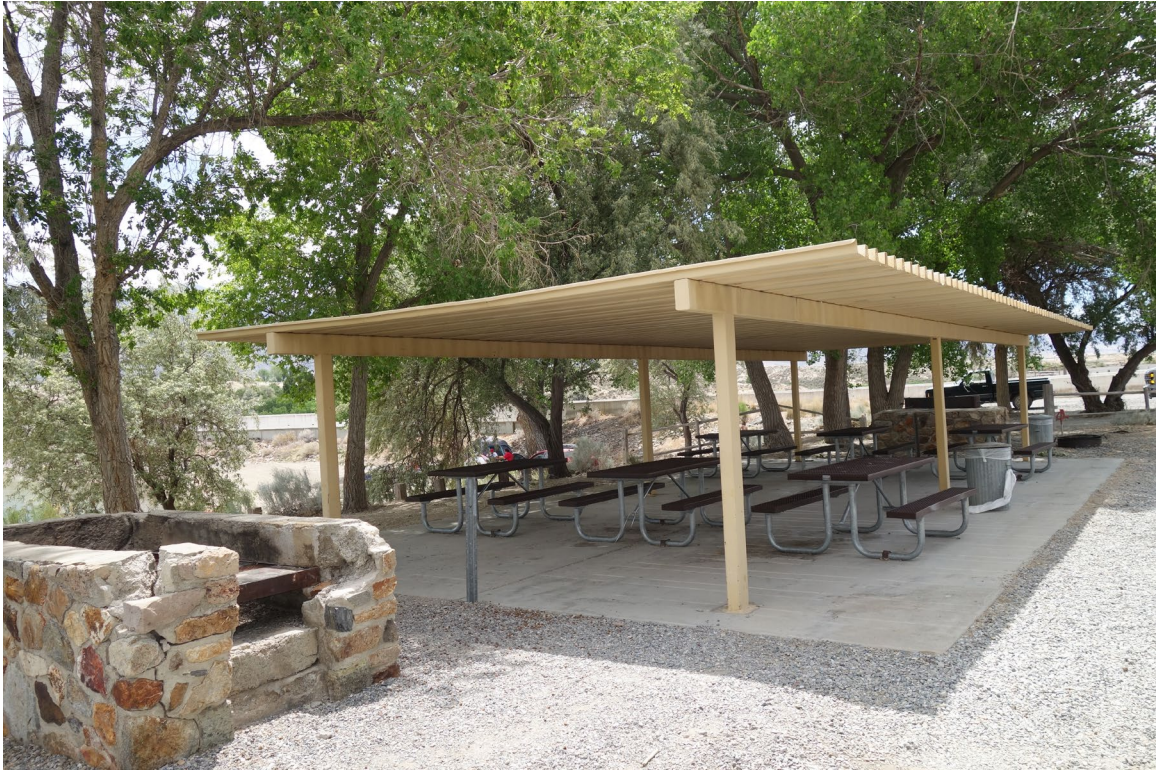
The exterior finishes are in poor condition. It is important to maintain the finish, weather resistance, and appearance of the structure. It is recommended that the structure be painted in the next 3 - 4 years and that this project be scheduled on a cyclical basis to maintain the integrity of the structure.

Rye Patch SRA - FCA Building #1299
Description: Group Use Ramada.

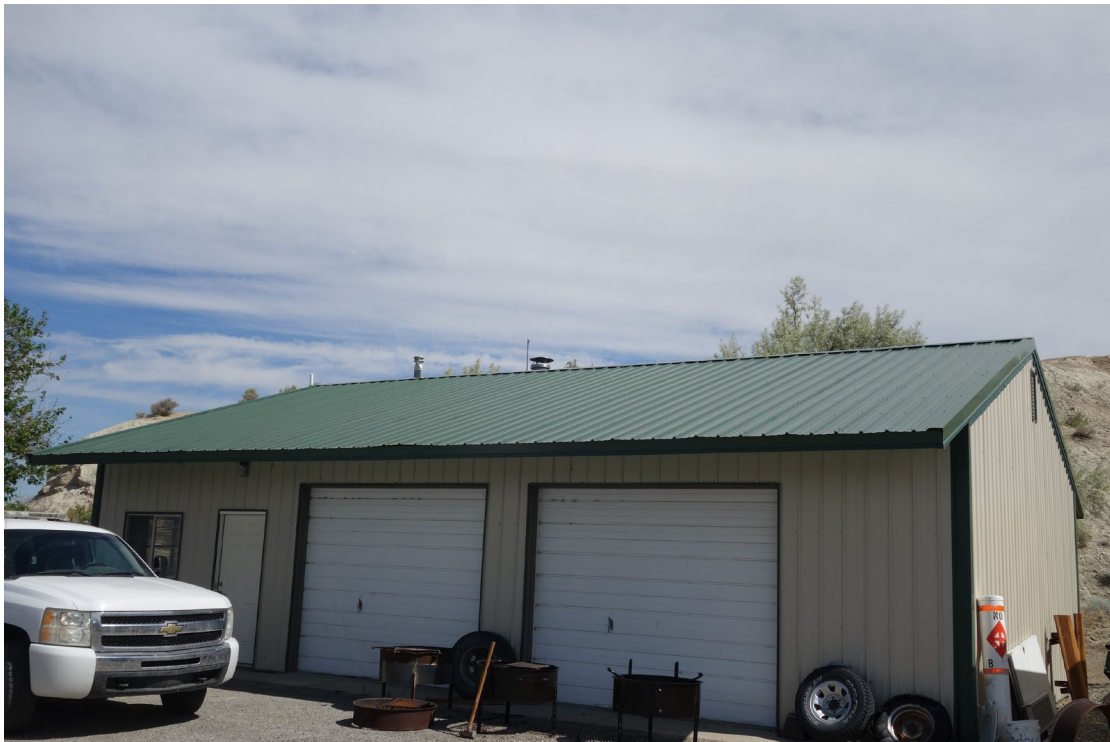
The Park Office & Garage building is a wood framed structure which contains the support staff's offices and garage/repair shop for the State Recreation Area. There are a couple of offices and a small bathroom on one side and the garage/repair shop on the other. The building sits on a concrete slab-on-grade foundation and has a prefinished metal panel gable roof. The building is in fair condition and at the time of the survey, it was not ADA compliant.

This building is lacking a fire detection and alarm system. It is recommended that a fire detection and alarm system be installed. When completed, the new system will provide visual, as well as audible notification, in accordance with ADA requirements located in ICC/ANSI A117.1 Section 7 and the 2018 International Fire Code.

The exterior concrete apron in front of the overhead doors has extensive cracking, is too small, and is due for an upgrade. This project would provide for the installation of a new 4" thick concrete slab-on-grade apron at the vehicle garage doors. Removal and disposal of the existing concrete is included in this estimate. This project should be implemented concurrently with the ADA PARKING SPACE project.

The building is heated by one wall mounted propane-fired heating unit. It is original to the building and is reaching the end of its useful life. This project provides for disposal of the existing unit and replacement with a new propane-fired unit including connections to utilities.

Rye Patch SRA - FCA Building #1298
Description: Park Office & Garage.

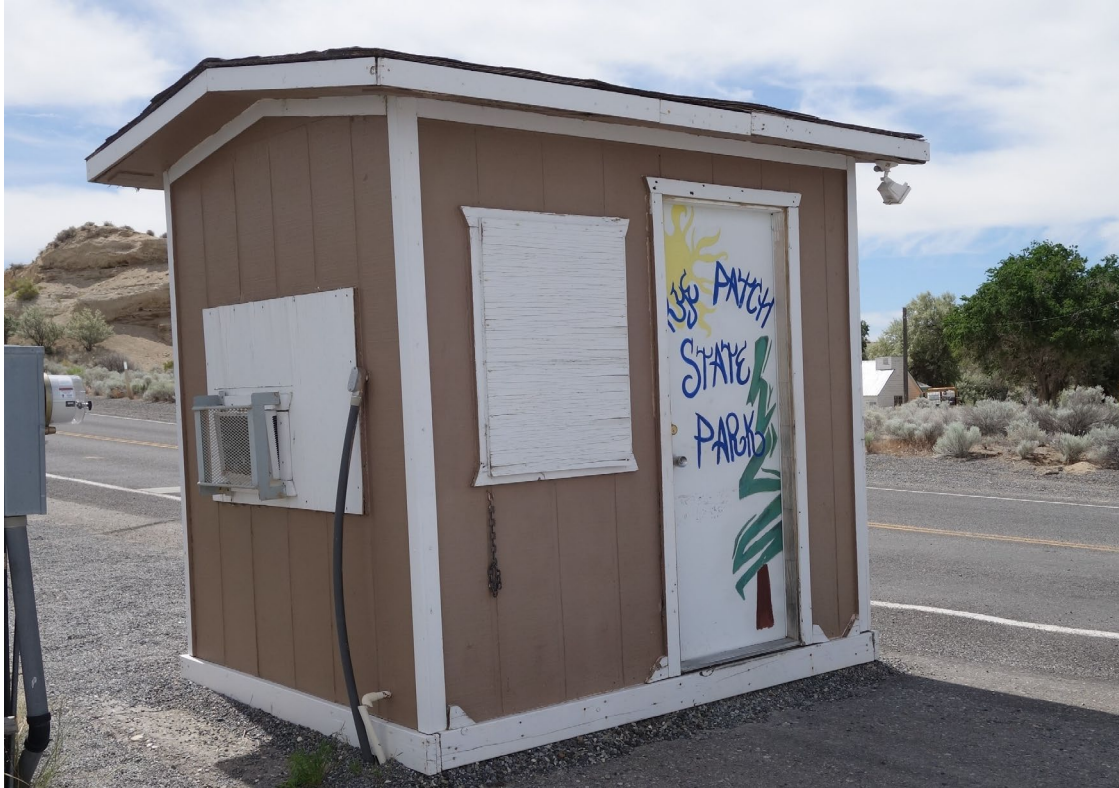
Rye Patch SRA - FCA Building #1297
Description: Entrance Station Electrical Upgrade Feeder Conduit Project.

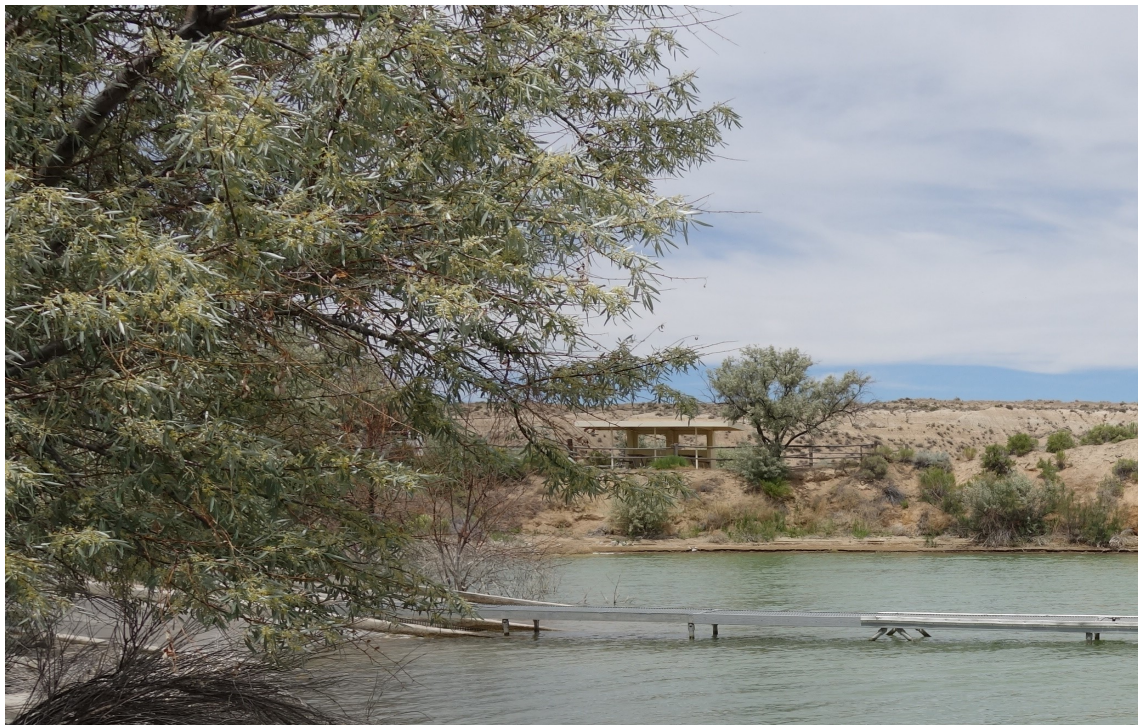
Rye Patch SRA - FCA Building #1296
Description: Ramada #8.

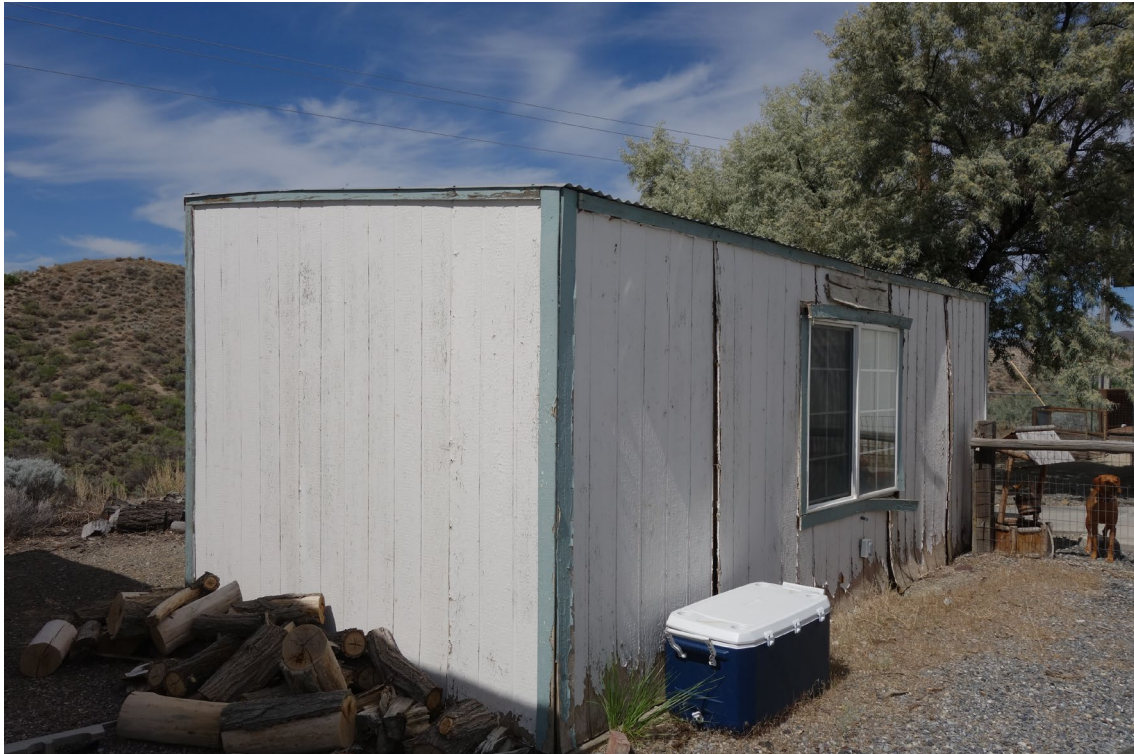
Rye Patch SRA - FCA Building #0545
Description: Storage Building #2.

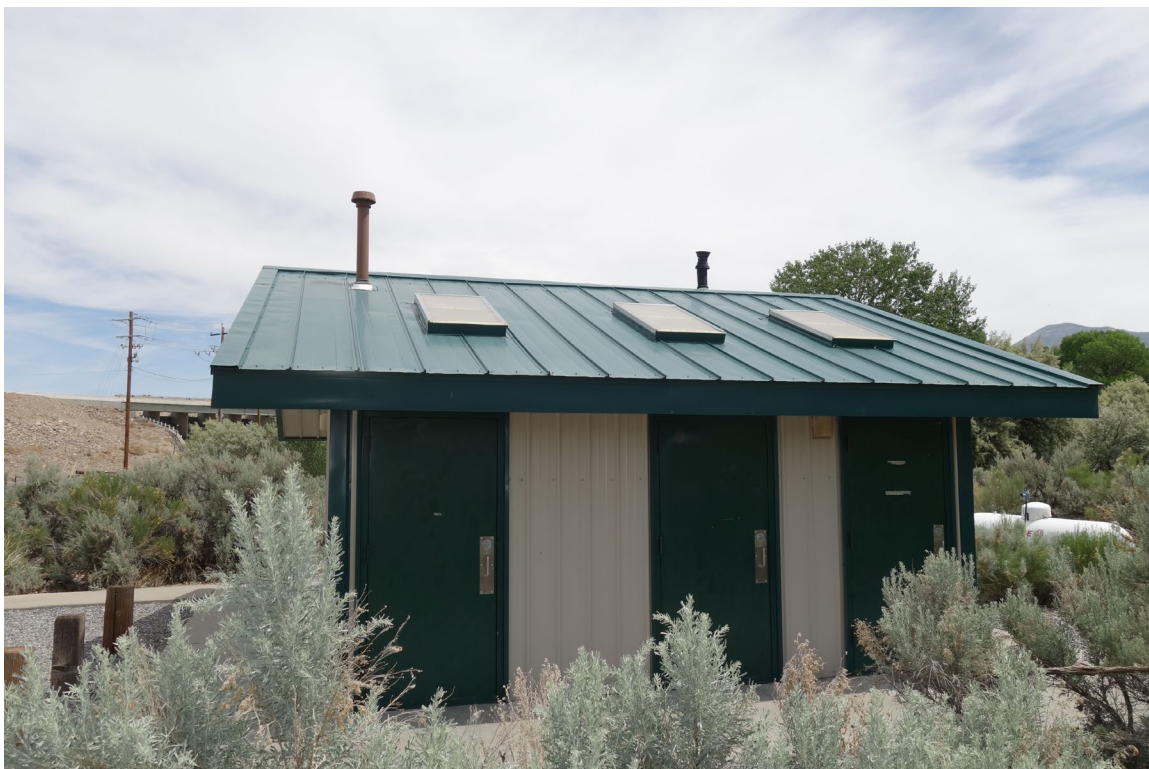
Rye Patch SRA - FCA Building #0479
Description: Comfort Station #4.
