RYE PATCH STATE RECREATION AREA

Site Number: 9883
STATE OF NEVADA PUBLIC WORKS DIVISION
FACILITY CONDITION ANALYSIS

Report distributed in January 2022

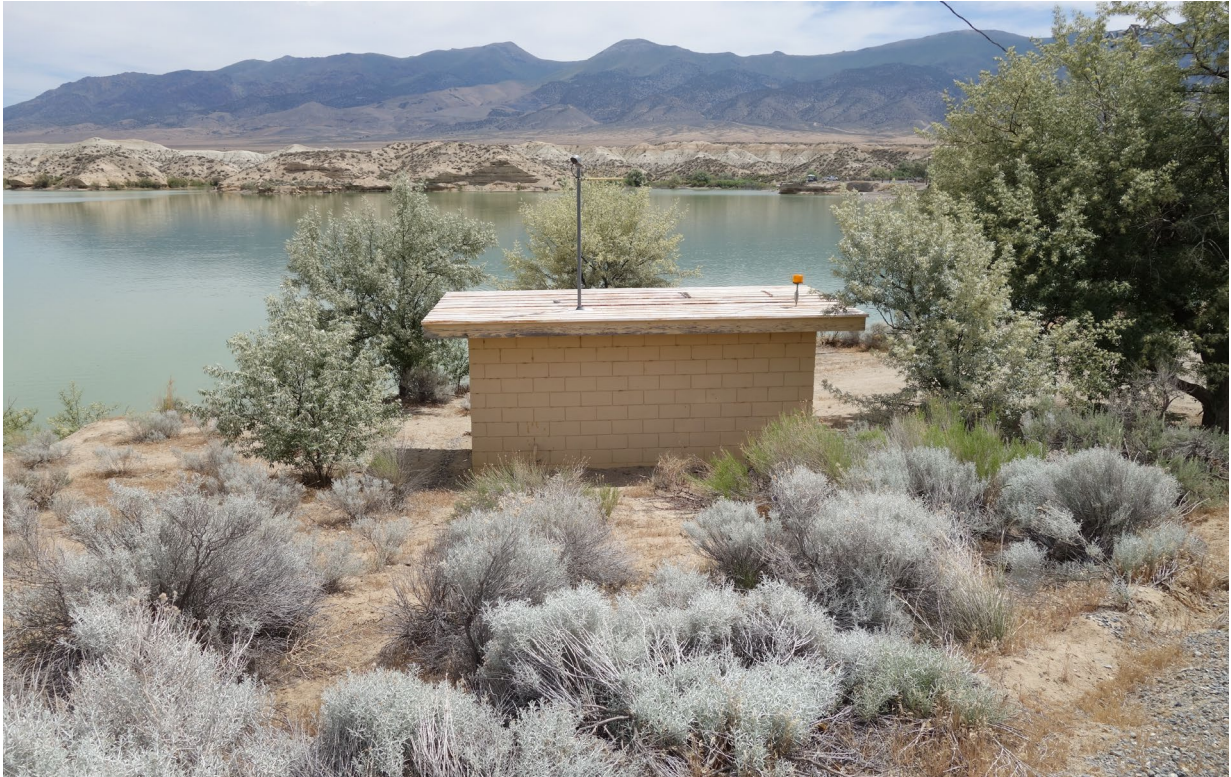
Rye Patch SRA - FCA Building #0477
Description: Well House.

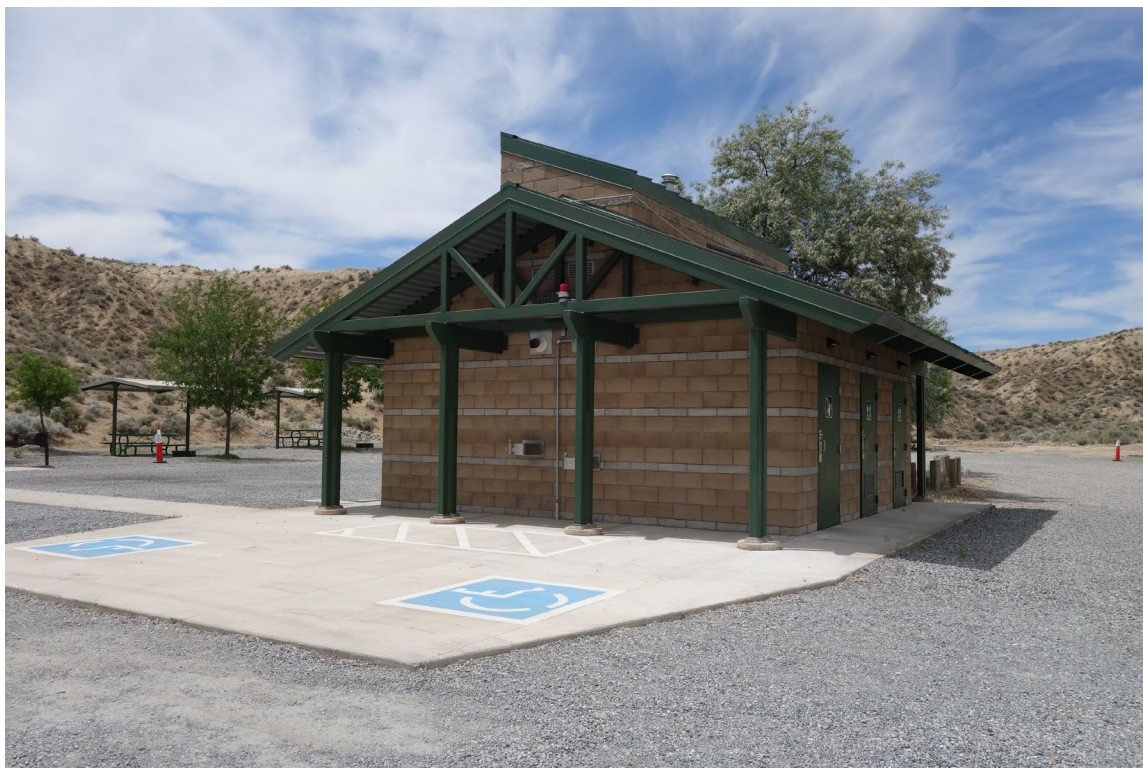
Rye Patch SRA - FCA Building #0476
Description: Boat Ramp Comfort Station – Accessible.
