State of Nevada
Department of Military
Nevada National Guard
Facility Condition Analysis

NEVADA NATIONAL GUARD ARMORY WINNEMUCCA

735 West 4th Street
Winnemucca, Nevada

Site Number: 9884
FACILITY CONDITION ANALYSIS

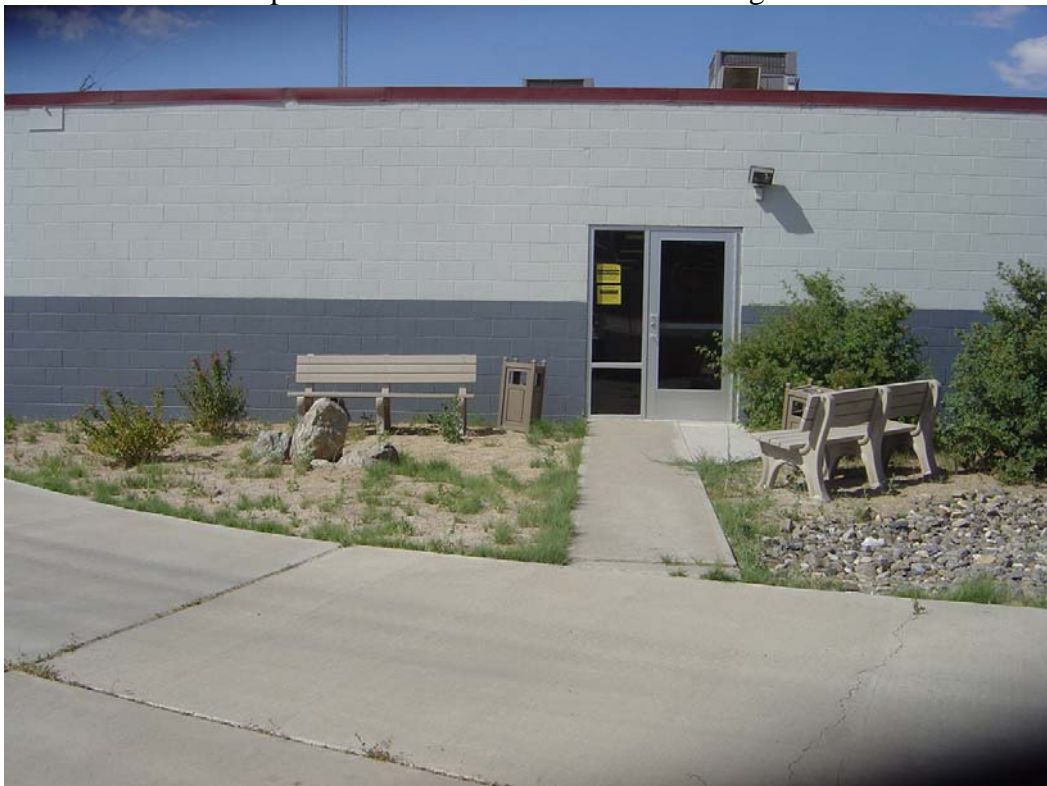
The accessible parking, travel route, and public entrance are not clearly defined. Currently, the public parks in the rear of the building and must utilize the side entrance for the accessible route of travel from the parking area to the building. The travel route from the parking area to the accessible door is a concrete walk that is in need of replacement. This project would provide for accessible parking, striping, signage and removal and replacement of about 50 lineal feet of a three foot wide concrete accessible route of travel to the building.

Description: Accessible travel route into the Armory.

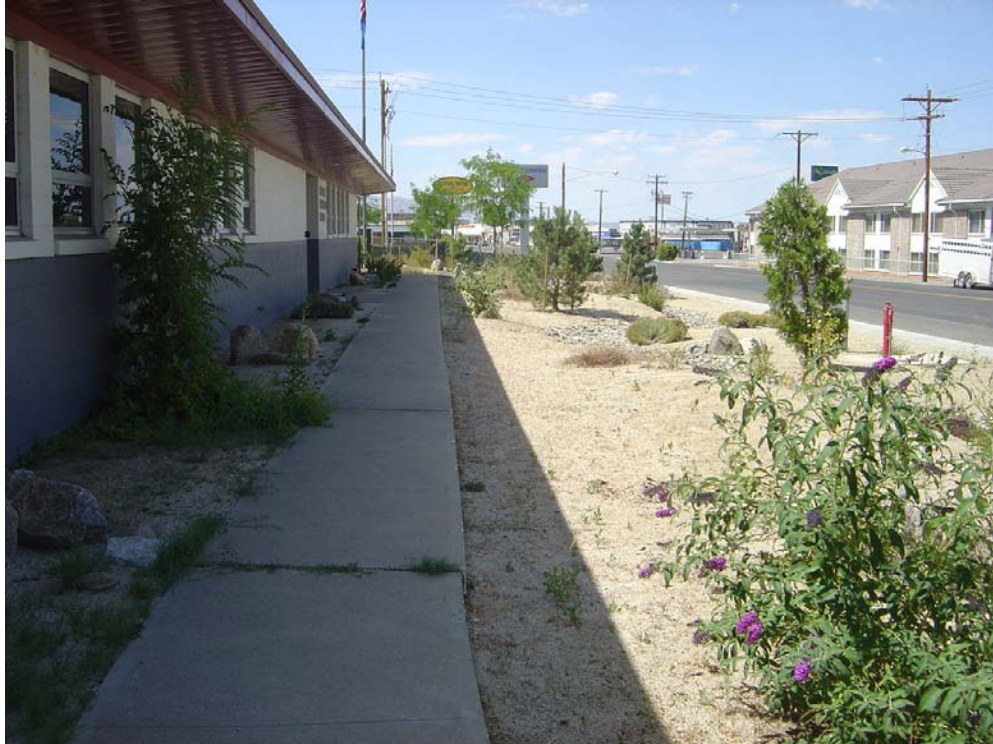
The concrete sidewalks and parking appear to be part of the original construction. Deterioration, spalling, and cracking has occurred mainly from exposure to the weather and possible water accumulation. This project would provide for the removal and replacement of the concrete sidewalks in front of the Armory and the concrete parking area in the rear of the Armory. Disposal of the old concrete is included in this estimate.

Description: Front sidewalk of Armory and site view.

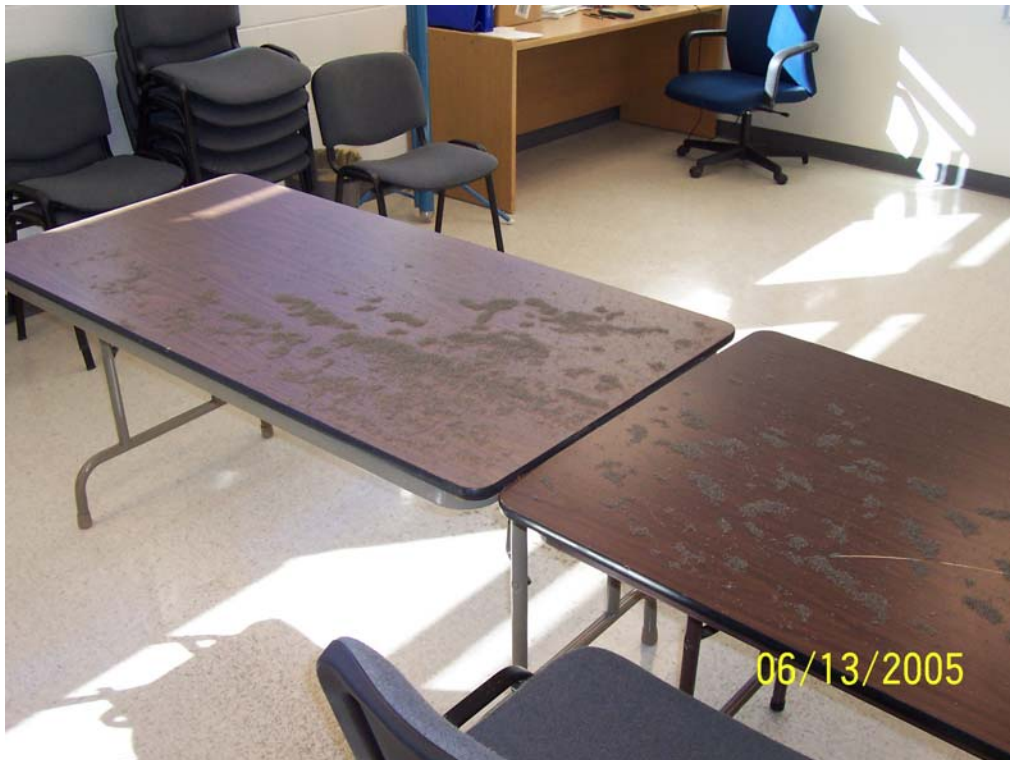
The existing HVAC system is equipped with an economizer cycle and enthalpy control for "free cooling" of the building. The air-handlers have large gaps in the duct work located around the economizers. The gaps are allowing insects and gnats access inside the building. This project would provide funding to modify the duct work system to eliminate the gaps.

Description: Table covered with gnats in the Armory # 0688.

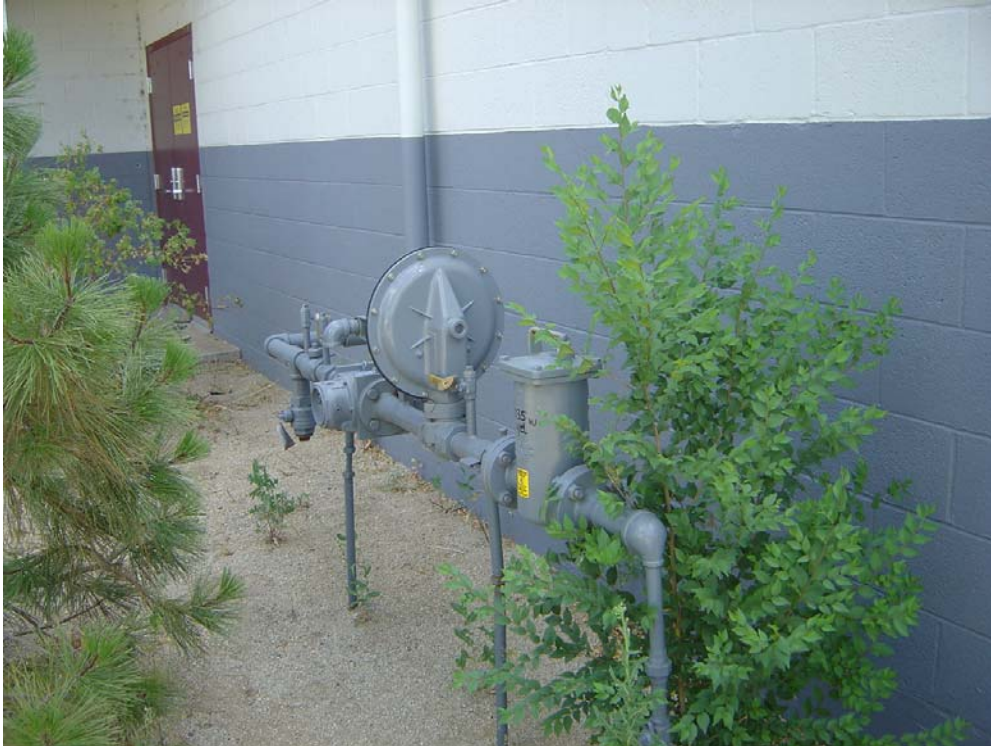
Agreements reached between the Nevada Risk Management Office and the State of Nevada's Insurance Underwriter require Seismic Gas Shutoff Valves (SGSV's) on all gas services to all State owned buildings. This project would install a SGSV to the gas line serving the building.

Description: Missing seismic gas shutoff valve on building #0688.

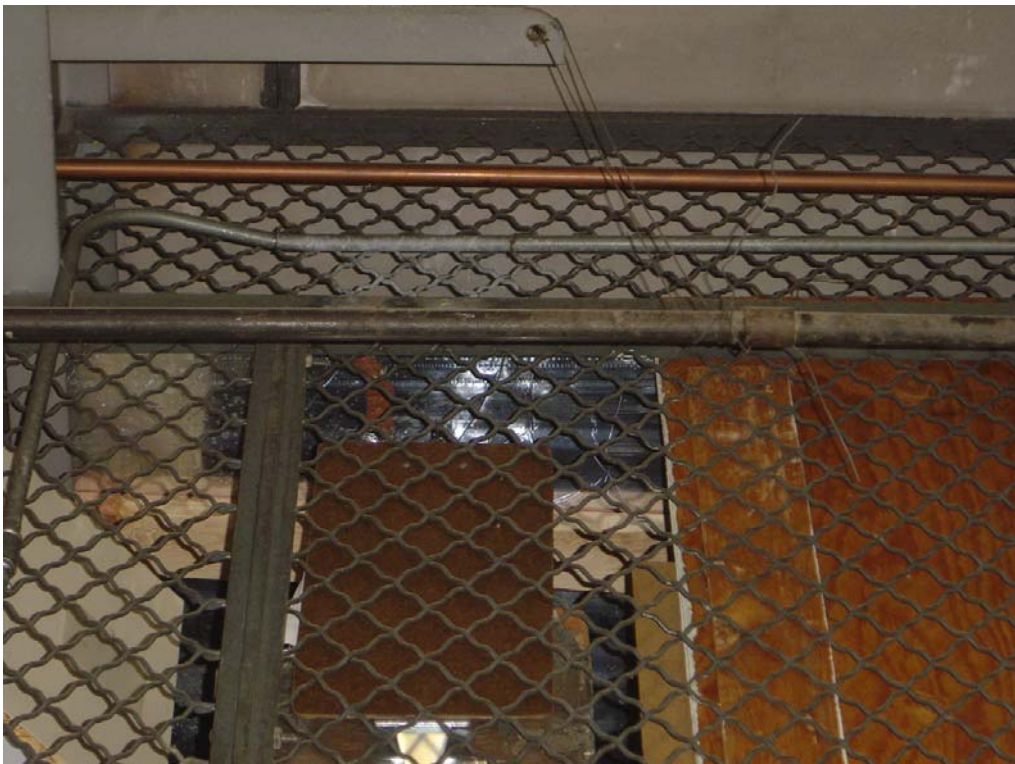
This building has natural gas fired heaters and natural gas lines suspended from the ceiling. They lack seismic bracing. This project would provide seismic bracing as required by IBC 2003, Chapter 16 Section 1621.

Description: Wire supporting natural gas line in OMS Building #0690.

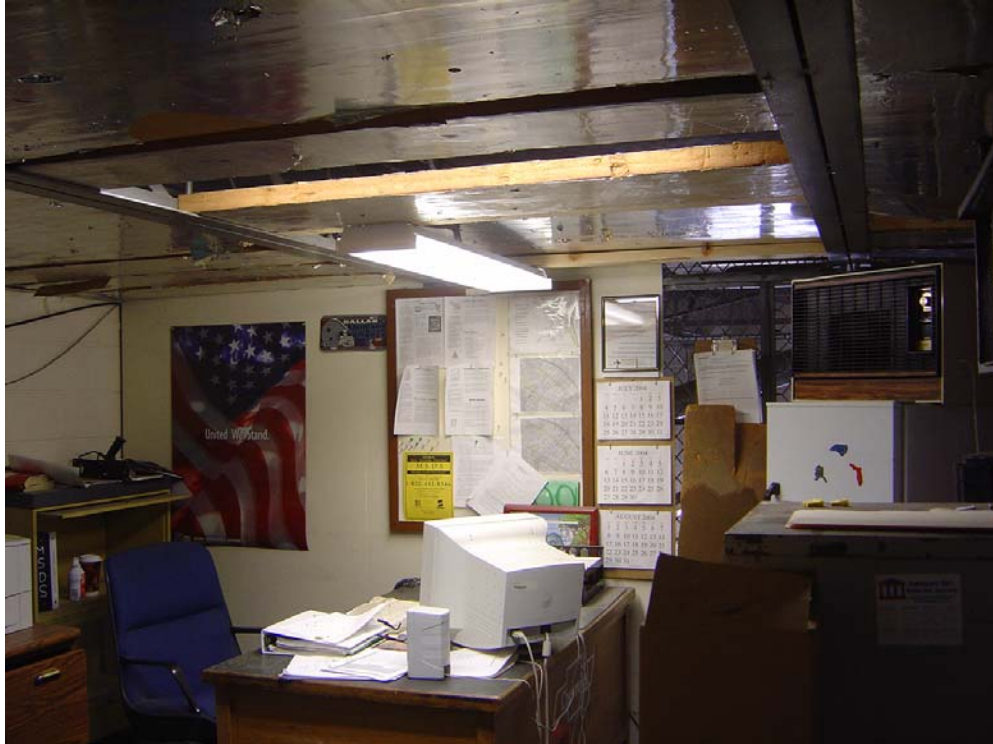
The mezzanine contains numerous code and safety issues including, ceiling height, electrical boxes with missing covers, inadequate HVAC system and possible structural issues. This project recommends a structural and seismic assessment of the mezzanine. Future projects would be generated from the report results.

Nevada National Guard Site # 9884
Description: Mezzanine office in maintenance shop # 0690.

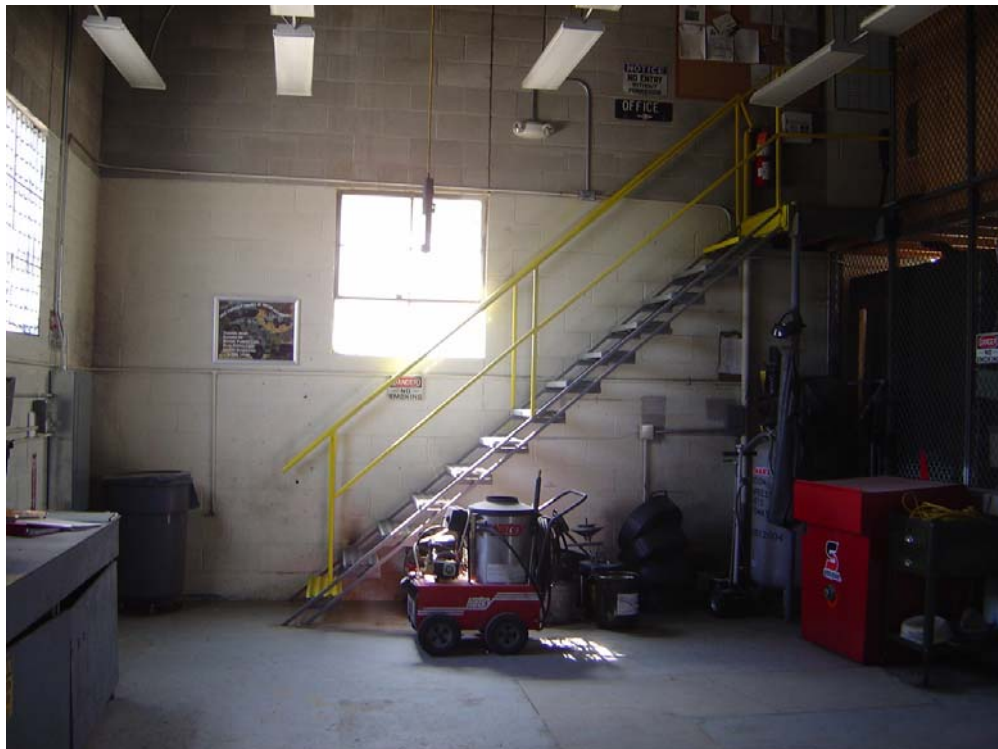
Nevada National Guard Site # 9884
Description: Stairs leading to mezzanine office in maintenance shop #0690.

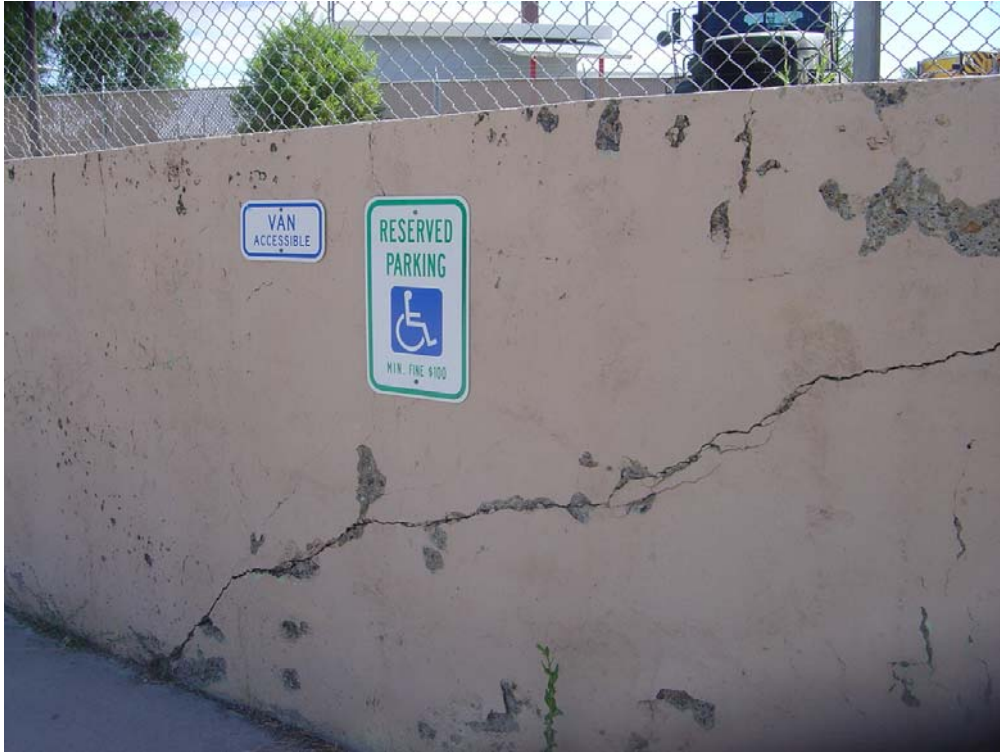
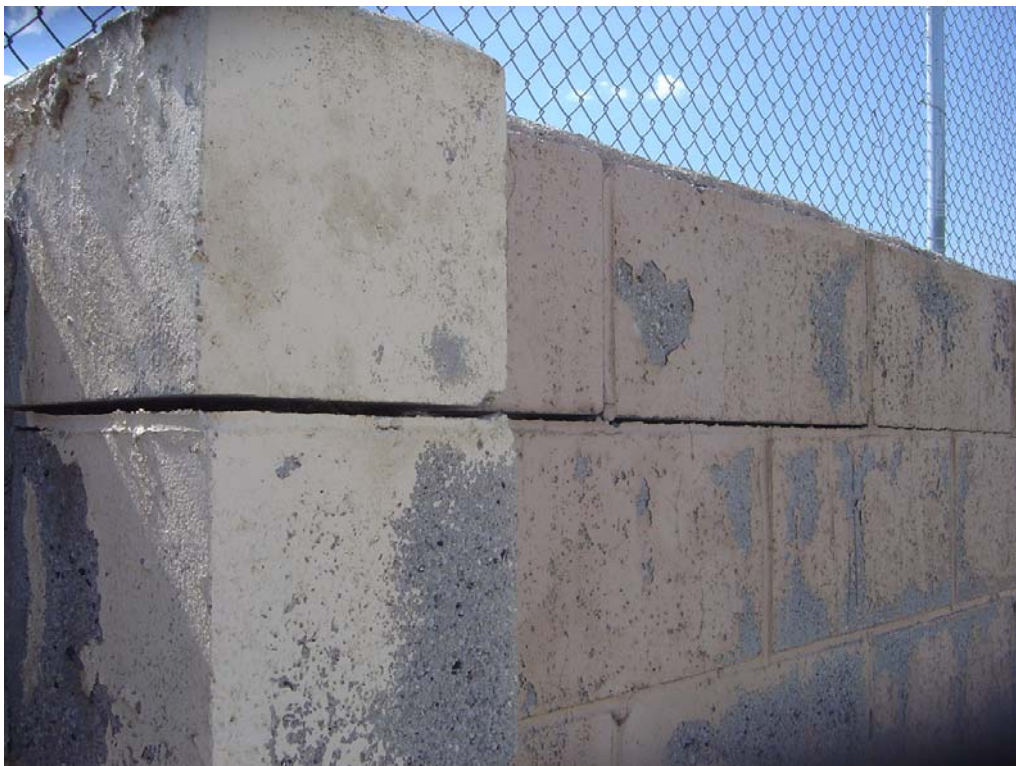
The site has a retaining wall that runs along the rear of the Armory building parking area that separates the lower and upper part of the facility. The wall is constructed of CMU and precast concrete and has numerous cracks due to water infiltration and age. This may be compromising the structural integrity of the wall. This project would provide for repairs to the wall and the application of a sealer to prevent further damage.

Nevada National Guard Site # 9884
Description: Damaged retaining wall.

Nevada National Guard Site #9884
Description: Damaged retaining wall.

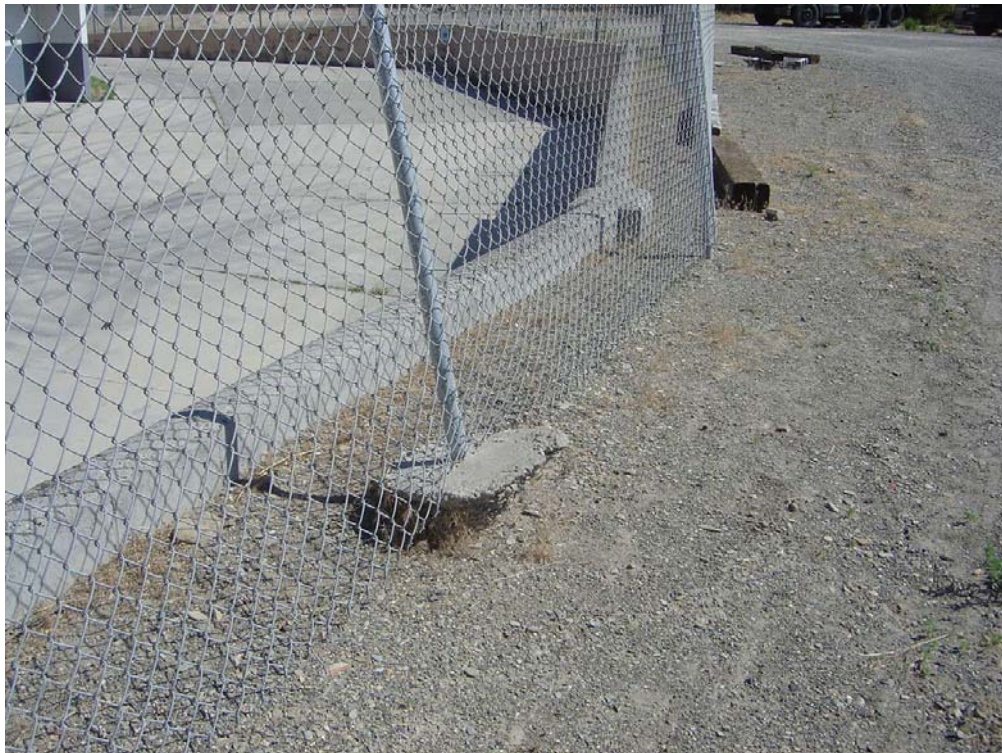
The Nevada National Guard - Winnemucca Site is currently fenced off to the general public for security and safety reasons. There is a chain link fence dividing the upper level from the lower level located adjacent to the retaining wall. There are some areas of the fence that are damaged and should be replaced. This project would provide for replacement of the 6 foot tall industrial chain link fence.

Nevada National Guard Site #9884
Description: Damaged fencing along the retaining wall.

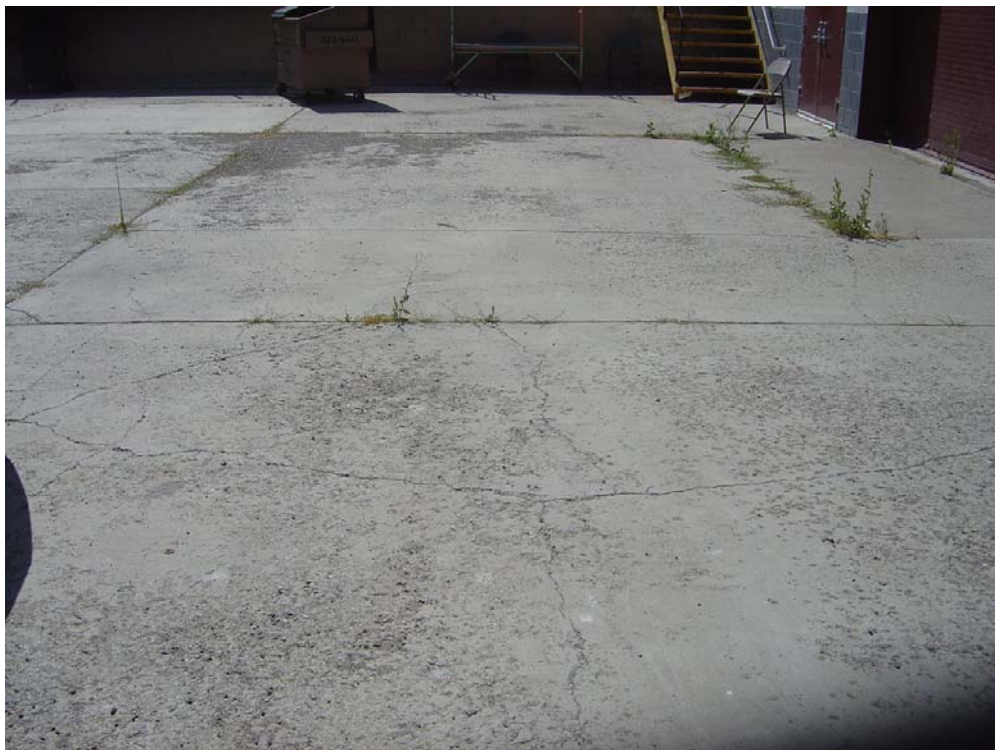
Nevada National Guard Site #9884
Description: Concrete parking area damage.
