State of Nevada Office of Military / Nevada National Guard Fallon National Guard Armory Facility Condition Analysis

FALLON NATIONAL GUARD ARMORY

Site Number: 9885 STATE OF NEVADA PUBLIC WORKS DIVISION FACILITY CONDITION ANALYSIS

Report Printed in April 2012

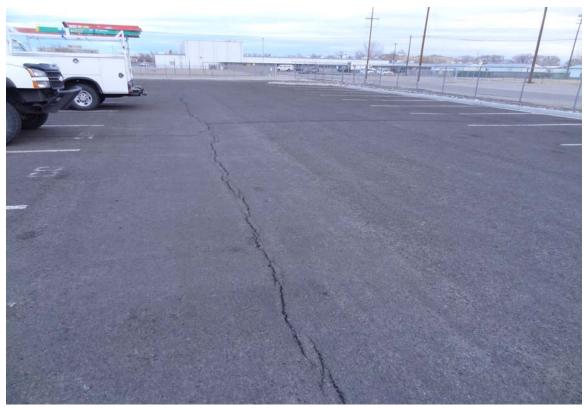
Fallon National Guard Armory Site - Site #9885 Description: Paved parking area in need of crack filling.

It is important to maintain the asphalt concrete paving on the site. This project would provide for minor crack filling and slurry sealing of the paving site wide including access roads, parking areas and the maintenance yard. Striping is included in this estimate. This project should be scheduled on a 5 year cyclical basis to maintain the integrity of the paving and prevent premature failure. 45,000 square feet of asphalt area was used to generate this estimate.

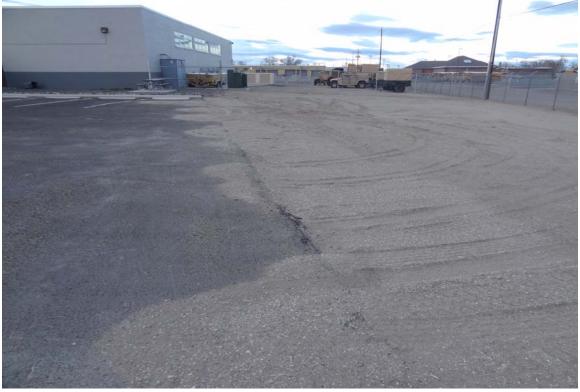
Fallon National Guard Armory Site - Site #9885 Description: Area where paving or soil stabilization is needed.

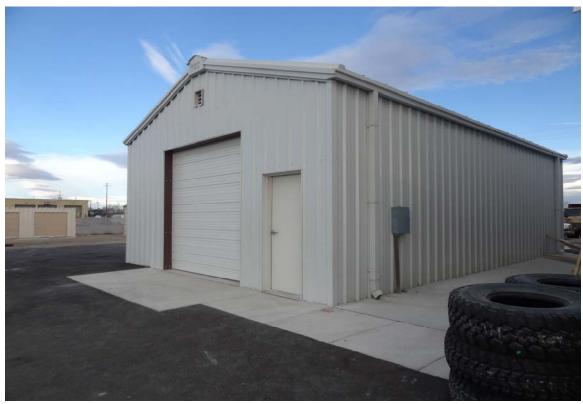
Storage Building - Building #3087 Description: Exterior of the building.

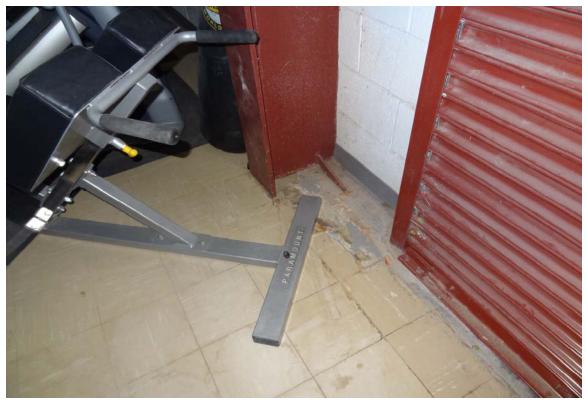
Fallon Armory - Building #0678 Description: Damaged VCT in Gym.

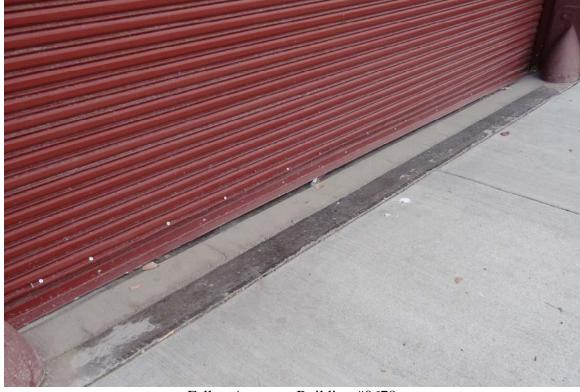
Fallon Armory - Building #0678 Description: Damaged overhead coiling door.
