State of Nevada
Office of the Military / Nevada National Guard
Yerington National Guard Armory
Facility Condition Analysis

YERINGTON NATIONAL GUARD ARMORY

14 Joe Parr Way
Yerington, Nevada 89447

Site Number: 9886
STATE OF NEVADA PUBLIC WORKS DIVISION
FACILITY CONDITION ANALYSIS

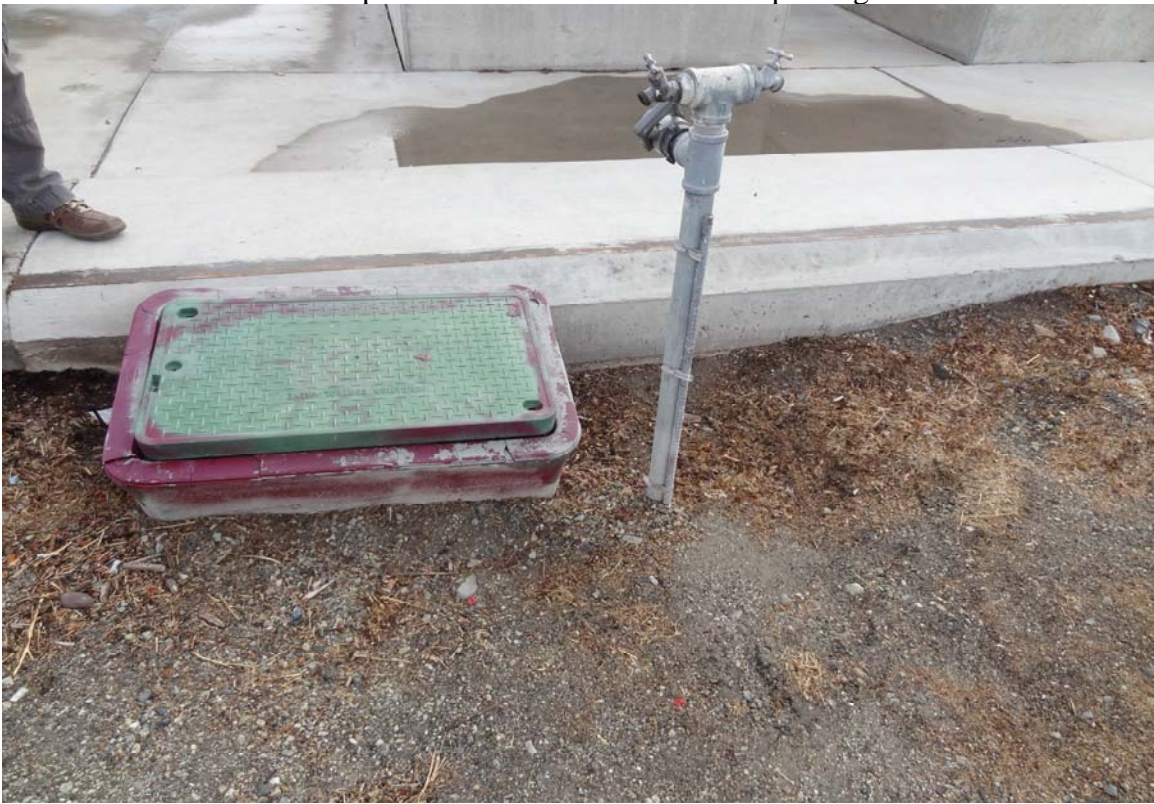
The main site electrical equipment is in disrepair and should be scheduled for replacement. Much of the equipment is original to the site dating back more than 50 years, including the transformers and main switchgear. Insects and rodents have infested some exterior boxes due to missing cover plates and the in-ground electrical boxes are missing proper covers and do not drain water effectively. There are also numerous loose and/or exposed electrical wires and damaged electrical outlets, disconnects, switches and wrong identifying covers for electrical pull boxes. This project would provide for replacement of the main electrical switchgear, transformers, in-ground boxes, trenching and backfill, repairs to the damaged electrical outlets, disconnects, new pull box cover lids with the proper identification indicated, and termination of loose or exposed electrical wires.

Yerington National Guard Armory Site - Site #9886
Description: Electrical pull box in need of relocation / upgrade.

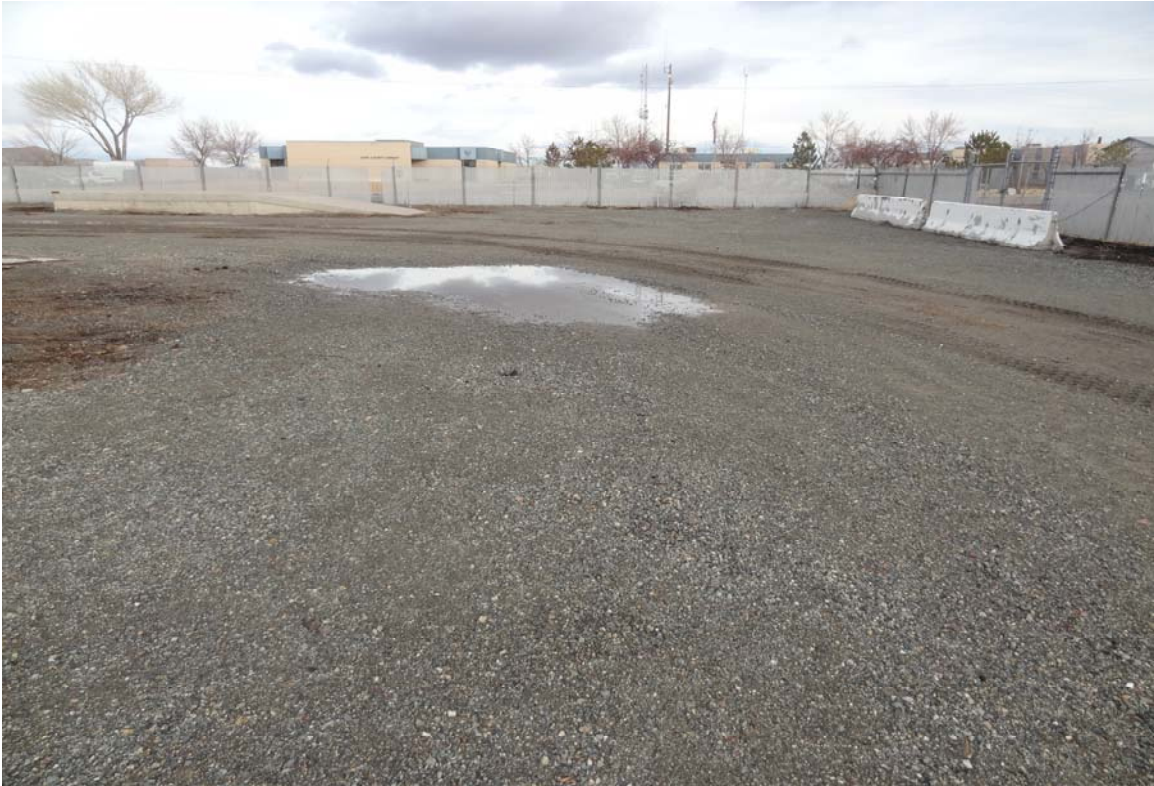
The majority of the site is covered with dirt and has poor drainage. Other than the front parking lot there is no asphalt paving for vehicle and equipment circulation throughout the yard. Due to the large and heavy equipment commonly on site, the dirt and mud areas quickly become rutted and uneven. Poor drainage in the dirt areas also leaves large areas of standing water further exacerbating the problem. This project would provide asphalt cement paving to cover the majority of the site that is used for vehicle or equipment, circulation or storage. The estimate includes grading, base, compaction and installation of asphalt cement paving. If asphalt is not provided, it is recommended to regrade the site to ensure proper drainage.

Yerington National Guard Armory Site - Site #9886
Description: Yard area drainage issues.

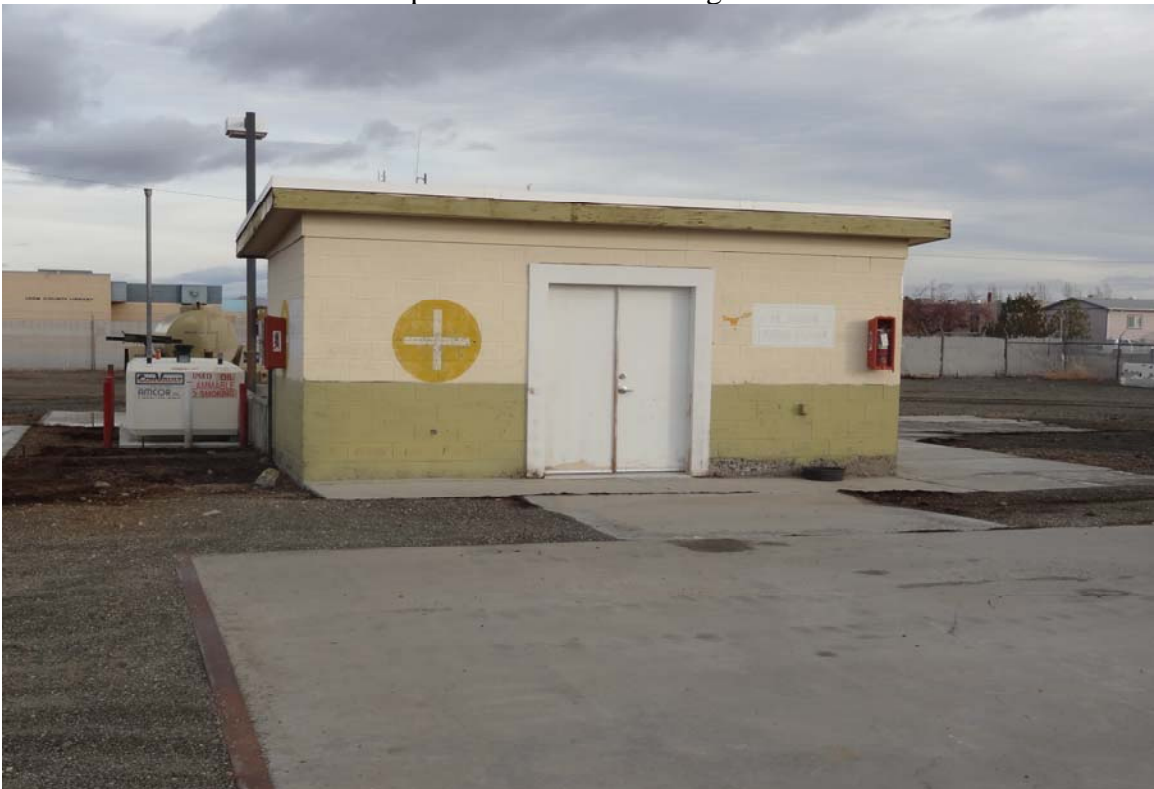
Hazardous Material Storage Building 2 - Building #2528
Description: Exterior of the structure.

The Hazardous Material Storage Building 2 is a painted concrete masonry unit structure with an asphalt based roofing system on a concrete foundation. There is a built-in containment area inside. The building is in fair shape.

It is important to maintain the finish, weather resistance and appearance of the building. This project would provide funding to protect the exterior of the building excluding the roof. Included in the cost is painting the concrete masonry unit walls and caulking of the flashing, fixtures and all other penetrations. It is recommended that the building be painted and caulked in the next 2-3 years and that this project be scheduled on a cyclical basis to maintain the integrity of the structure.

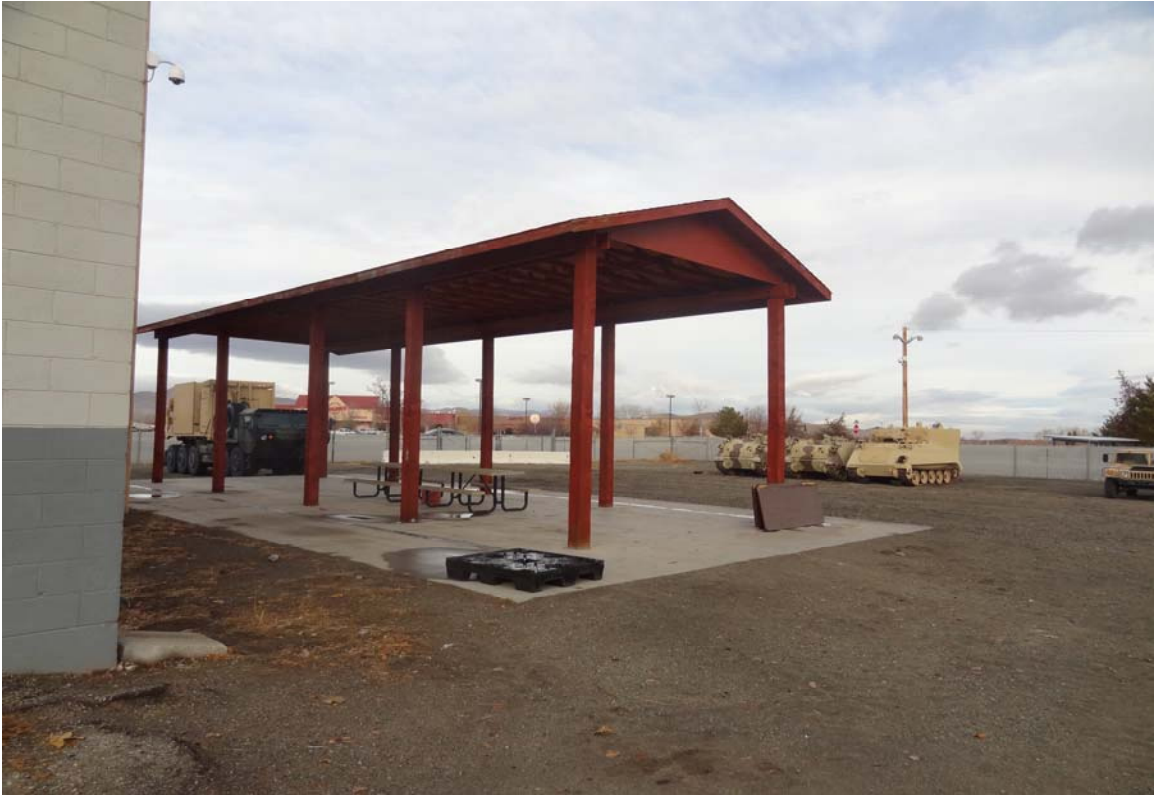
MCOFF Ramada - Building #2527
Description: Exterior of the structure.

The Mcoff Ramada is primarily used as a shade structure for storing a large mobile Generator. The construction funding for this building was provided by the Federal Government. The Ramada is constructed with 8"x8" pressure treated posts, gable trusses and an asphalt composition roof. The structure is open on all 4 sides and is in good shape.

It is important to maintain the finish, weather resistance and appearance of the structure. This project would provide for painting of the structure and it is recommended that this project be scheduled on a cyclical basis to maintain the integrity of the structure.

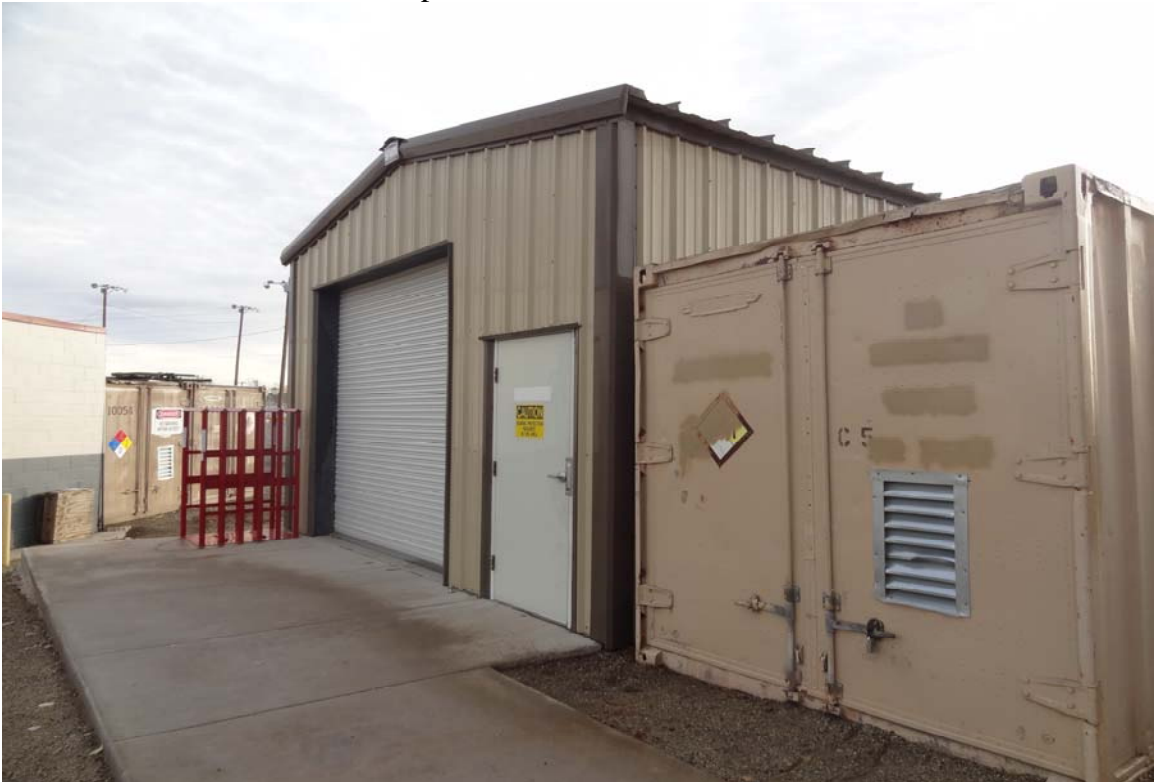
Tire Repair / Storage Building - Building #2058
Description: Exterior of the structure.

The Tire Repair/Storage Building is an uninsulated pre-fabricated steel structure with metal siding, metal roof and a concrete slab-on-grade floor/foundation. The building is used primarily for storage and repair of tires. It has an 8 foot wide overhead coiling door, a 3 foot wide exit door, and electrical service. The building is in very good condition.

It is important to maintain the finish, weather resistance and appearance of the building. This project would provide funding to protect the exterior of the building excluding the roof. Included in the cost is the caulking and sealing of the flashing, fixtures and all other penetrations. It is recommended that the building be caulked and sealed in the next 3-4 years and that this project be scheduled on a cyclical basis to maintain the integrity of the structure.

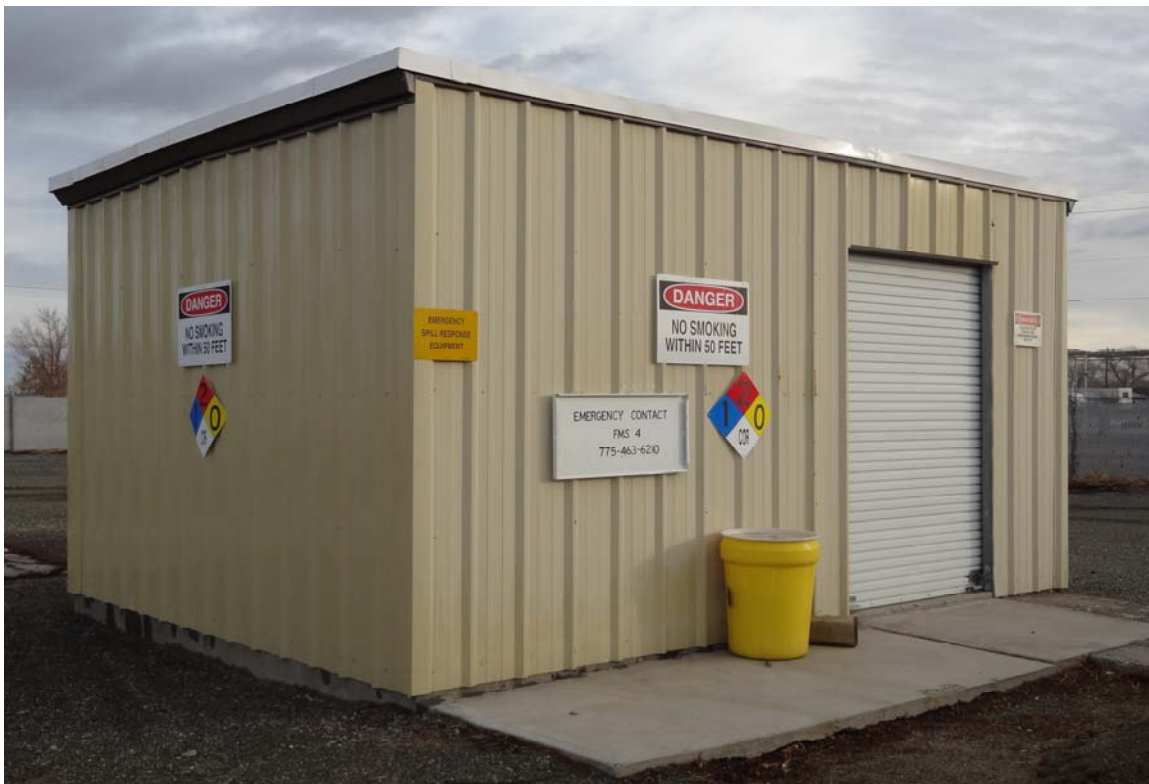
Hazardous Waste Storage Building 1 - Building #2057
Description: Exterior of the structure.

The Hazardous Waste Storage Building 1 is a pre-fabricated steel building used primarily for the storage of hazardous waste. The building has a concrete slab-on-grade containment floor and one overhead coiling access door. The building is in fair condition.

It is important to maintain the finish, weather resistance and appearance of the building. This project would provide funding to protect the exterior of the building excluding the roof. Included in the cost is the caulking and sealing of the flashing, fixtures and all other penetrations. It is recommended that the building be caulked and sealed in the next 4-5 years and that this project be scheduled on a cyclical basis to maintain the integrity of the structure.
