State of Nevada
Department of Conservation & Natural Resources
Jean Conservation Camp - NDF
Facility Condition Analysis

JEAN CONSERVATION CAMP - NDF

Site Number: 9887
STATE OF NEVADA PUBLIC WORKS DIVISION
FACILITY CONDITION ANALYSIS

Report Printed in August 2014

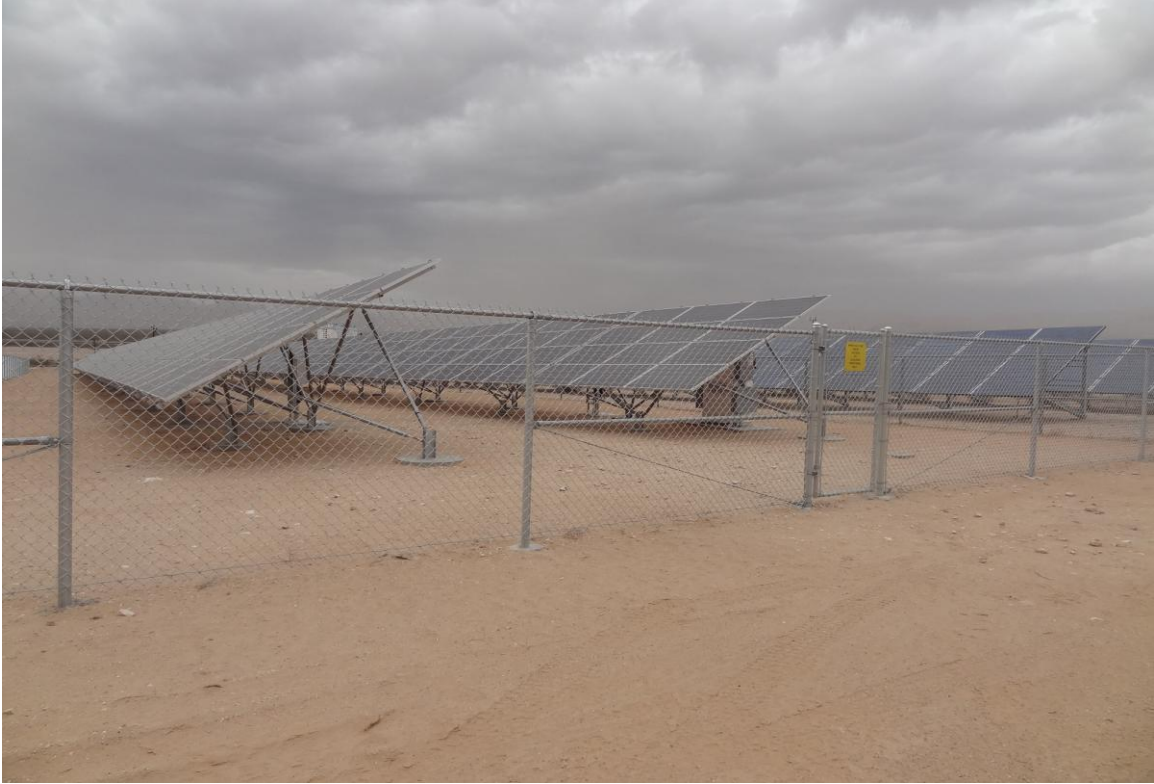
Jean NDF Conservation Camp Site – FCA Site #9887
Description: View of the solar array.

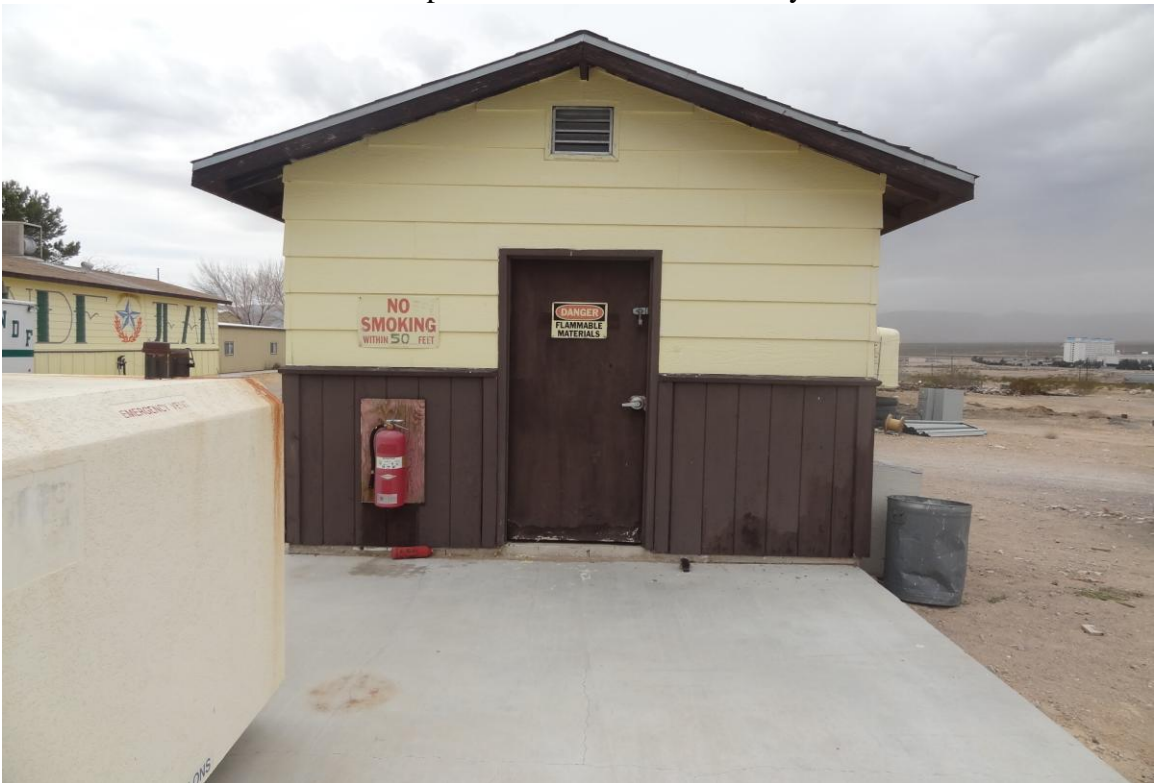
NDF Fuel Building – FCA Building #2517
Description: Exterior of the building.

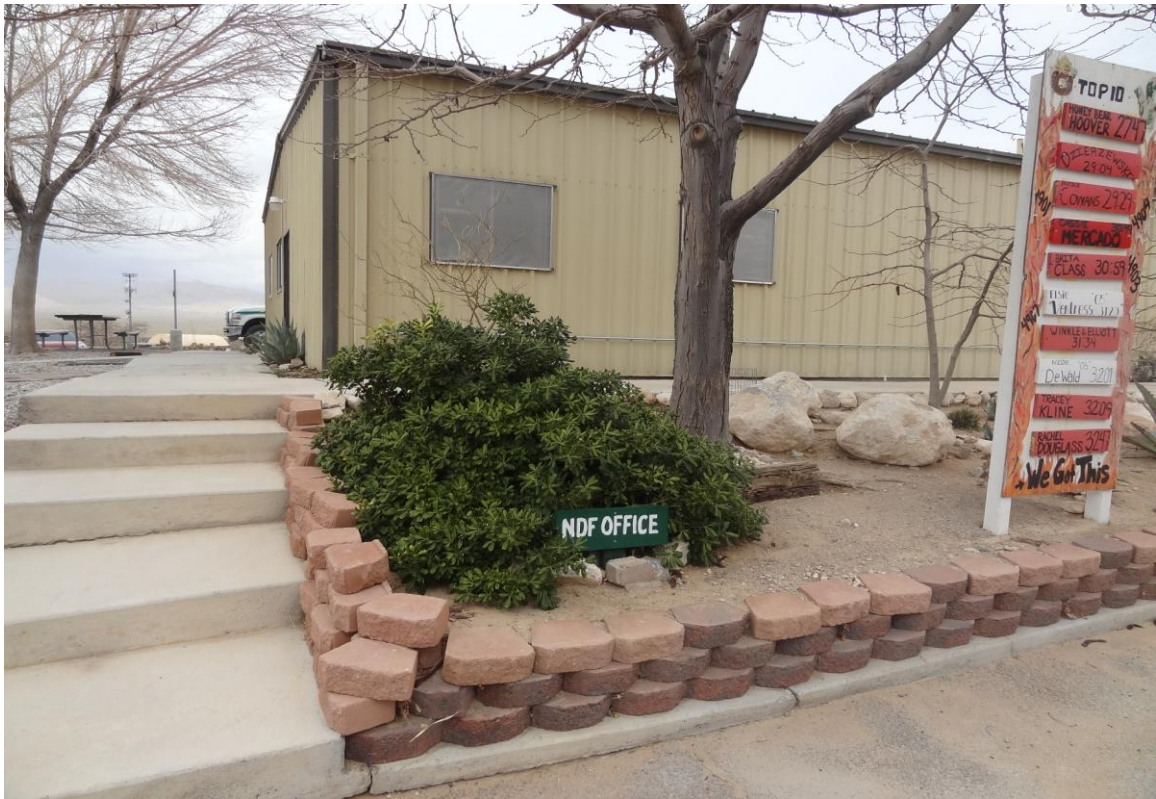
Jean CC NDF Office – FCA Building #2494
Description: Main entrance stairs / walkway to building.

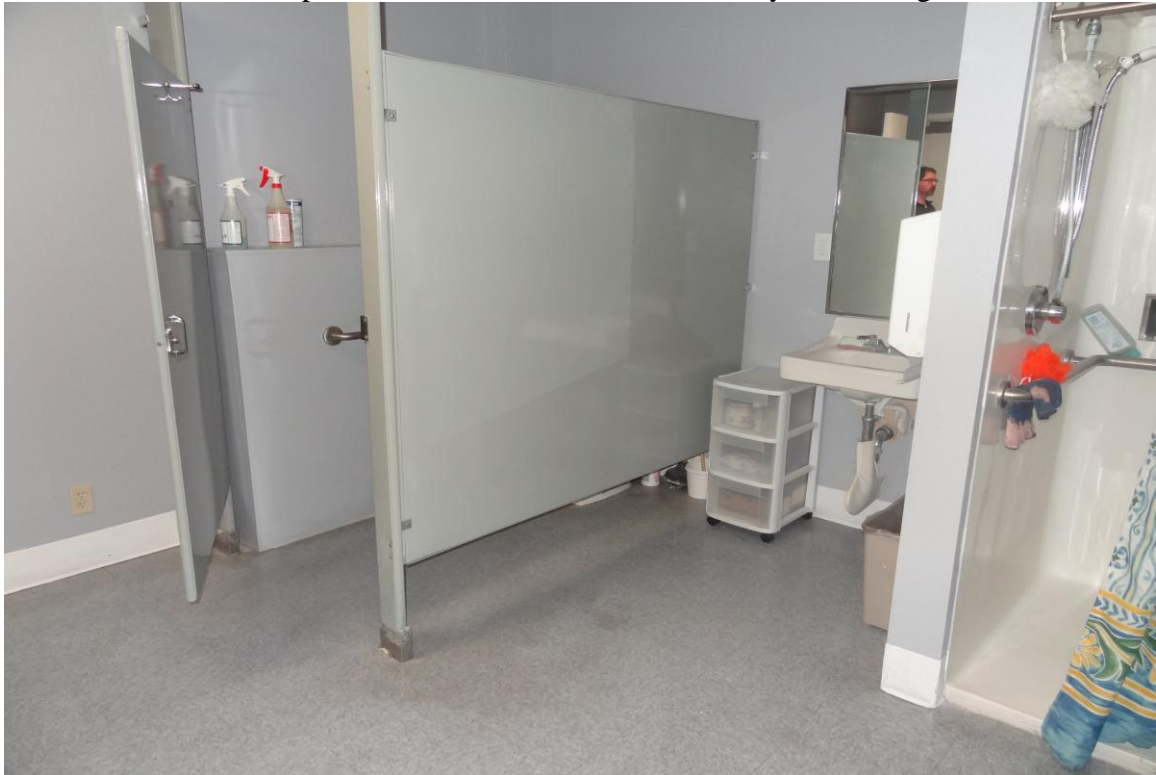
The unisex restroom is original to the building and in overall poor condition. It does not meet the Americans with Disabilities Act (ADA) requirements. A complete retrofit is necessary. This project would provide funding for construction of a unisex accessible restroom. These items may include a new sink, toilet, shower, hardware, mirrors, fixtures, flooring and paint. The 2012 IBC, ICC/ANSI A117.1 - 2009, NRS 338.180 and the most current version of the ADA Standards For Accessible Design were used as a reference for this project.

Jean CC NDF Office – FCA Building #2494
Description: Restroom.

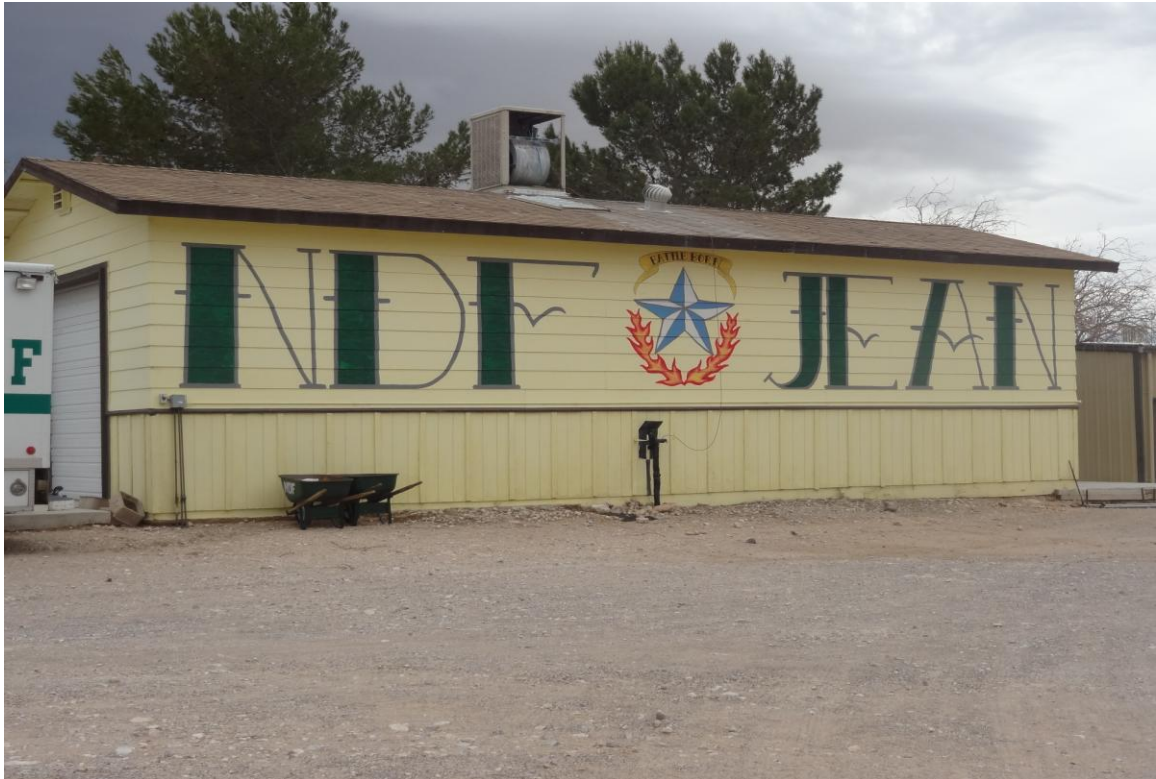
Conservation Camp Storage – FCA Building #2198
Description: Exterior of the building.

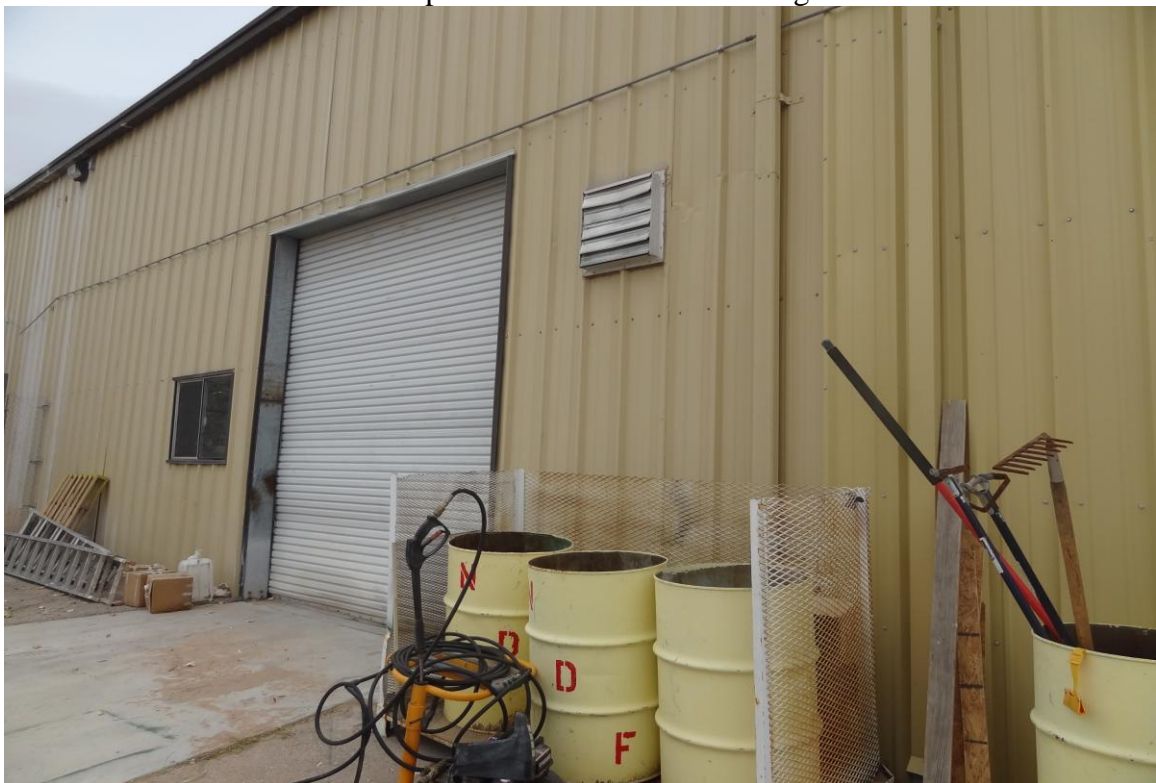
MPR / Visitation / NDF Shop – FCA Building #1898
Description: Exterior of the building.

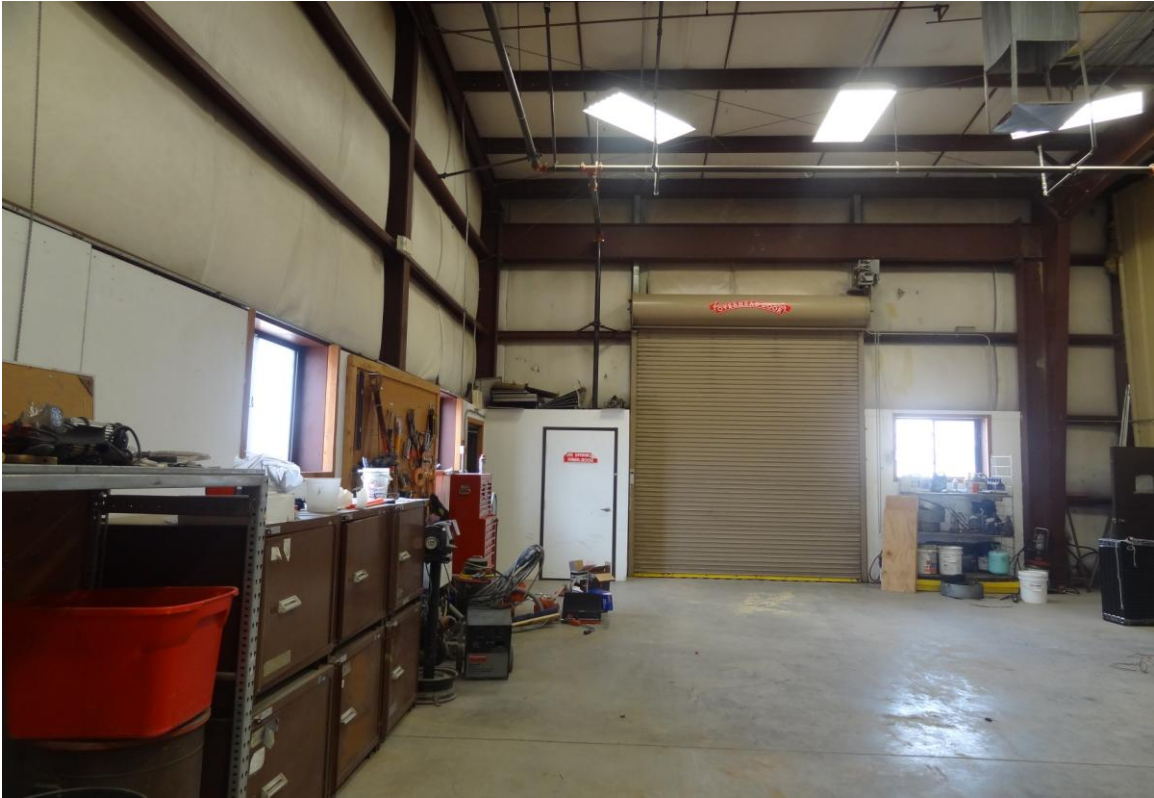
MPR / Visitation / NDF Shop – FCA Building #1898
Description: Interior of the building.
