State of Nevada
Department of Corrections

JEAN CONSERVATION CAMP SITE

Site Number: 9892
STATE OF NEVADA PUBLIC WORKS DIVISION
FACILITY CONDITION ANALYSIS

Report distributed in December 2022

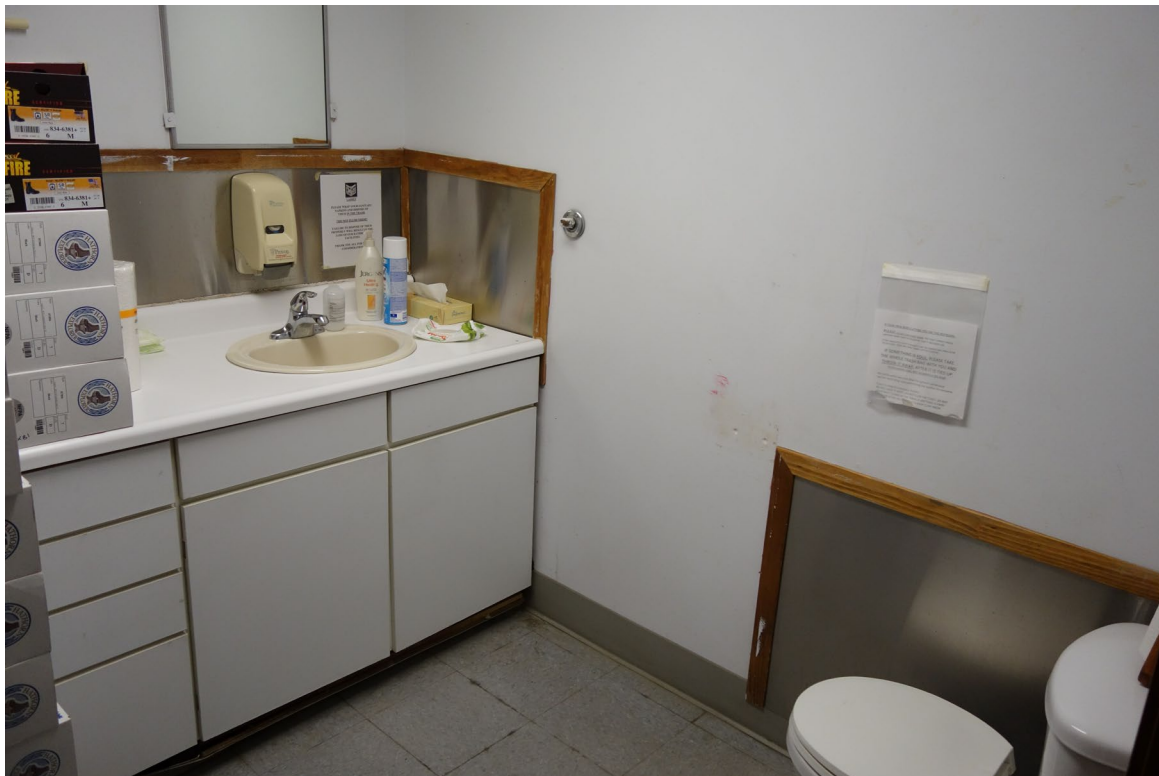
MPR / Visitation / NDF Shop – FCA Building #1898
Description: ADA Restroom Upgrade Needed.

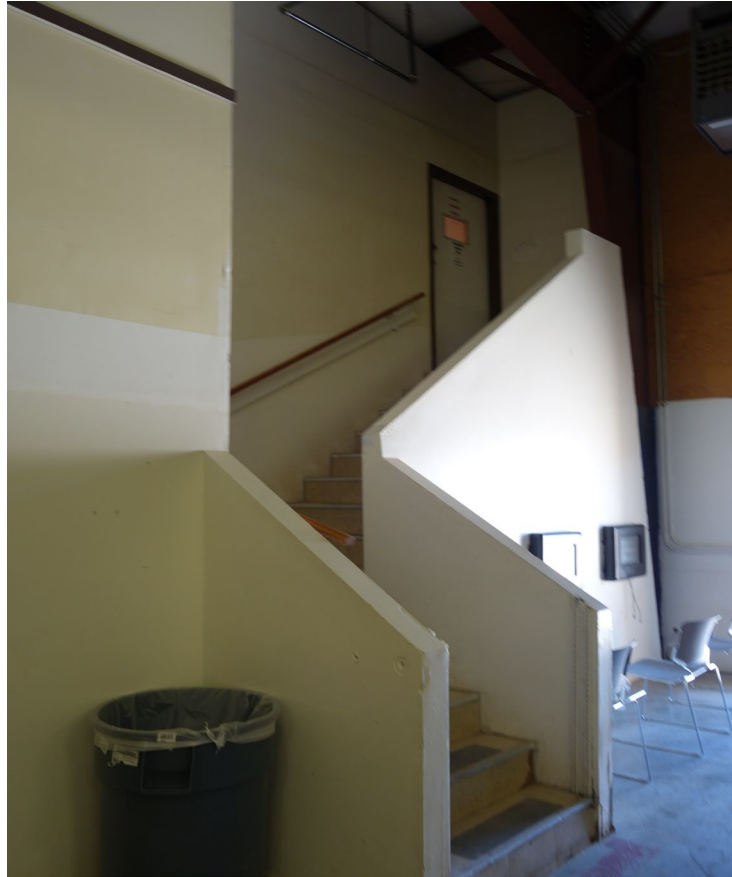
MPR / Visitation / NDF Shop – FCA Building #1898
Description: Stair Replacement Recommended.
