State of Nevada
Department of Corrections

FLORENCE McCLURE WOMEN'S CORRECTIONAL CENTER

Site Number: 9893
STATE OF NEVADA PUBLIC WORKS DIVISION
FACILITY CONDITION ANALYSIS

SPWD Facility Condition Analysis - 9893

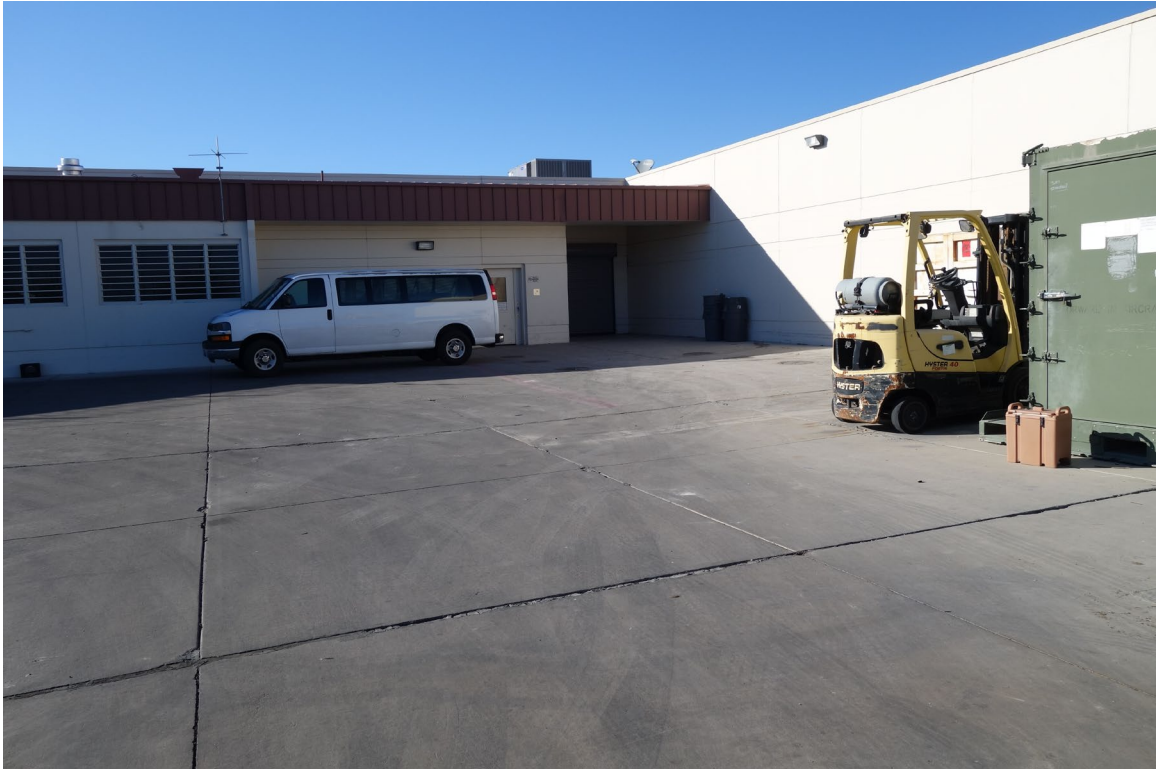
The concrete in the delivery area is beginning to fail and planned for replacement. In order for this to occur, temporary access to the delivery area must be provided. The project will fund the replacement of the failing concrete in the delivery area. Demolition and temporary entrance and fencing are included in this project.

Florence McClure Women's Correctional Center Site - Site #9893
Description: View of the Delivery Area and Site Concrete Condition.

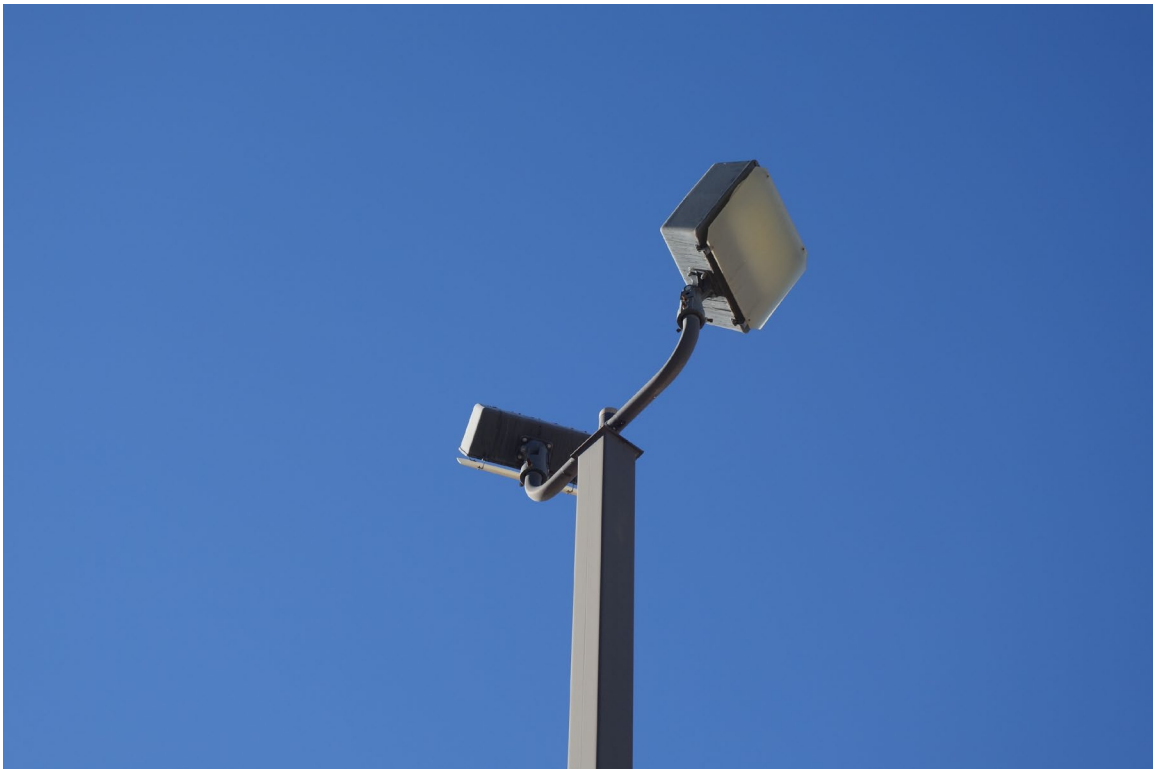
The existing light fixtures are high pressure sodium (orange light) and are original to the facility. The light fixtures are at the end of their life and should be replaced with an energy efficient fixture. With the replacement fixtures, the facility will have reduced maintenance for the LED fixtures, better light distribution, better quality of light (white light) and energy savings. This project will replace the high pressure sodium parking and perimeter lights for an LED equivalent on existing light poles.

Florence McClure Women's Correctional Center Site - Site #9893
Description: Site Lighting Upgrade Needed.

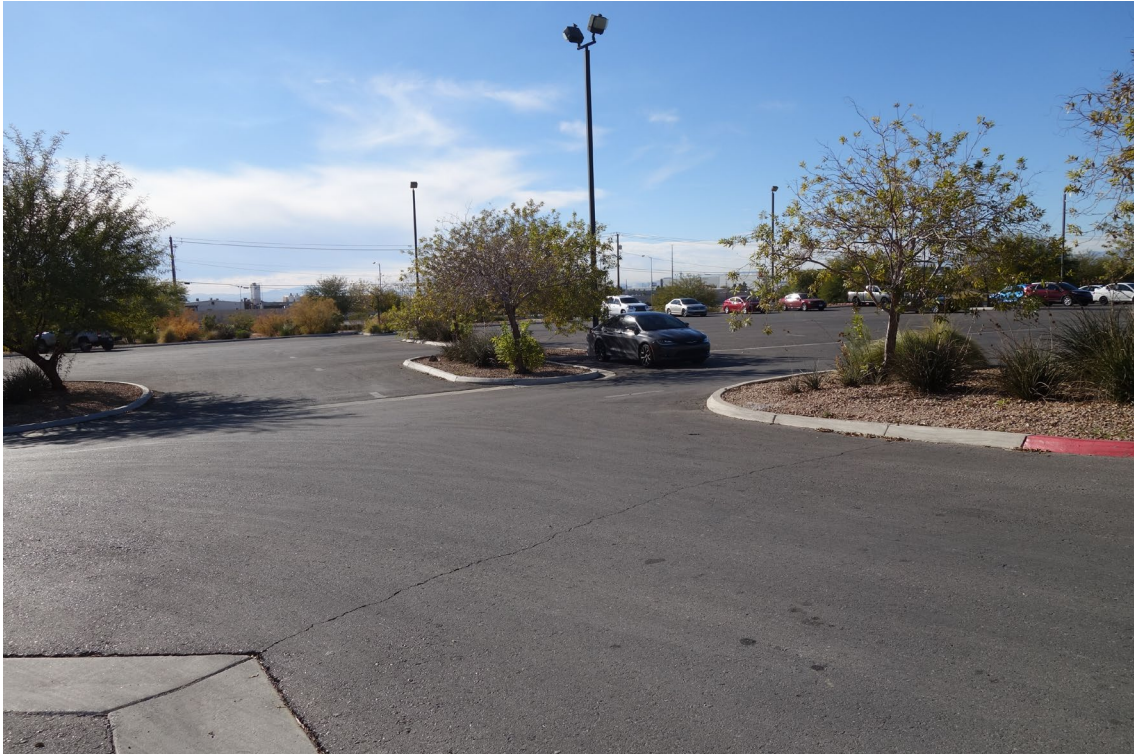
It is important to maintain the asphalt concrete paving on the site. This project would provide for minor crack filling and slurry sealing of the paving site wide including access roads, parking areas and the maintenance yard. Striping is included in this estimate. This project should be scheduled on a 5 year cyclical basis to maintain the integrity of the paving and prevent premature failure. 220,000 square feet of asphalt area was used to generate this estimate.

Florence McClure Women's Correctional Center Site - Site #9893
Description: Crack & Slurry Seal Asphalt Paving.

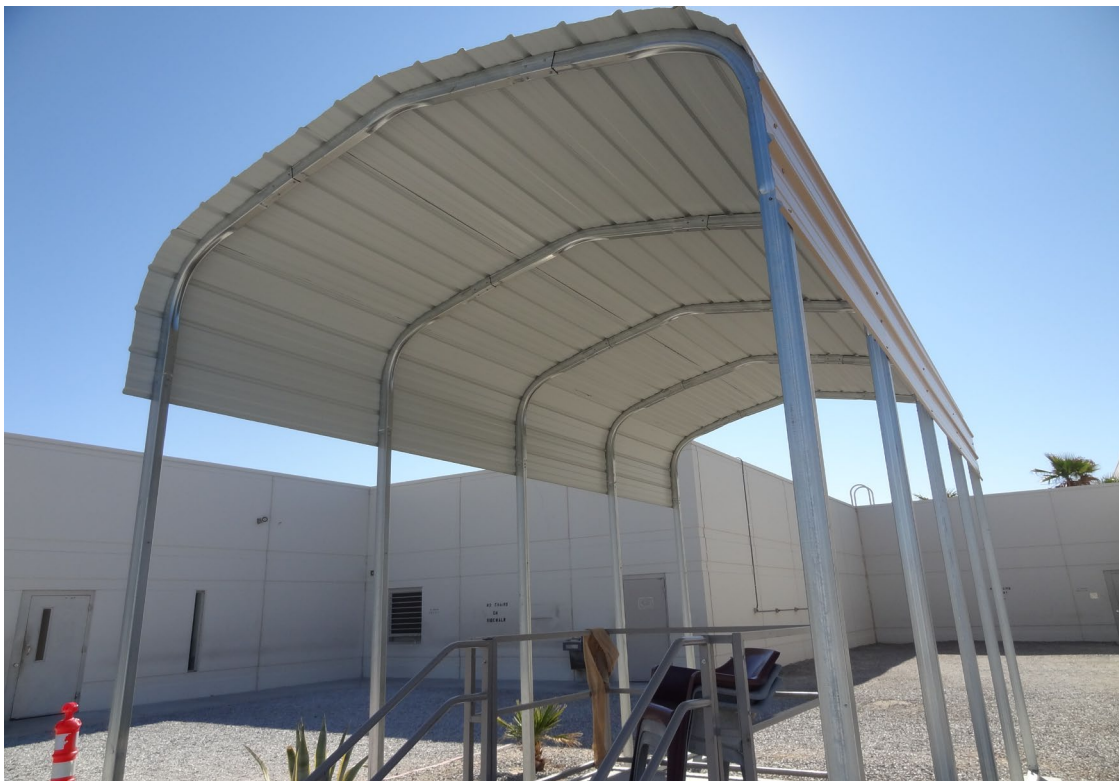
The Shade Ramada is a prefabricated steel shelter designed to provide shade for correctional officers out in the inmate yard area. The structure is new (2010) and in excellent condition.

Shade Ramada 2 - Building #3108
Description: Exterior of the Structure.

It is important to maintain the finish, weather resistance and appearance of the structure. This project would provide for painting of the structure and it is recommended that this project be scheduled on a cyclical basis to maintain the integrity of the structure.

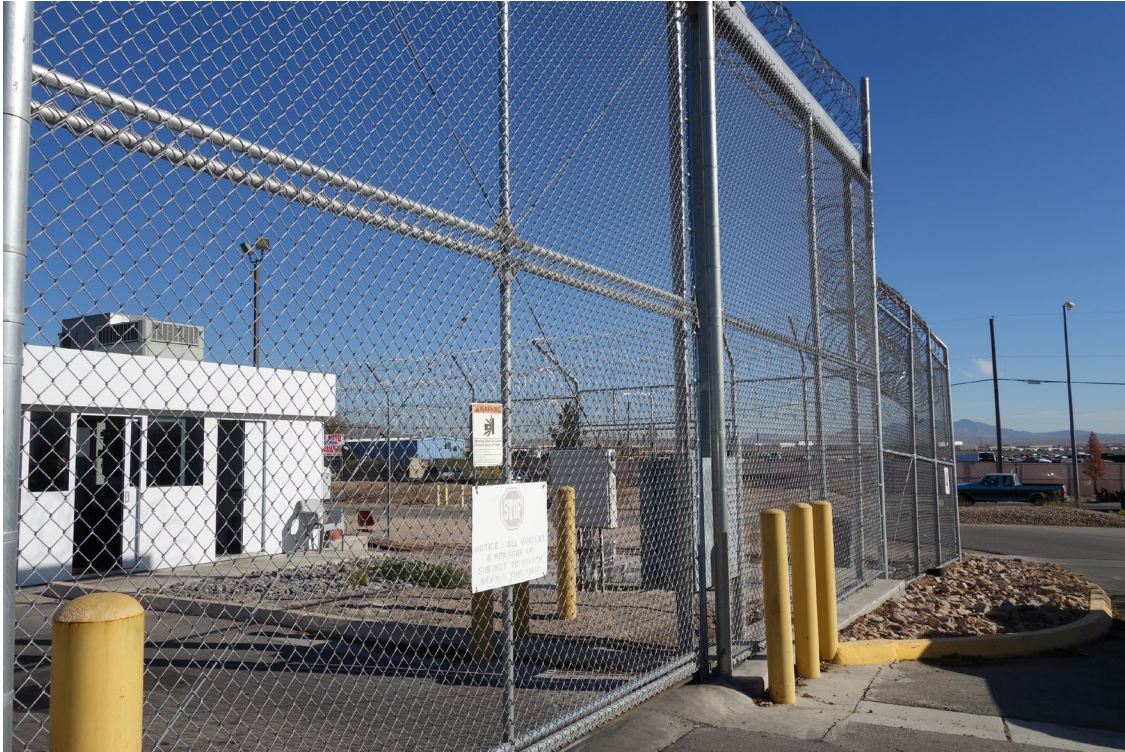
The Sally Port Guard Station is a prefabricated steel structure located adjacent to the sally port. The facility's single ply roofing system was replaced in 2013 and has a 20 year warranty. It is primarily a guard shack and has a small office space and a unisex restroom. The new structure is in excellent condition.

Sally Port Guard Station - Building #3107
Description: Exterior of the Building.

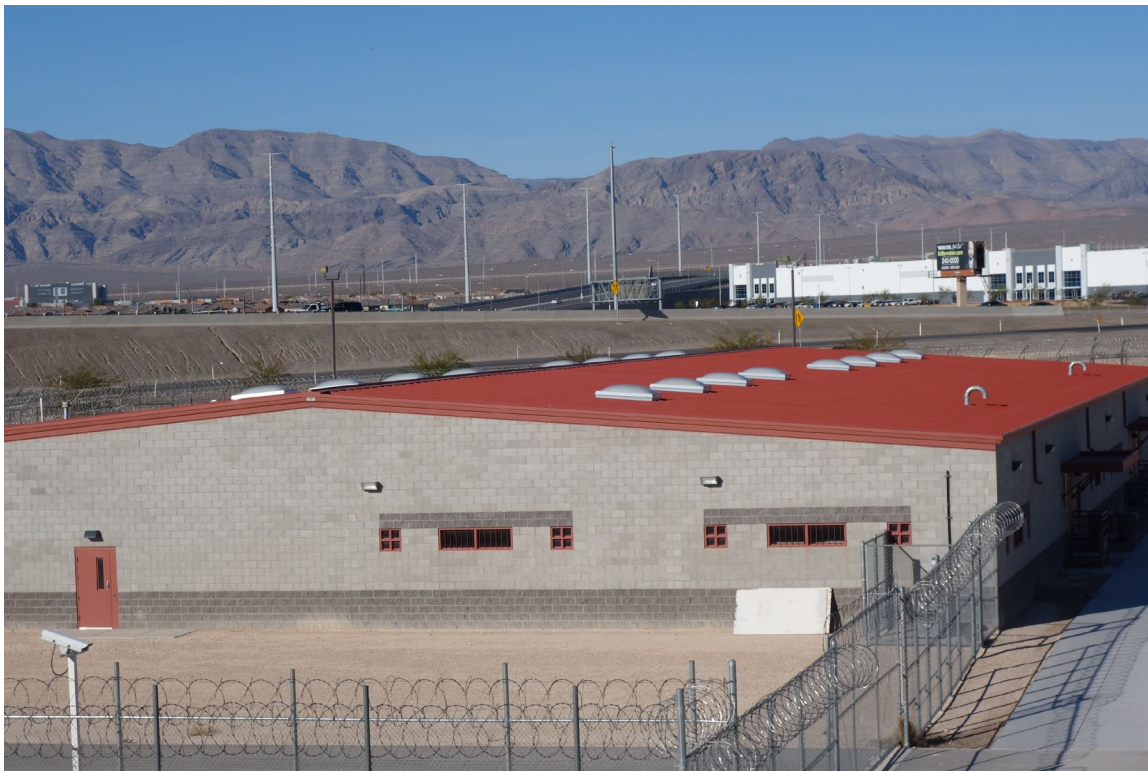
The Dorm Housing Unit is a concrete masonry unit and steel framed structure with a metal roofing system on a concrete foundation. The building is divided into two housing sections each with restrooms and showers. It has exterior ground mounted HVAC packaged units and has a fire protection system including alarms and sprinklers. The facility is in good condition.

FMWCC Dorm Housing Unit #9 - Building #2786
Description: Exterior of the Housing Unit.

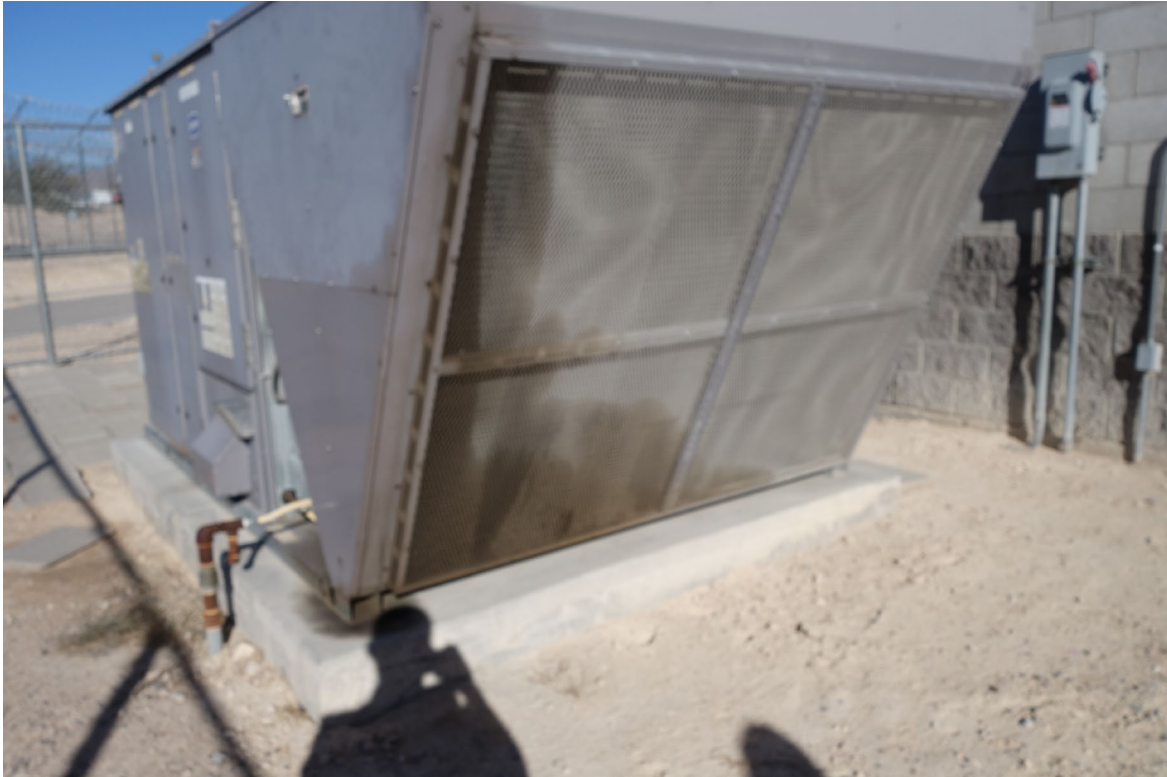
The ground mounted HVAC units are original to the building and should be scheduled for replacement. They are not energy efficient and have reached the end of their expected and useful life. This project would provide for installation of a new HVAC system and cleaning of the existing duct work and grilles. This project includes removal and disposal of the existing HVAC system and all required connections to utilities.

FMWCC Dorm Housing Unit #9 - Building #2786
Description: HVAC Equipment Replacement Needed.

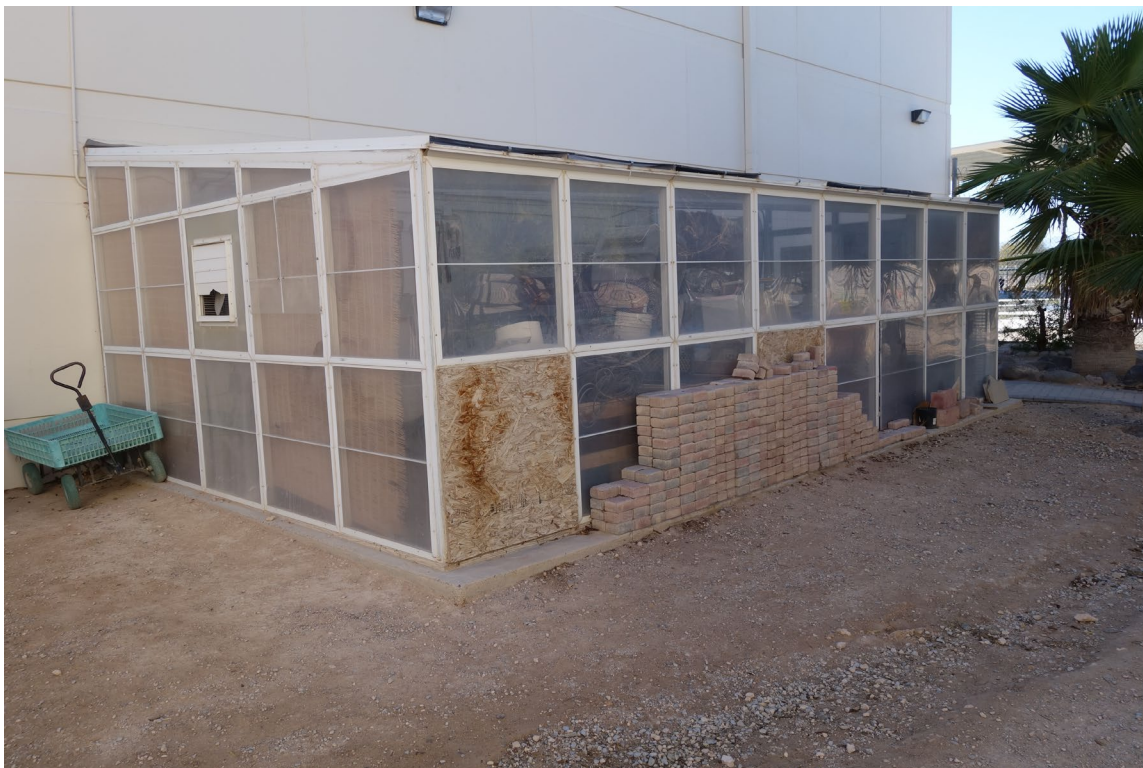
FMWCC Greenhouse - Building #2514
Description: Exterior of the Structure.

It is important to maintain the finish, weather resistance and appearance of the structure. This project recommends work to protect the exterior building envelope including repairs to the exterior polycarbonate panels and caulking around the panels, flashing, fixtures, and other penetrations to maintain the building in good, weather tight condition. It is recommended that this project be implemented in the next 3-4 years and that this project is scheduled on a cyclical basis to maintain the integrity of the structure.

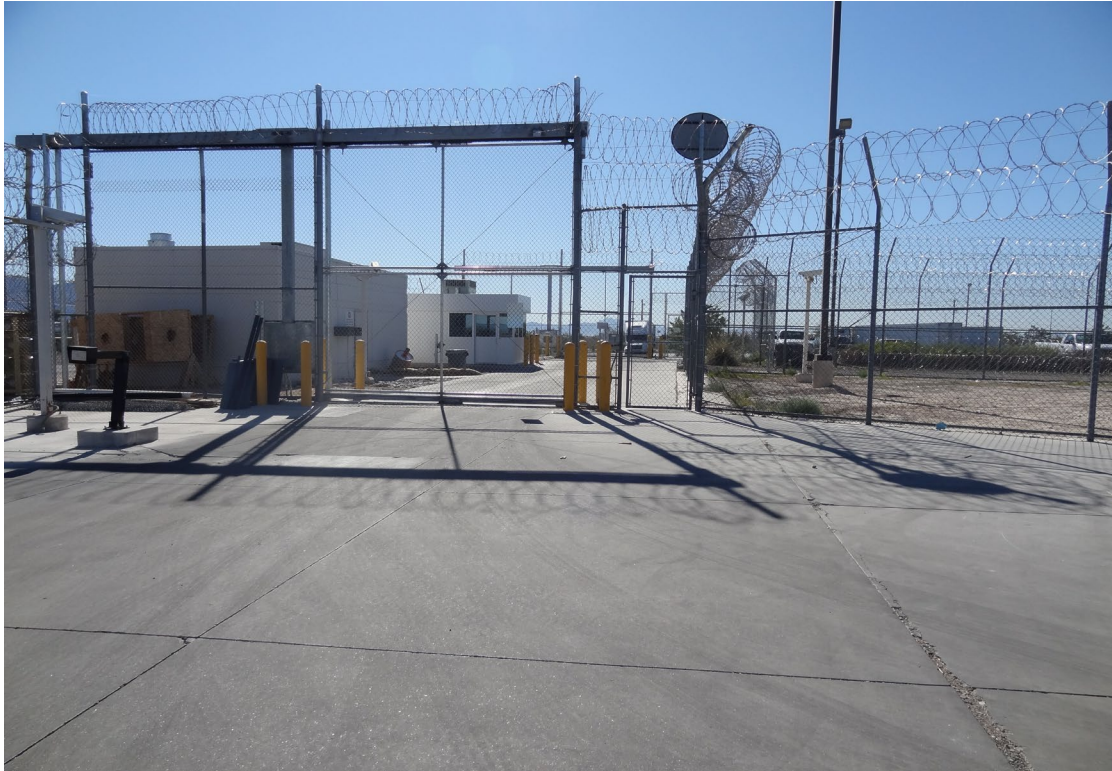
The Armory is a reinforced tilt-up concrete structure with an EPDM roofing system on a concrete foundation. It is located adjacent to the sally port and is in good condition.

FMWCC Armory - Building #2512
Description: Armory in Foreground.

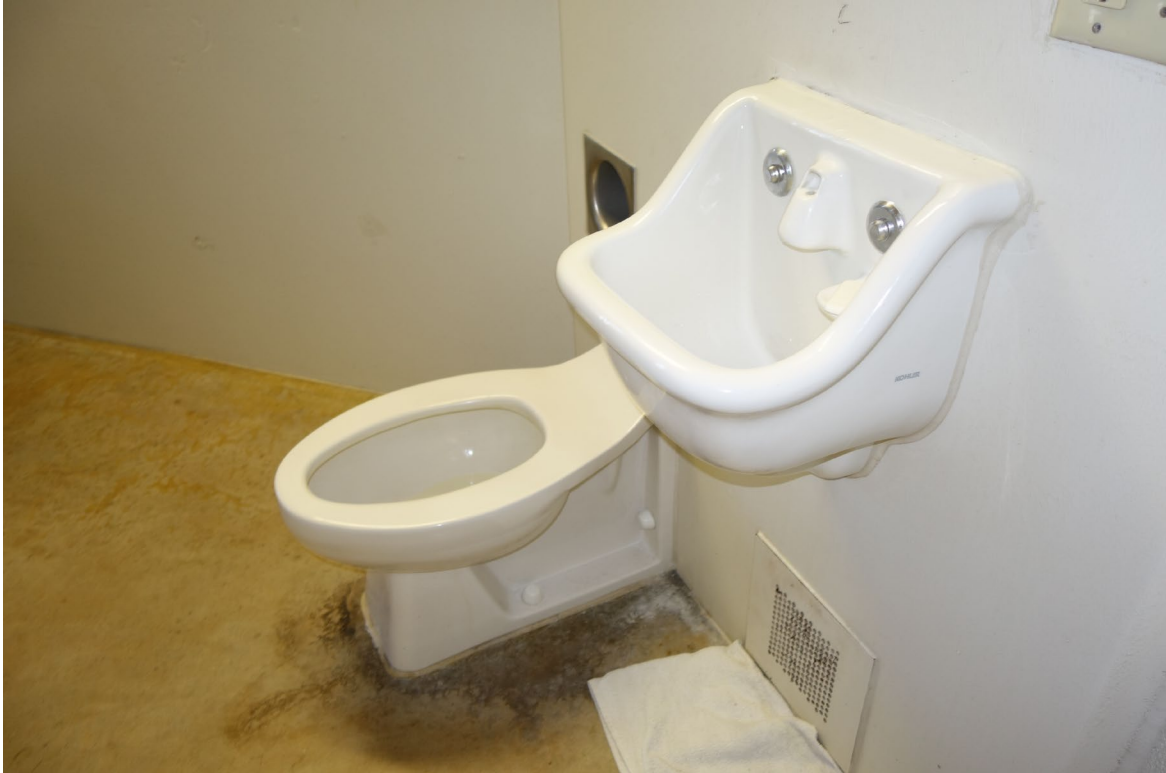
The original construction provided porcelain fixtures which are over 20 years old and require frequent maintenance. Replacement fixtures will be stainless steel combination units that are standard issue for correctional center housing units. This project will replace the housing unit plumbing fixtures in the original buildings.

Administration / Housing Units - Building #2457
Description: Plumbing Fixture Replacement to Stainless Steel.

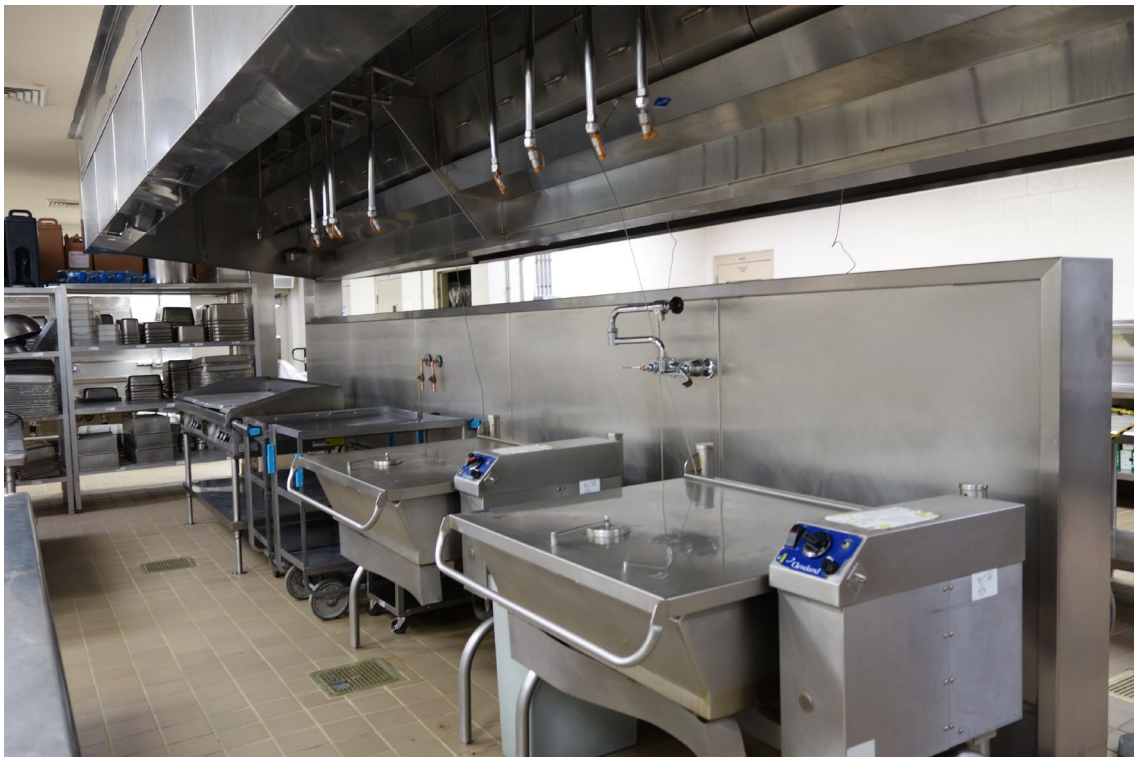
The hot and cold serving trays in the culinary are original to the building and are no longer operating. Considering the age of the equipment and the evolving needs of the facility it is recommended to replace them. This project provides for removal and disposal of the 6-well steam table and the 6-well cold table with new equipment.

Administration / Housing Units - Building #2457
Description: View of the Culinary Area.

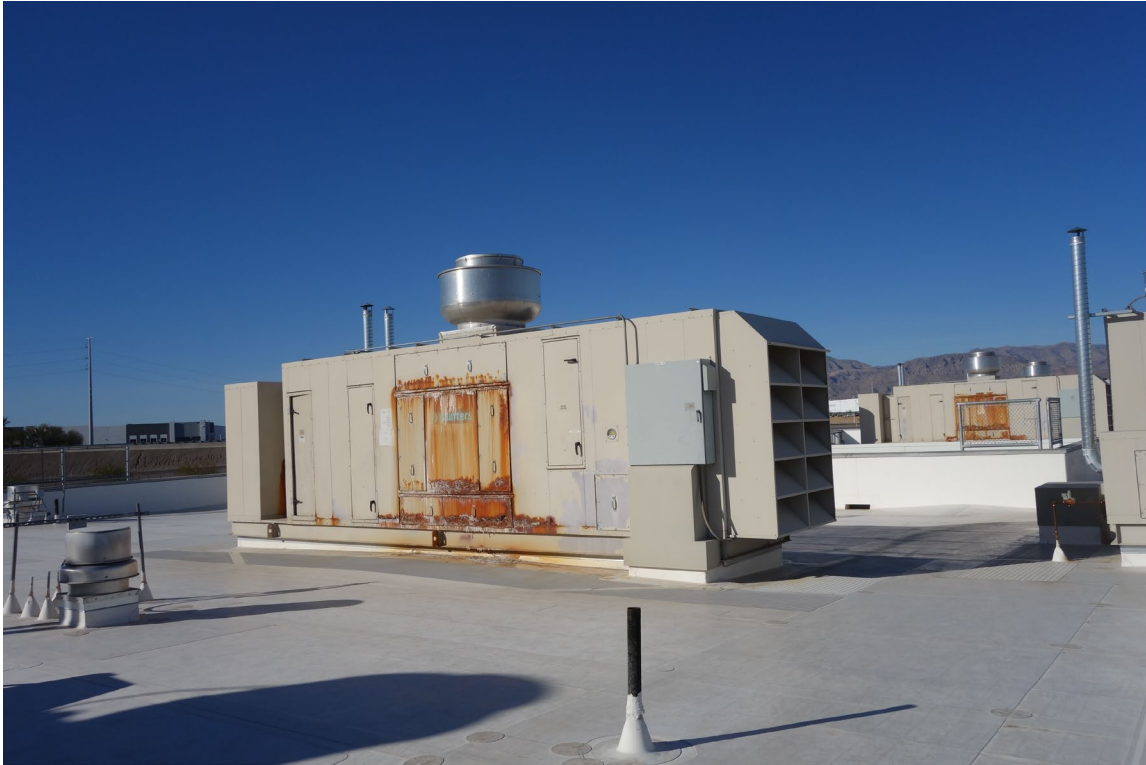
The eight evaporative coolers installed in 2009 have deteriorated significantly showing rusted frame and sides. The HVAC system is original to the building and have reached the end of their useful life. This project will replace the eight rooftop HVAC units. This project includes removal and disposal of the existing HVAC system and all required connections to utilities.

Administration / Housing Units - Building #2457
Description: HVAC Replacement Needed on 2009 Built Housing Units.

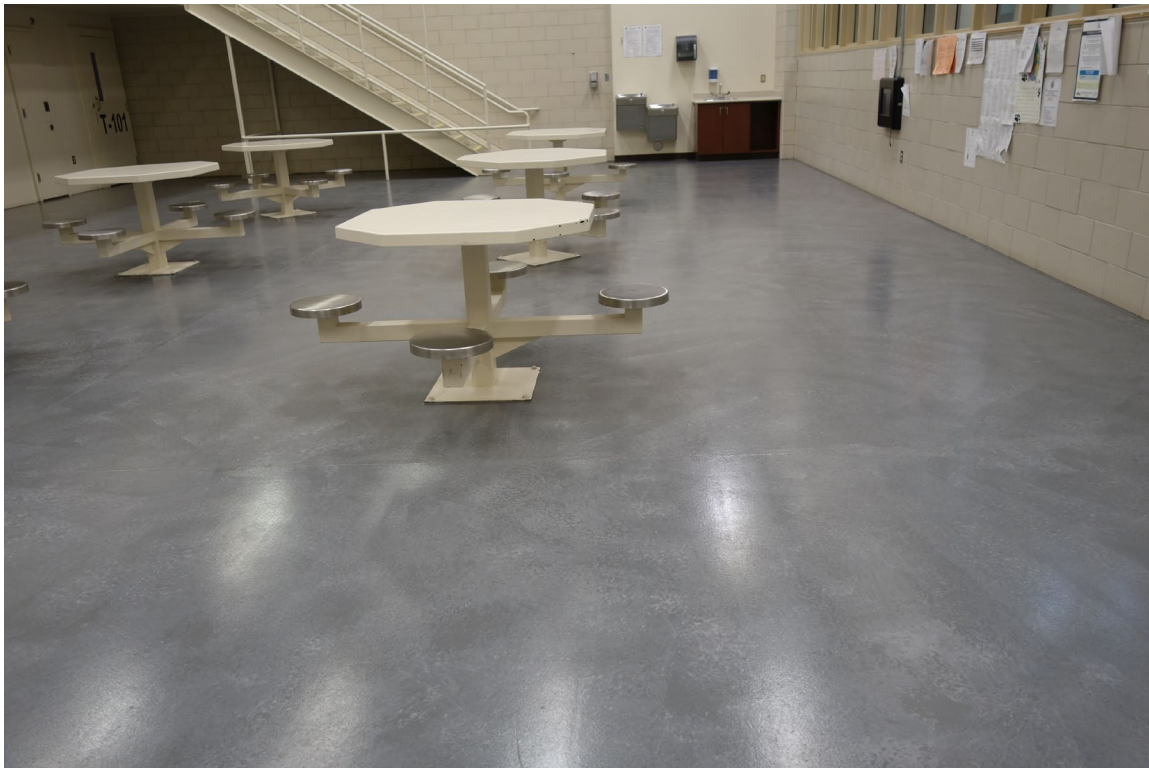
The interior finishes are in fair condition. It is recommended that the interior walls and ceilings be painted at least once in the next 4 - 6 years and that this project be scheduled on a cyclical basis to maintain the integrity of the structure. Prior to painting, all surfaces should be repaired and prepped. An epoxy-based paint should be utilized in wet areas for durability.

Administration / Housing Units - Building #2457
Description: Typical Interior Finishes in Housing Unit.

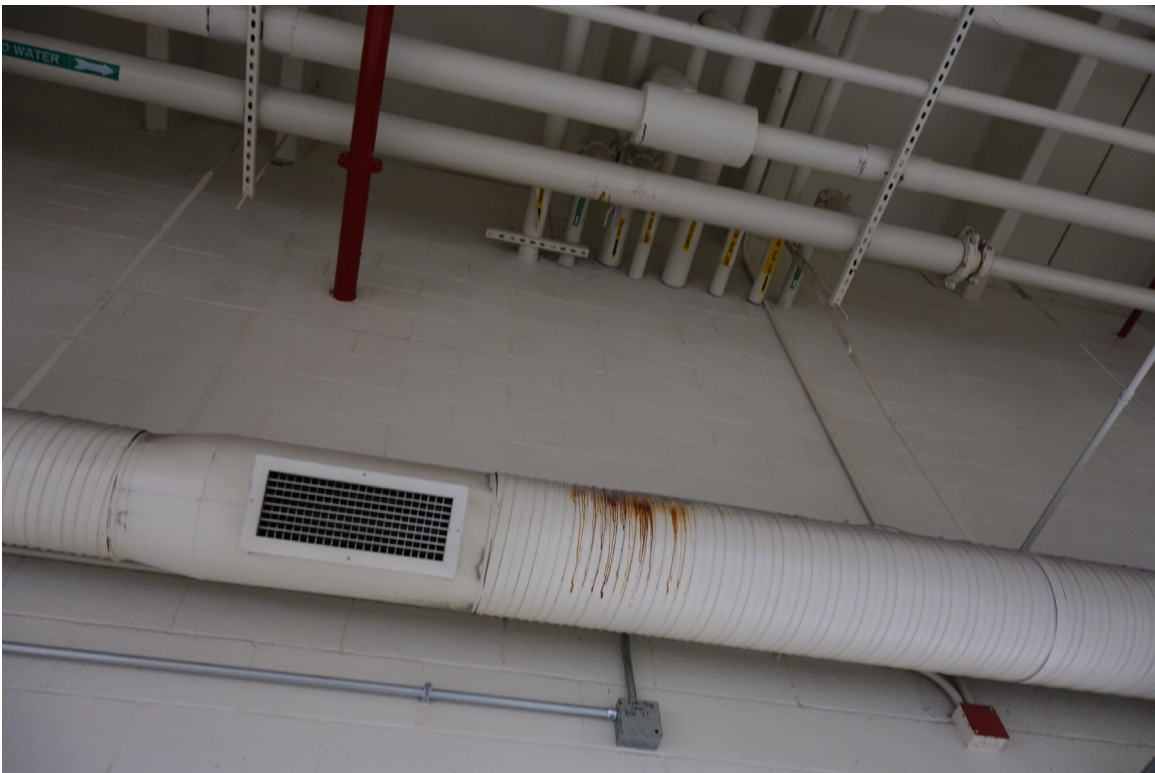
The facility is over 20 years old and the water supply piping has deteriorated. Currently there are no isolation valves installed to separate the different housing units and staff areas when the leaks occur. The water service for the entire facility has to be shut down in order to make repairs. This project will replace the domestic cold and hot water piping mains in the original buildings.

Administration / Housing Units - Building #2457
Description: Domestic Plumbing Replacement Recommended.
