State of Nevada
Department of Administration
Public Works Division
Facility Condition Analysis

MARLETTE LAKE / ASH CANYON SITE

Site Number: 9895
STATE OF NEVADA PUBLIC WORKS DIVISION
FACILITY CONDITION ANALYSIS

Report distributed in February, 2018

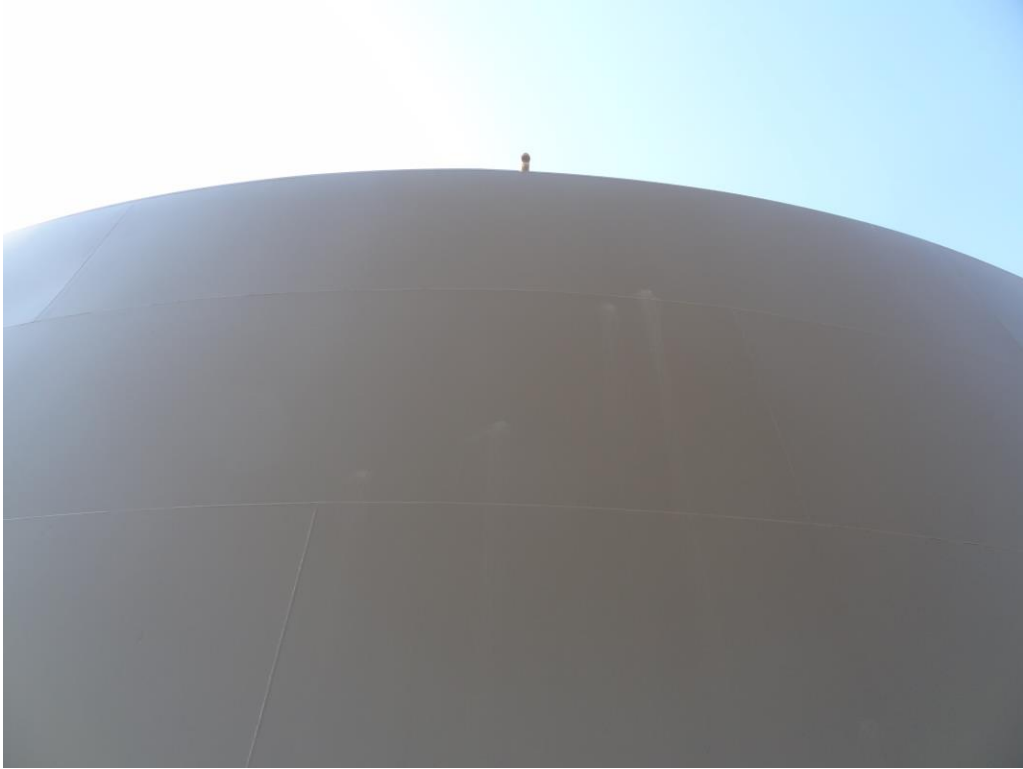
The NFPA 22 standard designates the requirements for water tanks used for private fire protection. This tank is used to store water for fire protection and is an AWWA D100 tank that is required to have 360° guardrails. This project would provide for the purchase and installation of new guardrails to be located at the top of the water tank.

Marlette Lake 3 Million Gallon Tank - Building #2485
Description: Guardrails needed.

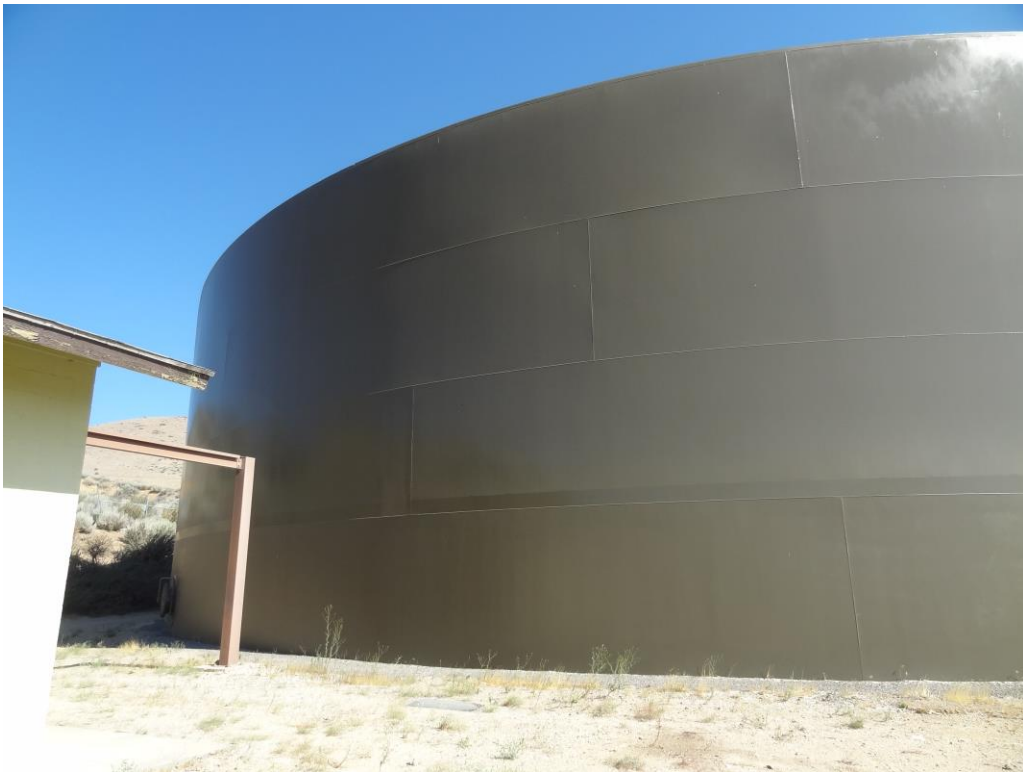
It is important to maintain the finish, weather resistance and appearance of the tank. This project recommends work to protect the exterior of the tank to include; preparation for painting, caulk and paint. It is recommended for this project to be implemented in the next 2-3 years. Additional recommendation is to conduct inspections and testing on a cyclical basis based per NAC 445.

Marlette Lake 1 Million Gallon Tank - Building #2486
Description: Exterior finishes needed.

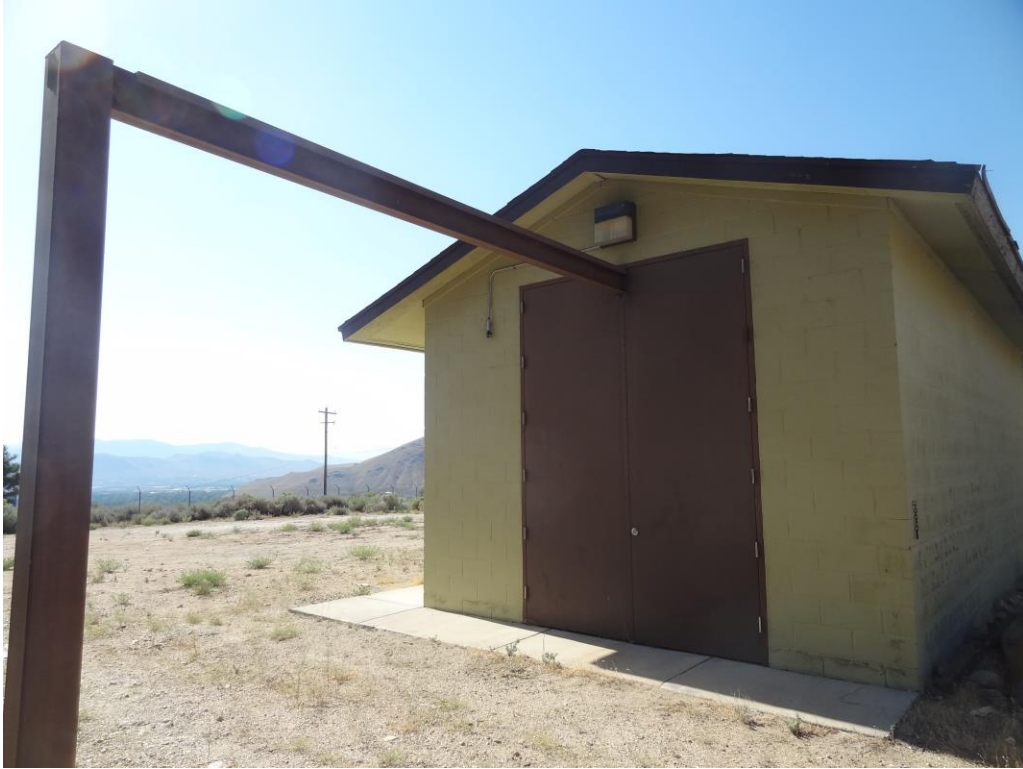
It is important to maintain the finish, weather resistance and appearance of the building. This project would provide funding to protect the exterior of the building excluding the roof. Included in the cost is the caulking, sealing of the windows, flashing, fixtures and all other penetrations. It is recommended that the building be caulked and sealed in the next 2-3 years and that this project be scheduled on a cyclical basis to maintain the integrity of the structure.

Marlette Lake Water Treatment - Building #2487
Description: Exterior finishes needed.

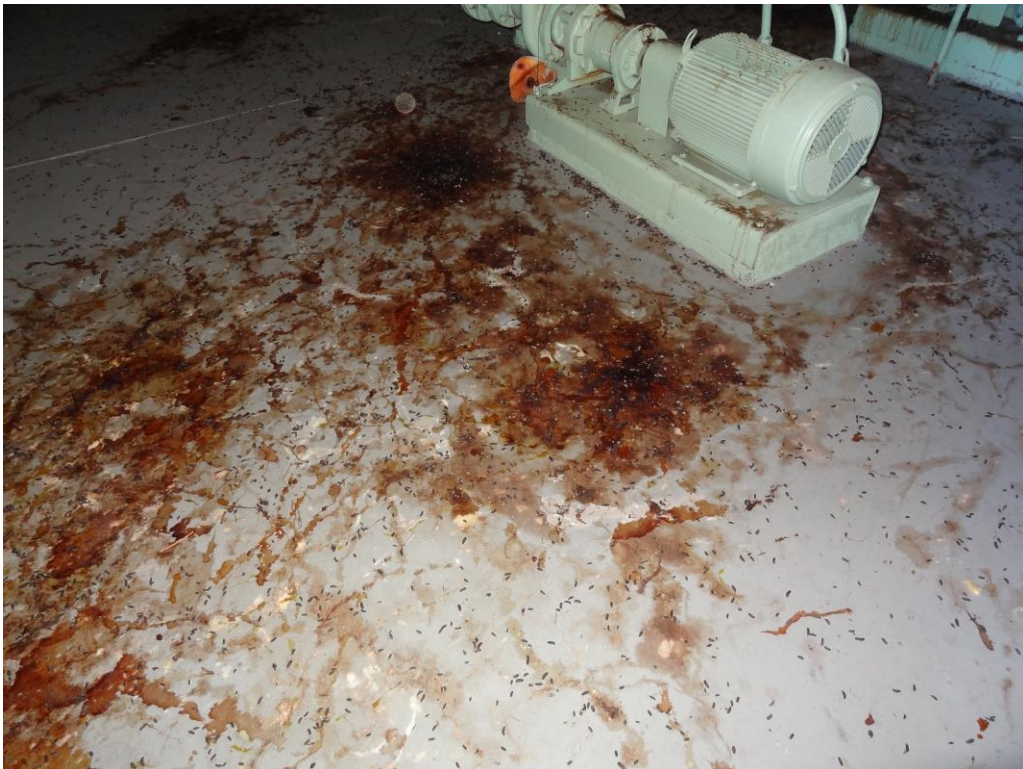
There are numerous rodent droppings throughout this building. Due to the potential risk of disease, this project would provide for treatment and cleanup of the rodent droppings by a licensed pest control business.

Marlette Lake Chlorine - Building #2489
Description: Pest control needed.

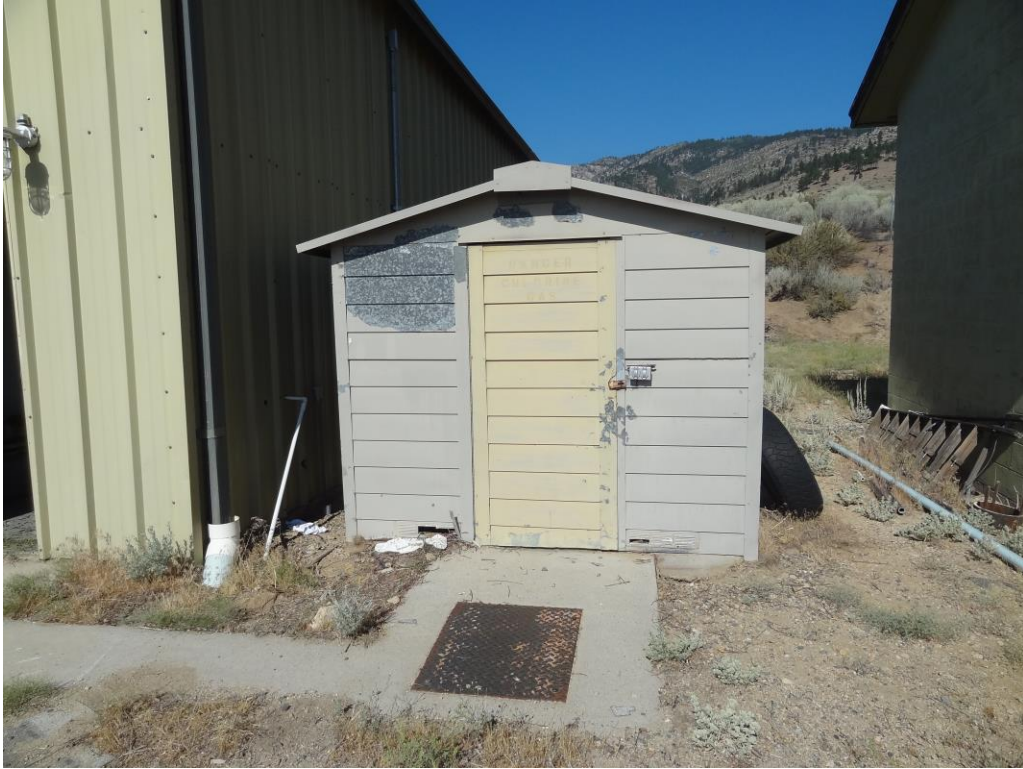
It is important to maintain the finish, weather resistance and appearance of the building. This project would provide funding to protect the exterior of the building excluding the roof. Included in the cost is sanding, priming, painting and caulking of the windows, flashing, fixtures and all other penetrations. It is recommended that the building be painted in the next 2-3 years and that this project be scheduled on a cyclical basis to maintain the integrity of the structure.

Marlette Lake Storage Shed - Building #2503
Description: Exterior finishes needed.

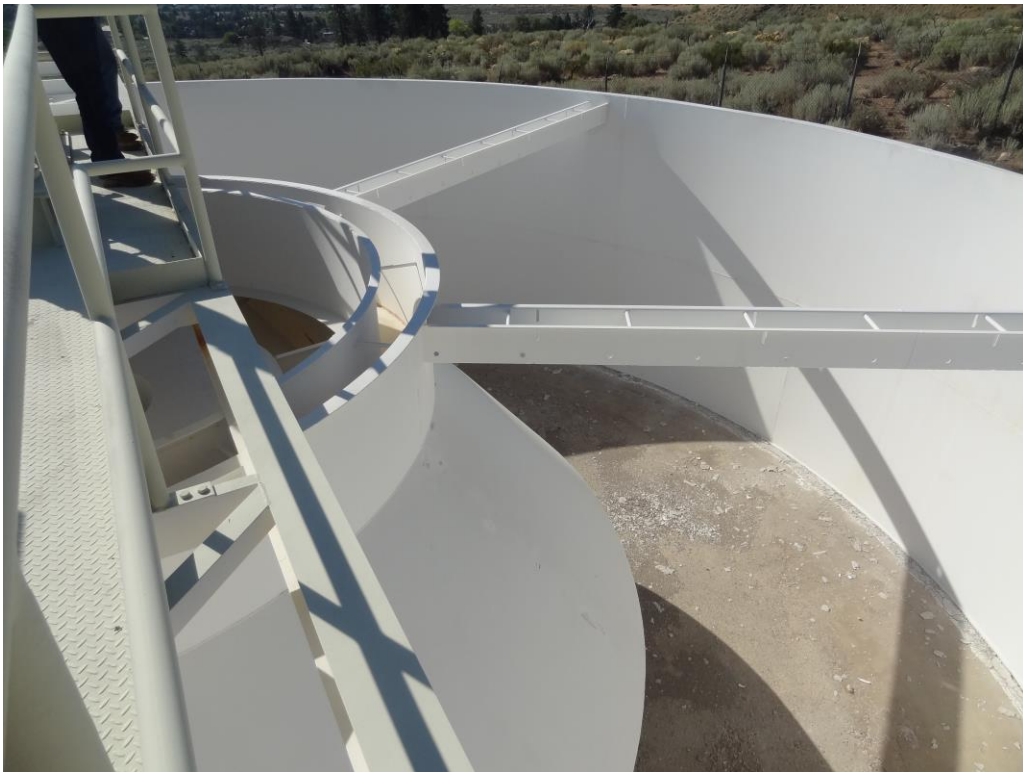
The storage tank floor is made of concrete and was in poor condition at the time of the survey. This project would provide for the removal of the spalling and cracking concrete floor and the installation of a 4" thick concrete floor inside the walls of the water tank.

Marlette 1.5 Gallon Storage Tank - Building #2504
Description: Concrete foundation needed.
