# **LAKE MEAD FISH HATCHERY SITE**

**Site Number: 9897**

**STATE OF NEVADA PUBLIC WORKS DIVISION  
FACILITY CONDITION ANALYSIS**

Report distributed in September 2022

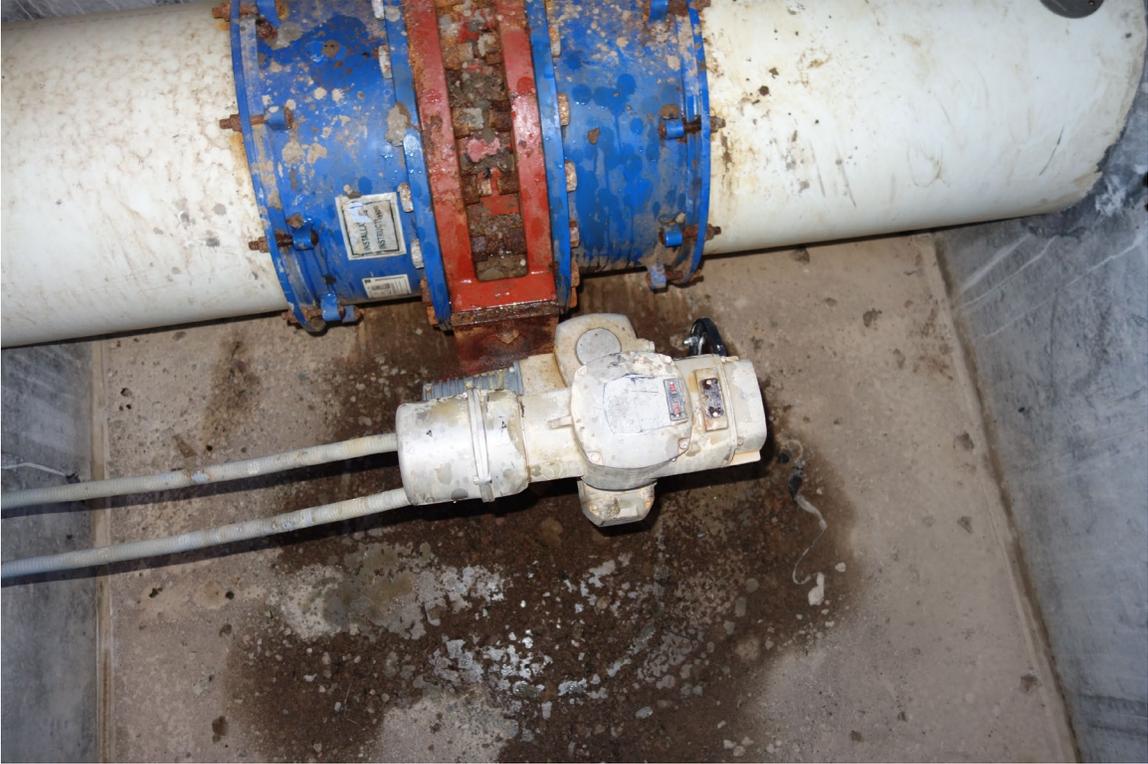
A 24" diameter lake water supply main provides water to support hatchery operations. A motorized isolation valve is located in the public parking lot in an underground vault. It is leaking and will not completely shut off the water supply. Removal and replacement is recommended. This project will fund shutting down the water main, removal and replacement of the valve and electric actuator.

Lake Mead Fish Hatchery Site – FCA Site #9897  
Description: Lake Water Main Valve Replacement Needed.

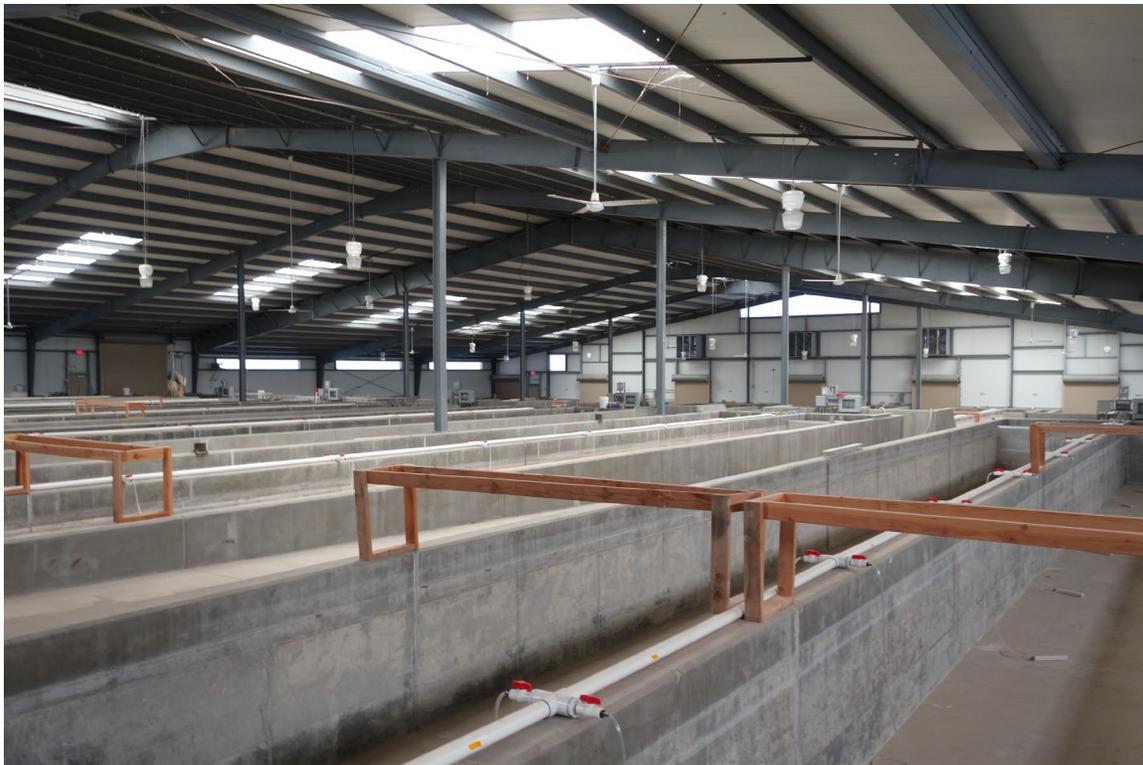
Lower Rearing Building – FCA Building #2469  
Description: Interior Lighting Upgrade.

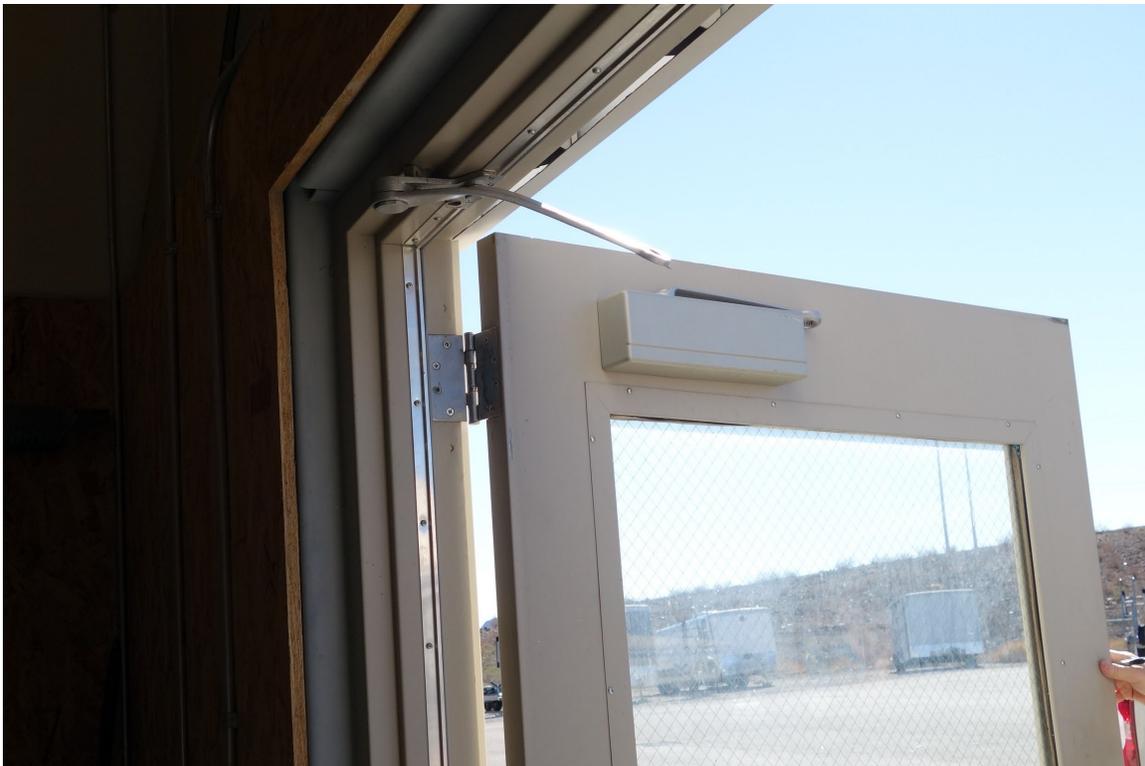
The 5 exterior metal doors are damaged from wind and general wear and tear and have reached the end of their expected life. This project would provide for the replacement of the two double door assemblies and the single door assembly with new metal doors, frames and hardware. Removal and disposal of the existing doors is included in this estimate.

Hatchery Shop / Feed Storage – FCA Building #2466  
Description: Exterior Door Damage & Replacement Needed.

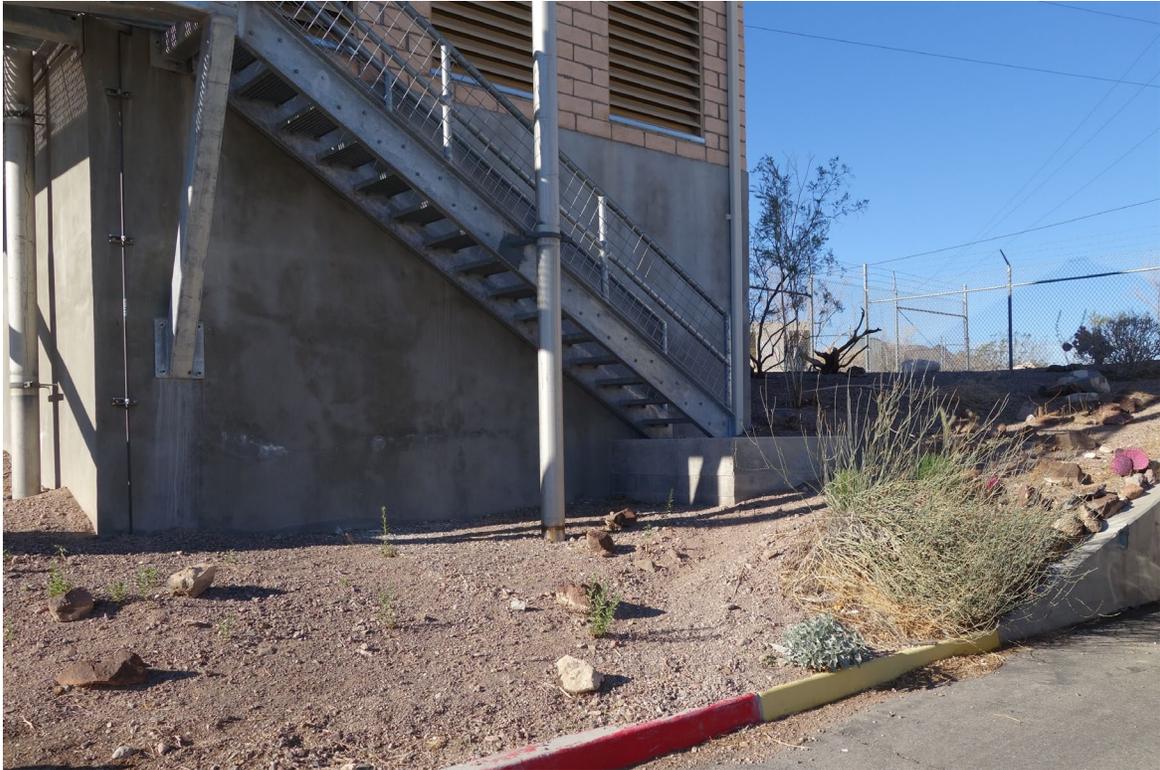
The access stairway to the Aeration Tower ends at a landing that is not continuous to a paved walking surface. For convenience and safety of on site personnel accessing the tower, it is recommended that a concrete stair access be installed from the existing stairway landing to the paved surface below the landing. Code compliant design is included in this estimate.

Hatchery Water Aeration Tower – FCA Building #0913  
Description: Concrete Stair Installation Recommended.

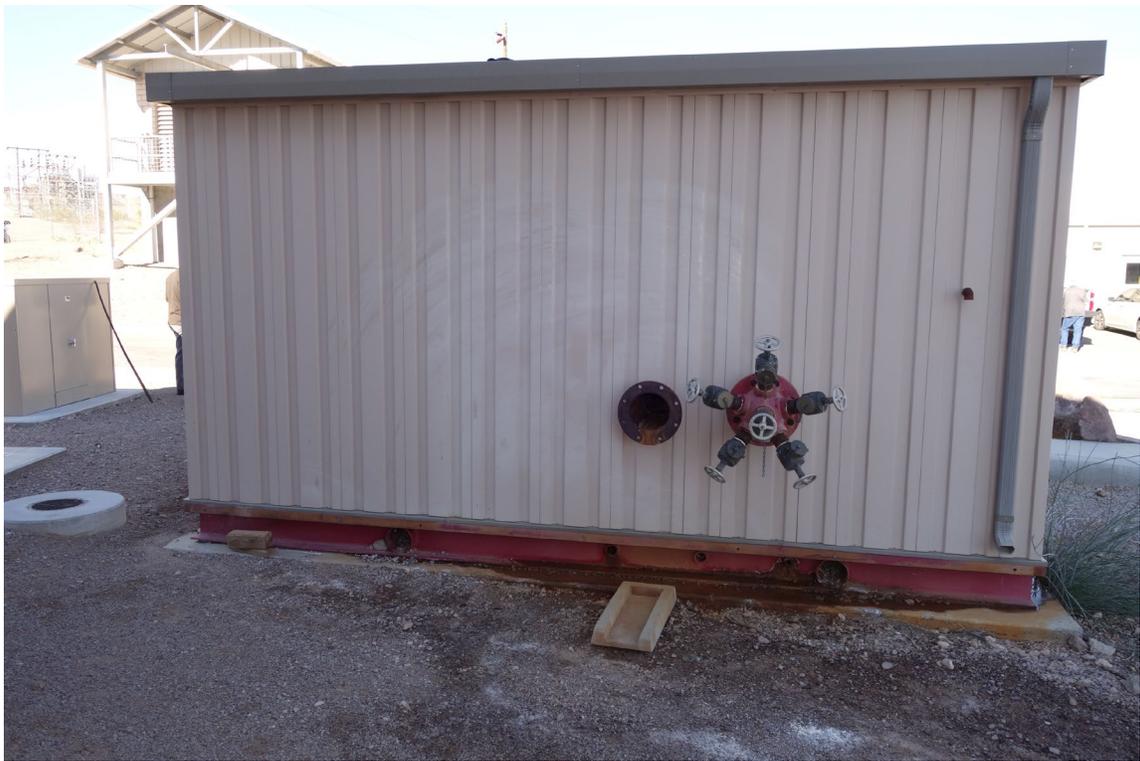
The fire pump station maintains fire suppression water system pressure supplied from the 180,000 gallon water storage tank located next to it. It provides fire suppression water to various buildings on the site. There is an electric "jockey" pump to maintain the system pressure when there is no fire water flow event. The jockey pump is currently cycling on approximately every 15 minutes indicating a leak in the system. This is putting unnecessary strain on the electric motor and if the leak worsens will exceed the motor's duty cycle and cause premature failure. A visual survey of the pump station indicates potential sources of these leaks being located in the pump station itself indicated by water leaking out of the east side of the building. This project will fund a limited investigation to identify and repair local leaks.

Hatchery Fire Pump Station – FCA Building #0657  
Description: Leak Investigation Needed.

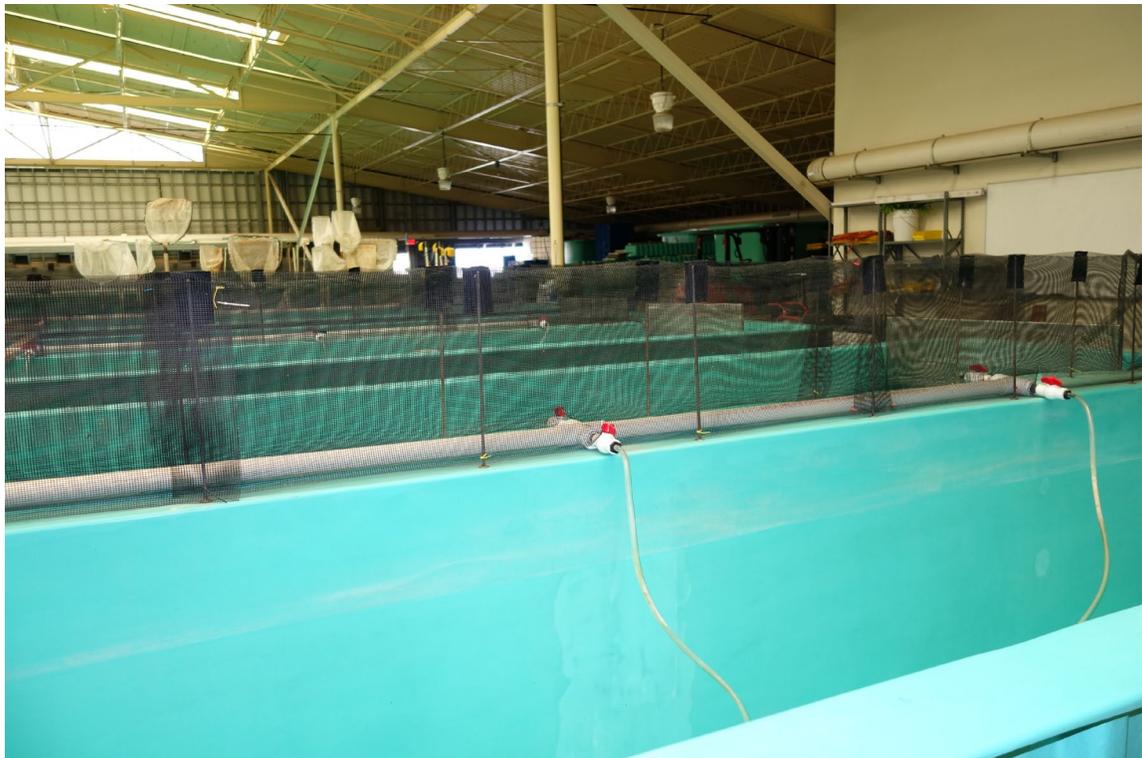
Visitation / Upper Rearing Building – FCA Building #0655  
Description: Lighting Upgrade Recommended.

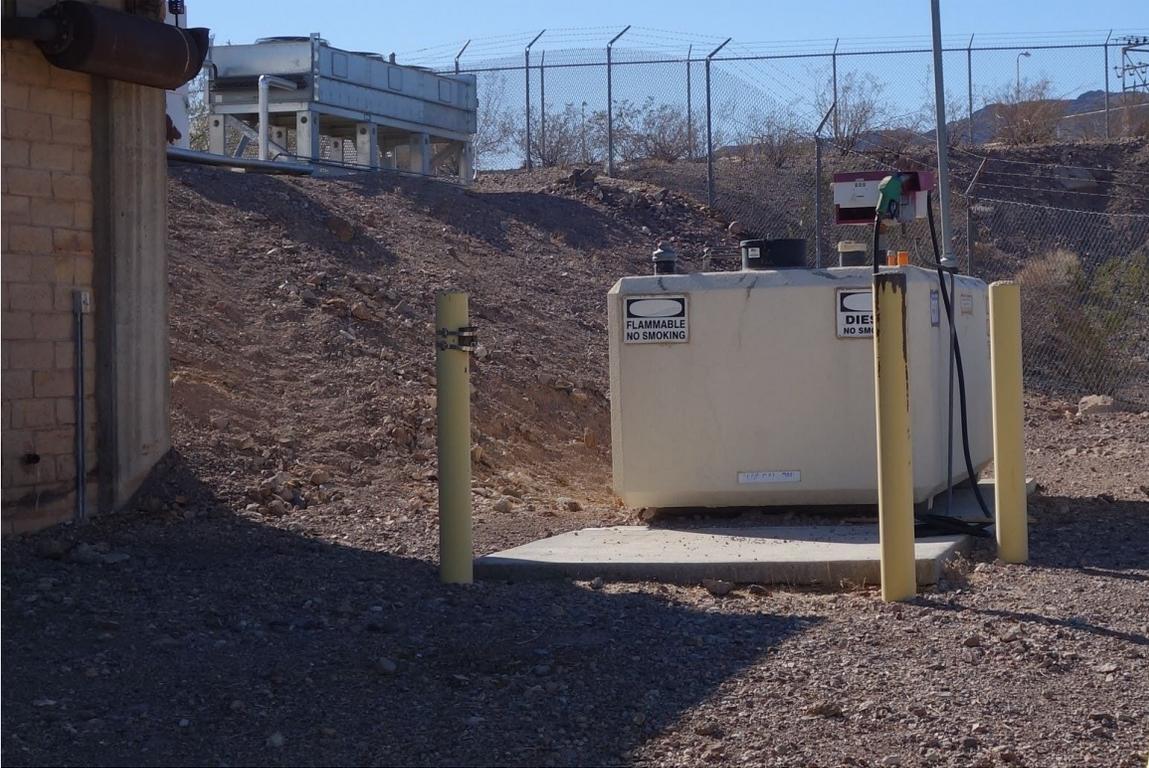
The emergency generator exterior fuel tank has a fuel dispenser. Fuel in this tank is for off-highway use only (no highway vehicles). Additionally, this fuel is for emergency generator consumption and any use of this fuel for other purposes, risks generator availability. It is recommended that the fuel dispenser be removed.

Visitation / Upper Rearing Building – FCA Building #0655  
Description: Fuel Dispenser Removal Recommended.
