State of Nevada
Department of Wildlife
Lake Mead Fish Hatchery
Facility Condition Analysis

LAKE MEAD FISH HATCHERY

Site Number: 9897
STATE OF NEVADA PUBLIC WORKS DIVISION
FACILITY CONDITION ANALYSIS

Report Printed in November 2012

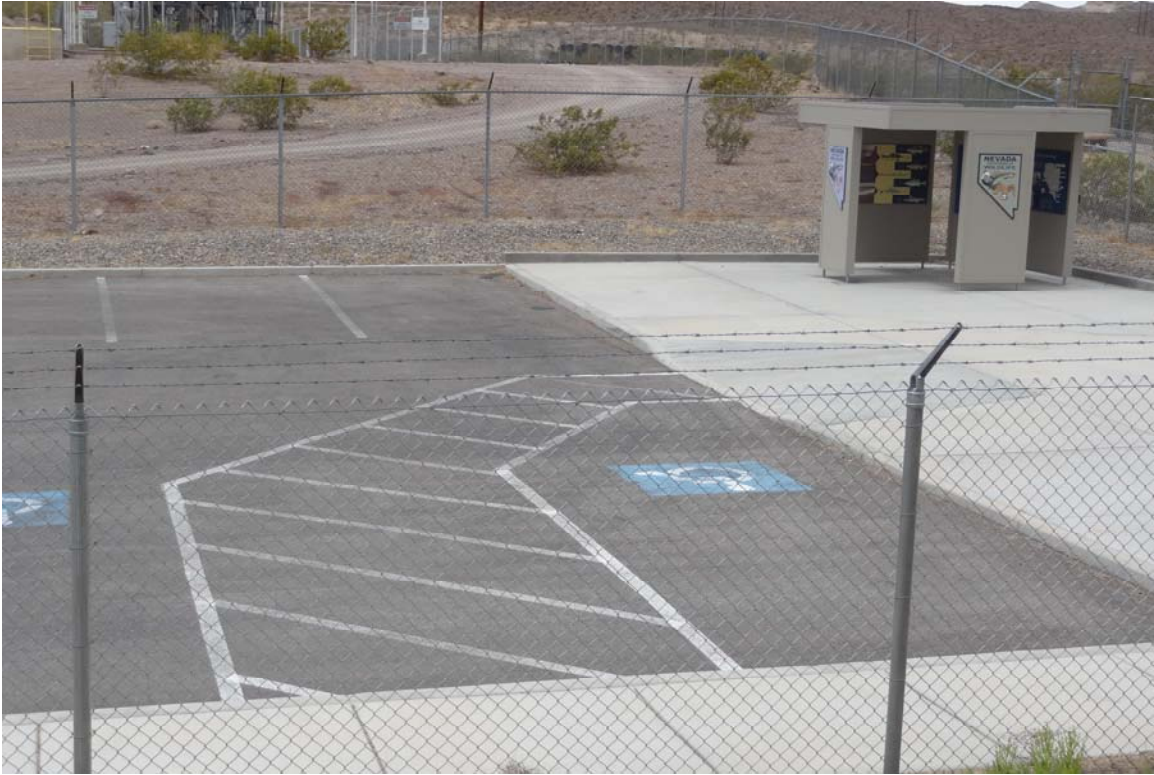
Lake Mead Fish Hatchery Site – FCA Site #9897
Description: ADA accessible parking at Visitor's Center public entrance.

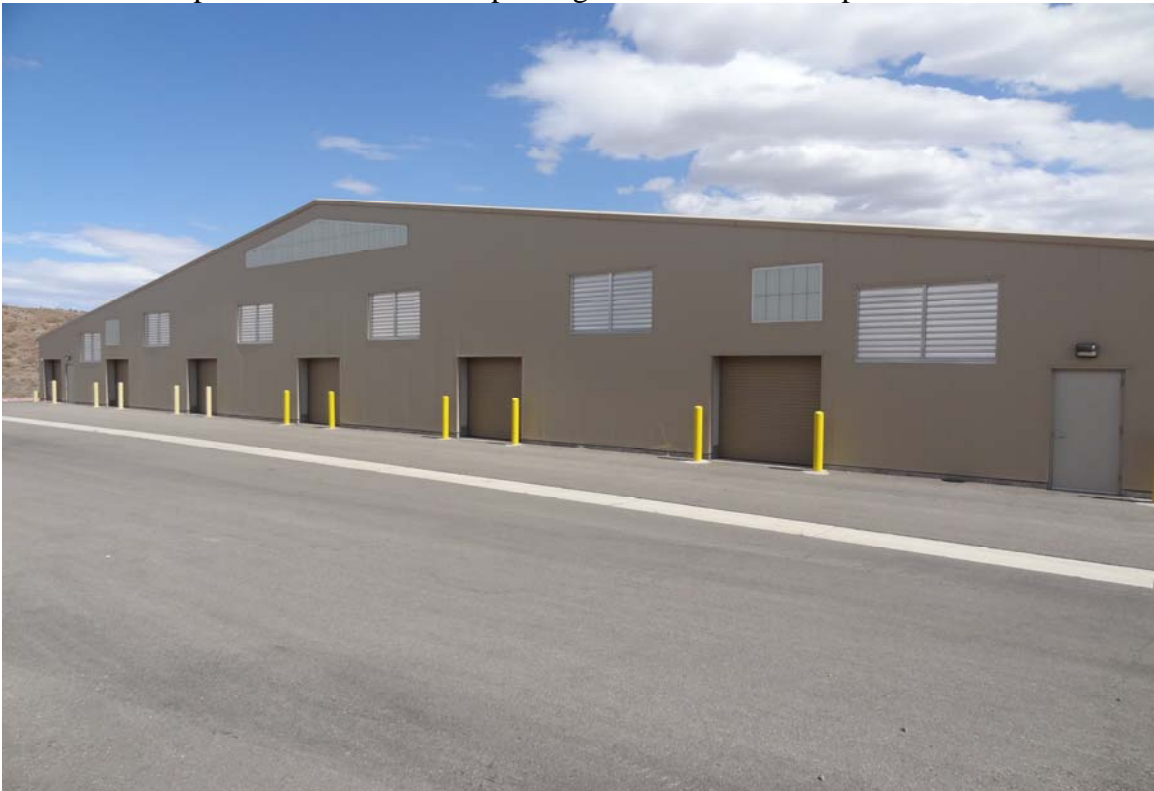
Upper Rearing Building – FCA Building #2469
Description: Exterior of the building.

It is important to maintain the finish, weather resistance, and appearance of the building. This project would provide funding to protect the exterior of the building excluding the roof. Included in the cost is the caulking and sealing of the windows, flashing, fixtures and all other penetrations. It is recommended that the building be caulked and sealed in the next 3-4 years and that this project be scheduled on a cyclical basis to maintain the integrity of the structure.

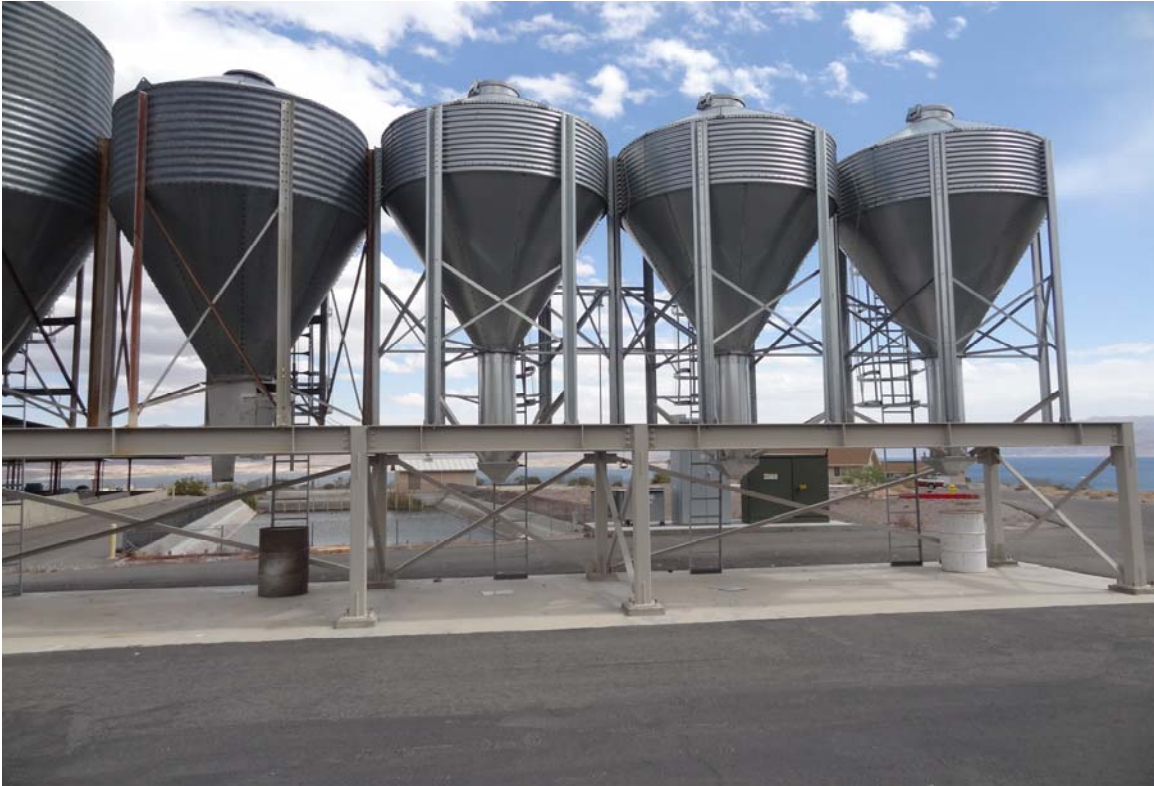
Hatchery Feed Bins – FCA Building #2468
Description: Exterior of the structure.

It is important to maintain the finish, weather resistance, and appearance of the structure. This project would provide funding to protect the exterior of the structure. Included in the cost is the caulking and sealing of the flashing, fixtures and all other penetrations. It is recommended that the structure be painted and sealed in the next 3-4 years and that this project be scheduled on a cyclical basis to maintain the integrity of the structure.

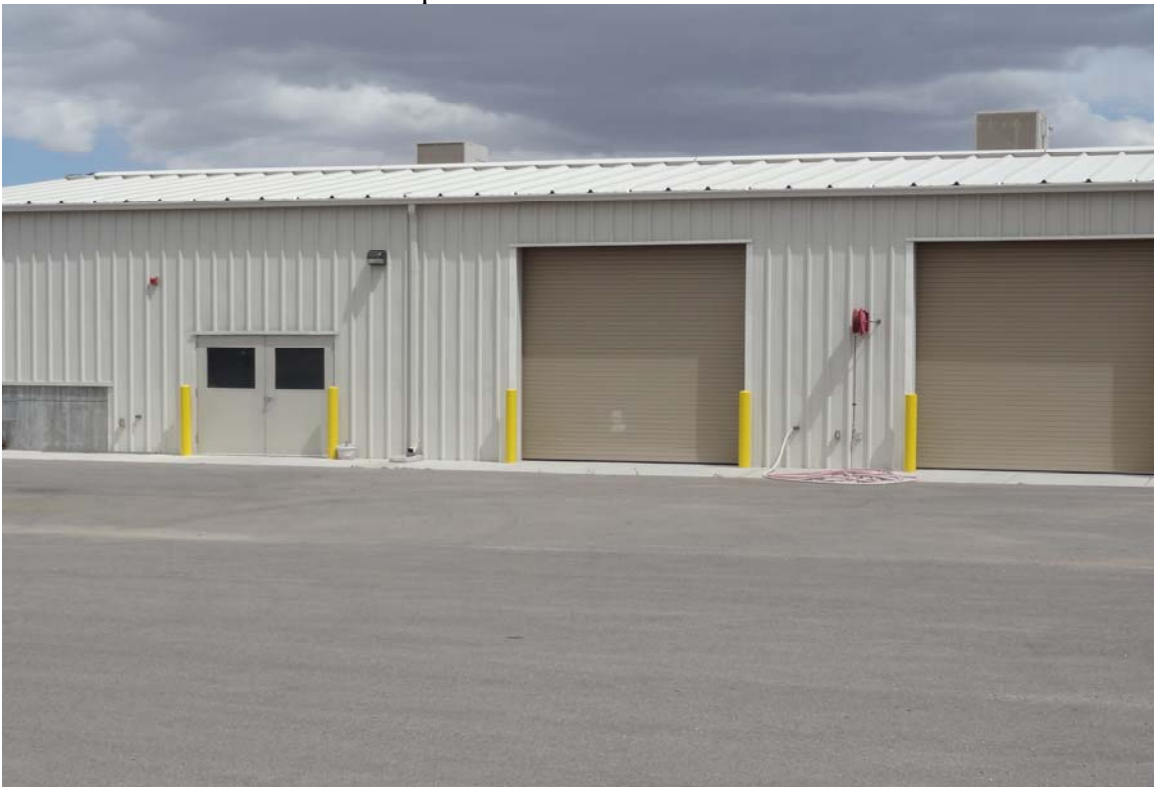
The building has two roof-mounted evaporative coolers that are leaking water and damaging the roof. The condensate lines have leaks in them and since the water is untreated, it is staining the standing seam metal roof and will cause corrosion and rusting if left unrepaired. This project would provide for replacement of the condensate lines to prevent any further damage.

Hatchery Shop / Feed Storage – FCA Building #2466
Description: Exterior of the building.

It is important to maintain the finish, weather resistance, and appearance of the building. This project would provide funding to protect the exterior of the building excluding the roof. Included in the cost is the caulking and sealing of the flashing, fixtures and all other penetrations. It is recommended that the building be caulked and sealed in the next 3-4 years and that this project be scheduled on a cyclical basis to maintain the integrity of the structure.

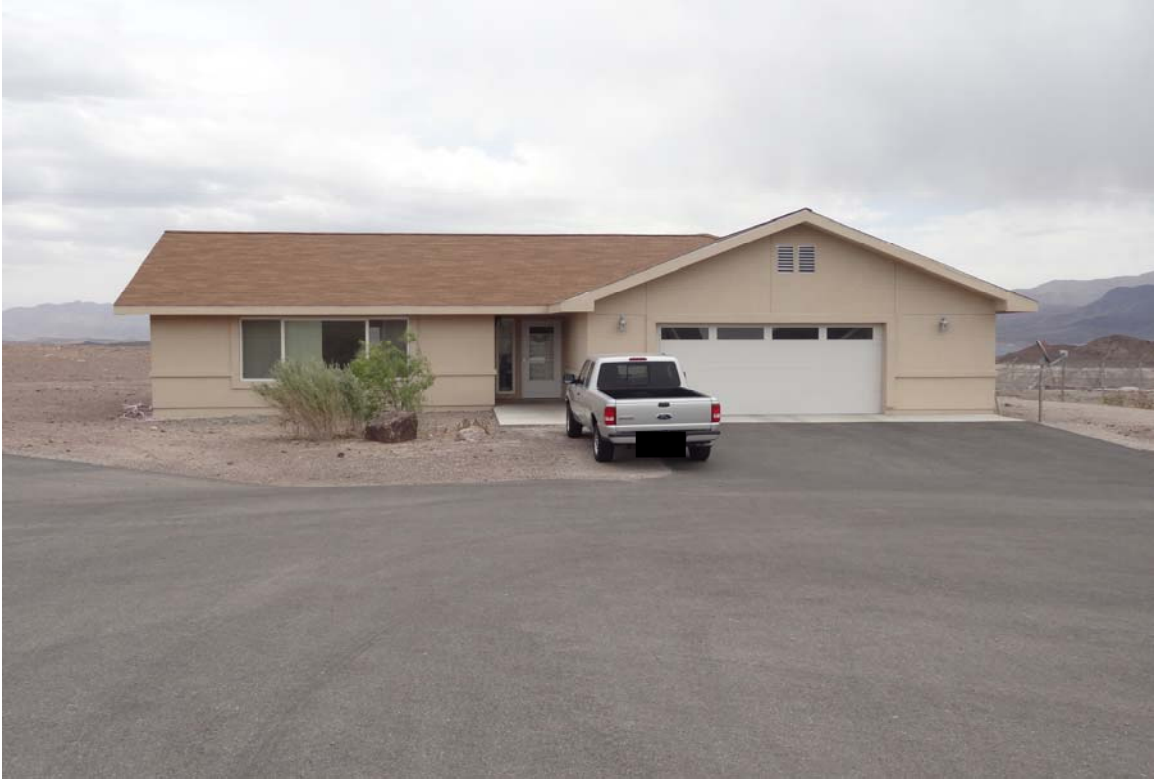
Hatchery Residence #4 – FCA Building #2465
Description: Exterior of the residence.

It is important to maintain the finish, weather resistance, and appearance of the building. This project would provide funding to protect the exterior of the building excluding the roof. Included in the cost is power washing, priming and painting and caulking of the windows, flashing, fixtures and all other penetrations. It is recommended that the building be painted in the next 3-4 years and that this project be scheduled on a cyclical basis to maintain the integrity of the structure. This project or a portion thereof was previously recommended in the FCA report dated 10/11/2005. It has been amended accordingly to reflect conditions observed during the most recent survey date of 04/11/2012.

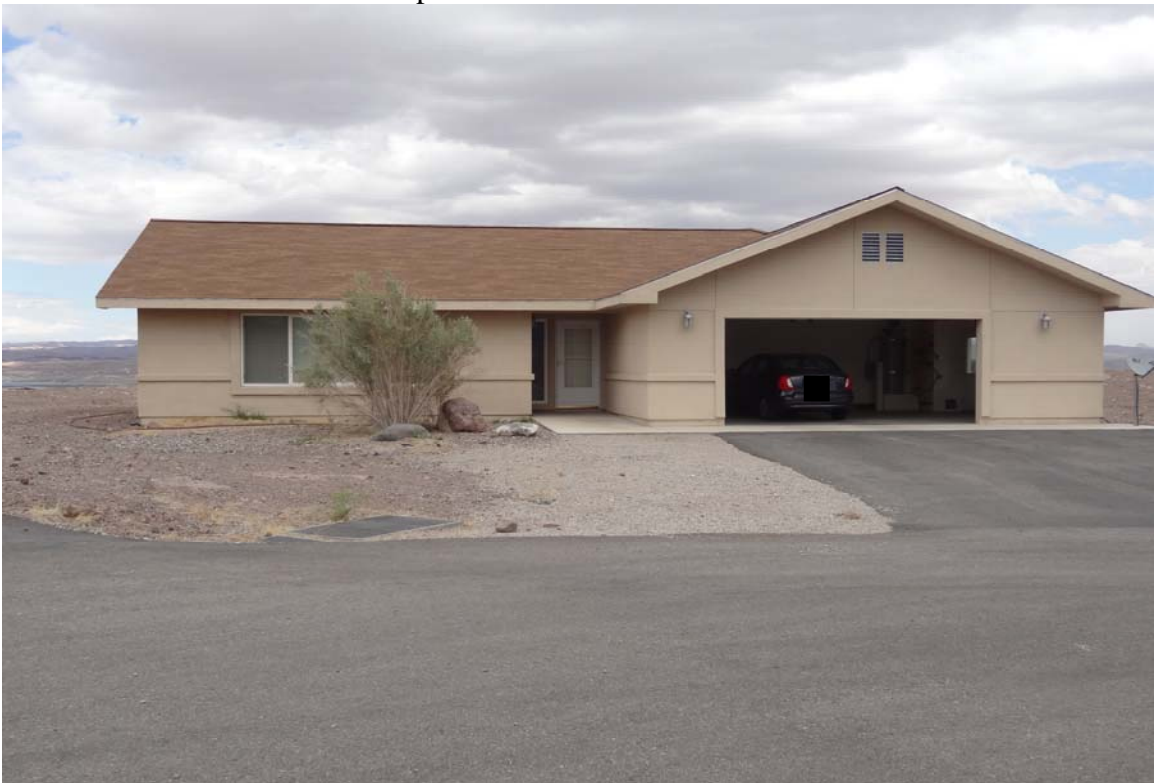
Hatchery Residence #3 – FCA Building #2464
Description: Exterior of the residence.

It is important to maintain the finish, weather resistance and appearance of the building. This project would provide funding to protect the exterior of the building excluding the roof. Included in the cost is power washing, priming and painting and caulking of the windows, flashing, fixtures and all other penetrations. It is recommended that the building be painted in the next 3-4 years and that this project be scheduled on a cyclical basis to maintain the integrity of the structure. This project or a portion thereof was previously recommended in the FCA report dated 10/11/2005. It has been amended accordingly to reflect conditions observed during the most recent survey date of 04/11/2012.

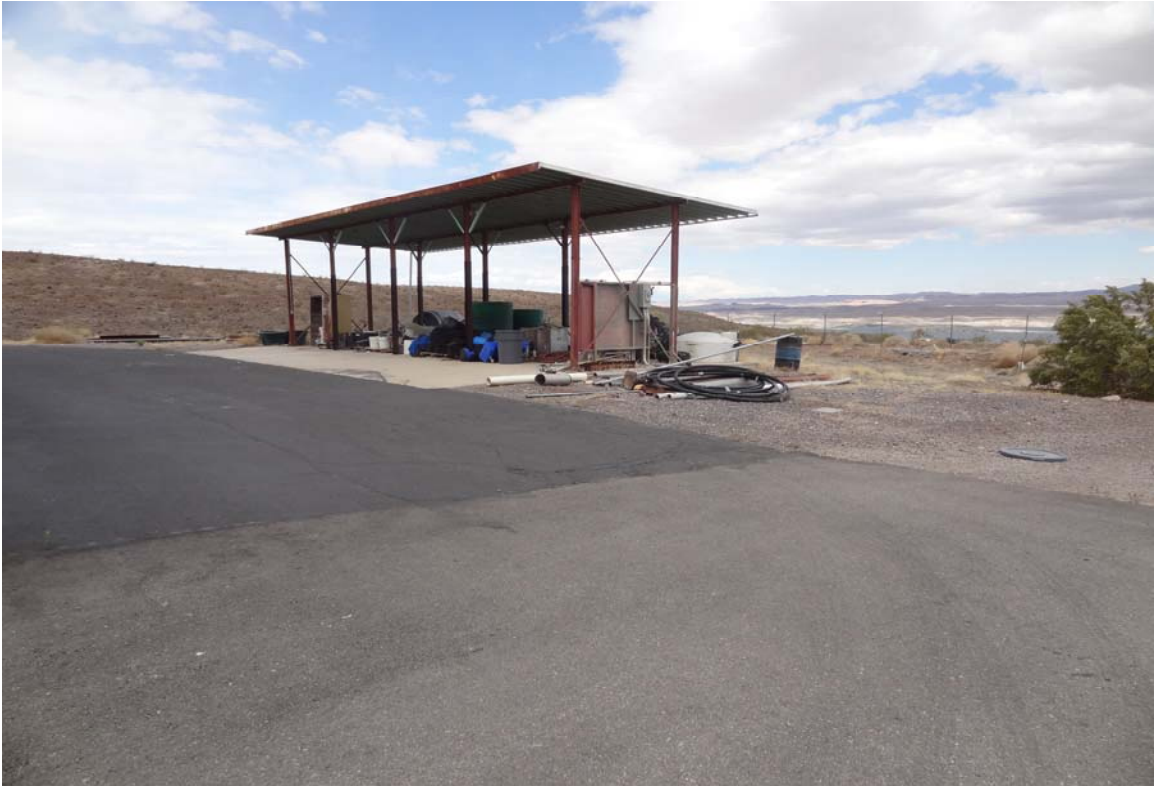
North Equipment Storage – FCA Building #0914
Description: Exterior of the building.

It is important to maintain the finish, weather resistance and appearance of the structure. This project would provide for painting of the structure and it is recommended that this project be scheduled on a cyclical basis to maintain the integrity of the structure.

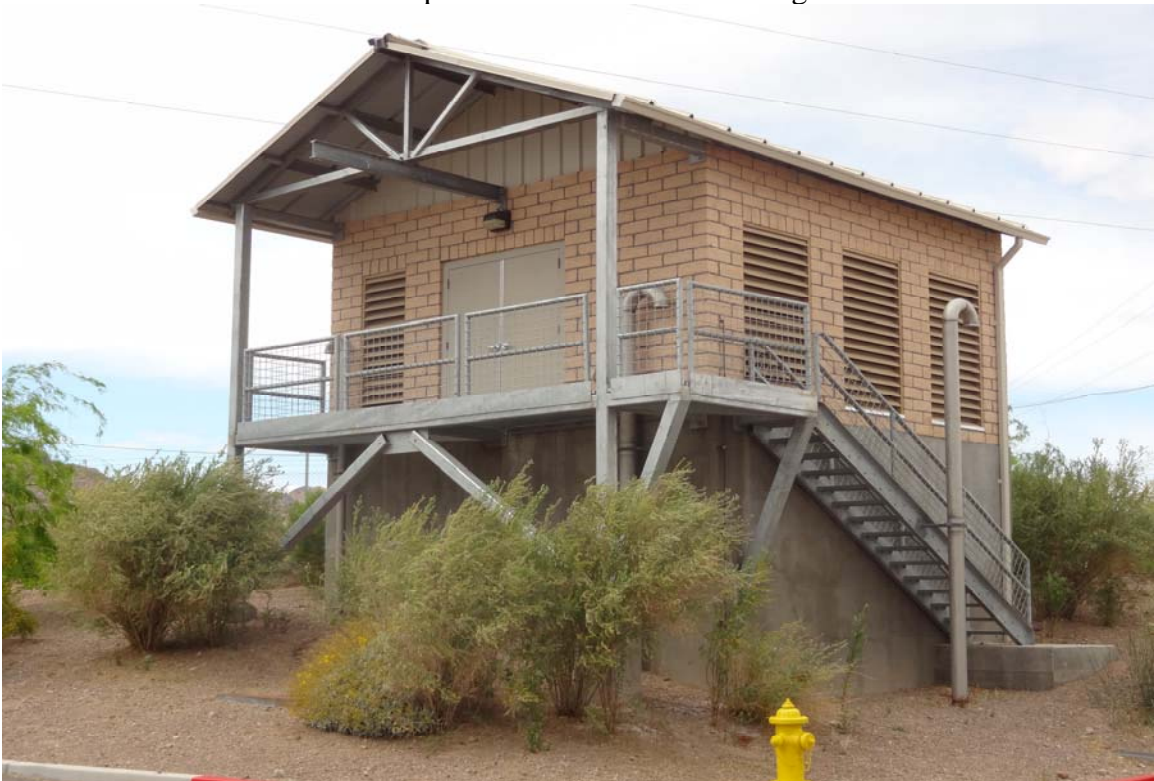
Hatchery Water Aeration Tower – FCA Building #0913
Description: Exterior of the building.

It is important to maintain the finish, weather resistance, and appearance of the building. This project would provide funding to protect the interior and exterior of the building. Included in the cost are cleaning and sealing the concrete masonry units and caulking of the flashing, fixtures and all other penetrations. It is recommended that the building be sealed and caulked in the next 3-4 years and that this project be scheduled on a cyclical basis to maintain the integrity of the structure.

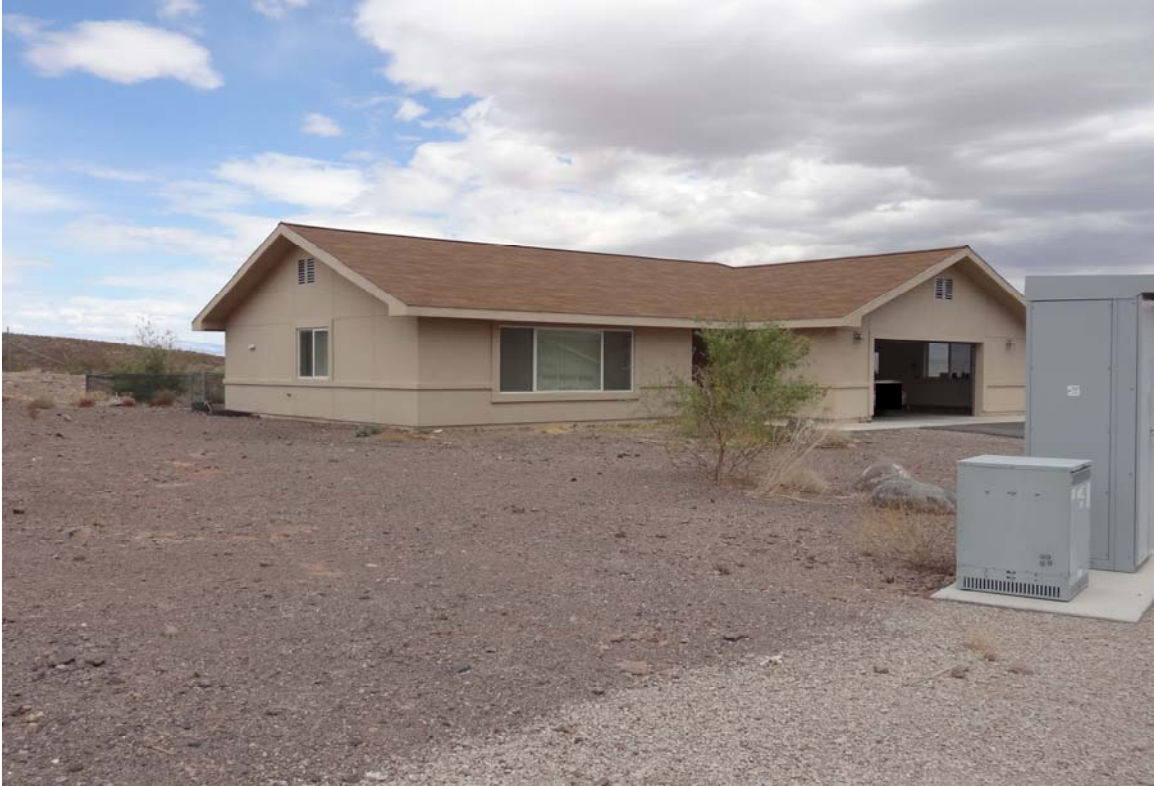
Hatchery Residence #2 – FCA Building #0907
Description: Exterior of the residence.

It is important to maintain the finish, weather resistance, and appearance of the building. This project would provide funding to protect the exterior of the building excluding the roof. Included in the cost is power washing, priming and painting and caulking of the windows, flashing, fixtures and all other penetrations. It is recommended that the building be painted in the next 3-4 years and that this project be scheduled on a cyclical basis to maintain the integrity of the structure. This project or a portion thereof was previously recommended in the FCA report dated 10/11/2005. It has been amended accordingly to reflect conditions observed during the most recent survey date of 04/11/2012.

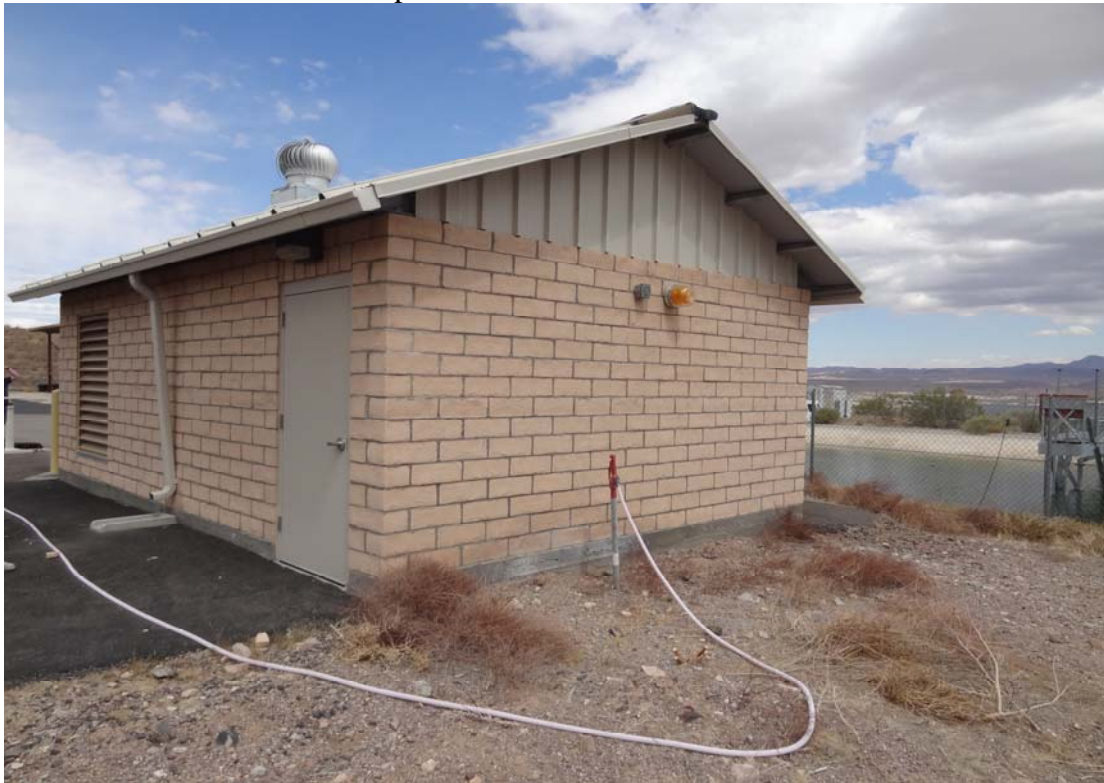
Filter Building – FCA Building #0906
Description: Exterior of the building.

It is important to maintain the finish, weather resistance, and appearance of the building. This project would provide funding to protect the exterior of the building excluding the roof. Included in the cost are cleaning and sealing the concrete masonry units and caulking of the flashing, fixtures and all other penetrations. It is recommended that the building be sealed and caulked in the next 3-4 years and that this project be scheduled on a cyclical basis to maintain the integrity of the structure.

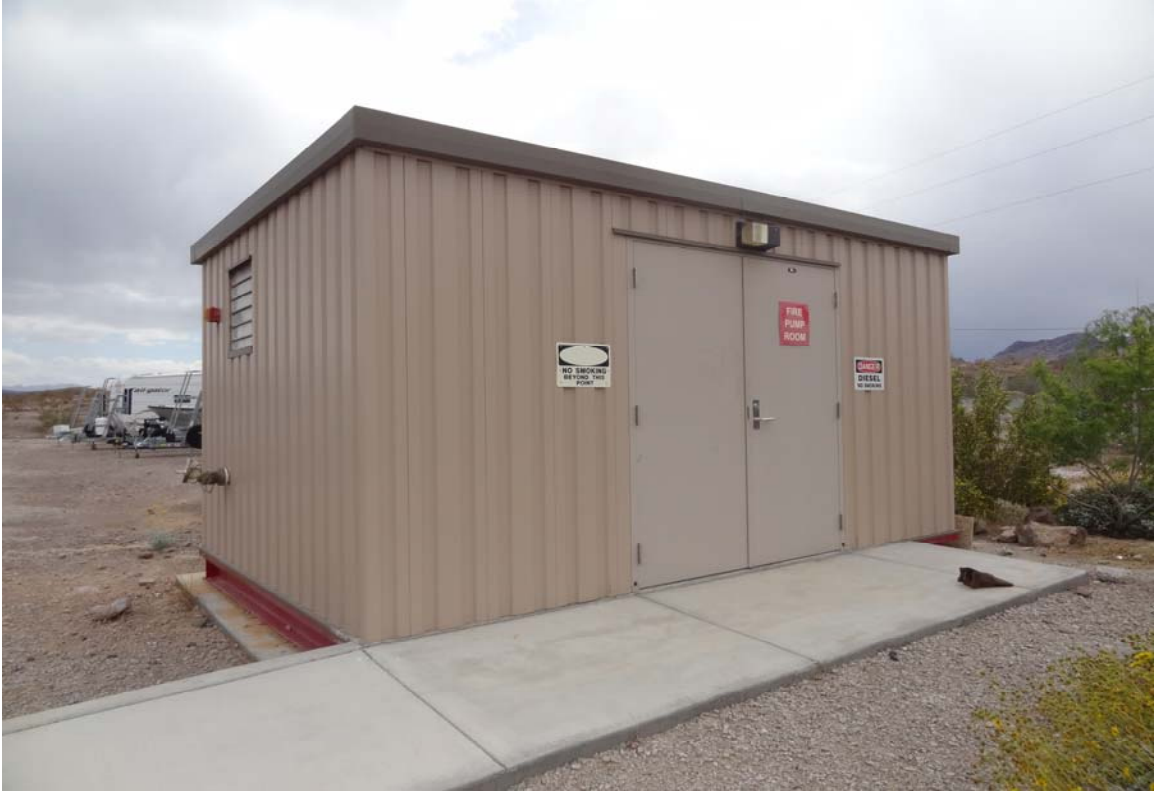
Hatchery Fire Pump Station – FCA Building #0657
Description: Exterior of the building.

It is important to maintain the finish, weather resistance, and appearance of the building. This project would provide funding to protect the exterior of the building excluding the roof. Included in the cost is the caulking and sealing of the flashing, fixtures and all other penetrations. It is recommended that the building be caulked and sealed in the next 3-4 years and that this project be scheduled on a cyclical basis to maintain the integrity of the structure.

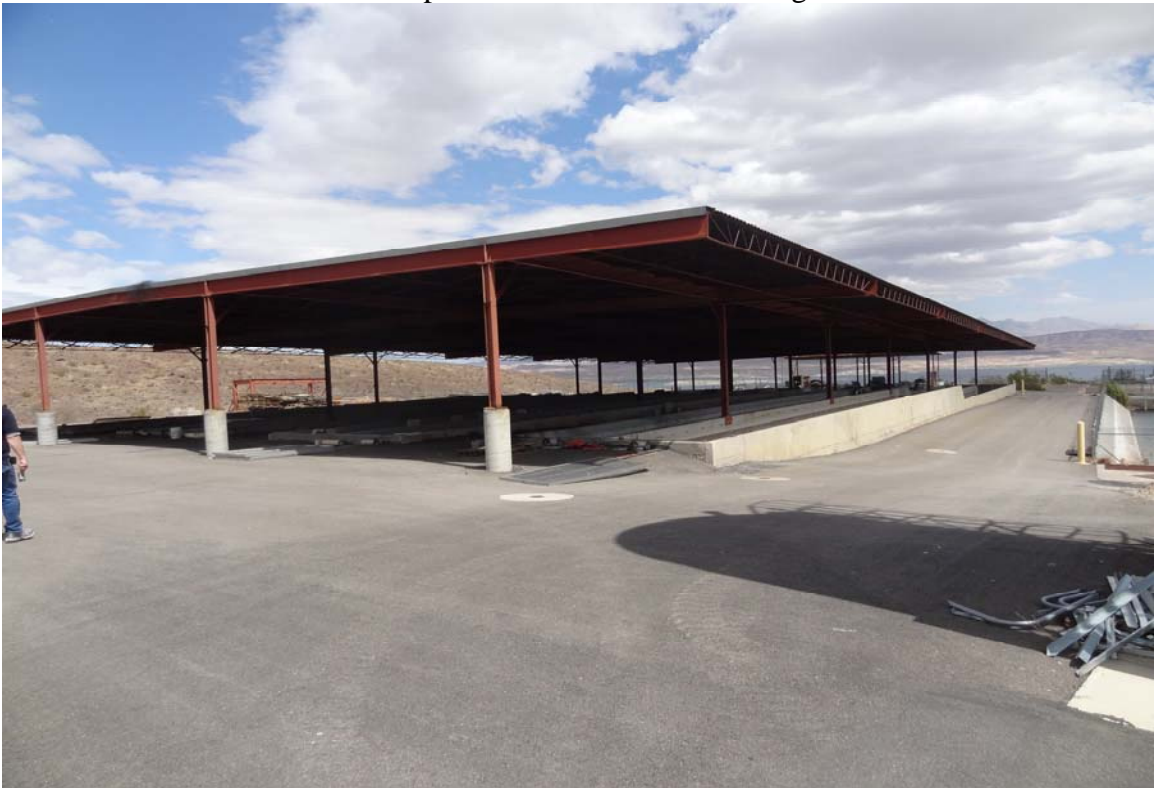
Lower Rearing Shade Shelter – FCA Building #0656
Description: Exterior of the building.

It is important to maintain the finish, weather resistance, and appearance of the structure. This project would provide for painting of the structure and it is recommended that this project be scheduled on a cyclical basis to maintain the integrity of the structure.

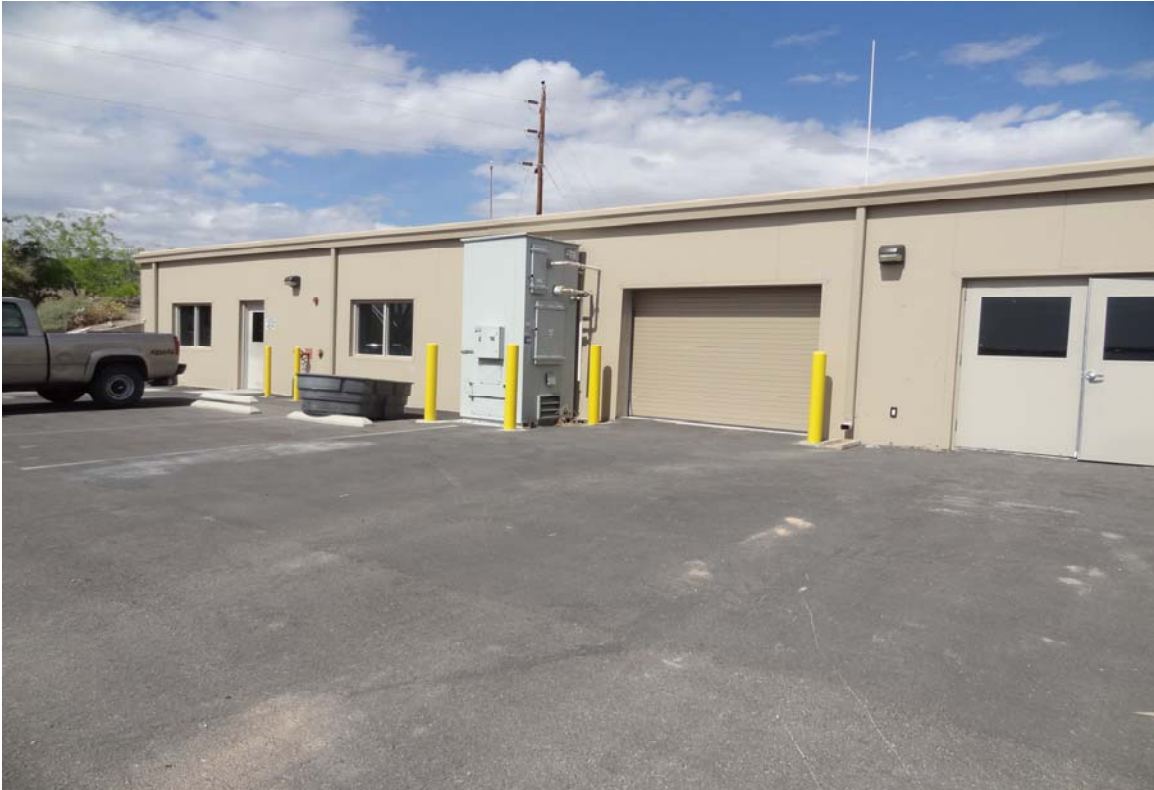
Visitation / Hatchery Building – FCA Building #0655
Description: Exterior of the building.

It is important to maintain the finish, weather resistance, and appearance of the building. This project would provide funding to protect the exterior of the building excluding the roof. Approximately 1/8 of the exterior of the building is sealed concrete masonry units, the rest is steel framing with metal siding. Included in the cost are cleaning and sealing the concrete masonry units and caulking of the windows, flashing, fixtures and all other penetrations. It is recommended that the building be sealed and caulked in the next 2-3 years and that this project be scheduled on a cyclical basis to maintain the integrity of the structure.

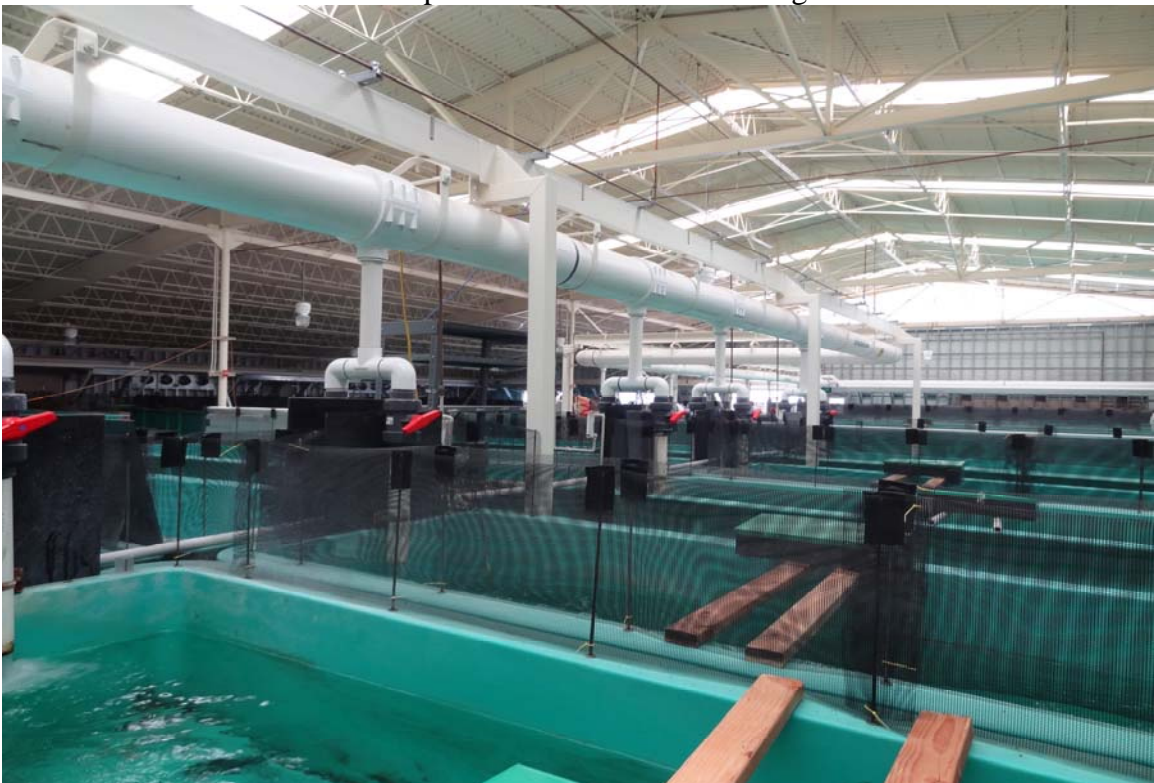
Visitation / Hatchery Building – FCA Building #0655
Description: Interior of the hatchery area.

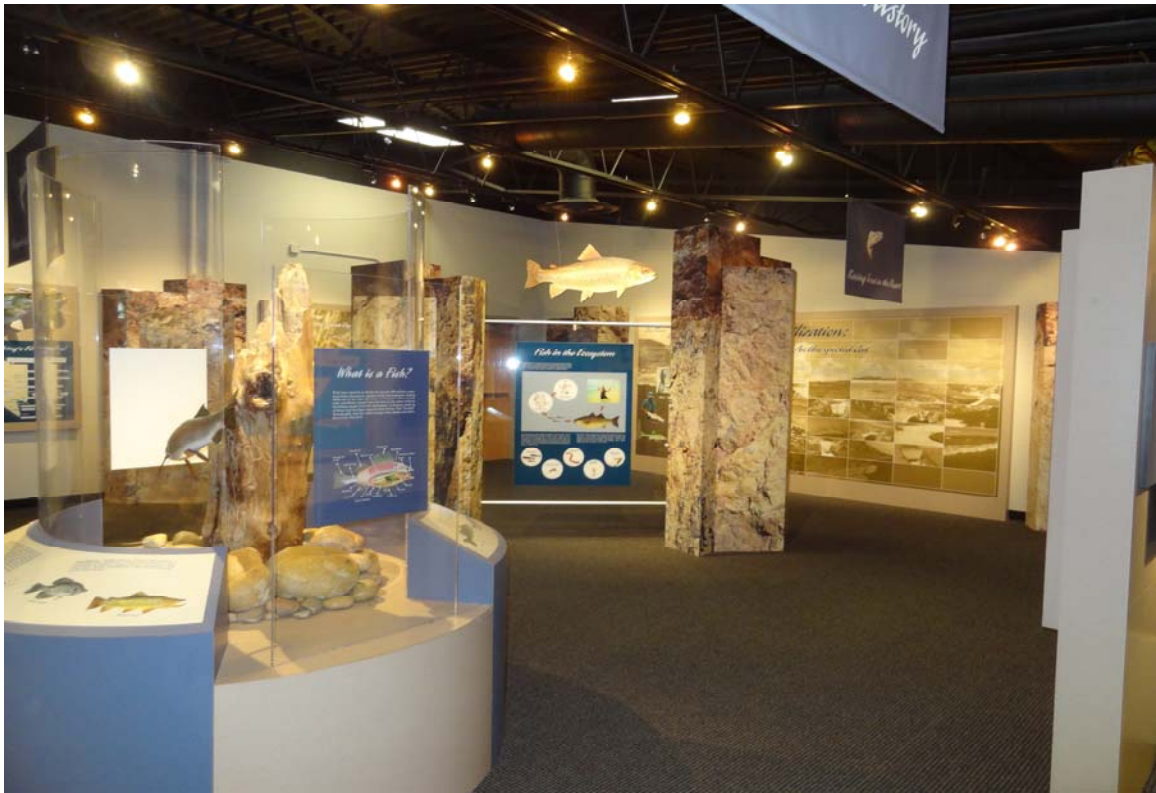
Visitation / Hatchery Building – FCA Building #0655
Description: Interior of the visitation area.

The interior finishes are in fair condition. Approximately 3,500 square feet of the building is finished with painted gypsum board. It is recommended that the painted interior walls and ceilings be painted at least once in the next 2-3 years and that this project be scheduled on a cyclical basis to maintain the integrity of the structure. Prior to painting, all surfaces should be repaired and prepped. An epoxy-based paint should be utilized in wet areas for durability.

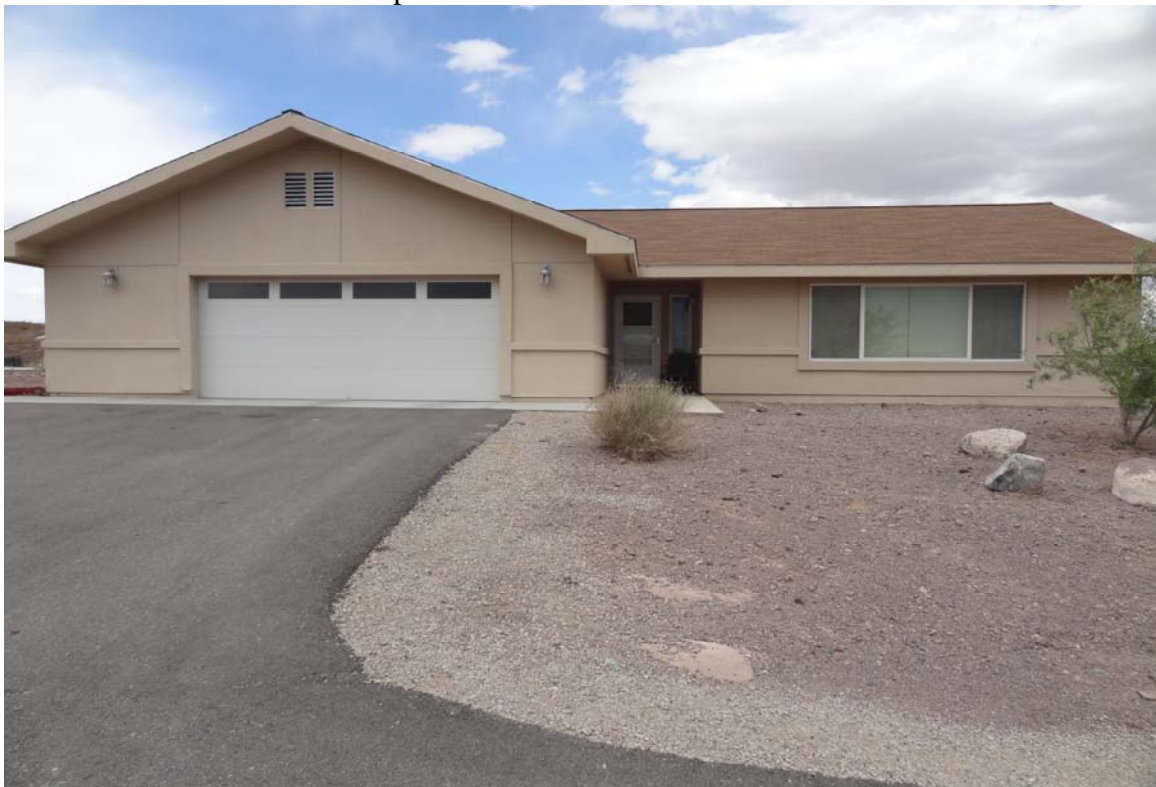
Hatchery Residence #1 – FCA Building #0654
Description: Exterior view of the residence.
