SIERRA FRONT INTERAGENCY DISPATCH CENTER

Site Number: 9900
STATE OF NEVADA PUBLIC WORKS DIVISION
FACILITY CONDITION ANALYSIS

Report distributed in December 2021

SPWD Facility Condition Analysis

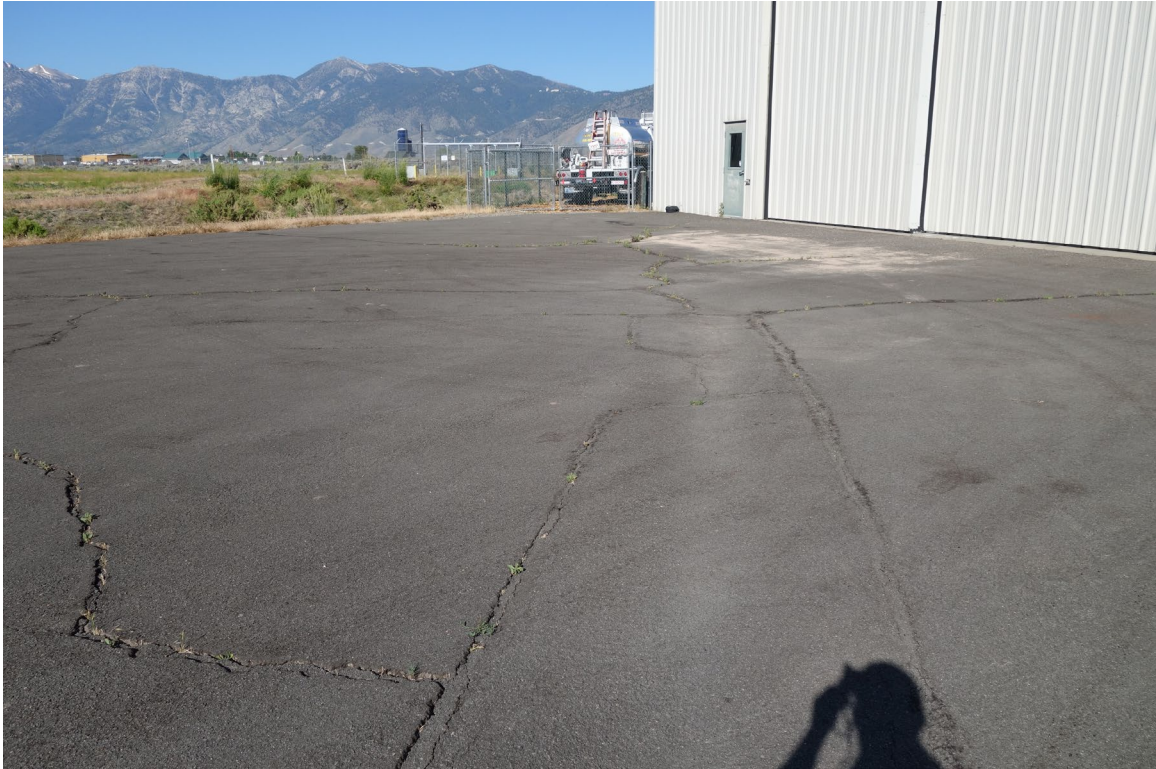
The asphalt apron in front of the NDOW hanger as a drainage swale extending diagonally across the hangar entry apron. This makes it difficult for aircraft to enter and exit the hangar. This project would fund pavement removal, relocation of storm water drop inlet, regrading and re-paving the hangar apron.

Sierra Front Interagency Dispatch Center Site – FCA Site #9900
Description: Regrade NDOW Hangar Apron.

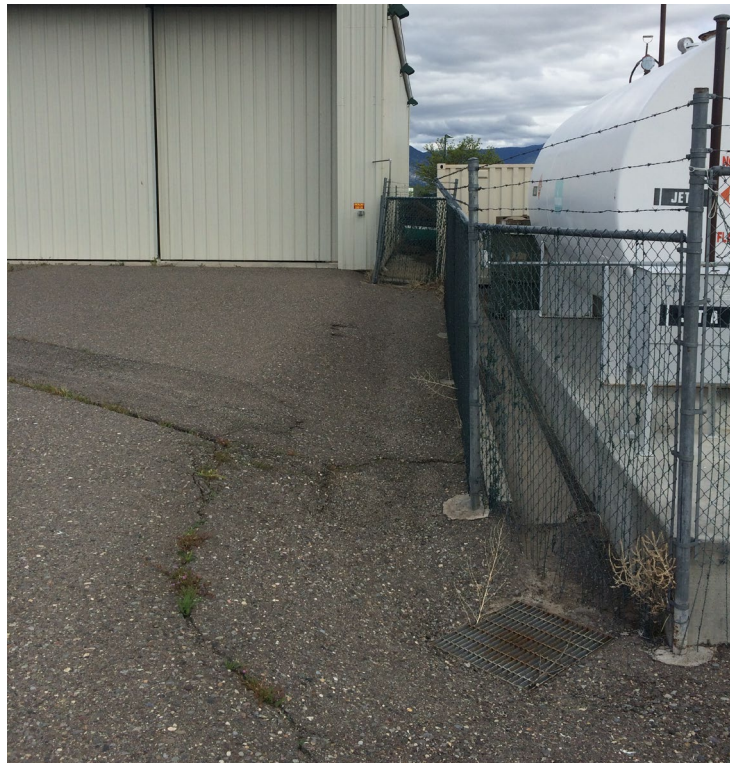
The existing above ground fuel tanks are located on a concrete slab with no curbs to contain spills, no lighting and the emergency shut-off switch is in the wrong building. The fuel tanks are double wall compliant tanks however due to the immediate proximity of a storm drain drop inlet, there are still risks of environmental contamination from fuel spillage during fueling operations. This project would install a concrete curb around the tanks to prevent soil contamination, a drain with a sand/ oil separator, outdoor lighting around the tanks and provisions to relocate the emergency shut-off switch from the Wildlife hangar to the Forestry hangar. This project should be implemented concurrently with the REGRADE NDOW HANGAR APRON project. This project or a portion thereof was previously recommended in the FCA report dated 11/12/2013. It has been amended accordingly to reflect conditions observed during the most recent survey date of 06/04/2021.

Sierra Front Interagency Dispatch Center Site – FCA Site #9900
Description: Fuel Tanks Containment & Drain Relocation Recommended.

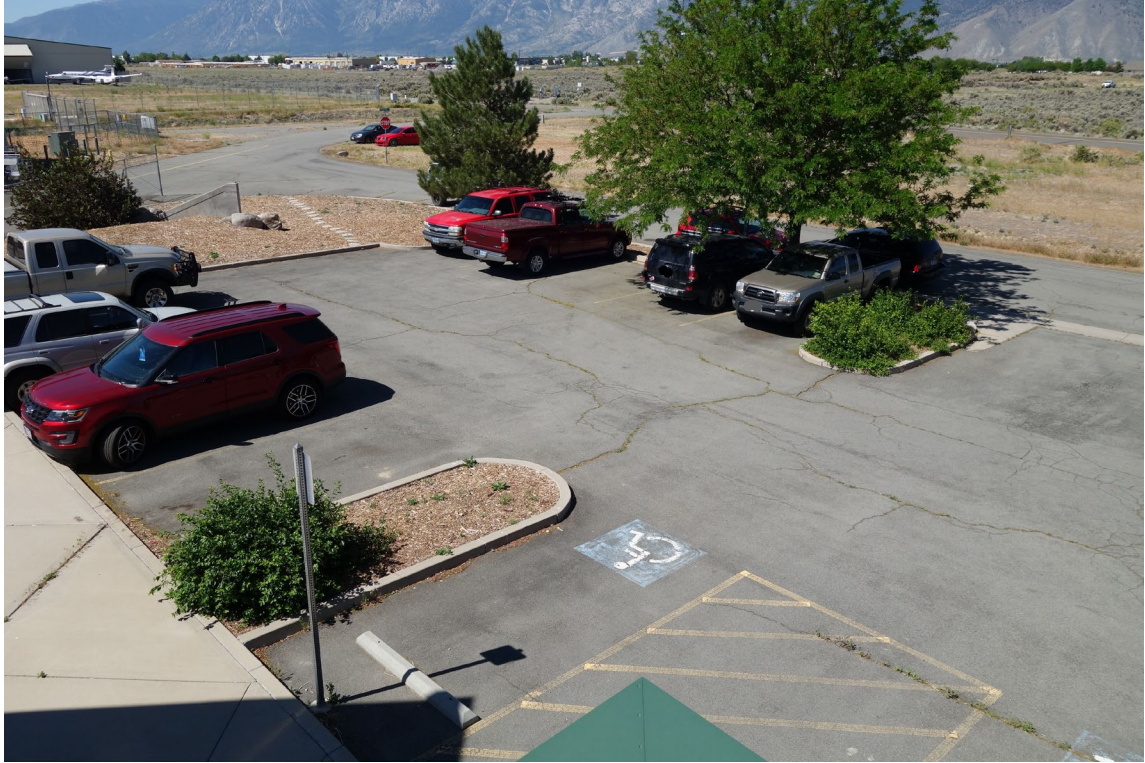
It is important to maintain the asphalt concrete paving on the site. This project would provide for crack filling and slurry sealing of the paving site wide including access roads, parking areas and the helicopter apron. Striping is included in this estimate. This project should be scheduled on a 5 year cyclical basis to maintain the integrity of the paving and prevent premature failure. 250,000 square feet of asphalt area was used to generate this estimate. This project or a portion thereof was previously recommended in the FCA report dated 11/12/2013. It has been amended accordingly to reflect conditions observed during the most recent survey date of 06/04/2021.

Sierra Front Interagency Dispatch Center Site – FCA Site #9900
Description: Crack Fill & Slurry Seal Needed.

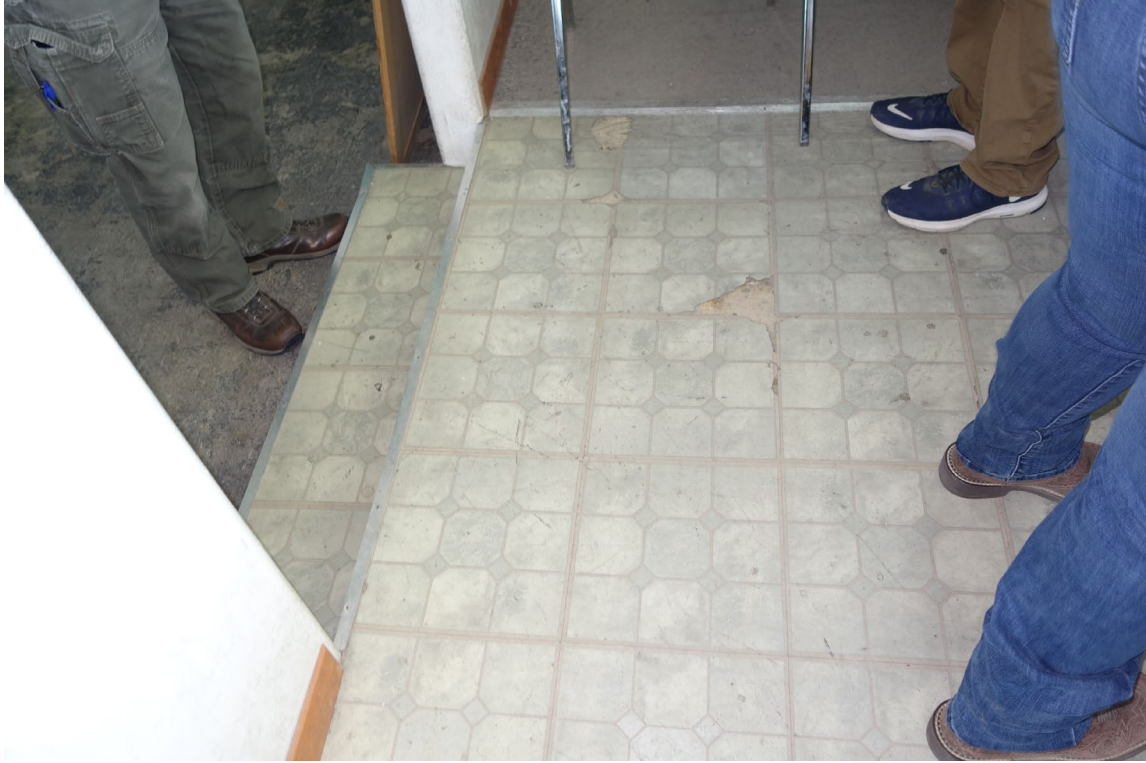
The vinyl flooring and carpet in the building are damaged and reaching the end of their useful life. It is recommended that the flooring be replaced. This project would provide for removal and disposal of the existing flooring and installation of new 12x12 VCT with a 6" base and heavy duty commercial grade carpet in the next 2 - 3 years.

Sierra Front Interagency Hangar – FCA Building #2491
Description: Flooring Replacement Needed.

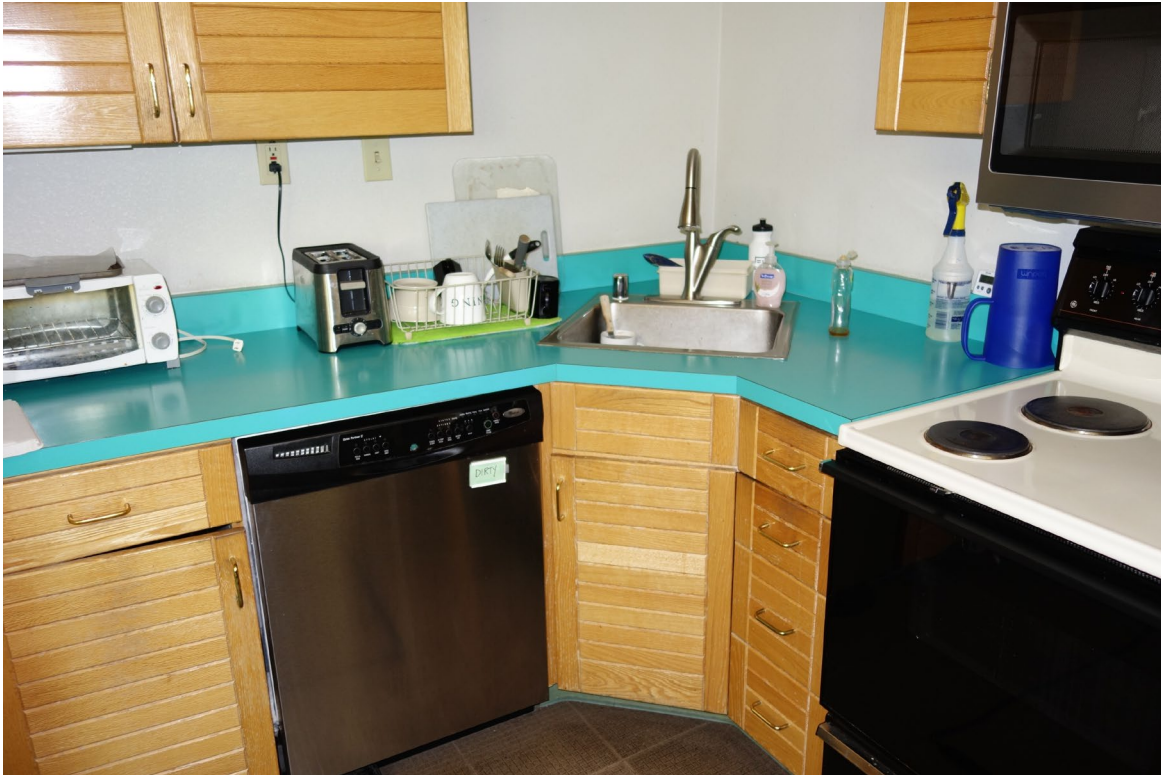
The employee lounge does not meet the Americans with Disabilities Act (ADA) requirements. It is recommended to upgrade some of the features of the room for compliance with accessibility standards for employees (Title I). This project would provide funding for construction of an accessible sink and faucet, an accessible space at one of the dining tables and an accessible path of travel throughout the room. The 2018 IBC, ICC/ANSI A117.1, NRS 338.180 and the most current version of the ADA Standards For Accessible Design were used as a reference for this project.

Sierra Front Interagency Dispatch Center – FCA Building #2490
Description: Non-Accessible Break Room Remodel Needed.

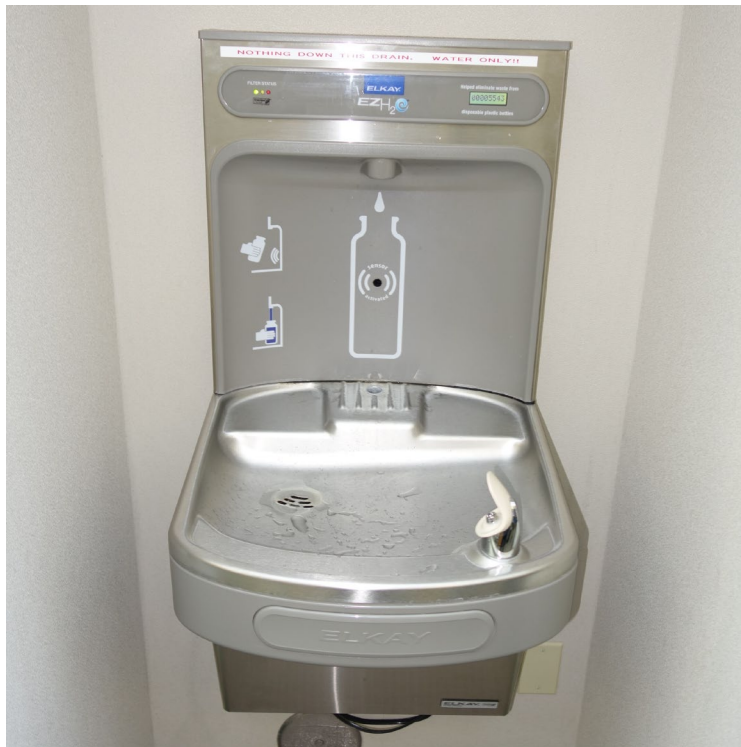
Sierra Front Interagency Dispatch Center – FCA Building #2490
Description: Dual Level Drinking Fountain Needed.

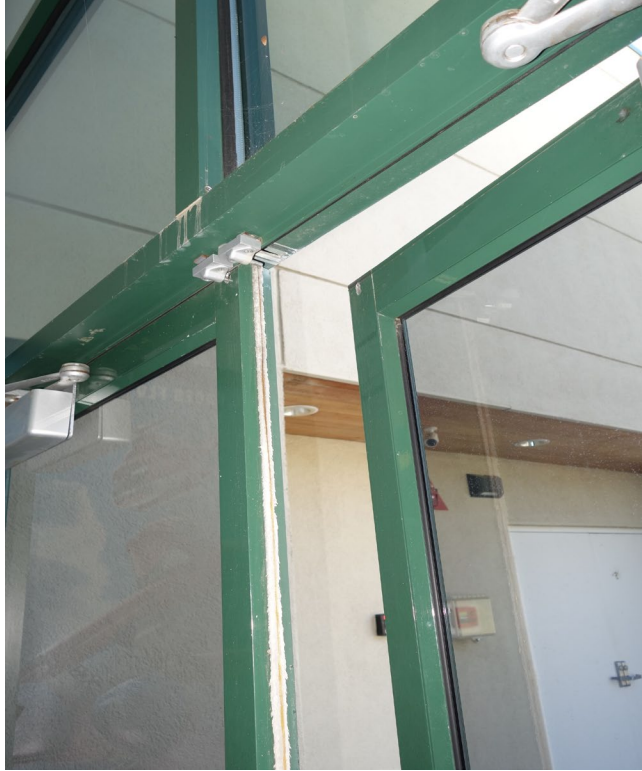
There are three sets of exterior aluminum entrance storefront systems that appear to be original to the building. They are damaged from age and general wear and tear and are a constant maintenance problem. This project would provide for the replacement and installation of three new exterior aluminum entrance storefront systems including hardware. Removal and disposal of the existing storefronts is included in this estimate.

Sierra Front Interagency Dispatch Center – FCA Building #2490
Description: Storefront Door System Replacement Needed.

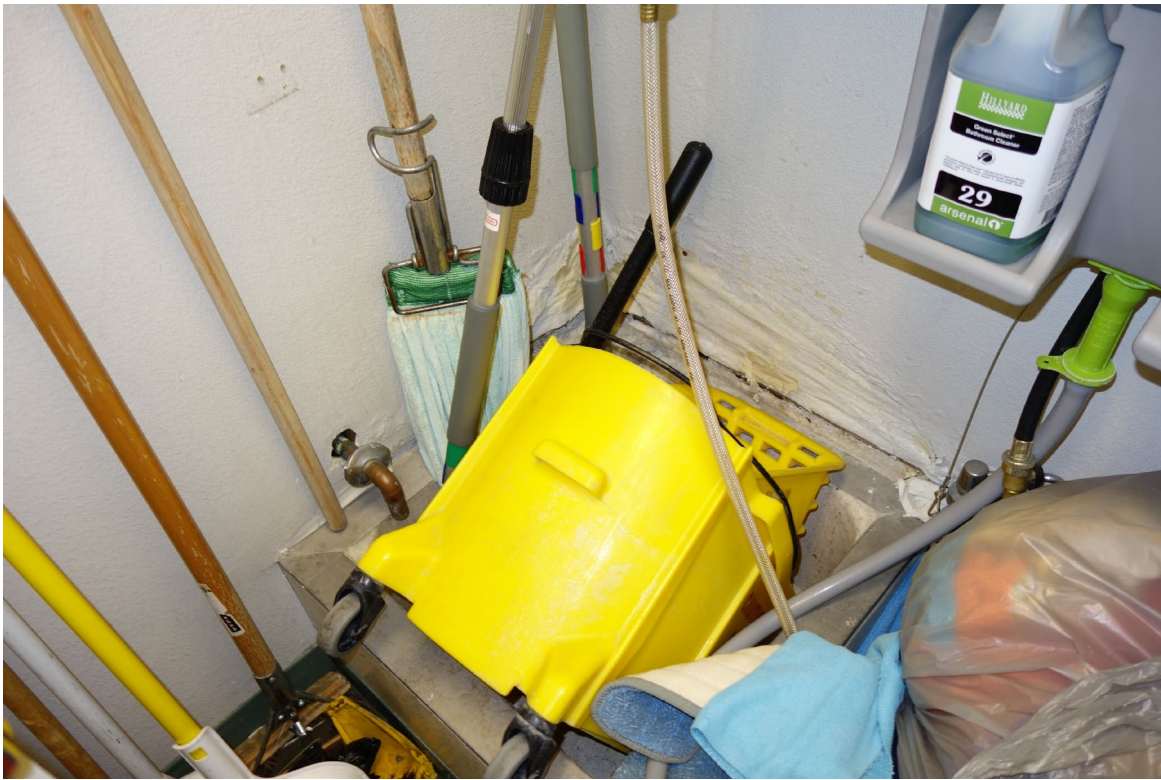
The mop sink in the Janitors Closet is mounted adjacent to gypsum board and is showing signs of water damage. This project would provide fiberglass reinforced panels (FRP) to be installed on the walls adjacent to the mop sink. The FRP shall extend two feet beyond the edge of the sink and a minimum of 54" above the floor finish.

Sierra Front Interagency Dispatch Center – FCA Building #2490
Description: Janitors Closet Wall Repairs Needed.

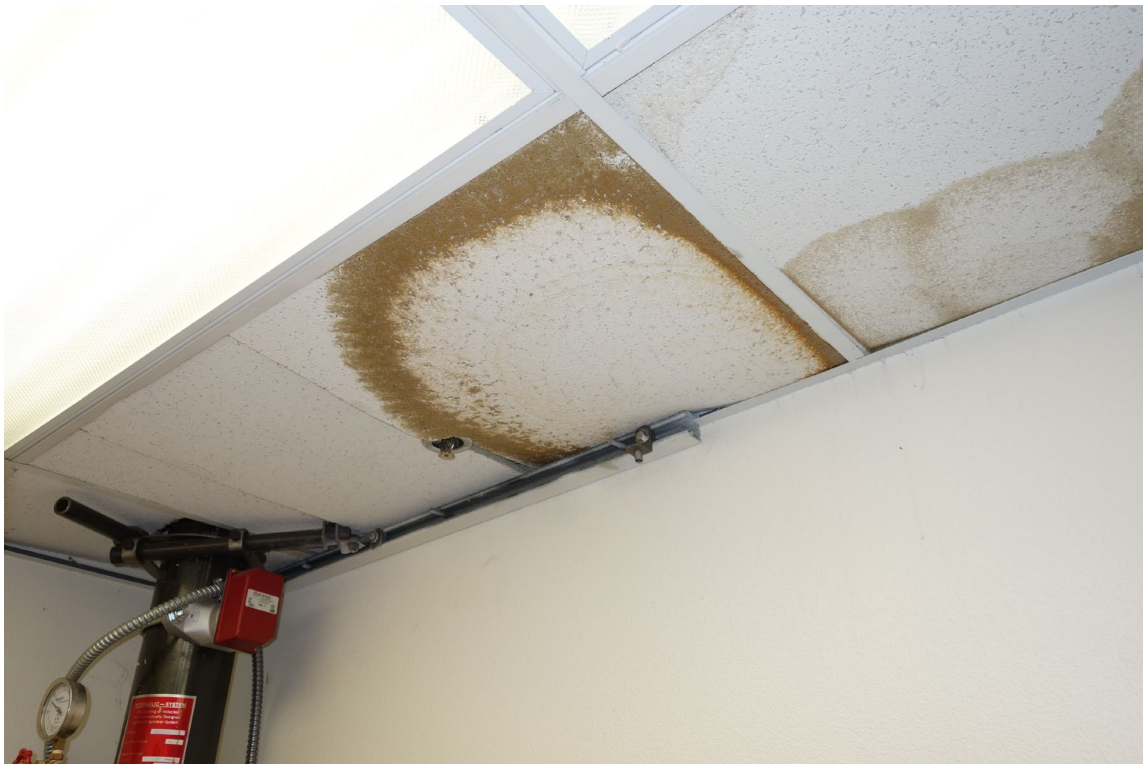
An intermittent water leak that is evident in the ceiling tiles of the fire riser and adjoining room had not been located at the time of the survey. Moisture in walls potentially could cause mold and dry rot. The source of the leak needs to be found and resolved.

NDOW Aircraft Hangar – FCA Building #0661
Description: Leak Repairs Needed.
