BOWERS NDF FIRE STATION (VACANT)

3905 Old Highway 395 North
Washoe Valley, Nevada

Site Number: 9903
STATE OF NEVADA PUBLIC WORKS DIVISION
FACILITY CONDITION ANALYSIS

Report distributed in November 2022

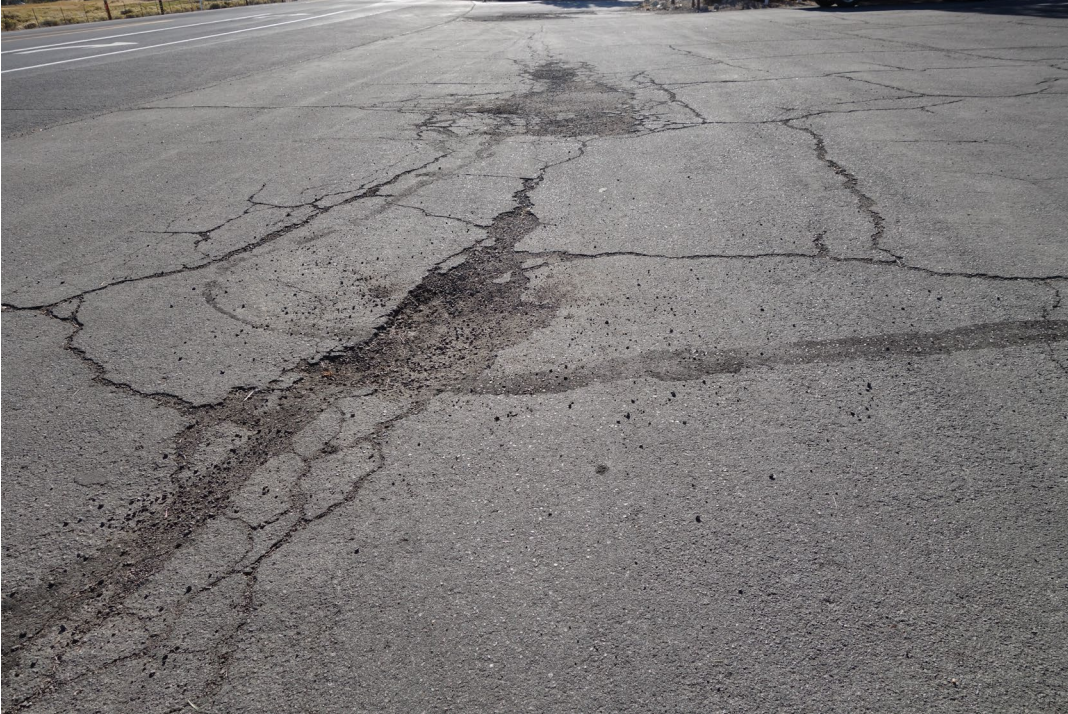
Bowers NDF Fire Station Site (Vacant) - FCA Site #9903
Description: Failing Pavement – Crack, Patch and Slurry Seal Needed.

It is important to maintain the asphalt concrete paving on the site. This project would provide for minor replacement of deteriorated paving, minor crack filling and slurry sealing of the paving site wide. Striping is included in this estimate. This project should be scheduled on a 5 year cyclical basis to maintain the integrity of the paving and prevent premature failure. 13,000 square feet of asphalt area was used to generate this estimate.

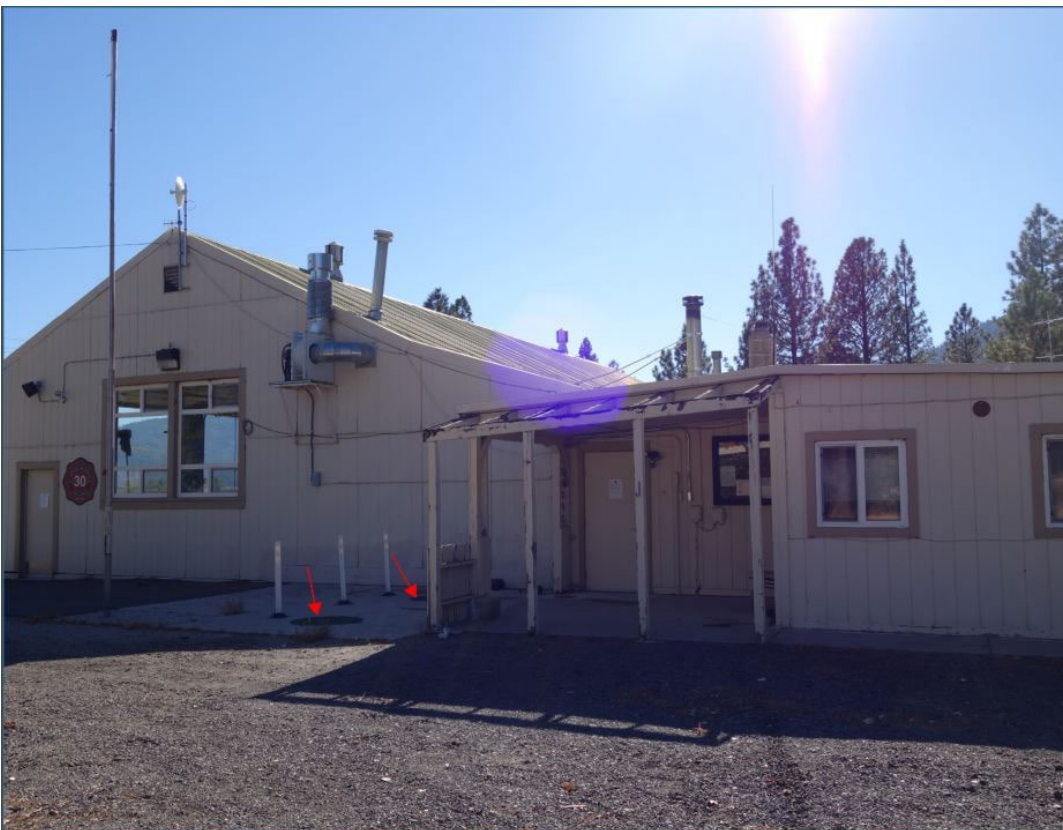
Bowers NDF Fire Station Site (Vacant) - FCA Site #9903
Description: 1st Septic Tank Maintenance Located NE of Apparatus Bay/Annex (#2479).

There are two buildings each with a septic tank and associated leach fields. They are in need of pumping to maintain the integrity of the leach lines and fields. This project would provide for the pumping of the two tanks. It is recommended that this project be scheduled on a cyclical basis based on usage.

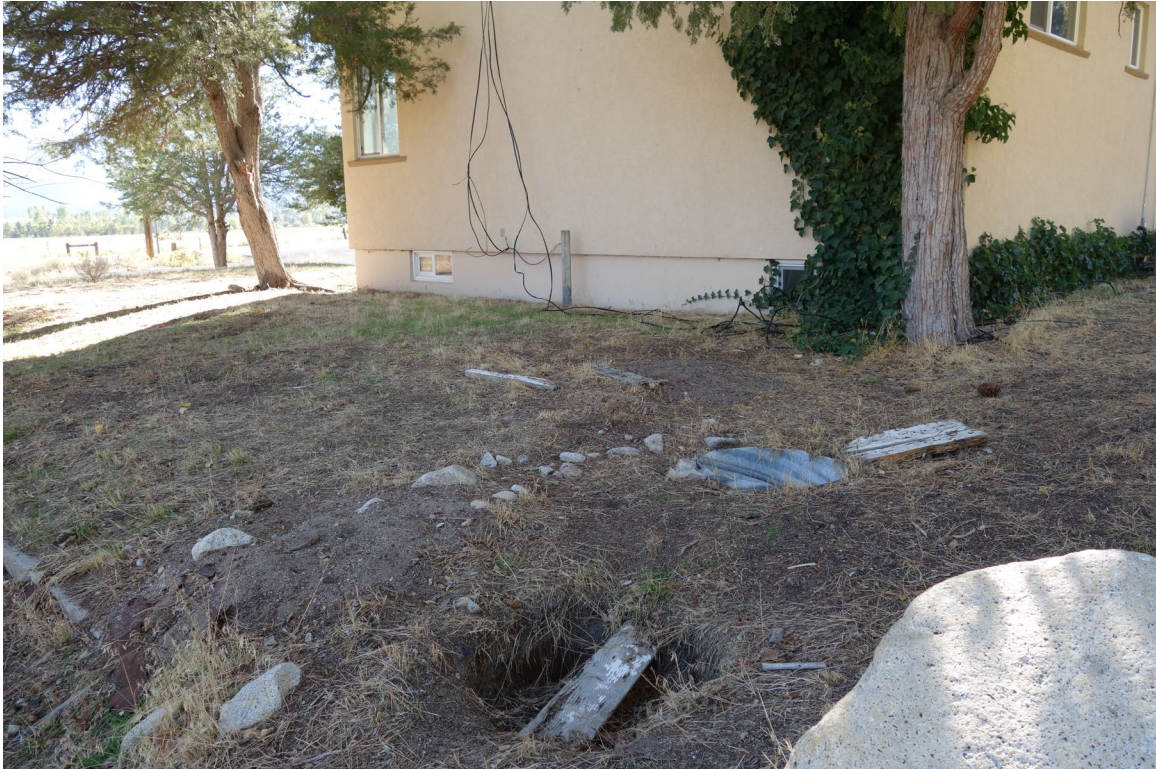
Bowers NDF Fire Station Site (Vacant) - FCA Site #9903
Description: 2nd Septic Tank Maintenance Located NE of Residence (#2480).

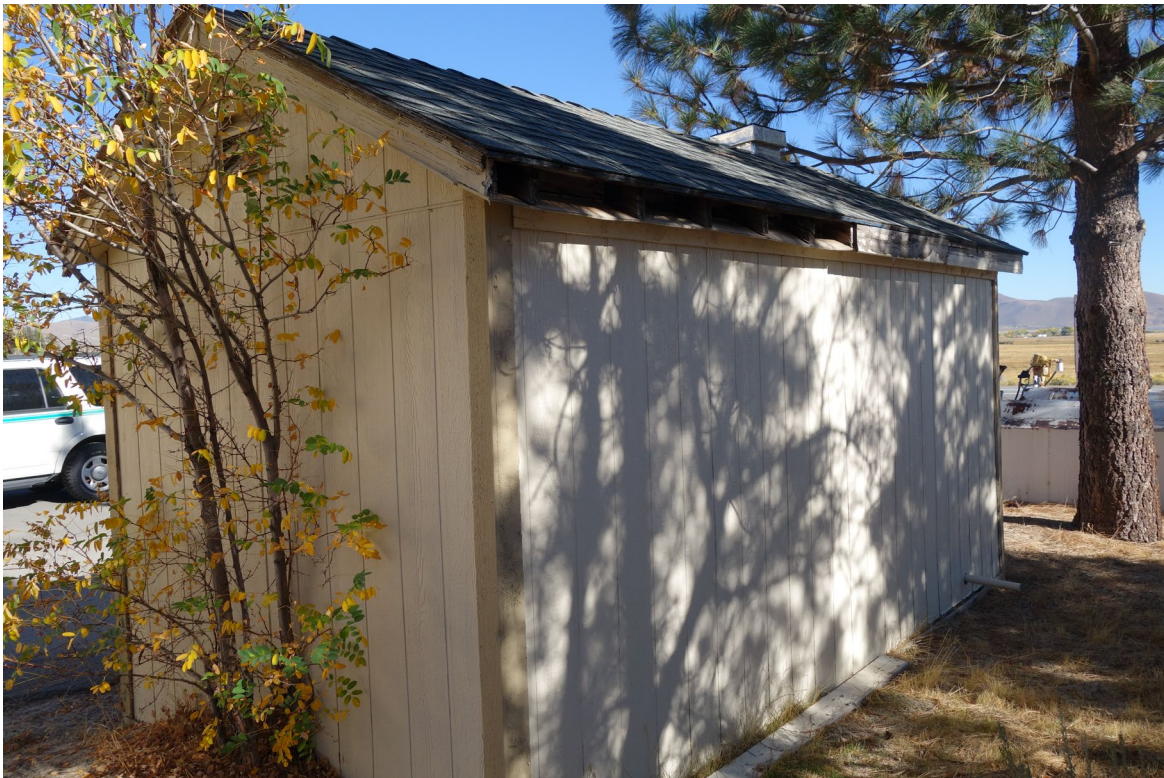
There is a shrub that is in need of removal to prevent damage to the structure. This project would provide for the removal of the shrub next to the Pump House building on the northwest side.

Domestic Well Pump House (Vacant) - FCA Building #2482
Description: Shrub Removal Needed.

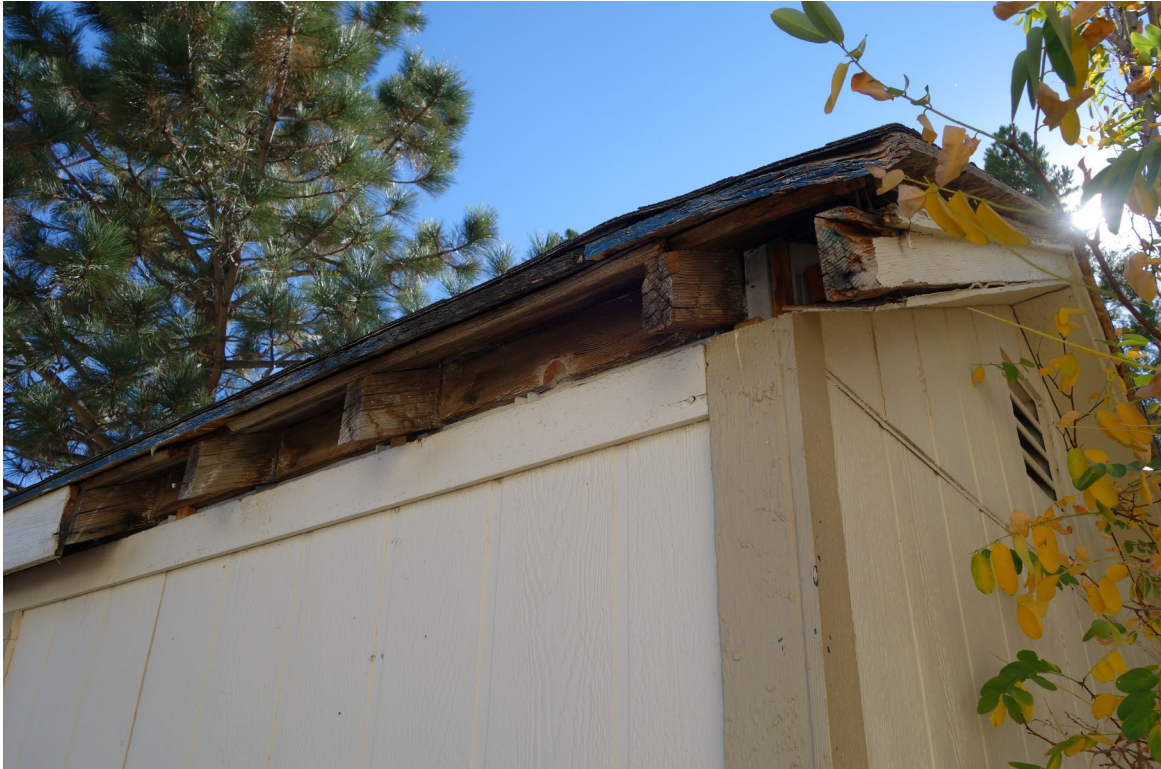
Roof members and sheathing are damaged and affect the integrity of the building. This project will replace the compromised rafters as well as fascia and sheathing as required.

Domestic Well Pump House (Vacant) - FCA Building #2482
Description: Structural Repairs Needed.

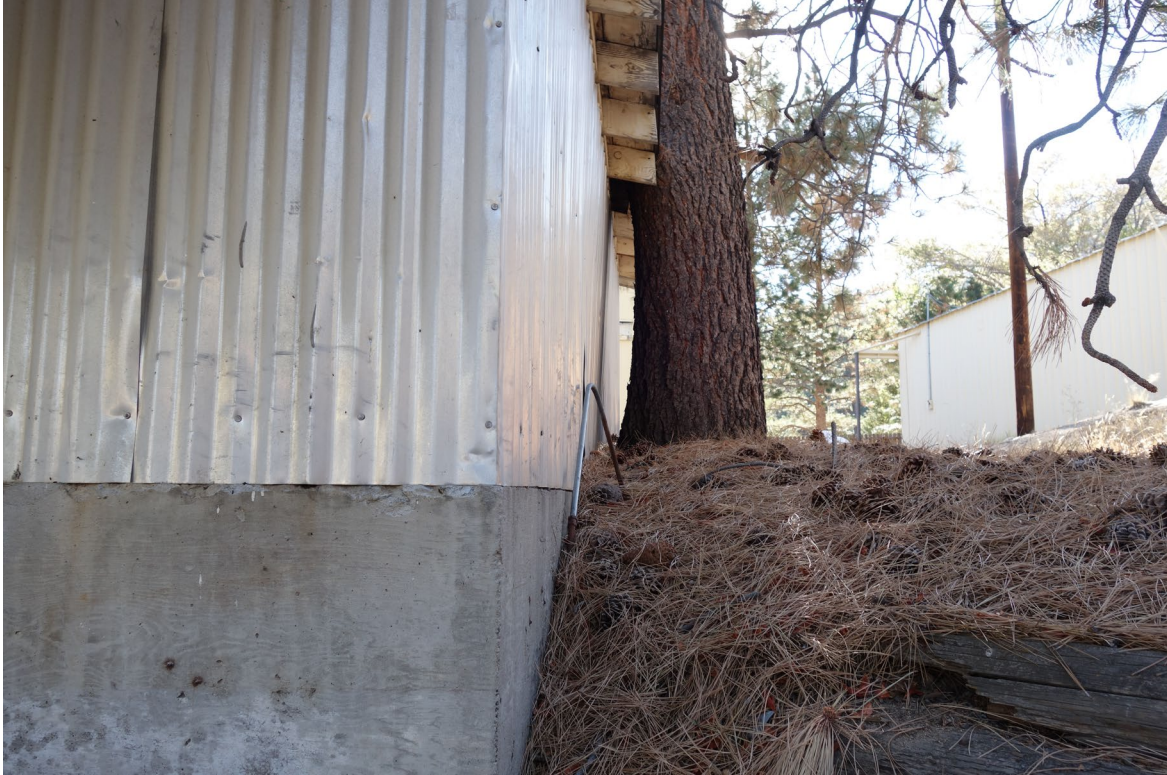
The raised stem wall at the rear of the building is visually bowing into the space. It appears that the tree growing on the exterior of the affected stem wall is the direct cause of the stem wall deflection. This project would fund a structural analysis of the affected stem wall and the necessary required corrective actions. The cost of stem wall repairs is not included in this estimate.

There is a tree in need of removal that has damaged the stem wall foundation of the building. This project would provide for removal of the tree behind the building, including the soil behind the stem wall, to determine the extent of stem wall damage.

Storage Shed (Vacant) - FCA Building #2481
Description: Tree Removal and Structural Assessment of Stem Wall Needed.

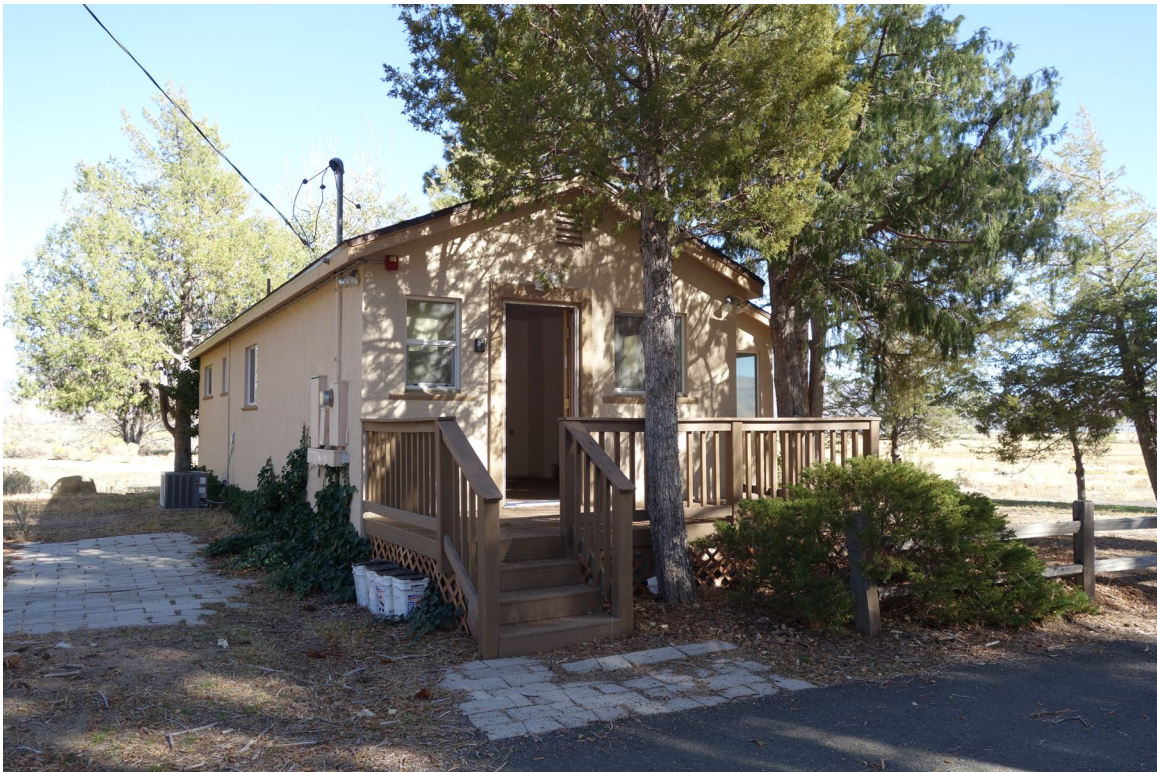
Bowers Fire Station Residence (Vacant) - FCA Building #2480
Description: Building Exterior and ADA Ramp Needed.

This project would provide for a concrete van accessible ADA parking and loading space and concrete walkway to both the Fire Station (#2479) and Residence (#2480). This will require regrading, placement of concrete, signage, striping and any other necessary upgrades. The 2018 IBC, ICC/ANSI A117.1, NRS 338.180 and the most current version of the ADA Standards for Accessible Design were used as a reference for this project. 1,300 square feet of concrete was used for this estimate.

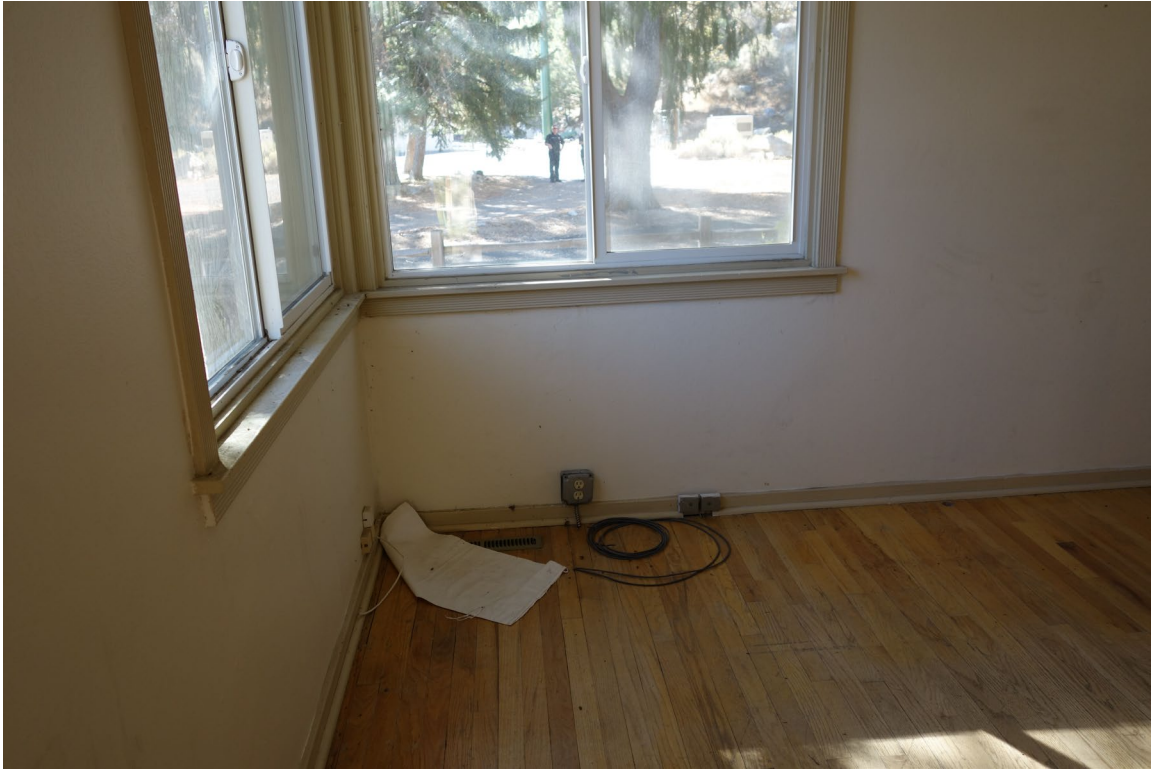
The wood flooring throughout the building is in poor condition showing signs of wear and should be scheduled to be refinished in the next 2 - 3 years. This project would provide for sanding, floor prep and application of a new floor finish

Bowers Fire Station Residence (Vacant) - FCA Building #2480
Description: Flooring Refinish Needed.

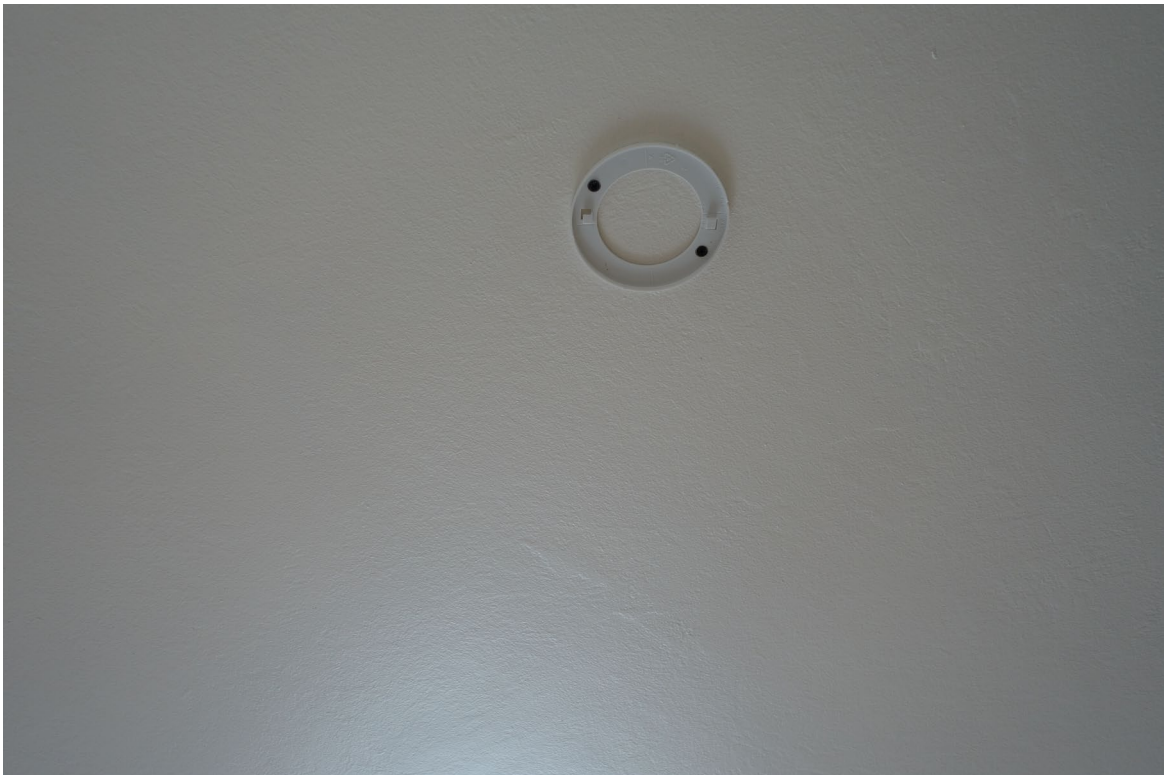
Section 907.2.9 of the 2018 IBC and 2018 IFC explain the requirements for smoke alarms in dwelling units including installing and maintaining smoke alarms in each sleeping room and on the ceiling or wall outside of each separate sleeping area in the immediate vicinity of bedrooms. IFC 2018 Section 908.7 carbon monoxide alarms group I or R occupancies located in a building containing a fuel-burning appliance or in a building which has an attached garage shall be equipped with carbon monoxide alarms. The carbon monoxide alarm shall be listed as complying with UL 2034 and be installed and maintained in accordance with NFPA 720 and the manufacturer’s instructions. State Fire Marshal NAC 477.915 (3) requires that smoke detectors and carbon monoxide alarms be connected to the wiring of the building with a battery backup. This project would provide funding for the purchase and installation of a smoke alarm and combo smoke alarm and carbon monoxide alarm in accordance with these codes.

Bowers Fire Station Residence (Vacant) - FCA Building #2480
Description: Wired Smoke and Carbon Monoxide Detectors Needed.

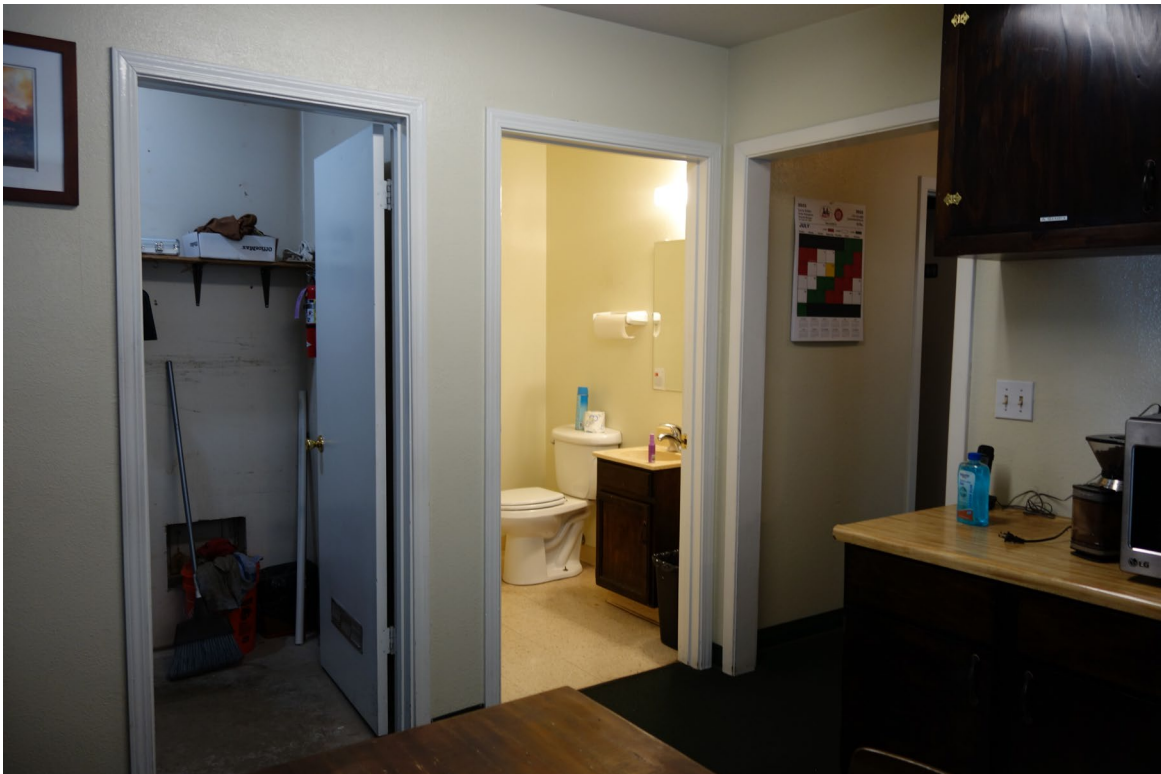
Bowers Fire Station Apparatus Bay/Annex (Vacant) - FCA Building #2479
Description: Accessible Unisex Restroom Needed.

This project addresses interior required ADA accessibility items. This project would provide for the remodeling of a restroom into a unisex ADA compliant facility including a sink, toilet, grab bars, mirror, plumbing jacket and signage as indicated in the 2018 IBC Chapter 11, Section 1109.2. Minor plumbing modifications and room reconfiguration may be required and this cost estimate includes funds for minor modifications including removing the bathtub to provide more space, new vinyl composition flooring, and a new 3'-0" wide door with lever action door handles to replace the existing +/- 28" door.

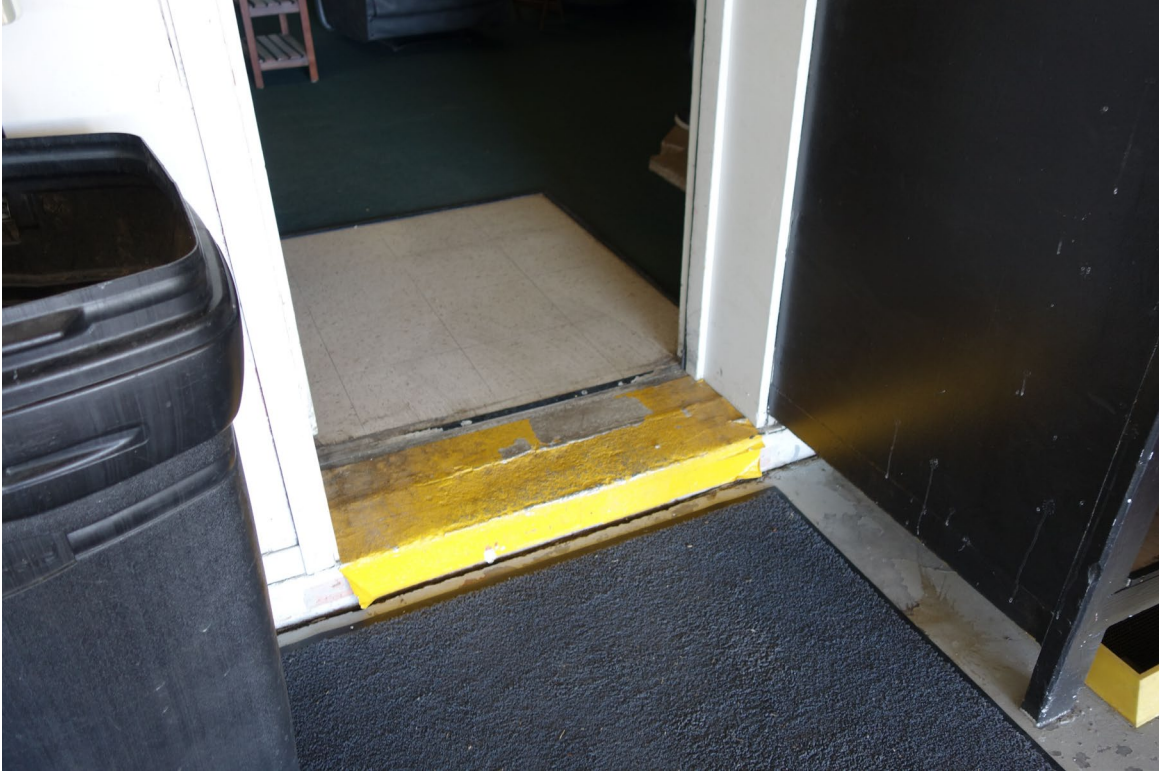
Bowers Fire Station Apparatus Bay/Annex (Vacant) - FCA Building #2479
Description: Interior Ramps/Accessibility Needed.

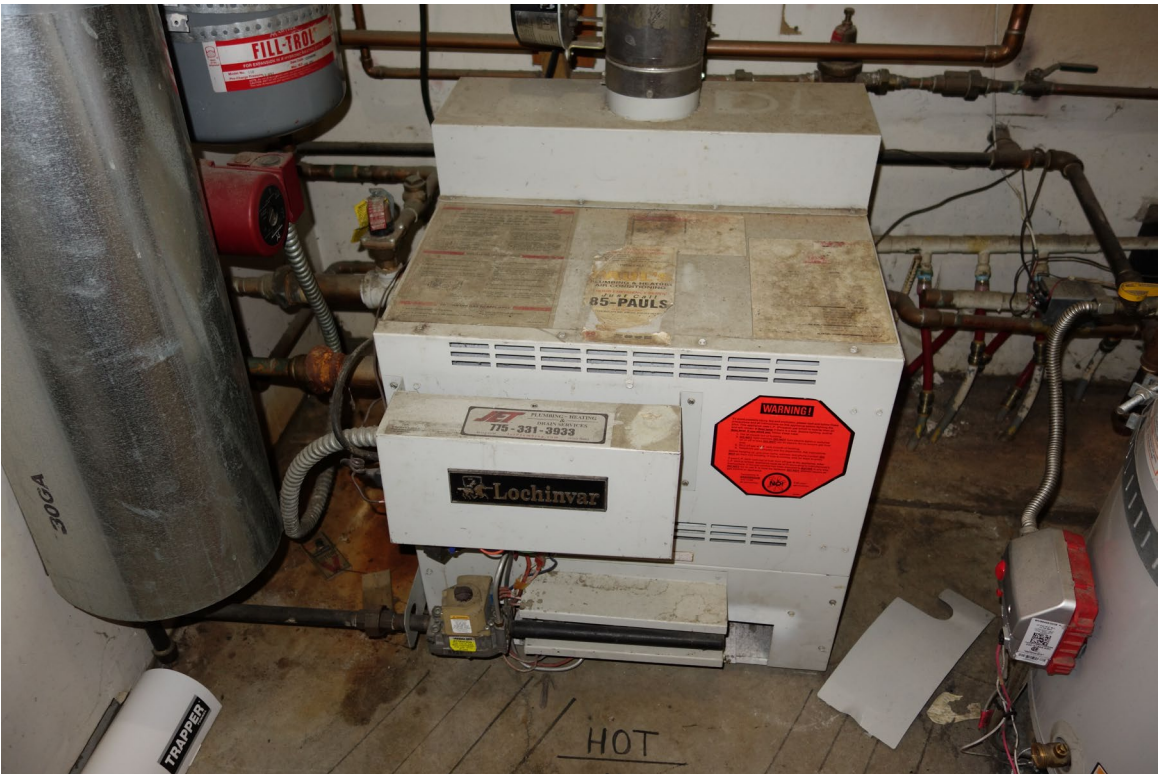
The hot water boiler servicing the building was installed in 1998 and should be scheduled for replacement. The life expectancy of this unit is 20 to 25 years with proper maintenance and water treatment programs. Replacement parts for performing routine and emergency maintenance are hard to find for this older equipment. The controls and mixing valves should be replaced for the same reasons. This project would provide for the removal and disposal of the existing boiler, controls and mixing valves and replacement with new equipment including all required connections to utilities and equipment. The estimate is based on a 1.2 MBH maximum output hot water boiler and associated equipment.

Bowers Fire Station Apparatus Bay/Annex (Vacant) - FCA Building #2479
Description: Boiler Replacement Planning Recommended.

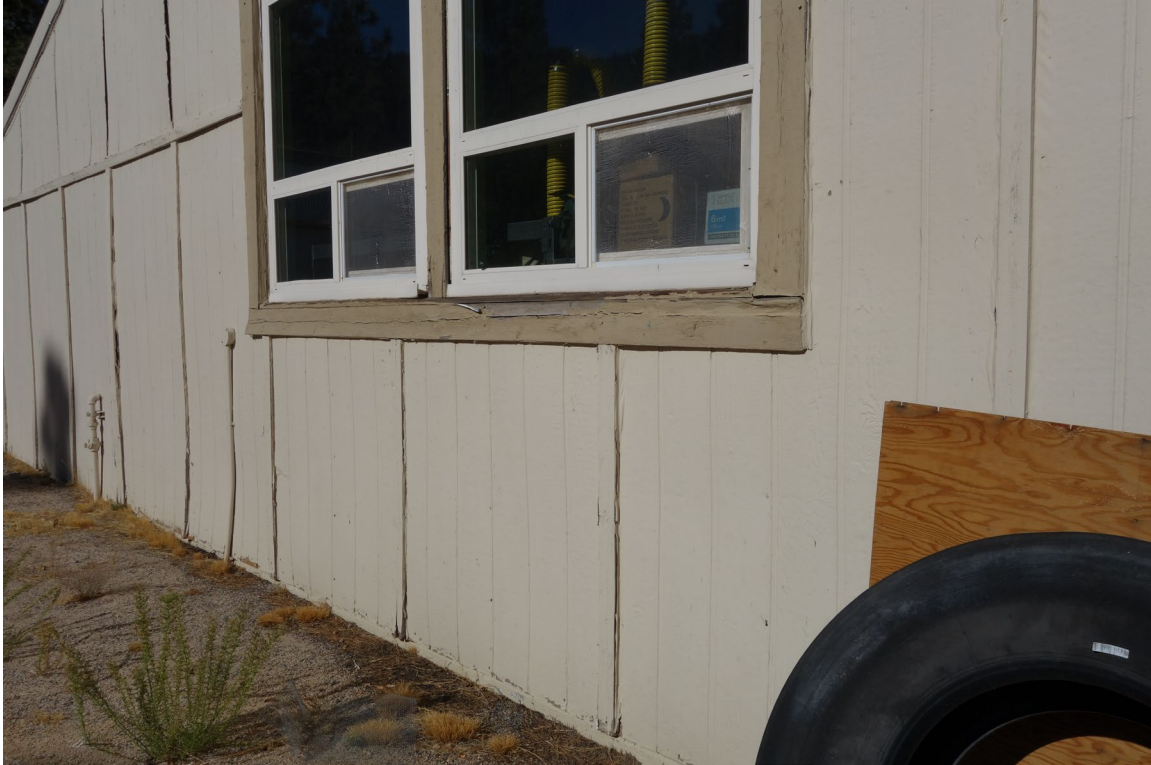
The building has a painted masonite siding that is due for replacement. The existing siding is in very poor condition and will no longer hold paint. This project recommends removing the masonite siding and replacing it with T1-11 panels finished with a durable coat of paint. The cost of any structural and or rot repairs discovered upon removal of the siding are not included in this estimate.

The building has grade soils in near contact with the exterior wood siding. Code (IBC 2018 Section 2304.12) requires a minimum of 6" clearance between wood siding and earth to prevent decay and termite infestations. This project provides for the removal of excess soils, regrading to ensure the proper slope away from the building and to provide the required soil clearances.

Bowers Fire Station Apparatus Bay/Annex (Vacant) - FCA Building #2479
Description: Siding Replacement and Clearance to Grade Needed.

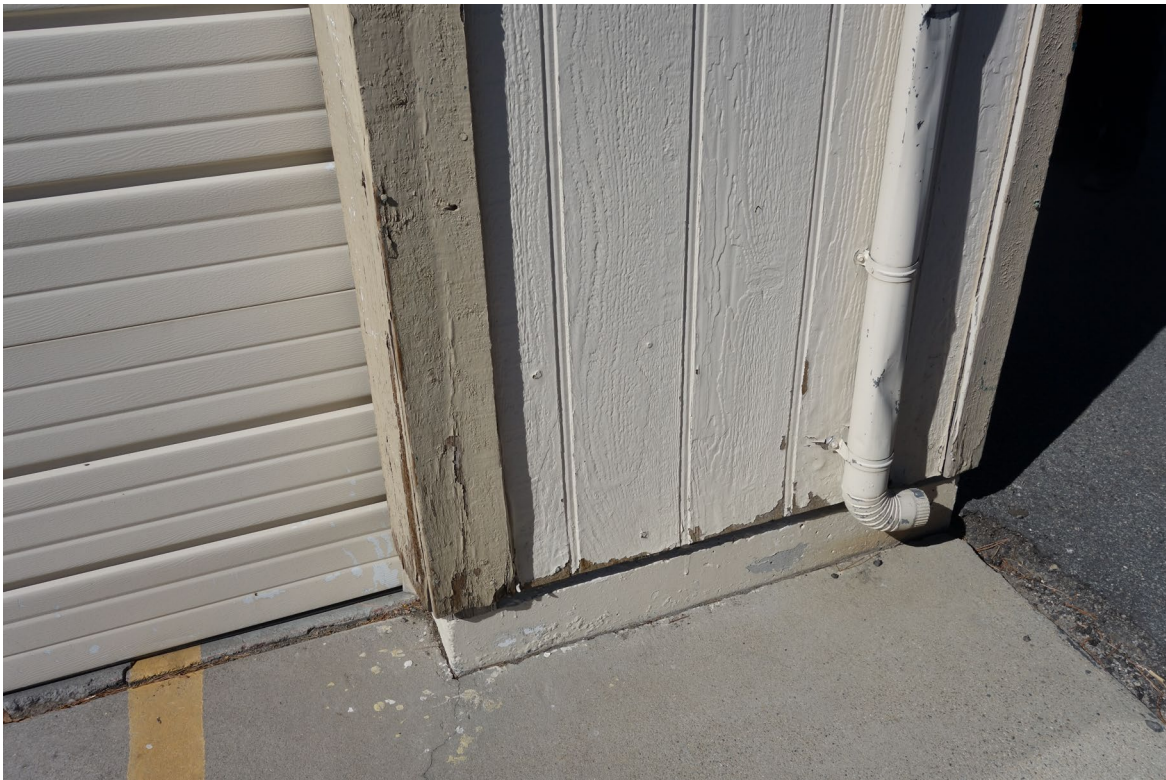
The roof drain downspouts are damaged and in need of replacement. This project would provide for the replacement of roof drains with extensions approximately 5'-0" away from the perimeter of the building to prevent pooling and damage to the building.

Bowers Fire Station Apparatus Bay/Annex (Vacant) - FCA Building #2479
Description: Roof Drain Downspout Replacement Needed.
