# MASON VALLEY WILDLIFE MANAGEMENT AREA

**Site Number: 9904**  
**STATE OF NEVADA PUBLIC WORKS DIVISION**  
**FACILITY CONDITION ANALYSIS**

Report distributed in November 2021

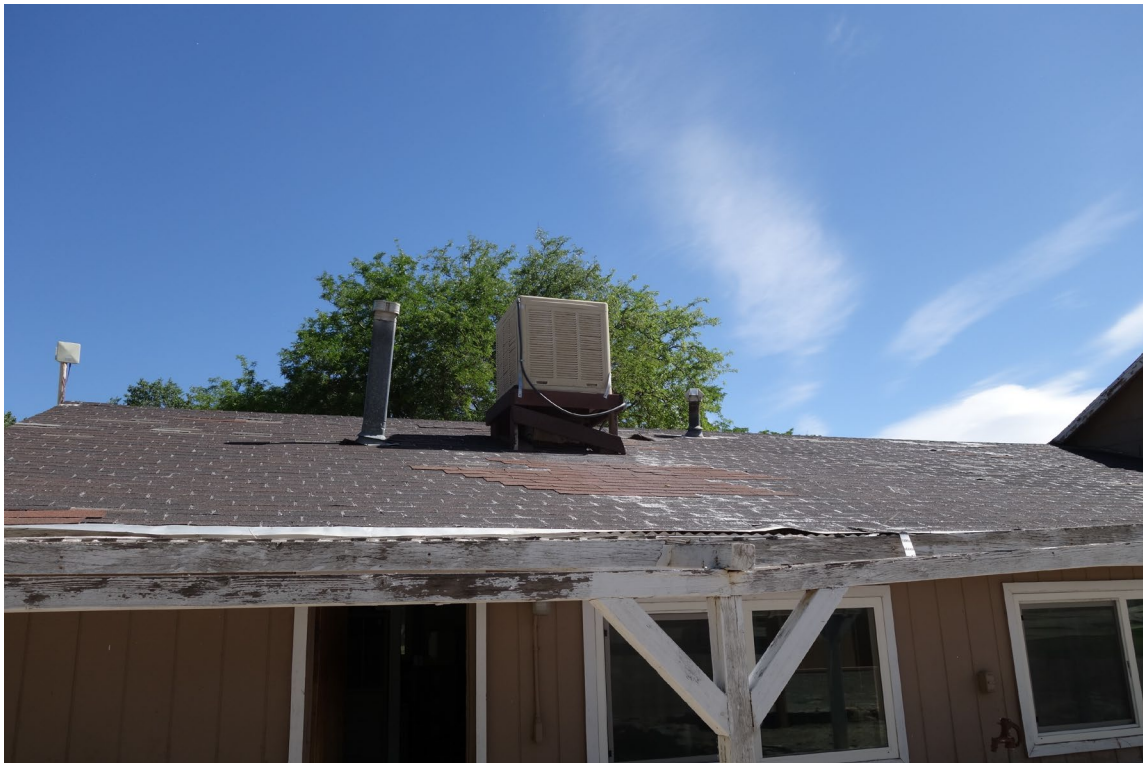
Mason Valley WMA Office / Headquarters - Building #0650  
Description: Exterior of the Building & Roof Replacement Needed.

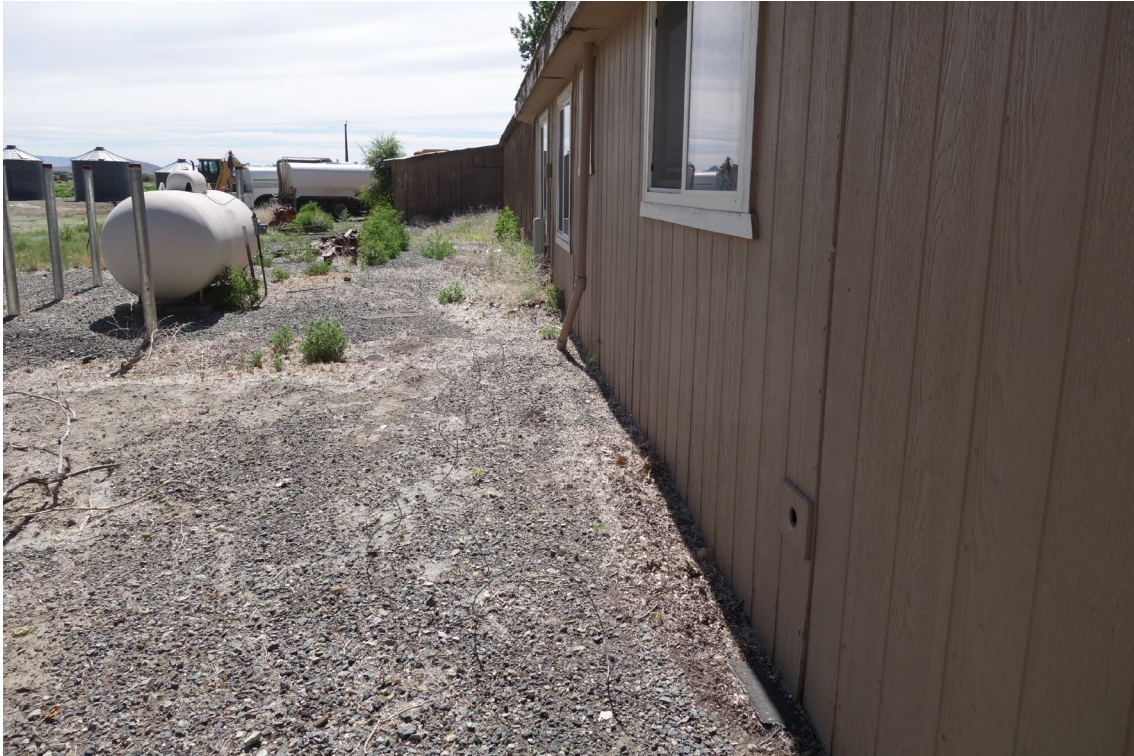
Mason Valley WMA Office / Headquarters - Building #0650  
Description: View of Wood Siding Clearance to Grade.

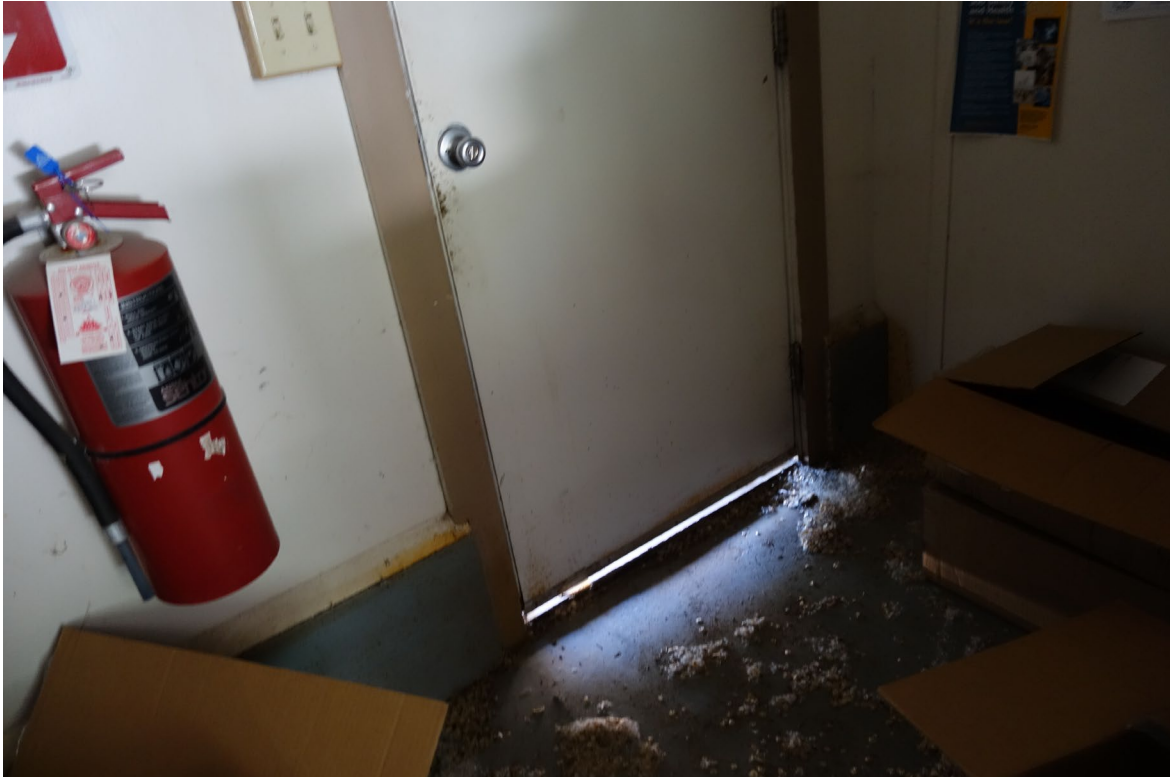
Mason Valley WMA Office / Headquarters - Building #0650  
Description: View of Exterior Door.

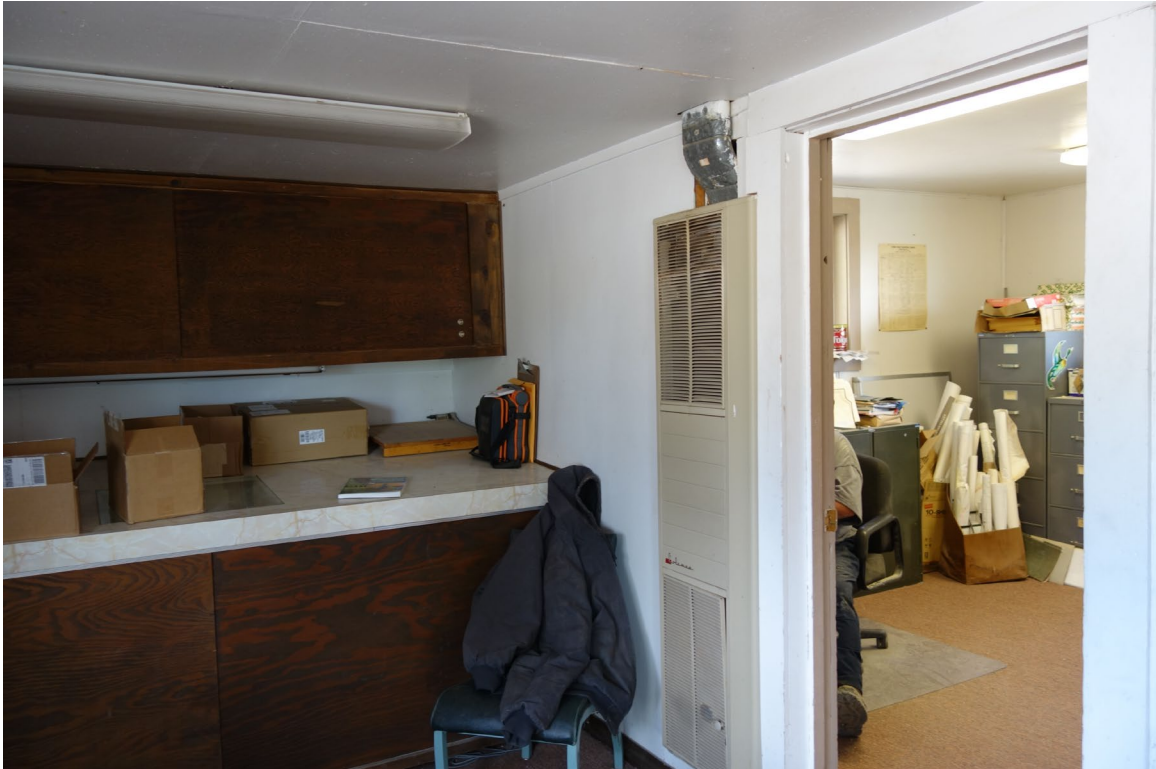
Mason Valley WMA Office / Headquarters - Building #0650  
Description: View of Heating System.

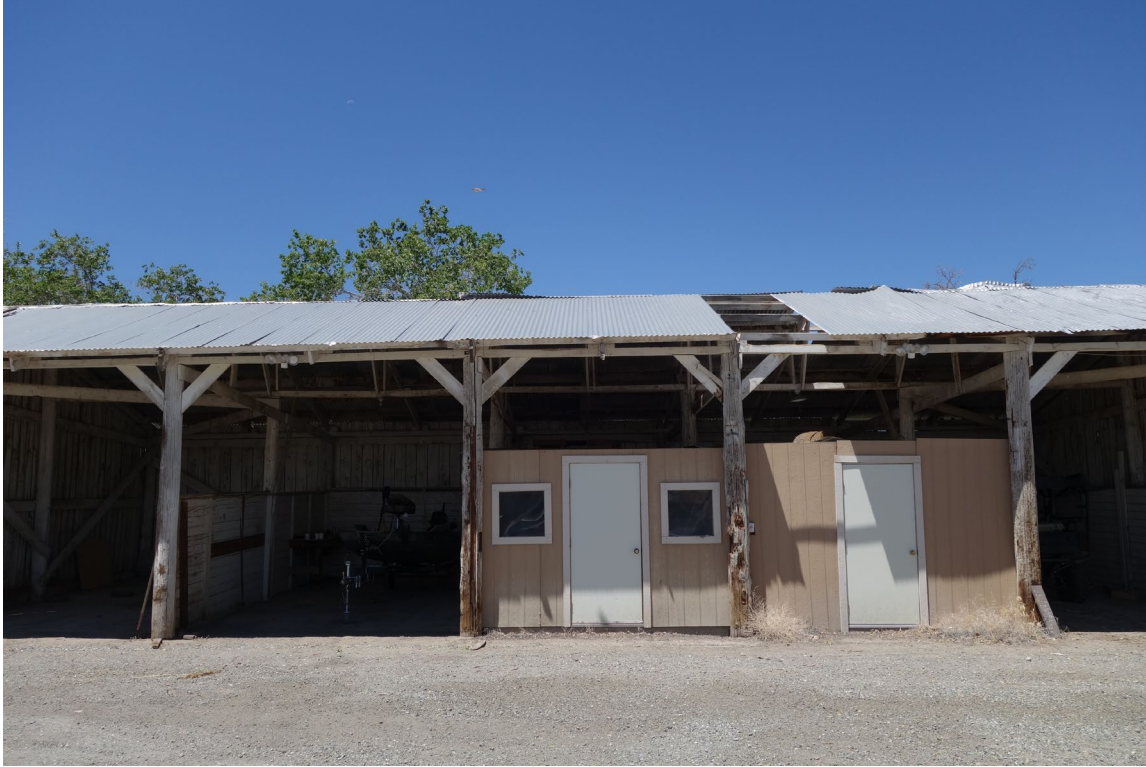
Mason Valley WMA Residence 4 Storage Shed- Building #2475  
Description: Exterior of the Building.

The Storage Shed is a wood framed 3-sided pole building with dirt floor. There are two bays that are enclosed within the shed. It is used for storage and is in poor shape. It is in poor condition with sections of the roof gone. Due to the magnitude of project repairs, demolition and construction of a new facility should be considered.

The metal roof on this building was in poor condition at the time of the survey and had active leaks. It is recommended that this building be re-roofed in the next 2 - 3 years with a standing seam metal roofing system. This estimate includes removal and disposal of the old roofing system.

The exterior finishes were in poor condition. It is important to maintain the finish, weather resistance and appearance of the building. This project would provide funding to protect the exterior and interior of the building. Included in the cost is power washing, priming and painting the exposed wood columns. It is recommended that the building be painted in the next 2 - 3 years and that this project be scheduled on a cyclical basis to maintain the integrity of the structure.

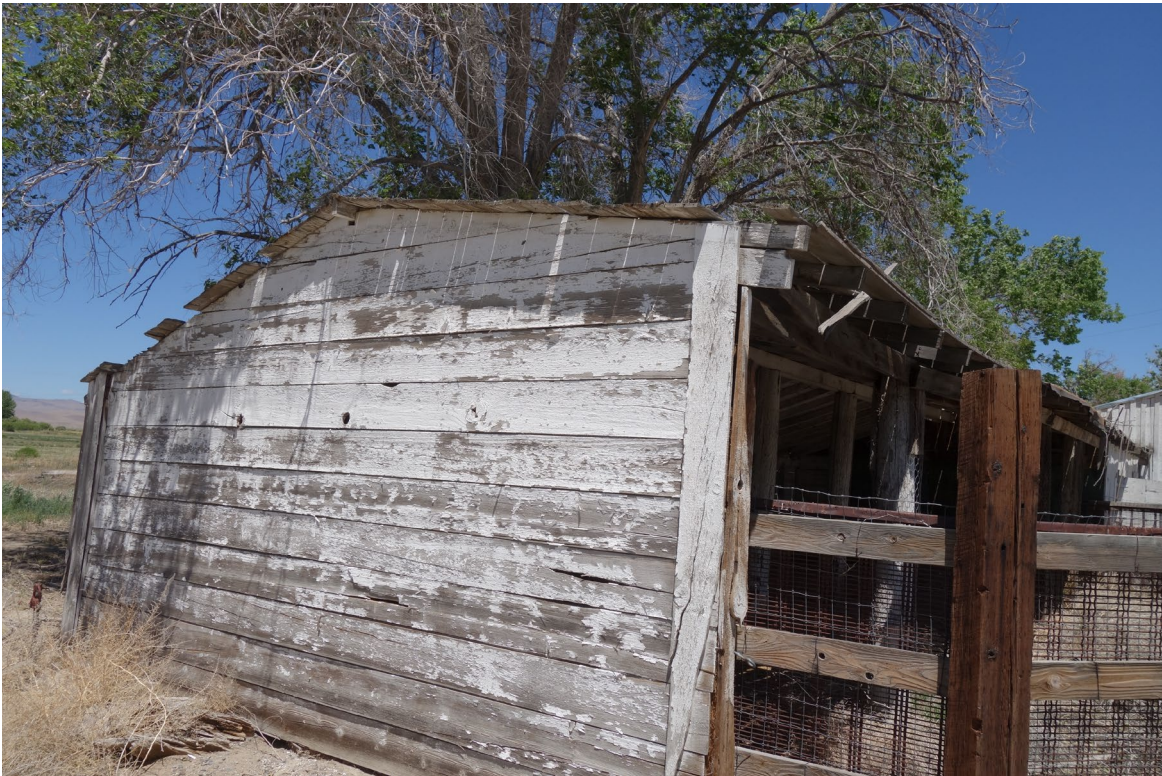
Mason Valley WMA Barn / Box Stalls - Building #2476  
Description: Exterior of the Building.

The Barn/ Box Stalls building is dilapidated and deteriorating and has reached the end of its useful life. This project would provide funding for the demolition of the building.

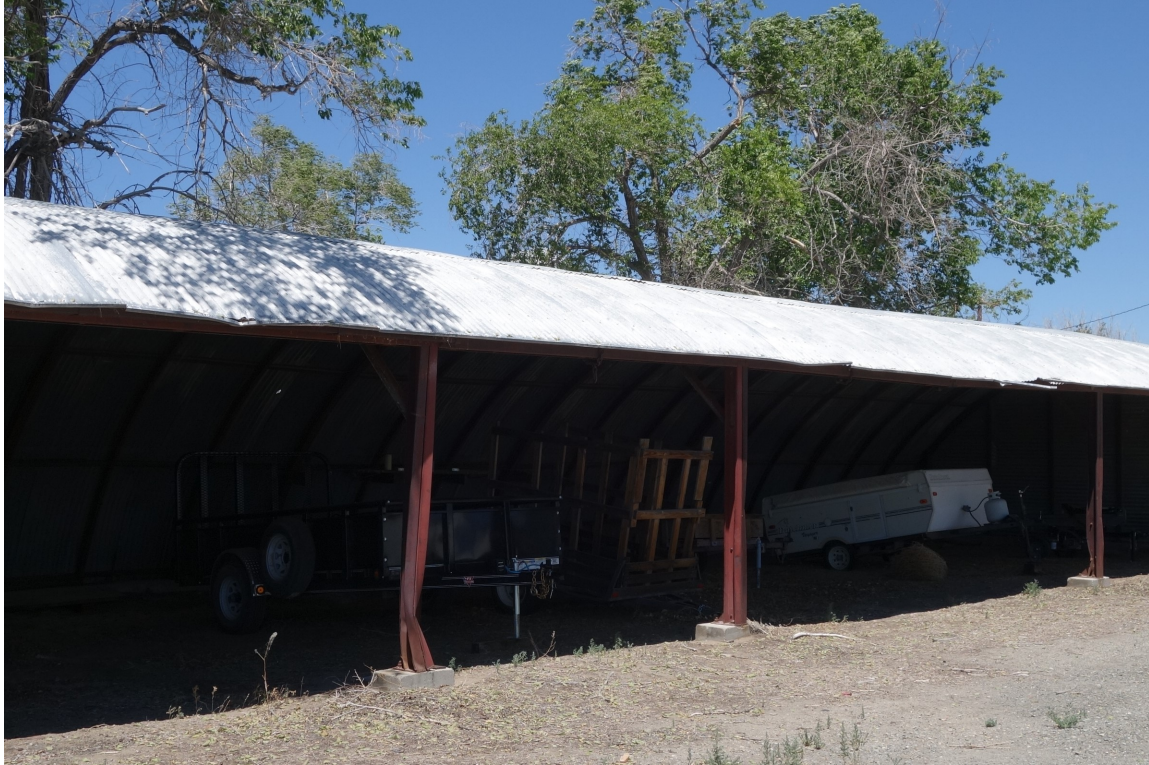
Mason Valley WMA Quonset Hut - Building #2477  
Description: Exterior of the Building.

The Quonset hut is a 3-sided storage building with dirt floor. The building is currently used to store equipment used by the tenant farmer. It is in fair shape. Due to the magnitude of project repairs, demolition and construction of a new facility should be considered.

This building has two steel supporting columns that have been severely damaged by vehicular impact. This project recommends a structural repair or replacement of the columns depending on a structural review.

The roof panels and flashing are due for repairs. The flashing is bent and deteriorating. This project would provide funds for repairing the roof. The estimate includes replacing flashing and roof panels as needed.

The building has a tree which is growing up against the structure. The trees move in windy conditions, rubbing the roofs, which can cause premature failure of the roof system and voiding roof warranties. The root systems are causing shifting and heaving of foundations and sidewalks, creating unsafe conditions. This lack of maintenance could become a safety issue. This project recommends removal of the tree.

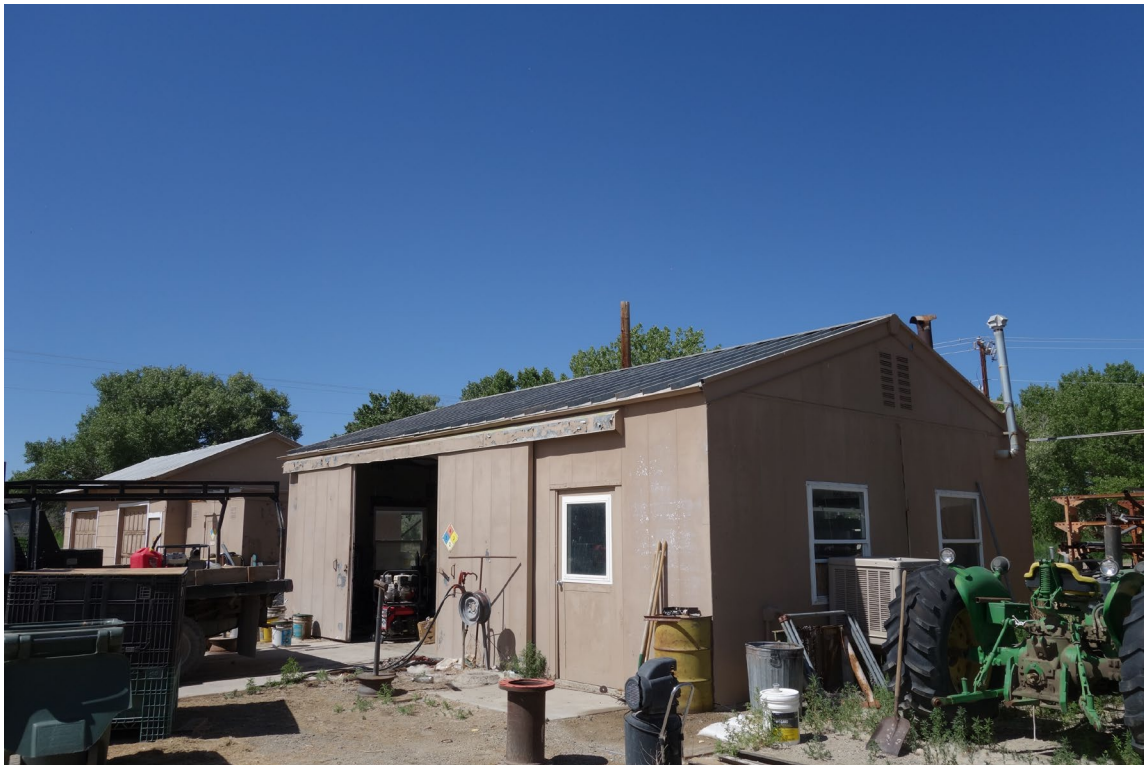
Mason Valley WMA Mechanics Shop - Building #2981  
Description: Exterior of the Building.

Additionally, the heater in the Mechanic's Shop is installed with a flexible gas line penetrating the heater metal cabinet. This is a Plumbing Code Violation. This project will install a solid pipe nipple to project beyond the heater case for connection.

The Mechanics Shop is an older steel framed structure with a metal roof on a concrete foundation. The interior is insulated with an R-Max board insulation. There is a ceiling mounted propane gas heating unit and an evaporative cooler mounted in the north wall. The building is primarily used by staff for storage and maintenance of the equipment and buildings on the site. The facility is in fair shape.

The existing exterior wood door is approaching the end of its expected life. It is damaged from age and general wear and tear. This project would provide for the replacement of the wood door with a new metal door, frame and hardware. Also, a 3'x3'x4" thick concrete landing is included in this project. Removal and disposal of the existing door and painting of the new door is included in this estimate.

The windows are original, single pane construction in a metal frame. These older windows are drafty and not energy efficient. This project recommends replacing the windows with dual pane, higher efficiency units. This estimate is for the replacement of 6 units. Removal and disposal of the existing windows is included in this estimate.

It is important to maintain the finish, weather resistance and appearance of the building. This project would provide funding to protect the exterior of the building. Included in the cost is the painting, sealing and caulking of the windows, flashing, fixtures and all other penetrations. It is recommended that the building be painted, caulked and sealed in the next 4 - 5 years and that this project be scheduled on a cyclical basis to maintain the integrity of the structure.

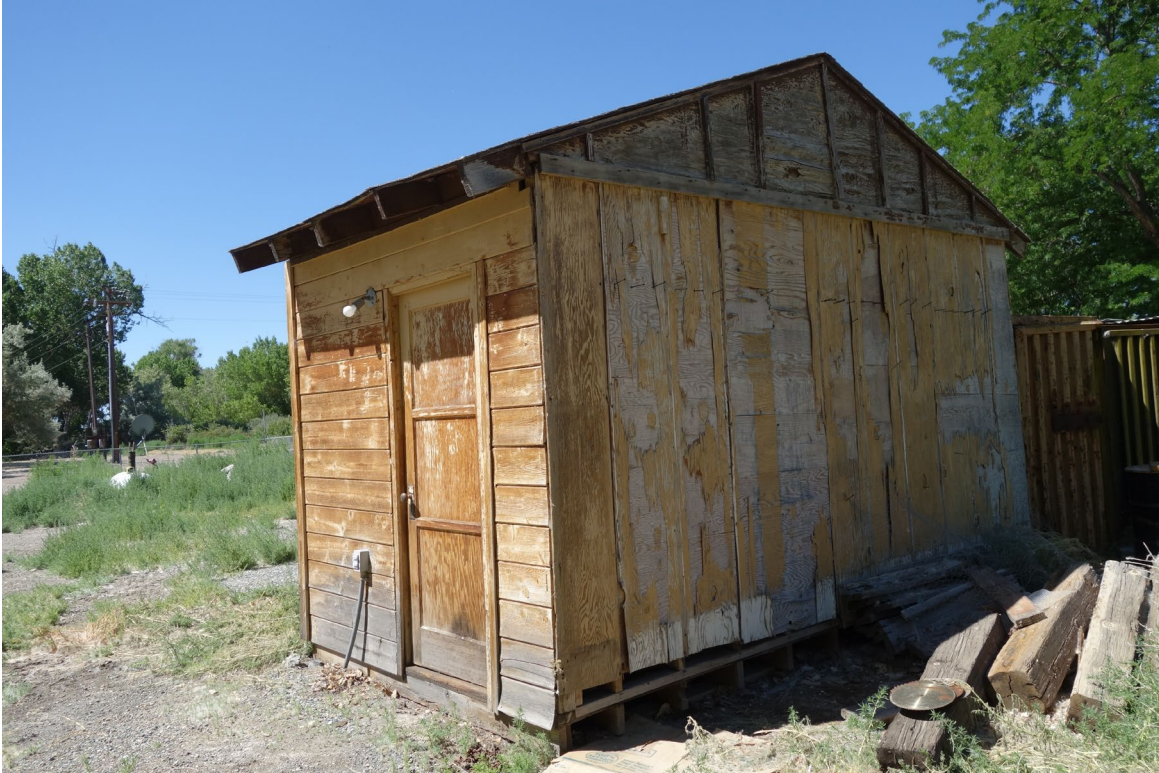
Mason Valley WMA Storage Building - Building #2982  
Description: Exterior of the Building.

The Storage Building is a wood framed structure with a composition roof. It is used as storage by staff and is in poor condition.

The Storage Building contains numerous code and safety issues including but not limited to damaged windows, broken or missing electrical fixtures, dry rot and possible structural damage due to the age of the building. The building is dilapidated and deteriorating and has reached the end of its useful life. This project would provide funding for the demolition of the building.

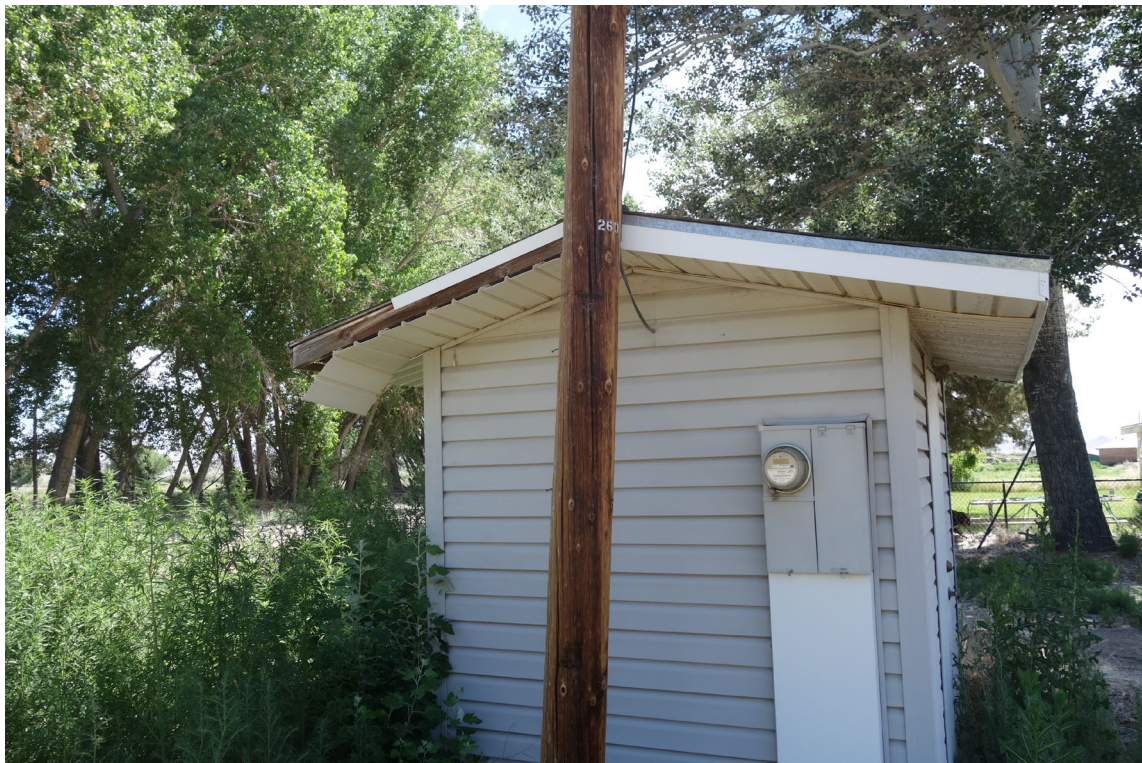
Mason Valley WMA Filter House 1 - Building #2983  
Description: Exterior of the Building.

The Filter House 1 is a wood framed structure with a composition roof on a concrete foundation. It has vinyl siding to match the residences on site. The building is in good shape.

It is important to maintain the finish, weather resistance and appearance of the building. This project would provide funding to protect the exterior of the building. Included in the cost is repairing and cleaning the vinyl siding and caulking of the flashing, fixtures and all other penetrations. It is recommended that the building be cleaned and caulked in the next 2 - 3 years and that this project be scheduled on a cyclical basis to maintain the integrity of the structure. This project also includes costs for installing a 3'x3' concrete landing at the door.

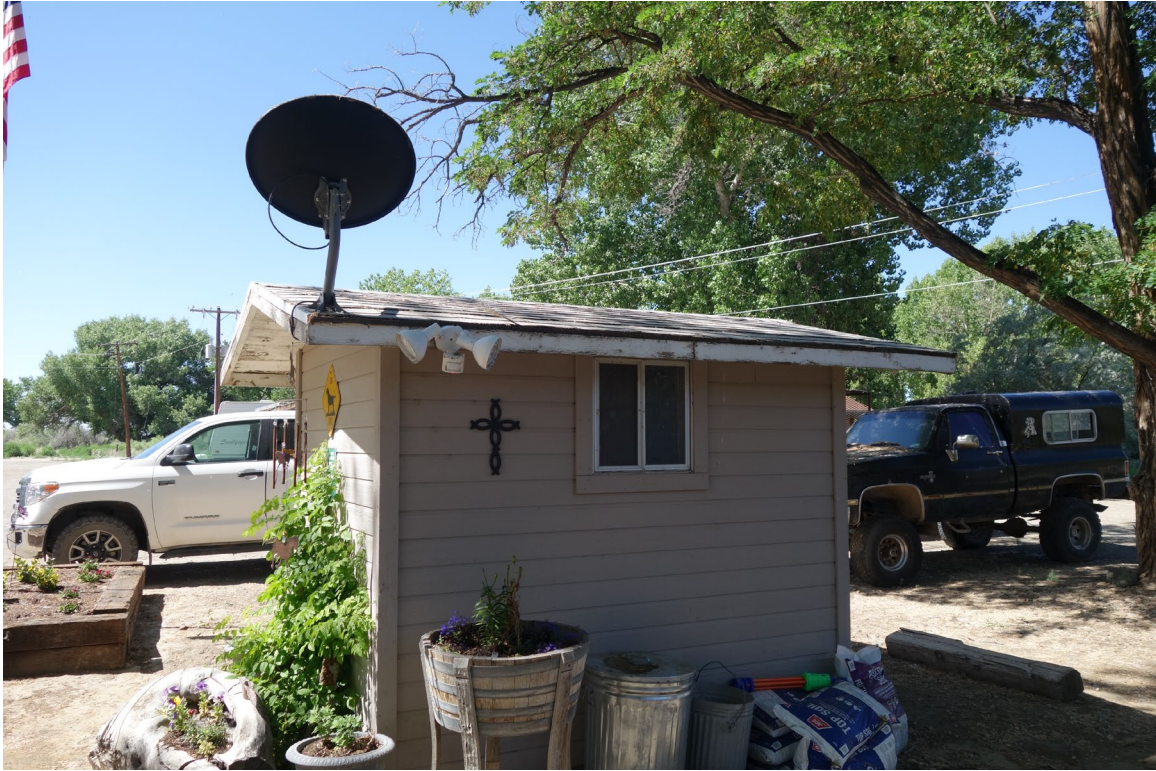
Mason Valley WMA Filter House 2 - Building #2984  
Description: Exterior of the Building.

The Filter House 2 is a wood framed structure with a composition roof on a concrete foundation. It has vinyl siding to match the residences on site. The building is in good shape.

It is important to maintain the finish, weather resistance and appearance of the building. This project would provide funding to protect the exterior of the building. Included in the cost is cleaning the vinyl siding and caulking of the flashing, fixtures and all other penetrations. It is recommended that the building be cleaned and caulked in the next 5 - 6 years and that this project be scheduled on a cyclical basis to maintain the integrity of the structure. This project also includes costs for installing a 3'x3' concrete landing at the door.

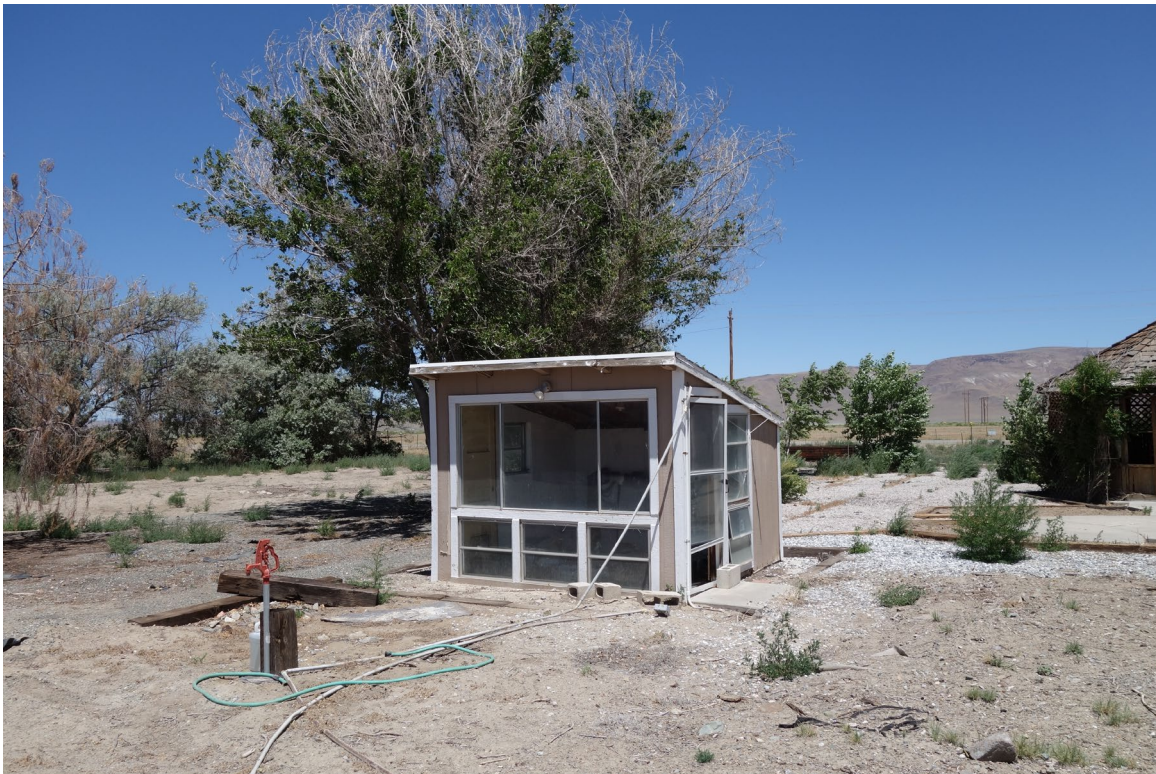
Mason Valley WMA Residence 4 Greenhouse - Building #2985  
Description: Exterior of the Building.

The interior finishes are in fair condition. It is recommended that the interior walls be painted at least once in the next two to four years. Prior to painting, all surfaces should be repaired and prepped. An epoxy-based paint should be utilized in wet areas for durability.

The asphalt composition shingle roof on this building was in poor condition at the time of the survey. It is recommended that this building be re-roofed in the next 2 - 3 years with a new 50 year asphalt composition roofing shingle and new underlayment. This estimate includes removal and disposal of the old roofing system.

It is important to maintain the finish, weather resistance and appearance of the building. This project would provide funding to protect the exterior of the building. Included in the cost is sanding, priming and painting and caulking of the windows, flashing, fixtures and all other penetrations. It is recommended that the building be painted in the next 2 - 3 years and that this project be scheduled on a cyclical basis to maintain the integrity of the structure.

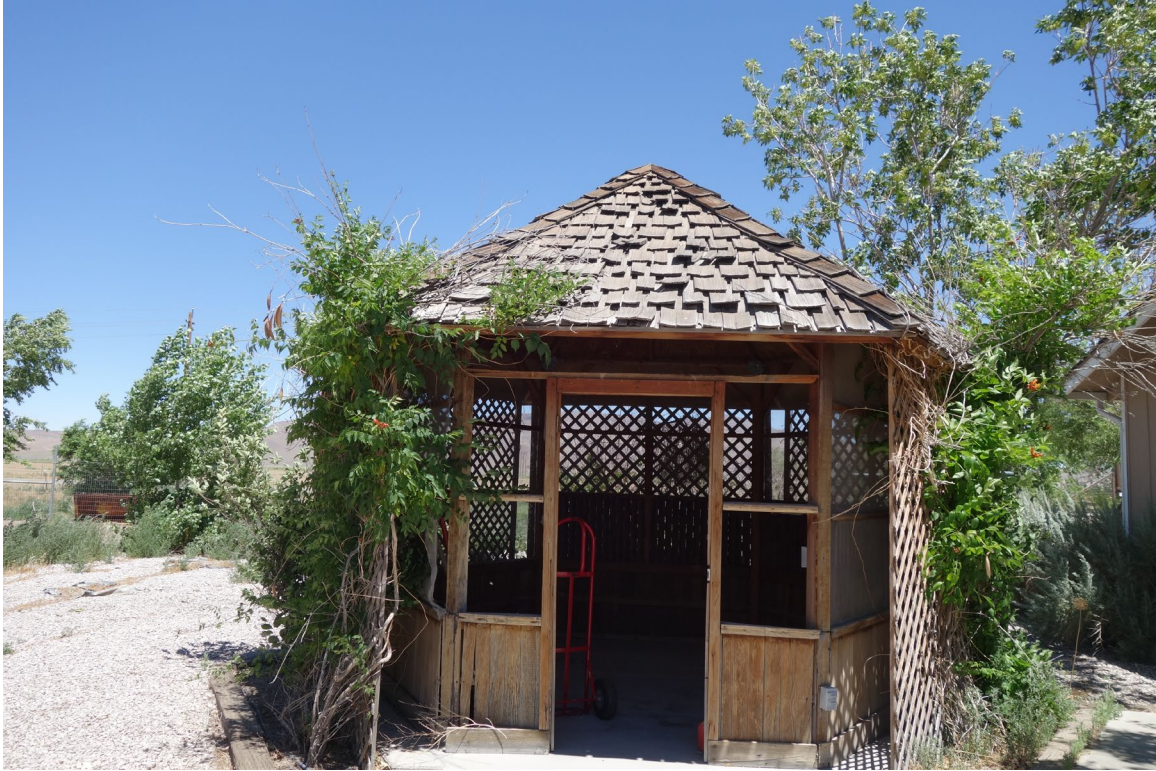
Mason Valley WMA Residence 4 Gazebo - Building #2986  
Description: Exterior of the Building.

The Gazebo is a wood framed structure with a wood shingle roof on a concrete foundation. There is currently a hot tub underneath and it is located adjacent to Residence 4. It is in fair shape.

It is important to maintain the finish, weather resistance and appearance of the building. This project would provide funding to protect the exterior of the building. Included in the cost is sanding and sealing and caulking of the windows, flashing, fixtures and all other penetrations. It is recommended that the building be painted in the next 5 - 6 years and that this project be scheduled on a cyclical basis to maintain the integrity of the structure.
