# MASON VALLEY HATCHERY SITE

50 Hatchery Way  
Yerington, Nevada 89447

**Site Number: 9905**

**STATE OF NEVADA PUBLIC WORKS DIVISION  
FACILITY CONDITION ANALYSIS**

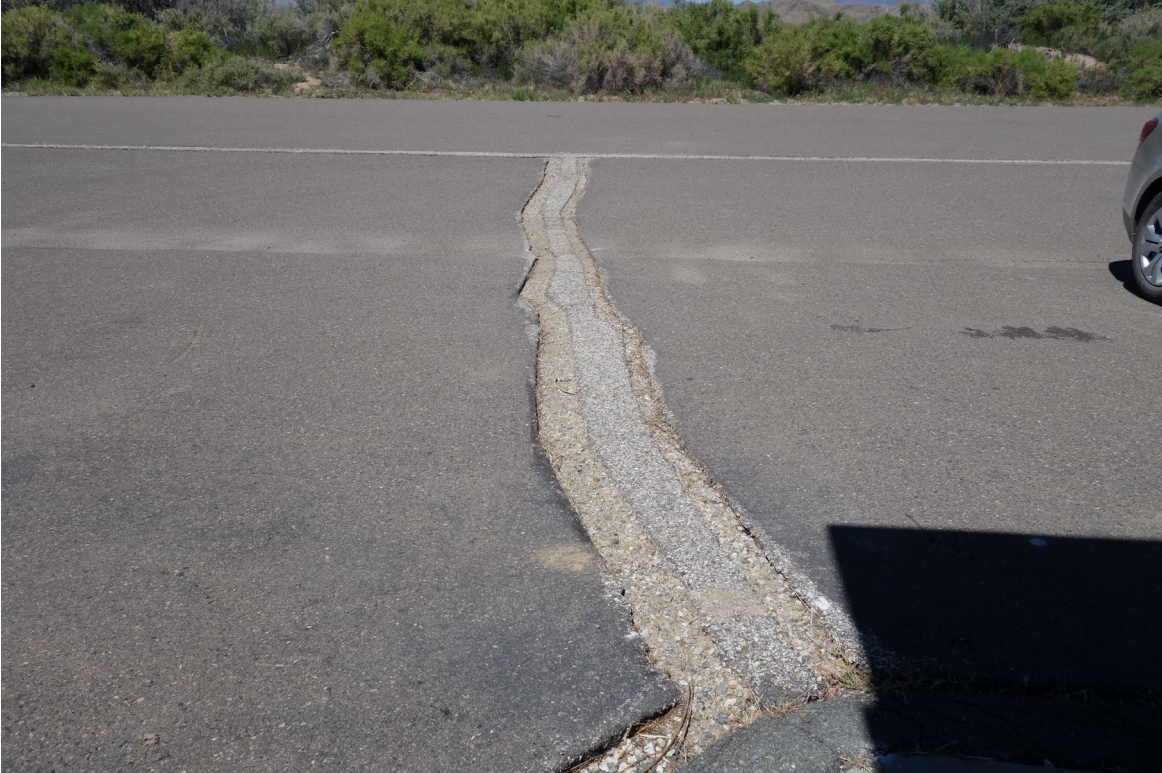
There is approximately 327,150 Square feet of asphalt paving on the site that is failing. Large cracks have previously been patched and the pavement continues to shrink. This project would provide for pulverize in place, regrading and placement of new asphalt pavement. Striping is included in this estimate. Slurry sealing of the entire paved area is also recommended on a 5 - 7 year cycle to maintain the integrity of the paving on site.

Mason Valley Hatchery - Site #9905  
Description: Asphalt Paving Patches Failing.

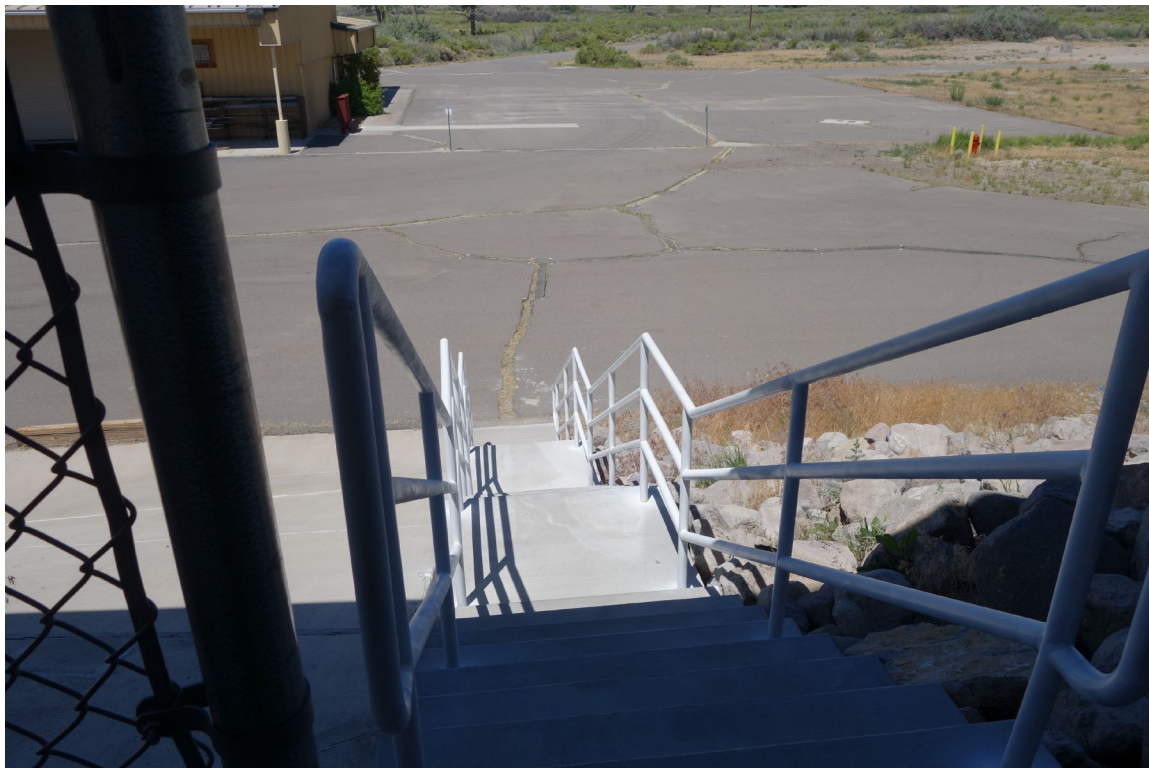
Mason Valley Hatchery - Site #9905  
Description: Pavement Cracking West of Raceway.

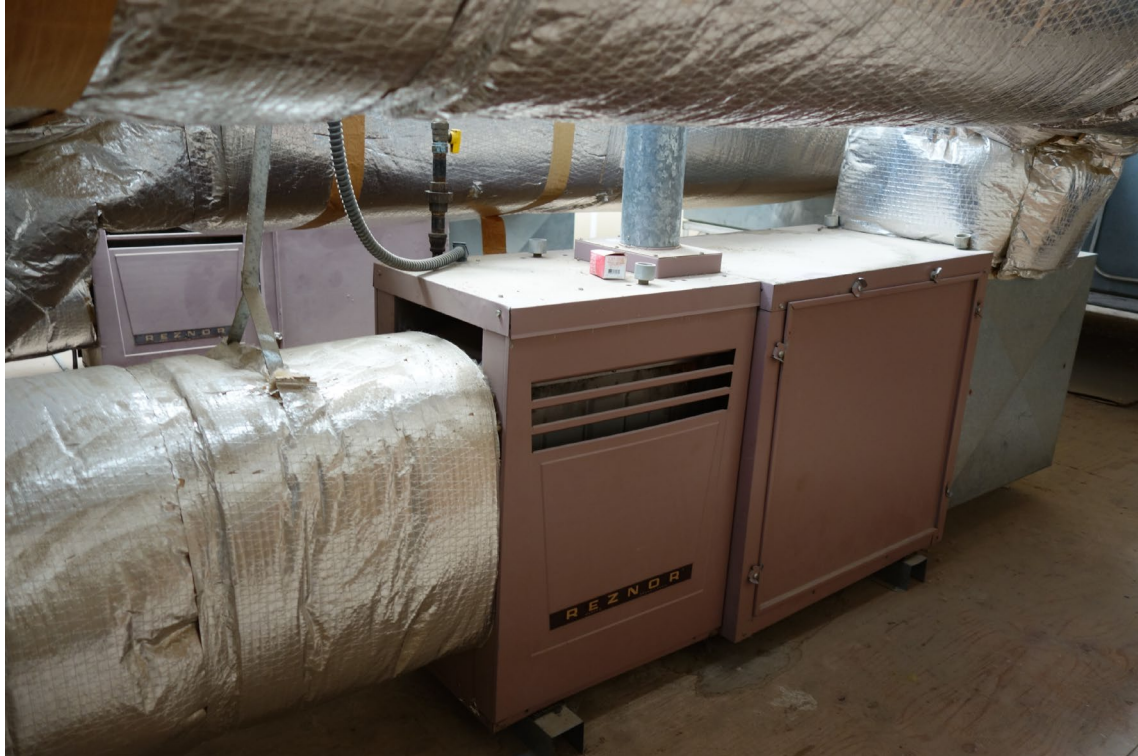
Hatchery Office / Shop - Building #1656  
Description: Original HVAC Equipment Needing Replacement.

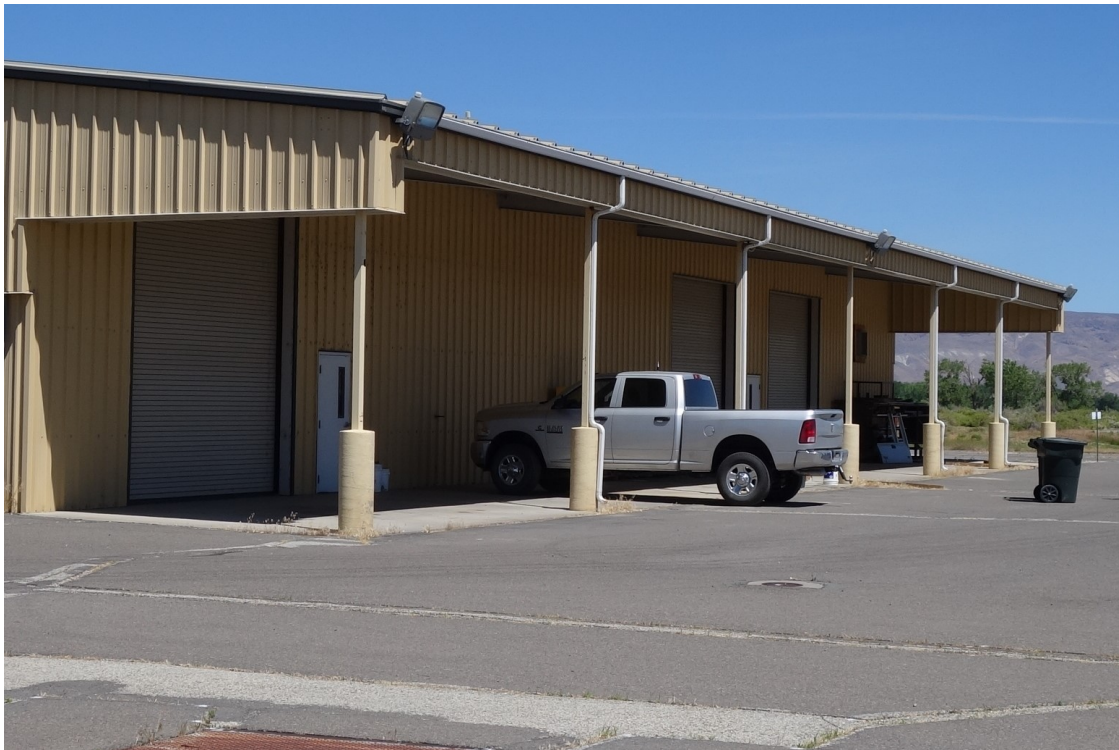
Hatchery Office / Shop - Building #1656  
Description: Exterior View of the Shop & Exterior Lighting Upgrade.

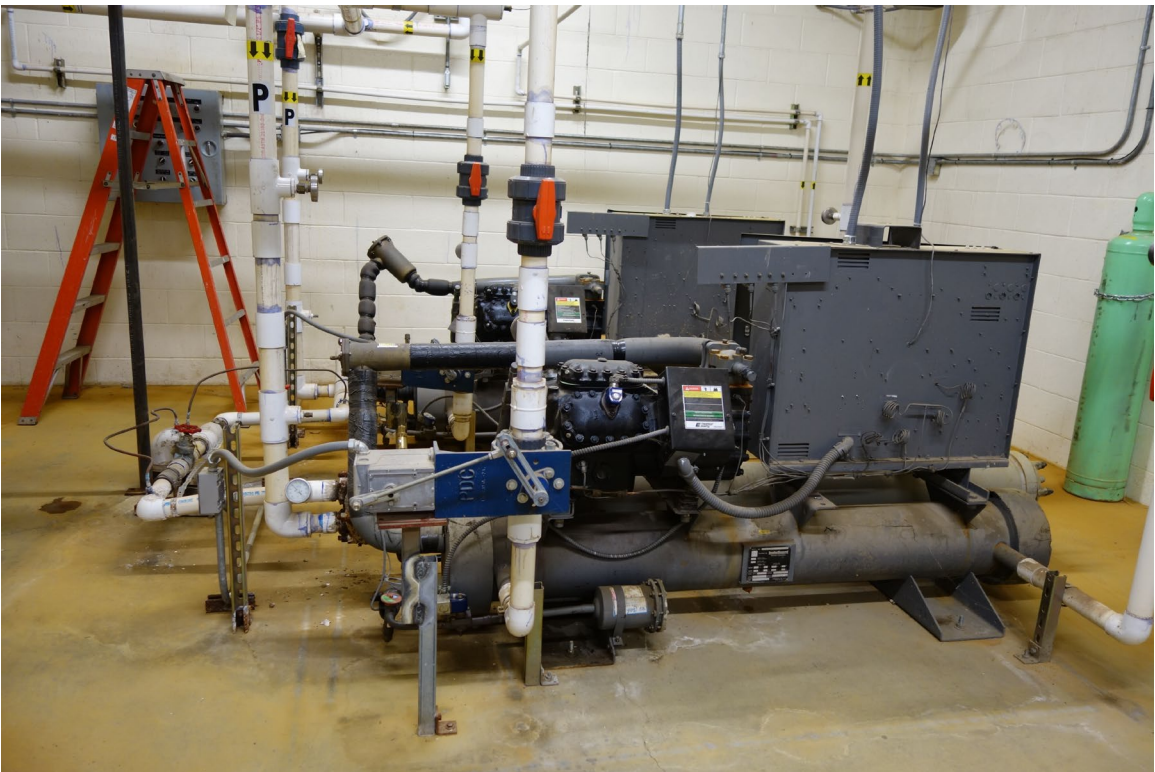
Hatchery Building - Building #1657  
Description: Chiller Replacements Needed.

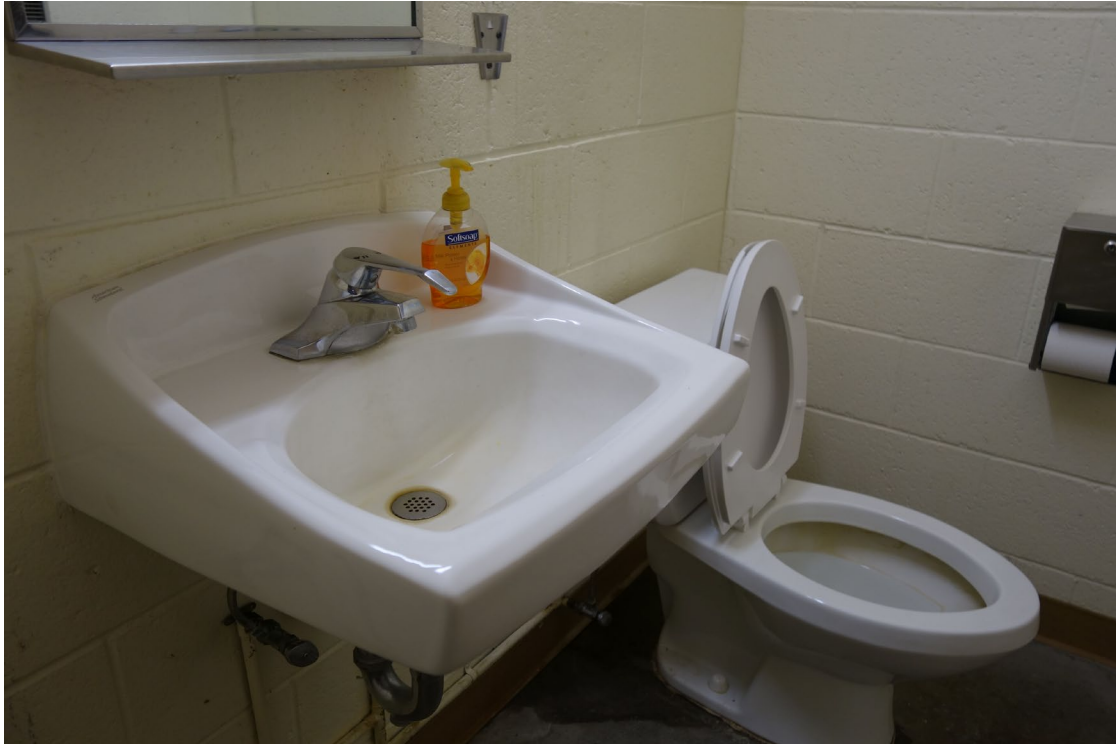
Hatchery Building - Building #1657  
Description: ADA Unisex Restroom Needed.

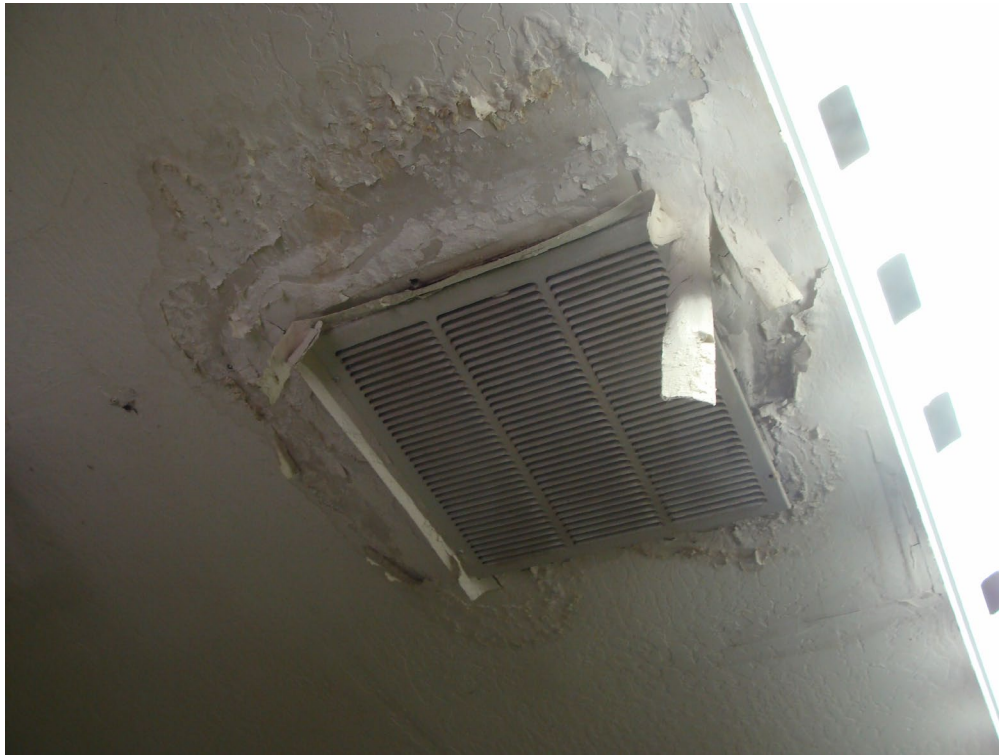
Hatchery Pump House B - Building #1661  
Description: Damage to the ceiling.

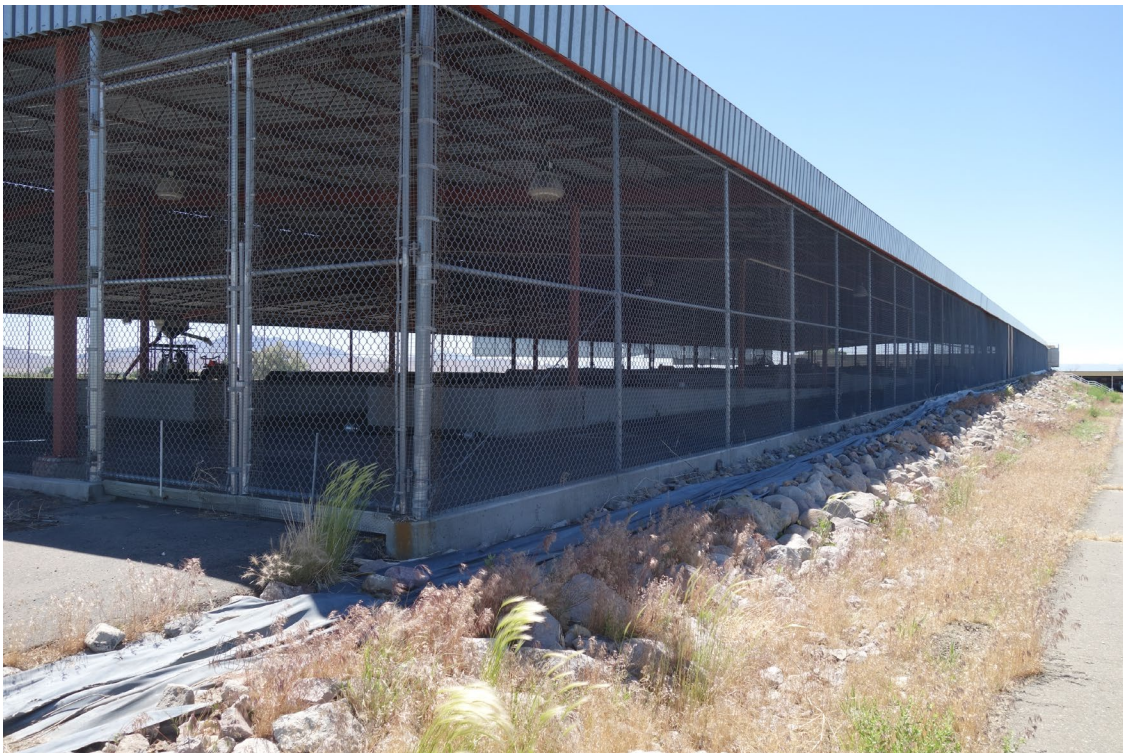
The building does not have gutters or downspouts to control the runoff from the roof. The water currently sheet drains off the roof causing extensive erosion to the rip-rap slope around the foundation. This will eventually lead to failure of the foundation undermining the integrity of the entire structure. This project would provide funding for the installation of a seamless gutter and downspout system for the building.

Hatchery Raceway Shelter - Building #2978  
Description: Exterior of the Building Needing Rain Gutters.

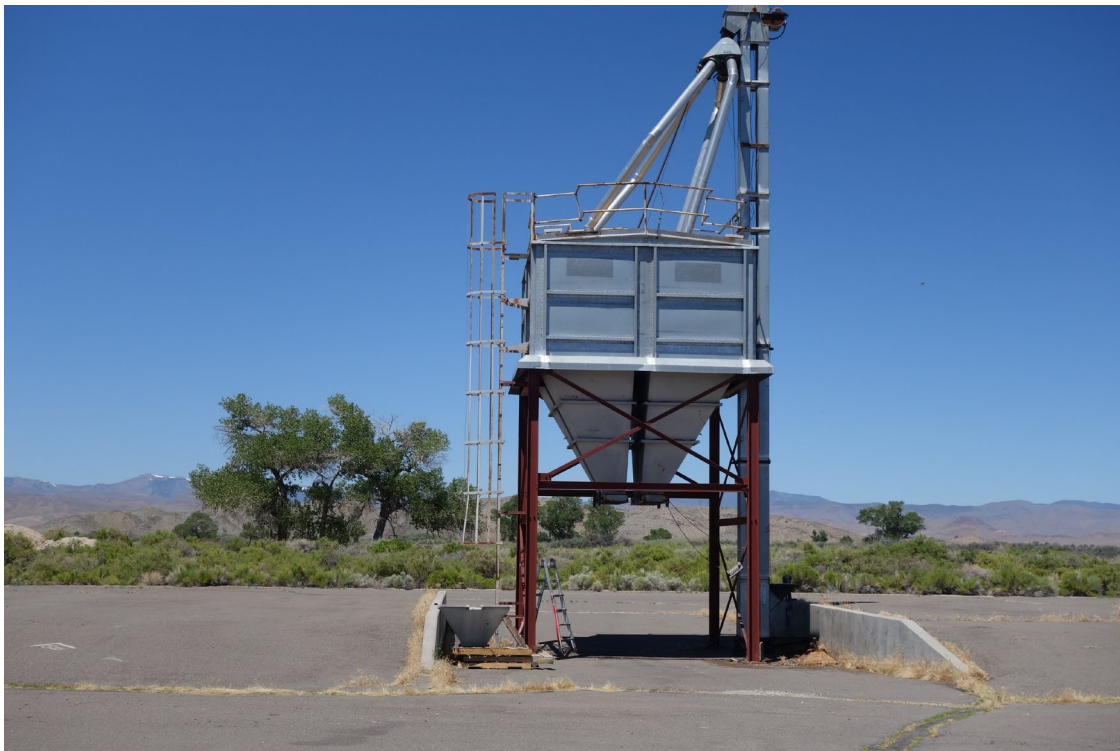
The Hatchery Bulk Feed Bin is a large storage bin used for large quantities of fish food. It is supported by structural steel posts and a concrete foundation. The bin is in excellent shape.

Hatchery Bulk Feed Bin - Building #2979  
Description: Exterior of the Structure.
