State of Nevada  
Department of Wildlife  
Mason Valley Fish Hatchery  
Facility Condition Analysis

# MASON VALLEY FISH HATCHERY

50 Hatchery Way  
Yerington, Nevada 89447

**Site Number: 9905**  
**STATE OF NEVADA PUBLIC WORKS BOARD**  
**FACILITY CONDITION ANALYSIS**

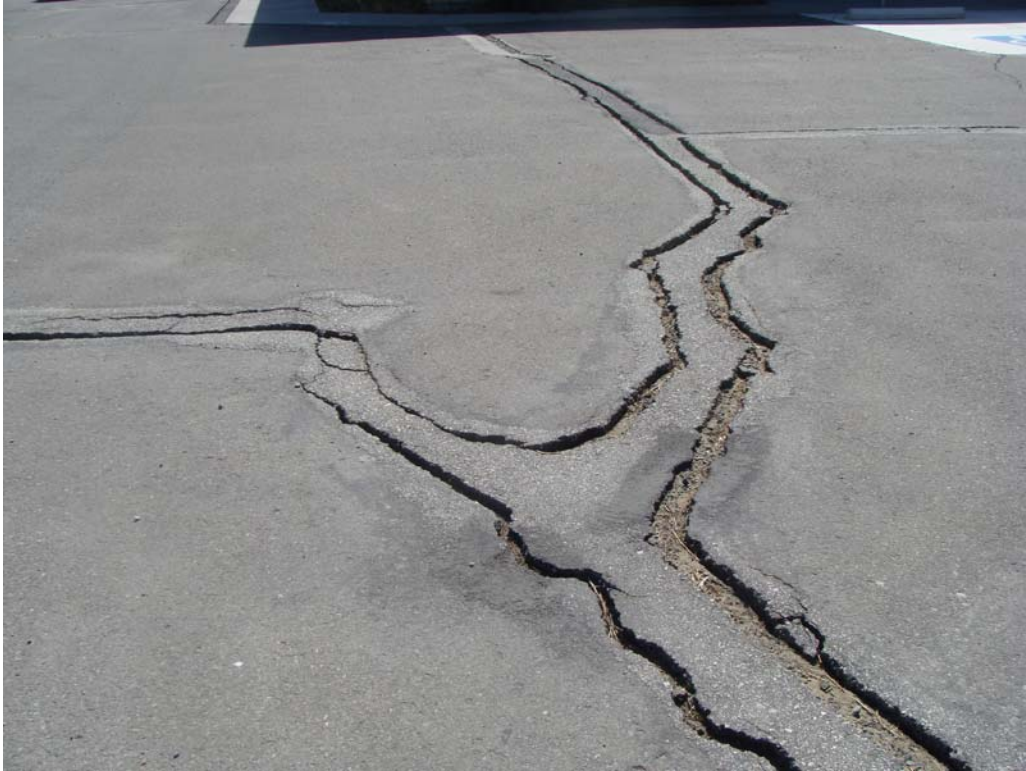
There is approximately 327,150 Square feet of asphalt paving on the site. There are numerous areas that are damaged and the entire paved area is in need of a slurry seal. This project would provide for the removal and replacement of 260,550 square feet of pavement and crack fill and slurry sealing of 66,600 square feet of existing paving to remain. Striping is included in this estimate. Slurry sealing of the entire paved area is also recommended on a 5-7 year cycle to maintain the integrity of the paving on site. For budgeting purposes, a construction cost figure of 50 cents a square foot could be used for slurry sealing which is not included in this estimate.

Mason Valley Hatchery - Site #9905  
Description: Typical cracks in the pavement.

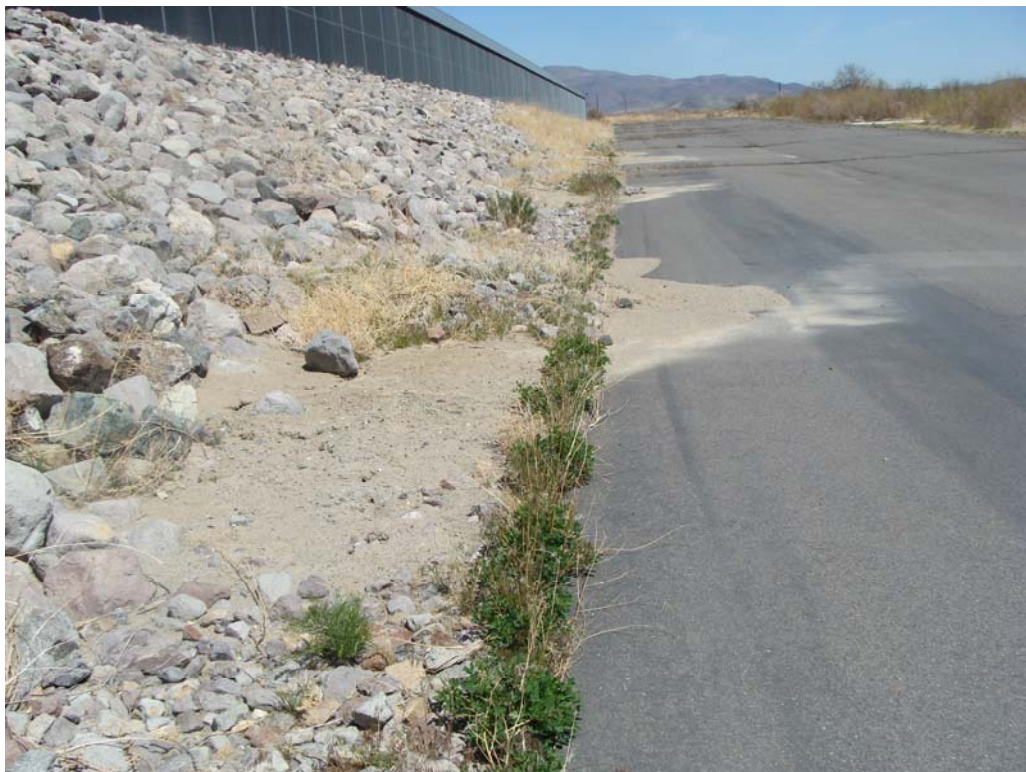
The building does not have gutters or downspouts to control the runoff from the roof. The water currently sheet drains off the roof causing extensive erosion to the rip-rap slope around the foundation. This will eventually lead to failure of the foundation undermining the integrity of the entire structure. This project would provide funding for the installation of a seamless gutter and downspout system for the building.

Mason Valley Hatchery - Site #9905  
Description: Erosion at rip-rap bank by Raceway.

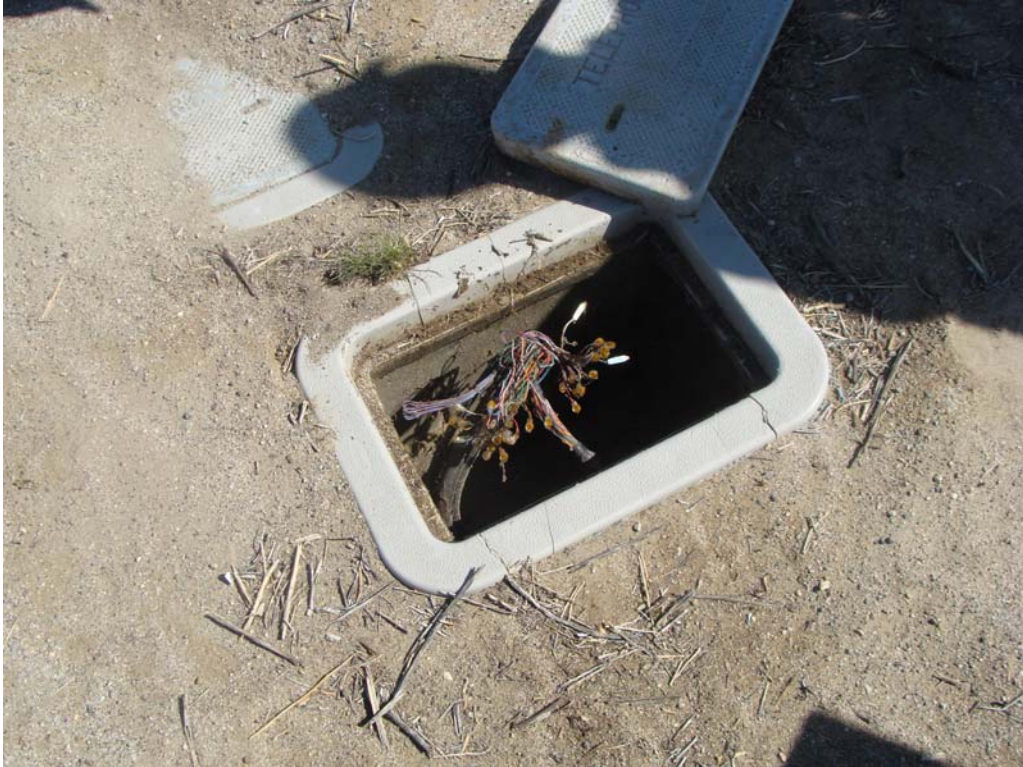
The phone system in the housing area is subject to frequent outages due to lightning strikes. In addition, the main junction box is in a below ground vault, which subjects the terminations to corrosion due to ground moisture reducing the quality of service. This project would relocate the junction box to an above ground location and install lightning protection.

Mason Valley Hatchery - Site #9905  
Description: Residence telephone box.

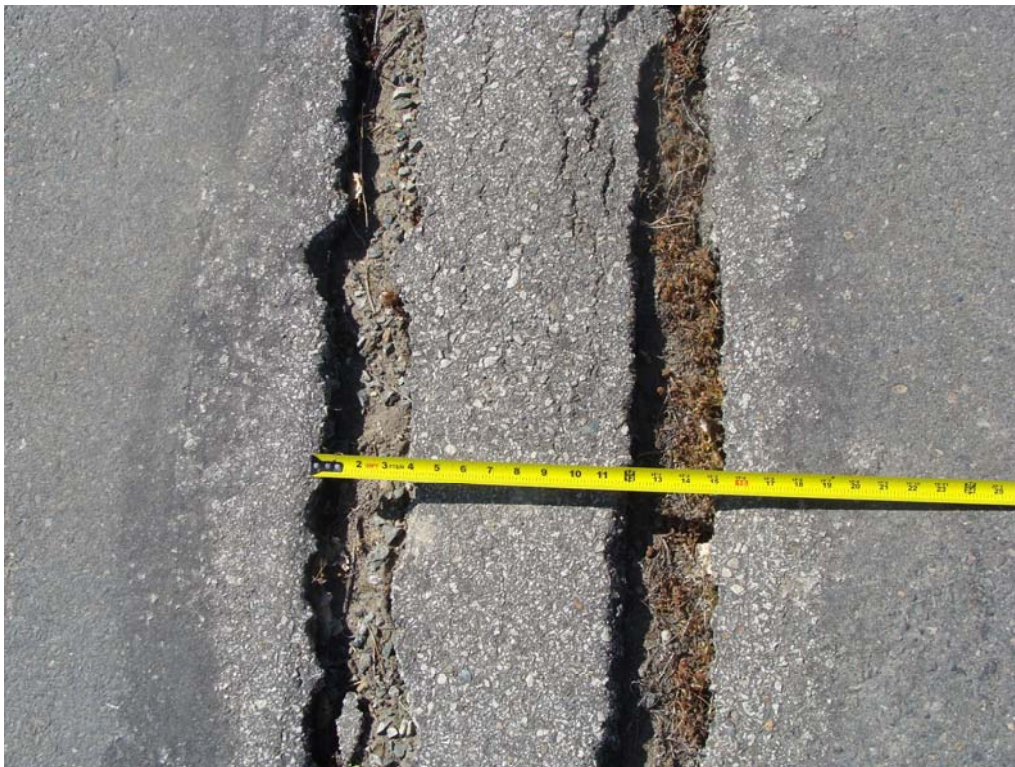
Mason Valley Hatchery - Site #9905  
Description: Cracks at east pavement area.

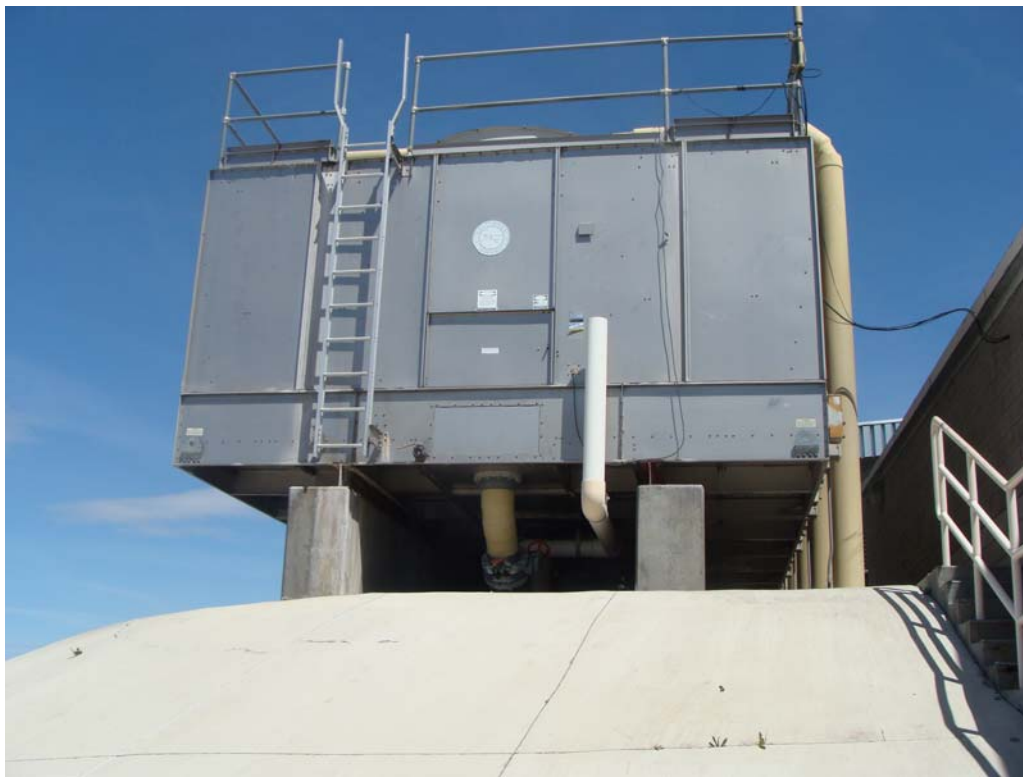
The cooling tower along the west side of the Hatchery building has a large sloped concrete apron which is showing signs of damage. There are cracks from settling and evidence of erosion occurring underneath the concrete. This may compromise the structural stability of the concrete foundation below the cooling tower. This project would provide for the necessary repairs to be made to prevent water infiltration and erosion.

Hatchery Building - Building #1657  
Description: Hatchery cooling tower.

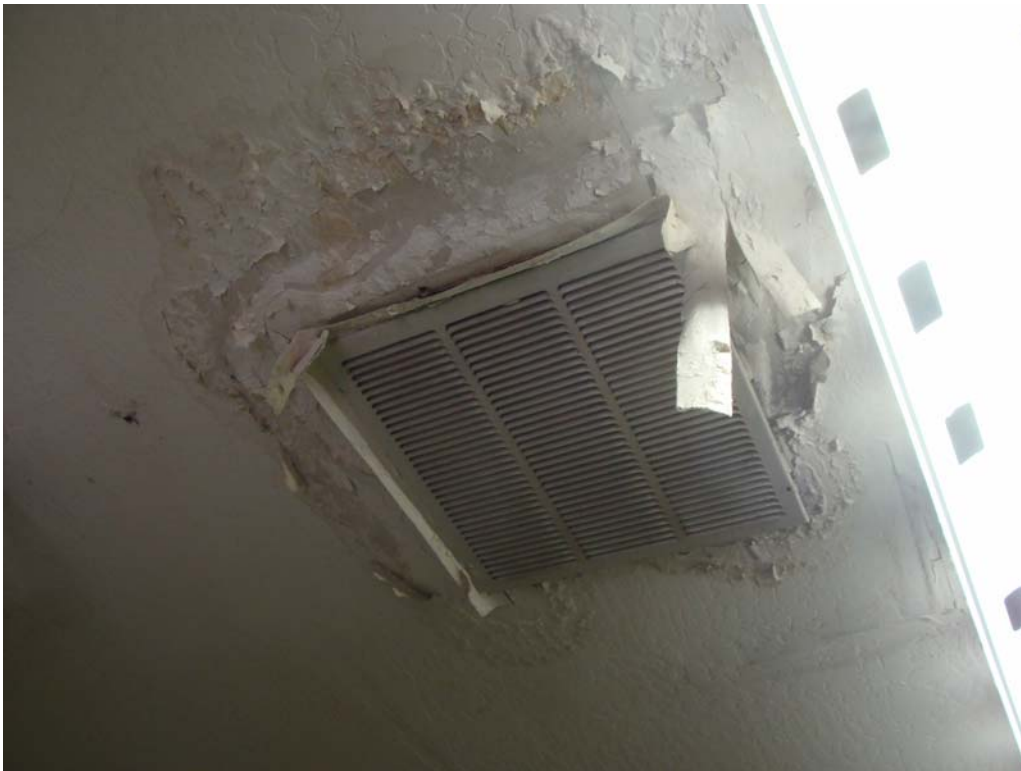
Hatchery Pump House B - Building #1661  
Description: Damage to the ceiling.

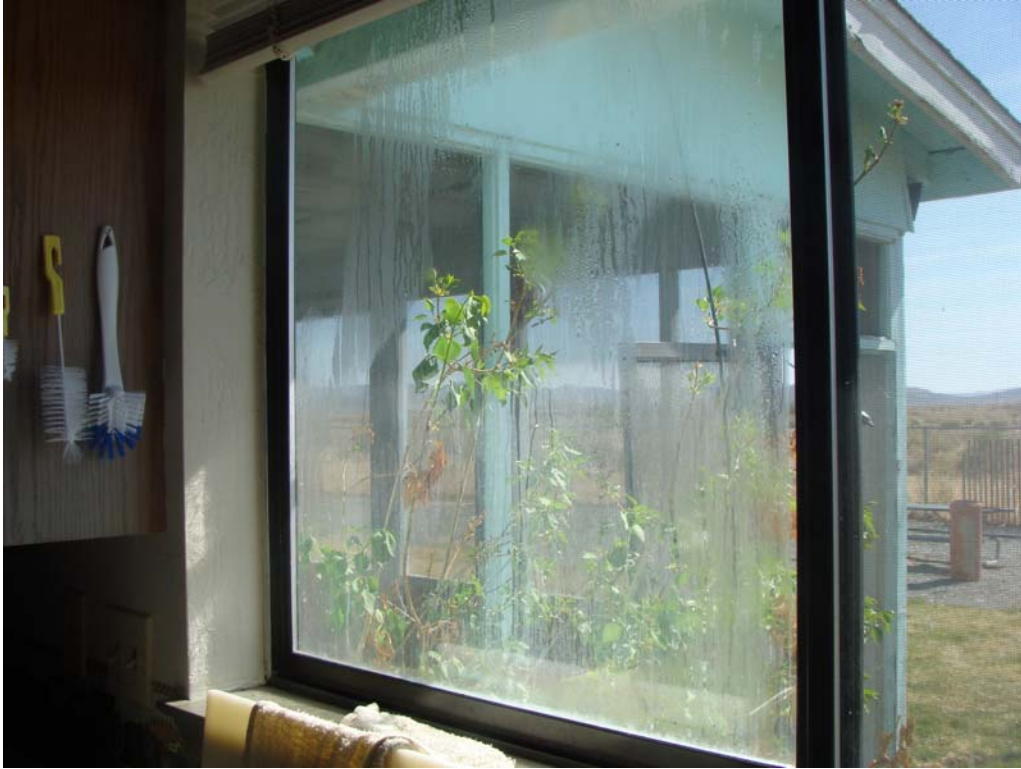
Hatchery Residence 1 - Building #1666  
Description: Damaged window seal.

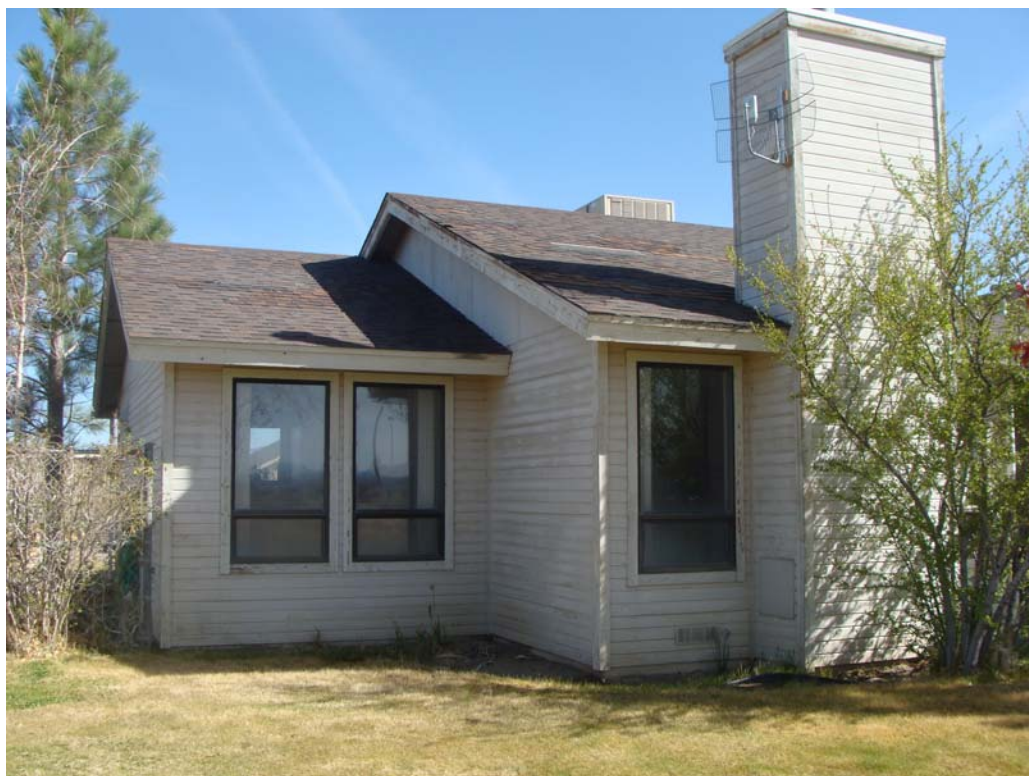
The asphalt composition shingle roof on this building was in poor condition at the time of the survey. It is recommended that this building be re-roofed in the next one to two years with a new 50 year asphalt composition roofing shingle and new underlayments. This estimate includes removal and disposal of the old roofing.

Hatchery Residence 4 - Building #1669  
Description: Exterior of the building and damaged roof shingles.

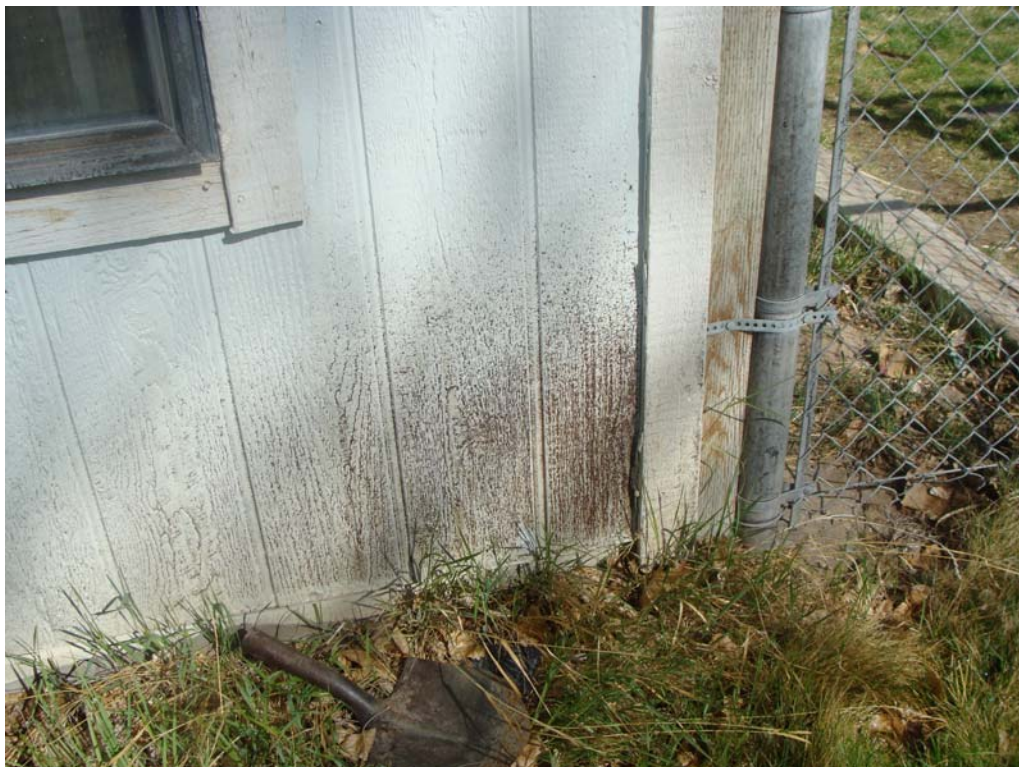
The house has considerable damage to the siding from lawn sprinklers wetting the siding. This project would create drip irrigated planters within three feet of the house and relocate sprinklers so they do not wet the house. Backflow prevention devices would be enclosed in a heated enclosure to prevent freezing. Existing hose bibs upstream of the backflow preventers would be relocated downstream of the valve.

Hatchery Residence 5 - Building #1670  
Description: Paint damage from irrigation system.
