# NEVADA STATE MUSEUM

600 North Carson Street  
Carson City, Nevada 89701

**Site Number: 9907**  
**STATE OF NEVADA PUBLIC WORKS DIVISION**  
**FACILITY CONDITION ANALYSIS**

Report distributed in December 2021

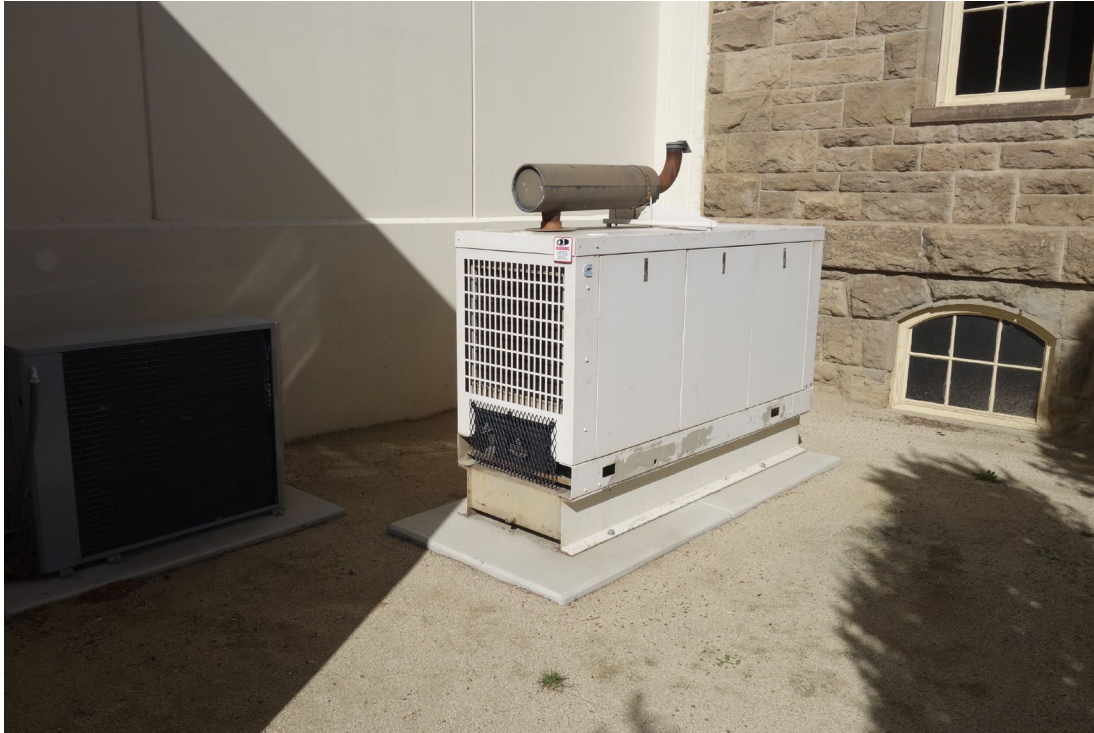
There is a diesel-fired generator on site is approaching 40 years old and has reached the end of its expected life. The generator provides emergency backup power for the Museum complex. It is recommended that a new 50 kW diesel-fired generator be installed. This estimate includes removal of the existing generator

Nevada State Museum – FCA Building #0205  
Description: Electrical Generator Replacement Needed.

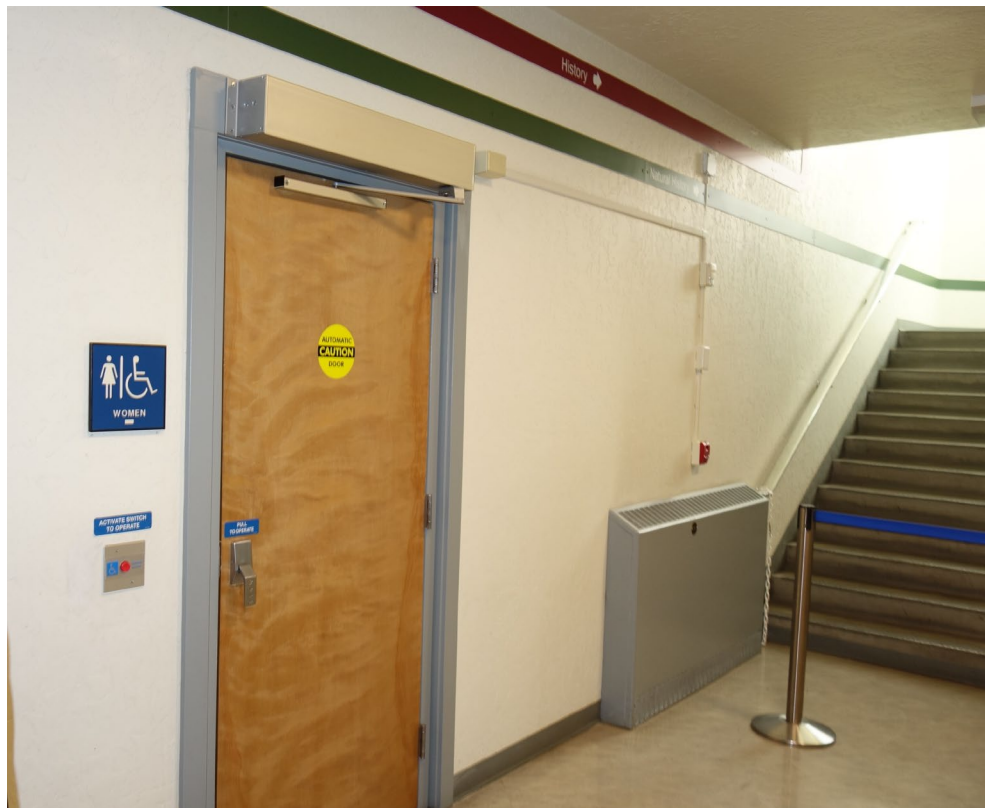
The central plant portion of the HVAC system was replaced in 2018. However all air handling equipment was not replaced and has reached the end of its useful life. The temperature control system (TCS) is also old and only the interface at the boilers and chillers were upgraded in 2018. This project will replace 33 fan coil units, piping and upgrade the TCS system. Removal and replacement of the existing equipment is included in this estimate.

Nevada State Museum – FCA Building #0205  
Description: HVAC Air Distribution Equipment Replacement Needed.

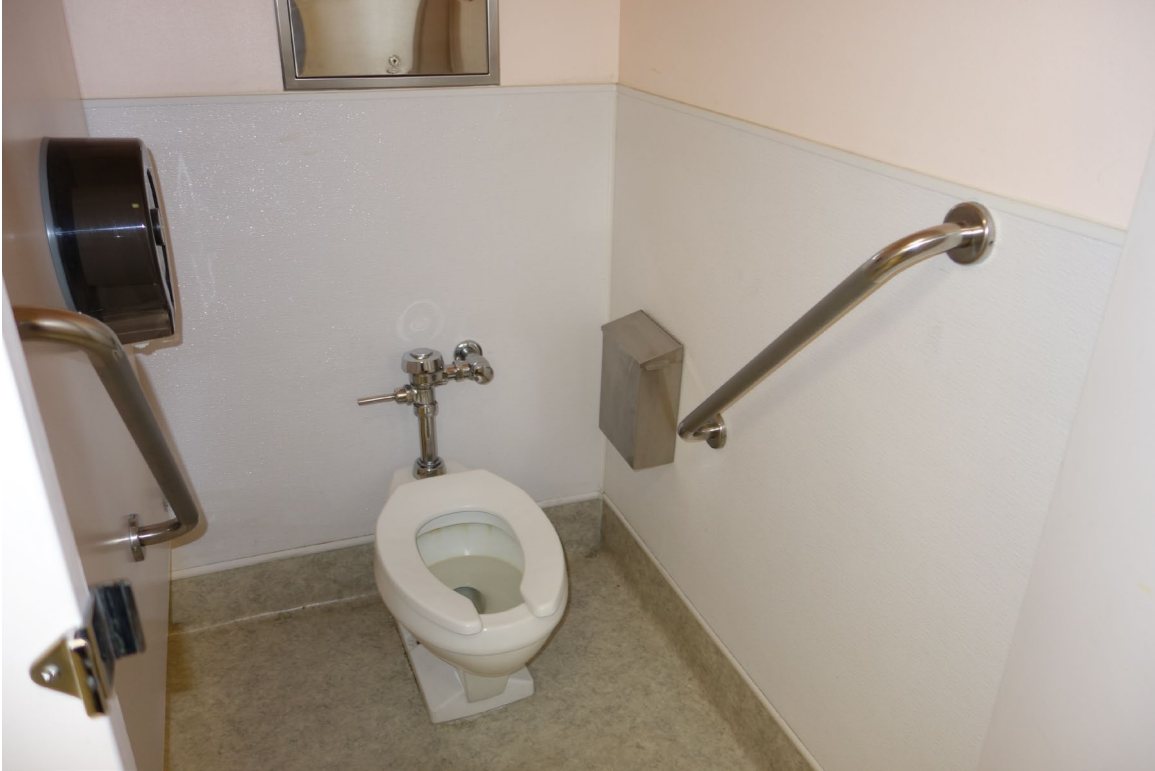
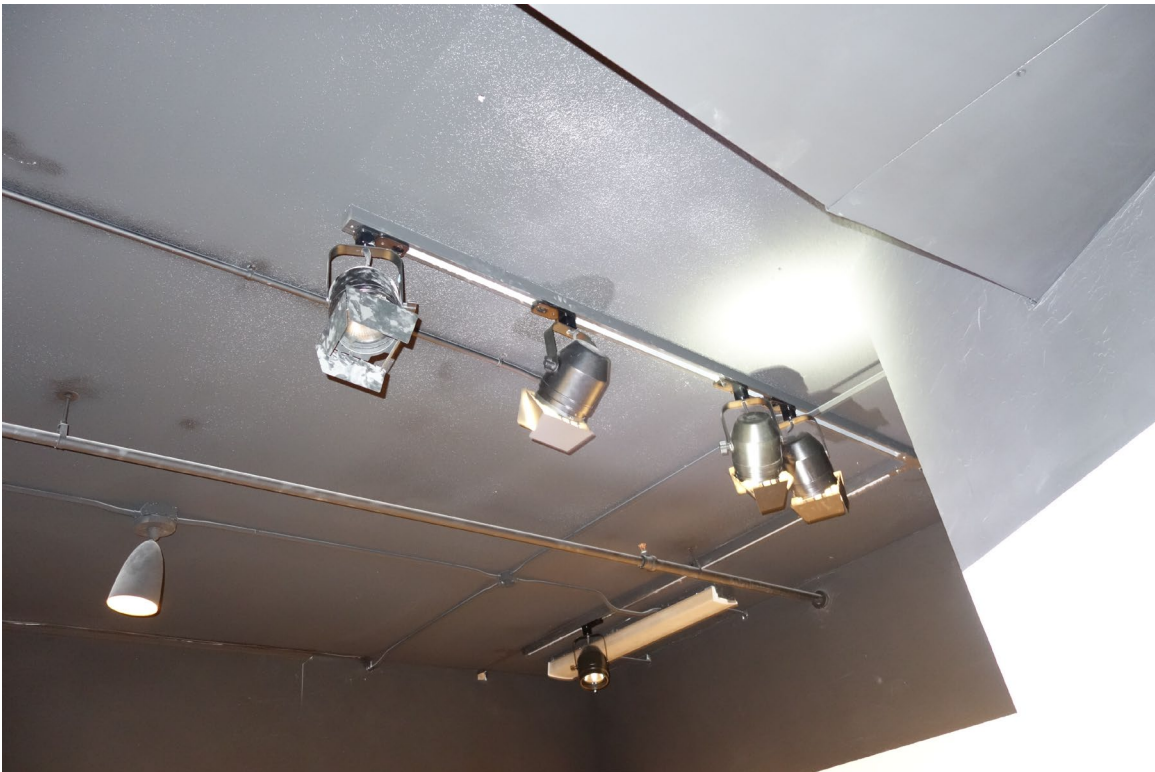
The existing Men's and Women's restrooms are in need of remodeling due to age and use. This project would provide for the remodeling of two Men's and two Women's restrooms in the basement and upper level including but not limited to new plumbing fixtures partitions, accessories, flooring and painting. If space permits, ADA accessible elements should be incorporated into the design as much as feasible but the main level of the museum does have ADA accessible Men's and Women's restrooms for the public and employees. It is recommended that ADA directional signage be installed to provide location details to ADA accessible restrooms.

Nevada State Museum – FCA Building #0205  
Description: Restroom Remodels 2<sup>nd</sup> Floor & Basement Needed.

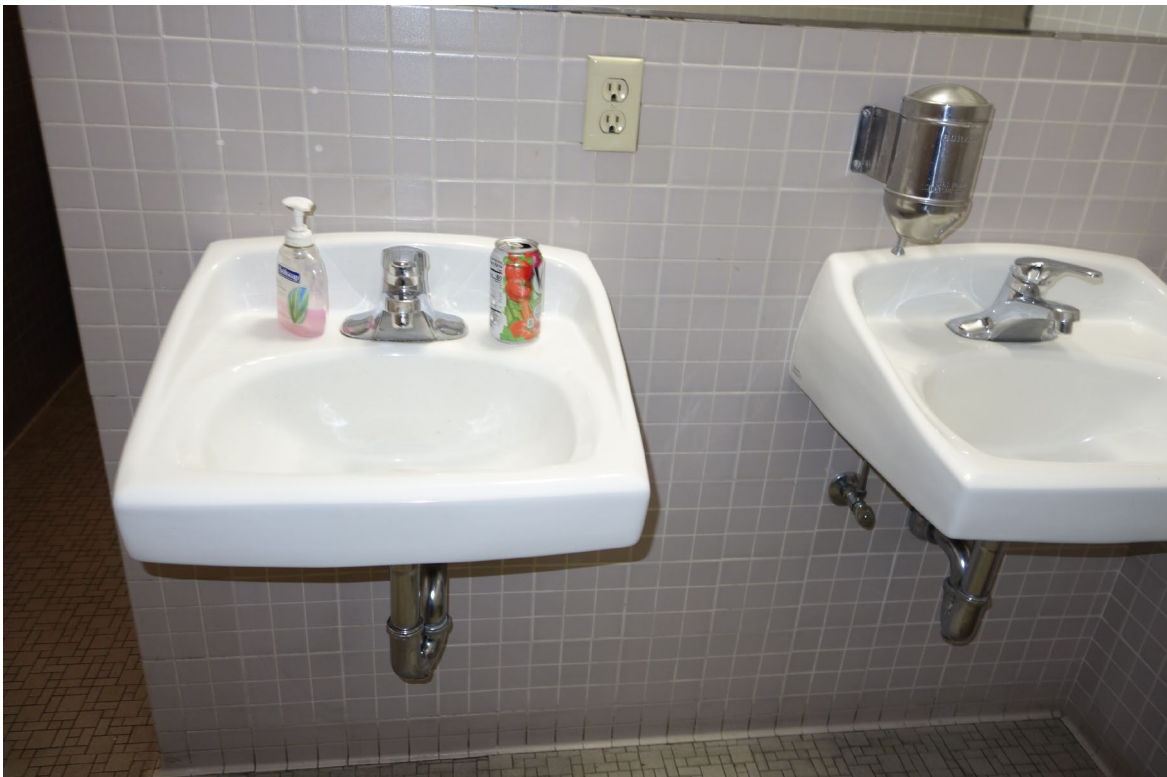
The existing receptacles in the bathrooms appear to be standard duplex receptacles and may not be GFCI protected. The 2017 NEC 210.8 requires all locations within 6 feet of a water source, garages & accessory buildings and outdoors shall have GFCI protection. This project would provide for removing the standard receptacles and installing GFCI receptacles or breakers protecting those receptacles.

Nevada State Museum – North Annex – FCA Building #2027  
Description: GFCI Outlet Protection Needed.

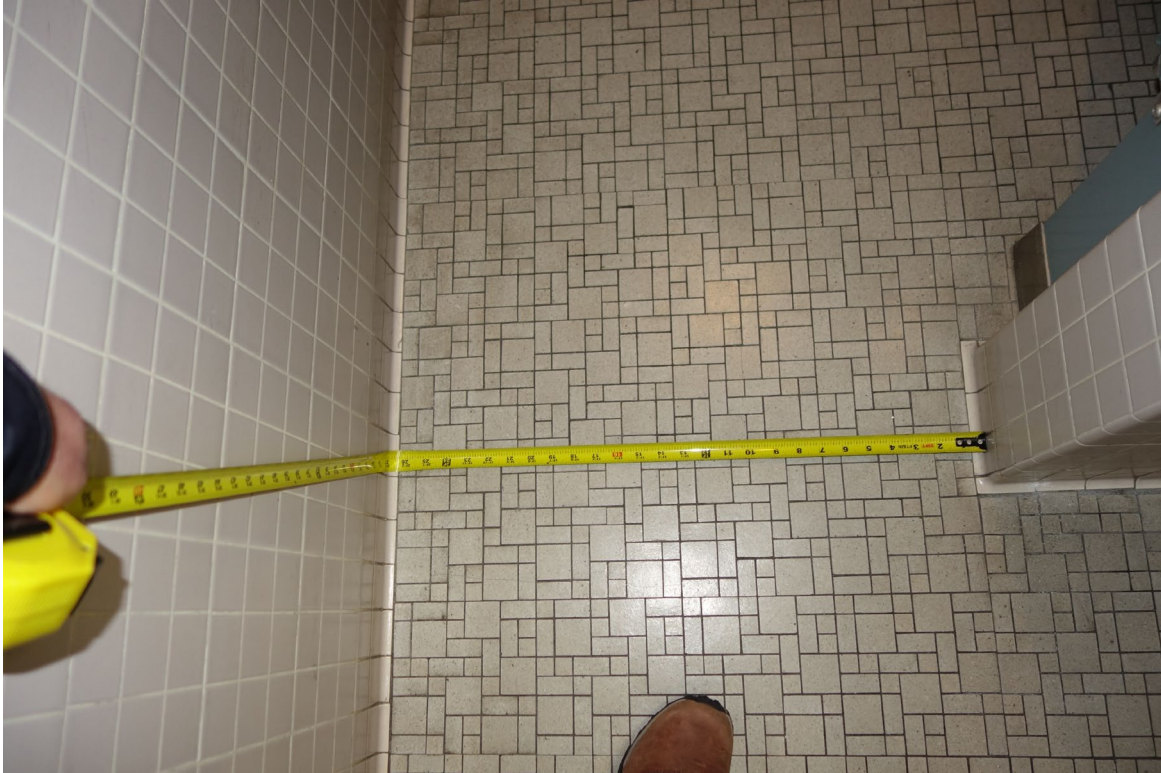
The existing upper level Men's and Women's restrooms are showing their age and are in need of an upgrade. They are not ADA compliant. This project would provide for architectural changes for accessible design, new fixtures and finishes to be installed including toilets, sinks faucets, toilet partitions, countertops and signage. It is recommended that the existing tile be removed and replaced with new floor and wall tile. Removal and disposal of the existing fixtures is included in this estimate.

Nevada State Museum – North Annex – FCA Building #2027  
Description: Remodel Upper Level Restroom (26" Non-Accessible Width).

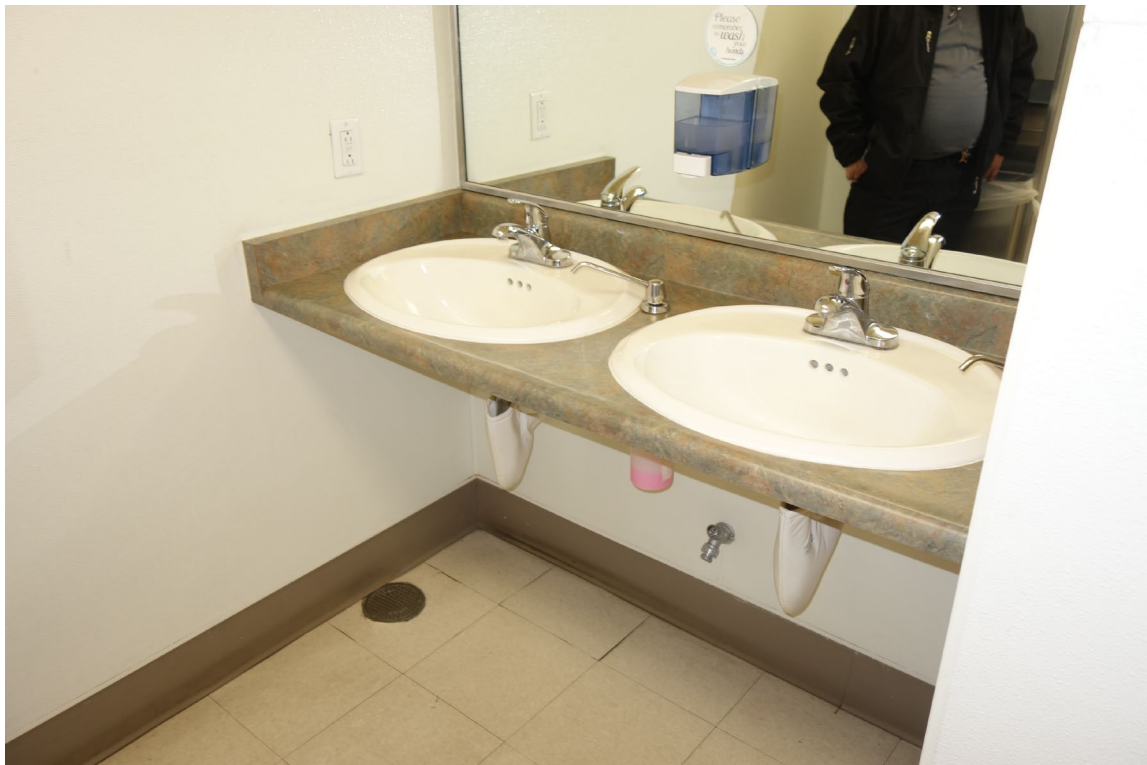
The existing flooring in the lower level ADA accessible restrooms is vinyl composition tile (VCT). This creates a potential unsanitary condition and increases maintenance and also is showing signs of wear. This project would provide for removal of the existing VCT and installation of a slip resistant sheet vinyl.

Nevada State Museum – North Annex – FCA Building #2027  
Description: Restroom Flooring Replacement Needed.
