DEPARTMENT OF ADMINISTRATION
STATE PUBLIC WORKS DIVISION
FACILITY CONDITION ASSESSMENT

PROPERTY PORTFOLIO REVIEW PROJECT ADDENDUM

9908 - SUMMIT VIEW YOUTH CORRECTIONAL CENTER SITE 5730 RANGE RD LAS VEGAS, NV 89115-1927 CLARK COUNTY

SURVEY DATE: 03/08/2023

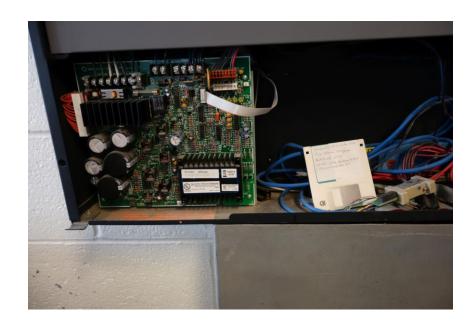
SUMMIT VIEW YOUTH CORRECTIONAL CENTER SITE

NEW SAFETY ISSUES - 10/31/2024 9908-SFT-3: FIRE ALARM REPLACEMENT

The buildings on the site are equipped with an automatic fire detection and alarm system that is failing. The existing system's program resides on a floppy disk and parts are difficult to acquire. This estimate includes the cost of replacing the existing system with a new system that will provide visual, as well as audible notification, in accordance with ADA requirements located in ICC/ANSI A117.1 Section 7 and the 2018 International Fire Code.

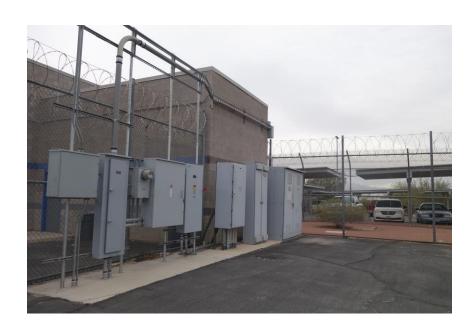
SUMMIT VIEW YOUTH CORRECTIONAL CENTER SITE

NEW ELECTRICAL - 11/6/2024 9908-ELE-1: ARC FLASH AND ELECTRICAL COORDINATION STUDY

Arc flash and electrical breaker coordination studies have not been performed on the site electrical systems or it has been more than 5 years since the last coordination study. Safety requirements for maintenance personnel and the latest electrical code require

coordination studies to be verified and performed every 5 years, along with arc flash labeling on all electrical panels. This project will perform the required coordination study, evaluation, adjustments and labeling for the site's electrical distribution system.

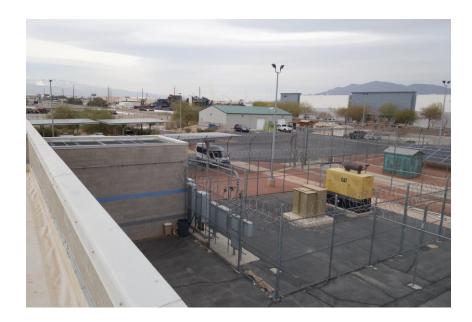
SUMMIT VIEW YOUTH CORRECTIONAL CENTER SITE

9908-SFT-4: EMERGENCY GENERATOR REPLACEMENT

The current backup generator is 25 years old and only capable of supporting emergency services. During extended electrical outages the kitchen and all other important functions are not available. This project recommends a replacement of the existing emergency generator with a unit capable of supporting the entire site's power needs.

This project is in design under CIP 23-M02(6) and the estimate is based off that project.

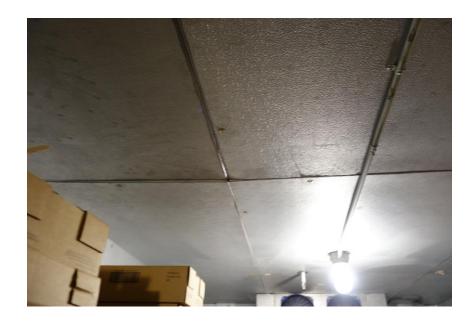
ADMINISTRATION & EDUCATION

NEW BUILDING INTERIOR - 10/31/2024 2428-INT-5: WALK-IN COOLER & FREEZER ENCLOSURE REPLACEMENT

The walk-in cooler and freezer enclosures are original construction and failing. The paneling of both enclosures is splitting allowing moisture to enter degrading the insulation and creating possible mold issues. This project recommends replacement of the enclosures. This project includes removal and disposal of the existing enclosures.

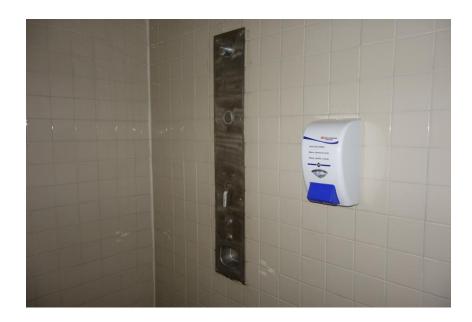
HOUSING UNIT #1 - SIERRA

NEW BUILDING INTERIOR - 11/6/2024 2429-INT-4: SHOWER REFURBISHMENT

The 6 showers in the Housing Unit are original tile enclosures and have reached the end of their useful life. The shower valves have been replaced with manual ball valves to maintain operation. On site staff require shower controls outside of the enclosure to control water usage. This project scope includes demolition of the existing showers and installation of stainless steel shower enclosures, epoxy flooring, wall and ceiling paint and new remote controlled shower fixtures are included in this estimate.

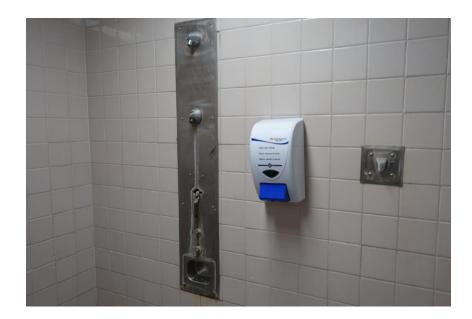
HOUSING UNIT #2 - EVEREST

NEW BUILDING INTERIOR - 11/6/2024 2430-INT-5: SHOWER REFURBISHMENT

The 6 showers in the Housing Unit are original tile enclosures and have reached the end of their useful life. The shower valves have been replaced with manual ball valves to maintain operation. On site staff require shower controls outside of the enclosure to control water usage. This project scope includes demolition of the existing showers and installation of stainless steel shower enclosures, epoxy flooring, wall and ceiling paint and new remote controlled shower fixtures are included in this estimate.

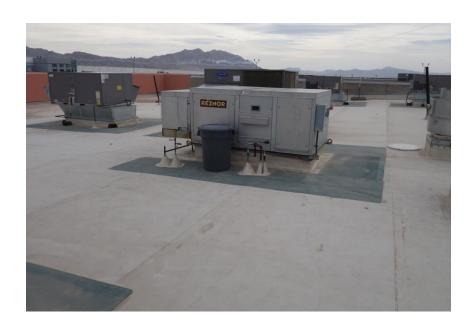
ADMINISTRATION & EDUCATION

2428-HVA-2: HVAC EQUIPMENT REPLACEMENT

There are 15 exhaust fans and 1 Make-Up-Air (MUA) unit supplying conditioned air to the culinary space that are original equipment installed in 2000. The equipment is 24 years old and reaching the end of useful life. The balance of rooftop units were replaced in approximately 2016 and appear to be in good condition. This project includes removal and disposal of the existing HVAC equipment and all required connections to utilities.

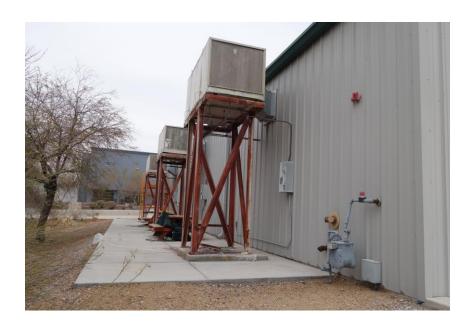
WAREHOUSE/MAINTENANCE SHOP

2432-HVA-1: EVAPORATIVE COOLER REPLACEMENT

Three large evaporative cooling units which are elevated on steel structures and located on the west side of the building, are original equipment and have reached the end of their useful life. They are very difficult to maintain requiring elevated work platforms for ordinary maintenance. This project recommends the replacement of the evaporative coolers by removal of the elevated steel structures, removal and installation of new concrete equipment pads and extending the supply air ductwork down to the pad mounted equipment. This project includes the removal and the disposal of the existing equipment and all required connections to utilities.

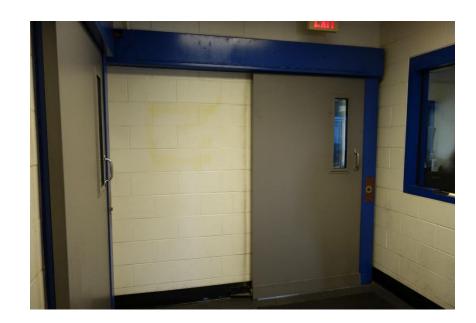
ADMINISTRATION & EDUCATION

2428-SEC-2: SALLY PORT DOOR REPLACEMENT

The 3 sally port doors are original, are failing and require continuous maintenance. This project recommends the replacement of the sally port doors, operator hardware and controls. This project includes removal and disposal of the existing equipment and all required connections to utilities.

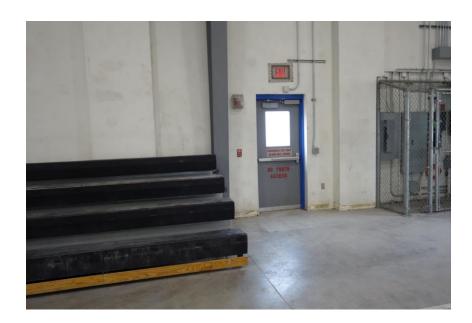
GYMNASIUM

NEW BUILDING INTERIOR - 11/6/2024 2431-INT-2: INTERIOR FINISHES

The interior finishes are in poor condition. It is recommended to paint the interior walls and ceilings at least once in the next 3 - 4 years and that this project is scheduled on a cyclical basis to maintain the integrity of the structure. Prior to painting, all surfaces should be repaired and prepped. An epoxy-based paint should be utilized in wet areas for durability.

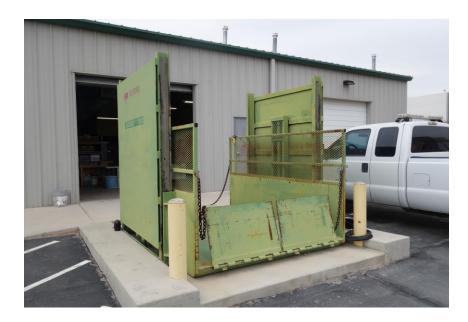
WAREHOUSE/MAINTENANCE SHOP

DEFERRED SITE ISSUES - 11/6/2024 2432-SIT-1: DOCK LIFT REPLACEMENT

The 10,000 pound capacity scissor dock lift is damaged from age and general wear and tear and has reached the end of its expected life. This project would provide for the replacement of the lift with a new dock lift for deliveries. Removal and disposal of the existing lift is included in this estimate. It may be possible to repair the existing lift or replace parts on the existing lift to save costs.

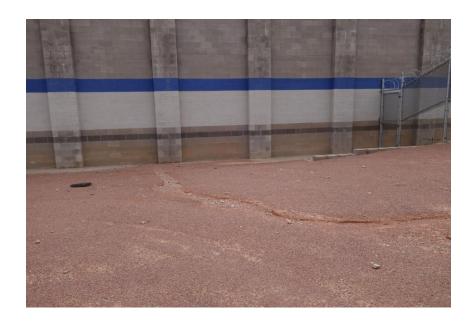
GYMNASIUM

NEW SITE ISSUES - 11/6/2024 2431-SIT-1: SITE DRAINAGE IMPROVEMENTS

Heavy rains exposed drainage problems on the west side of the building. The grade does not slope away from the building and eroded soil has been deposited on the sidewalk and up to the building foundation. This project would create positive flow away from the buildings by extending retaining walls, regrading and installing additional drainage swales to direct the flow to the east and around the gymnasium.

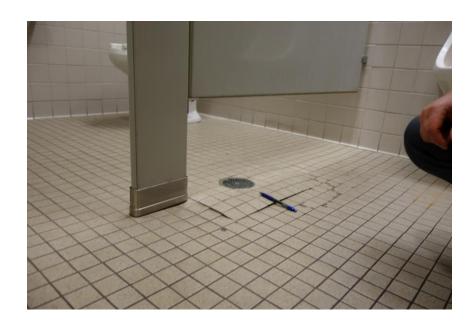
ADMINISTRATION & EDUCATION

NEW BUILDING INTERIOR - 11/1/2024 2428-INT-6: RESTROOM FLOOR STRUCTURAL SURVEY

The restroom concrete slab floor has heaved near the floor drain and failing under the floor tile. This project recommends the removal of portions of the floor tile to further determine the extent of the concrete slab failure. Removal of portions of the concrete slab may be necessary to complete the investigation. Repair costs will be developed at the conclusion of the study.

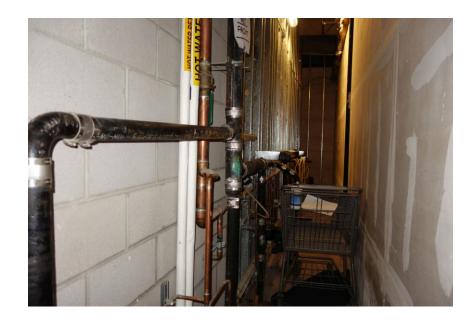
SUMMIT VIEW YOUTH CORRECTIONAL CENTER SITE

9908-PLM-1: SEWER INSPECTION SITEWIDE

The sewer systems in the buildings have experienced increasing problems. The cast iron waste and vent piping has become corroded and in plugged in some locations. The condition of the underground sewer piping is unknown. This project recommends a comprehensive survey of the waste and vent piping systems sitewide to create a plan for repair and replacement as needed.

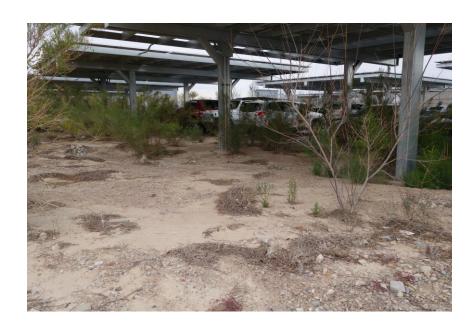
SUMMIT VIEW YOUTH CORRECTIONAL CENTER SITE

NEW SITE ISSUES - 10/30/2024 9908-SIT-4: STORM DRAINAGE STUDY

During storm water events, storm water floods the existing storm swales flooding the public parking lot, eroding soil under the perimeter fence and damaging the landscaping. This project recommends a full drainage study of the site. The cost to implement recommendations as a result of the Study is not included in this project.

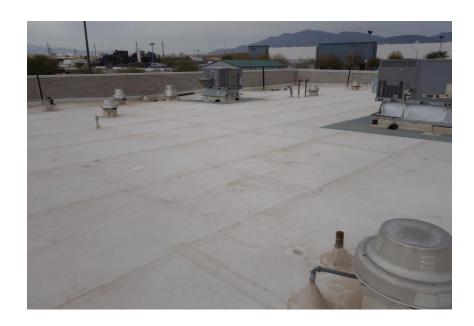
ADMINISTRATION & EDUCATION

DEFERRED BUILDING EXTERIOR - 10/31/2024 2428-EXT-4: ROOF REPLACEMENT

The roof on this building was in fair condition at the time of the survey. The statewide roofing program has set the useful life of an average roof at 20 - 25 years. The temperature fluctuations throughout the year, consistent wind which blows sand and dirt on to the roof membrane, and constant exposure to the sun are contributing factors to wear and deterioration. The current roofing system was installed in 2000. It is recommended that this building be re-roofed in the next 4 - 5 years to be consistent with the roofing program and the end of the warranty period.

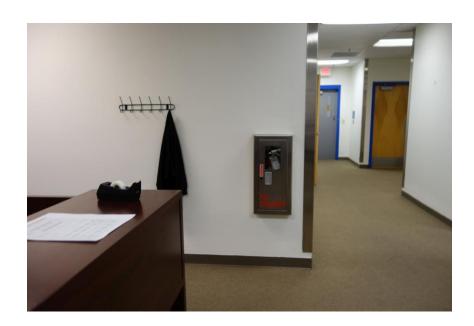
ADMINISTRATION & EDUCATION

NEW BUILDING INTERIOR - 10/31/2024 2428-INT-4: INTERIOR FINISHES

The interior finishes were in good condition. It is recommended to paint the interior walls and ceilings at least once in the next 8 - 10 years and that this project is scheduled on a cyclical basis to maintain the integrity of the structure. Prior to painting, all surfaces should be repaired and prepped. An epoxy-based paint should be utilized in wet areas for durability.

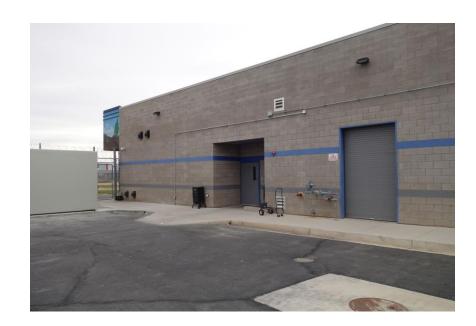
ADMINISTRATION & EDUCATION

NEW BUILDING EXTERIOR - 10/30/2024 2428-EXT-5: EXTERIOR FINISHES

The exterior finishes were in fair condition. It is important to maintain the finish, weather resistance and appearance of the building. This project would provide funding to protect the exterior of the building excluding the roof. Included in the cost is painting the concrete masonry unit walls and caulking of the windows, flashing, fixtures and all other penetrations. It is recommended that the building be painted and caulked in the next 7 - 8 years and that this project is scheduled on a cyclical basis to maintain the integrity of the structure.

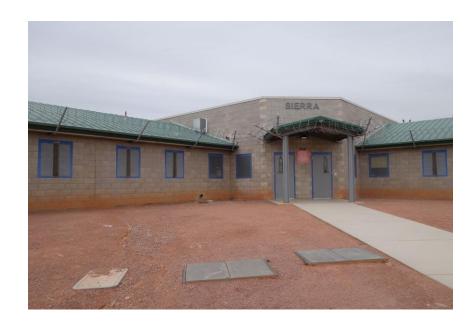
HOUSING UNIT #1 - SIERRA

NEW BUILDING EXTERIOR - 11/5/2024 2429-EXT-4: EXTERIOR FINISHES

The exterior finishes were in good condition. It is important to maintain the finish, weather resistance and appearance of the building. This project would provide funding to protect the exterior of the building excluding the roof. Included in the cost are cleaning and sealing the concrete masonry units, painting the metal trim and caulking of the windows, flashing, fixtures and all other penetrations. It is recommended that the building be sealed and caulked in the next 7 - 8 years and that this project is scheduled on a cyclical basis to maintain the integrity of the structure.

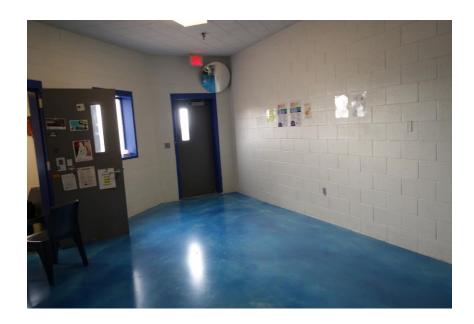
HOUSING UNIT #1 - SIERRA

NEW BUILDING INTERIOR - 11/5/2024 2429-INT-3: INTERIOR FINISHES

The interior finishes were in good condition. It is recommended to paint the interior walls and ceilings at least once in the next 6 - 8 years and that this project is scheduled on a cyclical basis to maintain the integrity of the structure. Prior to painting, all surfaces should be repaired and prepped. An epoxy-based paint should be utilized in wet areas for durability.

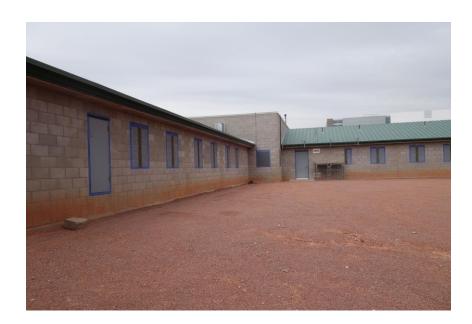
HOUSING UNIT #2 - EVEREST

NEW BUILDING EXTERIOR - 11/6/2024 2430-EXT-4: EXTERIOR FINISHES

The exterior finishes were in good condition. It is important to maintain the finish, weather resistance and appearance of the building. This project would provide funding to protect the exterior of the building excluding the roof. Included in the cost are cleaning and sealing the concrete masonry units, painting the metal trim and caulking of the windows, flashing, fixtures and all other penetrations. It is recommended that the building be sealed and caulked in the next 7 - 9 years and that this project is scheduled on a cyclical basis to maintain the integrity of the structure.

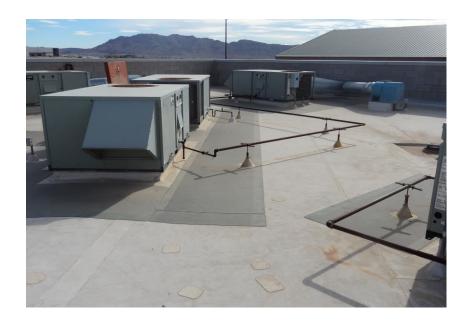
HOUSING UNIT #2 - EVEREST

DEFERRED BUILDING EXTERIOR - 11/6/2024 2430-EXT-3: ROOF REPLACEMENT

The single ply roof portion on this building was in fair condition at the time of the survey. The statewide roofing program has set the useful life of an average roof at 20 - 25 years. The temperature fluctuations throughout the year, consistent wind which blows sand and dirt on to the roof membrane, and constant exposure to the sun are contributing factors to wear and deterioration. The current roofing system was installed in 2000. It is recommended that this building be re-roofed in the next 4 - 5 years to be consistent with the roofing program and the end of the warranty period.

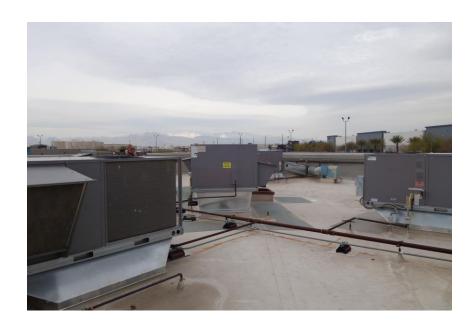
HOUSING UNIT #1 - SIERRA

NEW BUILDING EXTERIOR - 11/5/2024 2429-EXT-5: ROOF REPLACEMENT

The single ply roof portion on this building was in fair condition at the time of the survey. The statewide roofing program has set the useful life of an average roof at 20 - 25 years. The temperature fluctuations throughout the year, consistent wind which blows sand and dirt on to the roof membrane, and constant exposure to the sun are contributing factors to wear and deterioration. The current roofing system was installed in 2000. It is recommended that this building be re-roofed in the next 4 - 5 years to be consistent with the roofing program and the end of the warranty period.

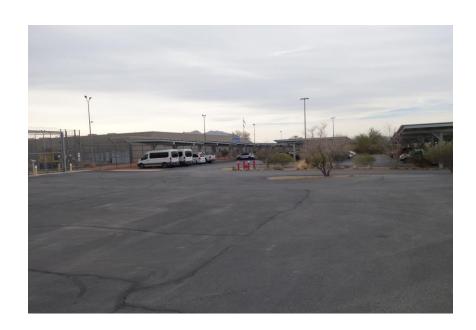
SUMMIT VIEW YOUTH CORRECTIONAL CENTER SITE

NEW SITE ISSUES - 10/30/2024 9908-SIT-5: CRACK FILL & SLURRY SEAL

It is important to maintain the asphalt concrete paving on the site. This project would provide for minor crack filling and sealing of the paving site wide including access roads, parking areas and driving test areas. Striping is included in this estimate. This project should be scheduled on a 5 year cyclical basis to maintain the integrity of the paving and prevent premature failure. 65,000 square feet of asphalt area was used to generate this estimate.

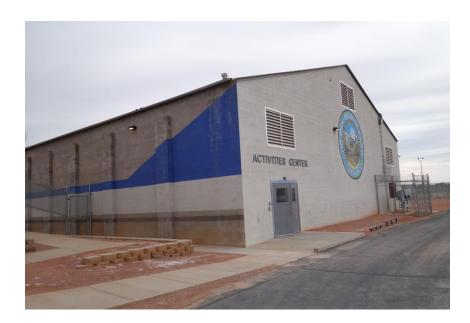
GYMNASIUM

NEW BUILDING EXTERIOR - 11/6/2024 2431-EXT-3: EXTERIOR FINISHES

The exterior finishes were in good condition. It is important to maintain the finish, weather resistance and appearance of the building. This project would provide funding to protect the exterior of the building excluding the roof. Included in the cost are cleaning and sealing the concrete masonry units, painting the metal trim and caulking of the windows, flashing, fixtures and all other penetrations. It is recommended that the building be sealed and caulked in the next 7-8 years and that this project is scheduled on a cyclical basis to maintain the integrity of the structure.

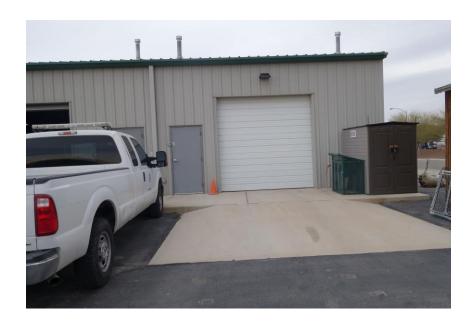
WAREHOUSE/MAINTENANCE SHOP

DEFERRED BUILDING EXTERIOR - 11/6/2024 2432-EXT-2: EXTERIOR FINISHES

The exterior finishes were in good condition. It is important to maintain the finish, weather resistance and appearance of the building. This project would provide funding to protect the exterior of the building excluding the roof. Included in the cost is the caulking and sealing of the windows, flashing, fixtures and all other penetrations. It is recommended that the building be caulked and sealed in the next 7 - 9 years and that this project is scheduled on a cyclical basis to maintain the integrity of the structure.

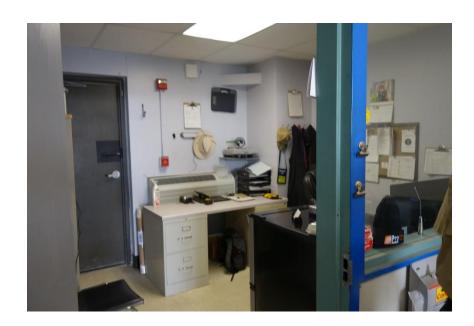
WAREHOUSE/MAINTENANCE SHOP

The interior finishes are in fair condition. It is recommended that the interior walls and floors be painterd or sealed at least once in the next four to six years. Prior to painting or sealing, all surfaces should be repaired and prepped. An epoxy-based paint should be utilized in wet areas for durability.
