State of Nevada
Department of Wildlife

WINNEMUCCA SITE

Site Number: 9909

STATE OF NEVADA PUBLIC WORKS DIVISION FACILITY CONDITION ANALYSIS

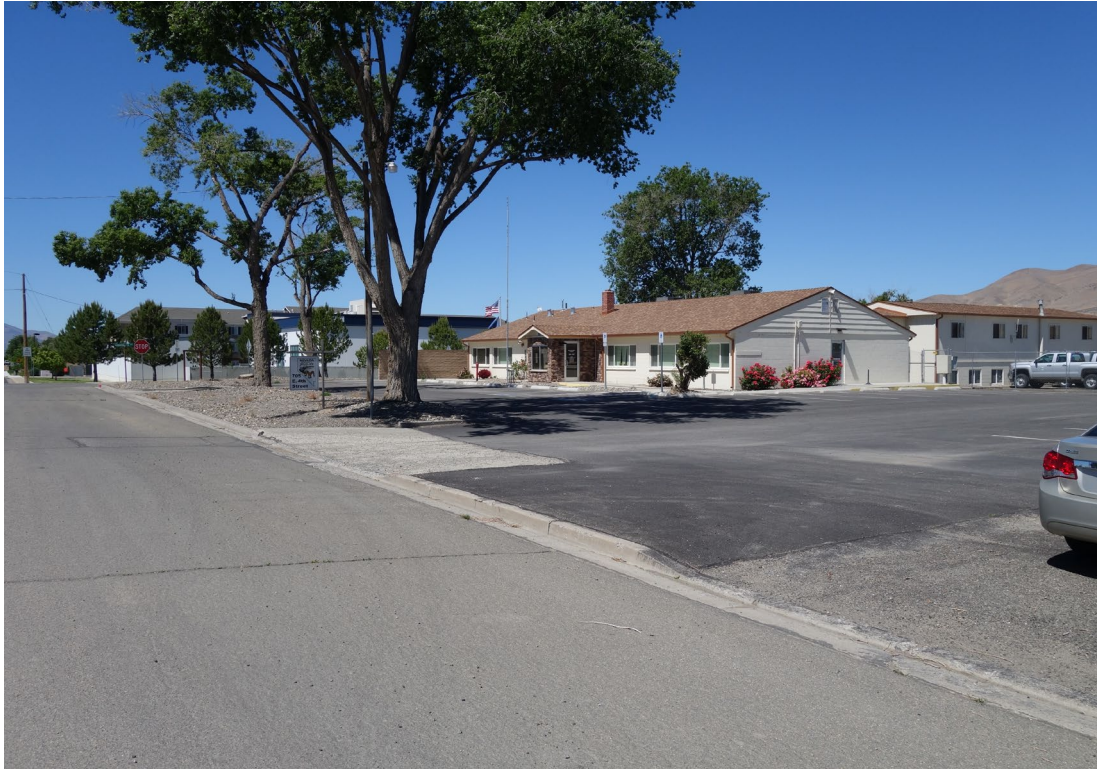
The concrete entrances to the parking lot of the Winnemucca Main Office Building has extensive cracking and spalling and is due for replacement. This project would provide for the installation of a new concrete slab-on-grade driveway at the entrances to the parking lot. Removal and disposal of the existing concrete is included in this estimate. This project or a portion thereof was previously recommended in the FCA report dated 05/11/2011. It has been amended accordingly to reflect conditions observed during the most recent survey date of 06/18/2020.

Winnemucca Site - Site #9909
Description: Concrete Apron Replacement.

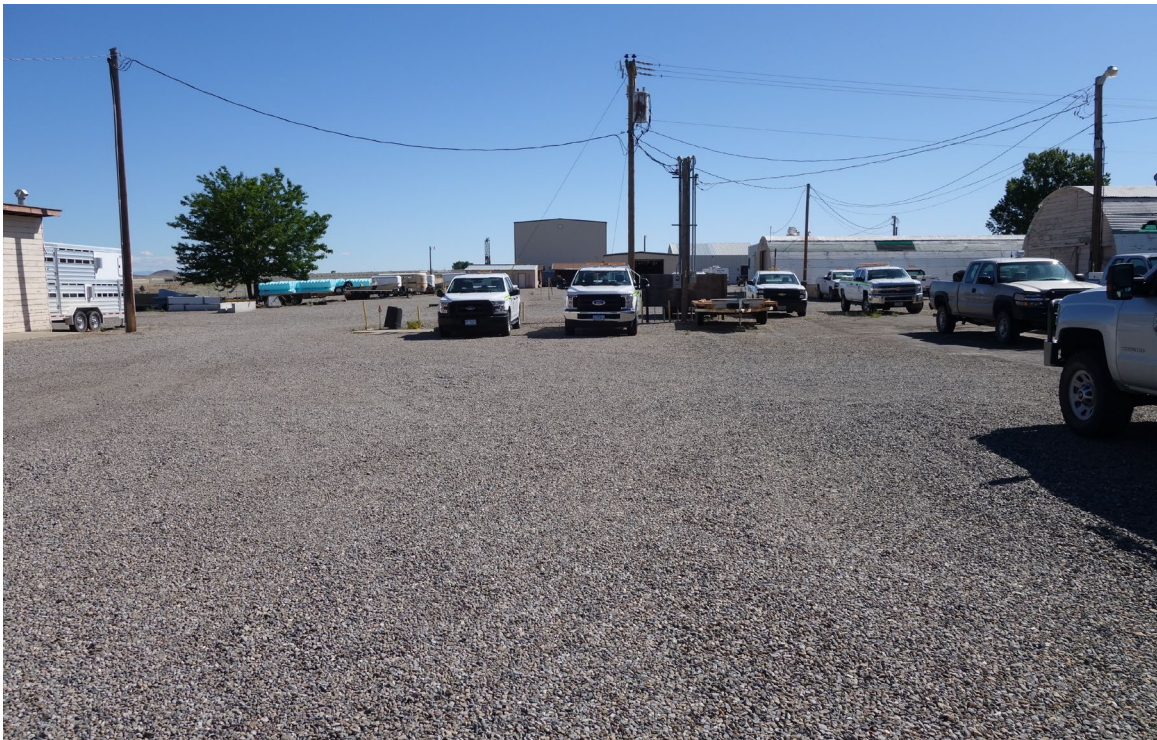
Winnemucca Site - Site #9909
Description: Typical Gravel Parking in the Wildlife Area of the Site.

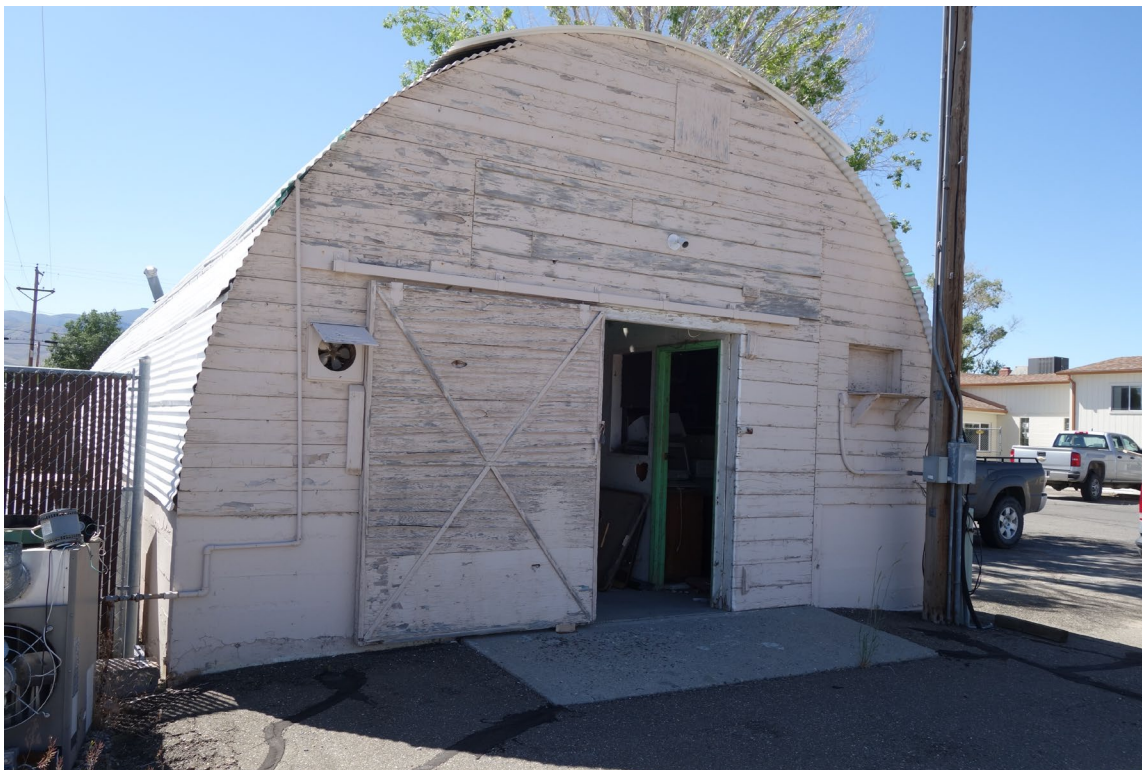
The structure is dilapidated and deteriorating and has reached the end of its useful life. The structure is over 50 years of age, has had continuous roof leaks. This project would provide funding for the demolition and disposal of the building.

Quonset Storage - Building #2447
Description: Exterior of the Building.

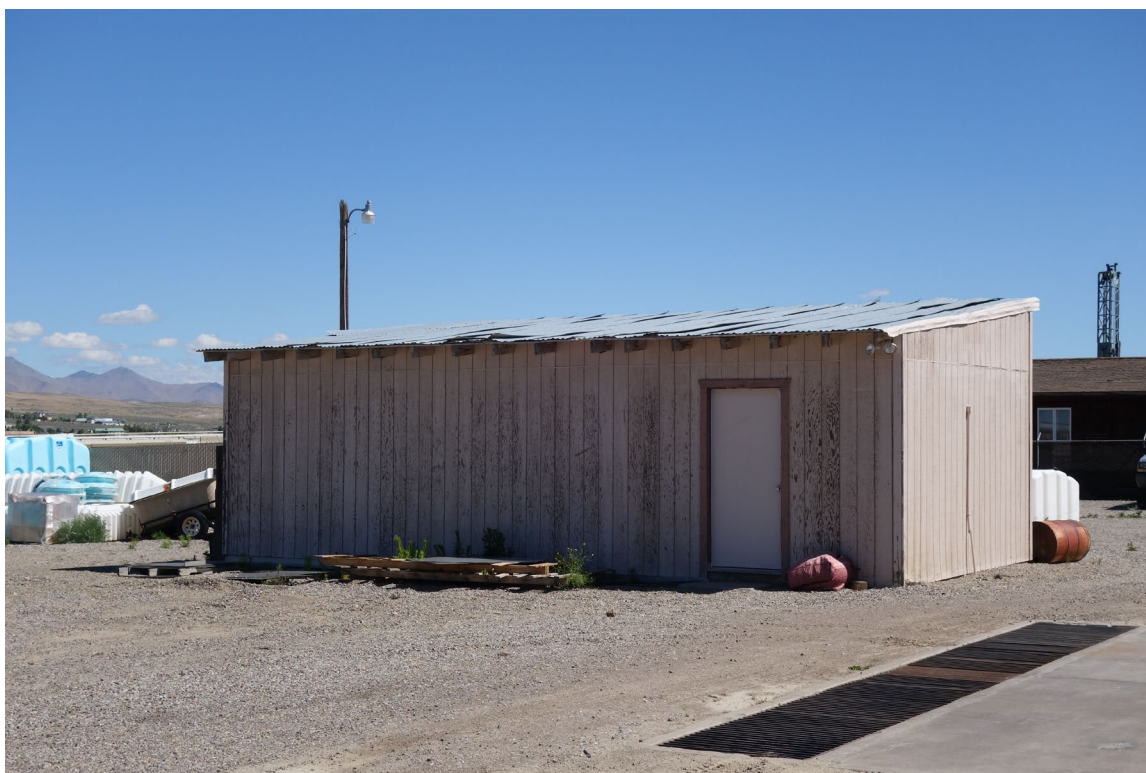
The corrugated metal roof on this building was in poor condition at the time of the survey and staff reported that there are active leaks. It is recommended that this building be re-roofed in the next 1-2 years with a standing seam metal roofing system. This estimate includes removal and disposal of the old roof.

The exterior finishes are in poor condition. It is important to maintain the finish, weather resistance, and appearance of the building. This project would provide funding to protect the exterior of the building excluding the roof. Included in the cost is sanding, priming and painting, and caulking of the windows, flashing, fixtures and all other penetrations. It is recommended that the building be painted in the next 2 -3 years and that this project be scheduled on a cyclical basis to maintain the integrity of the structure.

NDOW Gas Storage - Building #2446
Description: Exterior of the Building.

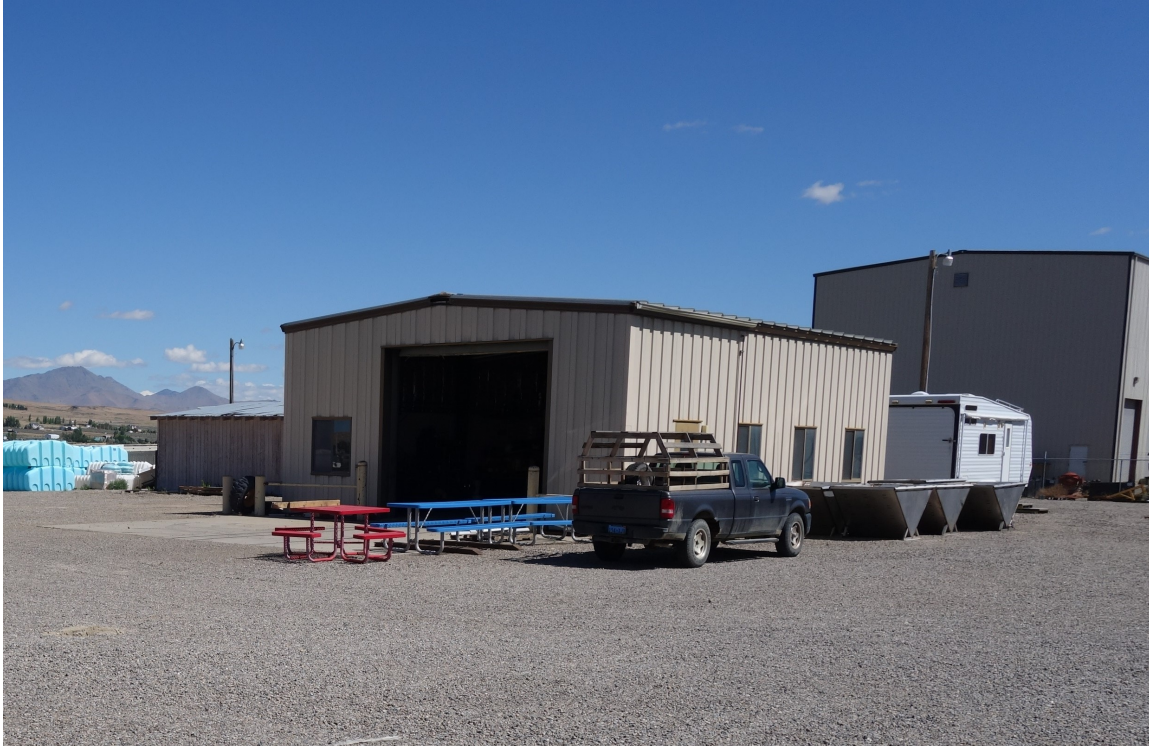
The two exterior metal man doors are damaged from age, general wear and tear, and are due for repairs. This project would provide for painting the doors and replacing the weather seals to maintain the doors in good working condition.

NDOW Shop - Building #2445
Description: Exterior of the Building.

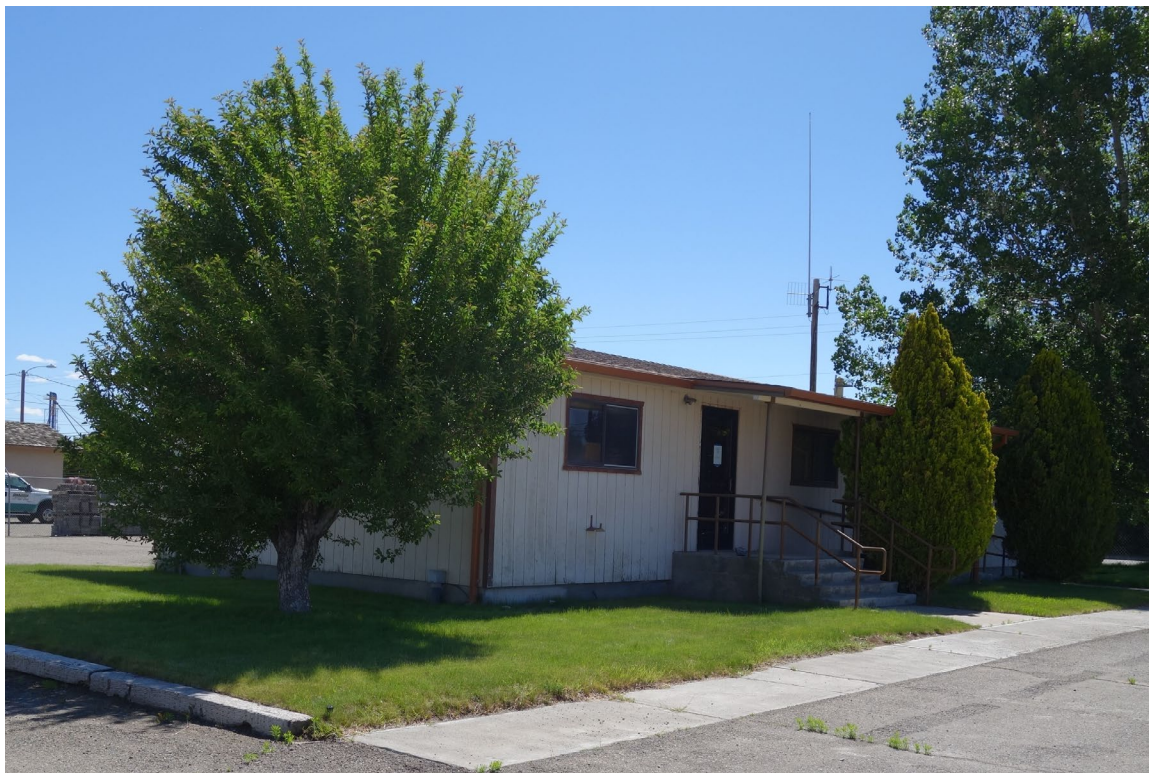
The exterior finishes are in poor condition. It is important to maintain the finish, weather resistance, and appearance of the building. This project would provide funding to protect the exterior of the building excluding the roof. Included in the cost is sanding, priming and painting, and caulking of the windows, flashing, fixtures and all other penetrations. It is recommended that the building be painted in the next 2 - 3 years and that this project be scheduled on a cyclical basis to maintain the integrity of the structure.

NDOW Office (Vacant) - Building #2444
Description: Exterior of the Building and Exterior Finishes.

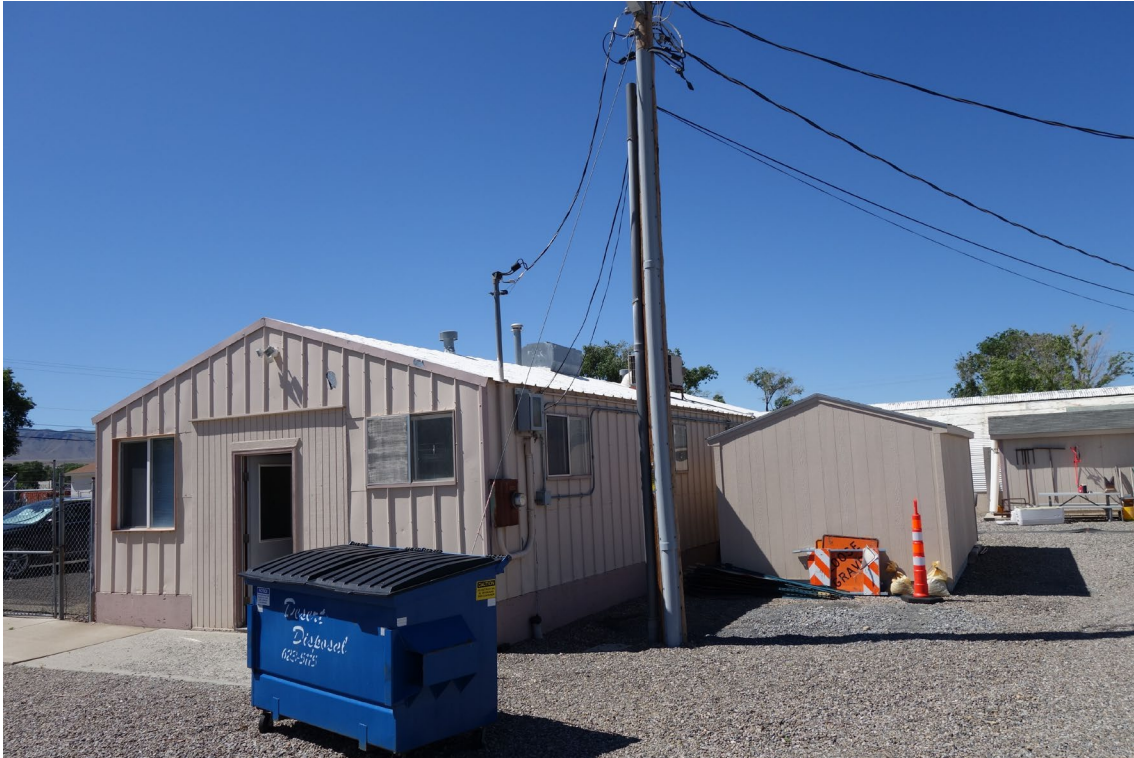
NDOT East Office Bldg. - Building #2443
Description: Exterior of the Building.

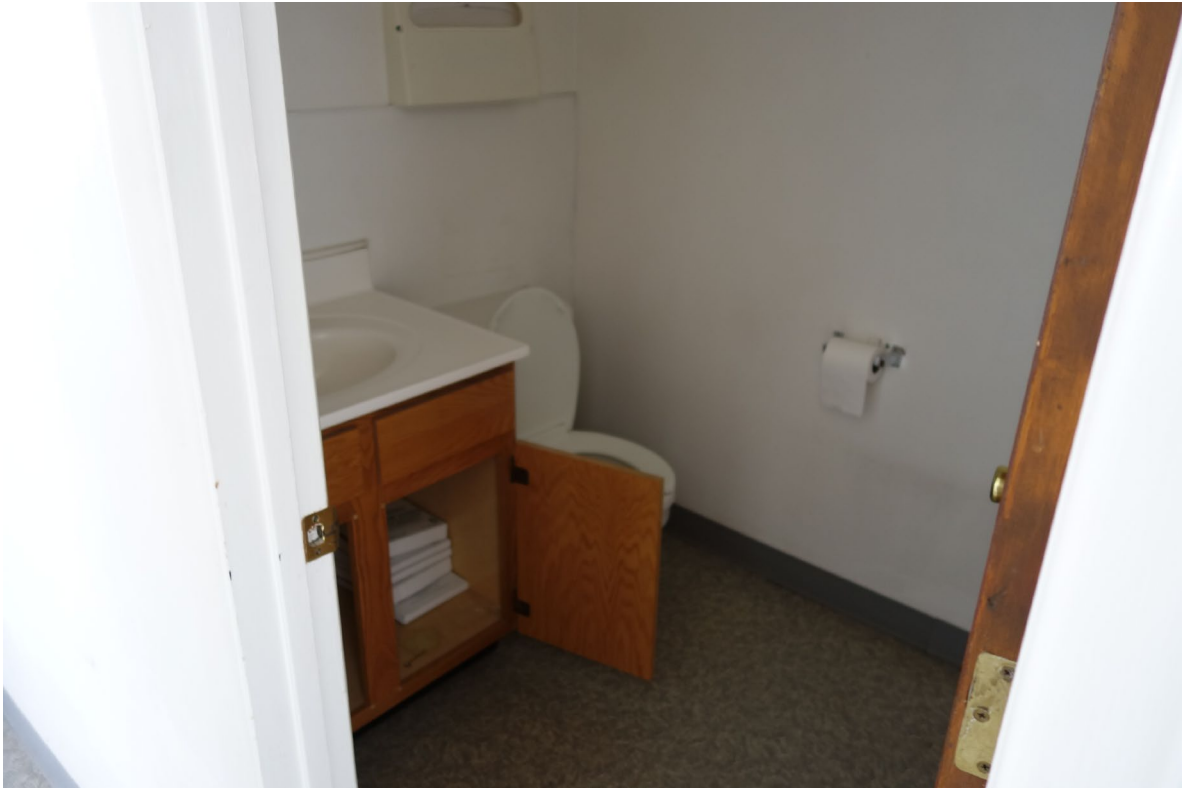
NDOT East Office Bldg. - Building #2443
Description: ADA Restroom Upgrade.

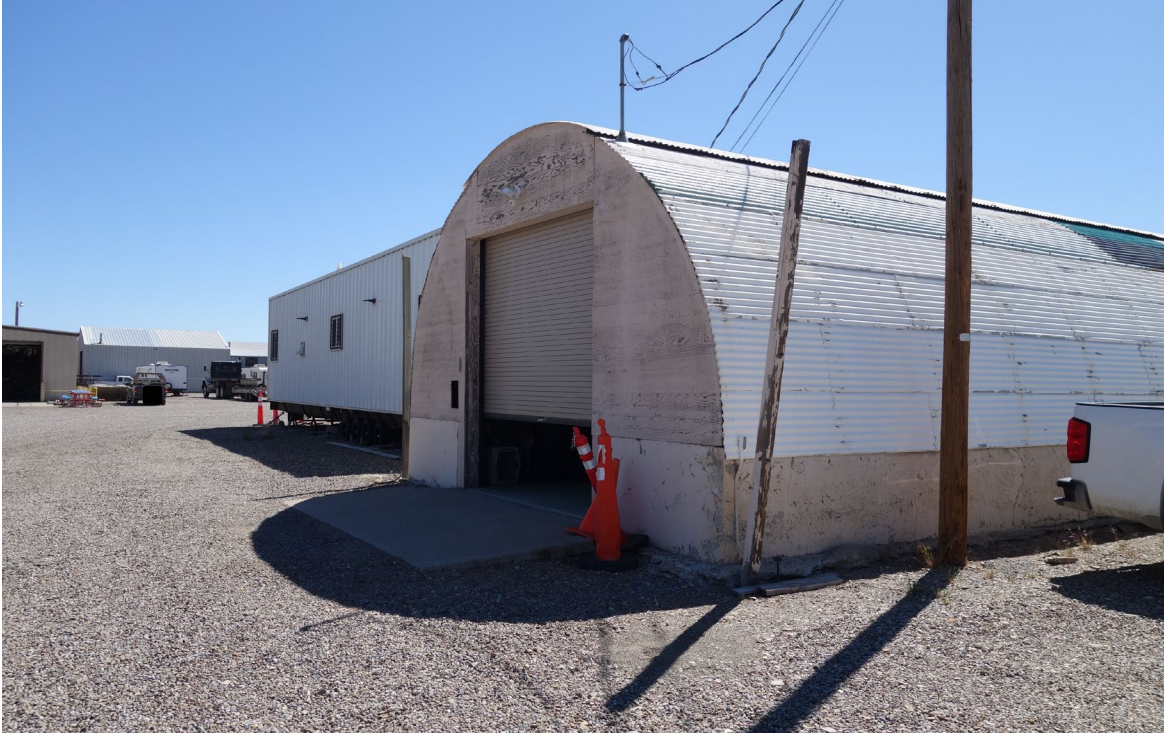
The exterior finishes on the ends of the building are in poor condition. It is important to maintain the finish, weather resistance, and appearance of the building. This project would provide funding to protect the exterior of the building excluding the roof. Included in the cost is painting the walls and caulking of the flashing, fixtures and all other penetrations. It is recommended that the building be painted and caulked in the next 2 - 3 years and that this project be scheduled on a cyclical basis to maintain the integrity of the structure.

The corrugated metal roof on this building was in poor condition at the time of the survey. It is recommended that this building be re-roofed in the next 2-3 years, including the fiberglass skylights. This estimate includes removal and disposal of the old roofing system.

NDOW Dry Storage Quonset - Building #2439
Description: Exterior of the Building.

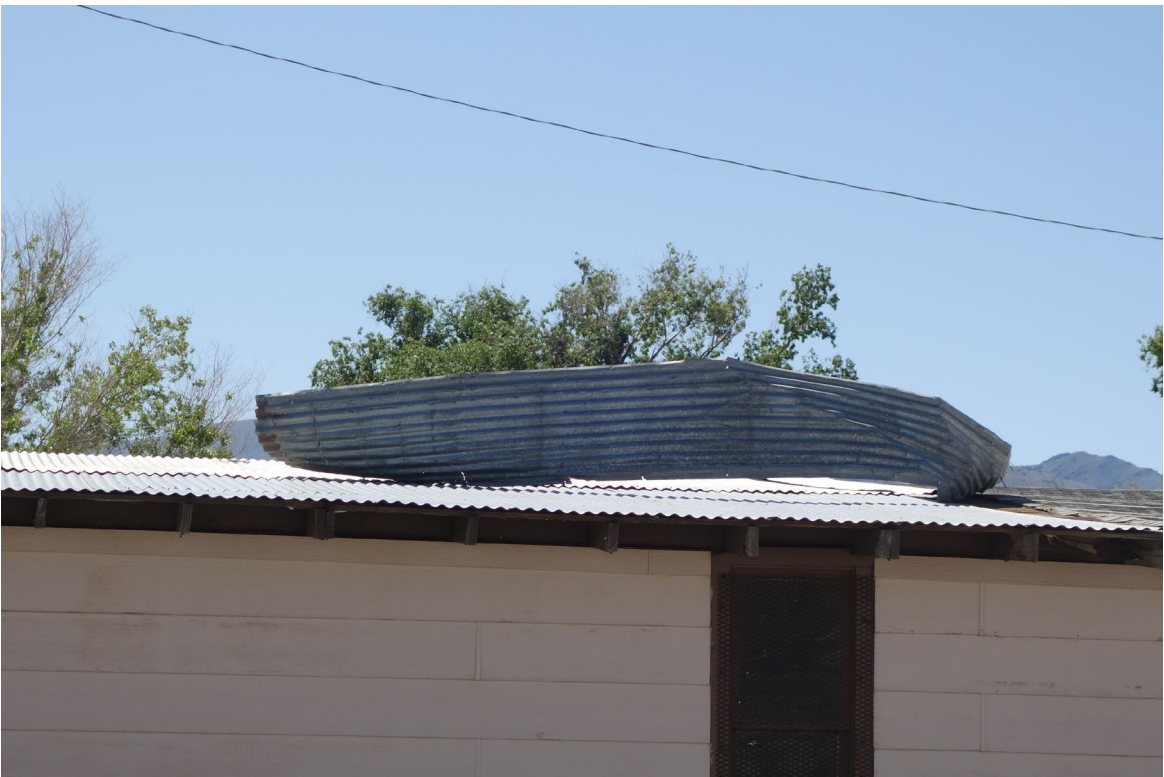
The corrugated metal on this building was in poor condition at the time of the survey and is showing signs of leaking. It is recommended that this building be re-roofed in the next 2 - 3 years with a standing seam metal roofing system. This estimate includes removal and disposal of the old roofing system.

NDOW Lean-To Storage - Building #2436
Description: Roof Replacement.

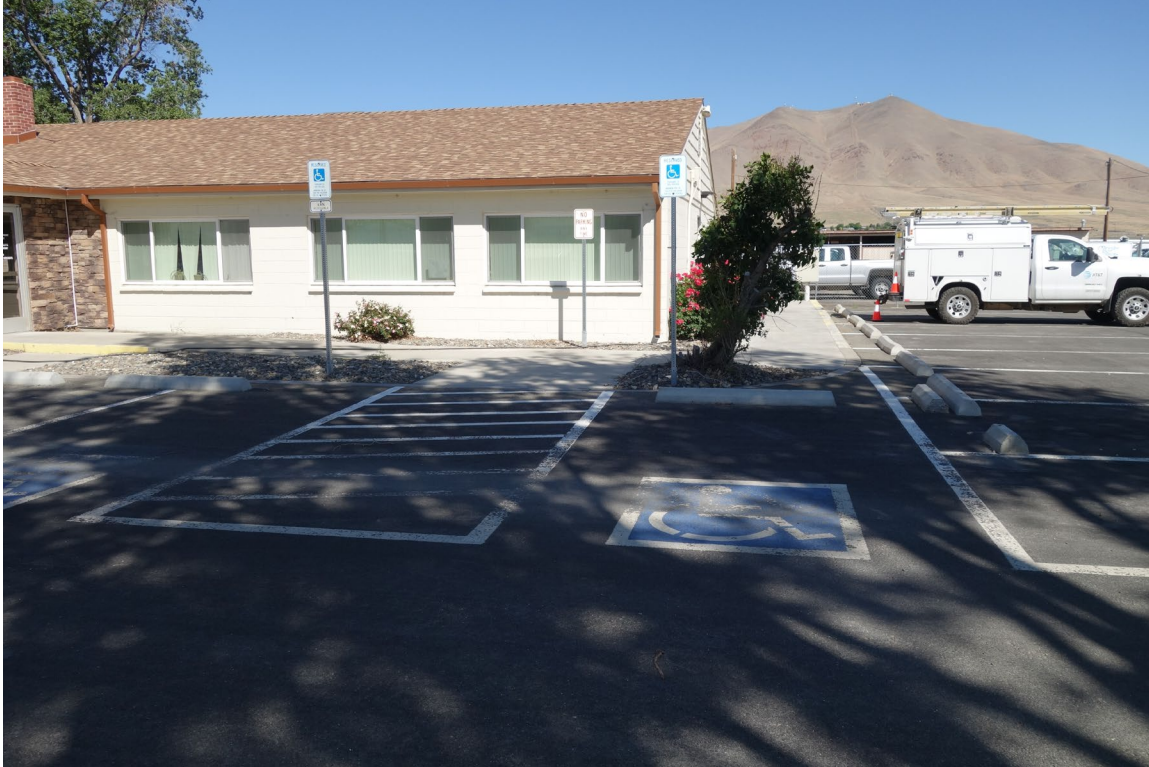
Winnemucca Main Office Bldg. - Building #2433
Description: Exterior of the Building and Accessible Parking.

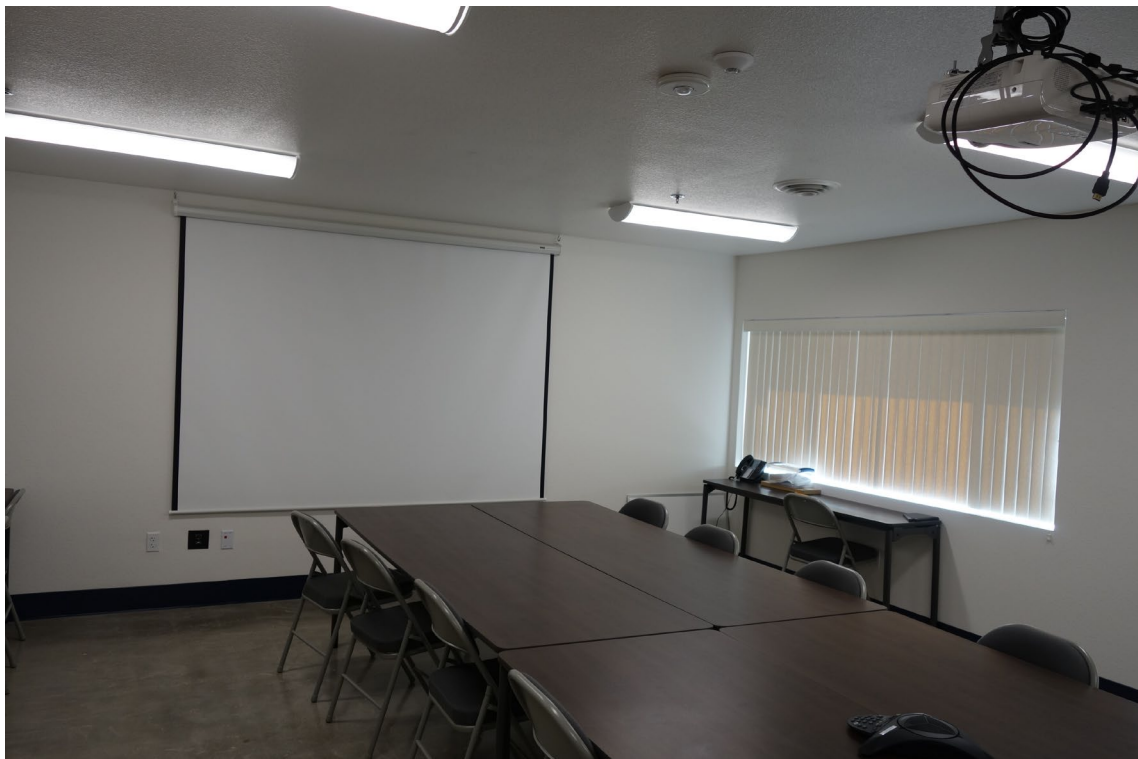
The single story portion of the building has been newly renovated; however, the floors were left as polished concrete. Acoustically, this is a difficult environment to work in due to hard surfaces on the floor, walls and hard-lid ceiling, and lack of sound absorbing materials. To address this issue, it is recommended that carpet or carpet tiles be installed with a high Noise Reduction Coefficient (NRC).

Winnemucca Main Office Bldg. - Building #2433
Description: Carpet Installation (Acoustical Issues).

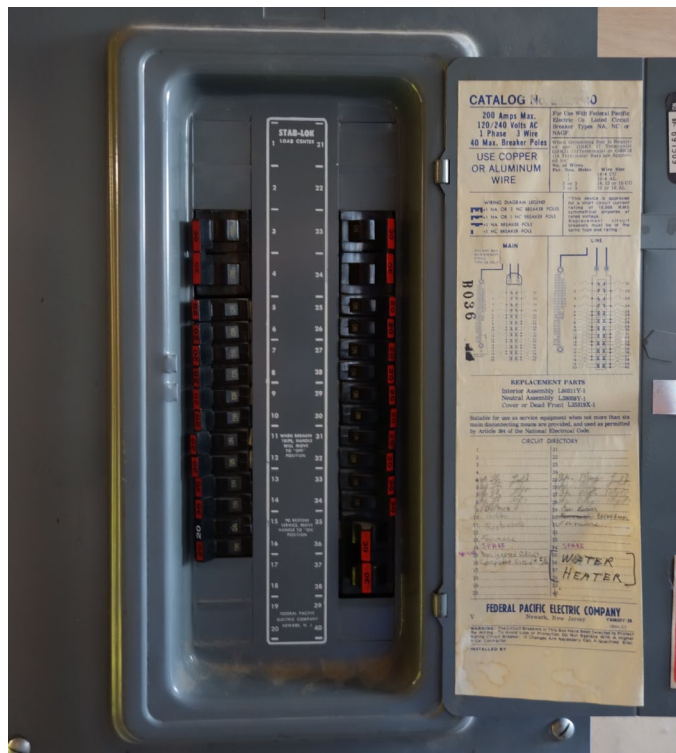
The electrical panel on the second floor is recognized as a safety hazard. Federal Pacific Stab-Loc panels were part of a safety recall and should be replaced. Additionally, complaints by local staff indicate nuisance trips of the 30 amp breaker in this panel feeding the water heater. This project would provide funding for the installation of a replacement breaker panel, investigate and solve the cause of the nuisance trips, and removal and disposal of the existing panel.

Winnemucca Main Office Bldg. - Building #2433
Description: Electrical Panel Upgrade.
