State of Nevada
Office of the Military
Nevada National Guard

HENDERSON ARMORY SITE

**STATE OF NEVADA PUBLIC WORKS DIVISION
FACILITY CONDITION ANALYSIS**

Survey Date: 12/14/2016

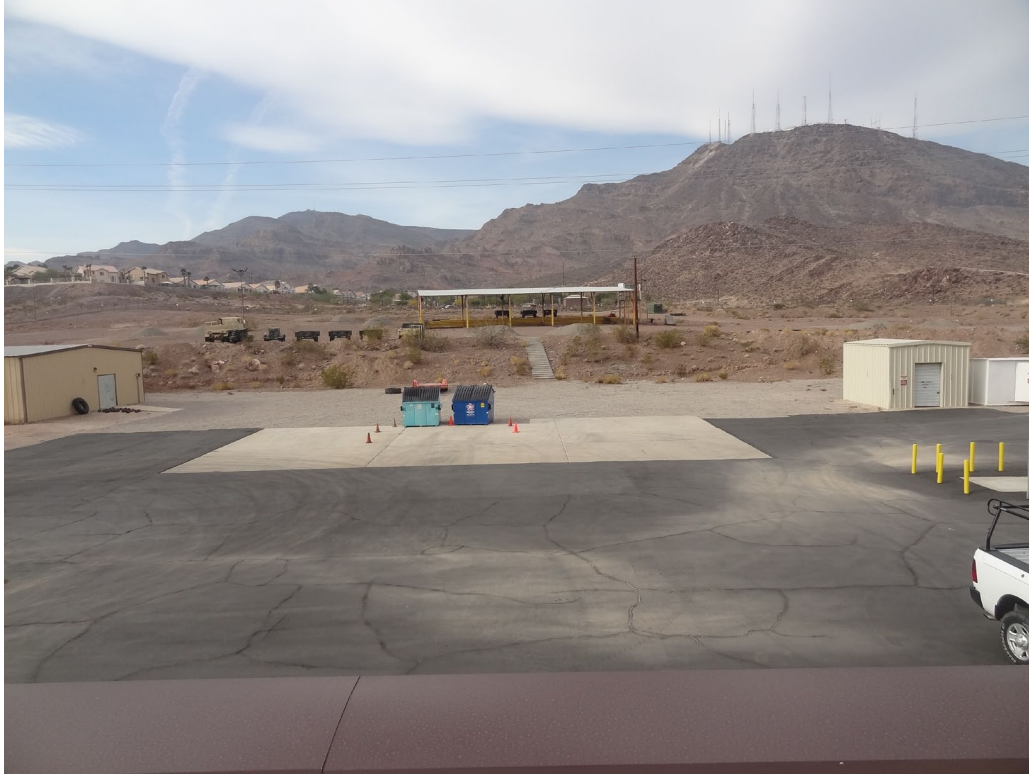
It is important to maintain the asphalt concrete paving on the site. This project would provide for minor crack filling and sealing of the paving site wide including access roads and parking areas. Striping is included in this estimate. This project should be scheduled on a 5 year cyclical basis to maintain the integrity of the paving and prevent premature failure. 100,000 square feet of asphalt area was used to generate this estimate. It is recommended that this project coincide with the ADA Accessible Path of Travel project.

Henderson Armory – Site #9912
Description: Crack Fill & Seal Asphalt Paving.

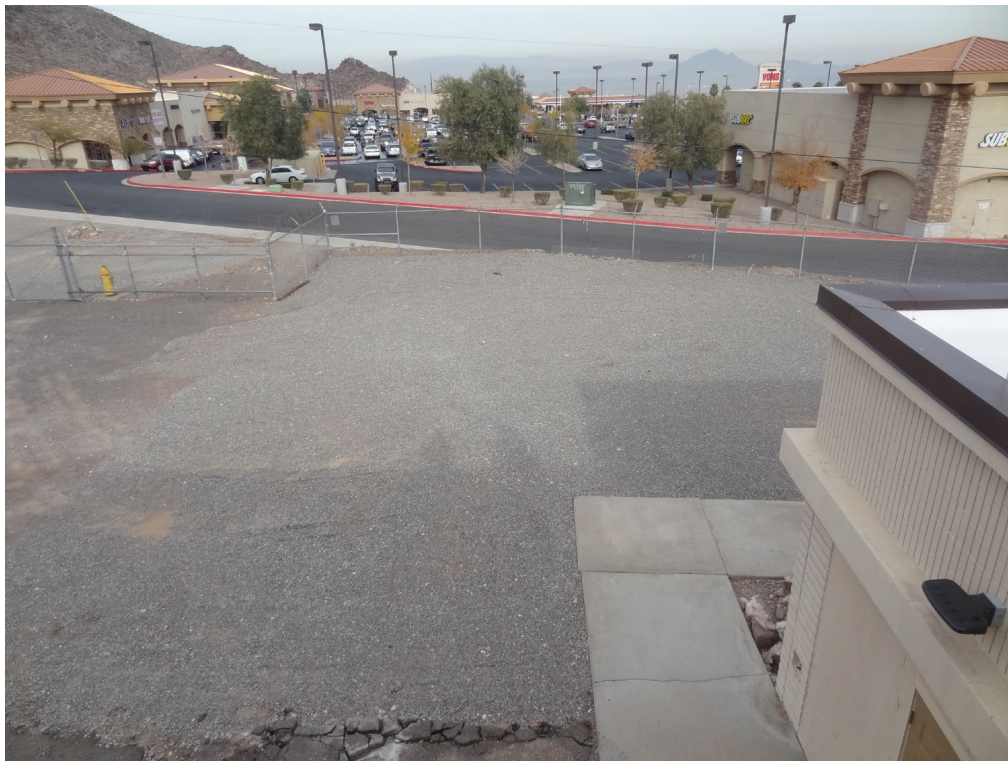
On the north and south sides of the site, the dirt banks are eroding to the sidewalk and parking area. This is now causing damage to the site parking and public sidewalks. There have been several minor improvements accomplished to control the situation, but it is apparent that a major improvement must happen in order to protect the site from permanent damage. This project recommends installing retaining walls in order to provide proper drainage and erosion control. The estimate is based on a 1000 foot long, 5'-0" high reinforced concrete masonry unit retaining wall.

Henderson Armory - Site #9912
Description: Erosion Control Needed on North and South Sides.

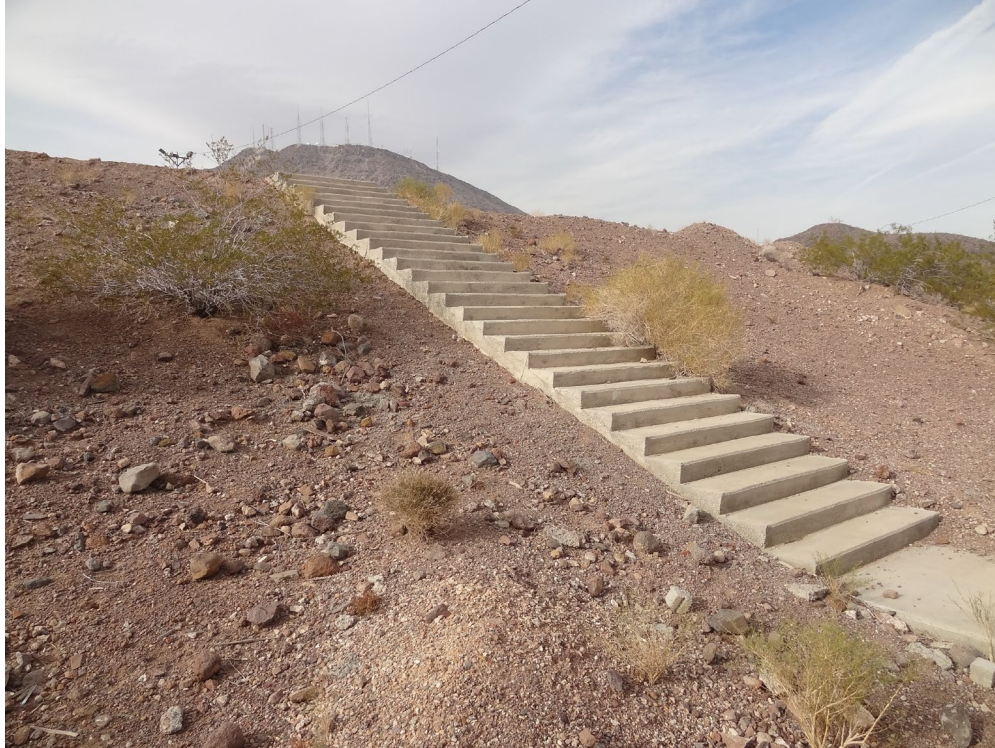
There are two sets of concrete stairs on the west side of the property that are lacking handrails as required in the 2018 IBC Chapter 10, Section 1012. The stairs connect the lower east side of the property to the higher west side. This project would provide for tubular steel framed handrails to be installed in accordance with code. If the vertical rise exceeds 12 feet, the entire stairway will need to be removed and replaced with a stair landing at the midpoint. Field verification will need to be done to estimate the vertical rise from the upper landing to the lower landing.

Henderson Armory - Site #9912
Description: Exterior Stair Handrail Installation.

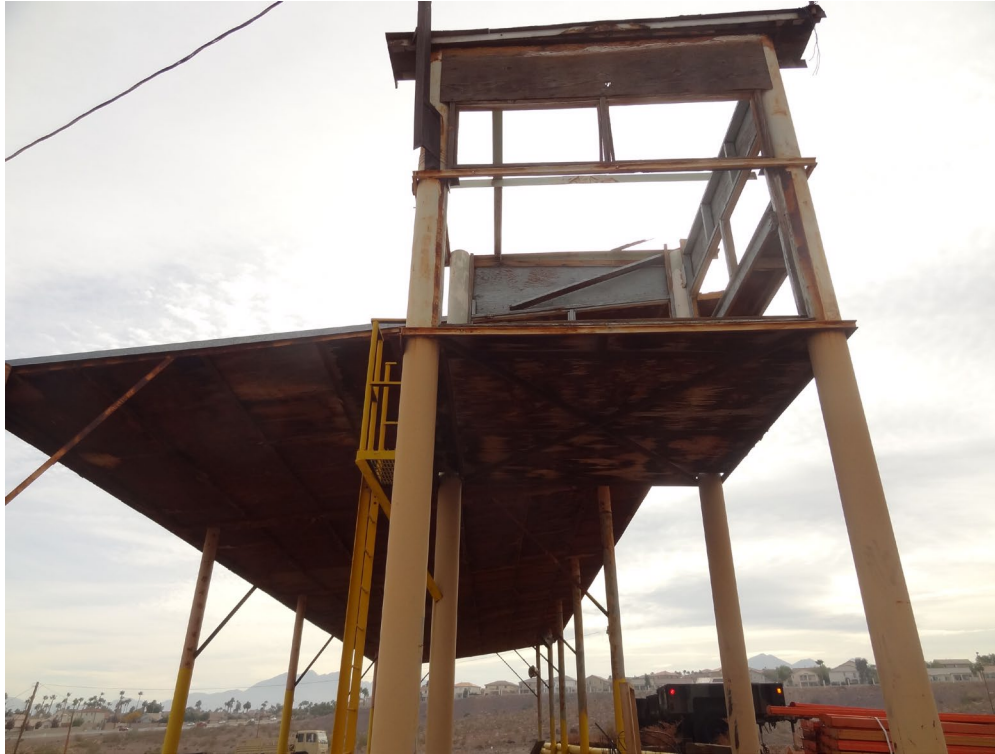
The tower is missing a solid wall or guardrail on one side of the platform. This project recommends the installation of a wall or guardrail to form a protective barrier along the open side.

Henderson Armory Range Tower - Building #2412
Description: Guardrail Installation.

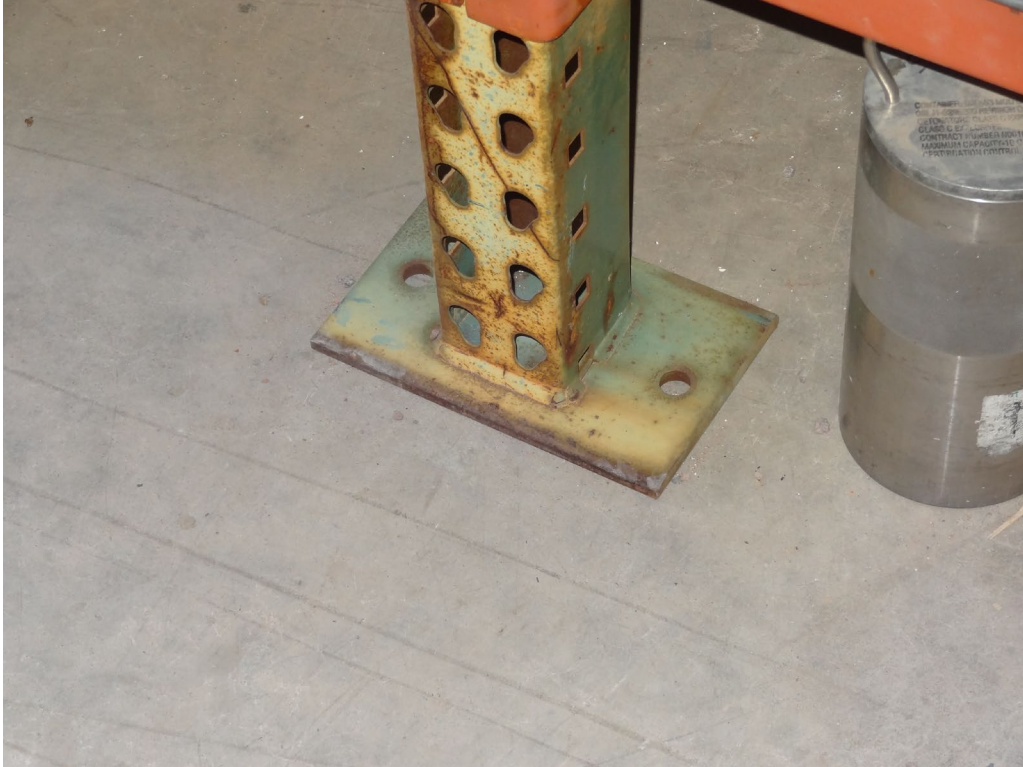
OSHA recommends that the bottom of all columns be furnished with column base plates, and be anchored to the floor with anchor bolts capable of resisting the forces caused by the loads on the shelving unit. Per OSHA standard 1926.250(a)(1), All materials stored in tiers shall be stacked, racked, blocked, interlocked, or otherwise secured to prevent sliding, falling or collapse. This project would provide for a licensed contractor to install anchor bolts and properly secure the shelving units to the floor and to the other shelves. This project should be overseen by a licensed engineer or architect.

Henderson Armory Butler Building #1 South - Building #0682
Description: Shelves Missing Proper Anchoring.

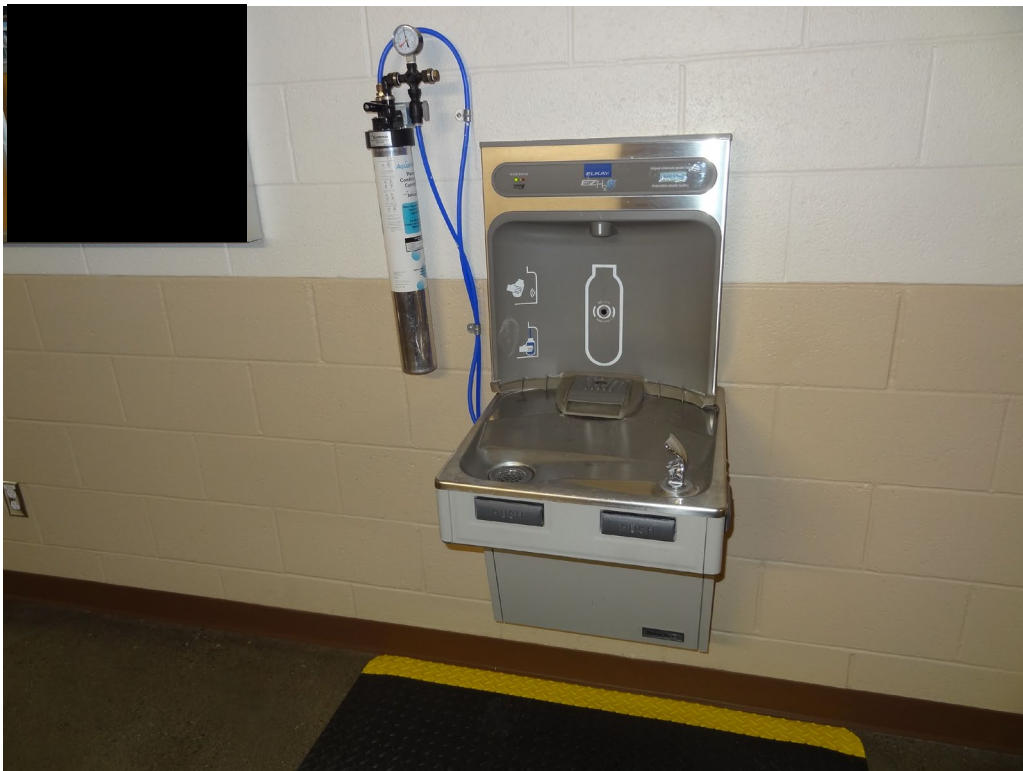
Henderson Armory - Building #0680
Description: Dual Level Drinking Fountain Installation Needed.

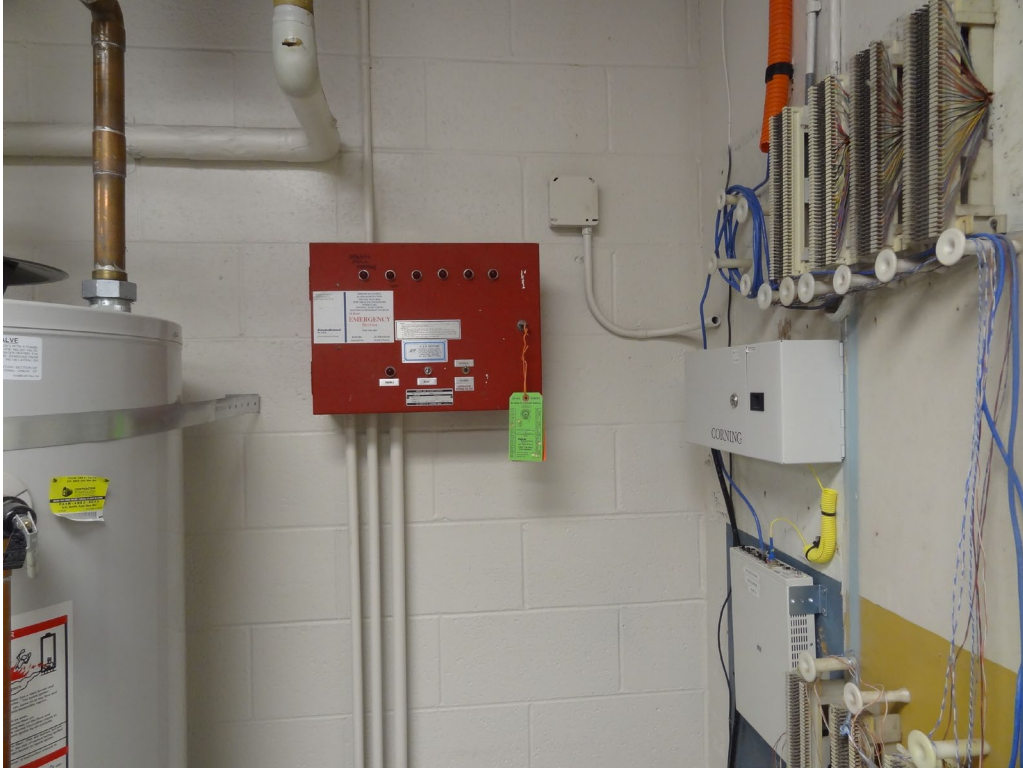
This building is equipped with an automatic fire detection and alarm system that no longer complies with current requirements. It is recommended that the system be upgraded to current requirements to ensure the safety of the occupants. Also, according to NAC 477.917 If the value of individual or cumulative additions, alterations and repairs to a building or structure in any 12-month period exceeds 50 percent of the value of the building or structure at the commencement of the 12-month period, the building or structure must conform to the requirements for a new building or structure. When completed, the new system will provide visual, as well as audible notification, in accordance with the 2018 IBC Chapter 9, Section 907 and the State Fire Marshal's requirements.

Henderson Armory - Building #0680
Description: Fire Alarm System Upgrades Needed.

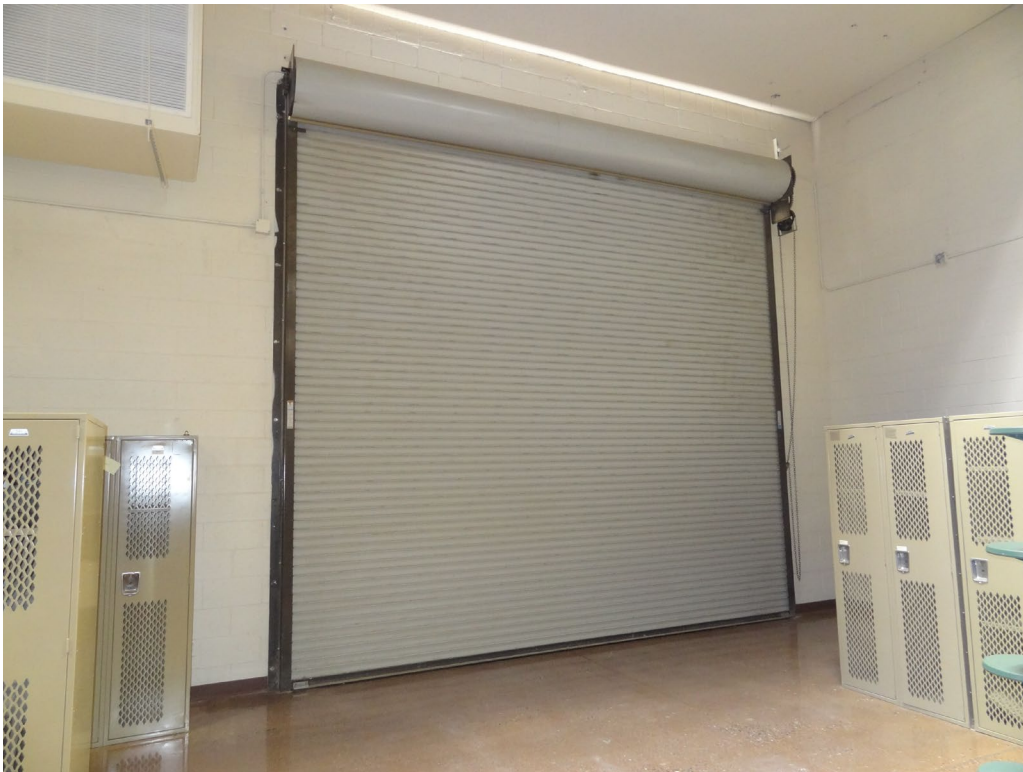
There is one 16'x14' and three 8'x10' overhead coiling doors on the building. They are not insulated and the weather stripping is damaged or missing causing heat loss in the winter and cooling loss in the summer. It is recommended to replace the doors with insulated doors and install new weather stripping. The door frames and mechanical equipment can be re-used with the new doors. This project would provide for the removal and disposal of the roll-up doors and installation of new doors.

Henderson Armory - Building #0680
Description: Overhead Door Replacement Needed.

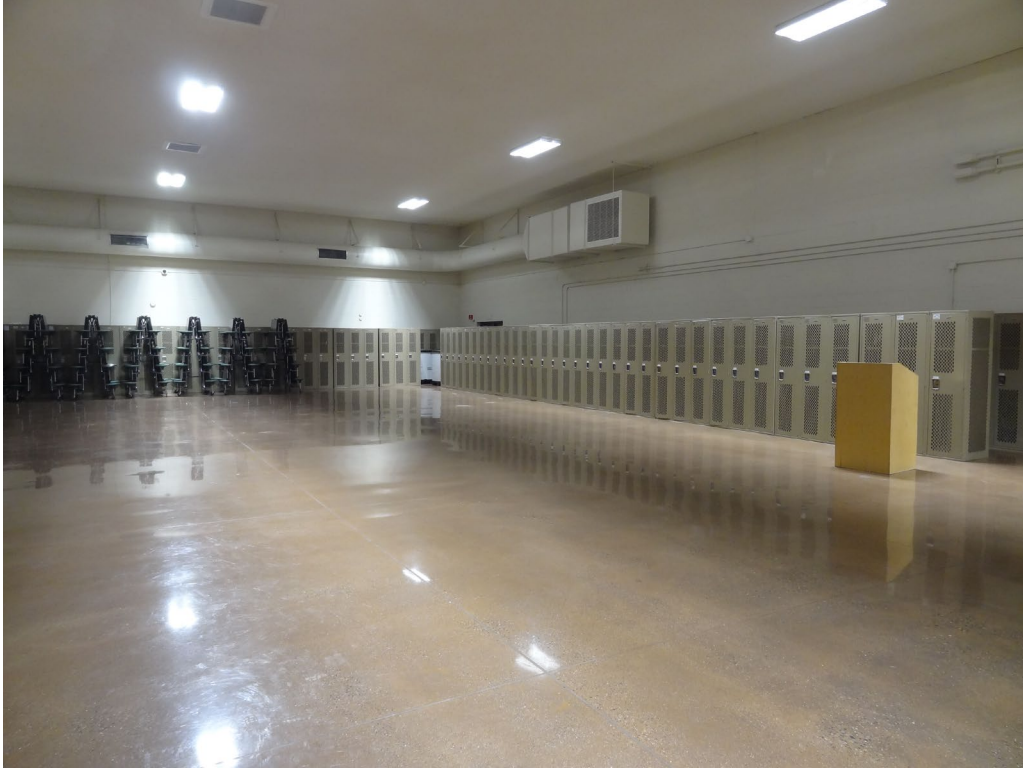
Henderson Armory - Building #0680
Description: Interior Finishes.

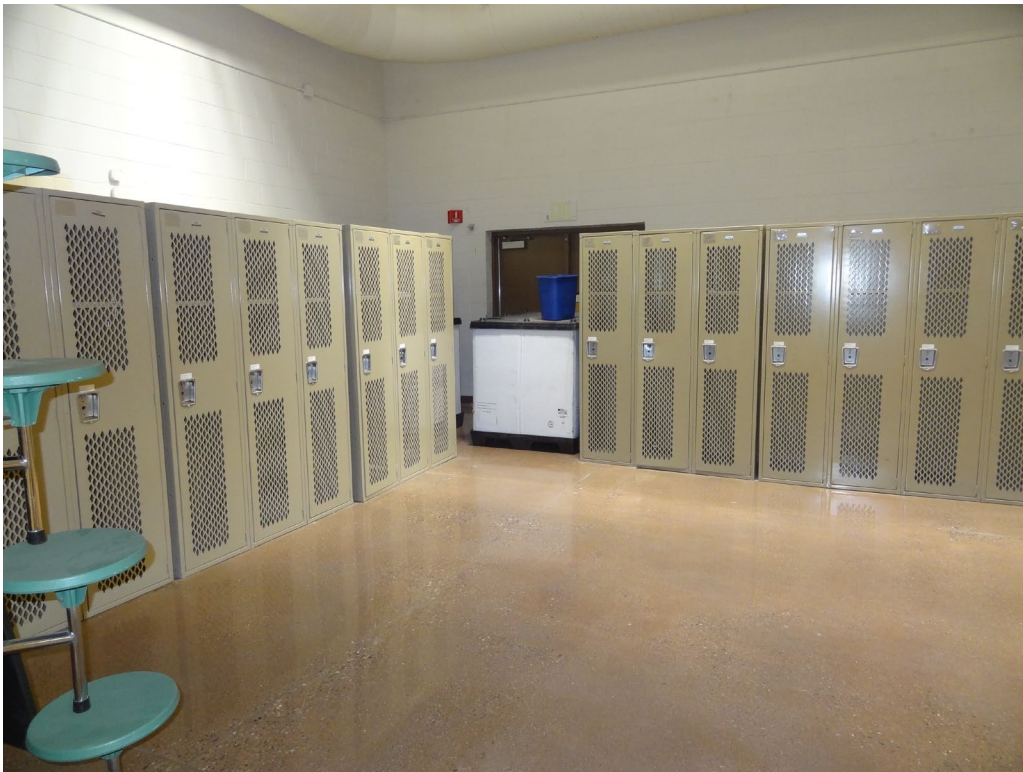
Henderson Armory - Building #0680
Description: Storage Removal Needed.

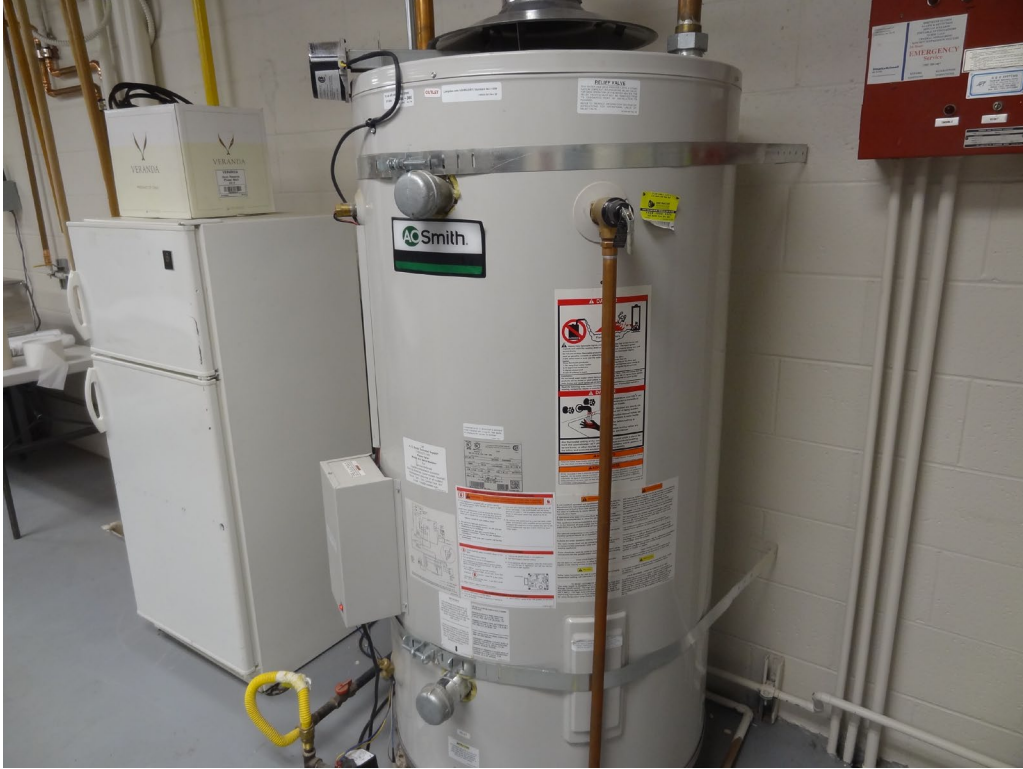
There is a 118 gallon natural gas-fired water heater in the building. The average life span of a water heater is eight to ten years. With the passage of time and constant use, this unit is showing signs of wear and should be scheduled for replacement in the next 2-3 years. It is missing proper seismic bracing and an expansion tank. It is recommended that a new gas-fired water heater be installed. Removal and disposal of the existing equipment is included in this estimate.

Henderson Armory - Building #0680
Description: Water Heater Replacement Needed.
