# **OLD LAS VEGAS MORMON FORT STATE HISTORIC PARK**

**Site Number: 9913**  
**STATE OF NEVADA PUBLIC WORKS DIVISION**  
**FACILITY CONDITION ANALYSIS**

Report distributed in October 2021

Survey Date: 12/12/2017

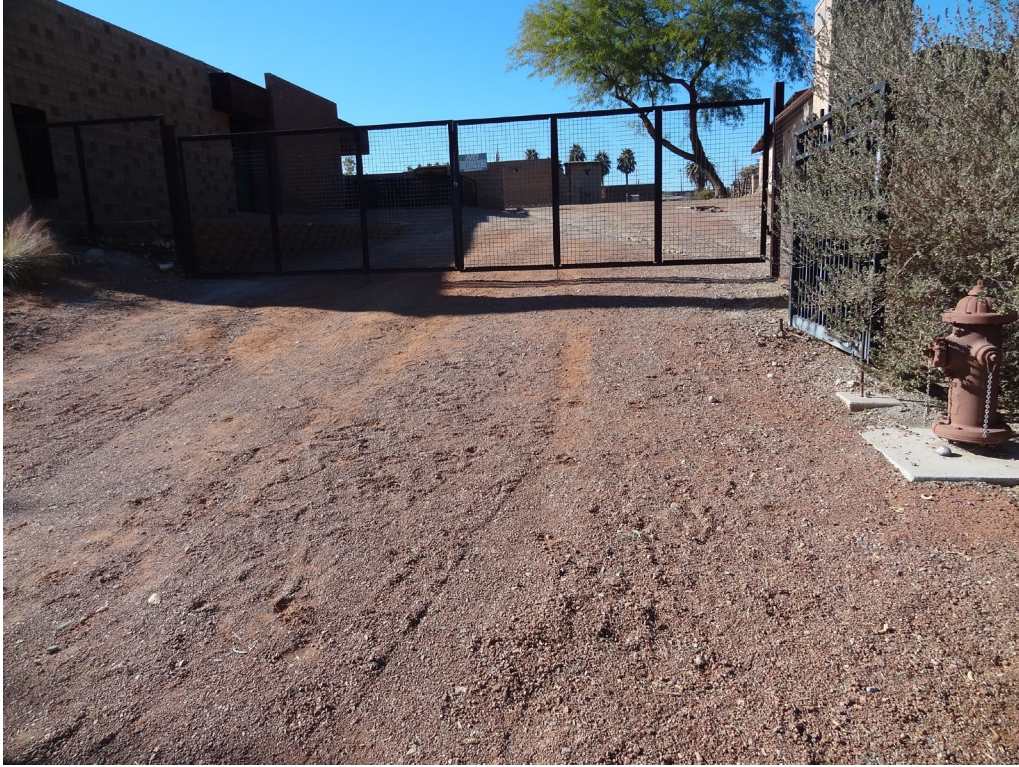
Old Las Vegas Mormon Fort State Historical Park - Site #9913  
Description: Paving Access Road Recommended.

It is important to maintain the asphalt concrete paving on the site. This project would provide for minor crack filling and sealing of the paving site wide including access roads, parking areas and the maintenance yard. Striping is included in this estimate. This project should be scheduled on a 5 year cyclical basis to maintain the integrity of the paving and prevent premature failure. 100,000 square feet of asphalt area was used to generate this estimate.

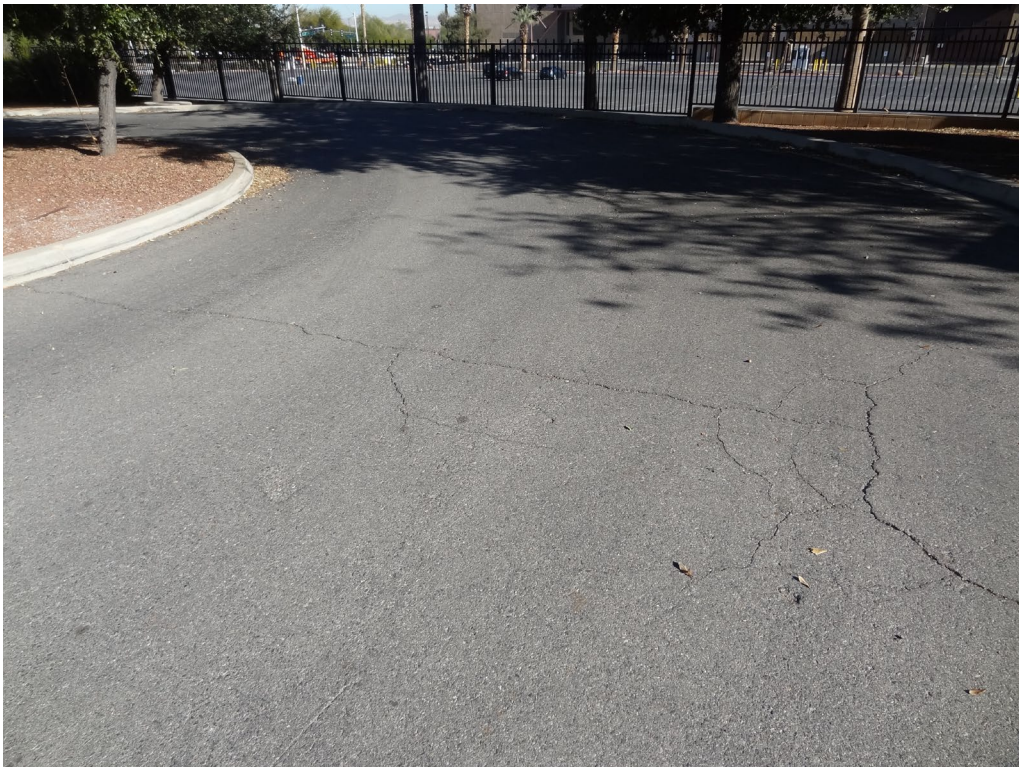
Old Las Vegas Mormon Fort State Historical Park - Site #9913  
Description: Crack Fill & Slurry Seal Needed.

It is important to maintain the asphalt concrete paving on the site. This project would provide for minor crack filling and fog sealing of the paved parking lot. Striping is included in this estimate. This project should be scheduled on a 5 year cyclical basis to maintain the integrity of the paving and prevent premature failure. 25,000 square feet of asphalt area was used to generate this estimate.

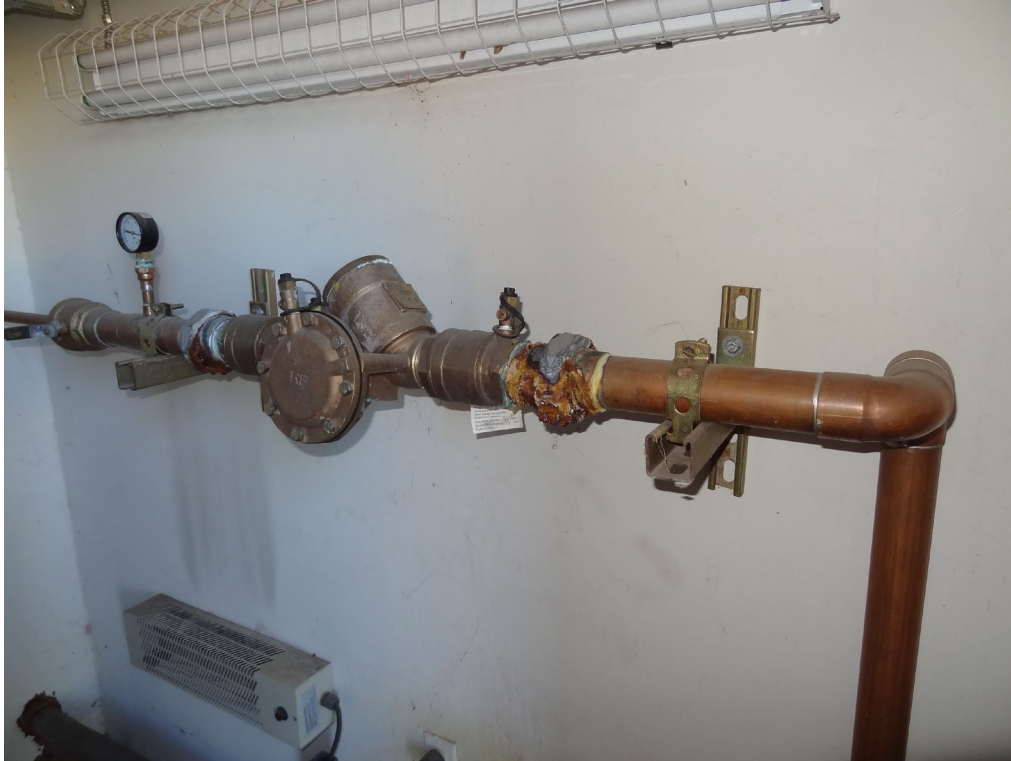
There is a backflow preventer on the main water line coming into the building. It is leaking and should be scheduled for replacement. There may be a pressure problem with the incoming water main. The psi valve is maxed out indicating the pressure is above 100 psi. This may be the cause of the broken prevention valve and should be analyzed by a licensed plumber. This project would provide for employing a licensed plumber to replace the backflow preventer and to analyze the system.

Mormon Fort Visitor's Center - Building #1681  
Description: Leaking Back Flow Prevention Assembly.

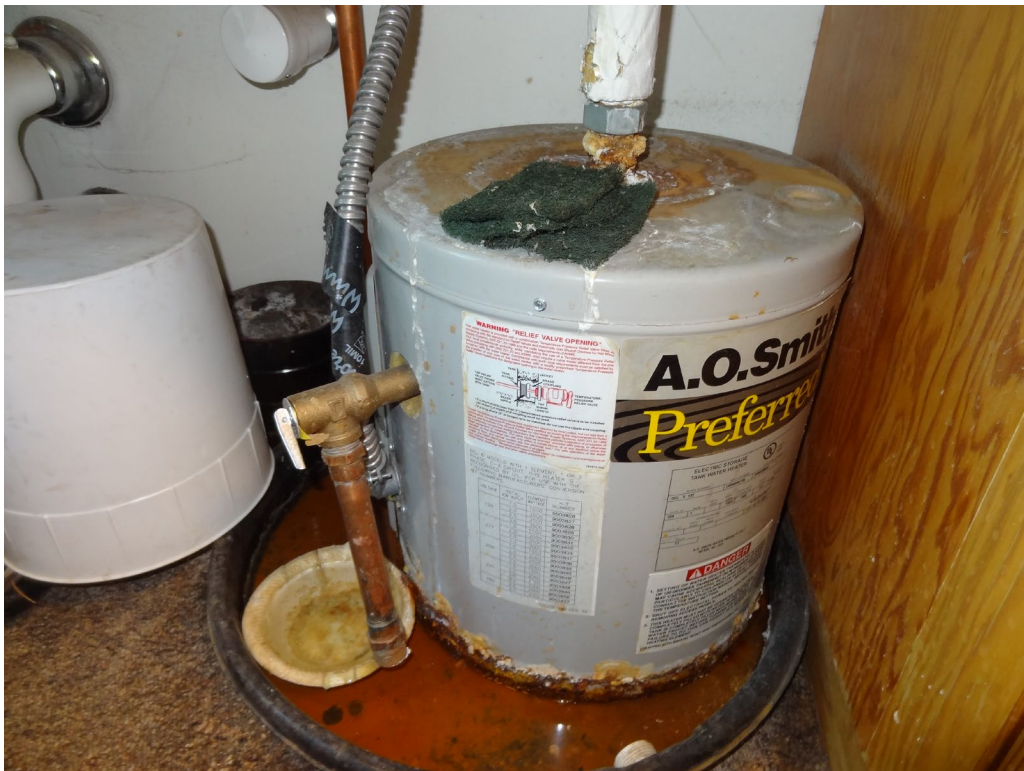
There is a 5 gallon electric water heater in the building. The average life span of a water heater is eight to ten years. With the passage of time and constant use, this unit is showing signs of wear and should be scheduled for replacement in the next 2-3 years. It is recommended that a new on-demand electric water heater be installed. Removal and disposal of the existing equipment is included in this estimate.

Mormon Fort Visitor's Center - Building #1681  
Description: Water Heater Replacement Needed.

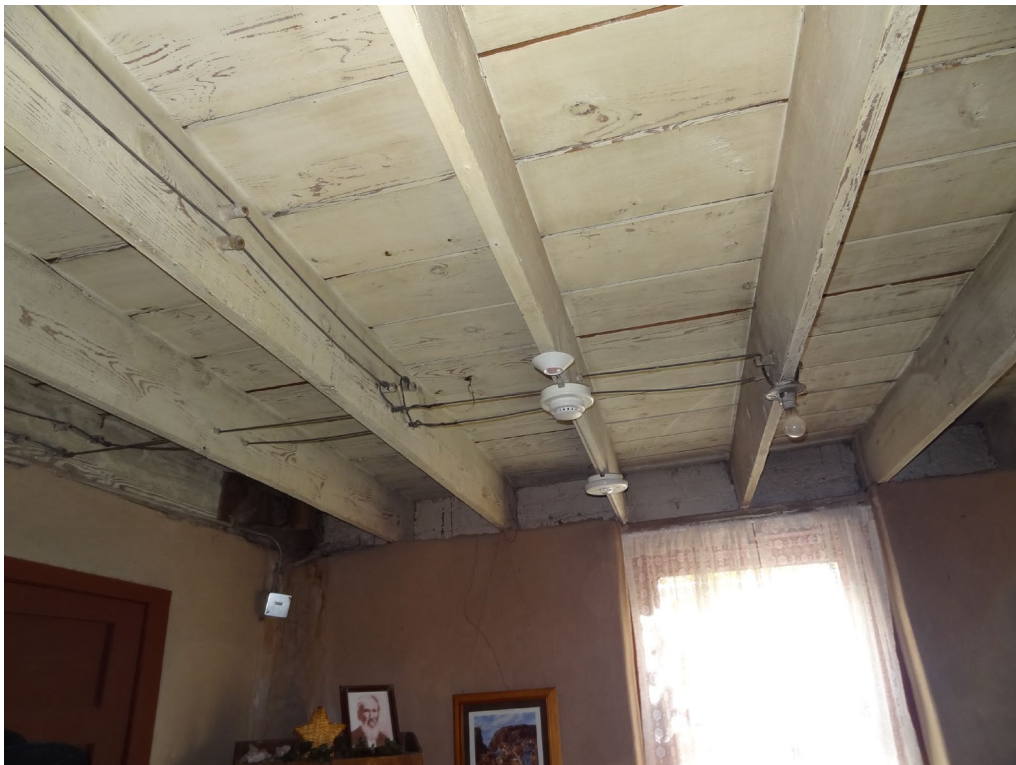
The building is equipped with a knob and tube electrical system. This type of system is no longer used and replacement parts are impossible to find. The main disadvantage of this electrical system is that there is no safety grounding conductor. Also, as the cotton and rubber wire insulation ages, it becomes dry and brittle and becomes easily damaged. It is recommended the entire system be upgraded to a modern electrical system. The existing knob and tube system could remain in place to display the historical nature of the Museum. Due to the historical nature of the building, this project is subject to review and approval from the State Historical Preservation Office.

Historic Fort Museum - Building #1905  
Description: Electrical Upgrade Needed.

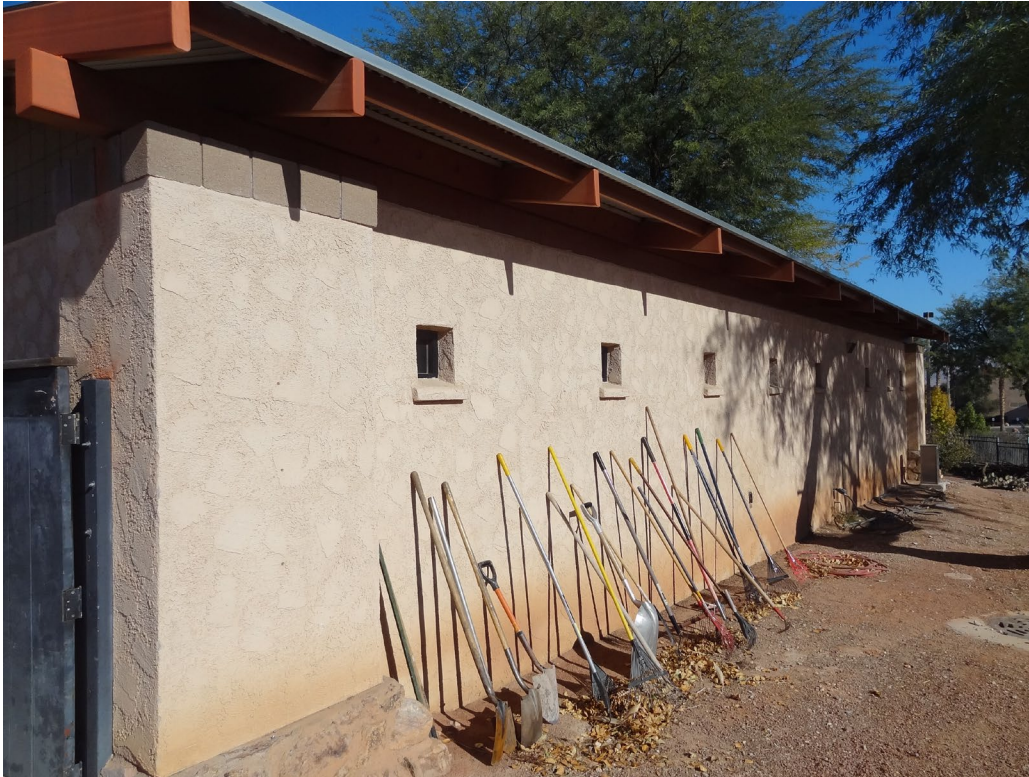
The building does not have gutters or downspouts to control the runoff from the roof. The water currently sheet drains off the roof causing extensive erosion to the built-up dirt slope around the foundation. This will eventually lead to failure of the foundation undermining the integrity of the entire structure. This project would provide funding for the installation of a seamless gutter and downspout system for the building.

Mormon Fort Vehicle Shop - Building #2397  
Description: Exterior of the Building & Need for Drain Gutters.

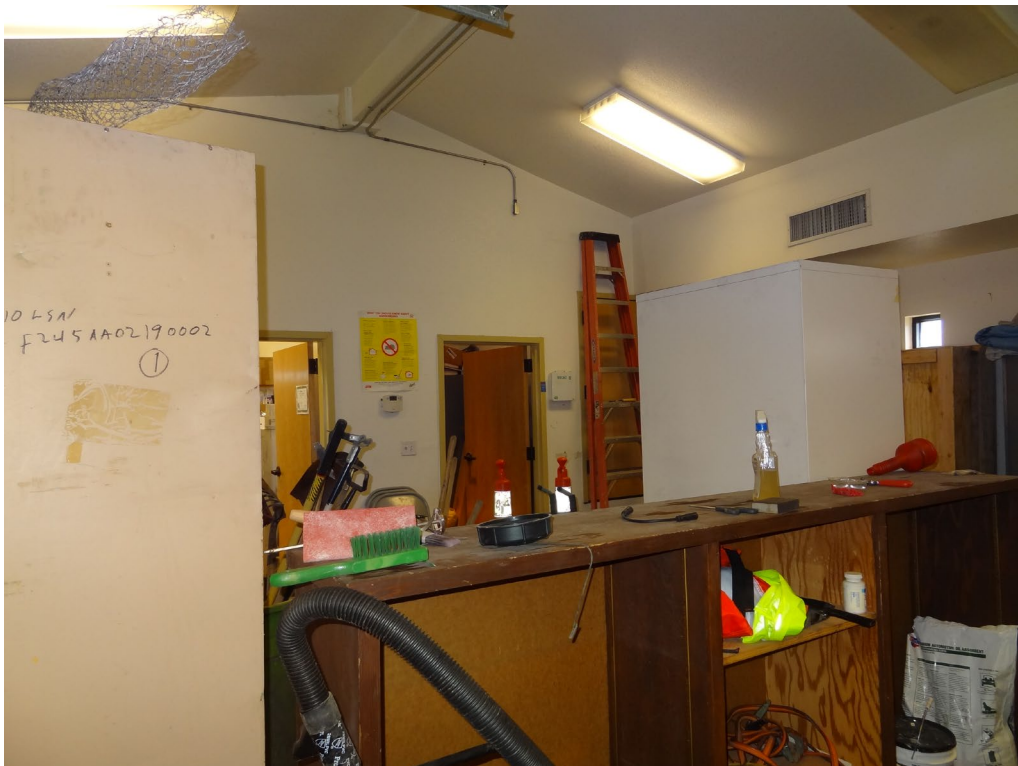
Mormon Fort Vehicle Shop - Building #2397  
Description: Lighting Upgrade.
