State of Nevada
Department of Administration
Purchasing Division
Las Vegas Purchasing Warehouse
Facility Condition Analysis

LAS VEGAS PURCHASING WAREHOUSE

1054 South Commerce Street
Las Vegas, Nevada

Site Number: 9914
STATE OF NEVADA PUBLIC WORKS DIVISION
FACILITY CONDITION ANALYSIS

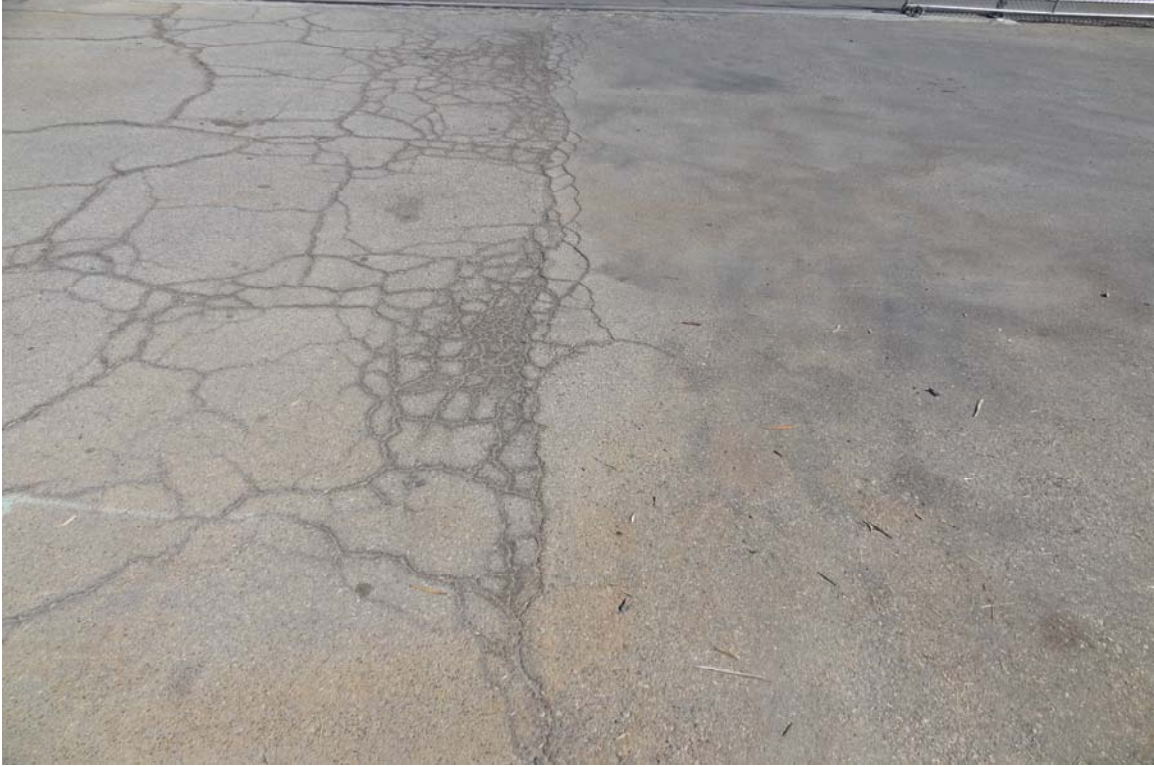
The asphalt paving around the building is failing, with significant alligatoring, settling and cracks observed. This project covers the removal and replacement of the existing asphalt site wide for parking, site access and deliveries. Striping for safety, parking and loading zones is included in this estimate. 25,000 square feet was used to generate this estimate. This project should be implemented concurrently with the ADA ACCESSIBLE PARKING AND PATH OF TRAVEL project. This project or a portion thereof was previously recommended in the FCA report dated 10/14/2003. It has been amended accordingly to reflect conditions observed during the most recent survey date of 04/10/2012.

Las Vegas Purchasing Warehouse Site - Site #9914
Description: Damaged asphalt paving.

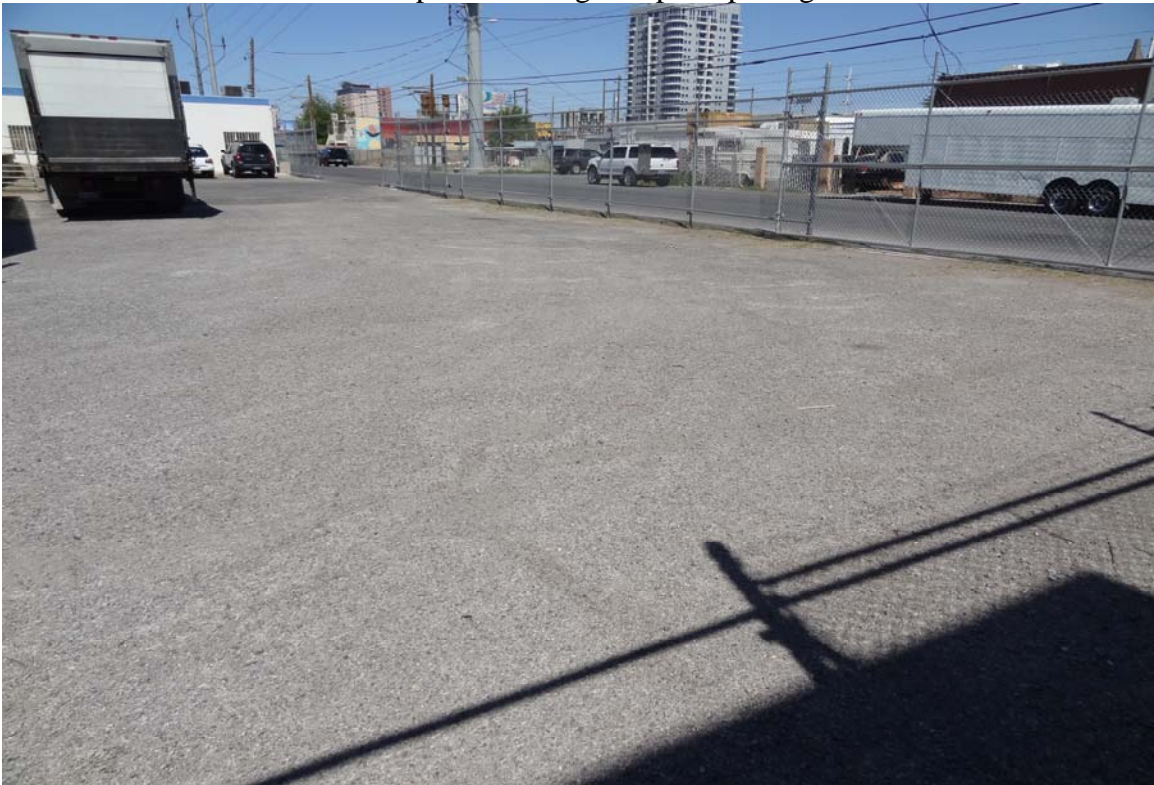
The majority of the fencing on the west and north sides has reached the end of its expected life and should be scheduled for replacement. This project recommends the installation of a 6 foot high 6 gauge wire perimeter chain link fence with barbed or razor wire on the south, west and north sides of the property. The fence on the east side was recently replaced and is in good condition. The cost estimate also includes demolition and disposal of the existing fence.

Las Vegas Purchasing Warehouse Site - Site #9914
Description: Damaged asphalt paving and fence.

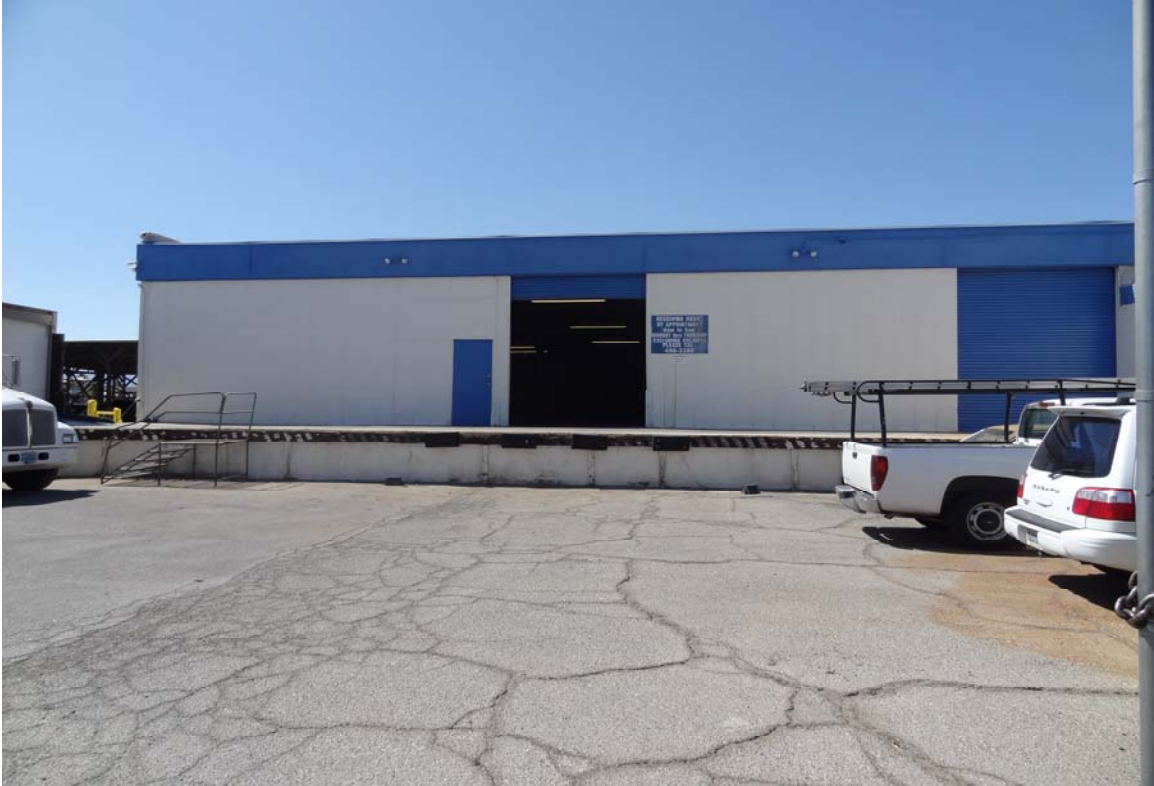
Las Vegas Purchasing Warehouse - Building #2395
Description: Exterior of the building / loading dock.

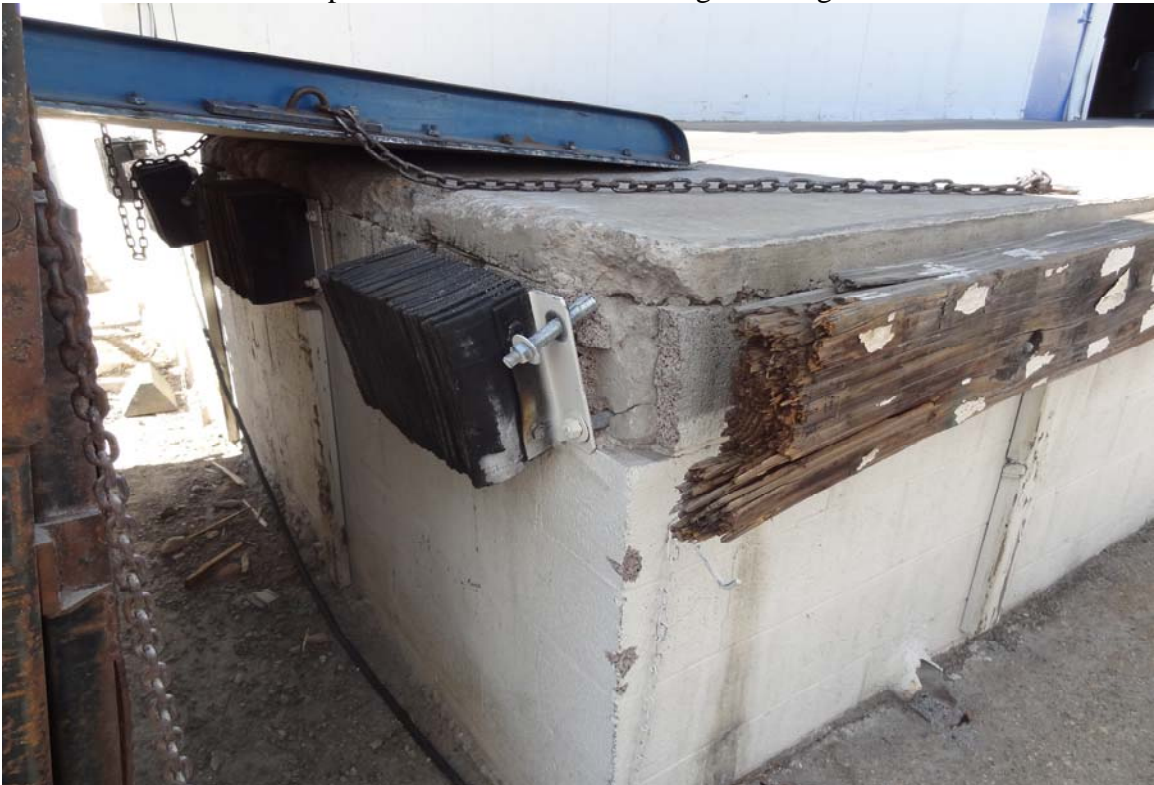
The loading dock is damaged and due for major repairs. The concrete is cracked and failing to the point of exposing the reinforcing steel and jeopardizing the integrity of the structure. The ramp from the parking lot also has significant deterioration and requires complete replacement. This project would provide for repairs to the loading dock including removing and replacing damaged concrete and bumpers, replacement of the ramp, and installing a mechanical dock leveler.

Las Vegas Purchasing Warehouse - Building #2395
Description: Damaged loading dock.

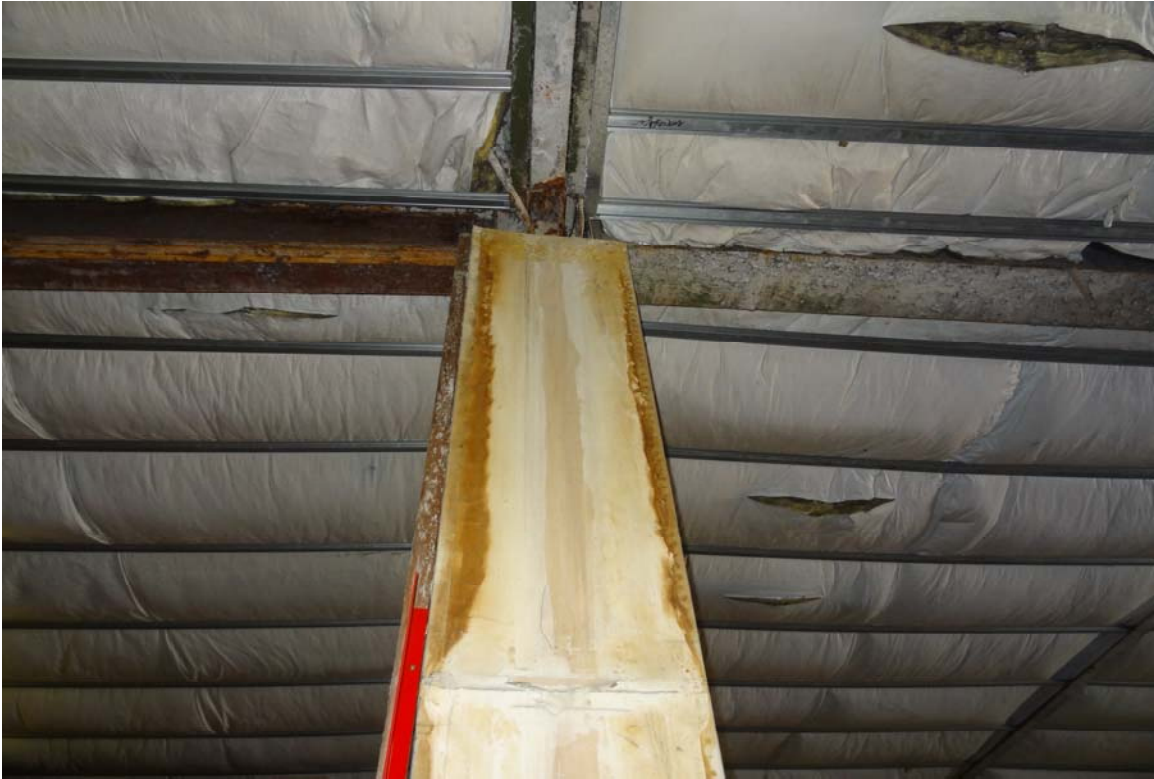
The existing gypsum board wrapped columns are severely damaged from water infiltration and impacts from forklifts and / or vehicles. This project would provide for column repairs which could include a spray on foam fire proofing system or a gypsum board column wrap.

Las Vegas Purchasing Warehouse - Building #2395
Description: Water damage at columns.

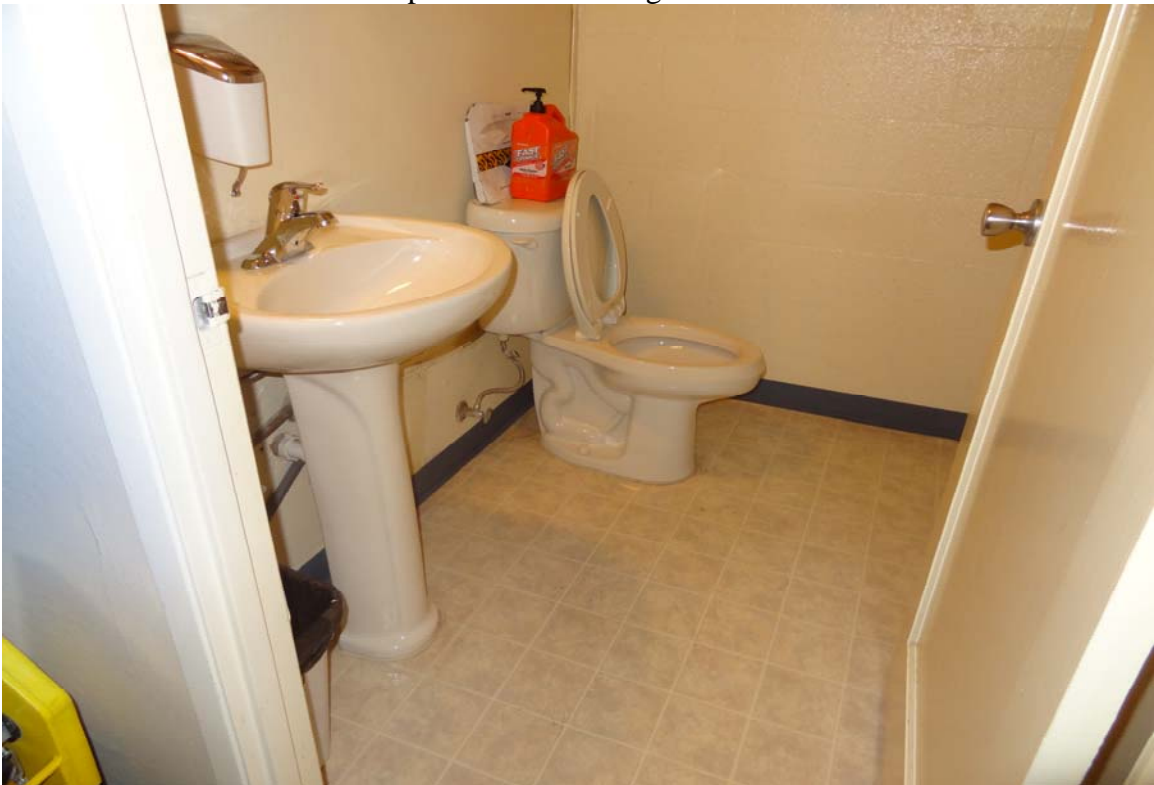
The Men's and Women's restrooms do not meet the Americans with Disabilities Act (ADA) requirements. A complete retrofit is necessary. This project would provide funding for construction of a unisex accessible restroom. The items may include a new sink, toilet, hardware, mirror, fixture, flooring and paint. NRS 338.180, IBC - 2006, ICC/ANSI A117.1 - 2003 and the most current version of the Americans with Disabilities Act Accessibility Guidelines (ADAAG) were used as a reference for this project.

Las Vegas Purchasing Warehouse - Building #2395
Description: Non ADA compliant restroom.

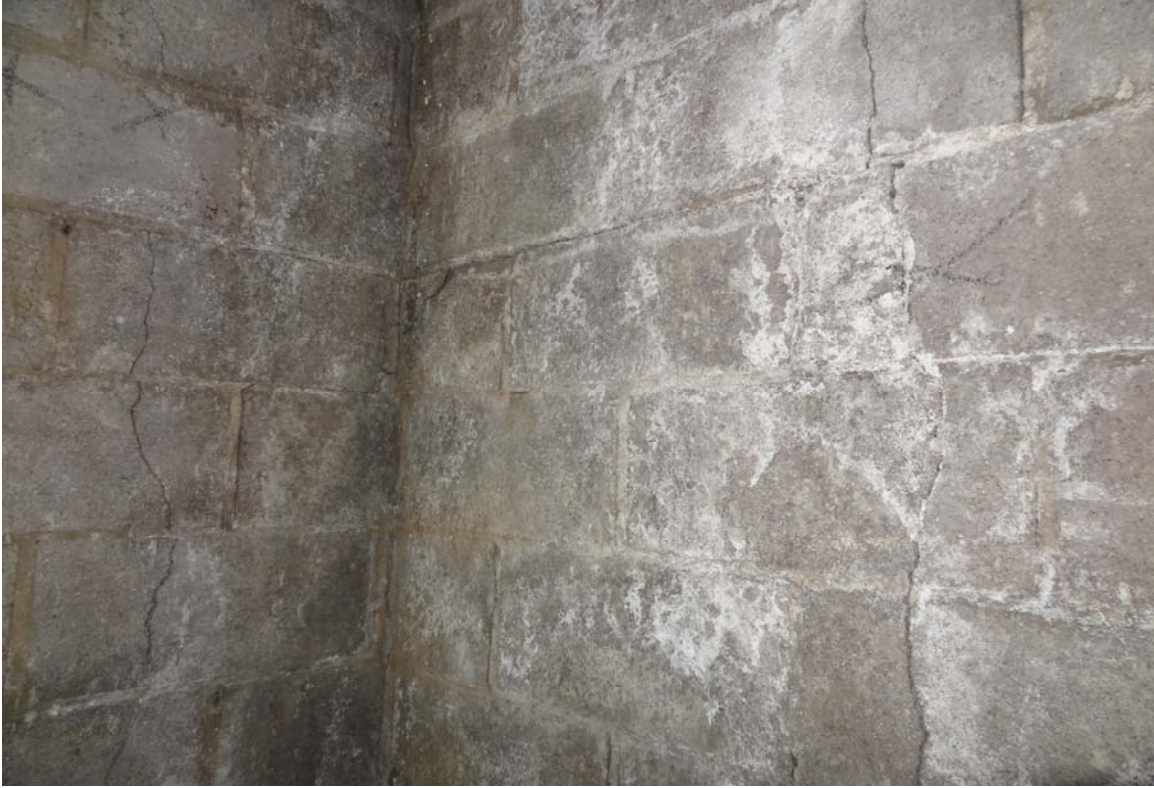
The concrete masonry and steel framed structure was built in 1960 and is due for structural repairs. There are major cracks in the concrete masonry unit walls which have gotten worse year by year. Water which infiltrates the cracks freezes in the winter and causes the cracks to widen. Cracking at the southwest corner of the building is significant and may indicate a settling issue below the foundation. The water infiltration also damages the interior of the building and is a health department violation due to the storage of dry goods in the building. It is recommended to repair the structure immediately by patching and sealing any existing cracks. Further evaluation of the structure should be done to determine whether more permanent repairs are needed such as pumping under the foundation or rebuilding the walls.

Las Vegas Purchasing Warehouse - Building #2395
Description: Damaged CMU walls.

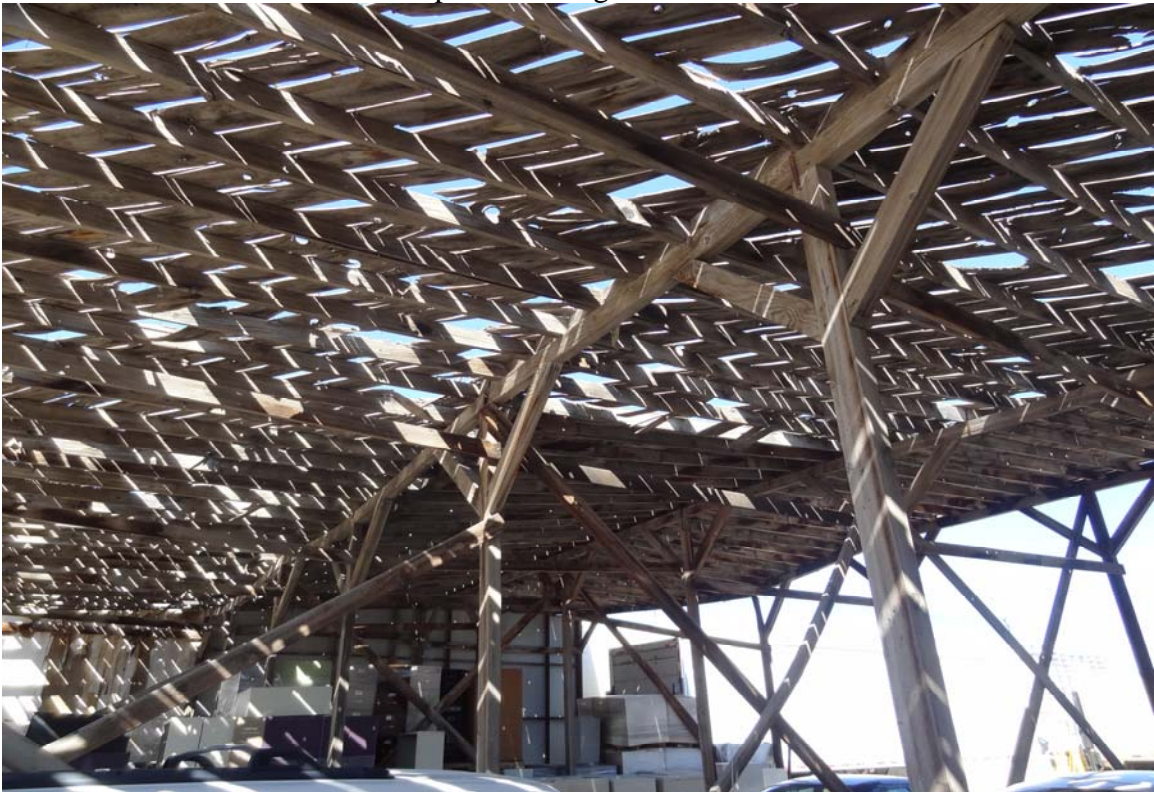
The wood framed structure is structurally failing and is in danger of falling down. At least one post has sheared off and is resting on the asphalt, numerous wood members are splitting and numerous connections between structural members have detached. The roof sheathing is also failing and is dangerous due to wood pieces becoming detached by the wind. The structure is dilapidated and deteriorating and has reached the end of its useful life. This project would provide funding for the demolition of the structure.

Purchasing Warehouse Carport - Building #2396
Description: Structural damage to carport.
