LAS VEGAS PURCHASING WAREHOUSE SITE

1054 South Commerce Street
Las Vegas, Nevada

Site Number: 9914
STATE OF NEVADA PUBLIC WORKS DIVISION
FACILITY CONDITION ANALYSIS

Survey Date: 5/24/2018

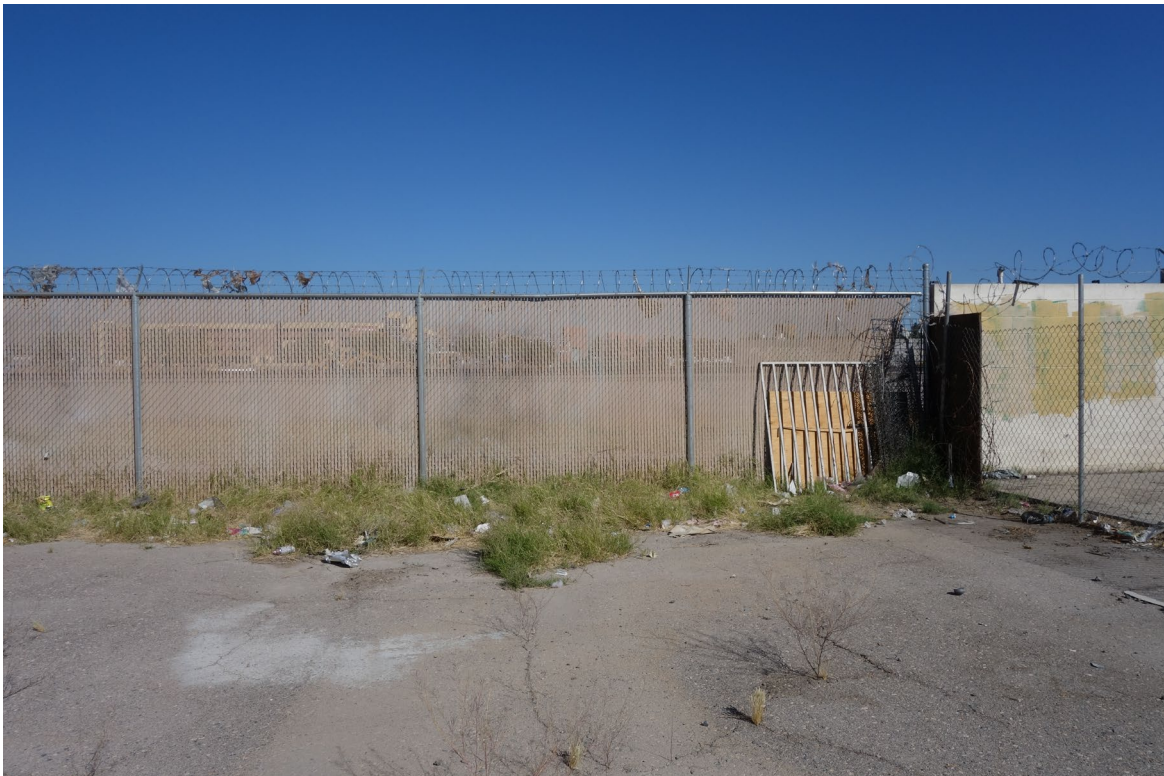
Las Vegas Purchasing Warehouse Site - Site #9914
Description: Weed and Debris Combustible Accumulation.

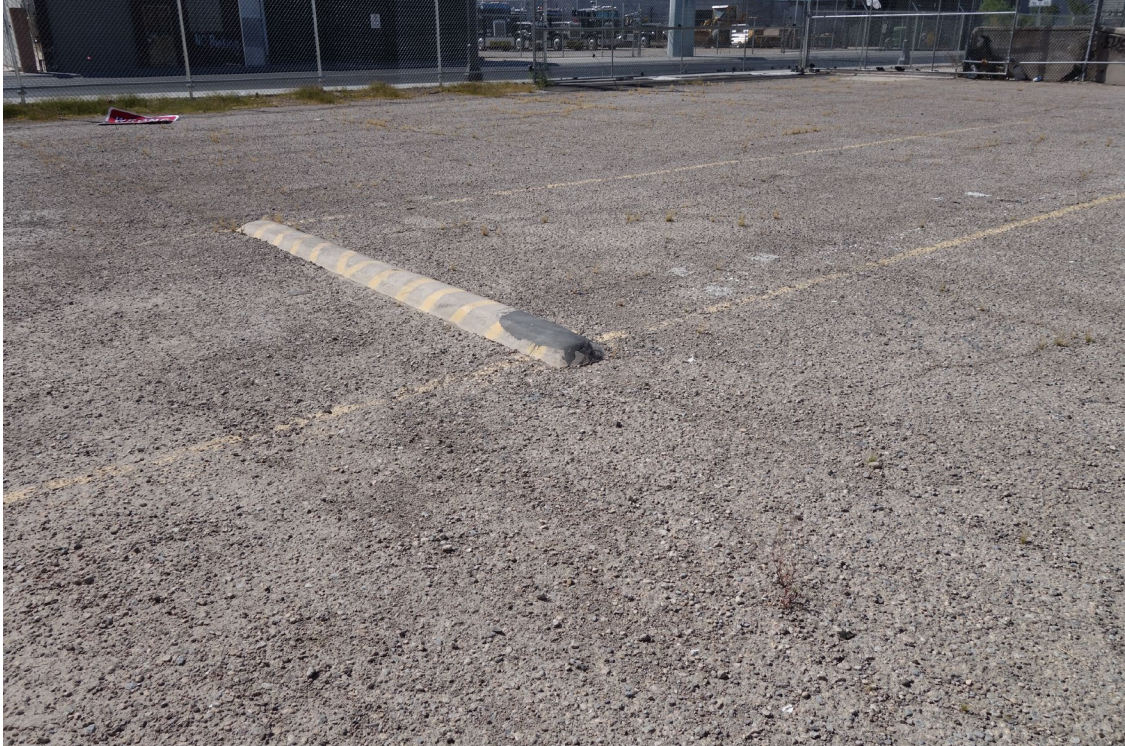
The asphalt paving around the building is failing, with significant alligatoring, settling and cracks observed. This project covers the removal and replacement of the existing asphalt site wide for parking, site access and deliveries. Striping for safety, parking and loading zones is included in this estimate. 30,000 square feet was used to generate this estimate. This project should be implemented concurrently with the ADA ACCESSIBLE PARKING AND PATH OF TRAVEL project. This project or a portion thereof was previously recommended in the FCA report dated 10/14/2003 and 04/10/2012. It has been amended accordingly to reflect conditions observed during the most recent survey date of 05/24/2018.

Las Vegas Purchasing Warehouse Site - Site #9914
Description: Asphalt Paving Replacement Needed.

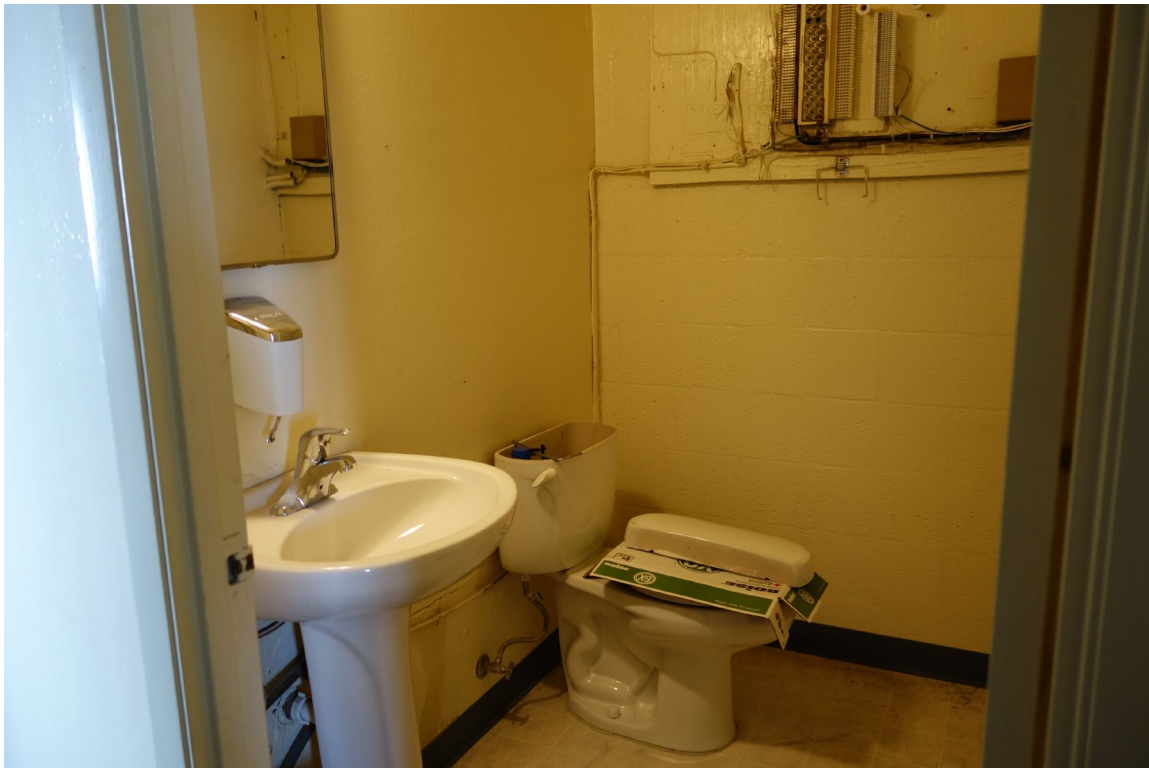
The Men's and Women's restrooms are not functioning and do not meet the Americans with Disabilities Act (ADA) requirements. A complete retrofit is necessary. This project would provide funding for construction of two unisex accessible restroom. The items may include a new sink, toilet, hardware, mirror, fixture, flooring and paint. NRS 338.180, IBC - 2018, ICC/ANSI A117.1 and the most current version of the Americans with Disabilities Act Accessibility Guidelines (ADAAG) were used as a reference for this project.

Las Vegas Purchasing Warehouse - Building #2395
Description: Restroom Remodel Needed.

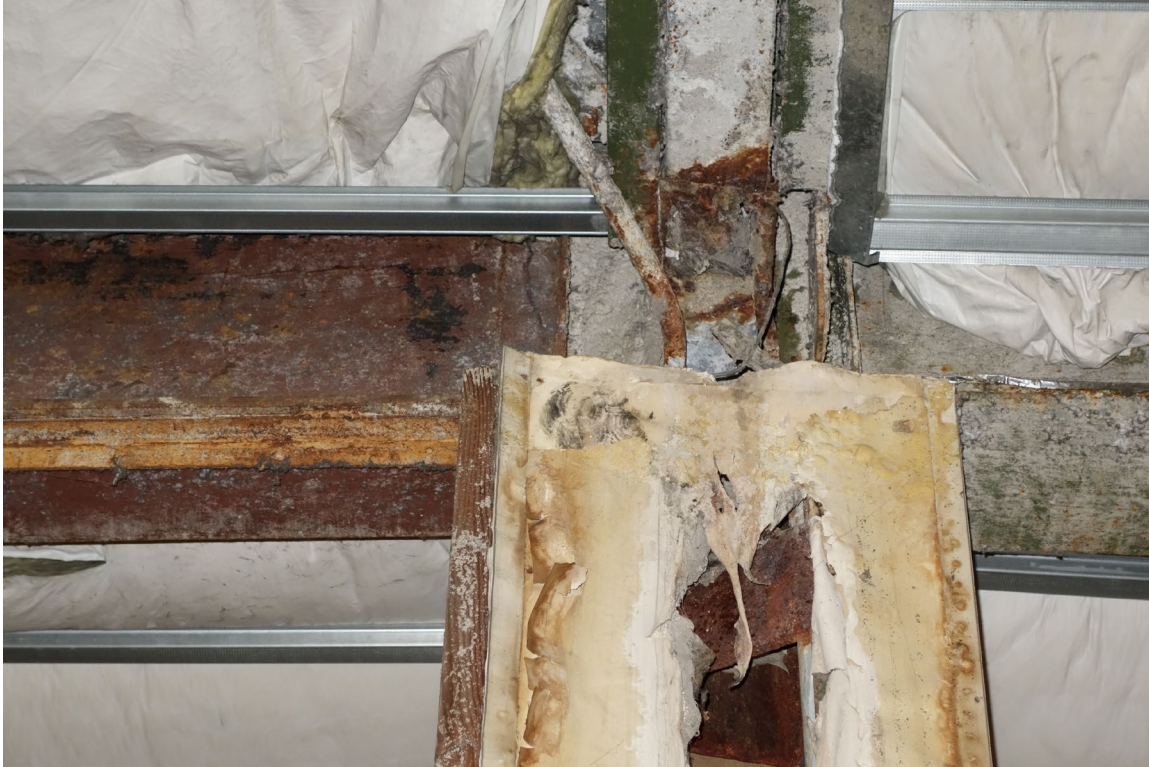
The existing gypsum board wrapped columns are severely damaged from water infiltration and impacts from forklifts and / or vehicles. The exposed sections of damaged drywall have the appearance of mold growth from water infiltration.. This project would provide for column repairs which could include a spray on foam fire proofing system or a gypsum board column wrap. Excluded from this estimate is any mold mitigation requirements.

Las Vegas Purchasing Warehouse - Building #2395
Description: Column Repairs due to Water Damage.

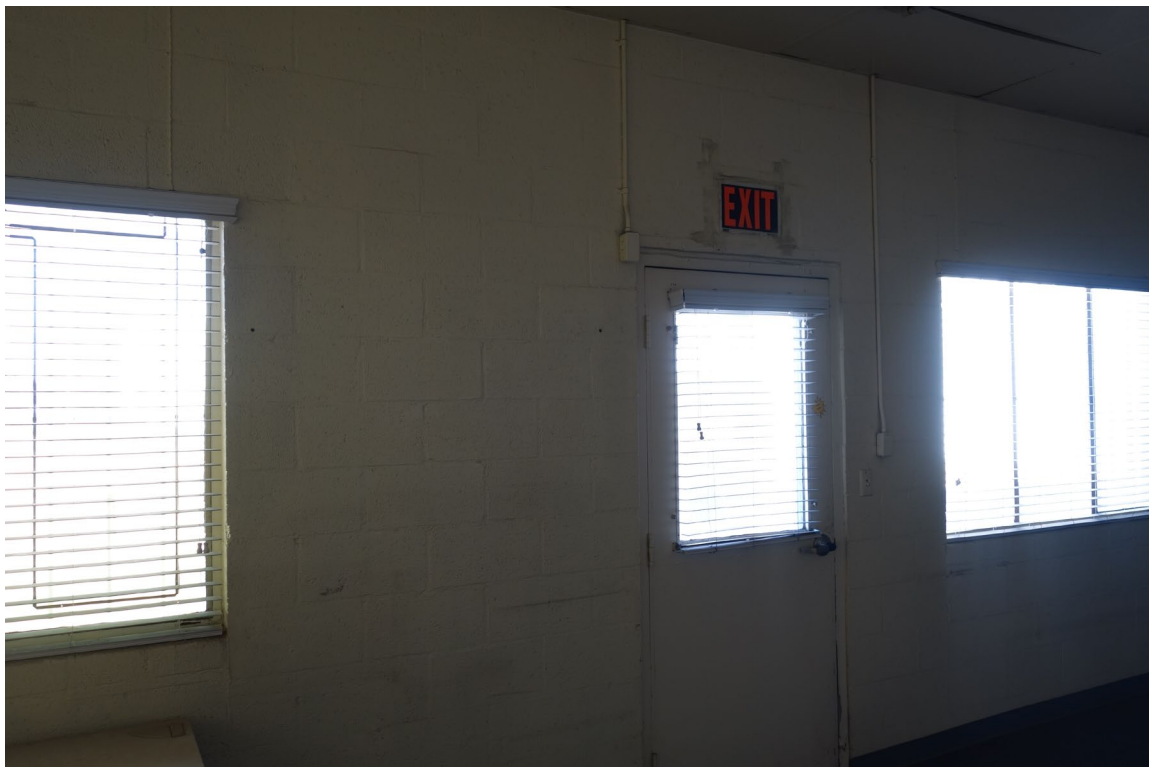
The office portion of the building does not have emergency lighting and the exit signs do not meet current standards. This project would provide for the purchase and installation of self-illuminated or LED style exit signs with battery-backed internal systems as well as emergency egress lighting to provide illumination along the egress route. IBC 2018 Chapter 10 Section 1008 was referenced for this project.

Las Vegas Purchasing Warehouse - Building #2395
Description: Exit Sign & Egress Lighting Needed.

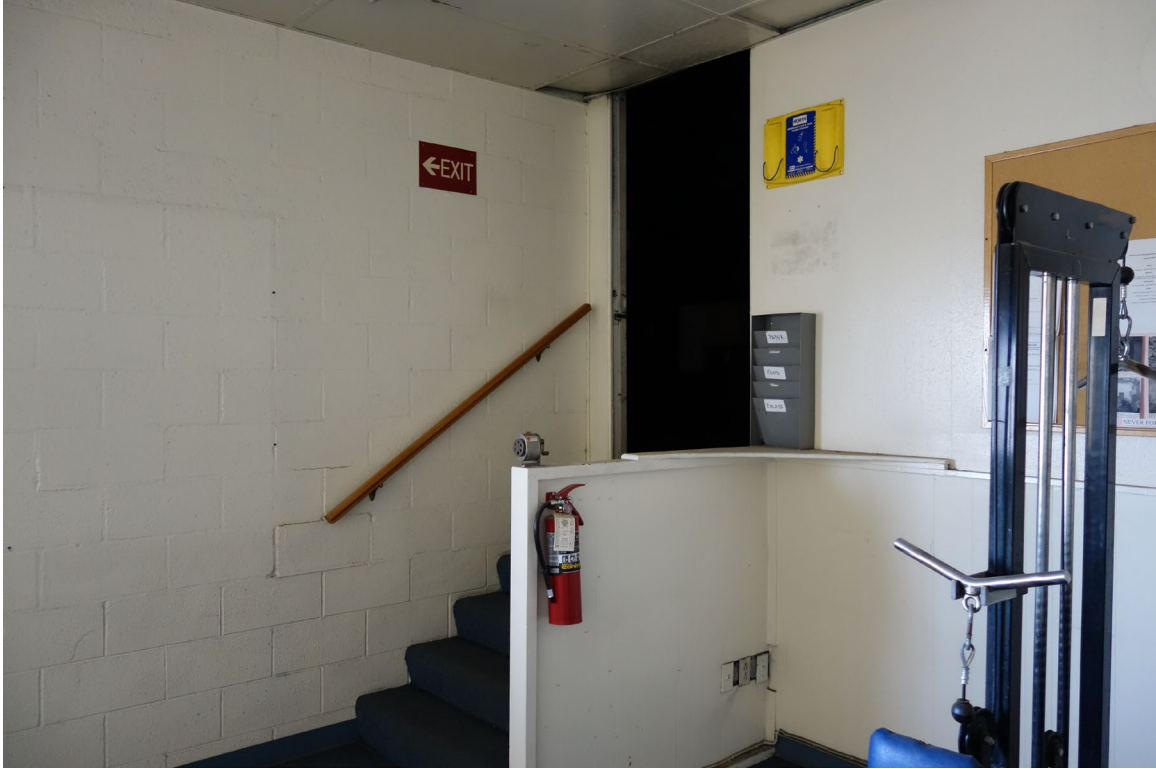
The interior stair handrail is older and does not meet code for safety or accessibility. The gripping surfaces are incorrect, the handrail is missing from one side of the stair and it does not have proper returns. This project recommends the installation of handrails on both sides of the stairs, with proper returns and supports. Removal and disposal of the existing railing is included. NRS 338.180, 2018 IBC Chapter 10, Section 1012, ICC/ANSI A117.1 and the most current version of the Americans with Disabilities Act Accessibility Guidelines (ADAAG) were used as a reference for this project.

Las Vegas Purchasing Warehouse - Building #2395
Description: Interior Stair Handrail Replacement.

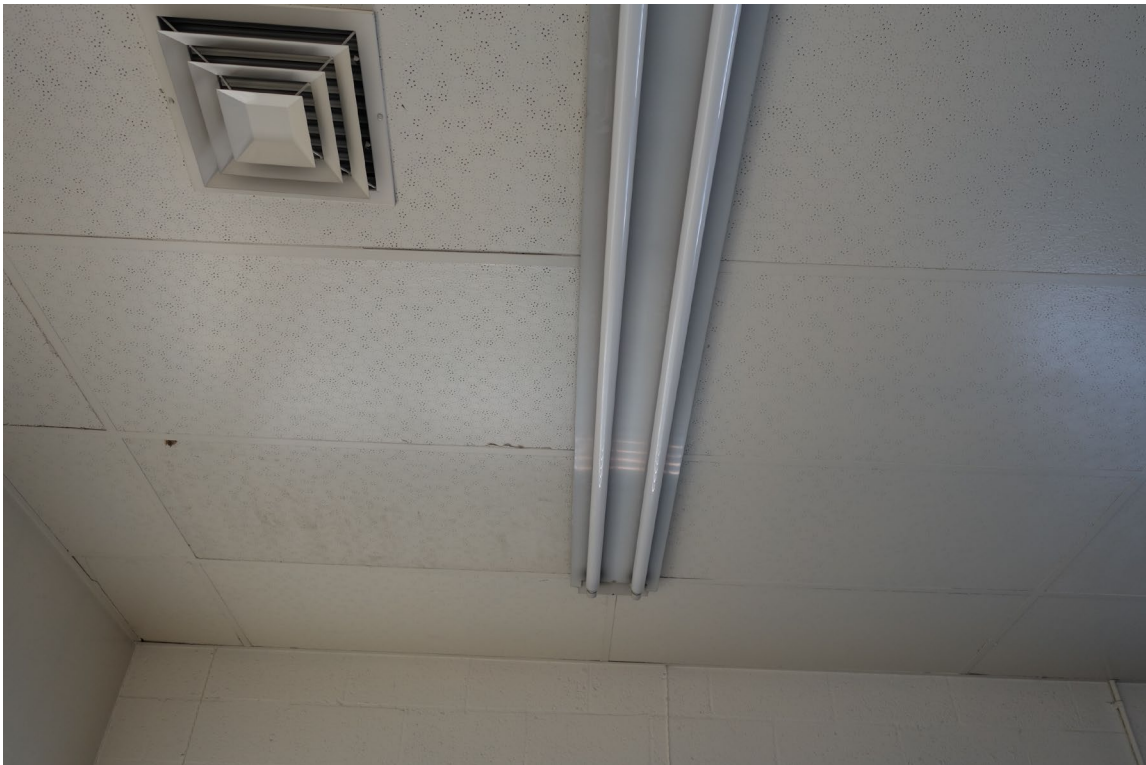
The existing lighting fixtures are the older fluorescent type, and are not energy efficient. This project will upgrade fixtures to higher efficiency units with a longer life cycle. 5,000K LED lamps, without the ballasts are suggested, and new tombstones (if needed). Occupancy sensors will be installed in low occupancy areas for additional savings. Electrical wiring upgrades are not included in this estimate.

Las Vegas Purchasing Warehouse - Building #2395
Description: Lighting Upgrade Needed.

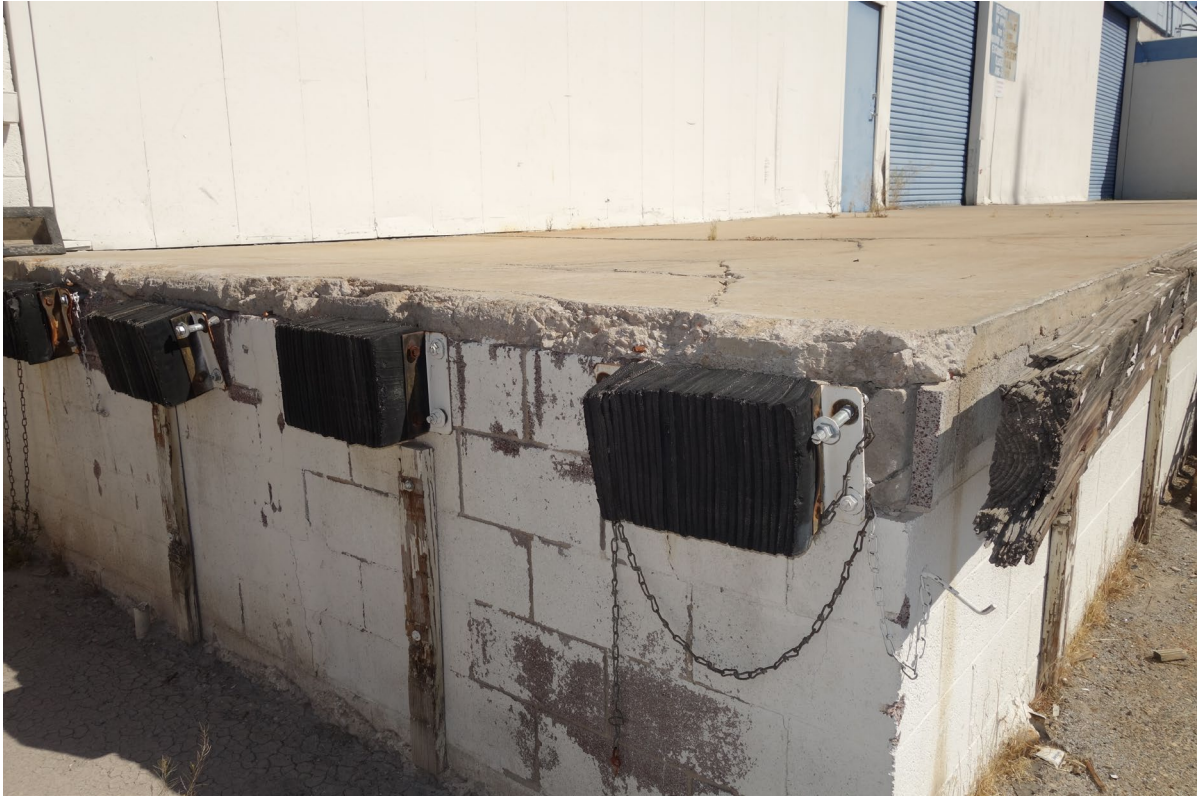
The loading dock is damaged and due for major repairs. The concrete is cracked and failing to the point of exposing the reinforcing steel and jeopardizing the integrity of the structure. The ramp from the parking lot also has significant deterioration and requires complete replacement. This project would provide for repairs to the loading dock including removing and replacing damaged concrete and bumpers, replacement of the ramp, and installing a mechanical dock leveler.

Las Vegas Purchasing Warehouse - Building #2395
Description: Damaged Loading Dock.

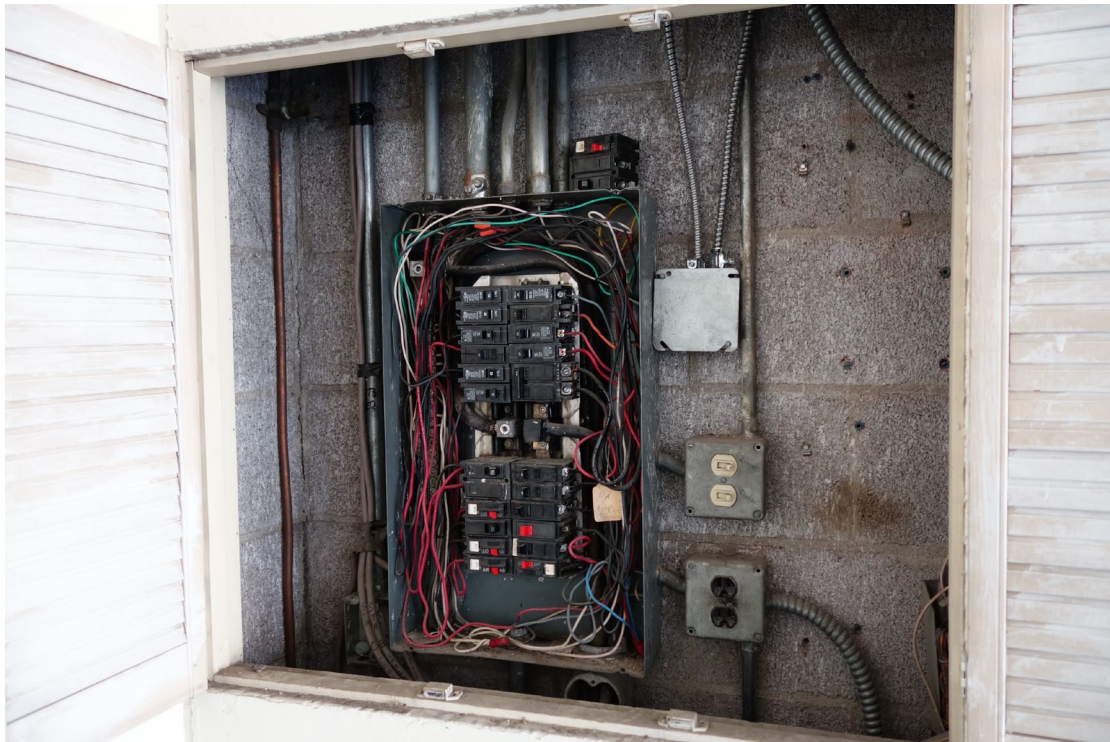
There are electrical panels in the building which do not have proper clear floor space around them. The 2018 IFC Section 604.3 states that, "A working space of not less than 30 inches in width, 36 inches in depth and 78 inches in height shall be provided in front of electrical service equipment. Where the electrical service equipment is wider than 30 inches, the working space shall not be less than the width of the equipment. No storage of any materials shall be located within the designated working space." This project would provide funds to demolish approximately 5 feet of drywall wall system and refinish the wall surrounding the hidden electrical panel. Additionally, this project will relocate furniture items currently blocking the required space around other electrical panels and install marking tape or paint highlighting the exclusion zone.

Las Vegas Purchasing Warehouse - Building #2395
Description: Blocked Electrical Panel Clearance.

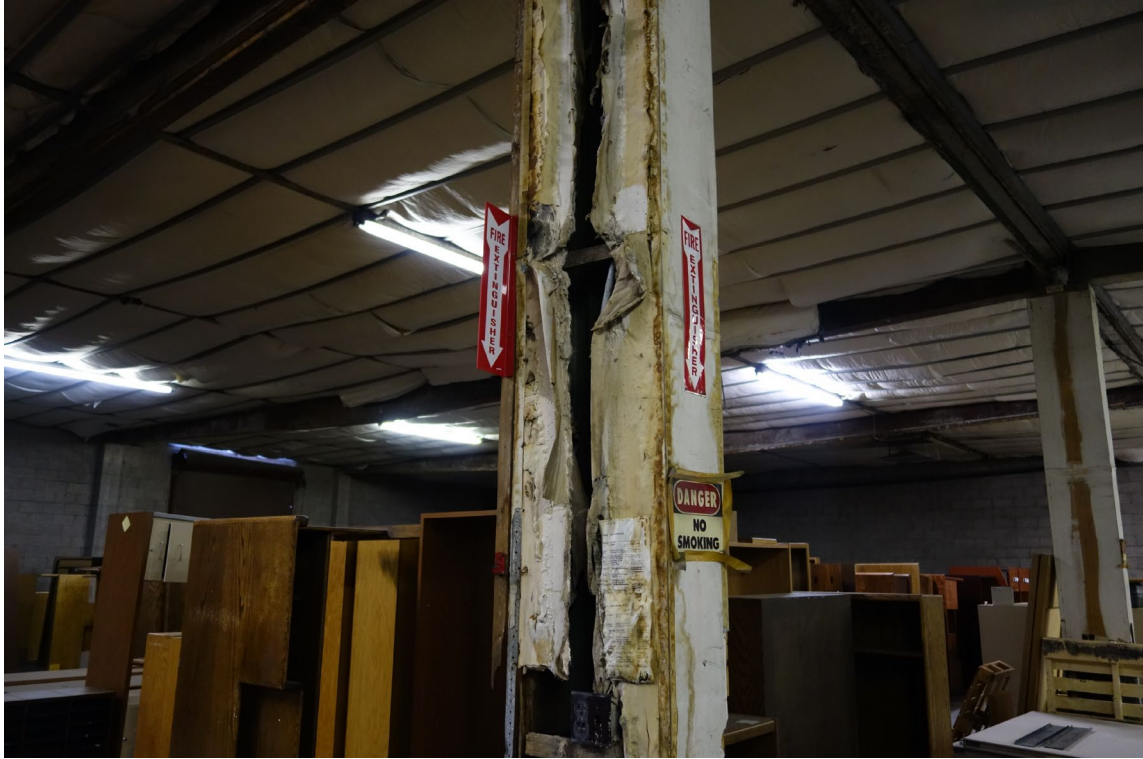
Column fire extinguisher signage indicates a location for an extinguisher that is missing. This project will provide for the installation of a mounting bracket and fire extinguisher.

Las Vegas Purchasing Warehouse - Building #2395
Description: Missing Fire Extinguisher.

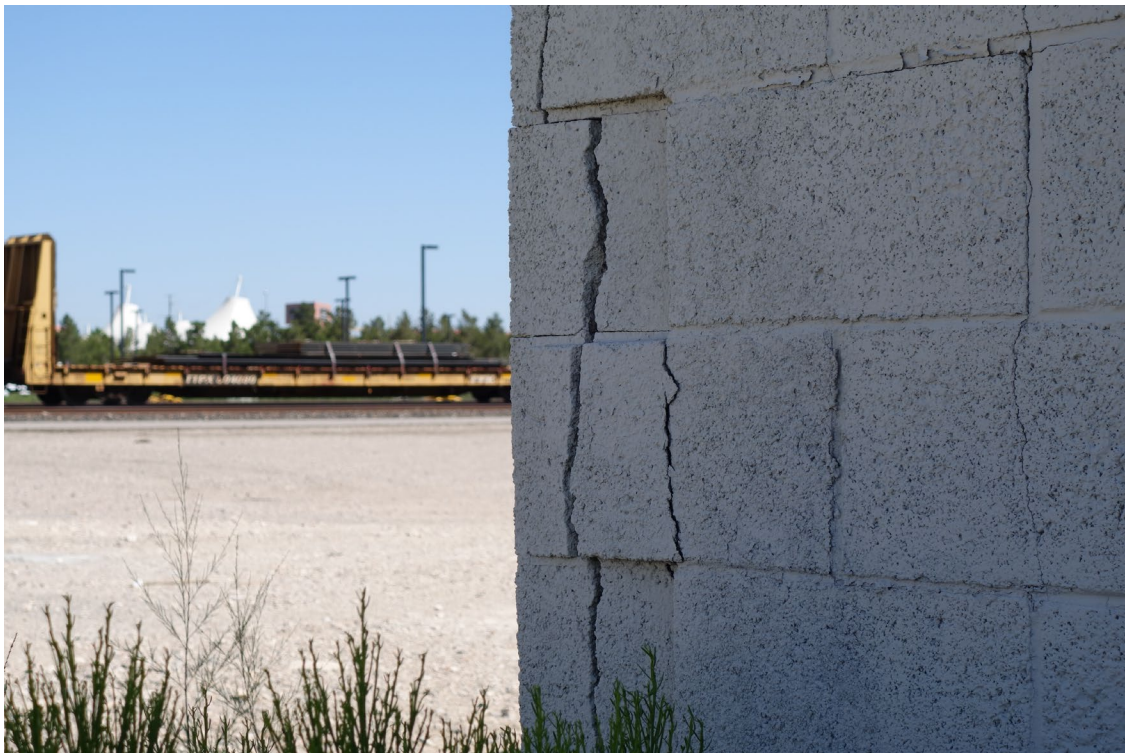
The concrete masonry and steel framed structure was built in 1960 and is due for structural repairs. There are major cracks in the concrete masonry unit walls which have gotten worse year by year. Water which infiltrates the cracks freezes in the winter and causes the cracks to widen. Cracking at the southwest corner of the building is significant and may indicate a settling issue below the foundation. The water infiltration also damages the interior of the building and is a health department violation due to the storage of dry goods in the building. Further evaluation of the structure should be done to determine whether more permanent repairs are needed such as pumping under the foundation or rebuilding the walls.

Las Vegas Purchasing Warehouse - Building #2395
Description: Damaged CMU Walls.

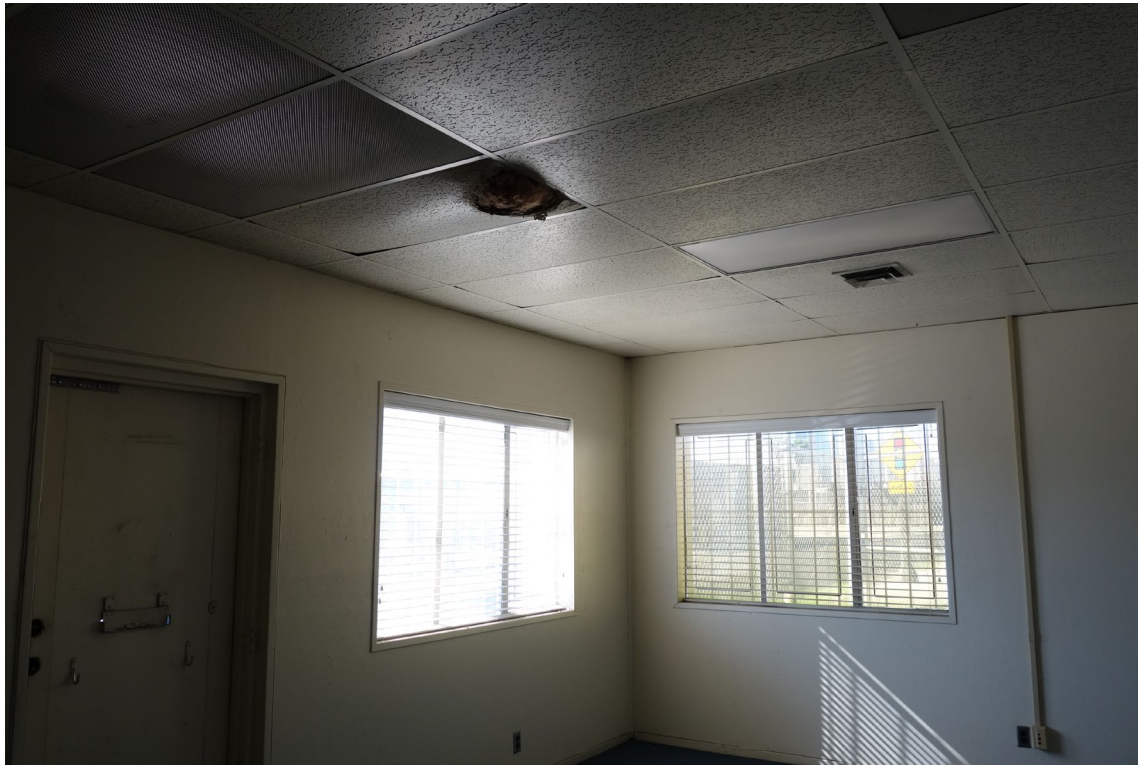
The office portion of the building has a suspended acoustical tile ceiling system. The T-bar framing is old, bent and rusted in many areas and many ceiling tiles are damaged and stained. This project would provide for the replacement of the suspended acoustical tile ceiling system including the framing, acoustical tile and seismic bracing assemblies. Removal and disposal of the existing ceiling system is included in this estimate.

Las Vegas Purchasing Warehouse - Building #2395
Description: Ceiling System Replacement.

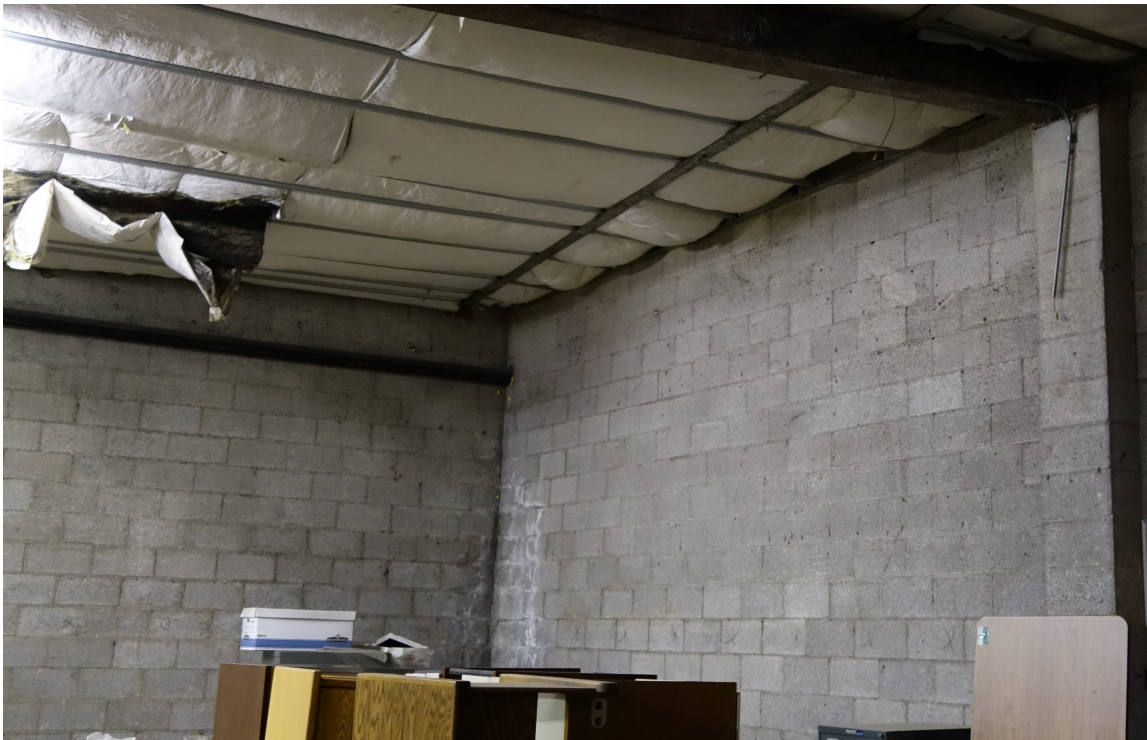
The ceiling in the warehouse has a layer of vinyl faced insulation supported by hat channel spaced approximately 24" on-center. The insulation is damaged from multiple roof leaks and some locations have the appearance of mold growth. Some of the insulation batts have partially fallen which has exposed the fiberglass fibers to the work area. This project recommends all of the blanket insulation be removed and the ceiling space inspected for mold growth. This project funds the removal, inspection and re-installation of new vinyl faced insulation. Excluded from this estimate is any mold mitigation requirements.

Las Vegas Purchasing Warehouse - Building #2395
Description: Ceiling Insulation Replacement.
