# ATTORNEY GENERAL OFFICES COMPLEX

100 North Carson Street  
Carson City, Nevada 89701

**Site Number: 9917**  
**STATE OF NEVADA PUBLIC WORKS DIVISION**  
**FACILITY CONDITION ANALYSIS**

Report distributed in November 2021

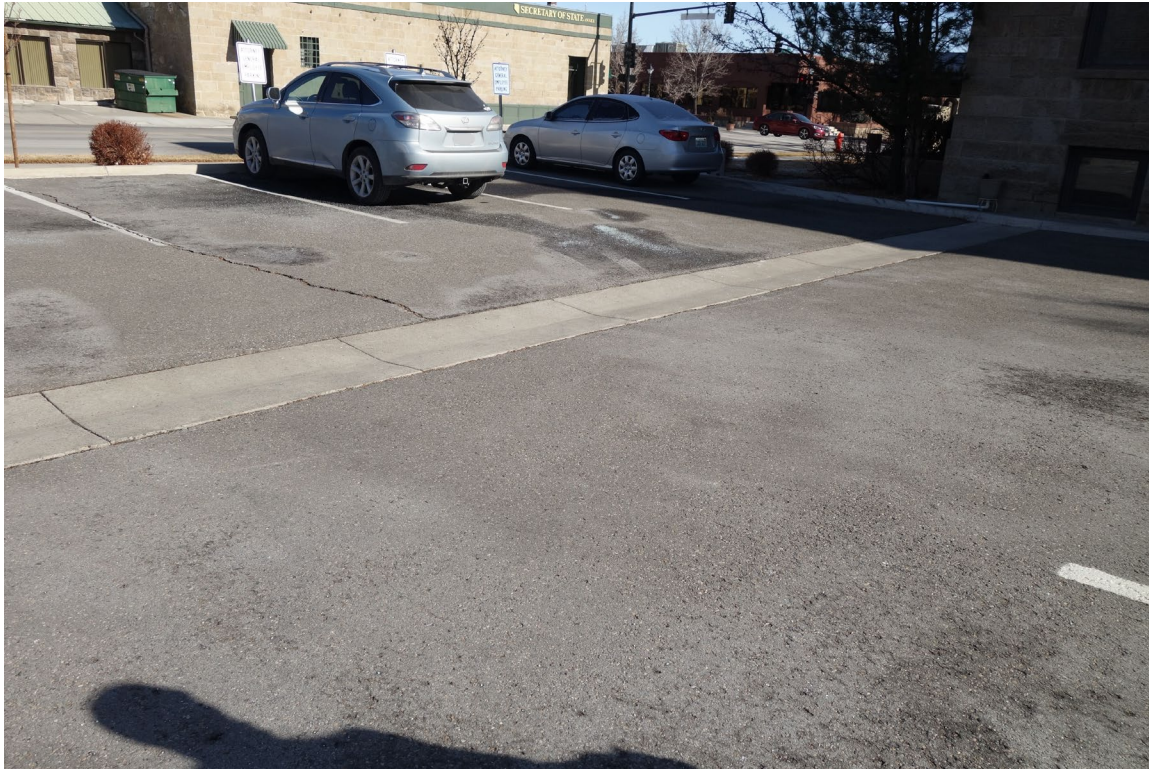
Attorney General Offices Complex - Site #9917  
Description: Crack Fill & Seal Parking Recommended.

It is important to maintain the asphalt concrete paving on the site. This project would provide for minor crack filling and sealing of the northwest parking lot within the next 4 - 5 years. Striping is included in this estimate. This project should be scheduled on a 5 year cyclical basis to maintain the integrity of the paving and prevent premature failure. 9,736 square feet of asphalt area was used to generate this estimate.

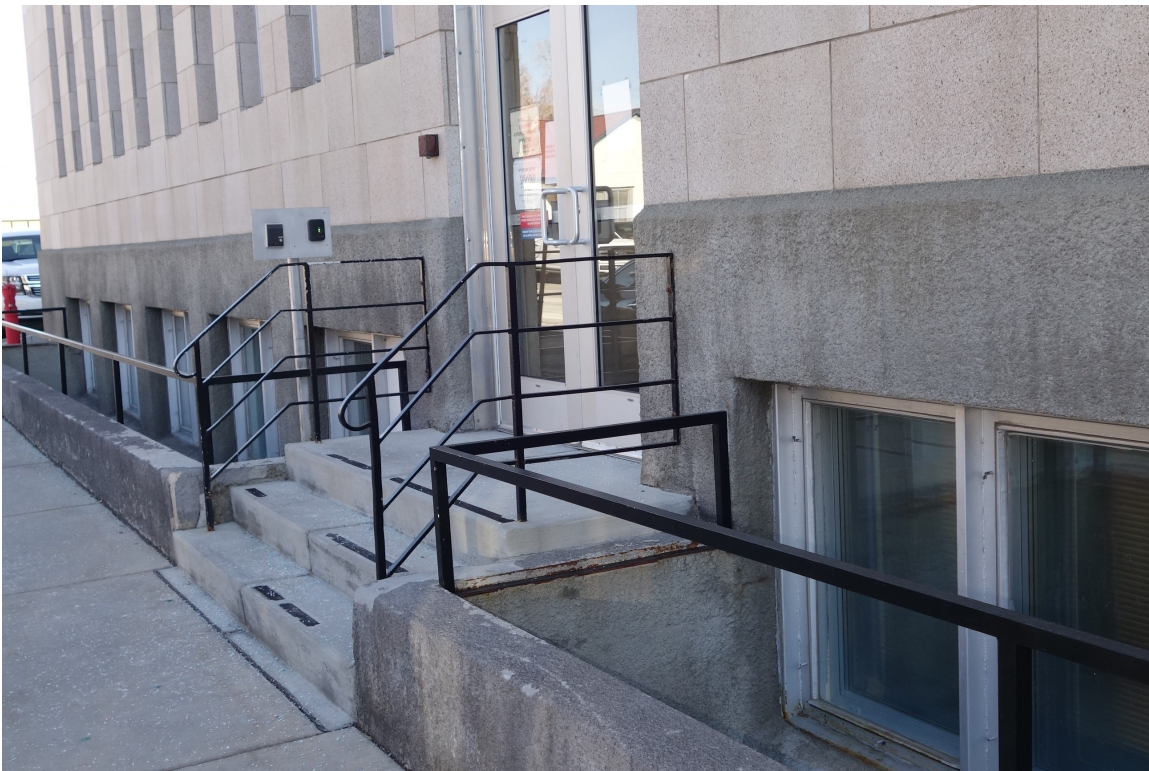
Attorney General Offices Complex - Site #9917  
Description: ADA Compliant Handrails Needed.

The handrails and guardrails on the exterior stairs at the front and rear of the Attorney General's Office and the fire escape stairways from the Heroes Annex Building, do not meet code for safety or accessibility. The gripping surfaces are incorrect, the handrails do not have proper returns and/or there are improper or missing guardrails. This project recommends the installation of new handrails, on both sides of the stairs, with proper guardrails, returns and supports. The rails should be replaced at the Heroes Memorial fire escape and the Heroes Memorial Annex fire escape. The 2018 IBC Chapter 10 was referenced for this project.

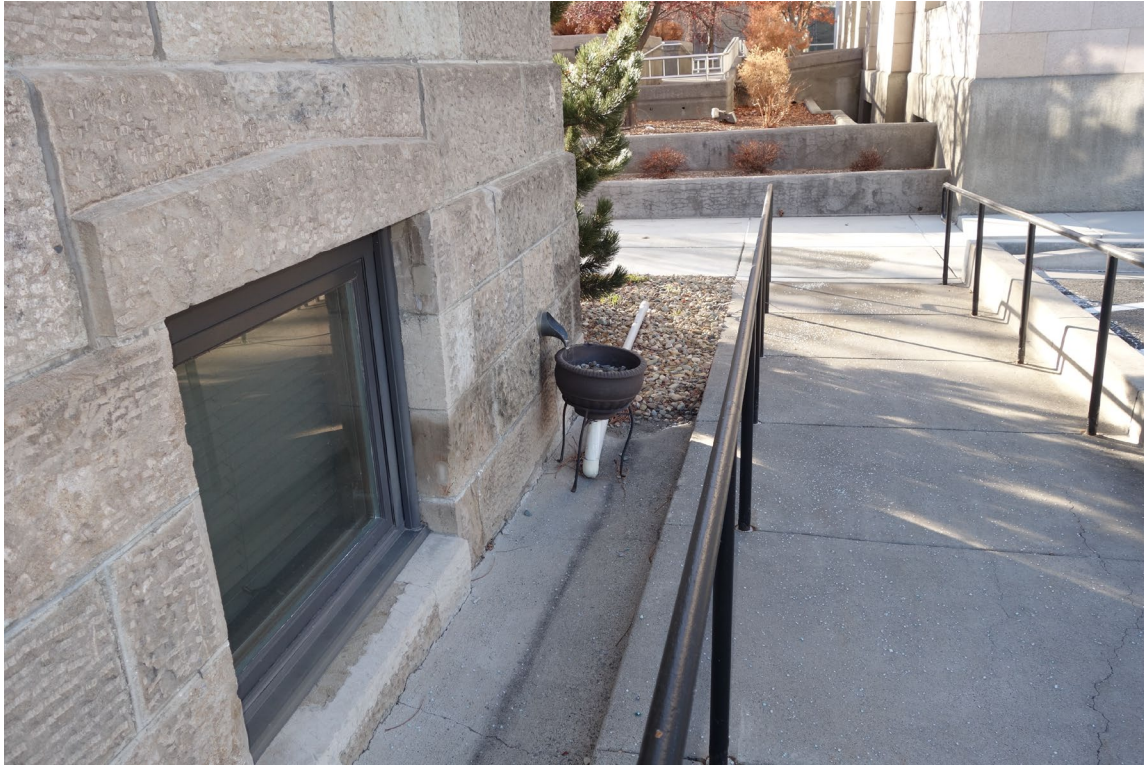
Attorney General Offices Complex - Site #9917  
Description: Building & Site Drainage Improvements Needed.

There are several site drainage problems around the complex including improper roof drains and window wells without drains. The site is fairly flat and the grading slopes toward the building in several locations, most noticeably at the Heroes Memorial and Heroes Memorial Annex. Several reports of water seeping into the building's basement have been reported over the past few years. Some of the roof drains do not drain to the storm drain system resulting in pooling against the buildings and leaking into the building. There have been reports of water accumulation in several of the window wells on the Attorney General's Office due to drainage problems. This project recommends grading the site, and installing a system of drains, catch basins and storm drain connections to minimize recurring flooding, water movement and accumulations. It would be most beneficial if this project be incorporated with the fence project that is also included in this report.

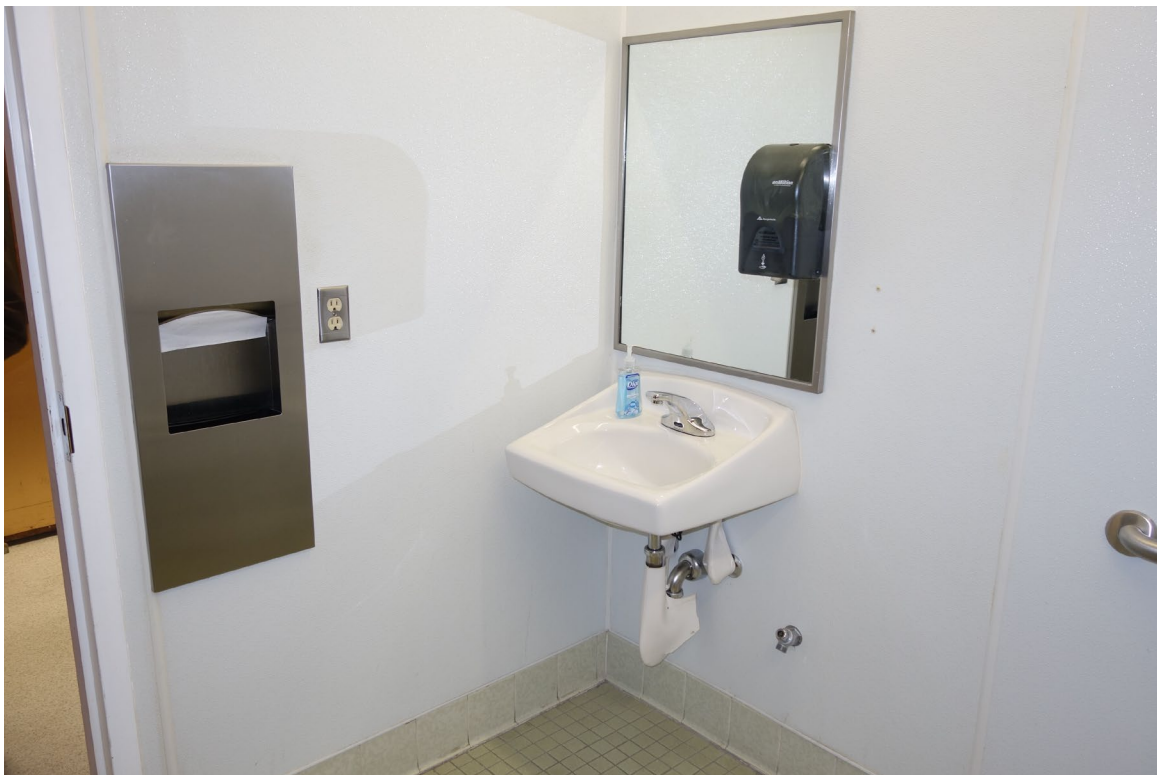
Heroes Memorial Building - Building #0244  
Description: GFCI Outlet Installation Needed.

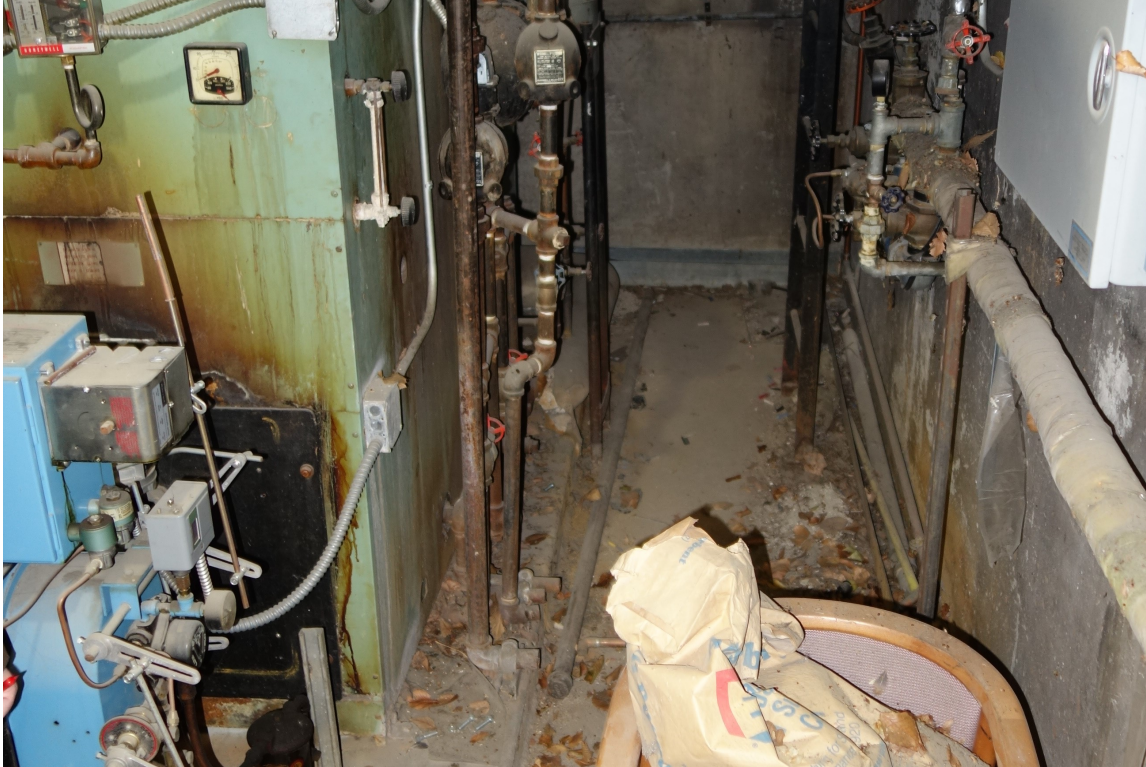
Heroes Memorial Building - Building #0244  
Description: Boiler Demolition Needed.

The boilers in the basement of this building were abandoned in place when the building heating function was replaced by service from the Service Cube boilers. They should be removed and the space reclaimed for another use. This project includes capping existing utilities and removal of possible asbestos containing materials.

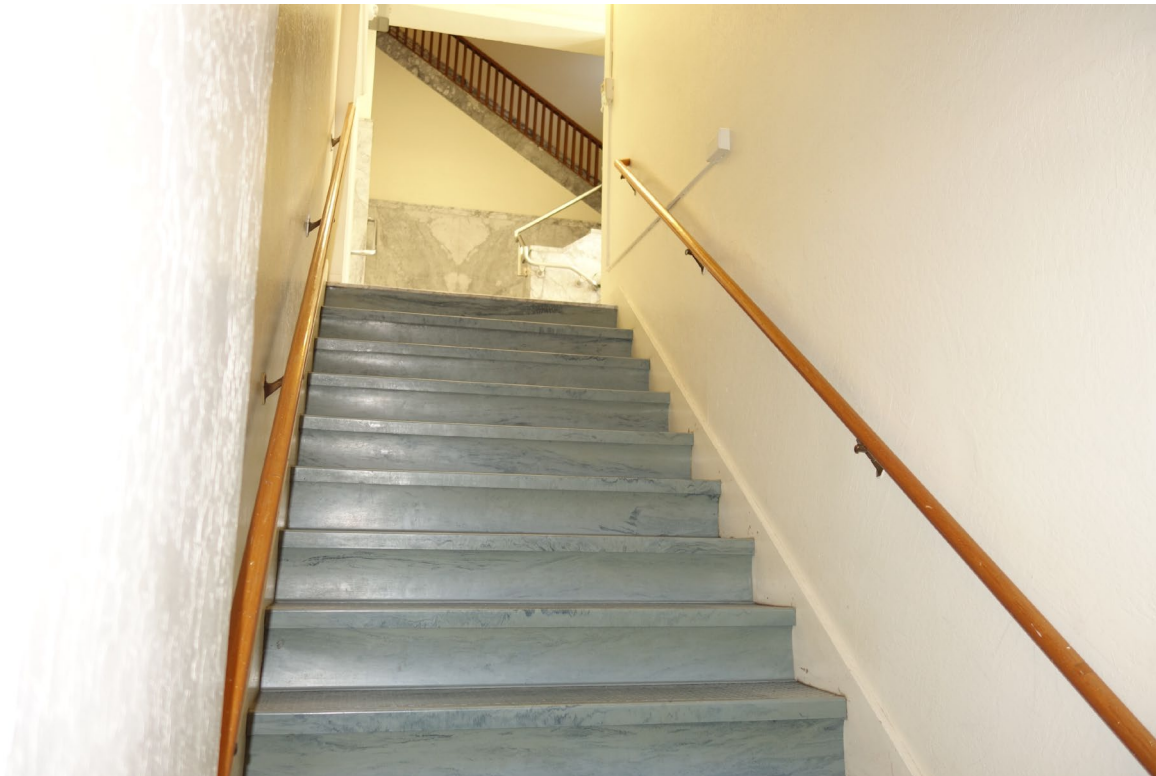
Heroes Memorial Building - Building #0244  
Description: Interior Handrail Replacement Needed.

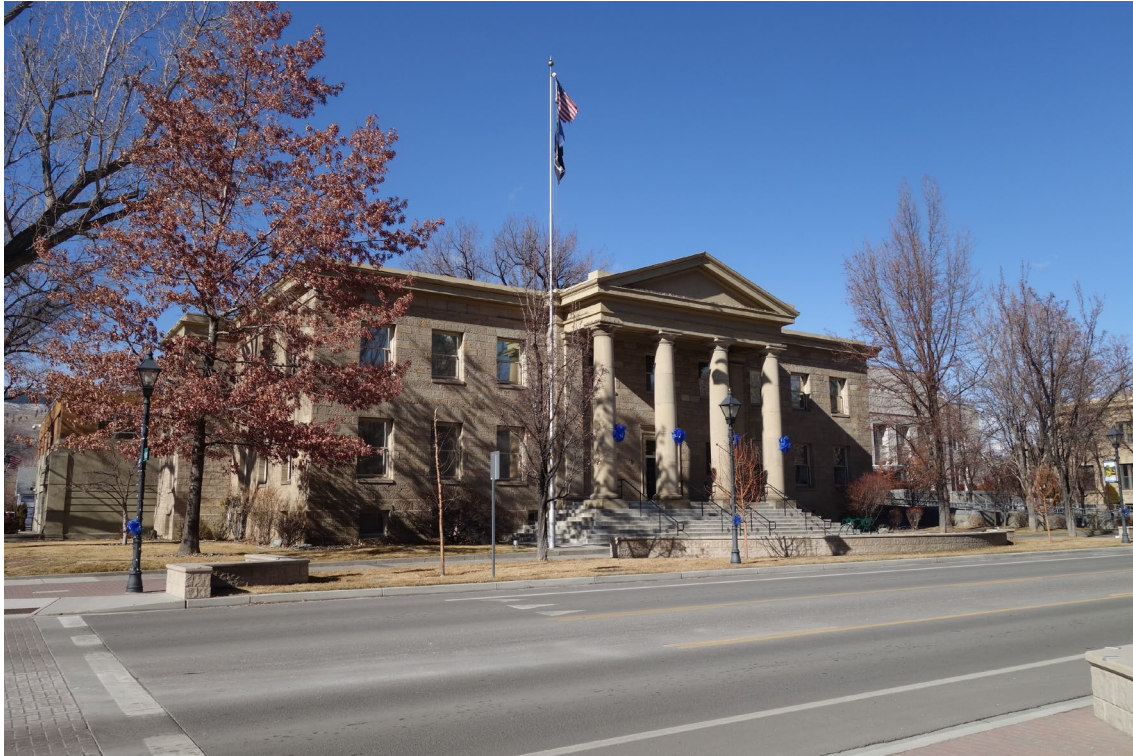
Heroes Memorial Building - Building #0244  
Description: Renovation & Seismic Upgrade Needed.

This building is an unreinforced masonry structure which requires seismic strengthening to meet current life safety codes. An initial study was done under CIP 07-M46 which provided detailed recommendations for a seismic retrofit. It also identified inefficient floor plans and circulation problems. The design through construction documents are being developed under CIP 19-P02. This project will provide significant upgrades to the structure, building systems, and provide more effective use of available spaces.

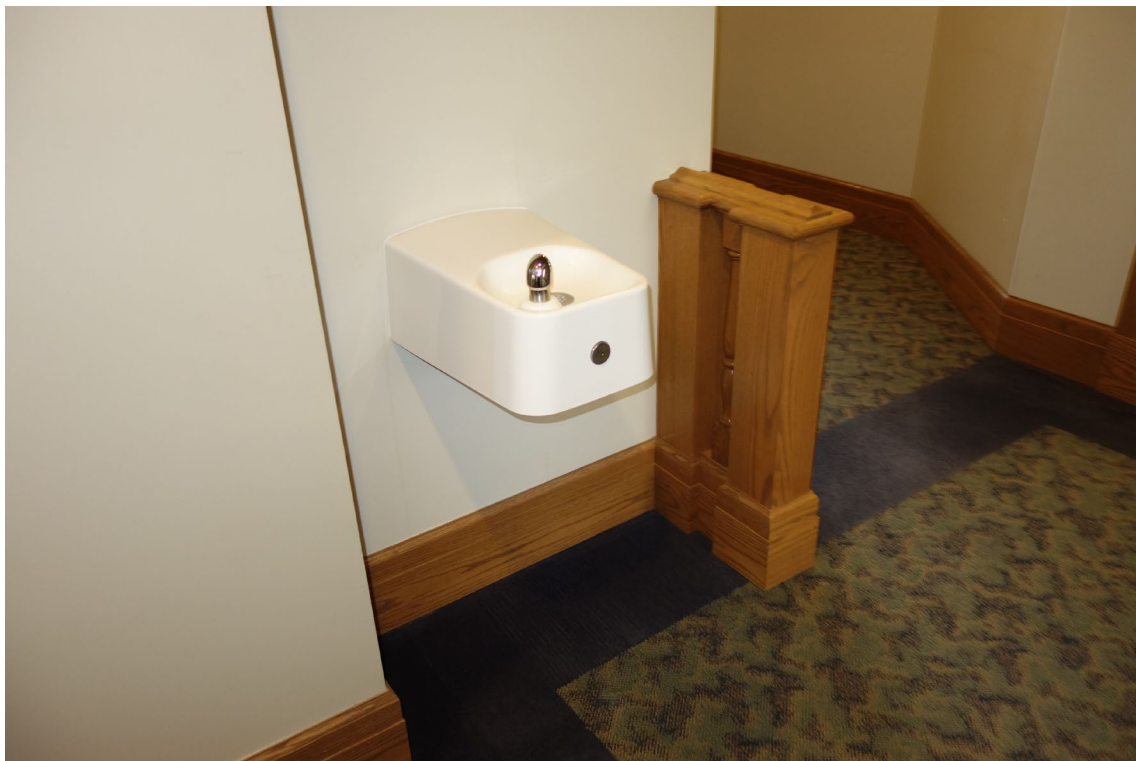
Frankie Sue Del Papa Building - Building #0261  
Description: Dual Level Drinking Fountains Needed.

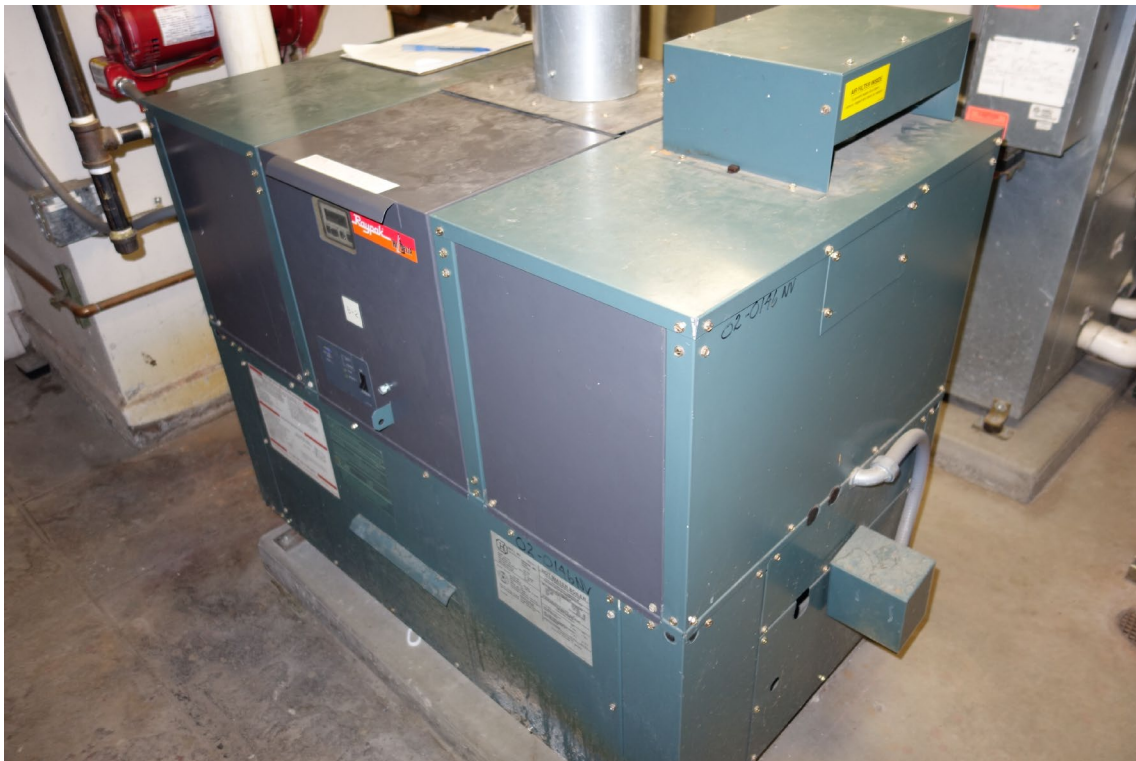
Frankie Sue Del Papa Building - Building #0261  
Description: HVAC System Replacement Planning Recommended.

The major components of the HVAC central plant are approaching 20 years old, and are nearing the end of their useful life. Replacement equipment will be more reliable, efficient, and will include code-required safety provisions that are not currently installed. The R-22 refrigerant in the existing chiller system is no longer EPA compliant and its production is mandated to be phased out completely by January 1, 2020. The temperature controls will be upgraded to improve energy efficiency. This project will replace the existing central plant equipment including chiller, cooling tower, boiler and associated pumps and accessories. Architectural modifications to the central plant are included in this estimate.

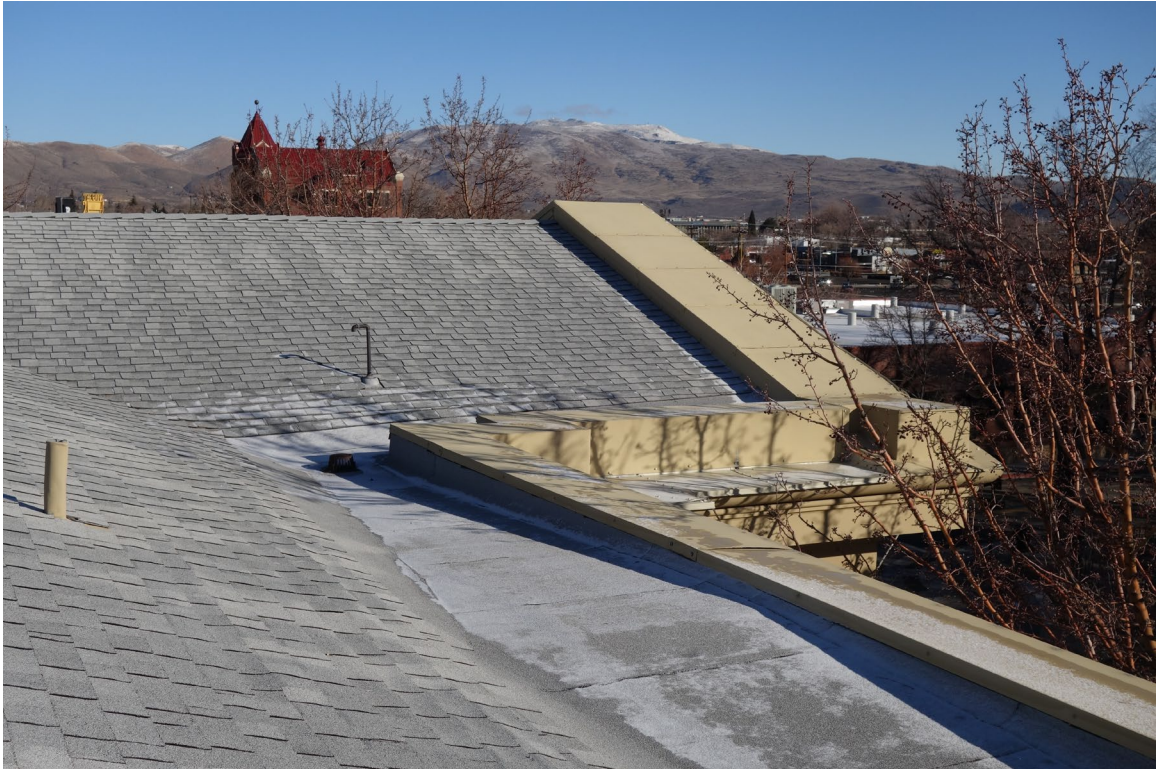
Frankie Sue Del Papa Building - Building #0261  
Description: Roof Replacement Planning Recommended.

The asphalt composition shingle roof on this building was in fair condition at the time of the survey. It is recommended that this building be re-roofed in the next 8 -10 years with a new 50 year asphalt composition roofing shingle and new underlayment. This estimate includes removal and disposal of the old roofing system.

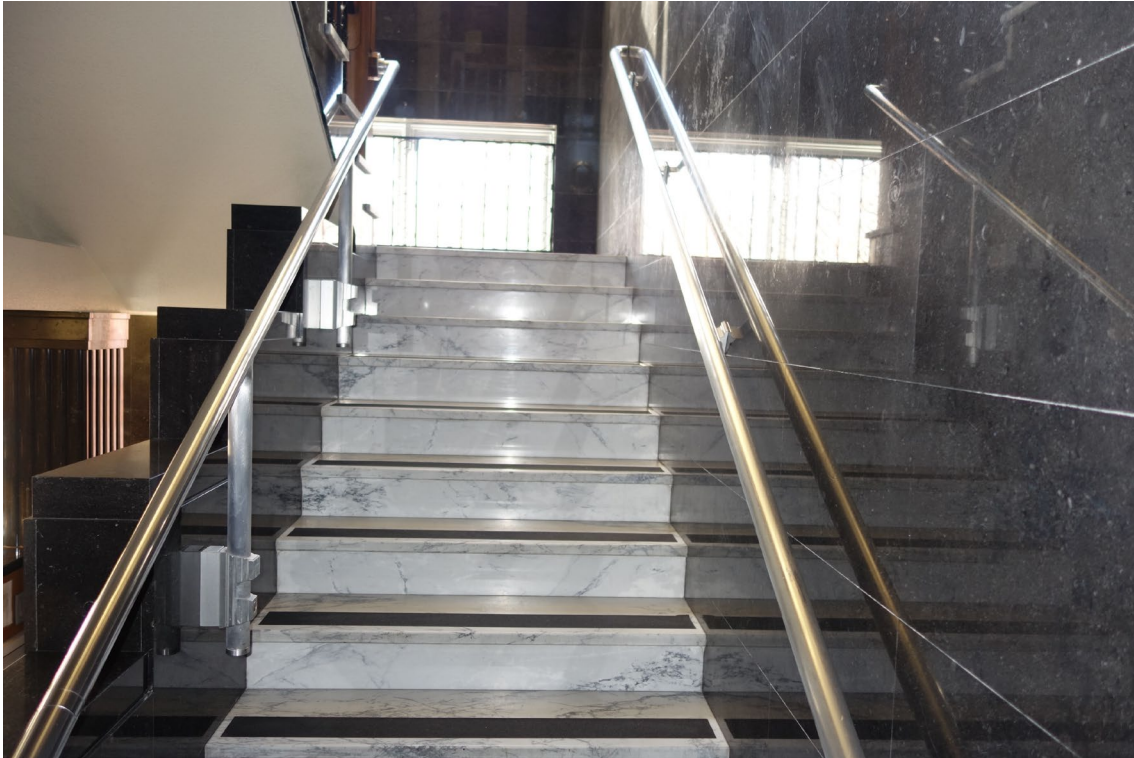
Attorney General's Office - Building #0306  
Description: Interior Handrail Replacement Needed.

The handrails in several stairwells do not meet code for safety or accessibility. The gripping surfaces are incorrect, the handrails do not have proper returns and they are not continuous from the top to bottom of the stairs. The east stairwell near the main entrance has an overhead hazard at the cane detection area under the stairs. This project recommends the installation of handrails on both sides of stairwells, with proper returns and supports as well as installing a barrier under the stairs. IBC - 2018 Section 1012 and ADAAG 4.4.2 were referenced for this project.

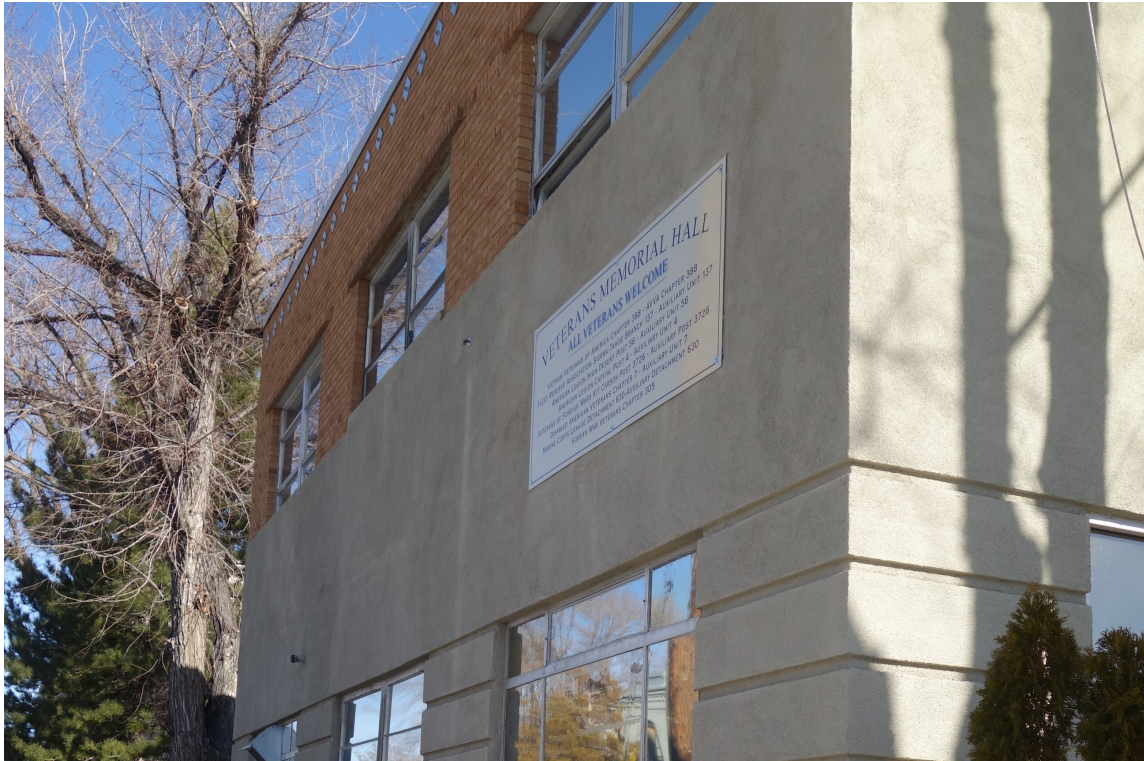
Heroes Memorial Annex - Building #2311  
Description: Renovation & Seismic Upgrade Needed.

This building is an unreinforced masonry structure which requires seismic strengthening to meet current life safety codes. An initial study was done under CIP 07-M46 which provided detailed recommendations for a seismic retrofit. It also identified inefficient floor plans and circulation problems. The design through construction documents are being developed under CIP 19-P02. This project will provide significant upgrades to the structure, building systems, and provide more effective use of available spaces.

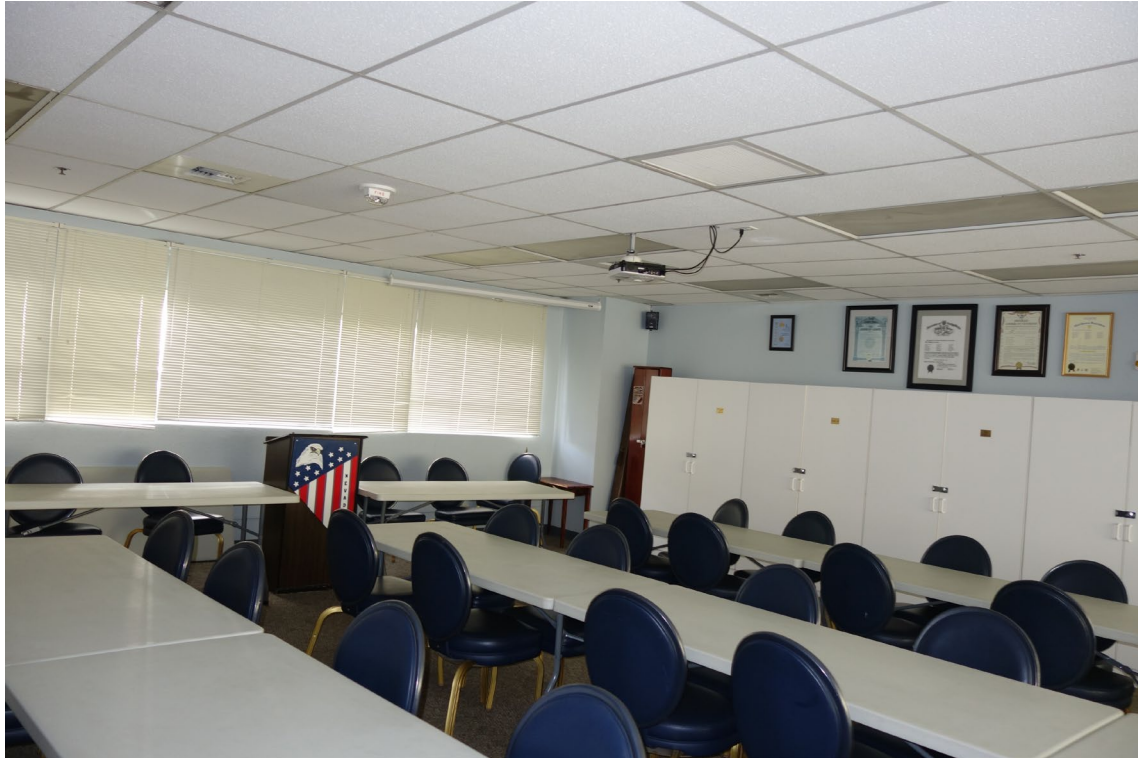
Heroes Memorial Annex - Building #2311  
Description: Interior Lighting Upgrade Needed.

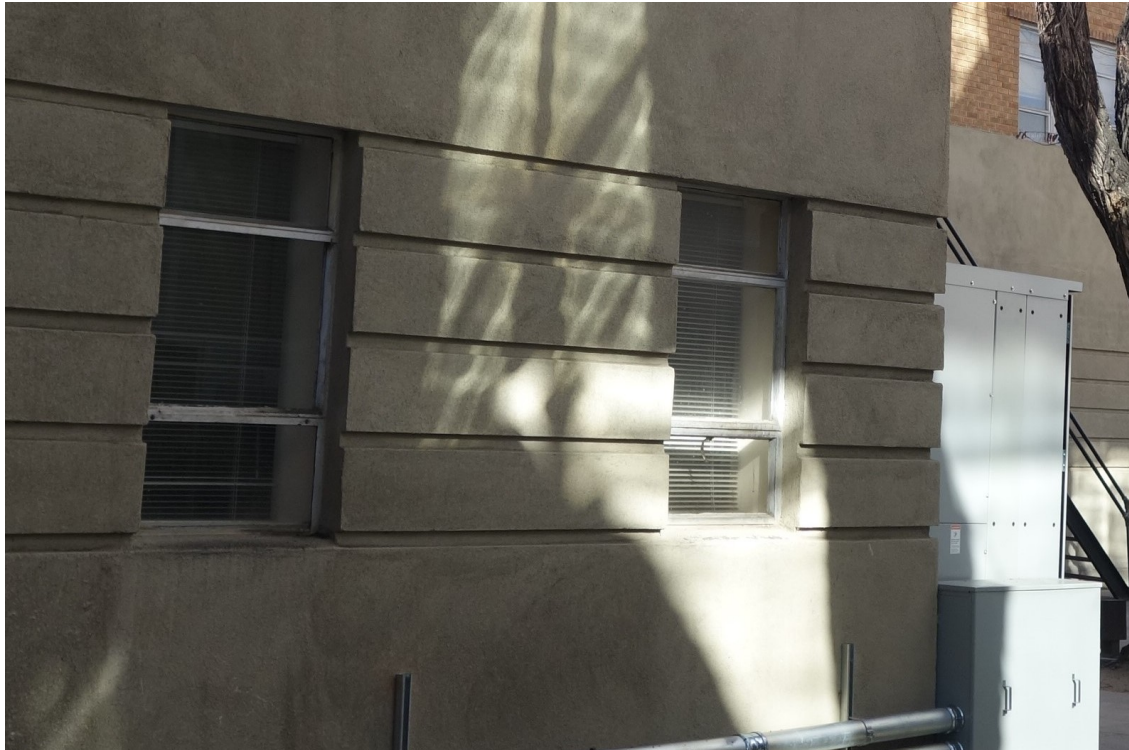
Heroes Memorial Annex - Building #2311  
Description: Window Replacement Needed.

The windows are original, single pane construction in a metal frame. These older windows are drafty and not energy efficient. This project recommends replacing the windows with dual pane, higher efficiency units. This estimate is for the replacement of 20 units. Removal and disposal of the existing windows is included in this estimate.

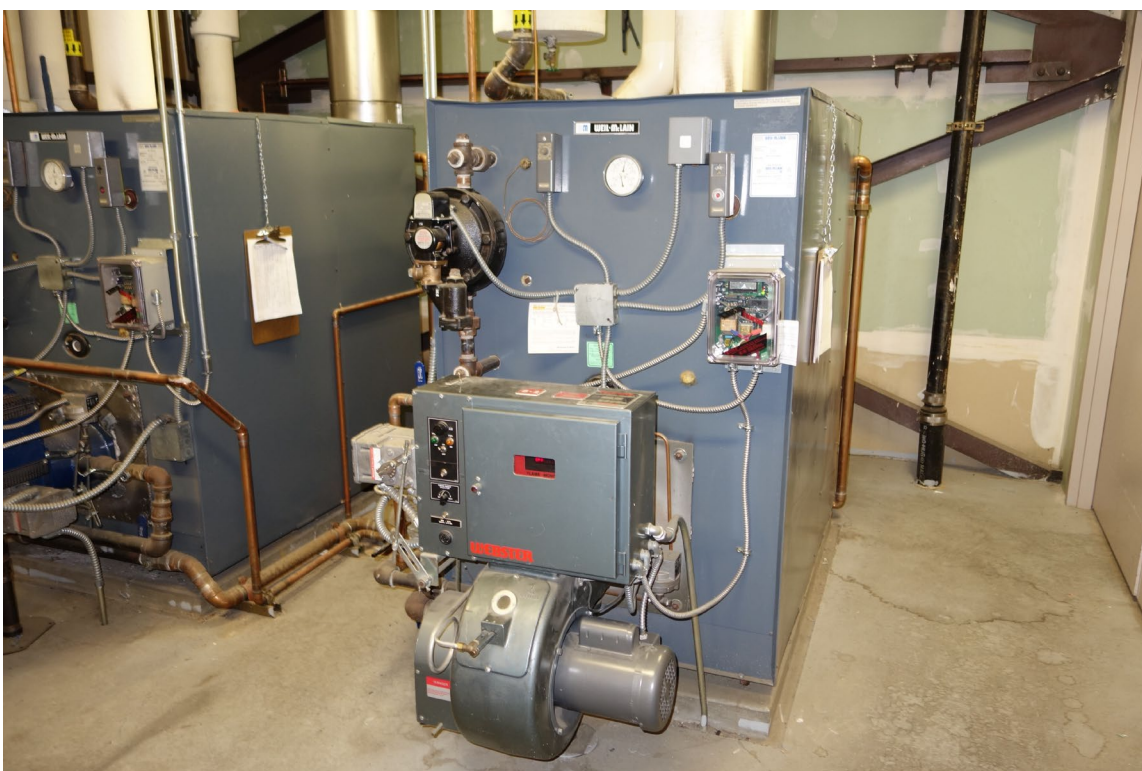
Service Cube Building - Building #2950  
Description: HVAC System Replacement Needed.

The major components of the HVAC central plant are original equipment, are approaching 30 years old, and are near the end of their useful life. Replacement equipment will be more reliable, efficient, and will include code-required safety provisions that are not currently installed. The R-22 refrigerant in the existing chiller system is no longer EPA compliant and its production is mandated to be phased out completely by January 1, 2020. The temperature controls will be upgraded to improve energy efficiency. This project will replace the existing central plant equipment including chiller, cooling tower, boiler and associated pumps and accessories. Architectural modifications to the central plant are included in this estimate.
