STATE OF NEVADA
STATE PUBLIC WORKS DIVISION

FACILITY CONDITION ASSESSMENT REPORT FOR:

OFFICE OF THE MILITARY
NATIONAL GUARD

PLUMB LANE READINESS CENTER SITE - USA
685 E PLUMB LN
RENO, NV 89502-3505

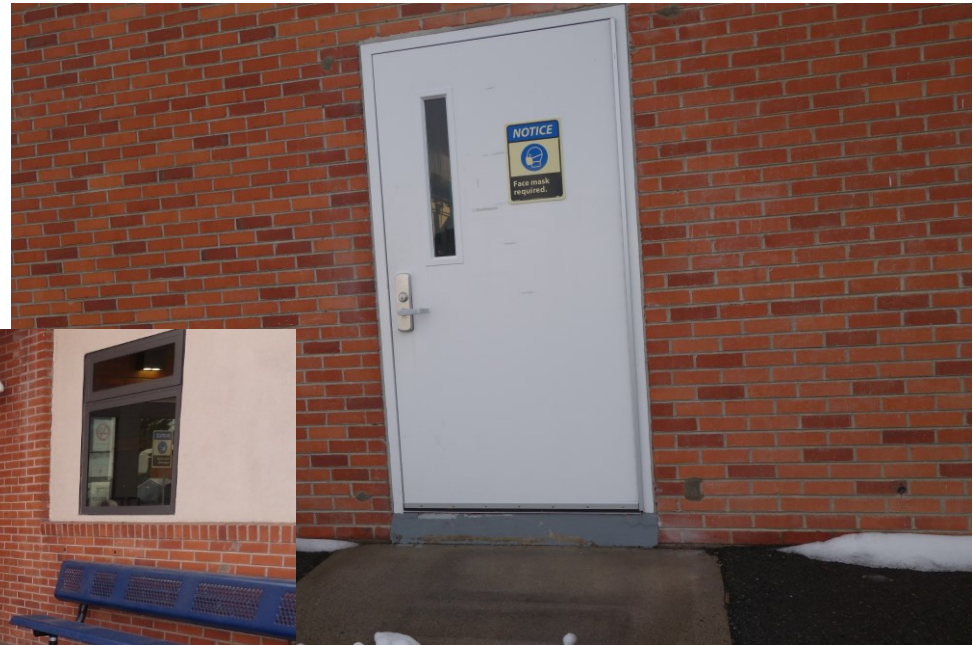
PROJECT # 2042ADA7 - ADA

QUANTITY	UNITS	TOTAL	SF COST
The exterior entrance door on the east side of the building is on an accessible path of travel. In addition, the facility is a secured facility requiring authorization to enter. In order to make the entrance accessible, approved modifications are needed. Subject to approval, a voice communication system with signage in conjunction with powered door lock release and opener are recommended. The NRS 338.180, IBC - 2018, ICC/ANSI A117.1 - 2009 and the most current version of the Americans with Disabilities Act Accessible Guidelines (ADAAG) was used as a reference for this project.	1	PKG	\$25,000.00	\$ 2.00

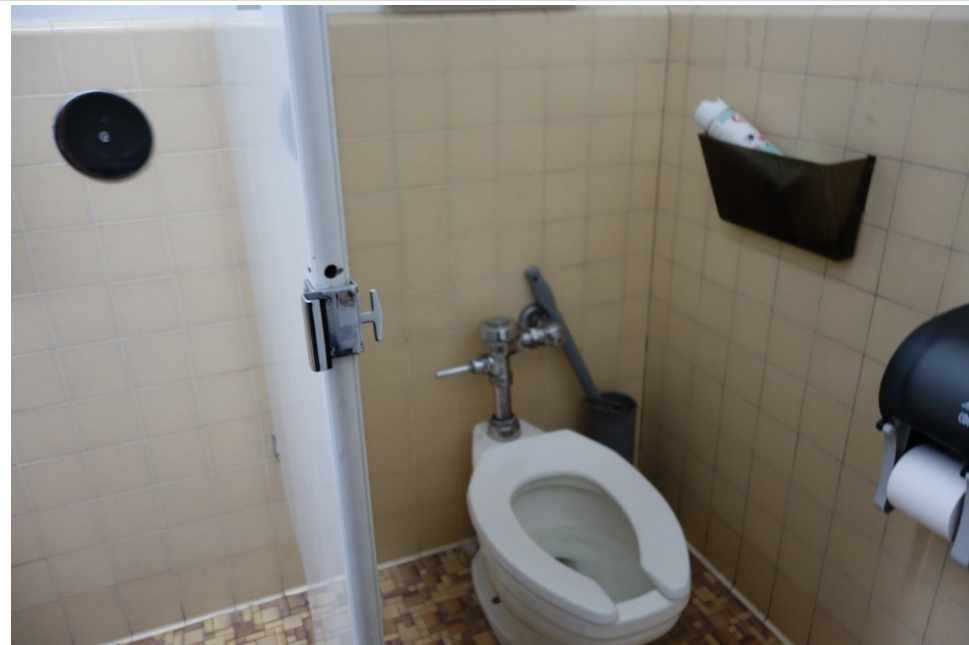
PROJECT # 2042PLM2 - PLUMBING

The entire plumbing system, including the sewer system is original to the building which is approaching 70 years. The galvanized water piping is fragile and easily damaged during repairs and modifications due to corrosion. There is concern for the under slab cast iron sewer and venting system also for the same reason. Due to the substantial investment to replace the sewer piping, a full assessment should be conducted. This project recommends the complete replacement of all domestic hot and cold water piping in the building. A full assessment of the underslab sewer and vent system is also included.

This project should be implemented concurrently with the RESTROOM REMODEL project.

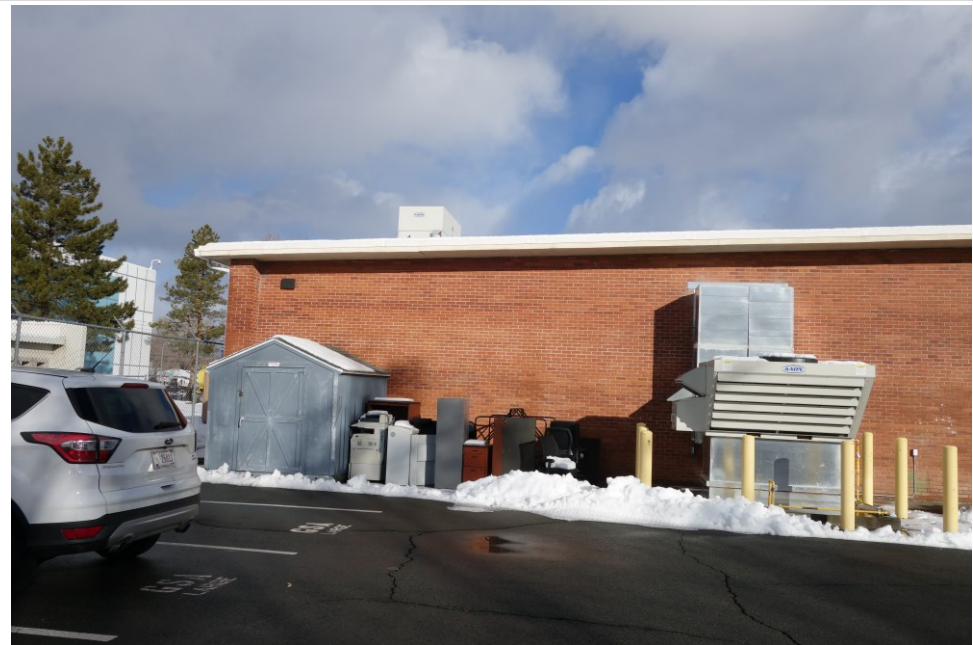
PROJECT # 2043EXT3 - BUILDING EXTERIOR

QUANTITY	UNITS	TOTAL	SF COST
There are locations of the stucco soffit that are failing due to leaking rain gutters, downspouts and/or failing roof flashing. Removal and replacement of the existing rain gutters, downspouts and roof flashing is recommended. With the gutters removed, a complete repair of the existing stucco is recommended. This project should be implemented concurrently with the ROOF REPLACEMENT project.	1	PKG	\$28,000.00	\$ 11.00

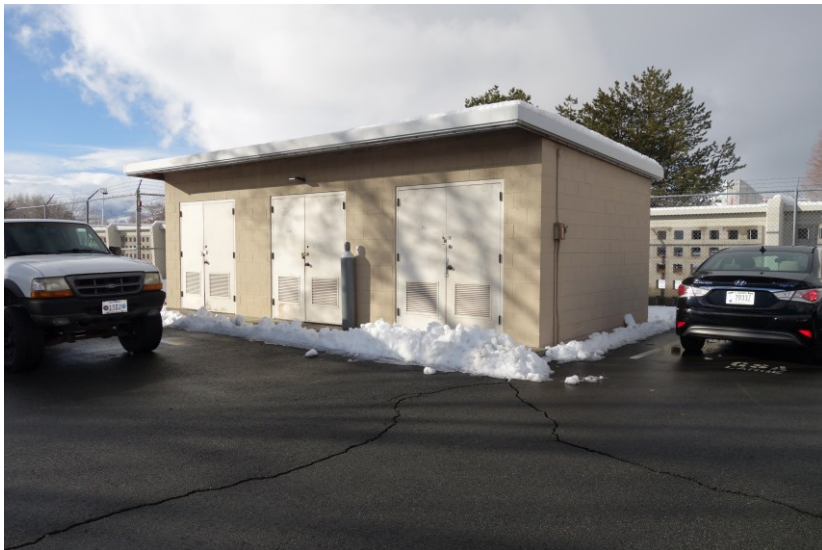
PROJECT # 2043EXT4 - BUILDING EXTERIOR

The roof on this building was in fair condition at the time of the survey. The statewide roofing program has set the useful life of an average roof at 20 - 25 years. The roof warranty expires during that time frame. Temperature fluctuations throughout the year, consistent wind which blows sand and dirt on to the roof membrane, and constant exposure to the sun are contributing factors to wear and deterioration. The current roofing system was installed in 2000 with a 20 year warranty. Based on the expected roofing lifespan, it is recommended that this building be re-roofed in the next 3 - 4 years to be consistent with the roofing program.

This project should be implemented concurrently with the SOFFIT AND RAIN GUTTER REPAIRS project.
