BERLIN ICHTHYOSAUR STATE PARK SITE

Site Number: 9922
STATE OF NEVADA PUBLIC WORKS DIVISION
FACILITY CONDITION ANALYSIS

Report distributed in November 2021

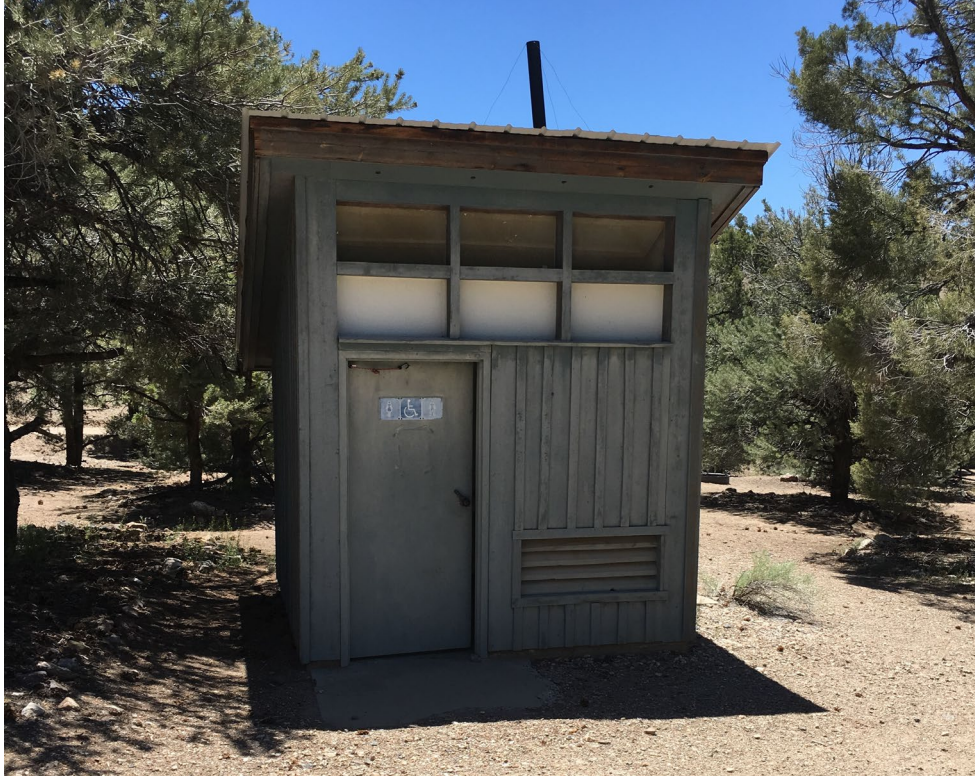
Restroom – Picnic Area - Building #0470
Description: Exterior of the Building Needing Replacement.

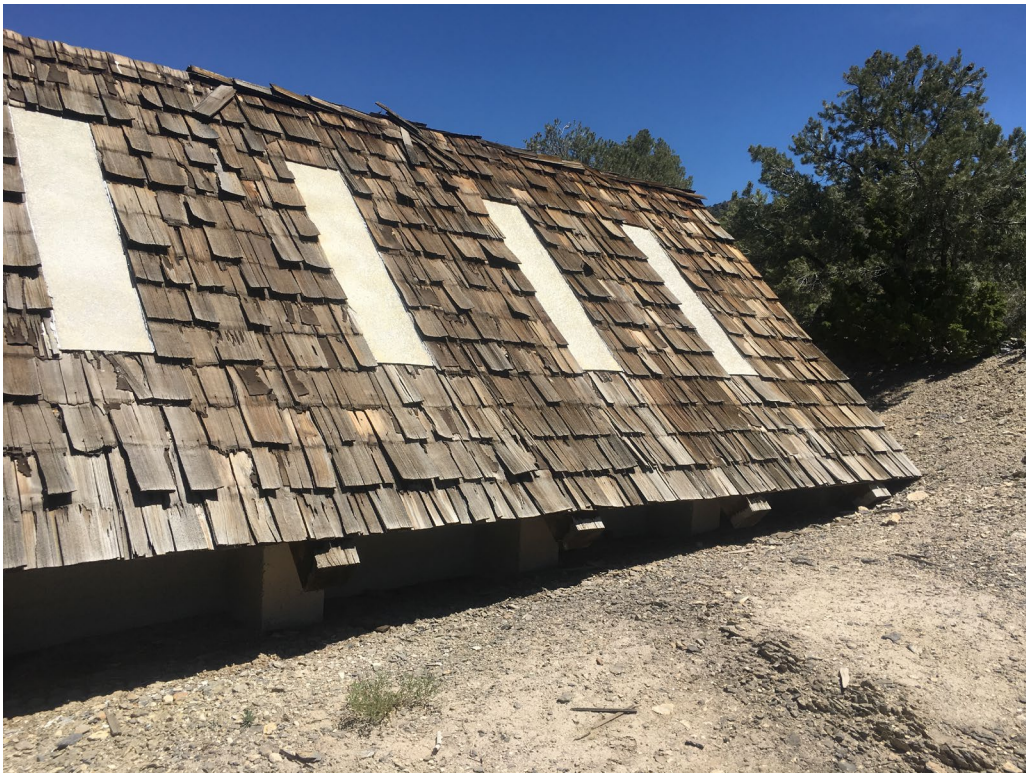
Fossil House Storage - Building #0473
Description: Building Roof Needing Replacement.

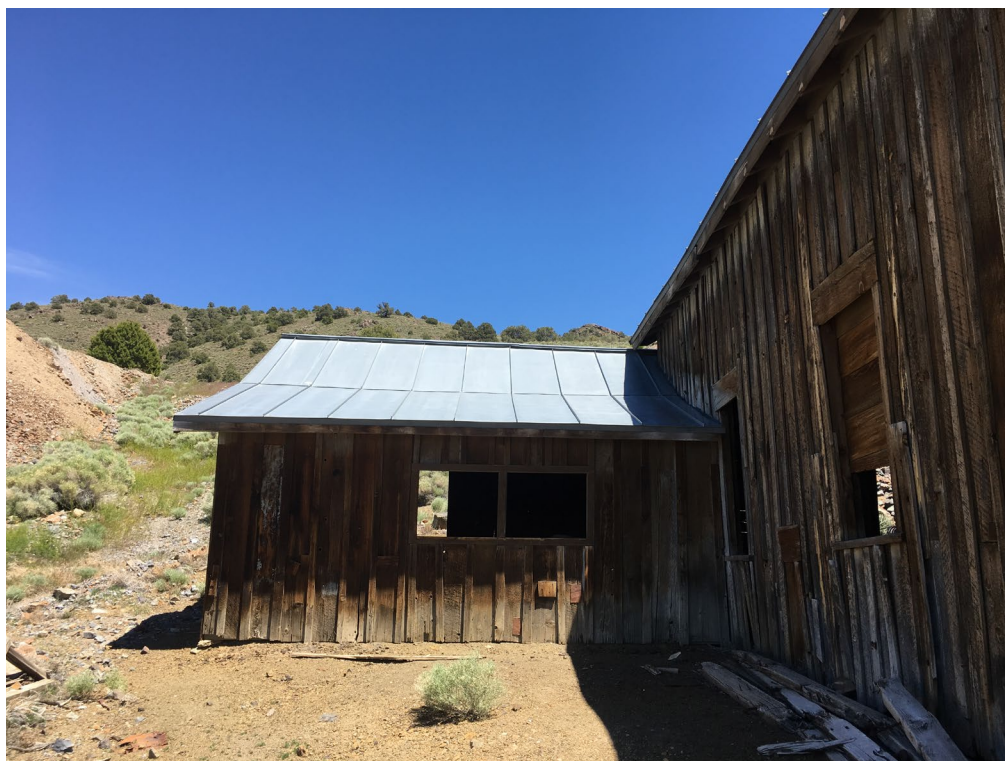
Machine Shop - Building #1011
Description: Exterior of the Building.

The wood structure is over 100 years old and there are numerous areas where the wood is splitting, warping and deteriorating. This is also an exhibit for the park and requires maintenance time to display the artifacts and maintain the signage. This project would provide for sealing the wood, caulking the flashing, fixtures and windows, replacing metal roof panels as needed, replacing wood siding as needed and maintaining the exhibit in a state of arrested decay. This project should be coordinated with the Nevada State Historical Preservation Office for possible restrictions or requirements which are not included in this estimate. It is recommended that the work be done in the next 2 - 3 years and that this project be scheduled on a cyclical basis to maintain the integrity of the structure.

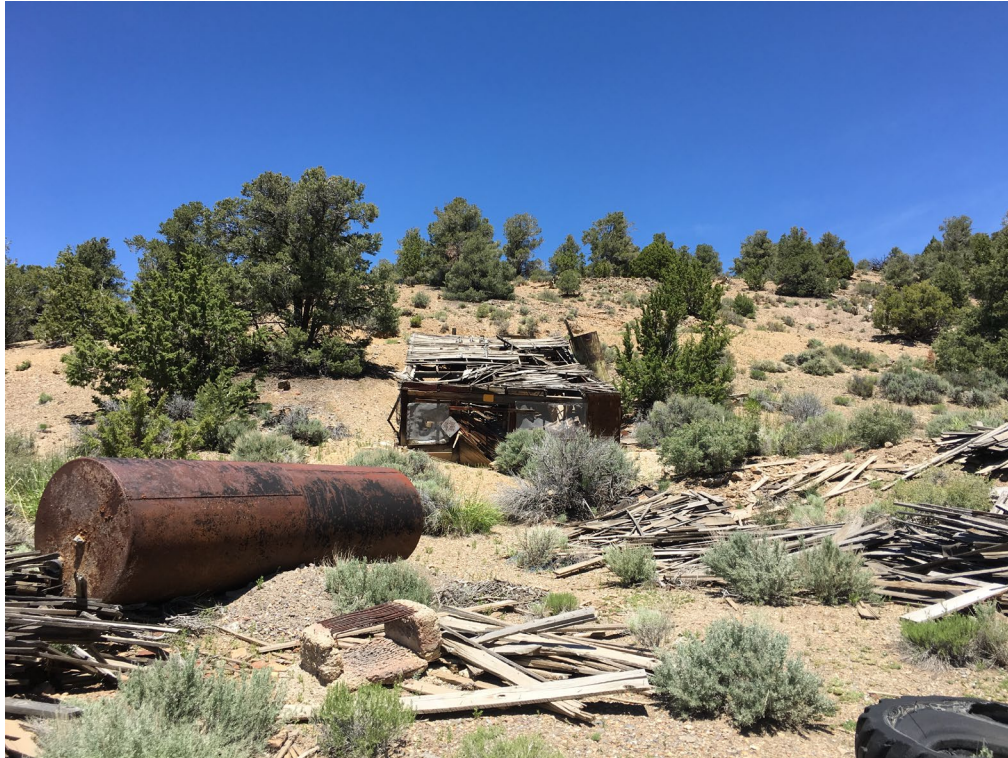
Ball Mill - Building #1012
Description: Exterior of the Building.

This is a historic wood framed structure that served as an ore crushing mill. It is located up the canyon road from the main town site close to the picnic area. It is maintained in a state of arrested decay and in poor condition.

The wood structure is over 100 years old and there are numerous areas where the wood is splitting, warping and deteriorating. This project would provide for replacing wood siding and roofing as needed and maintaining the exhibit in a state of arrested decay. This project should be coordinated with the Nevada State Historical Preservation Office for possible restrictions or requirements which are not included in this estimate. It is recommended that the work be done in the next 2-3 years and that this project be scheduled on a cyclical basis to maintain the integrity of the structure.

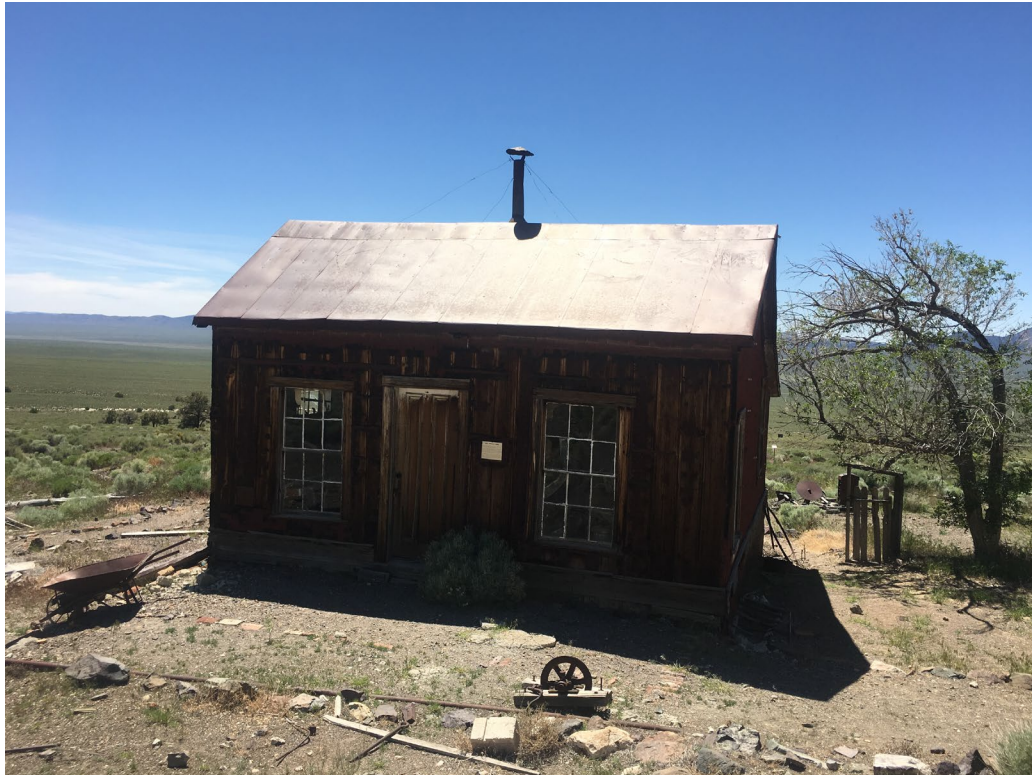
Phillips House - Building #1013
Description: Exterior of the Building.

The wood structure is over 100 years old and there are numerous areas where the wood is splitting, warping and deteriorating. This is also an exhibit for the park and requires maintenance time to display the artifacts and maintain the signage. This project would provide for sealing the wood, caulking the flashing, fixtures and windows, replacing metal roof panels as needed, replacing wood siding as needed and maintaining the exhibit in a state of arrested decay. This project should be coordinated with the Nevada State Historical Preservation Office for possible restrictions or requirements which are not included in this estimate. It is recommended that the work be done in the next 2 - 3 years and that this project be scheduled on a cyclical basis to maintain the integrity of the structure.

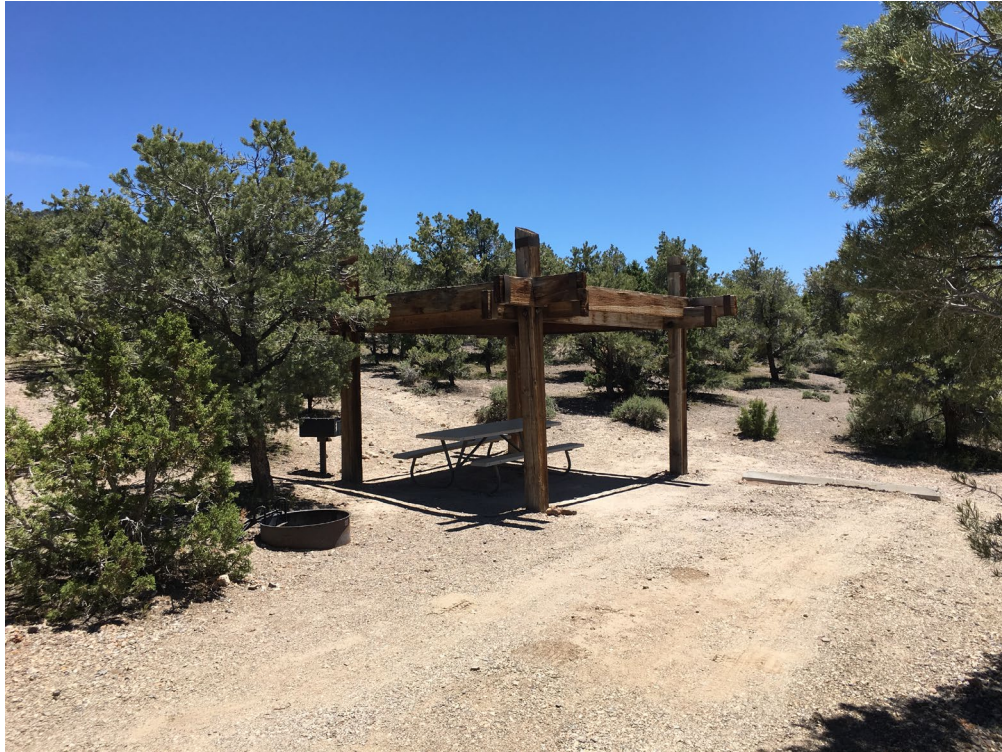
Typical Campground Ramada – Buildings #1014-1027
Description: Exterior of the Structure.

There are 14 wood shade ramadas in the campground which are 120 s.f. each for a total of 1,680 square feet. It is important to maintain the finish, weather resistance and appearance of the structures. This project would provide for staining the structures and it is recommended that this project be scheduled on a cyclical basis to maintain the integrity of the structures.

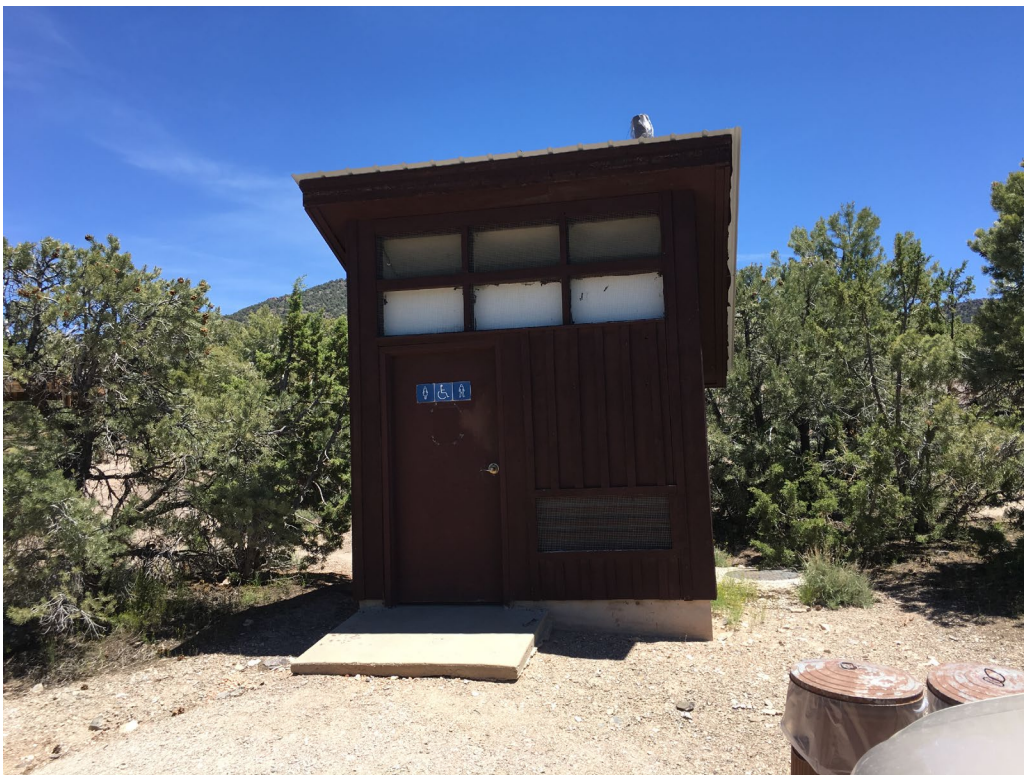
The restroom is a wood framed pit style unisex toilet with a metal roof located in the campground. This building has ADA signage on the door but is not ADA accessible. The report will address the replacement of this building with a new CXT precast comfort station.

Restroom B - Campground - Building #1028
Description: Exterior of the building.

PRIORITY CLASS 2 PROJECTS**Total Construction Cost for Priority 2 Projects: \$75,000****Necessary - Not Yet Critical****Two to Four Years****Project Index #: 1028ADA1****Construction Cost \$75,000****BUILDING REPLACEMENT**

The restroom is approaching the end of its expected life and should be scheduled for replacement. Although it has an ADA sign on it, it is not compliant with current ADA requirements. This project would provide for the demolition and disposal of the existing structure and installation of an ADA compliant precast CXT or similar unisex comfort station to be located adjacent to an ADA accessible parking space. An ADA accessible route of travel from the parking to the comfort station is included in this estimate.

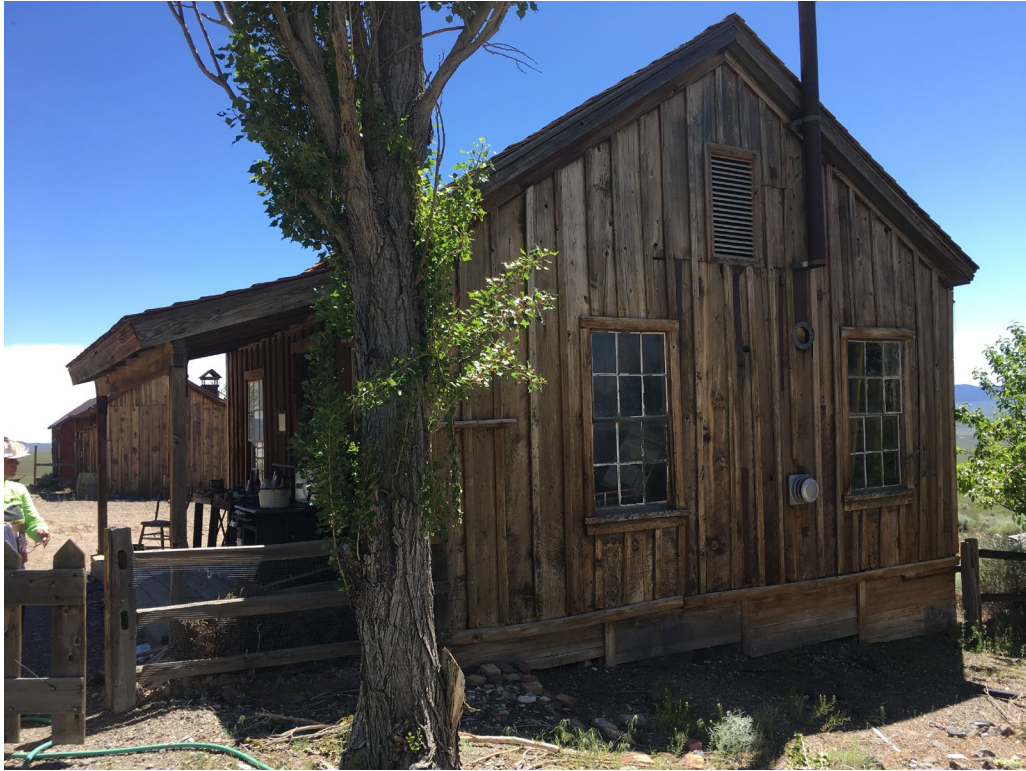
Watson House - Building #1032
Description: Exterior of the Building.

The wood structure is over 100 years old and there are numerous areas where the wood is splitting, warping and deteriorating. This is also an exhibit for the park and requires maintenance time to display the artifacts and maintain the signage. This project would provide for sealing the wood, caulking the flashing, fixtures and windows, replacing metal roof panels as needed, replacing wood siding as needed and maintaining the exhibit in a state of arrested decay. This project should be coordinated with the Nevada State Historical Preservation Office for possible restrictions or requirements which are not included in this estimate. It is recommended that the work be done in the next 2 - 3 years and that this project be scheduled on a cyclical basis to maintain the integrity of the structure.

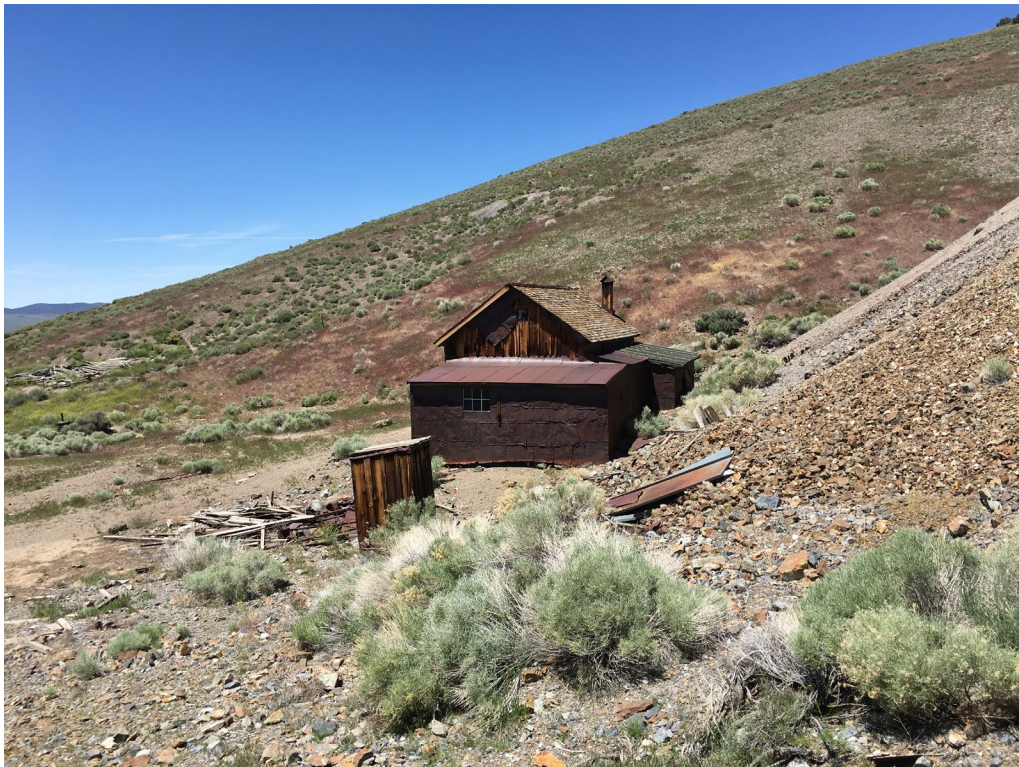
Tiffels Cabin / Stagecoach Stop - Building #1034
Description: Exterior of the Building.

The wood structure is over 100 years old and there are numerous areas where the wood is splitting, warping and deteriorating. This is also an exhibit for the park and requires maintenance time to display the artifacts and maintain the signage. This project would provide for sealing the wood, caulking the flashing, fixtures and windows, replacing wood shake roof shingles as needed, replacing wood siding as needed and maintaining the exhibit in a state of arrested decay. This project should be coordinated with the Nevada State Historical Preservation Office for possible restrictions or requirements which are not included in this estimate. It is recommended that the work be done in the next 2 - 3 years and that this project be scheduled on a cyclical basis to maintain the integrity of the structure.

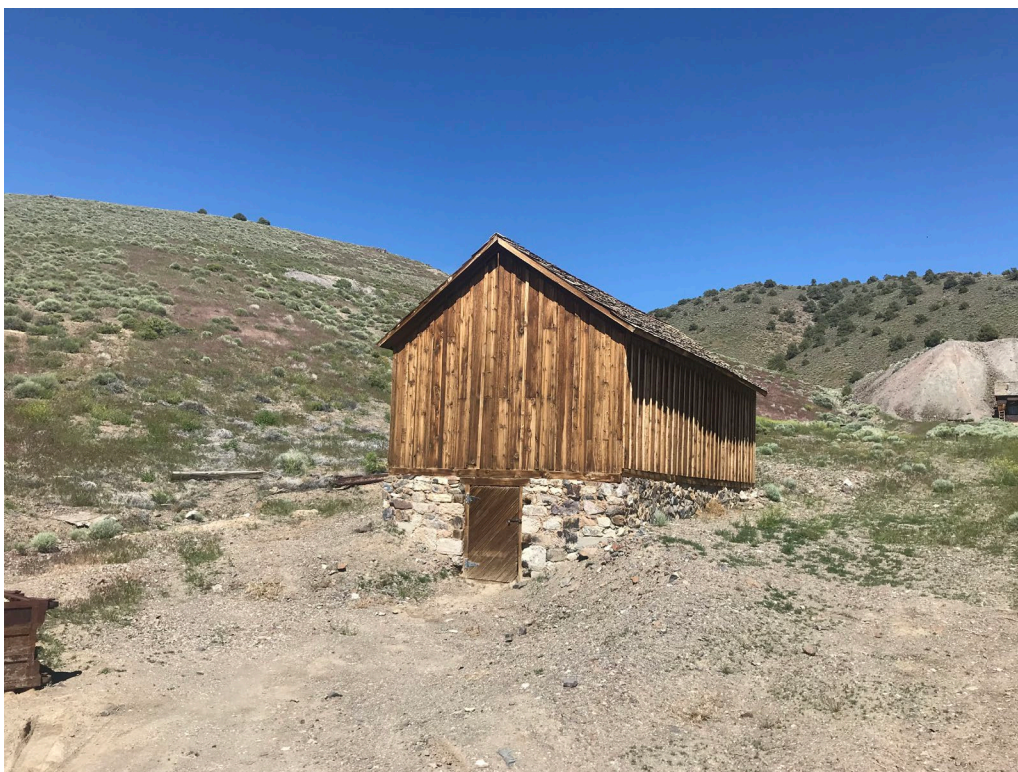
Store Warehouse - Building #1035
Description: Exterior of the Building.

The wood and stone structure is over 100 years old and there are numerous areas where the wood is splitting, warping and deteriorating. This is also an exhibit for the park and requires maintenance time to display the artifacts and maintain the signage. This project would provide for sealing the wood, cleaning, repair and re-pointing of the stone work, caulking the flashing, fixtures and windows, replacing wood shake roof shingles as needed, replacing wood siding as needed and maintaining the exhibit in a state of arrested decay. This project should be coordinated with the Nevada State Historical Preservation Office for possible restrictions or requirements which are not included in this estimate. It is recommended that the work be done in the next 2 - 3 years and that this project be scheduled on a cyclical basis to maintain the integrity of the structure.
