Department of Public Safety
Highway Patrol Division
NHP Regional Headquarters
Facility Condition Analysis

NHP REGIONAL HEADQUARTERS

357 Hammill Lane
Reno, Nevada 89511

Site Number: 9923
STATE OF NEVADA PUBLIC WORKS DIVISION
FACILITY CONDITION ANALYSIS

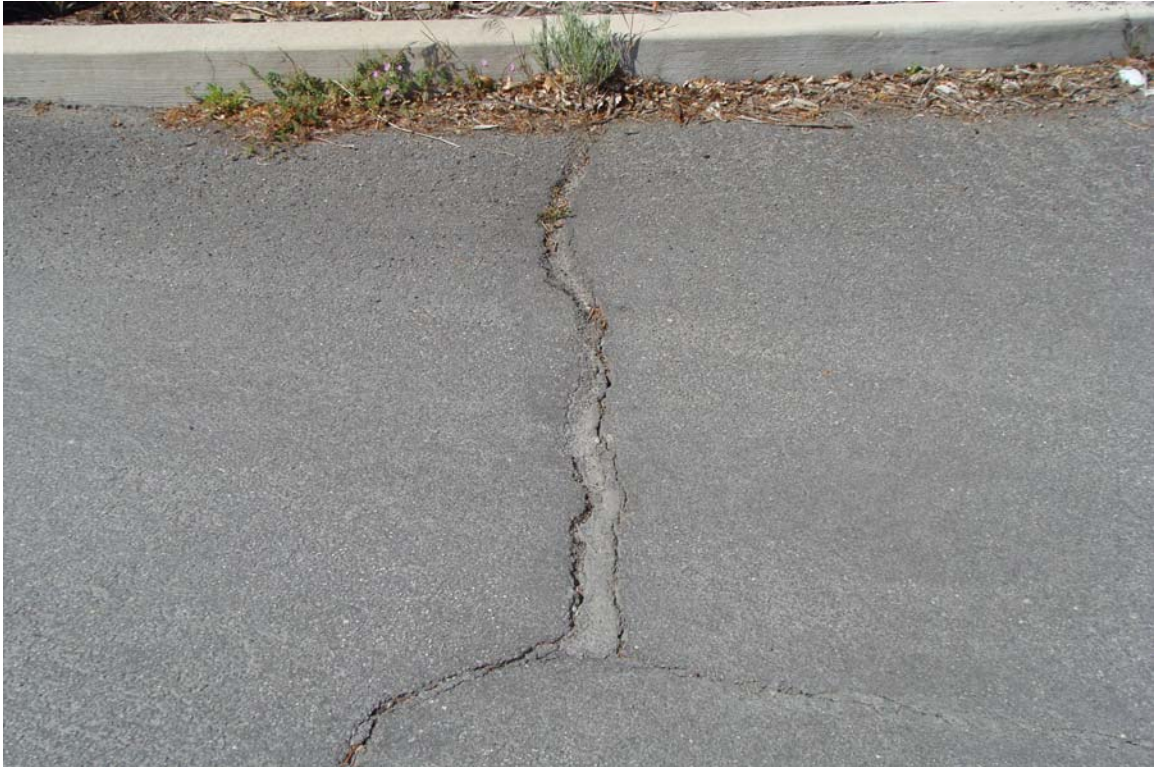
It is important to maintain the asphalt concrete paving on the site. This project would provide for minor crack filling and slurry sealing of the paving site wide including access roads, parking areas and the maintenance yard. Striping is included in this estimate. The rear parking lot is extremely tight which has caused numerous minor vehicle accidents. It may be beneficial to redesign the flow of the parking lot and striping pattern. This project should be scheduled on a 5 year cyclical basis to maintain the integrity of the paving and prevent premature failure. 60,000 square feet of asphalt area was used to generate this estimate.

Reno NHP Headquarters Site - Site #9923
Description: AC paving in need of crack filling and sealing.

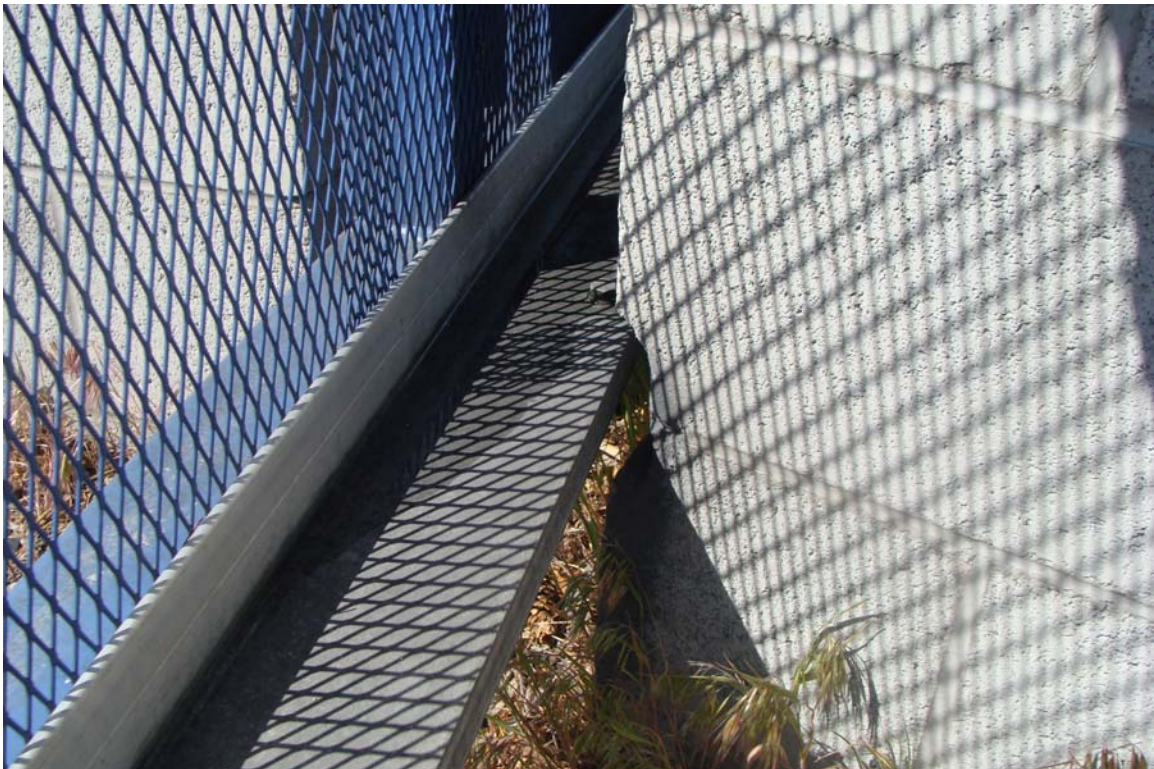
The site has a perimeter fence with two automatic vehicle access gates off of Hammill Lane and Kietzke Lane. The gate operators are malfunctioning, have been problematic, and have difficulty opening and closing the gates. This project recommends replacing the two gate operators with high quality operators that can handle heavy traffic as well as servicing the gates and related hardware to ensure prolonged operation. The gate operators will be required to meet UL Standard 325, per NRS 405.270.

Reno NHP Headquarters Site - Site #9923
Description: Security gate rubbing on CMU wall.

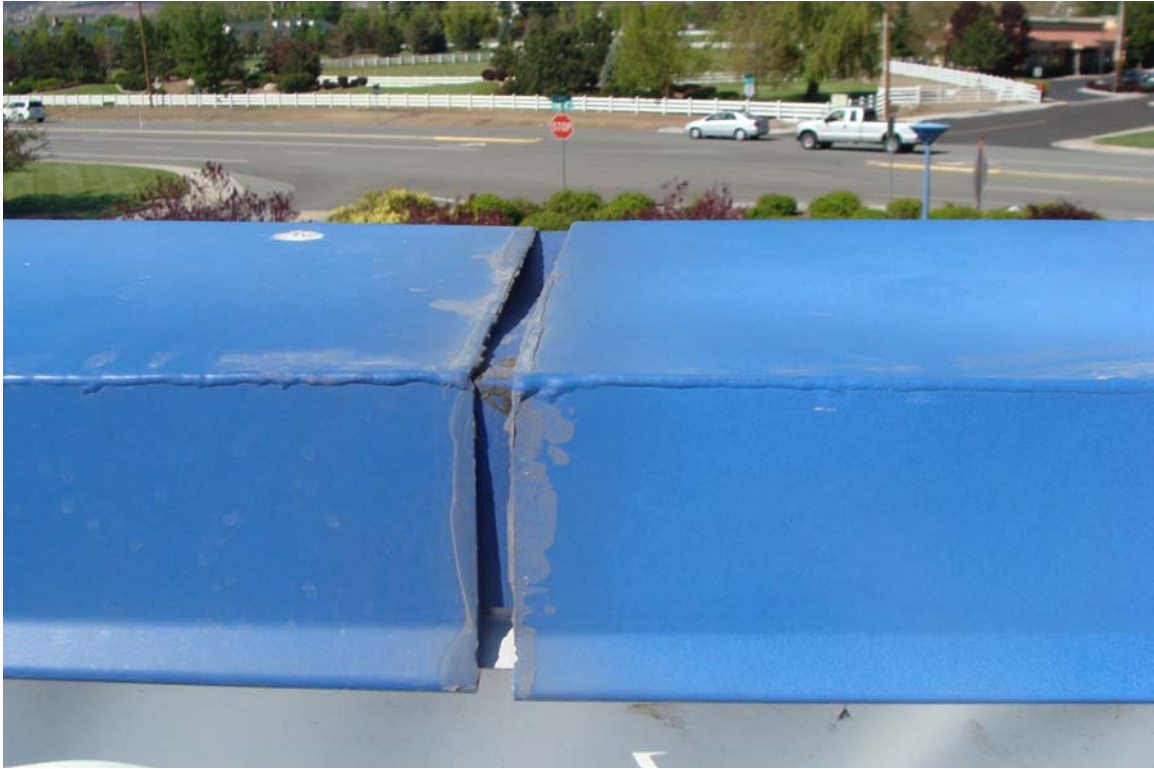
Reno NHP Headquarters - Building #0056
Description: View of cap flashing.

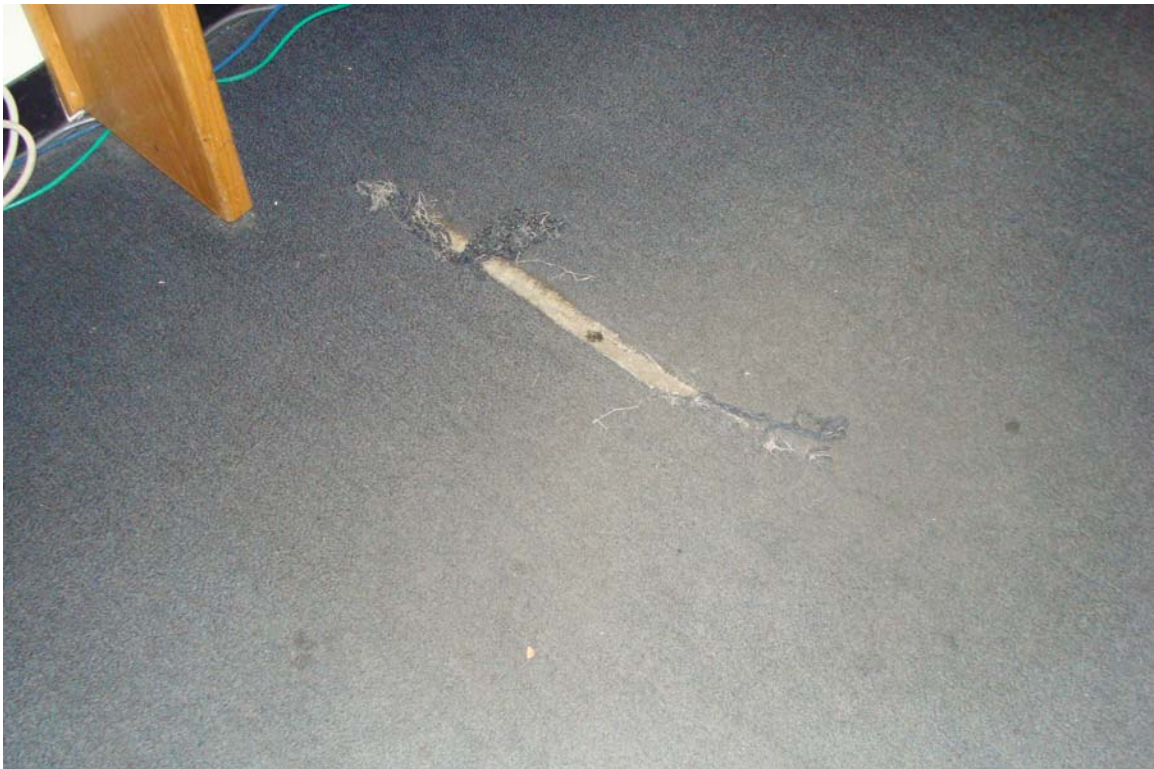
The carpet throughout the building is showing signs of extreme wear. It is recommended that the carpet be replaced with heavy duty commercial grade carpet in the next 2-3 years. This project or a portion thereof was previously recommended in the FCA report dated 07/15/2003. It has been amended accordingly to reflect conditions observed during the most recent survey date of 05/19/2011.

Reno NHP Headquarters - Building #0056
Description: Damaged carpet in report writing room.

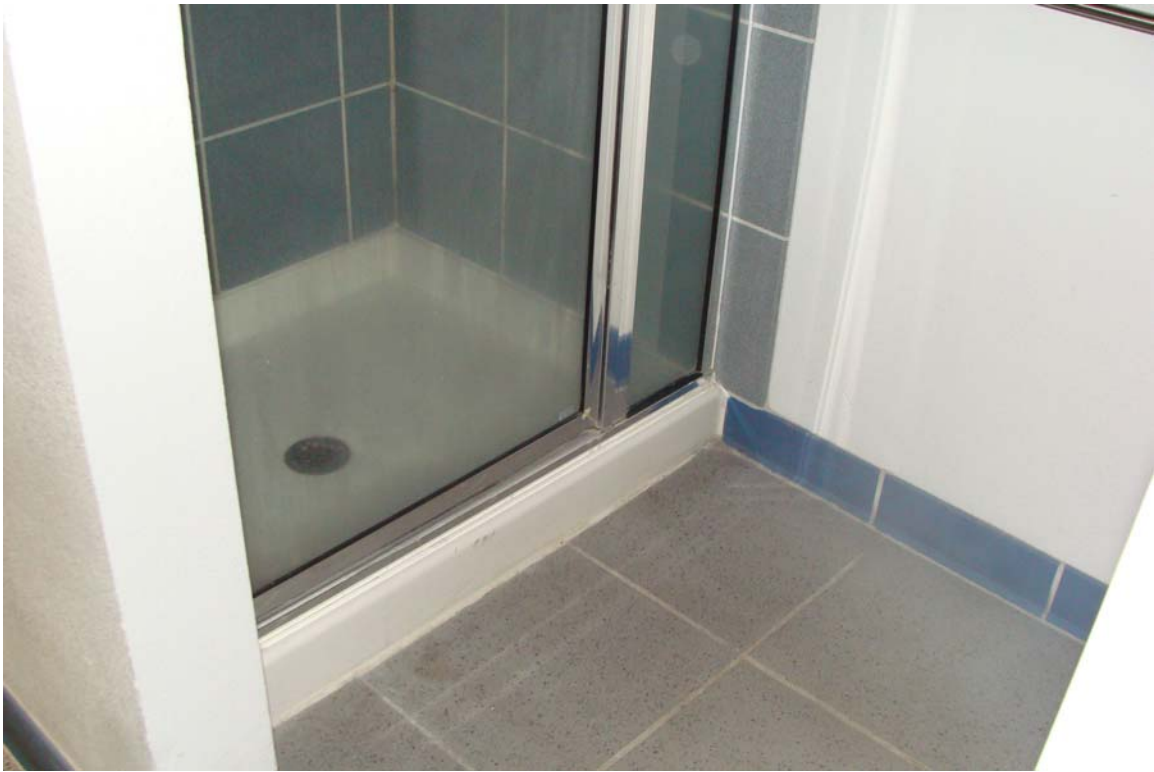
Reno NHP Headquarters - Building #0056
Description: Locker room shower in need of an ADA upgrade.

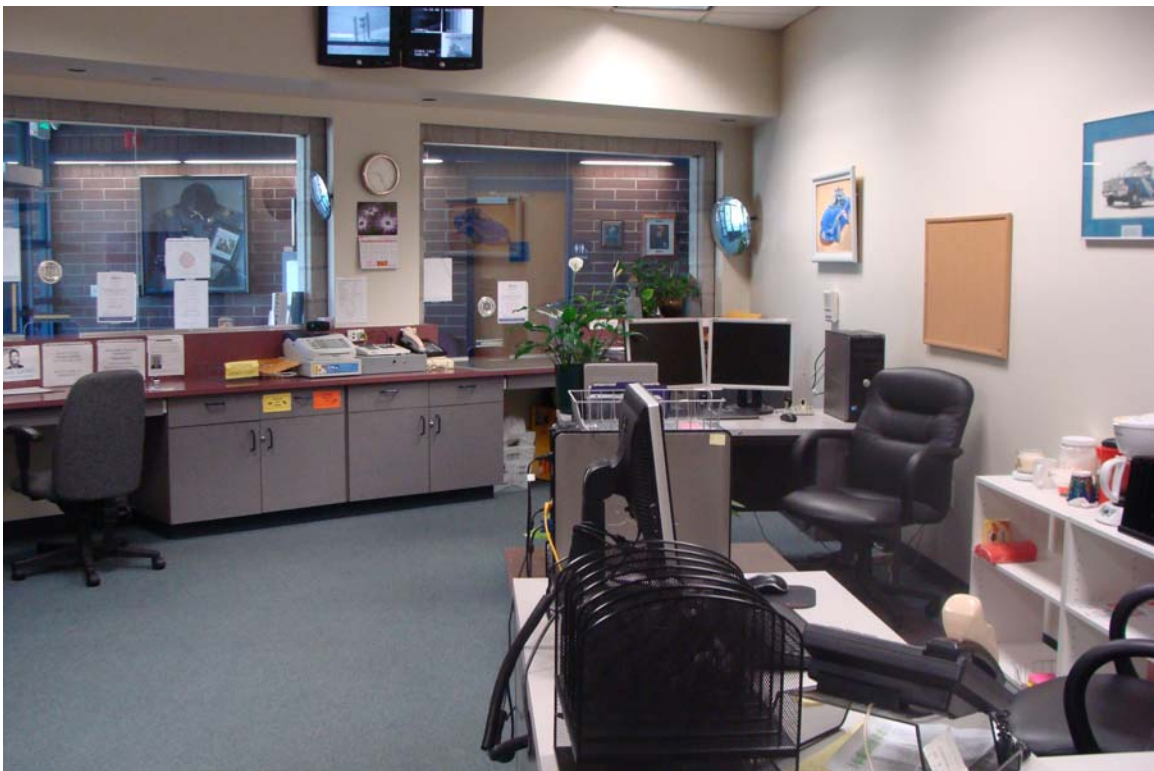
The Command Secretary desk and office space are in need of a remodel. The configuration of the space is not functional. The built-in desk does not have enough space for computer equipment, is missing a keyboard tray, and does not allow enough space for moving around in an office chair. This project would provide for removing the existing desk and replacing it with a new desk which fits the needs of the employee.

Reno NHP Headquarters - Building #0056
Description: View of the reception office area.

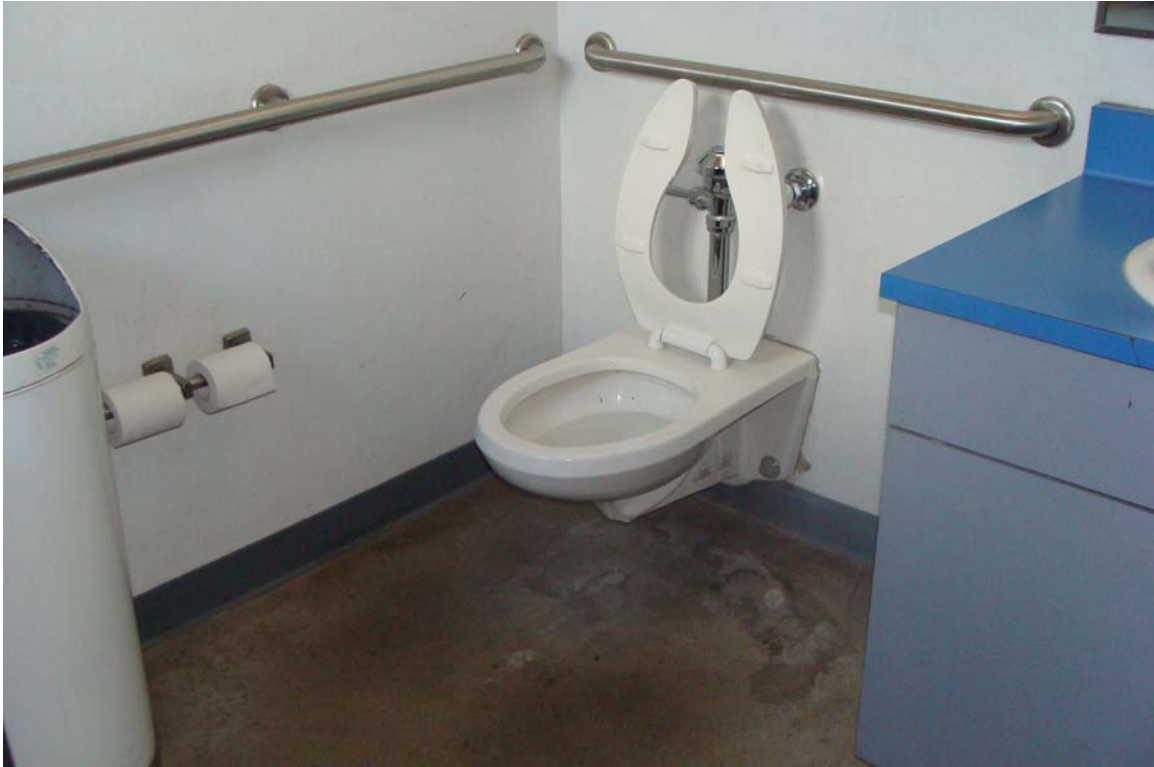
The existing accessible restroom does not fully meet the Americans with Disabilities Act (ADA) requirements. This project would provide for minor modifications to the existing restroom including flush handle relocation, sink and fixture modifications and accessory mounted location modifications. NRS 338.180, IBC - 2006, ICC/ANSI A117.1 - 2003 and the most current version of the Americans with Disabilities Act Accessible Guidelines (ADAAG) were used as a reference for this project.

Regional Headquarters Shop / Garage - Building #1682
Description: View of the ADA restroom, note flush handle on wrong side.

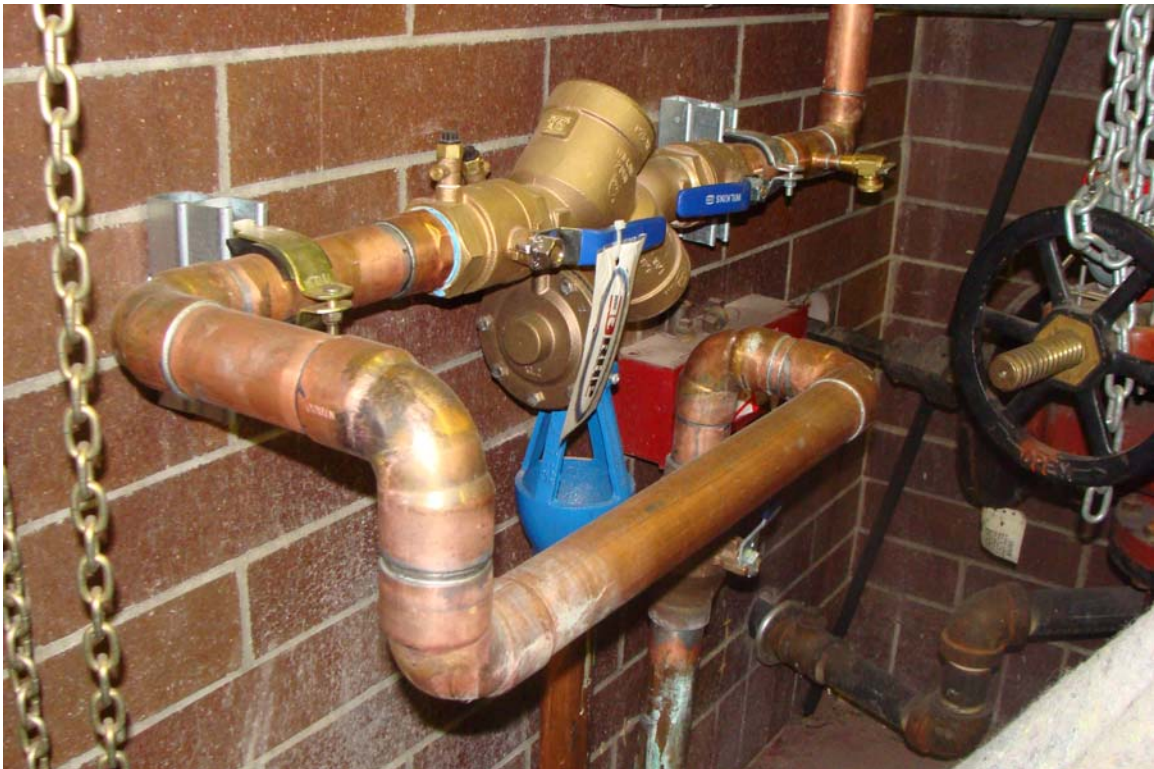
Regional Headquarters Shop / Garage - Building #1682
Description: View of domestic water check valve.
