DEPARTMENT OF ADMINISTRATION  
STATE PUBLIC WORKS DIVISION  
FACILITY CONDITION ASSESSMENT

### PROPERTY PORTFOLIO REVIEW FACILITY INSIGHTS

9924 - DEPARTMENT OF WILDLIFE REGIONAL SITE  
1100 VALLEY RD  
RENO, NV 89512-2817  
WASHOE COUNTY

SURVEY DATE: 01/05/2023

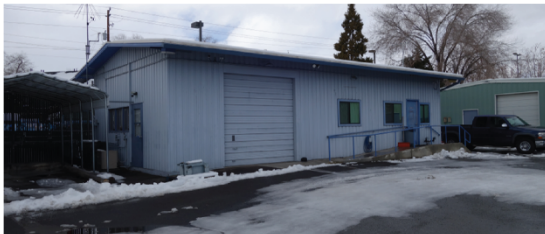
The pre-engineered metal Radio Shop/Dispatch Office includes office, workshop, and storage space. It has two offices, a dispatch wet bar, a unisex restroom, and a non-ADA-compliant ramp. Interior finishes include painted gypsum board, acoustical tile ceiling, and carpet. Climate control is provided by a gas-fired FAU with an exterior condenser. Smoke detection is installed.
