State of Nevada
Department of Conservation & Natural Resources
Division of State Parks
Lake Tahoe Nevada State Park – Cave Rock
Facility Condition Analysis

Cave Rock
Douglas County, Nevada

Site Number: 9926
STATE OF NEVADA PUBLIC WORKS DIVISION
FACILITY CONDITION ANALYSIS

Report Printed in December 2012

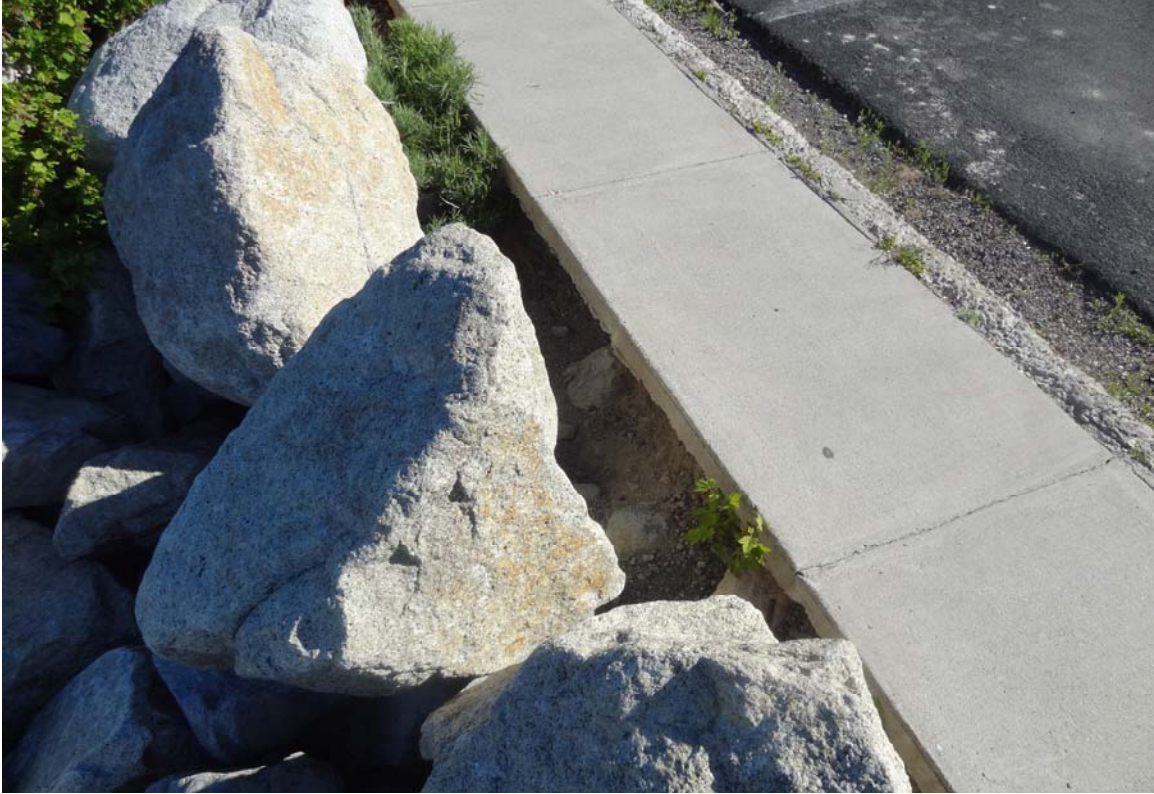
The existing AC and PC concrete pathways are failing, some due to exposure to the extreme weather and also erosion from the lake wave action and is a safety concern for the public. This project would provide for the removal repair or replacement as needed of the damaged portions of the walkway. Funds are also included to mitigate future erosion. 2000 square feet of area was used to generate this estimate.

Lake Tahoe Nevada State Park – Cave Rock Site – FCA Site #9926
Description: Undermining of walkway due to erosion from wave action.

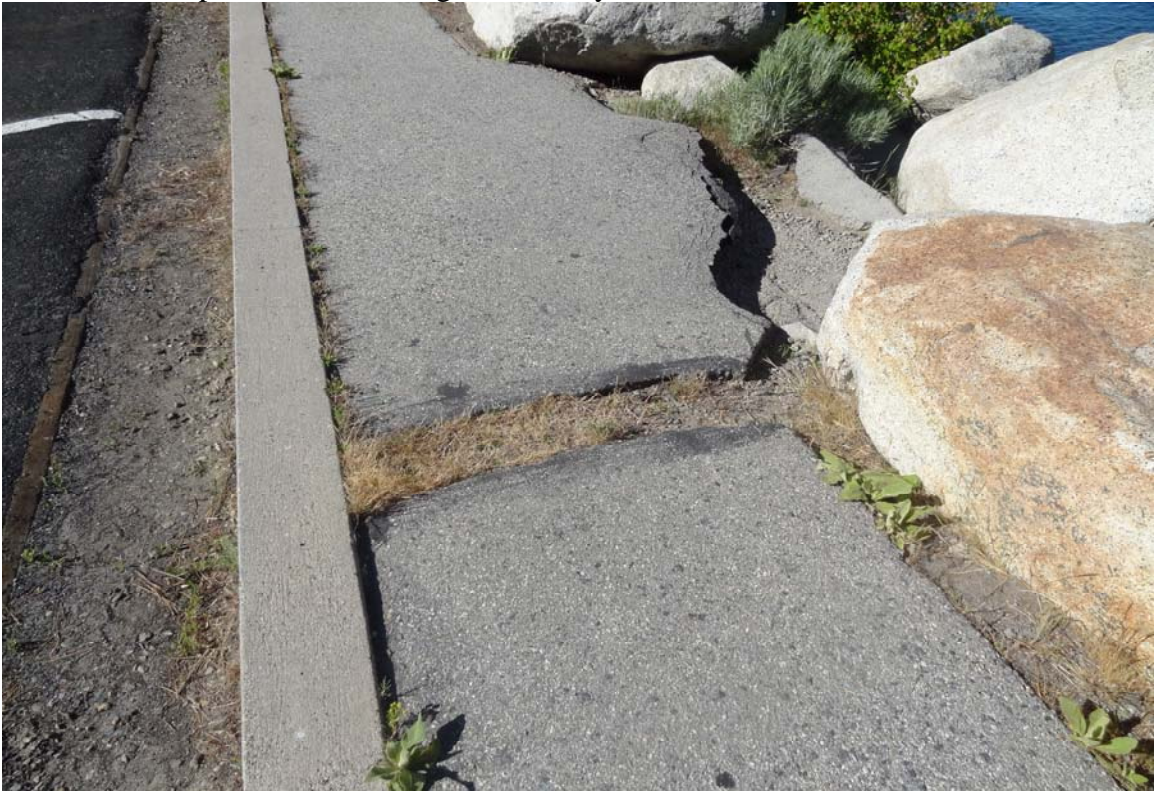
Lake Tahoe Nevada State Park – Cave Rock Site – FCA Site #9926
Description: Damaged walkway along parking area.

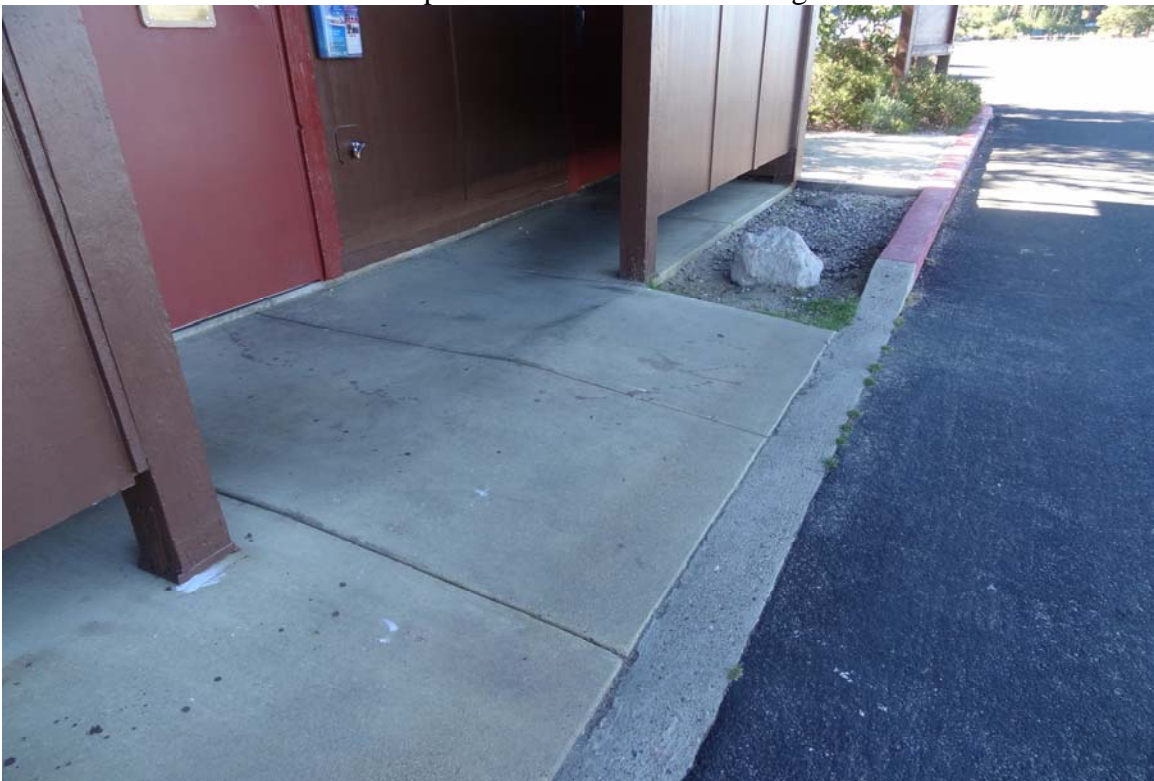
The existing Men's and Women's restrooms are not fully ADA complaint. This project would provide for modifications to the entrance into the restrooms including reworking the concrete ramp and privacy walls, installing the wall mounted dispensers at the proper location and other improvements as required. ADA signage is also included in this estimate. The 2012 IBC, ICC/ANSI A117.1 - 2009, NRS 338.180 and the most current version of the ADA Standards For Accessible Design were used as a reference for this project.

Cave Rock Comfort Station – FCA Building #0597
Description: Non-ADA compliant entrance.
