DEPARTMENT OF ADMINISTRATION
STATE PUBLIC WORKS DIVISION
FACILITY CONDITION ASSESSMENT

PROPERTY PORTFOLIO REVIEW FACILITY INSIGHTS

NORTHWEST REGION
LAKE TAHOE-NEVADA STATE PARKS
9928 - SPOONER LAKE STATE PARK
SR 28 @ SPOONER SUMMIT
DOUGLAS COUNTY, NV 89448-
DOUGLAS COUNTY

SURVEY DATE: 11/01/2023

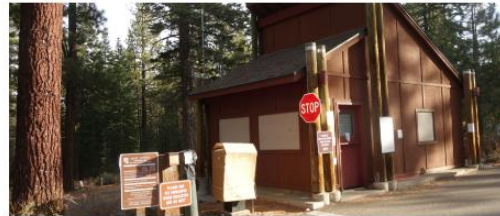
THE FEE STATION FACILITY DETAILS

The Fee Station is a wood framed building with an asphalt composition roof on a concrete slab-on-grade foundation. It is located at the entrance road to the park. The facility is a fee collection and information station for park visitors. It is in good shape.

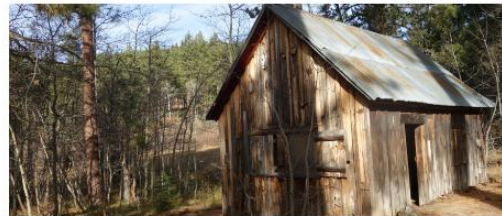
SPENCER'S CABIN FACILITY DETAILS

Spencer's Cabin is a wood framed building located in the backcountry of Lake Tahoe Nevada State Park in the lower North Canyon area. It is named after the caretaker that watched over the cattle grazing operations during the early part of the 20th century. The building is currently in a state of arrested decay.

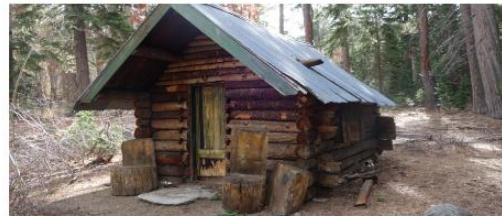
HANNA'S HIDEAWAY FACILITY DETAILS

Hanna's Hideaway is a log cabin located in the backcountry of Lake Tahoe Nevada State Park. It is named after Hannah Hobart, granddaughter of lumber baron Walter S. Hobart Sr., who built the cabin and spent her summers in it. The building is currently in a state of arrested decay.
