DEPARTMENT OF ADMINISTRATION
STATE PUBLIC WORKS DIVISION
FACILITY CONDITION ASSESSMENT

PROPERTY PORTFOLIO REVIEW PROJECT ADDENDUM

NORTHWEST REGION
LAKE TAHOE-NEVADA STATE PARKS
9928 - SPOONER LAKE STATE PARK
SR 28 @ SPOONER SUMMIT
DOUGLAS COUNTY, NV 89448-
DOUGLAS COUNTY

SURVEY DATE: 11/01/2023

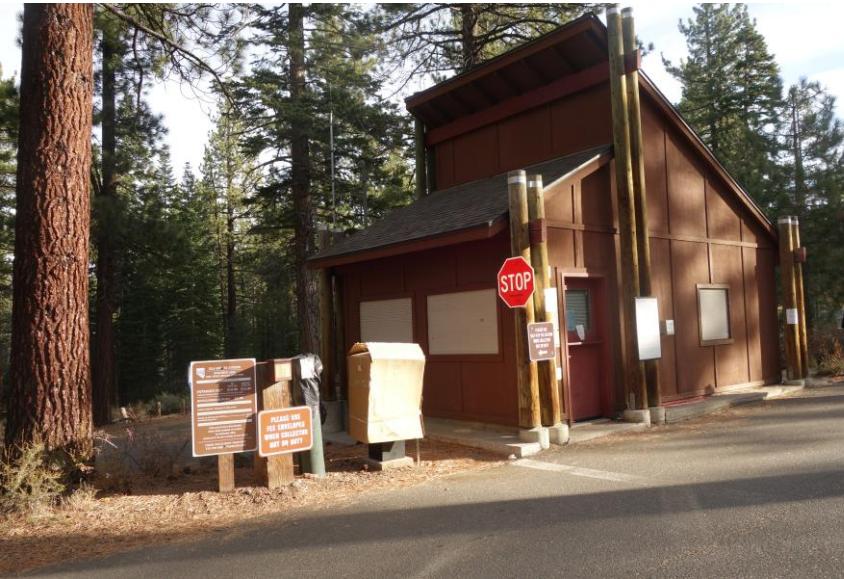
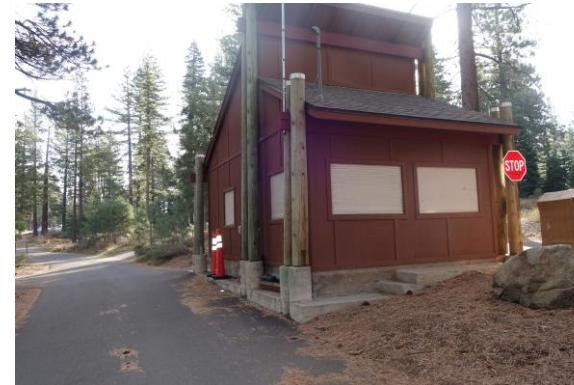
1291-EXT-2: ROOF REPLACEMENT

Class II - At the time of the survey, the building's roof was found to be in fair condition. Installed in 1991, the current roofing system has exceeded its typical 20 – 25-year useful life, and the original warranty has expired. Harsh environmental conditions—such as temperature fluctuations, windborne sand and debris, and prolonged sun exposure—have accelerated deterioration. Re-roofing is recommended within the next 2 – 3 years to align with the statewide roofing program and address the aging system.

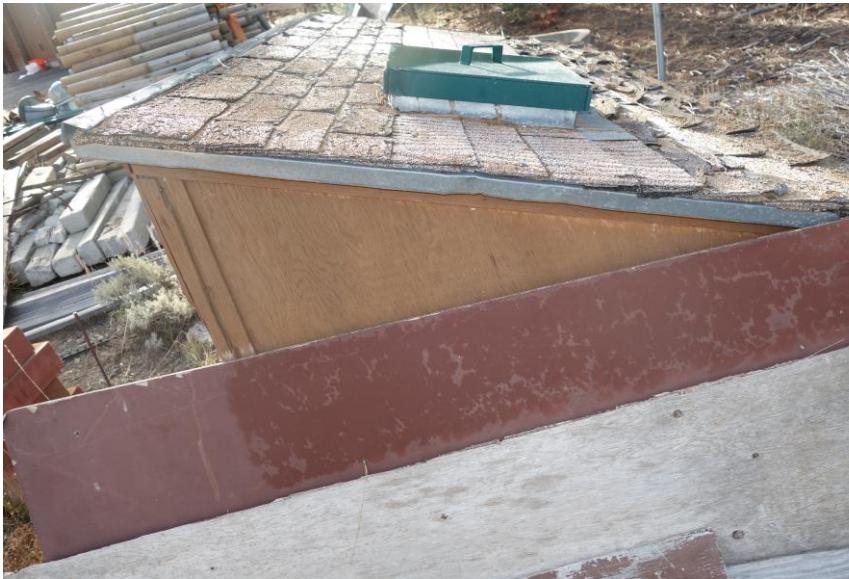
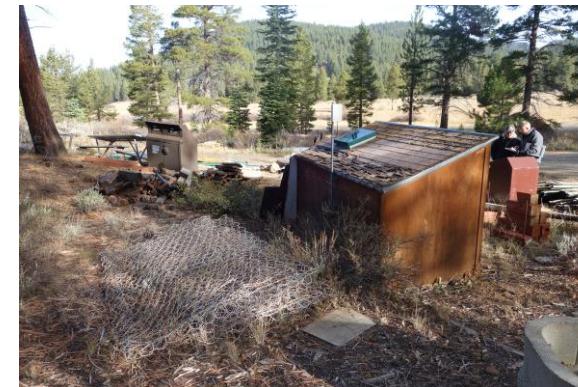
**REINSTATED BUILDING EXTERIOR - 11/18/2025****1325-EXT-1: ROOF REPLACEMENT**

At the time of the survey, the building's roof was found to be in poor condition. Installed in 1977, the current roofing system has exceeded its typical 15 – 30-year useful life, and the original warranty has expired. Harsh environmental conditions—such as temperature fluctuations, windborne sand and debris, and prolonged sun exposure have accelerated deterioration. Re-roofing is recommended within the next 2 – 3 years to align with the statewide roofing program and address the aging system.

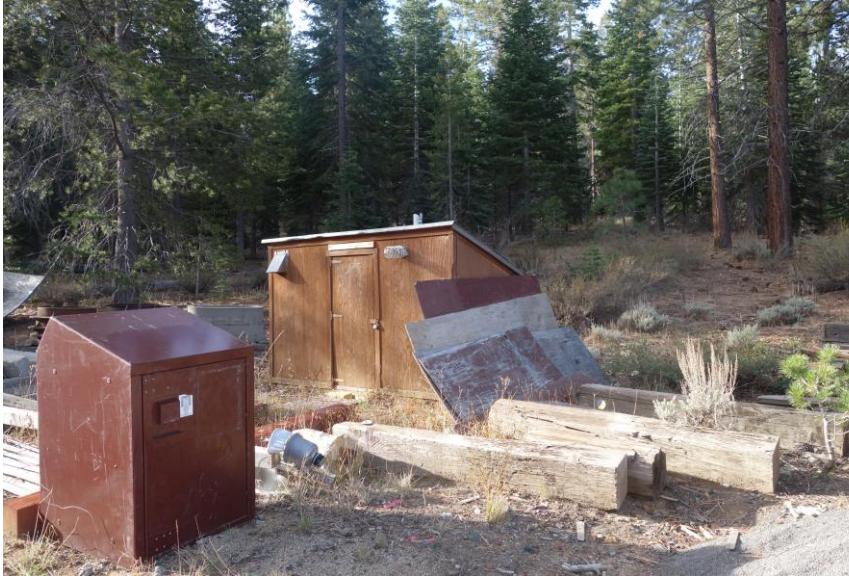
1325-EXT-2: EXTERIOR FINISHES

The exterior finishes of the building are in poor condition. Maintaining the building's finish, weather resistance, and appearance is essential. This project will fund improvements to protect the exterior envelope of the building, excluding the roof. The scope includes painting, staining, or sealing the exterior walls, along with caulking around windows, flashing, fixtures, and all other exterior penetrations. It is recommended that this work be completed within the next 2 to 4 years and scheduled on a recurring maintenance cycle to preserve the structural integrity and visual condition of the facility.

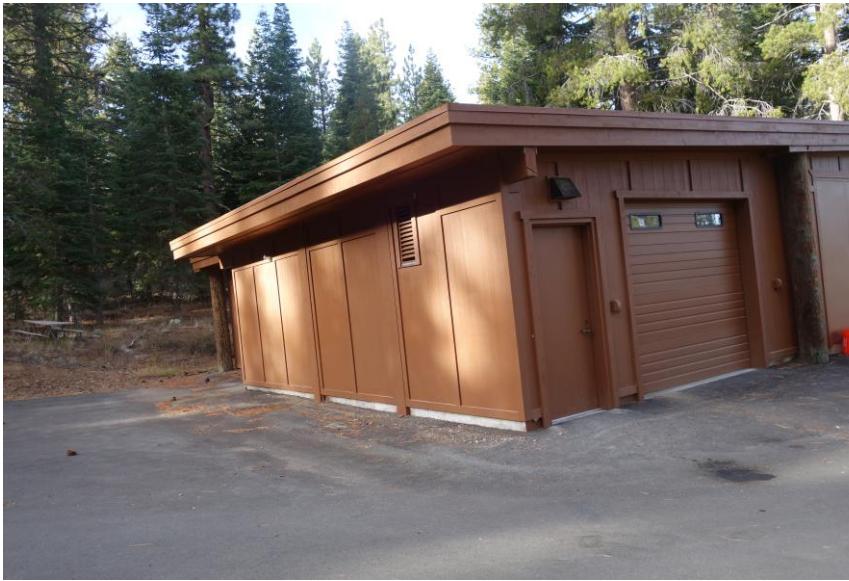
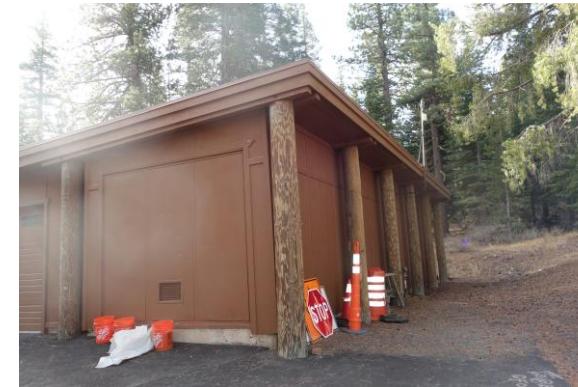
1323-EXT-2: ROOF REPLACEMENT

At the time of the survey, the building's roof was found to be in fair condition. Installed in 1977, the current roofing system has exceeded its typical 20 – 25-year useful life, and the original warranty has expired. Harsh environmental conditions—such as temperature fluctuations, windborne sand and debris, and prolonged sun exposure—have accelerated deterioration. Re-roofing is recommended within the next 2 – 3 years to align with the statewide roofing program and address the aging system.

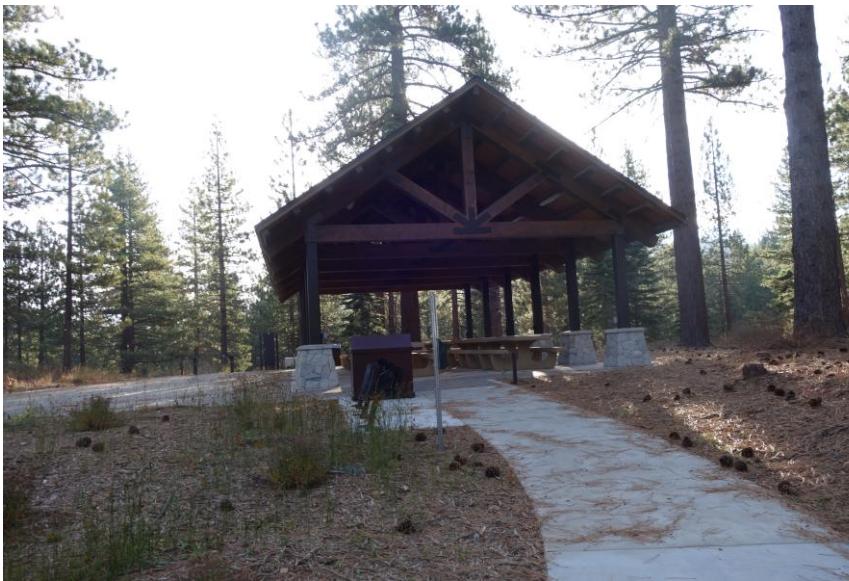
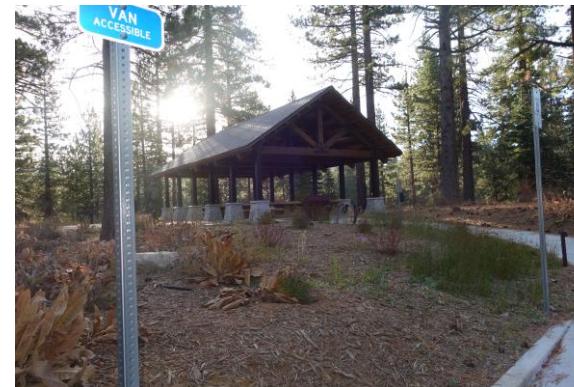
1292-EXT-2: EXTERIOR FINISHES

The exterior finishes of the building are in good condition. Maintaining the building's finish, weather resistance, and appearance is essential. This project will fund improvements to protect the exterior envelope of the building, excluding the roof. The scope includes painting, staining, or sealing the exterior walls, along with caulking around windows, flashing, fixtures, and all other exterior penetrations. It is recommended that this work be completed within the next 7 to 10 years and scheduled on a recurring

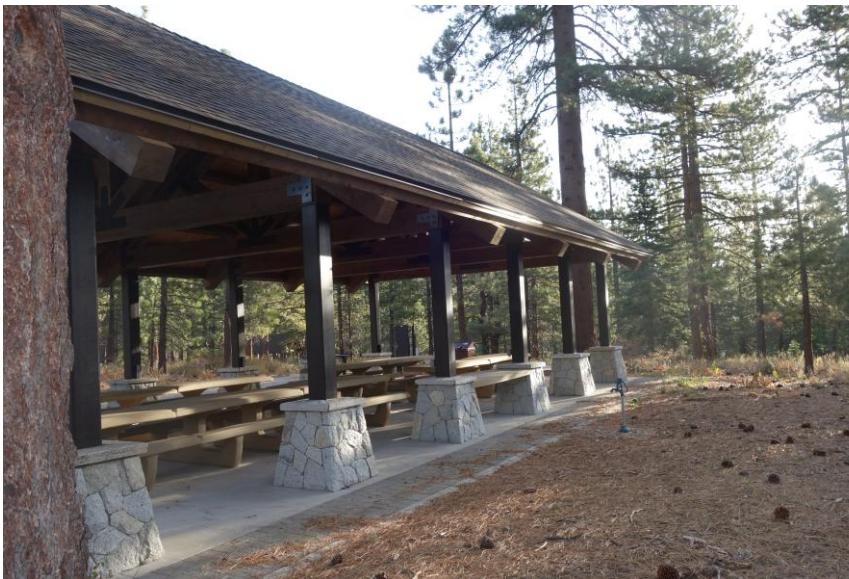
1292-INT-1: INTERIOR FINISHES

The interior finishes are in good condition. It is recommended that the interior beams and ceilings be stained within the next 7 - 10 years. Prior to staining, all surfaces should be properly repaired and prepared to ensure a durable and uniform finish. In wet or high humidity areas, the use of an high moisture resistance stain is recommended to enhance moisture resistance and durability. To preserve the quality of interior finishes and support the longevity of the structure, ongoing building maintenance should be scheduled on a regular, cyclical basis.

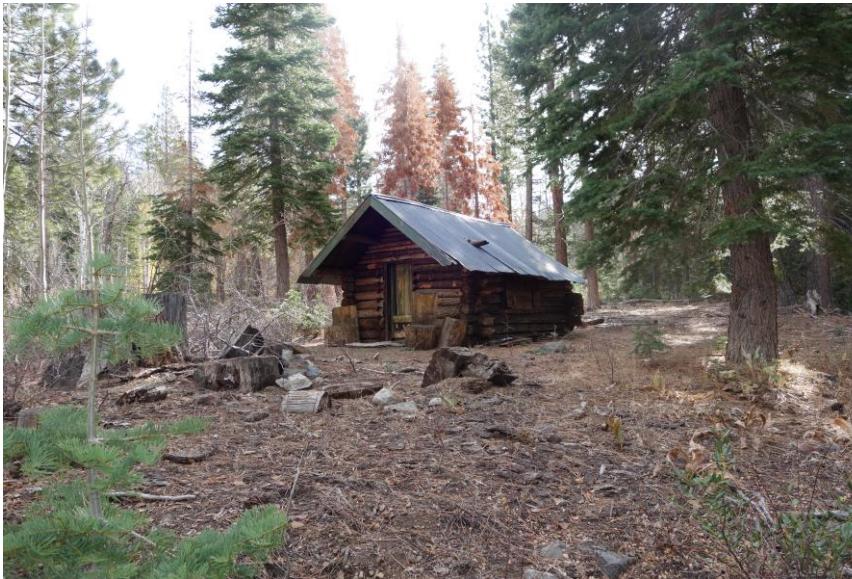
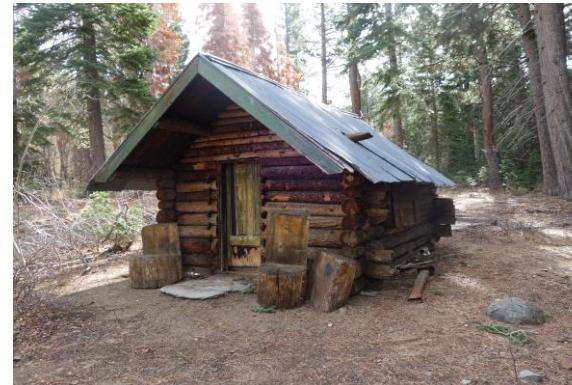
**DEFERRED BUILDING EXTERIOR - 4/23/2024****3672-EXT-1: CONSERVE AND PROTECT VACANT BUILDING**

The wood structure is over 80 years old and there are numerous areas where the wood is splitting, warping and deteriorating. This is also an exhibit for the park and requires maintenance time for presentation and displays. This project would provide for caulking the flashing, fixtures and windows, replacing metal roof panels as needed and maintaining the exhibit in a state of arrested decay. This project should be coordinated with the Nevada State Historical Preservation Office for possible restrictions or requirements which are not included in this estimate. It is recommended that the work

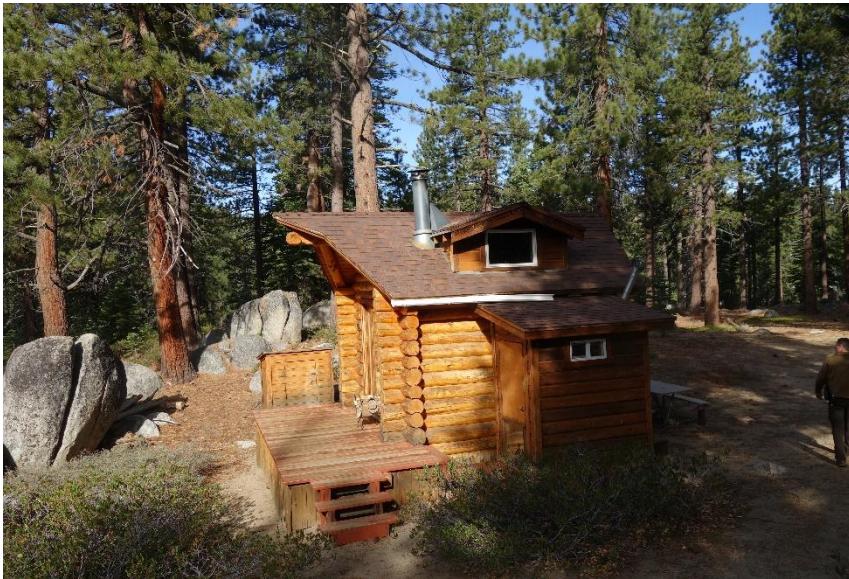
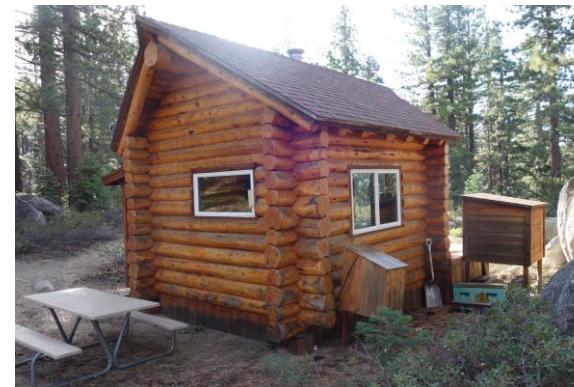
3757-EXT-0: ROOF REPLACEMENT

At the time of the survey, the building's roof was found to be in good condition. Installed in 1998, the current roofing system has exceeded its typical 20 – 25-year useful life, and the original warranty has expired. Harsh environmental conditions—such as temperature fluctuations, windborne sand and debris, and prolonged sun exposure—have accelerated deterioration. Re-roofing is recommended within the next 4 – 8 years to align with the statewide roofing program and address the aging system.

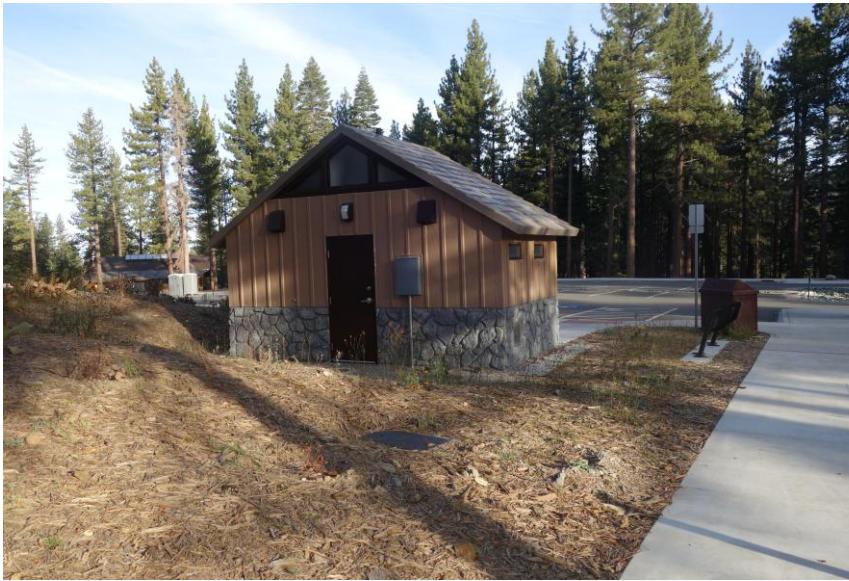
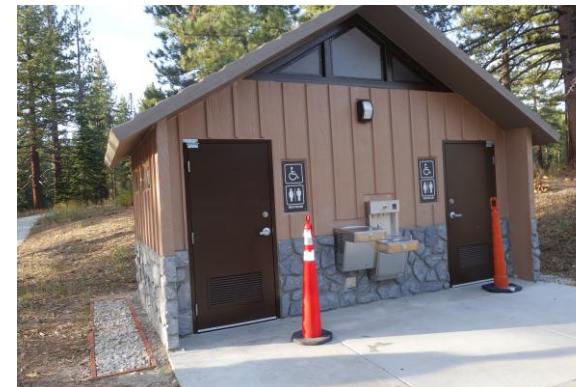
1290-EXT-1: EXTERIOR FINISHES

It is important to maintain the finish, weather resistance and appearance of the building. This project would provide funding to protect the exterior of the building excluding the roof. Included in the cost is sanding, priming and painting and caulking of the windows, flashing, fixtures and all other penetrations. It is recommended that the building be painted in the next 7-10 years and that this project be scheduled on a cyclical basis to maintain the integrity of the structure.

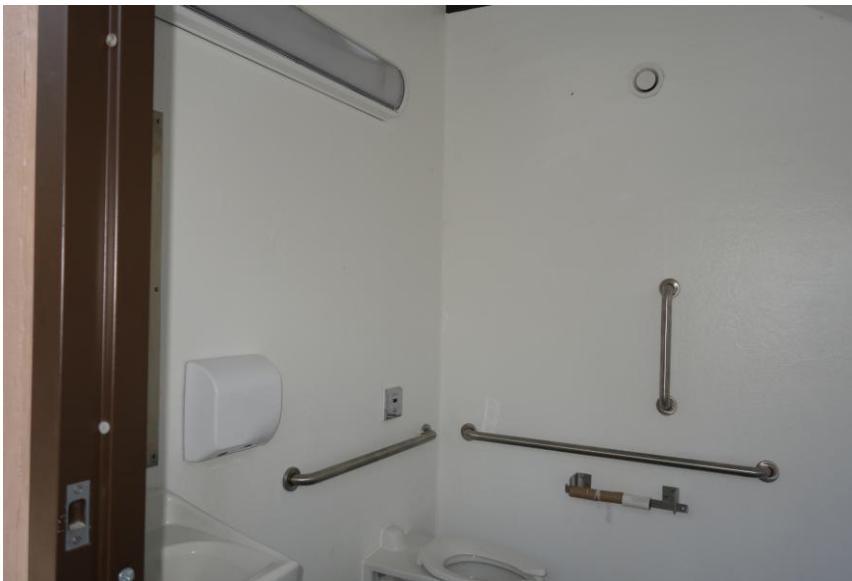
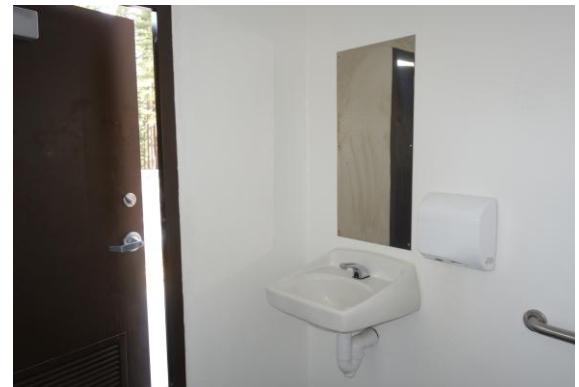
1290-INT-1: INTERIOR FINISHES

It is recommended to paint the interior walls and ceilings at least once in the next 7-10 years and that this project be scheduled on a cyclical basis to maintain the integrity of the structure. Prior to painting, all surfaces should be repaired and adequately prepared to receive the coating. An epoxy-based paint should be utilized in wet areas for durability.

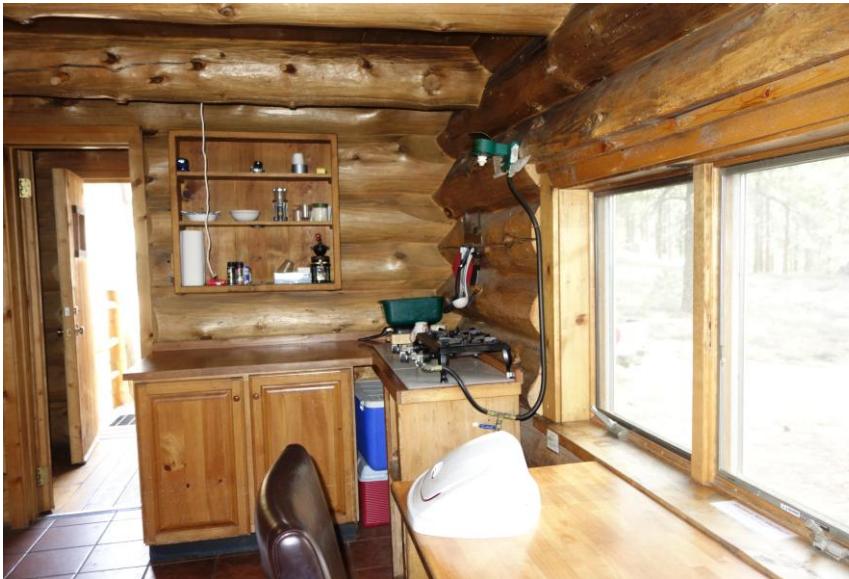
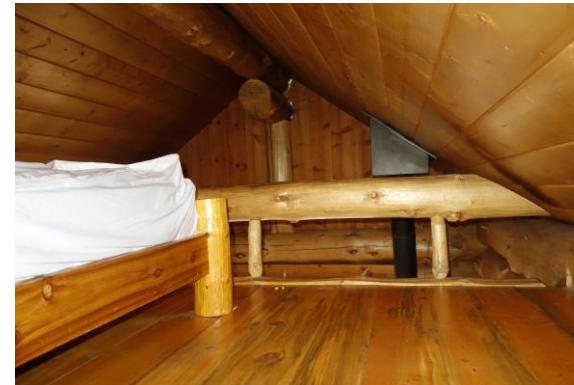
3756-INT-1: INTERIOR FINISHES

The interior finishes are in good condition and require attention to maintain the building's overall appearance and integrity. It is recommended that the interior walls and ceilings be repainted within the next 5 - 8 years. Prior to painting, all surfaces should be properly repaired and prepared to ensure a durable and uniform finish. In wet or high humidity areas, the use of an epoxy-based paint is recommended to enhance moisture resistance and durability. To preserve the quality of interior finishes and support

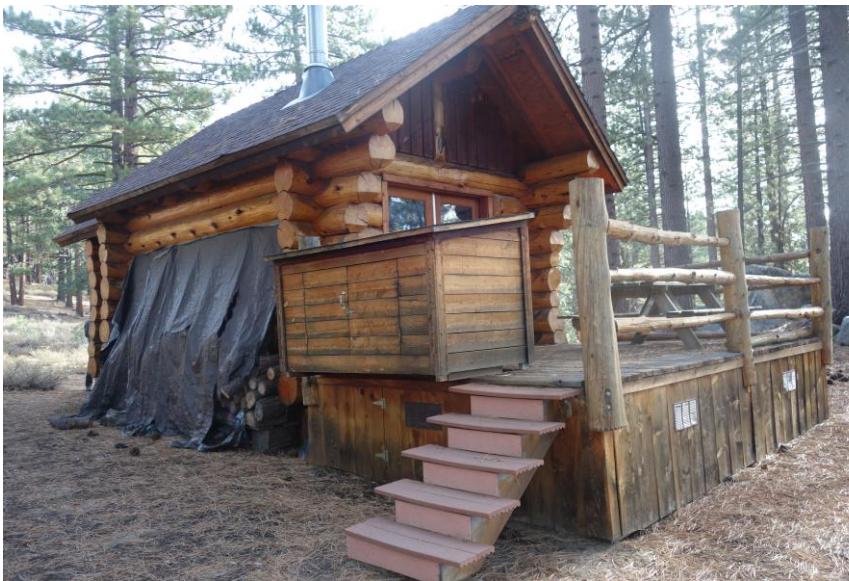
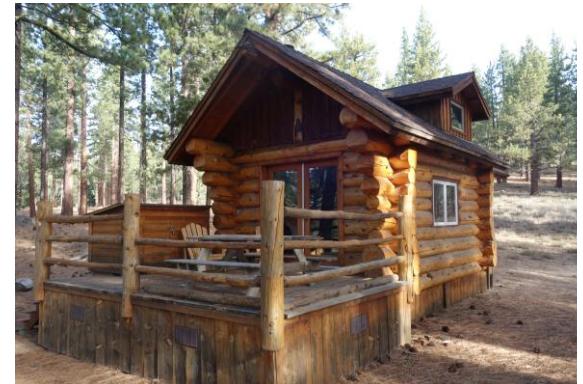
3756-EXT-1: EXTERIOR FINISHES

The exterior finishes of the building are in good condition, and maintaining the building's finish, weather resistance, and appearance is essential. This project will fund improvements to protect the exterior envelope of the building, excluding the roof. The scope includes painting, staining, or sealing the exterior walls, along with caulking around windows, flashing, fixtures, and all other exterior penetrations. It is recommended that this work be completed within the next 5 to 8 years and scheduled on a recurring

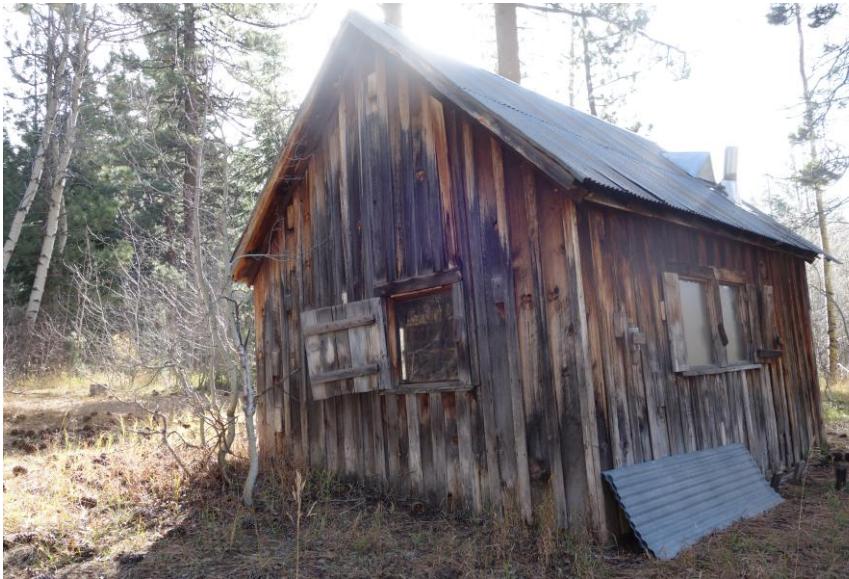
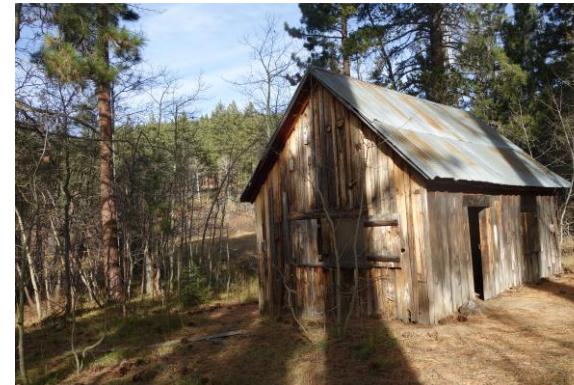
1371-EXT-3: CONSERVE AND PROTECT VACANT BUILDING

In order to preserve the building for future rehabilitation and reuse, this project recommends mothballing it in accordance with the U. S. Department of Interior Recommended Guidelines in Preservation Brief 31. Costs related to removing water in the basement or crawlspace, providing drainage away from the building to prevent future water accumulation, pest control and removal of accumulated waste are included. Windows and doors will be secured or covered, and some will include louvers to permit ventilation of the structure.

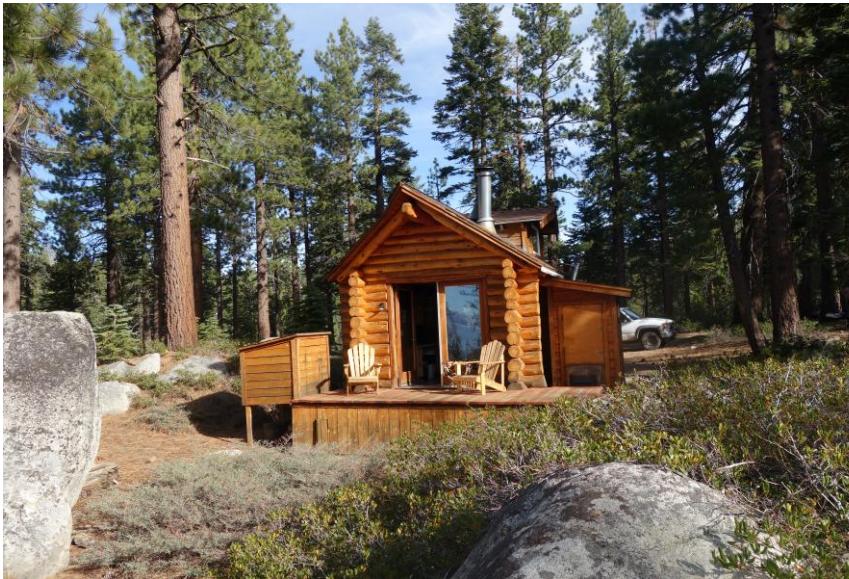
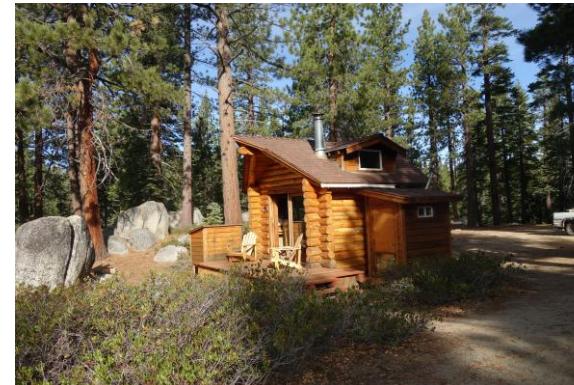
3757-EXT-1: EXTERIOR FINISHES

The exterior finishes of the building are in good condition. Maintaining the building's finish, weather resistance, and appearance is essential. This project will fund improvements to protect the exterior envelope of the building, excluding the roof. The scope includes painting, staining, or sealing the exterior walls, along with caulking around windows, flashing, fixtures, and all other exterior penetrations. It is recommended that this work be completed within the next 5 to 8 years and scheduled on a recurring

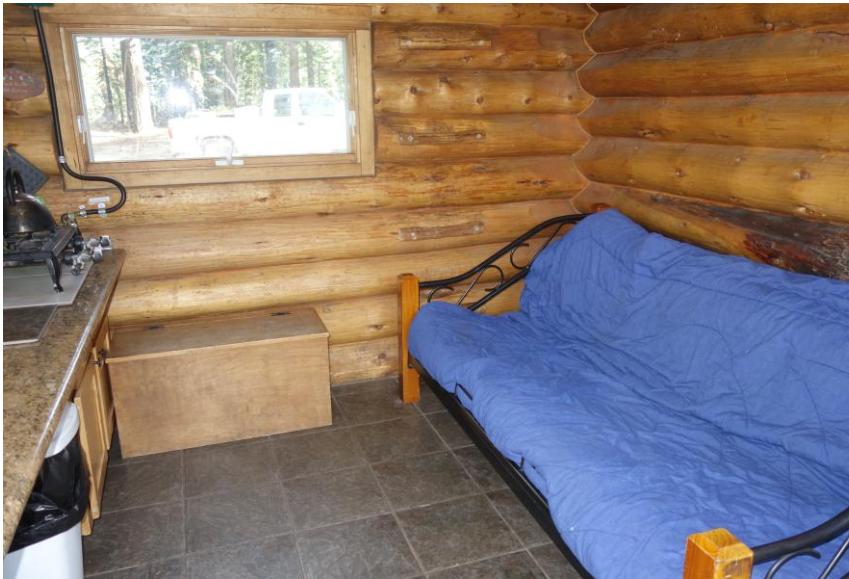
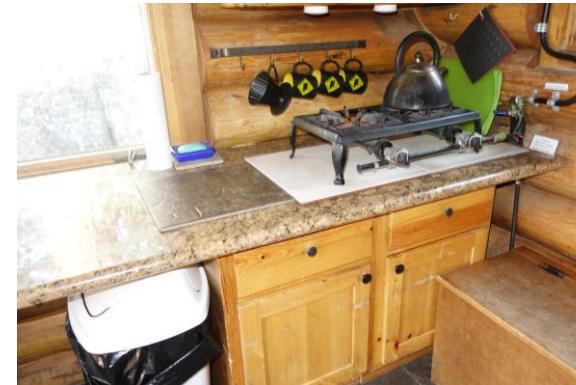
3757-INT-1: INTERIOR FINISHES

The interior finishes are in good condition. It is recommended that the interior walls and ceilings be repainted within the next 5 - 8 years. Prior to painting, all surfaces should be properly repaired and prepared to ensure a durable and uniform finish. In wet or high humidity areas, the use of an epoxy-based paint is recommended to enhance moisture resistance and durability. To preserve the quality of interior finishes and support the longevity of the structure, ongoing building maintenance should be scheduled on a regular, cyclical basis.

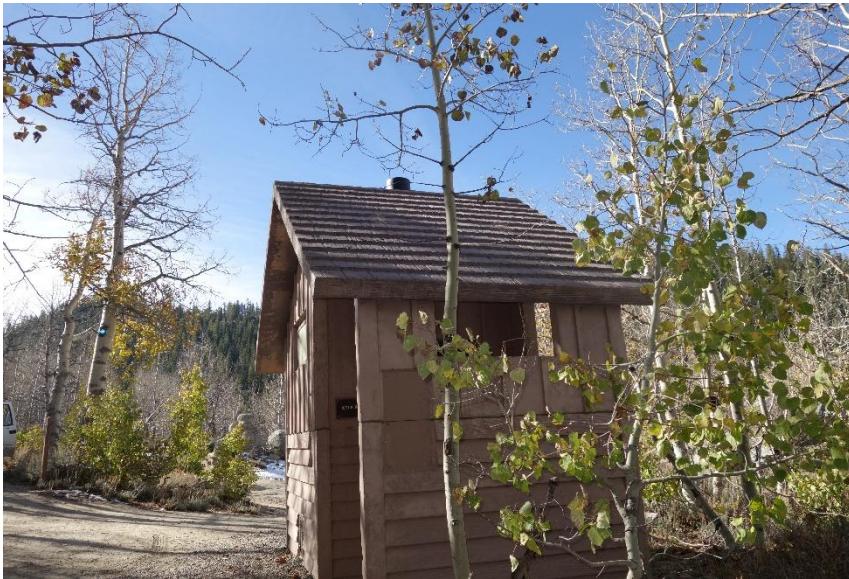
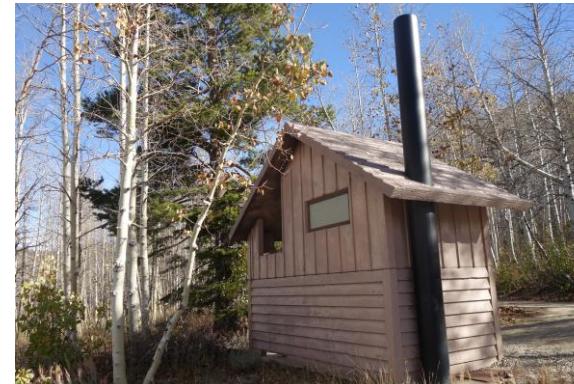
1375-EXT-2: ROOF REPLACEMENT

The existing roof was built approximately 19 years ago and is in fair condition. Budget planning for replacement should be done for replacement in the next 6 - 9 years. It is recommended that any current leaks or necessary repairs are done immediately to ensure the structural integrity of the roof and the ceiling below.

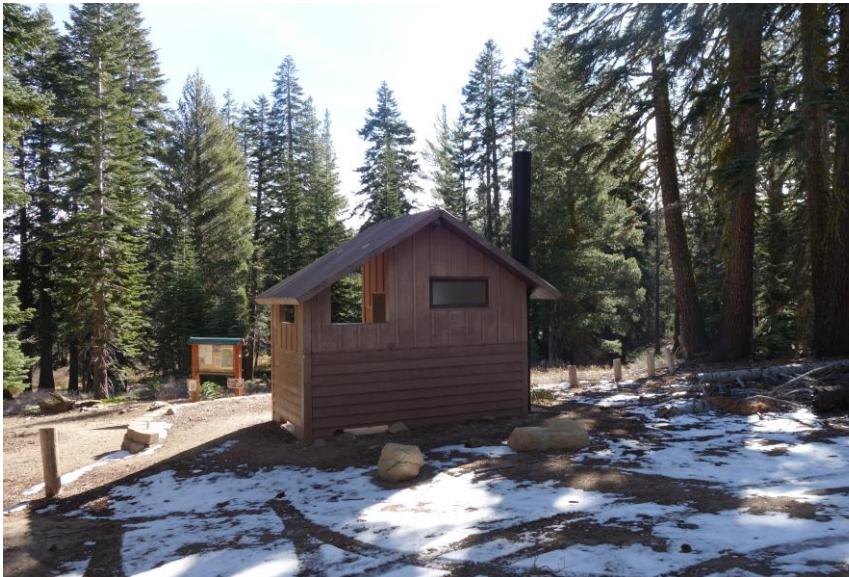
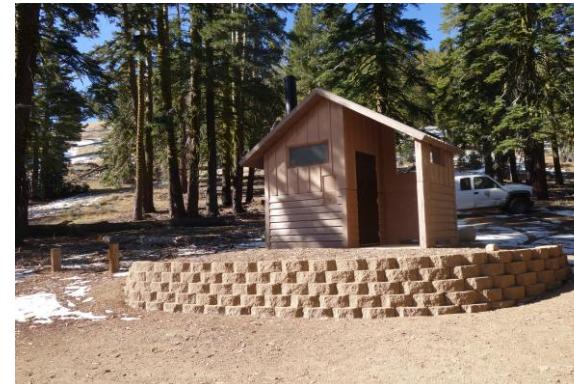
1374-EXT-2: ROOF REPLACEMENT

The existing roof was built approximately 19 years ago and is in good condition. Budget planning for replacement should be done for replacement in the next 6 - 9 years. It is recommended that any current leaks or necessary repairs are done immediately to ensure the structural integrity of the roof and the ceiling below.

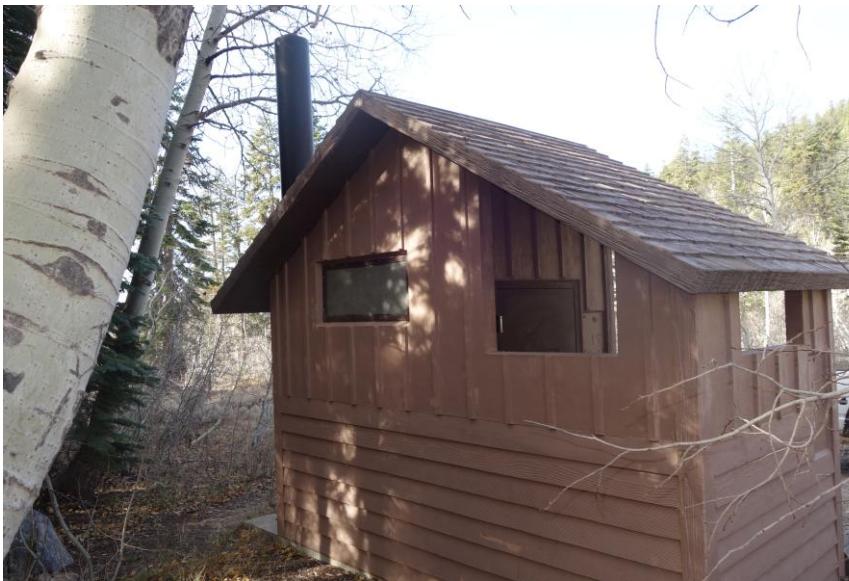
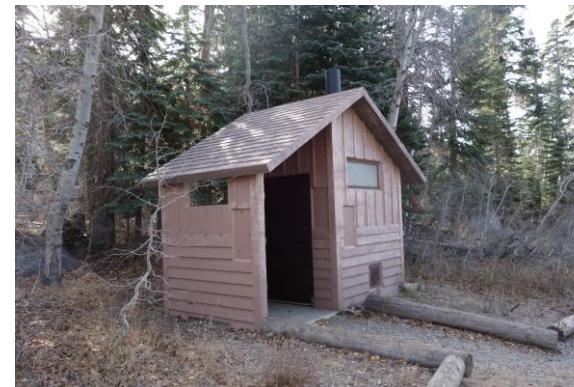
1376-EXT-2: ROOF REPLACEMENT

The existing roof was built approximately 19 years ago and is in fair condition. Budget planning for replacement should be done for replacement in the next 6 - 9 years. It is recommended that any current leaks or necessary repairs are done immediately to ensure the structural integrity of the roof and the ceiling below.

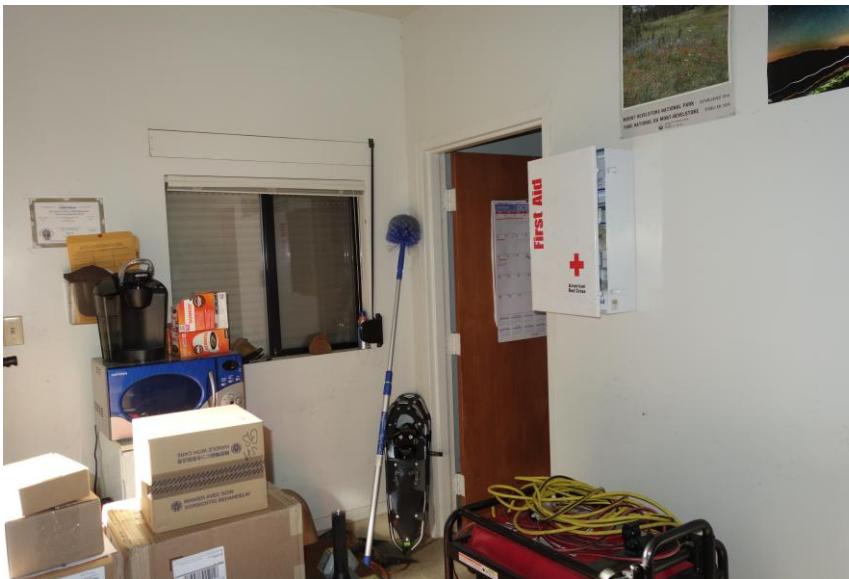
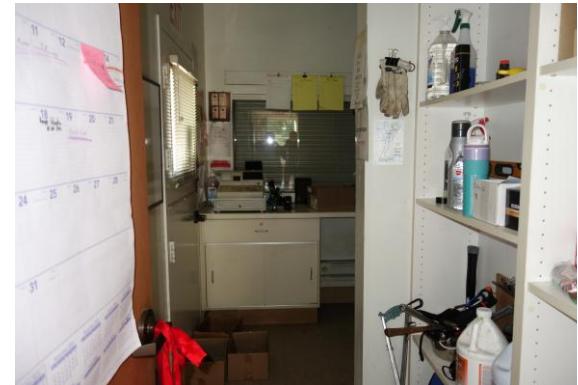
**REINSTATED BUILDING INTERIOR - 11/18/2025****1291-INT-1: INTERIOR FINISHES**

It is recommended to paint the interior walls and ceilings at least once in the next 7-10 years and that this project be scheduled on a cyclical basis to maintain the integrity of the structure. Prior to painting, all surfaces should be repaired and adequately prepared to receive the coating. An epoxy-based paint should be utilized in wet areas for durability.

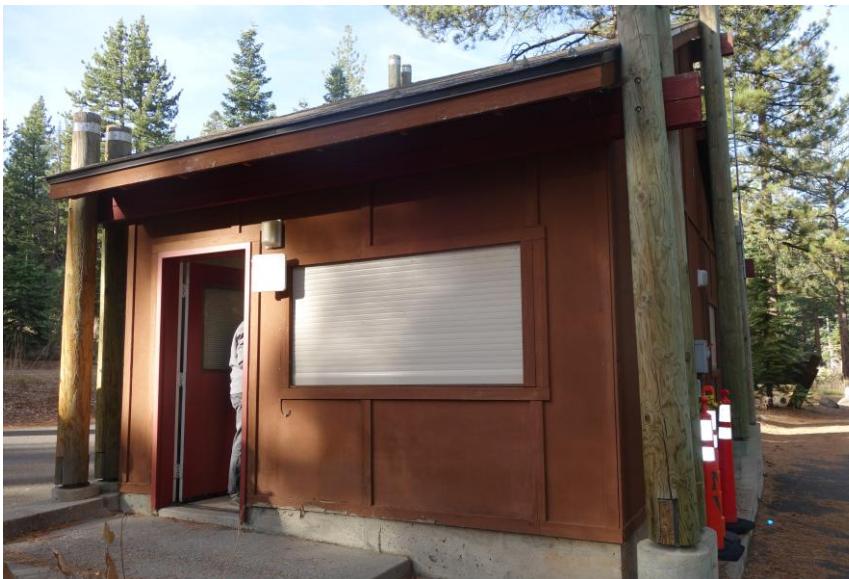
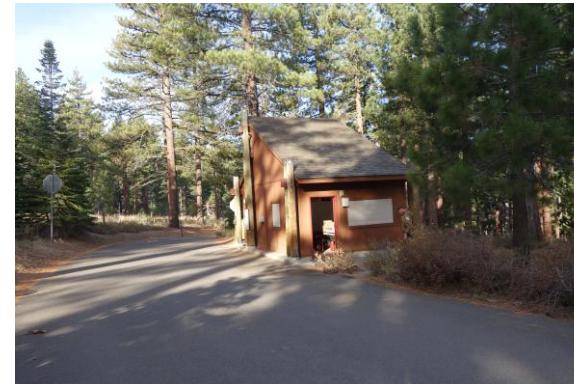
1291-EXT-1: EXTERIOR FINISHES

It is important to maintain the finish, weather resistance and appearance of the building. This project would provide funding to protect the exterior of the building, excluding the roof. Included in the cost is; sanding, priming, painting and caulking of the windows, flashing, fixtures and all other penetrations. It is recommended that the building be painted in the next 7-10 years and that this project be scheduled on a cyclical basis to maintain the integrity of the structure.

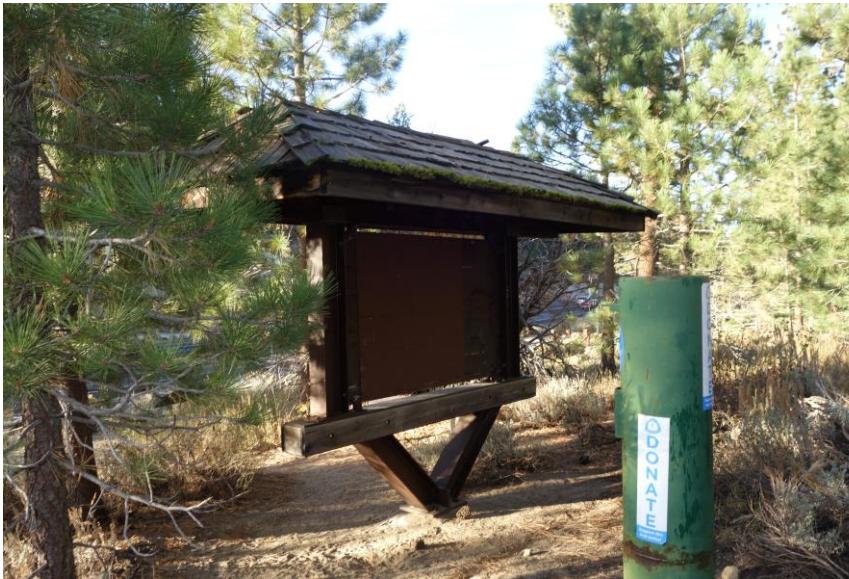
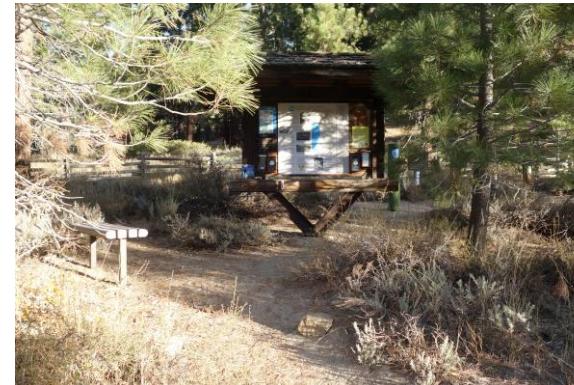
2697-EXT-2: ROOF REPLACEMENT

At the time of the survey, the building's roof was found to be in fair condition. The current roofing system on the building is original and should be scheduled for replacement. This project would remove and dispose of the existing wood shingle roofing and install new pre-painted metal panels in the next 4-5 years

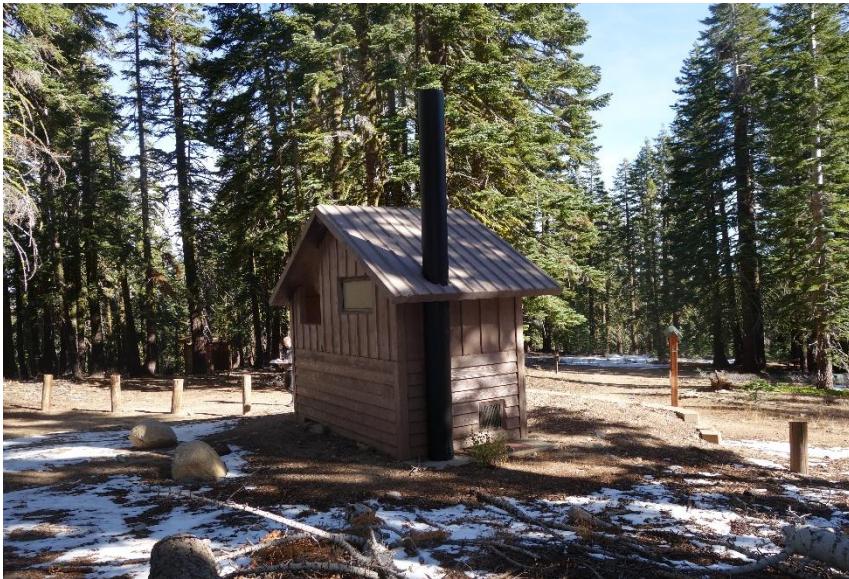
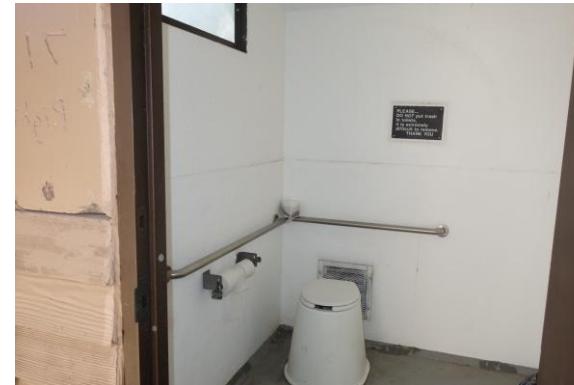
1374-EXT-1: EXTERIOR FINISHES

The exterior finishes of the building are in good condition. Maintaining the building's finish, weather resistance, and appearance is essential. This project will fund improvements to protect the exterior envelope of the building, excluding the roof. The scope includes painting, staining, or sealing the exterior walls, along with caulking around windows, flashing, fixtures, and all other exterior penetrations. It is recommended that this work be completed within the next 5 to 8 years and scheduled on a recurring

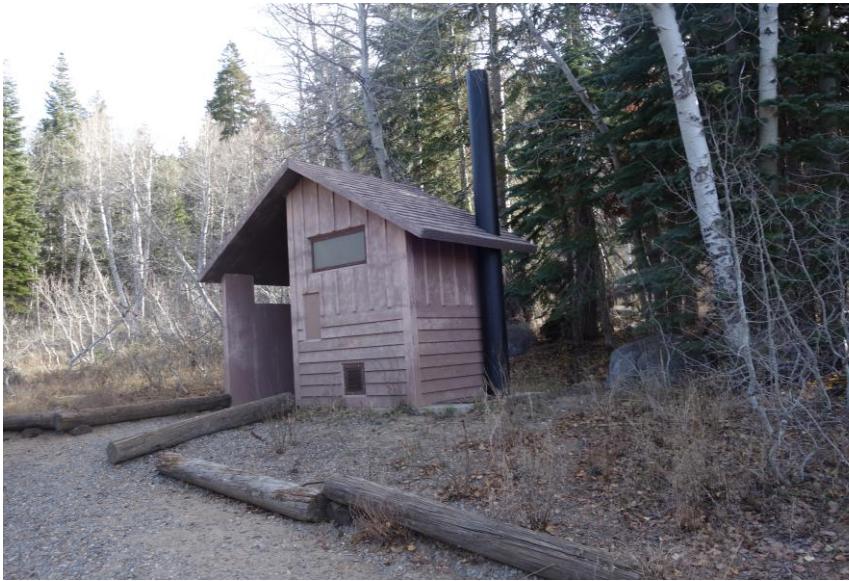
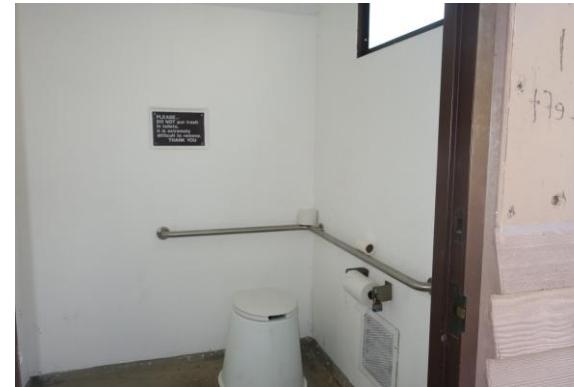
1376-EXT-1: EXTERIOR FINISHES

The exterior finishes of the building are in good condition. Maintaining the building's finish, weather resistance, and appearance is essential. This project will fund improvements to protect the exterior envelope of the building, excluding the roof. The scope includes painting, staining, or sealing the exterior walls, along with caulking around windows, flashing, fixtures, and all other exterior penetrations. It is recommended that this work be completed within the next 5 to 8 years and scheduled on a recurring

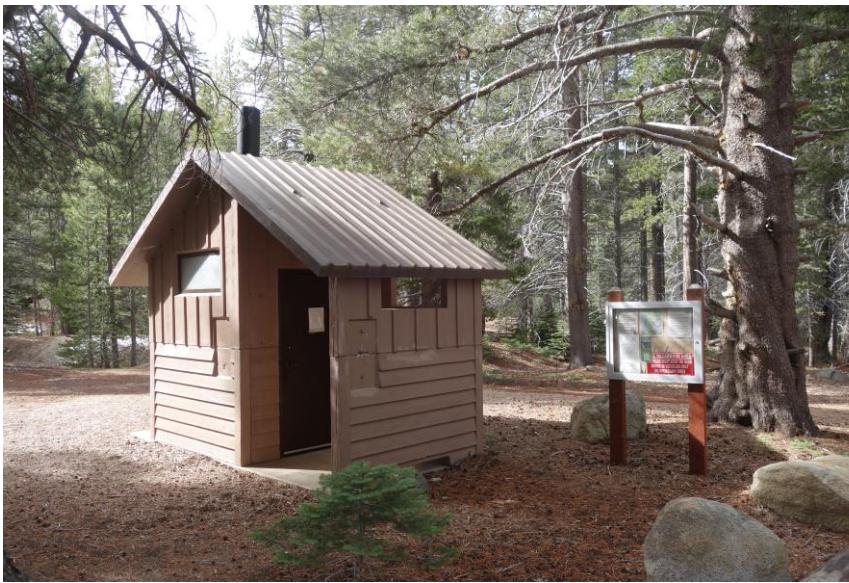
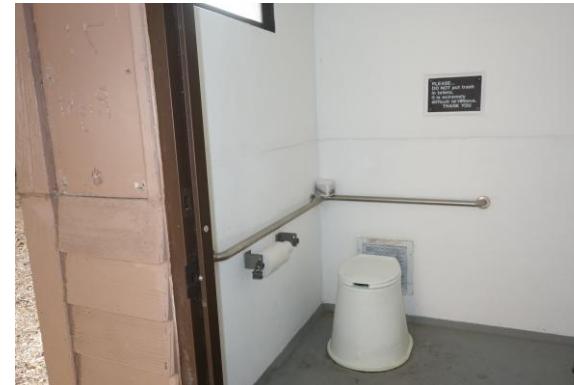
2699-EXT-1: EXTERIOR FINISHES

The exterior finishes of the building are in good condition. Maintaining the building's finish, weather resistance, and appearance is essential. This project will fund improvements to protect the exterior envelope of the building, excluding the roof. The scope includes painting, staining, or sealing the exterior walls, along with caulking around windows, flashing, fixtures, and all other exterior penetrations. It is recommended that this work be completed within the next 6 to 10 years and scheduled on a recurring

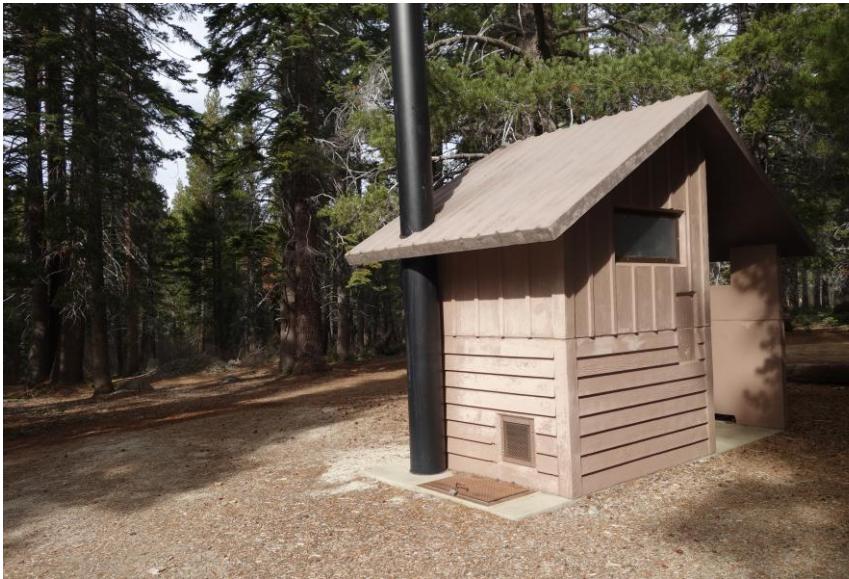
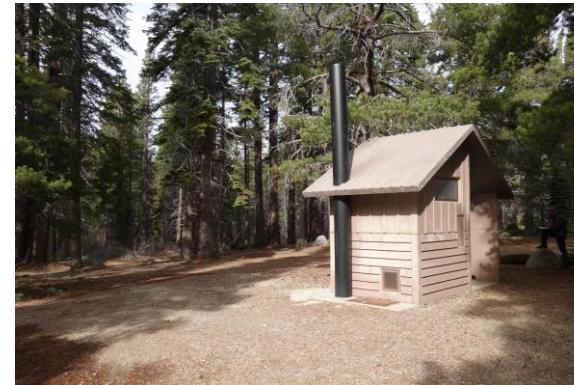
2699-EXT-2: ROOF REPLACEMENT

The existing roof was installed approximately 19 years ago and is in good condition. Budget planning for replacement should be done for replacement in the next 6 - 9 years. It is recommended that any current leaks or necessary repairs are done immediately to ensure the structural integrity of the roof and the ceiling below.

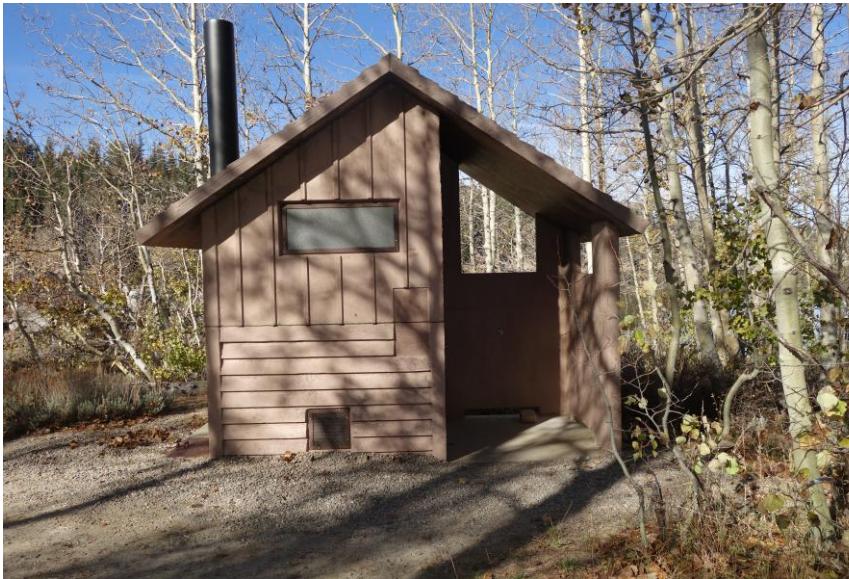
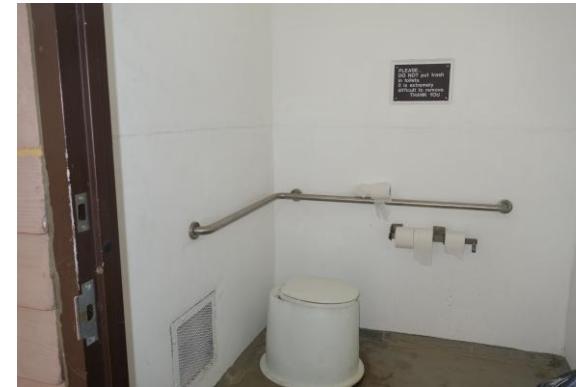
1375-EXT-1: EXTERIOR FINISHES

The exterior finishes of the building are in good condition. Maintaining the building's finish, weather resistance, and appearance is essential. This project will fund improvements to protect the exterior envelope of the building, excluding the roof. The scope includes painting, staining, or sealing the exterior walls, along with caulking around windows, flashing, fixtures, and all other exterior penetrations. It is recommended that this work be completed within the next 5 to 8 years and scheduled on a recurring

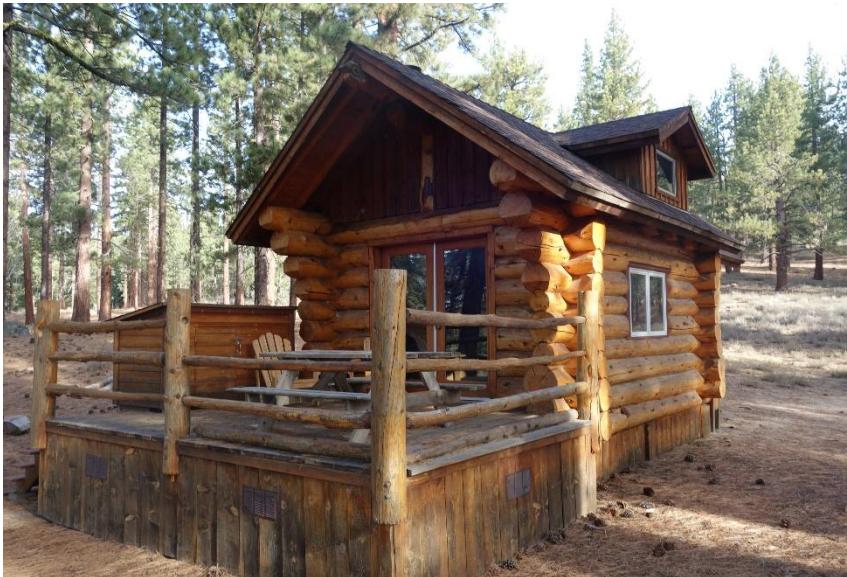
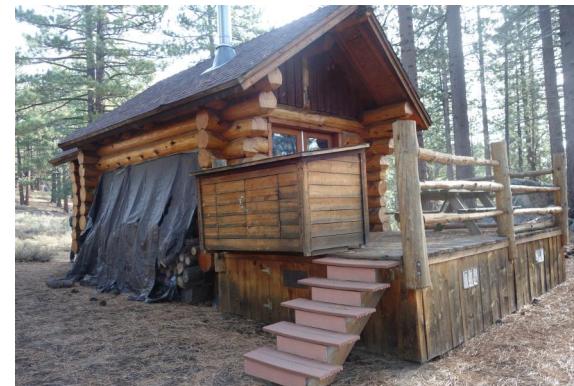
3756-EXT-2: ROOF REPLACEMENT

At the time of the survey, the building's roof was found to be in fair condition. Installed in 1998, the current roofing system has exceeded its typical 20 – 25-year useful life, and the original warranty has expired. Harsh environmental conditions—such as temperature fluctuations, windborne sand and debris, and prolonged sun exposure—have accelerated deterioration. Re-roofing is recommended within the next 4 – 8 years to align with the statewide roofing program and address the aging system.
