State of Nevada  
Department of Conservation and Natural Resources  
Division of State Parks  
Facility Condition Analysis

# LAKE TAHOE NEVADA STATE PARK SPOONER LAKE

State Highway 28  
Spooner Summit, Nevada

Site Number: 9928  
STATE OF NEVADA PUBLIC WORKS DIVISION  
FACILITY CONDITION ANALYSIS

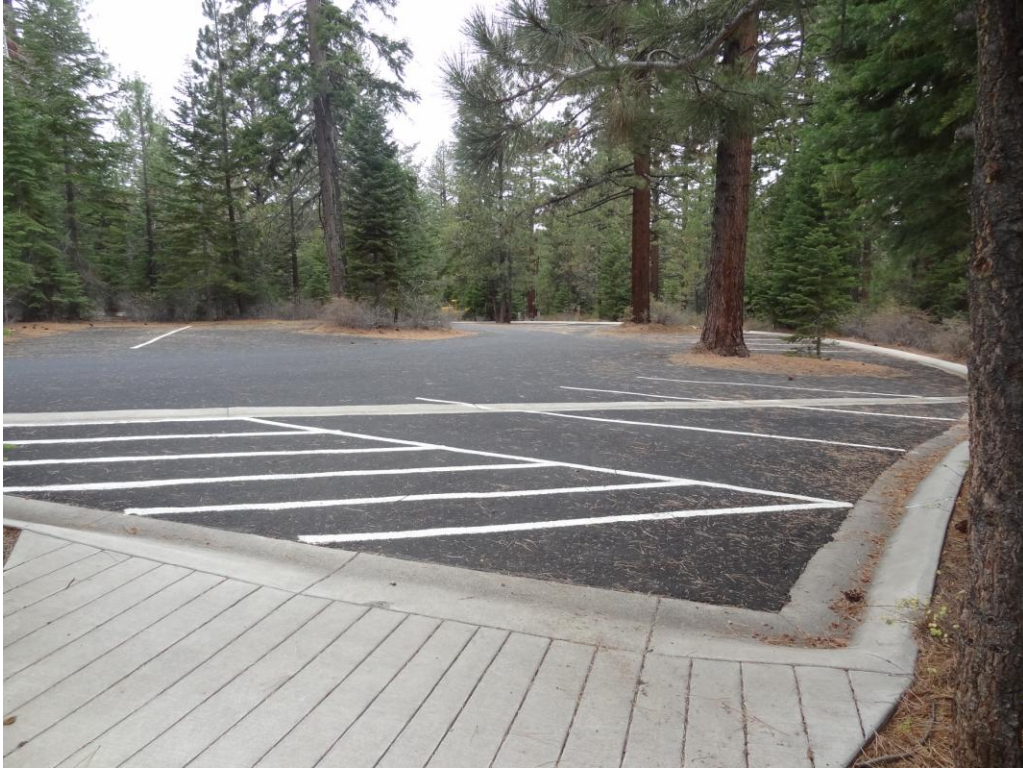
It is important to maintain the asphalt concrete paving on the site. This project would provide for minor crack filling and sealing of the paving site wide including access roads, parking areas, and park pathways. Striping is included in this estimate. This project should be scheduled on a 5 year cyclical basis to maintain the integrity of the paving and prevent premature failure. 279,875 square feet of asphalt area was used to generate this estimate.

Spooner Lake Site – FCA Site #9928  
Description: Asphalt parking lot.

**CRACK FILL & SEAL ASPHALT PAVING****Project Index #: 9928SIT2****Construction Cost \$349,844**

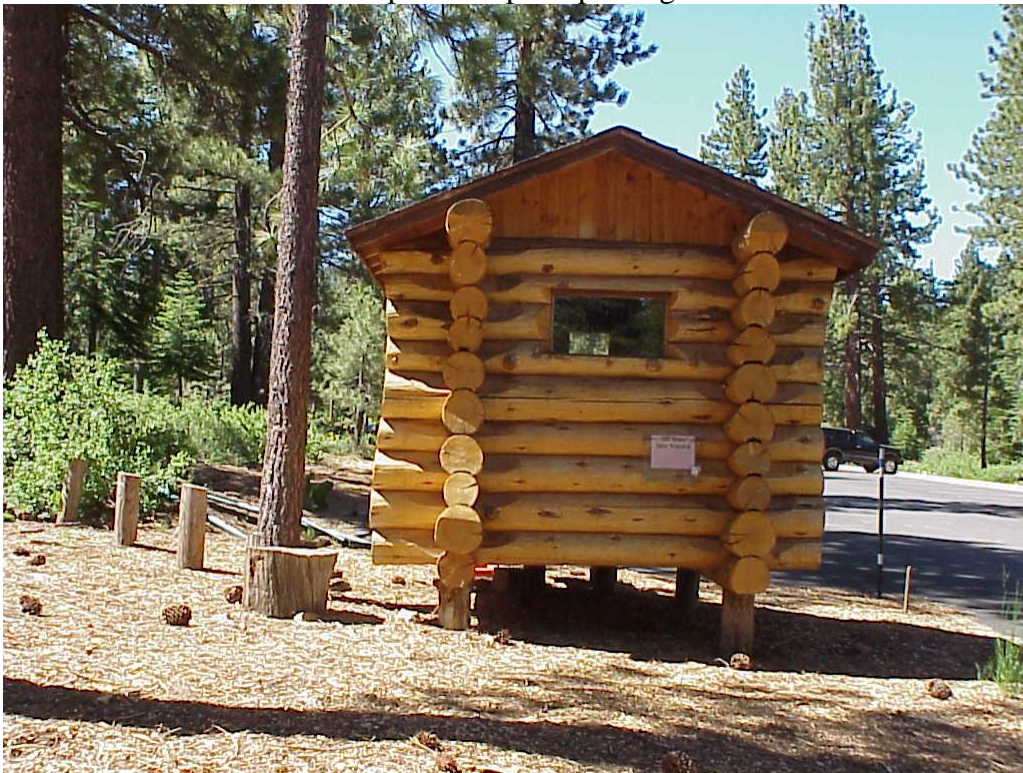
Demonstration Cabin – FCA Building #3758  
Description: Exterior of building.

It is important to maintain the finish, weather resistance and appearance of the building. This project would provide funding to protect the exterior of the building excluding the roof. Included in the cost is power washing and staining the wood and caulking of the windows, flashing, fixtures and all other penetrations. It is recommended that the building be stained and caulked in the next 2-3 years and that this project be scheduled on a cyclical basis to maintain the integrity of the structure.

It is recommended to stain the interior walls and ceilings at least once in the next 2-3 years and that this project be scheduled on a cyclical basis to maintain the integrity of the structure. Prior to staining, all surfaces should be repaired and adequately prepared to receive the coating.

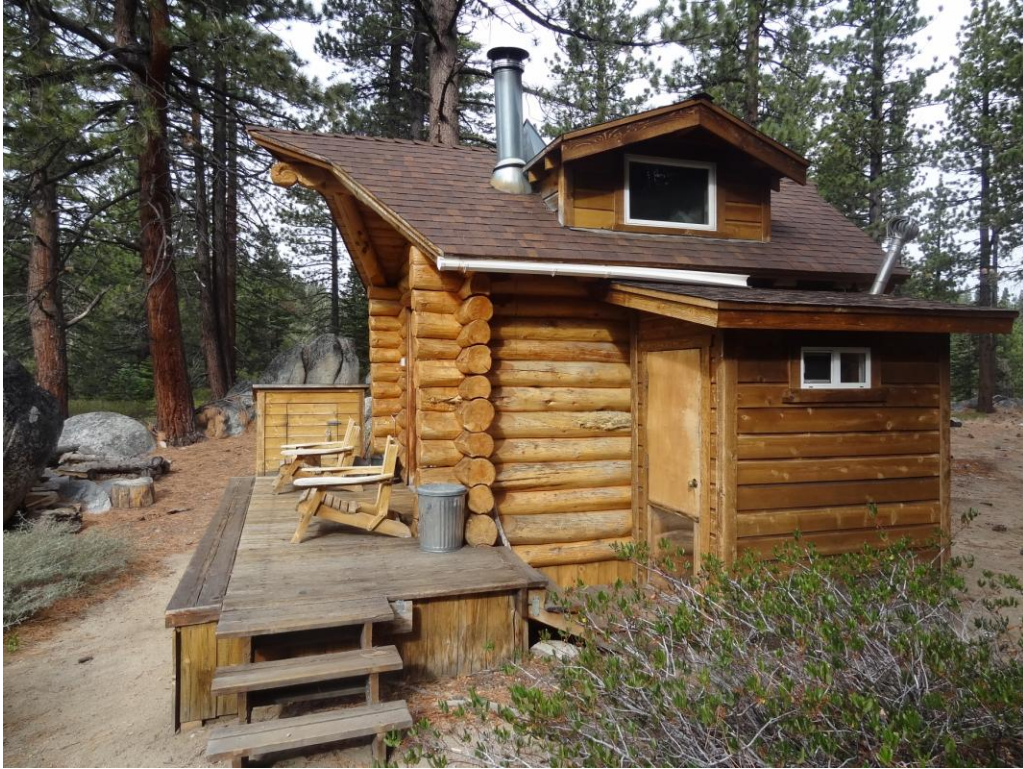
Wildcat Cabin – FCA Building #3757  
Description: Exterior of building.

It is important to maintain the finish, weather resistance and appearance of the building. This project would provide funding to protect the exterior of the building excluding the roof. Included in the cost is power washing and staining the wood and caulking of the windows, flashing, fixtures and all other penetrations. It is recommended that the building be stained and caulked in the next 2-3 years and that this project be scheduled on a cyclical basis to maintain the integrity of the structure.

It is recommended to stain the interior walls and ceilings at least once in the next 2-3 years and that this project be scheduled on a cyclical basis to maintain the integrity of the structure. Prior to staining, all surfaces should be repaired and adequately prepared to receive the coating. An epoxy-based stain should be utilized in wet areas for durability.

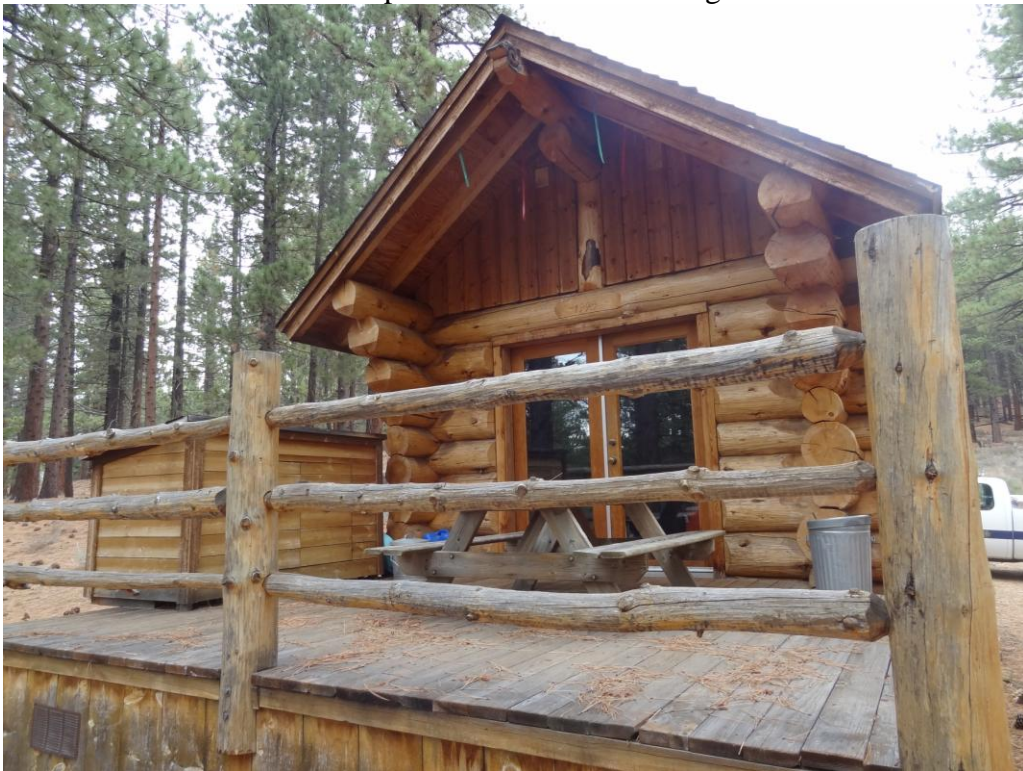
Spooner Cabin – FCA Building #3756  
Description: Exterior of building.

It is important to maintain the finish, weather resistance and appearance of the building. This project would provide funding to protect the exterior of the building excluding the roof. Included in the cost is power washing and staining the wood and caulking of the windows, flashing, fixtures and all other penetrations. It is recommended that the building be stained and caulked in the next 2-3 years and that this project be scheduled on a cyclical basis to maintain the integrity of the structure.

It is recommended to stain the interior walls and ceilings at least once in the next 2-3 years and that this project be scheduled on a cyclical basis to maintain the integrity of the structure. Prior to staining, all surfaces should be repaired and adequately prepared to receive the coating. An epoxy-based stain should be utilized in wet areas for durability.

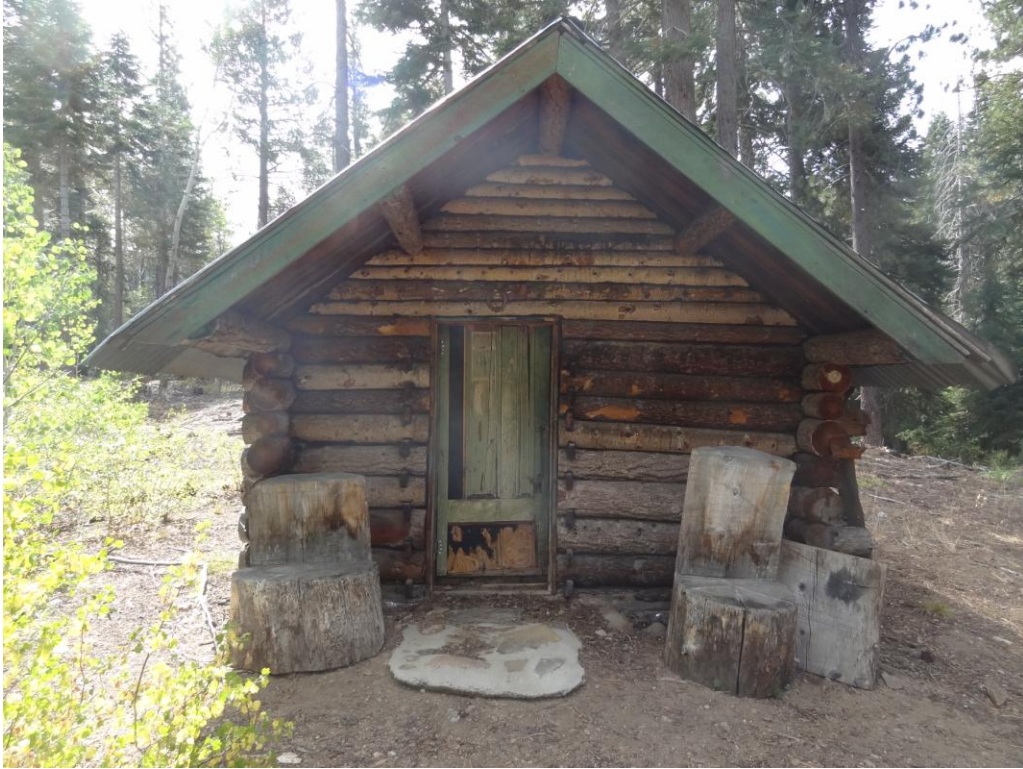
Hanna's Hideaway – FCA Building #3672  
Description: Exterior of building.

Hanna's Hideaway is a log cabin located in the backcountry of Lake Tahoe Nevada State Park. It is named after Hannah Hobart, granddaughter of lumber baron Walter S. Hobart Sr., who built the cabin and spent her summers in it. The building is currently in a state of arrested decay.

The wood structure is over 80 years old and there are numerous areas where the wood is splitting, warping and deteriorating. This is also an exhibit for the park and requires maintenance time for presentation and displays. This project would provide for caulking the flashing, fixtures and windows, replacing metal roof panels as needed and maintaining the exhibit in a state of arrested decay. This project should be coordinated with the Nevada State Historical Preservation Office for possible restrictions or requirements which are not included in this estimate. It is recommended that the work be done in the next 2-3 years and that this project be scheduled on a cyclical basis to maintain the integrity of the structure.

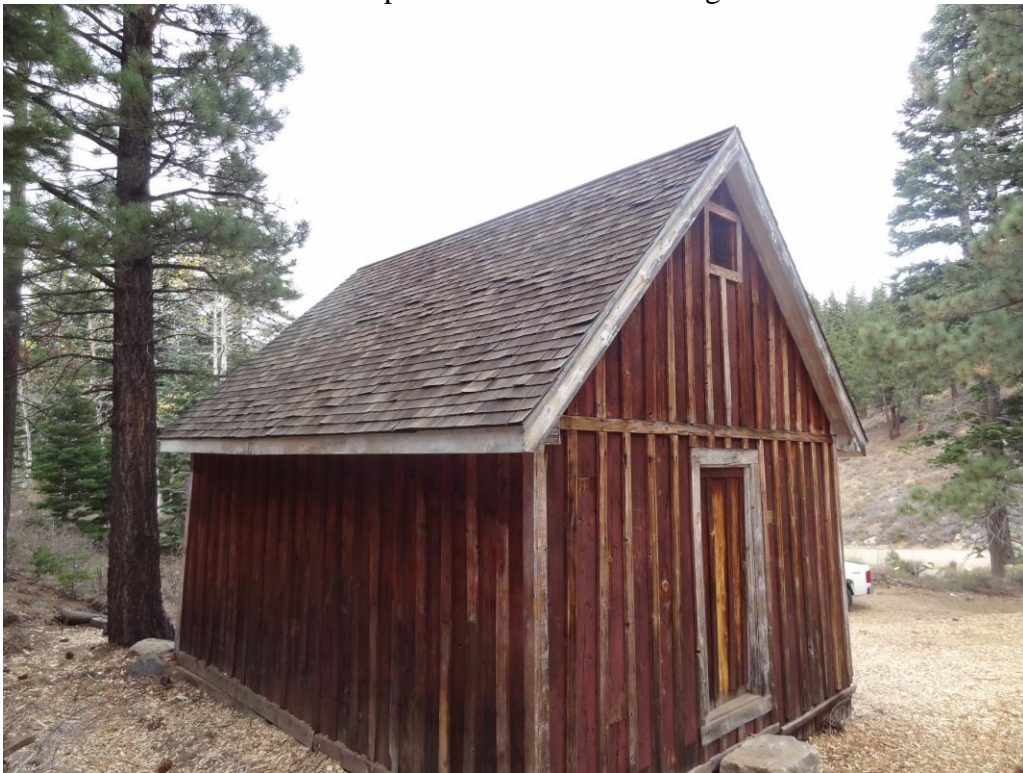
Bunk House – FCA Building #2696  
Description: Exterior of building.

It is important to maintain the finish, weather resistance and appearance of the building. This project would provide funding to protect the exterior of the building excluding the roof. Included in the cost is power washing and staining the wood and caulking of the windows, flashing, fixtures and all other penetrations. It is recommended that the building be stained and caulked in the next 4-5 years and that this project be scheduled on a cyclical basis to maintain the integrity of the structure.

The wood shingle roof on this building was installed in 1989. It is recommended that this building be re-roofed in the next 4-5 years with a new standing seam metal roof and new underlayments. This estimate includes removal and disposal of the old roofing.

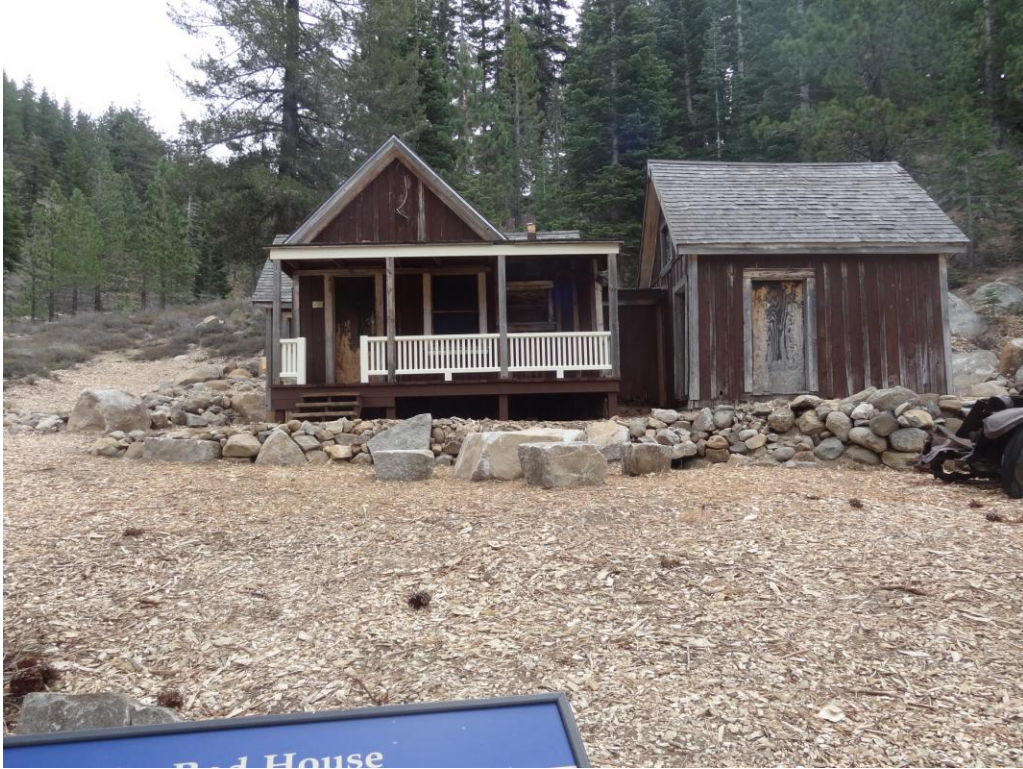
Red House – FCA Building #1372  
Description: Exterior of building.

It is important to maintain the finish, weather resistance and appearance of the building. This project would provide funding to protect the exterior of the building excluding the roof. Included in the cost is power washing and staining the wood and caulking of the windows, flashing, fixtures and all other penetrations. It is recommended that the building be stained and caulked in the next 4-5 years and that this project be scheduled on a cyclical basis to maintain the integrity of the structure.

The wood shingle roof was installed in 1989. It is recommended that this building be re-roofed in the next 4-5 years with a new standing seam metal roof and new underlayments. This estimate includes removal and disposal of the old roofing. Due to the historical nature of the building, this project is subject to review and approval from the State Historical Preservation Office.

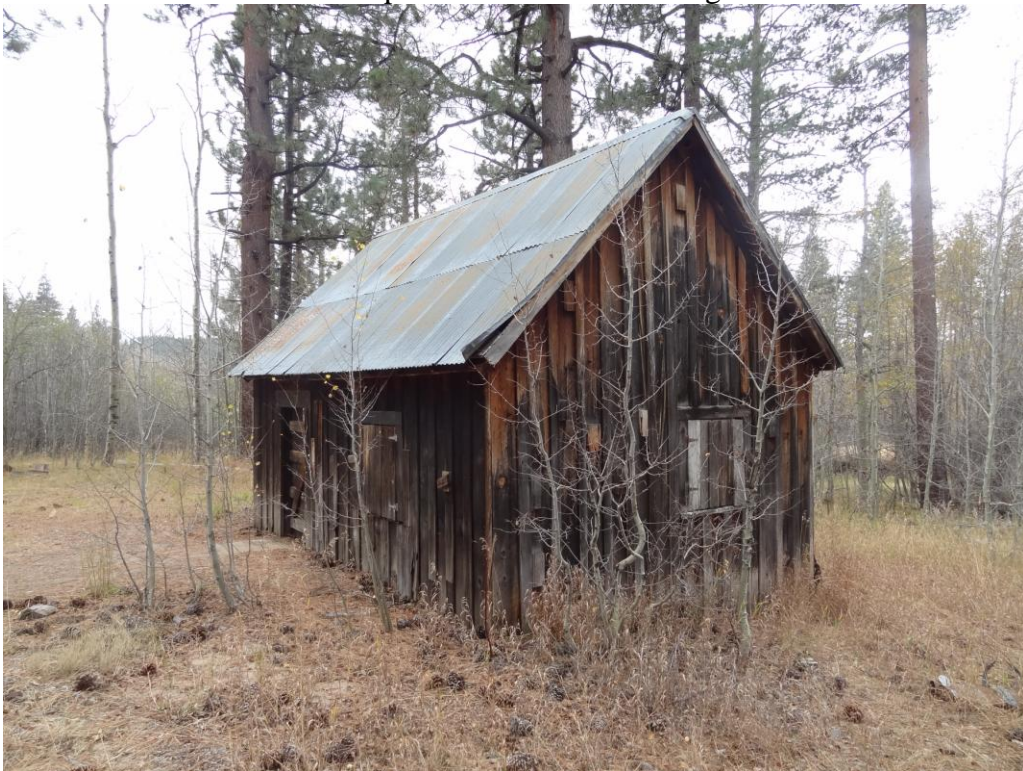
Spencer's Cabin – FCA Building #1371  
Description: Exterior of building.

Spencer's Cabin is a wood framed building located in the backcountry of Lake Tahoe Nevada State Park in the lower North Canyon area. It is named after the caretaker that watched over the cattle grazing operations during the early part of the 20th century. The building is currently in a state of arrested decay.

The wood shingle roof was installed in 1989. It is recommended that this building be re-roofed in the next 4-5 years with a new standing seam metal roof and new underlayments. This estimate includes removal and disposal of the old roofing. Due to the historical nature of the building, this project is subject to review and approval from the State Historical Preservation Office.

It is important to maintain the finish, weather resistance and appearance of the building. This project would provide funding to protect the exterior of the building excluding the roof. Included in the cost is power washing and staining the wood and caulking of the windows, flashing, fixtures and all other penetrations. It is recommended that the building be stained and caulked in the next 2-3 years and that this project be scheduled on a cyclical basis to maintain the integrity of the structure.

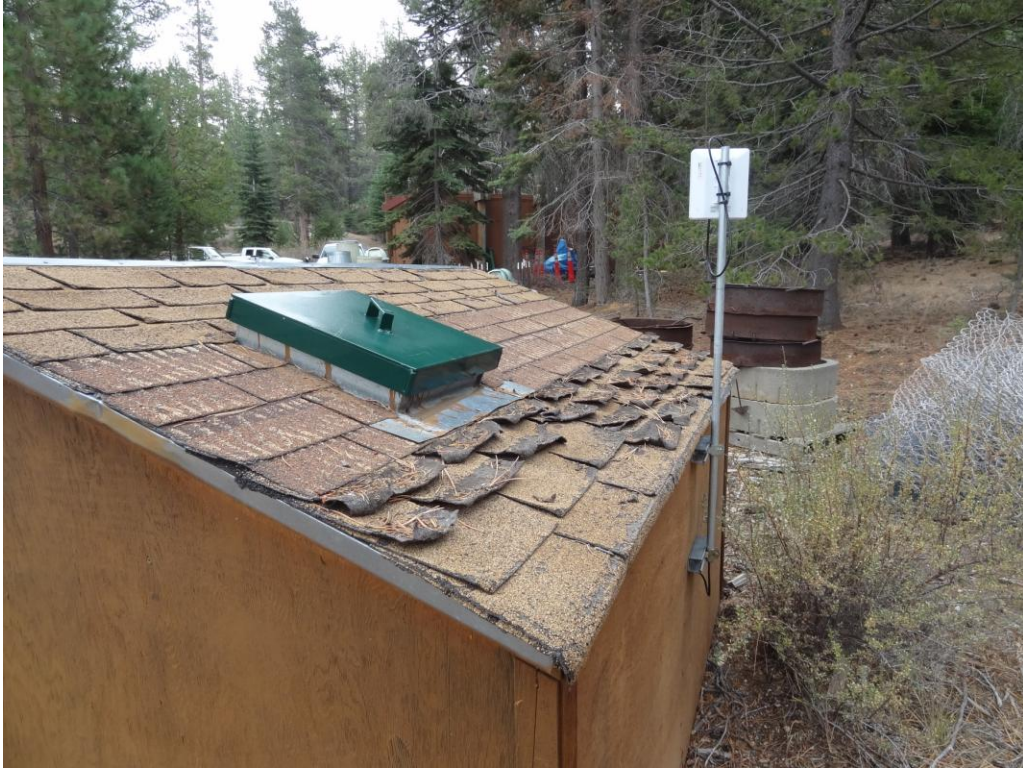
The asphalt composition shingle roof on this building was in poor condition at the time of the survey. It is recommended that this building be re-roofed in the next 1-2 years with a new 50 year asphalt composition roofing shingle and new underlayments. This estimate includes removal and disposal of the old roofing.

Pump House – FCA Building #1325  
Description: Roof in need of replacement.

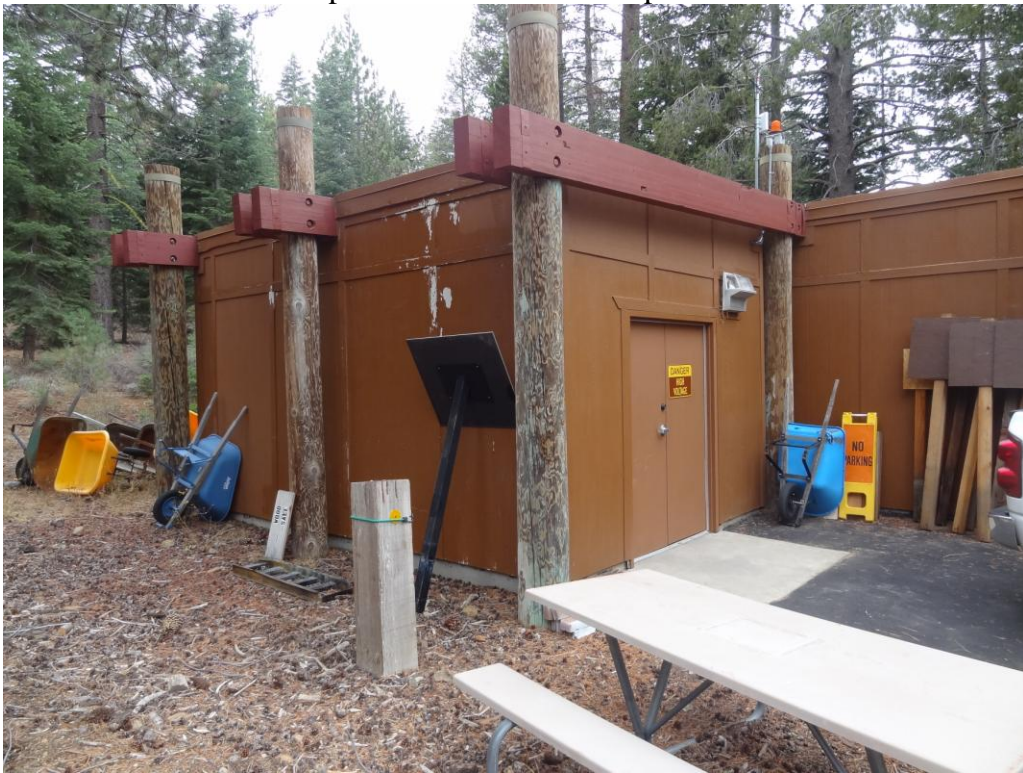
Well House – FCA Building #1323  
Description: Exterior of building.

The electrical transformer that provides electrical services to the building was damaged at the time of inspection and does not function properly. This project recommends replacing the electrical transformer.

It is important to maintain the finish, weather resistance and appearance of the building. This project would provide funding to protect the exterior of the building excluding the roof. Included in the cost is sanding, priming and painting and caulking of the windows, flashing, fixtures and all other penetrations. It is recommended that the building be painted in the next 1-2 years and that this project be scheduled on a cyclical basis to maintain the integrity of the structure.

The interior finishes are in fair condition. It is recommended to paint the interior walls and ceilings at least once in the next 1-2 years and that this project be scheduled on a cyclical basis to maintain the integrity of the structure. Prior to painting, all surfaces should be repaired and adequately prepared to receive the coating. An epoxy-based paint should be utilized in wet areas for durability.

The roof is due for replacement. This project would provide funds for: the demolition of the tar and gravel roof; the demolition of the underlayment; the installation of a new single-ply membrane roof; and the installation of sheet metal over the rafter tails. Additionally, this project will provide funds to fabricate the drip edge over the rafter tails to prevent the collection of snow and moisture and to keep the moisture from running back into the building.
