State of Nevada
Department of Conservation & Natural Resources
Division of State Parks

WASHOE LAKE STATE PARK

Site Number: 9929
STATE OF NEVADA PUBLIC WORKS DIVISION
FACILITY CONDITION ANALYSIS

Report distributed in December 2021

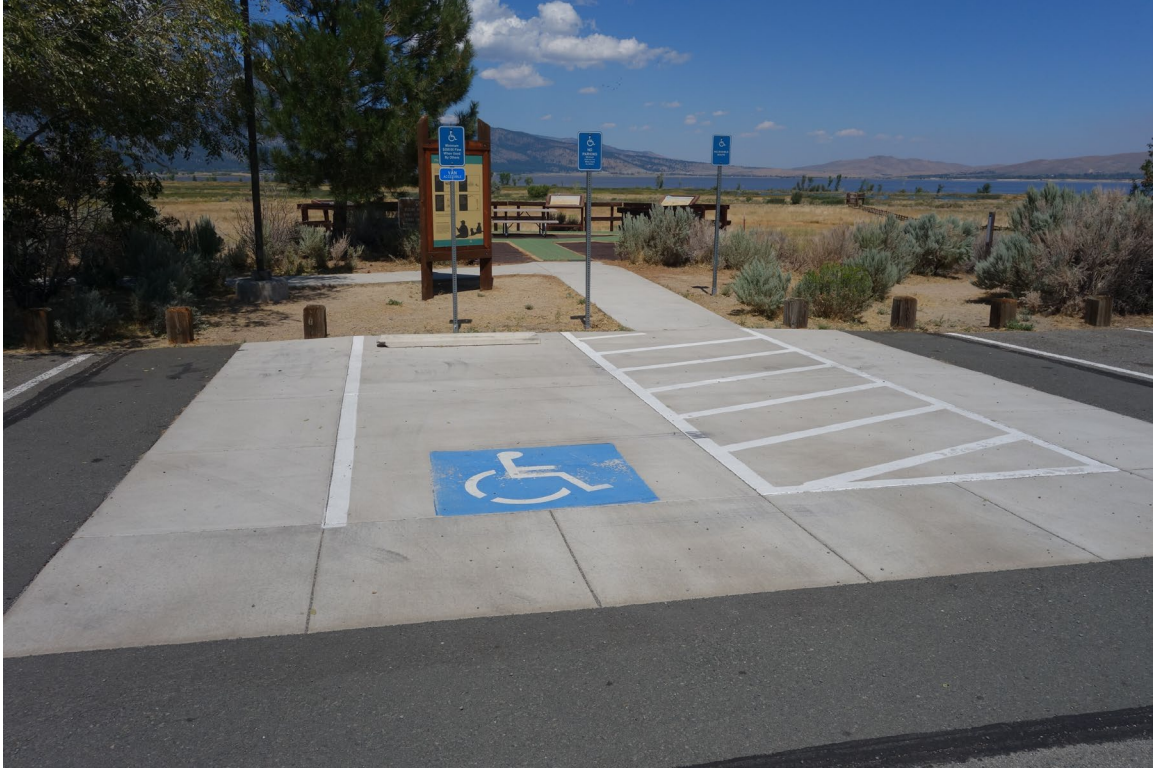
Washoe Lake State Park - Site #9929
Description: Wetlands Area ADA Improvements.

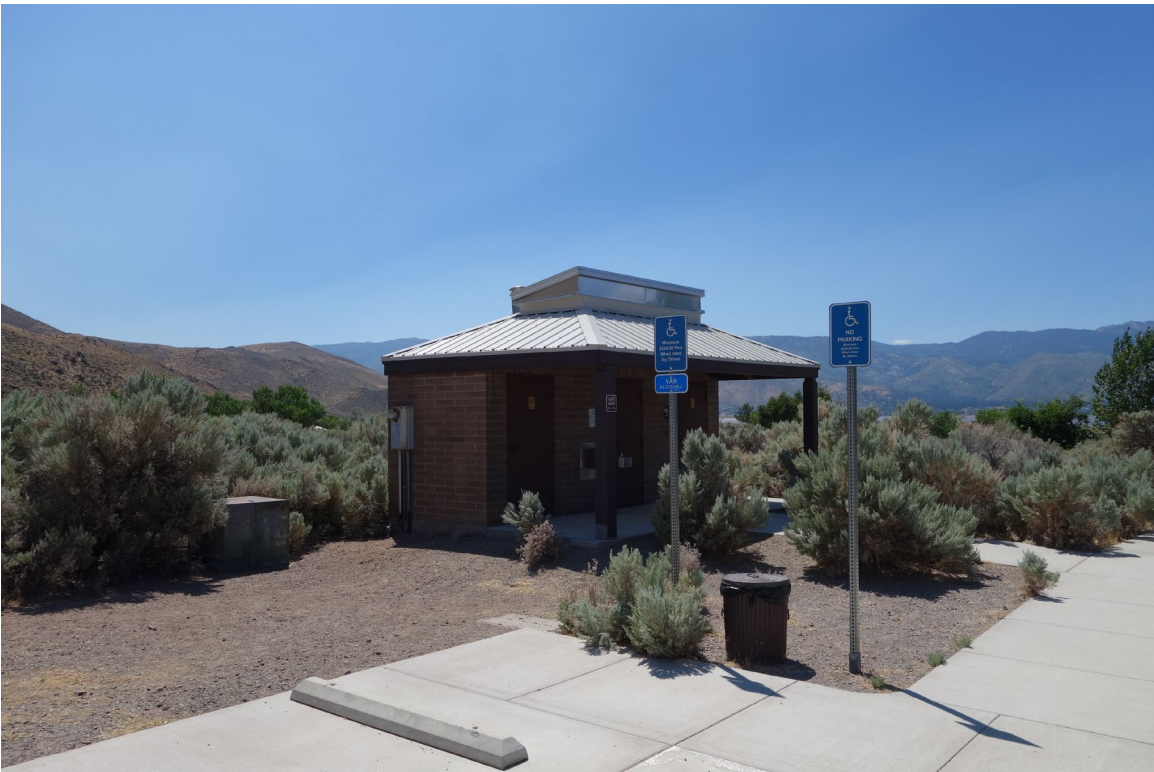
Washoe Lake State Park - Site #9929
Description: Group Use Area ADA Improvements.

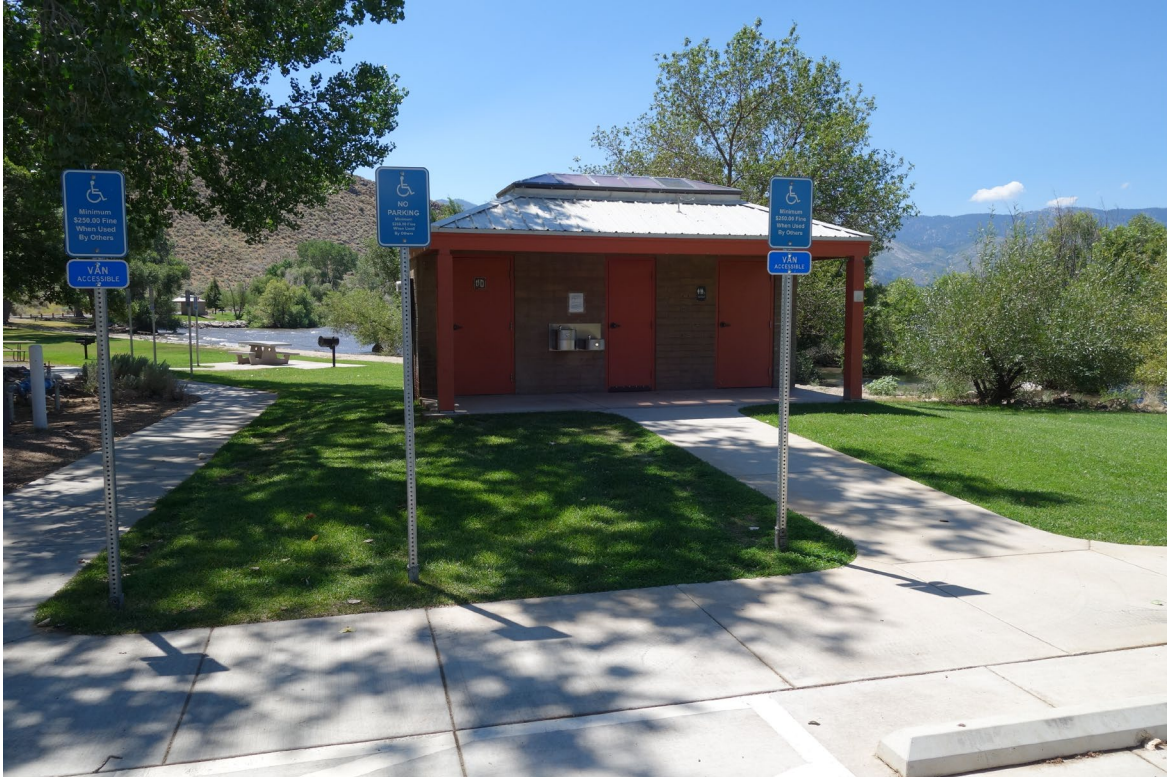
Washoe Lake State Park - Site #9929
Description: South Boat Launch Area ADA Improvements.

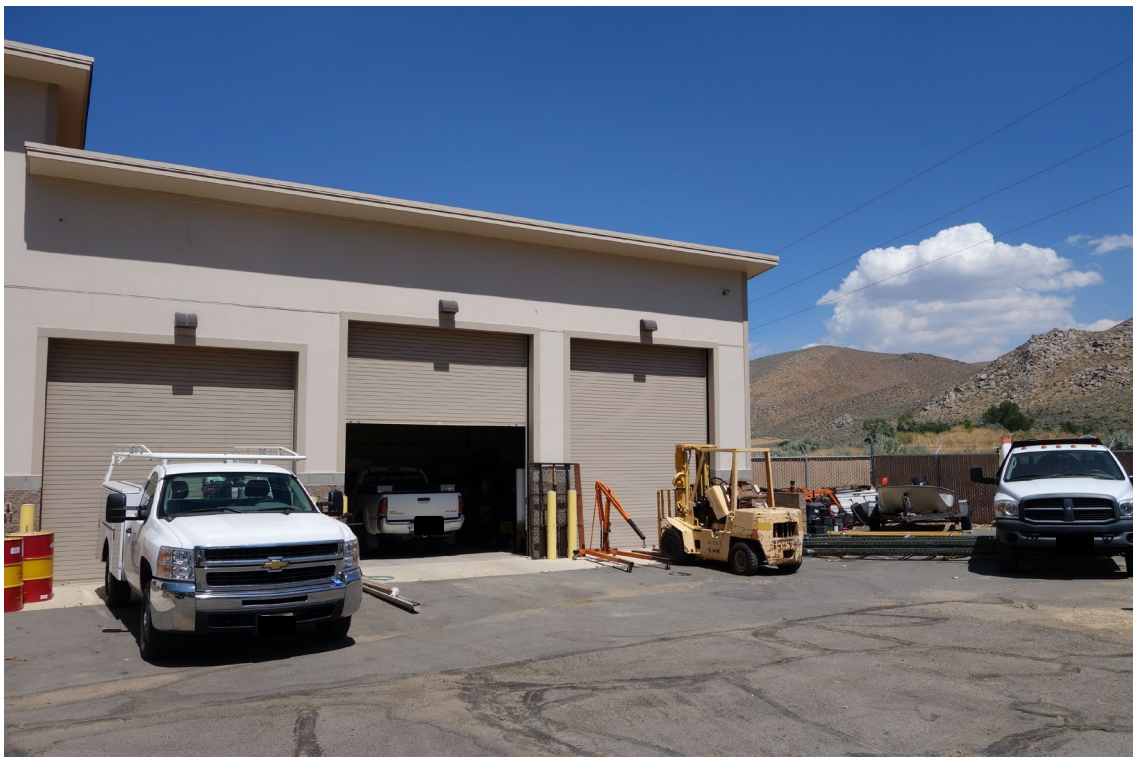
It is important to maintain the asphalt concrete paving on the site. This project would provide for minor crack filling and sealing of the paving site wide including access roads, parking areas and driving test areas. Striping is included in this estimate. This project should be scheduled on a 5 year cyclical basis to maintain the integrity of the paving and prevent premature failure. 300,000 square feet of asphalt area was used to generate this estimate.

Washoe Lake State Park - Site #9929
Description: Site Wide Crack Fill & Slurry Seal Needed.

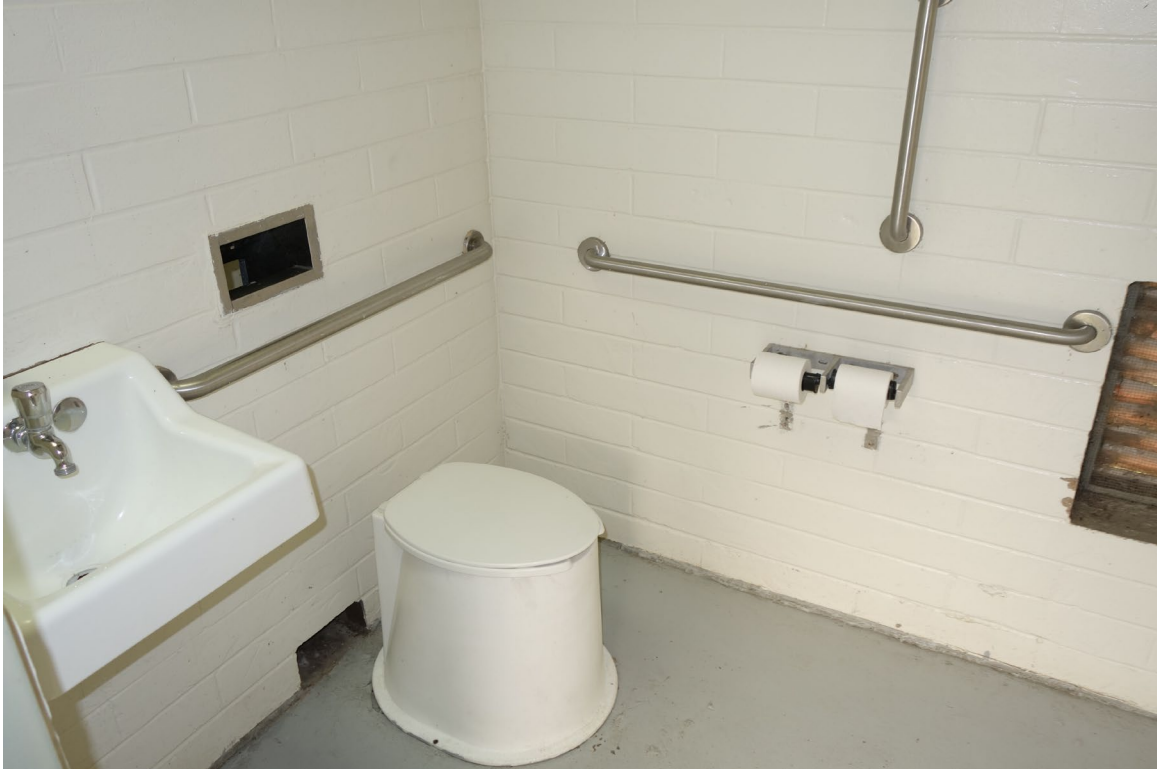
Comfort Station – Day Use #1 - Building #0593
Description: Accessibility Upgrades to Comfort Station.

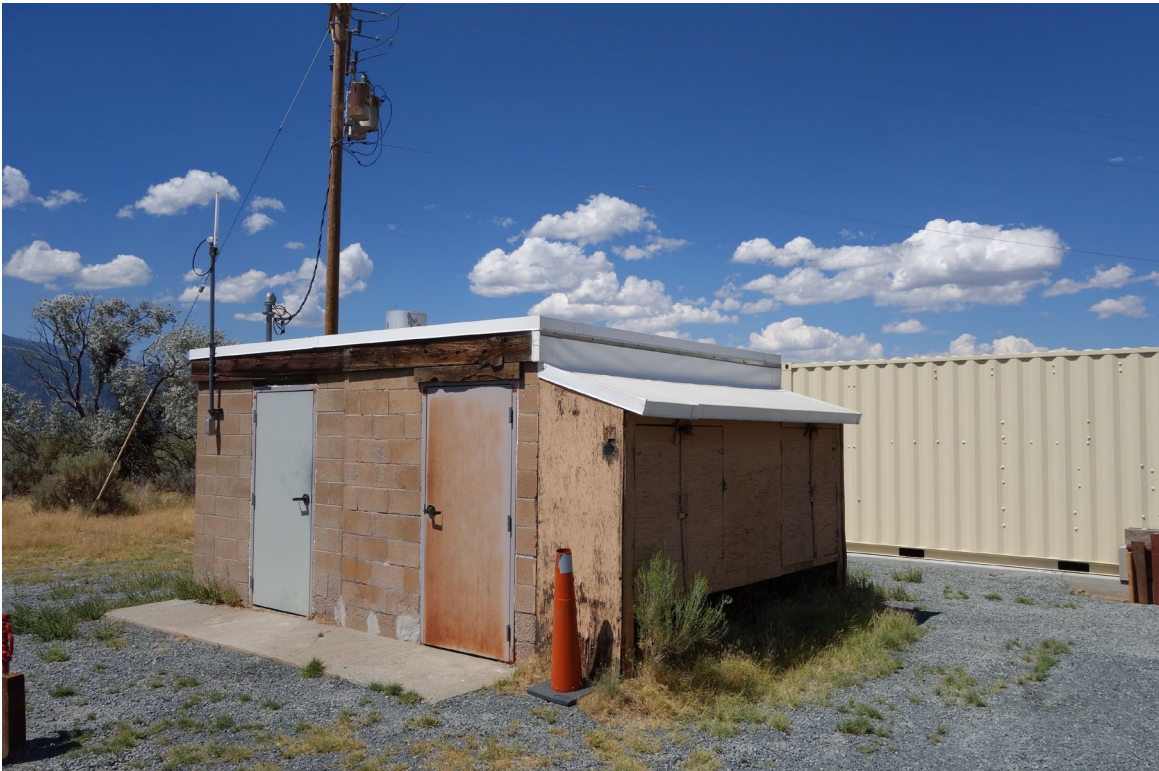
South Beach Pump House - Building #0869
Description: Exterior of the Building.

It is important to maintain the finish, weather resistance and appearance of the building. This project recommends work to protect the exterior building envelope, other than the roof, including painting, staining, or other applied finishes, and caulking around flashing, fixtures, and other penetrations to maintain the building in good, weather tight condition. It is recommended that this project be implemented in the next 4 to 5 years and is recommended on a cyclical basis based on environmental conditions.

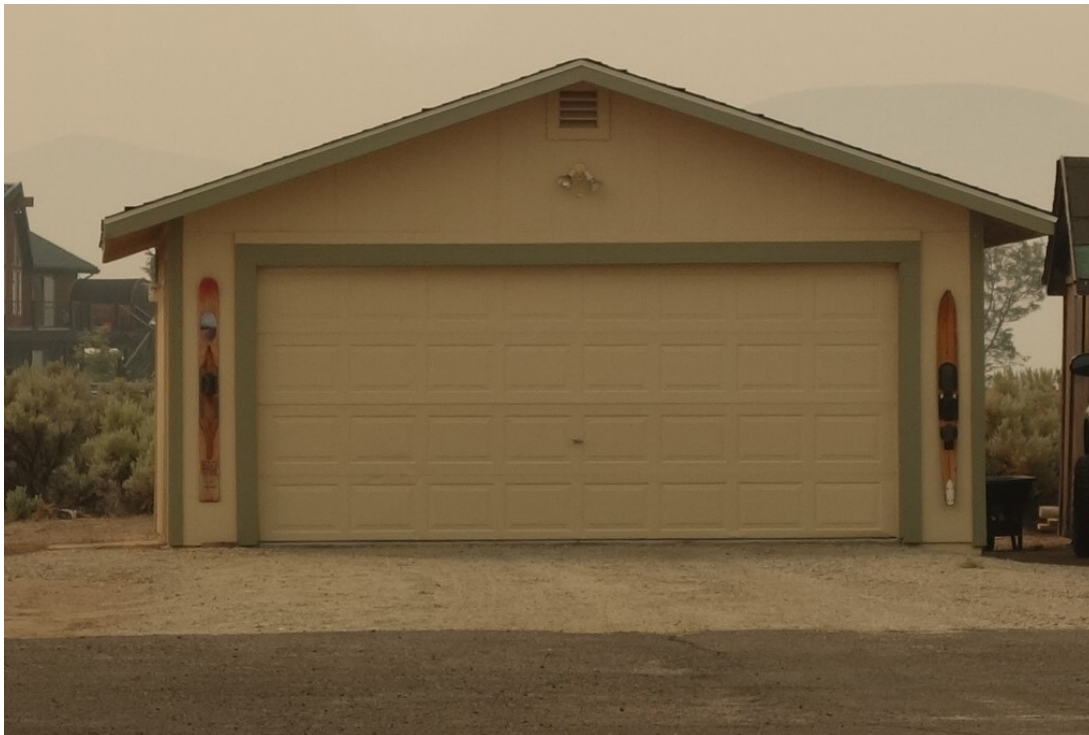
North Ramp Garage - Building #2375
Description: Exterior of the Building.

It is important to maintain the finish, weather resistance and appearance of the building. This project recommends work to protect the exterior building envelope, other than the roof, including painting, staining, or other applied finishes, and caulking around flashing, fixtures, and other penetrations to maintain the building in good, weather tight condition. It is recommended that this project be implemented in the next 4 to 5 years and is recommended on a cyclical basis based on environmental conditions.

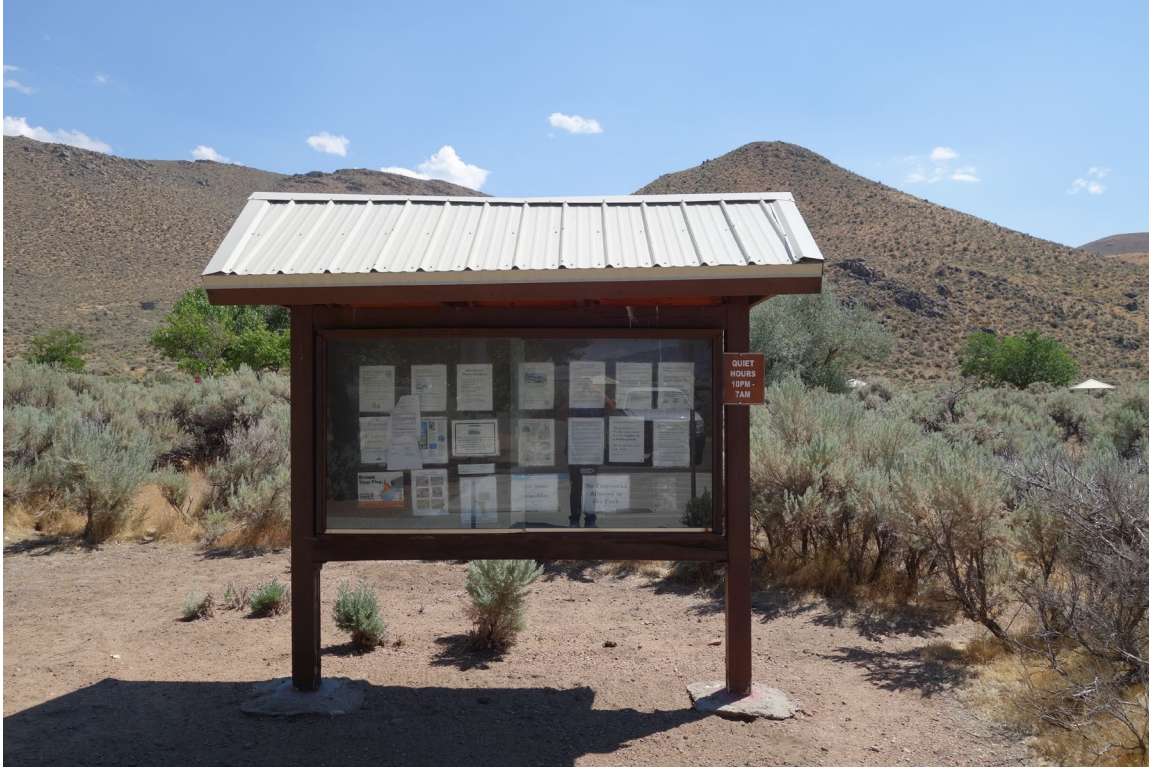
Kiosk – Campground Loop B - Building #2792
Description: View of the Kiosk.

It is important to maintain the finish, weather resistance and appearance of the building. This project recommends work to protect the exterior building envelope, other than the roof, including painting, staining, or other applied finishes, and caulking around flashing, fixtures, and other penetrations to maintain the building in good, weather tight condition. It is recommended that this project be implemented in the next 4 to 5 years and is recommended on a cyclical basis based on environmental conditions.

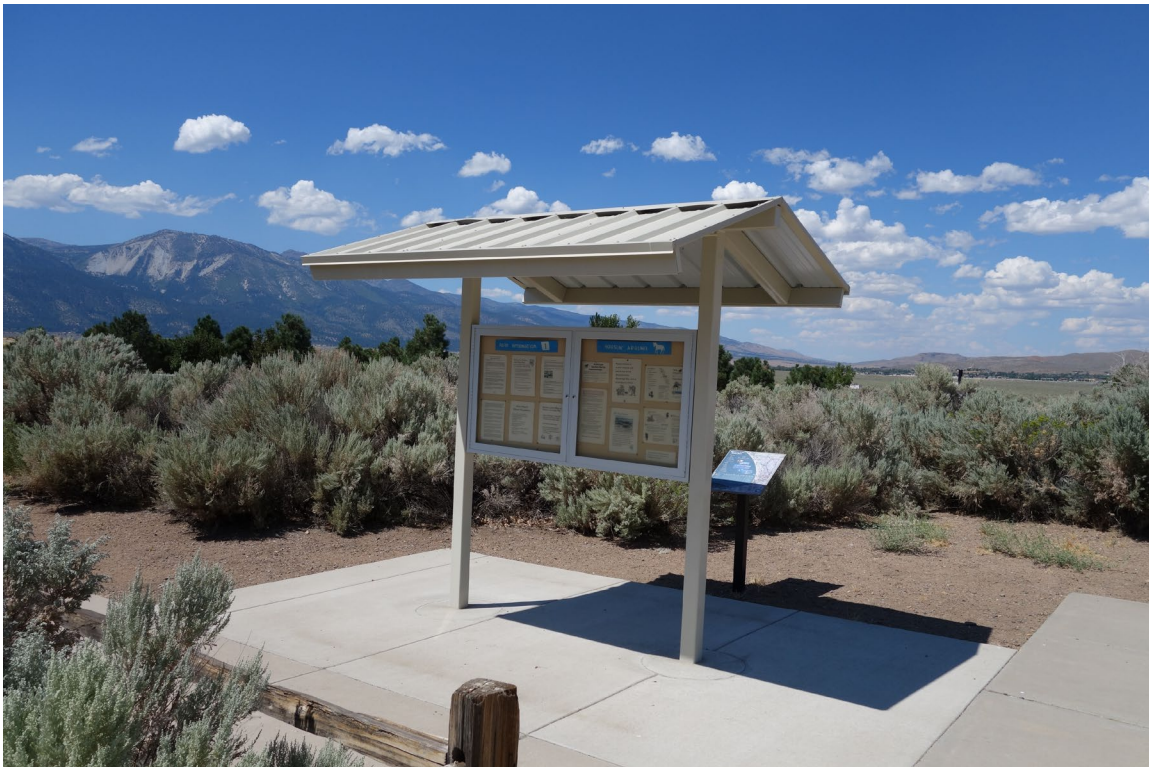
Kiosk – Equestrian - Building #2793
Description: View of the Kiosk.

It is important to maintain the finish, weather resistance and appearance of the building. This project recommends work to protect the exterior building envelope, other than the roof, including painting, staining, or other applied finishes, and caulking around flashing, fixtures, and other penetrations to maintain the building in good, weather tight condition. It is recommended that this project be implemented in the next 4 to 5 years and is recommended on a cyclical basis based on environmental conditions.

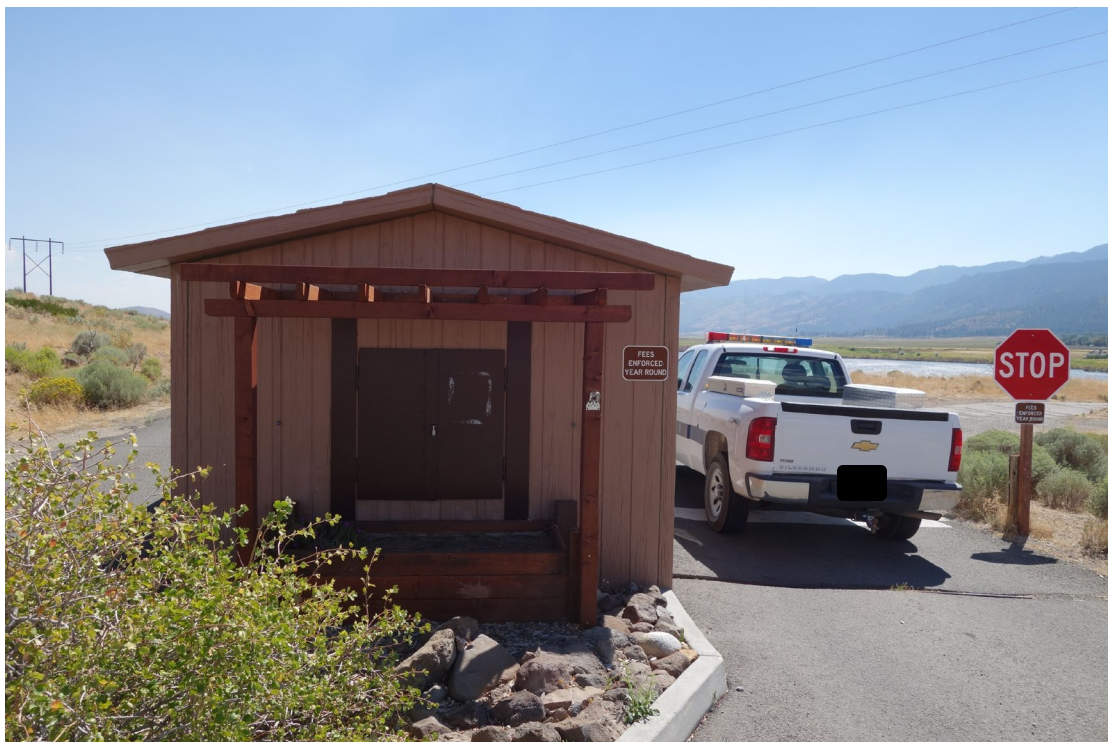
Fee Booth – Little Washoe - Building #2796
Description: Exterior of the Building.

It is important to maintain the finish, weather resistance and appearance of the building. This project recommends work to protect the exterior building envelope, other than the roof, including painting, staining, or other applied finishes, and caulking around windows, flashing, fixtures, and other penetrations to maintain the building in good, weather tight condition. It is recommended that this project be implemented in the next 4 to 5 years and is recommended on a cyclical basis based on environmental conditions.

The interior finishes are in fair condition. It is recommended that the interior walls and ceilings be painted at least once in the next 4 to 5 years and every 7 to 9 years thereafter to maintain the integrity of the interior of the building. Prior to painting, all surfaces should be repaired and prepped. An epoxy-based paint should be utilized in wet areas for durability.

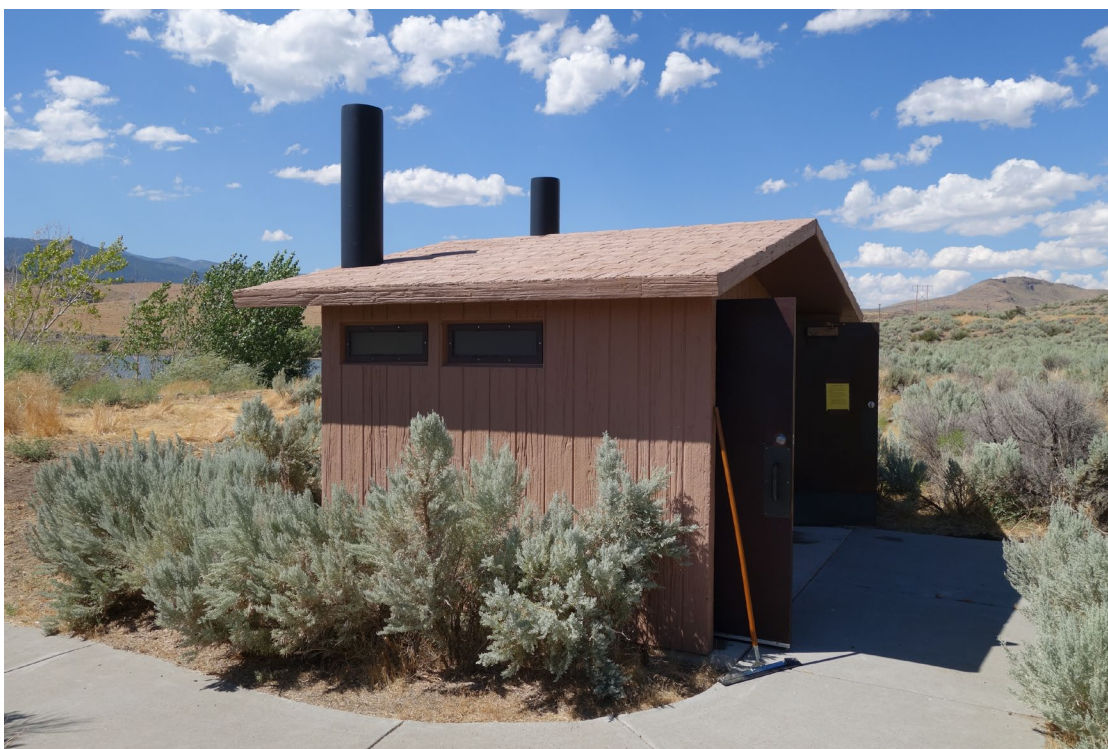
Comfort Station #1 – Little Washoe - Building #2797
Description: Exterior of the Building.

The exterior finishes are in fair condition. It is important to maintain the finish, weather resistance and appearance of the building. This project recommends work to protect the exterior building envelope, other than the roof, including painting, staining, or other applied finishes, and caulking around windows, flashing, fixtures, and other penetrations to maintain the building in good, weather tight condition. It is recommended that this project be implemented in the next 4 to 5 years and is recommended on a cyclical basis based on environmental conditions.

The interior finishes are in fair condition. It is recommended that the interior walls and ceilings be painted at least once in the next 4 to 5 years and every 7 to 9 years thereafter to maintain the integrity of the interior of the building. Prior to painting, all surfaces should be repaired and prepped. An epoxy-based paint should be utilized in wet areas for durability.

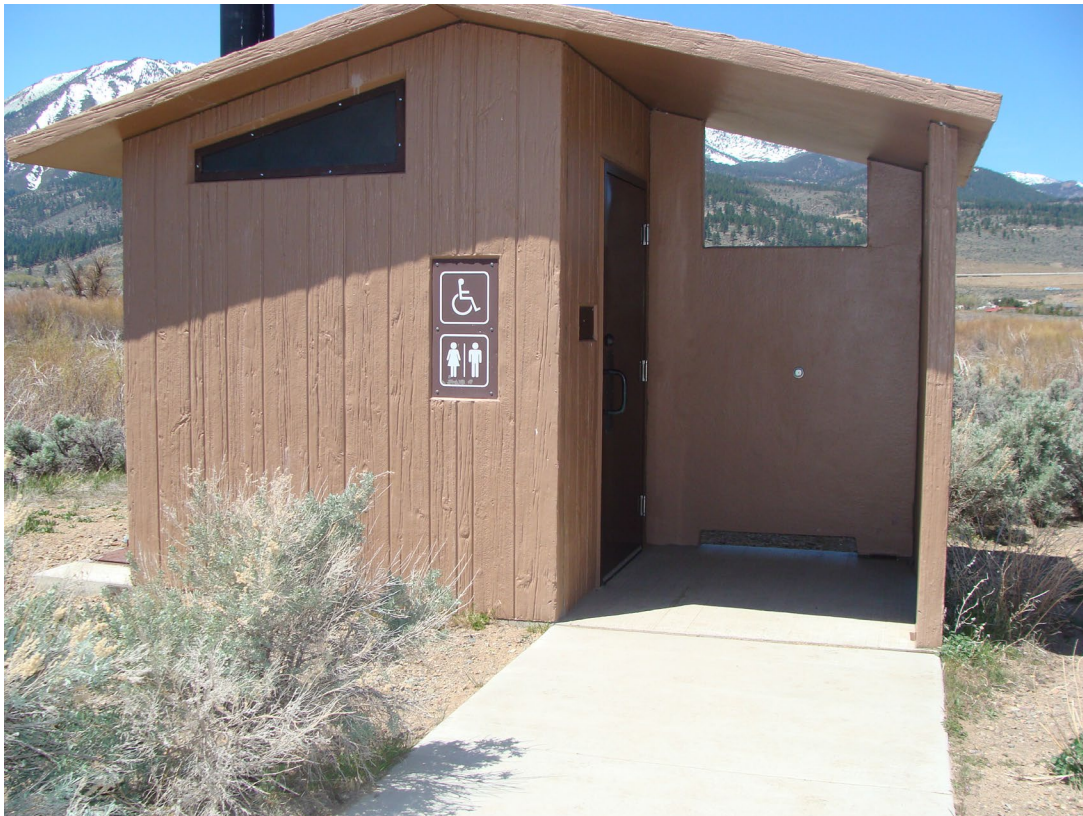
Comfort Station #2 – Little Washoe - Building #2798
Description: Exterior of the Building.

It is important to maintain the finish, weather resistance and appearance of the building. This project recommends work to protect the exterior building envelope, other than the roof, including painting, staining, or other applied finishes, and caulking around windows, flashing, fixtures, and other penetrations to maintain the building in good, weather tight condition. It is recommended that this project be implemented in the next 4 to 5 years and is recommended on a cyclical basis based on environmental conditions.

The interior finishes are in fair condition. It is recommended that the interior walls and ceilings be painted at least once in the next 4 to 5 years and every 7 to 9 years thereafter to maintain the integrity of the interior of the building. Prior to painting, all surfaces should be repaired and prepped. An epoxy-based paint should be utilized in wet areas for durability.

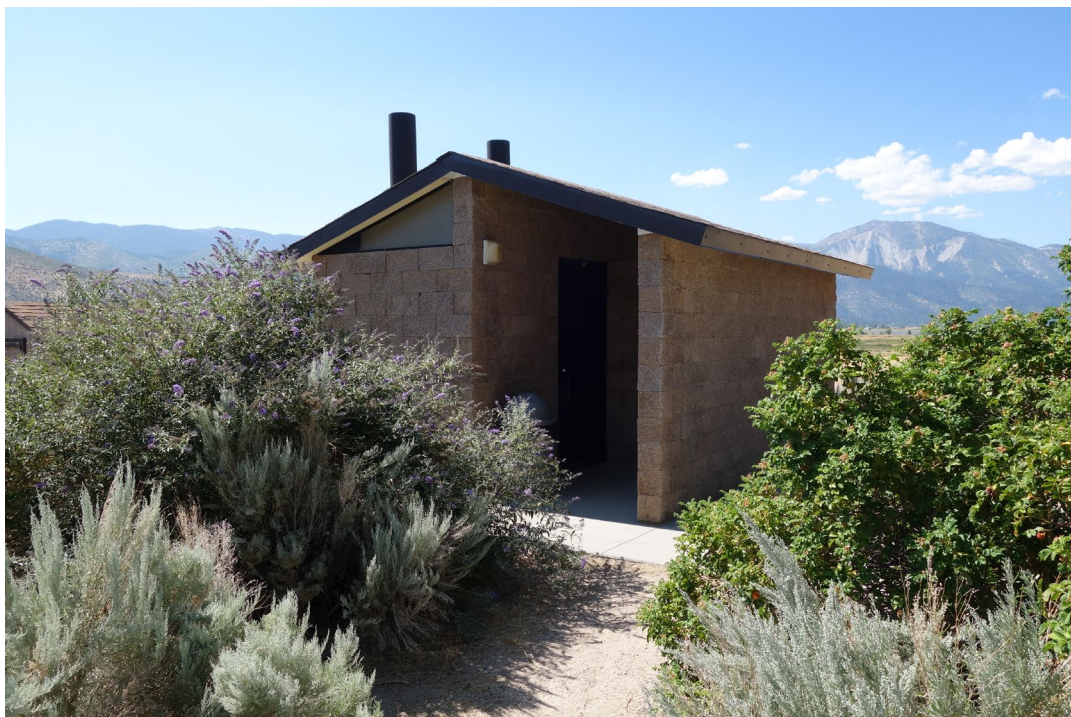
Comfort Station – Wetlands - Building #2799
Description: Exterior of the Building.

The exterior finishes are in good condition. It is important to maintain the finish, weather resistance and appearance of the building. This project recommends work to protect the exterior building envelope, other than the roof, including painting, staining, or other applied finishes, and caulking around windows, flashing, fixtures, and other penetrations to maintain the building in good, weather tight condition. It is recommended that this project be implemented in the next 7 to 9 years and is recommended on a cyclical basis based on environmental conditions.

The interior finishes are in good condition. It is recommended that the interior walls and ceilings be painted at least once in the next 7 to 9 years and every 7 to 9 years thereafter to maintain the integrity of the interior of the building. Prior to painting, all surfaces should be repaired and prepped. An epoxy-based paint should be utilized in wet areas for durability.

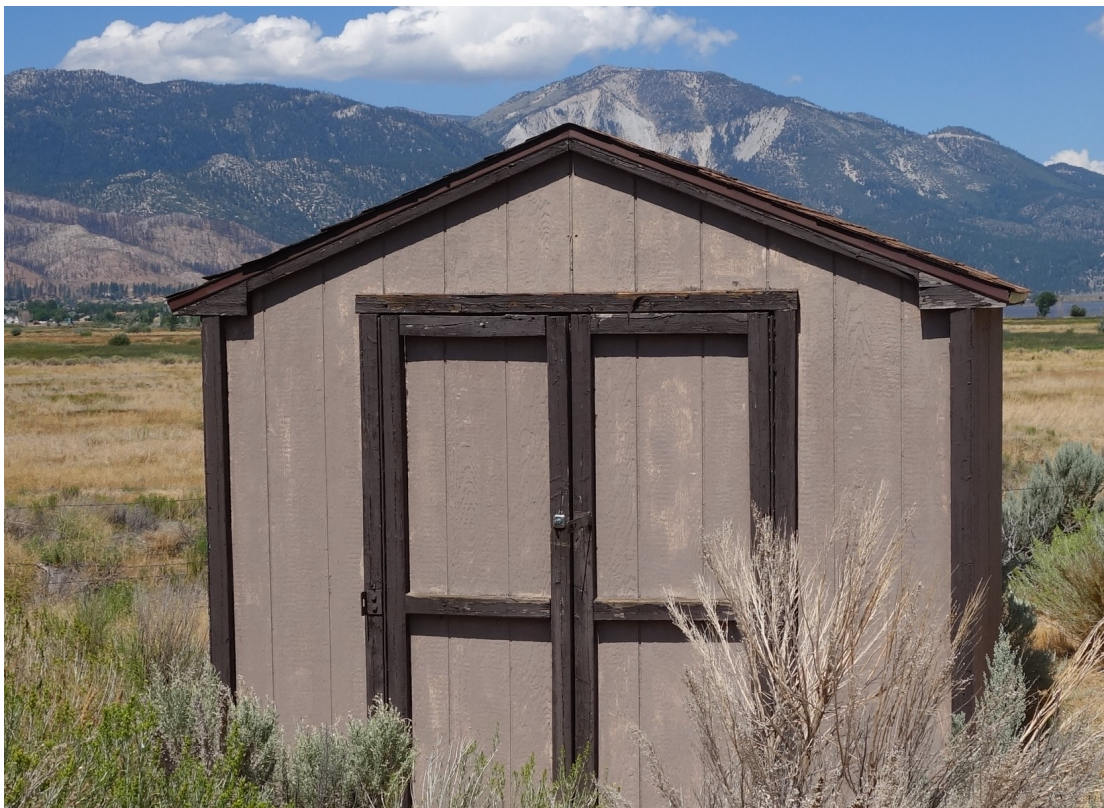
The exterior finishes are in poor condition. It is important to maintain the finish, weather resistance and appearance of the building. This project recommends work to protect the exterior building envelope, other than the roof, including painting, staining, or other applied finishes, and caulking around flashing, fixtures, and other penetrations to maintain the building in good, weather tight condition. It is recommended that this project be implemented in the next 2 to 3 years and is recommended on a cyclical basis based on environmental conditions.

Storage Shed – Wetlands - Building #2800
Description: Exterior Finishes of the Building.

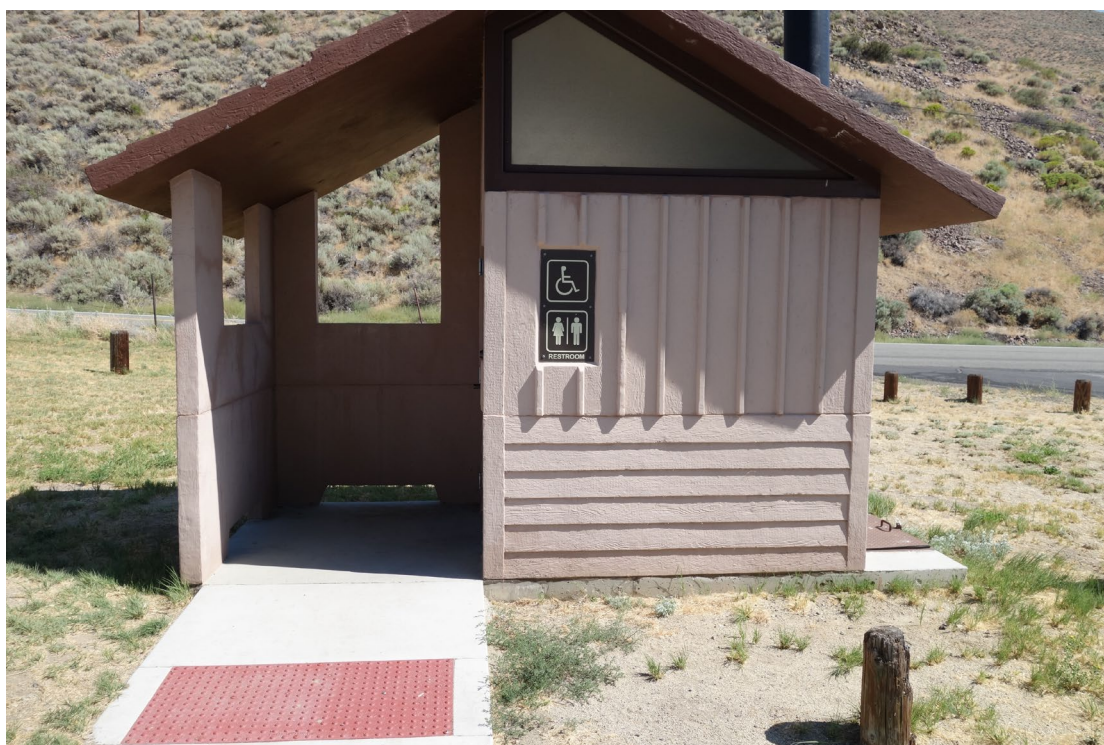
Comfort Station – South Beach - Building #3909
Description: Exterior of the Building.

The exterior finishes are in good condition. It is important to maintain the finish, weather resistance and appearance of the building. This project recommends work to protect the exterior building envelope, other than the roof, including painting, staining, or other applied finishes, and caulking around windows, flashing, fixtures, and other penetrations to maintain the building in good, weather tight condition. It is recommended that this project be implemented in the next 7 to 9 years and is recommended on a cyclical basis based on environmental conditions.

The interior finishes are in good condition. It is recommended that the interior walls and ceilings be painted at least once in the next 4 to 5 years and every 7 to 9 years thereafter to maintain the integrity of the interior of the building. Prior to painting, all surfaces should be repaired and prepped. An epoxy-based paint should be utilized in wet areas for durability.

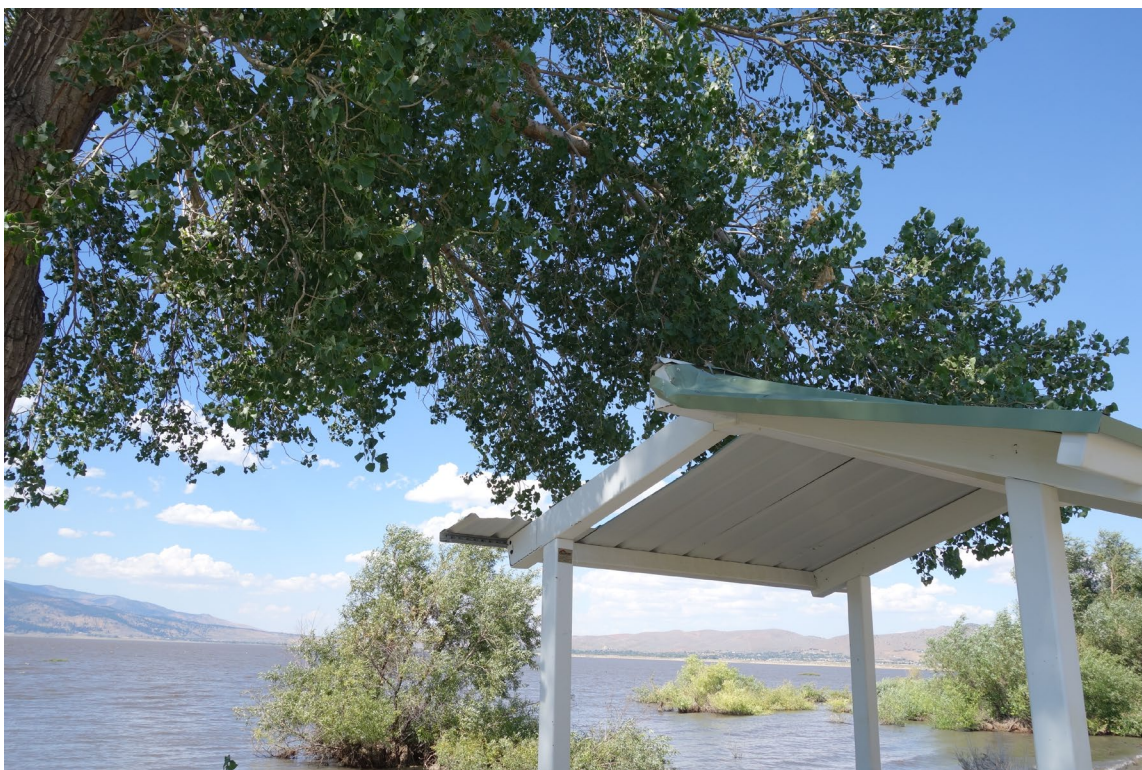
South Beach Shade Ramada - Building #3911
Description: Exterior of the Building.

The metal roof on this building was damaged at the time of the survey. It is recommended that this building be re-roofed in the next 2 - 3 years with a new metal roofing system.

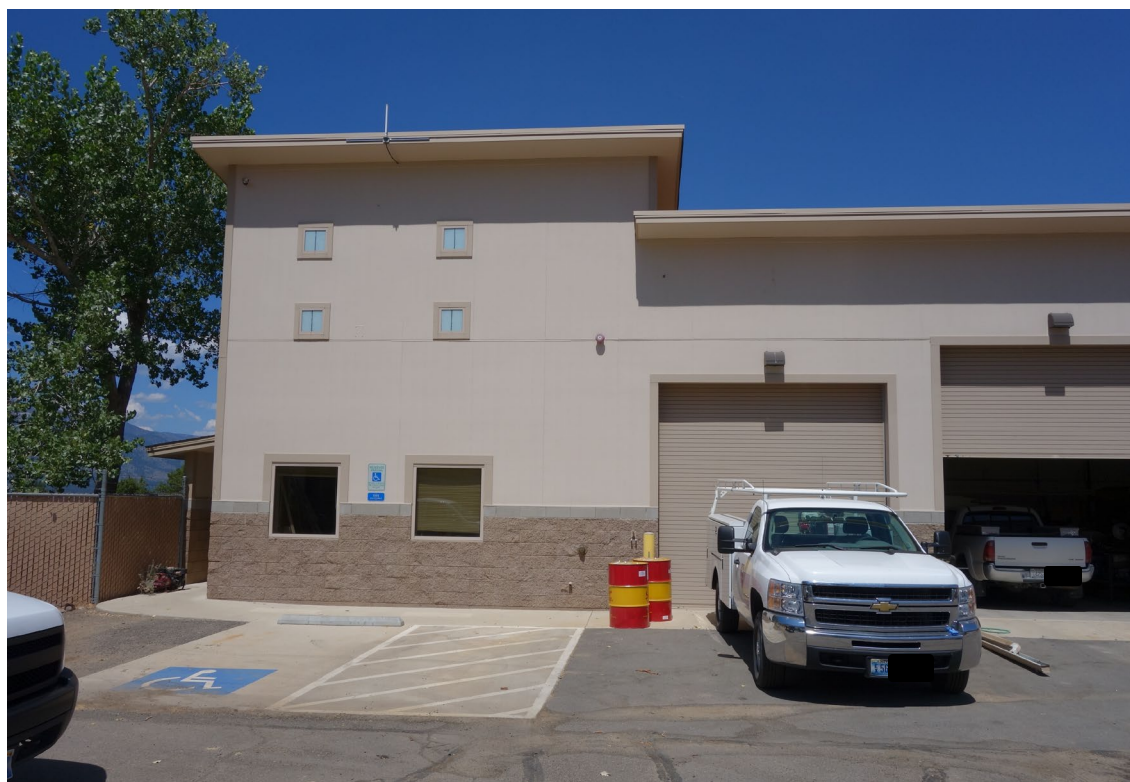
Vehicle Maintenance Building - Building #4182
Description: Exterior of the Building.

The exterior finishes are in good condition. It is important to maintain the finish, weather resistance and appearance of the building. This project would provide funding to protect the exterior of the building excluding the roof. Included in the cost is sanding, priming and painting the concrete siding, re-sealing the CMU block where needed and caulking the windows, flashing, fixtures and all other penetrations. It is recommended that the building be painted in the next 7 - 9 years and that this project be scheduled on a cyclical basis to maintain the integrity of the structure.

The interior finishes are in good condition. It is recommended that the interior walls and ceilings be painted at least once in the next 7 - 9 years and every 7 to 9 years thereafter to maintain the integrity of the interior of the building. Prior to painting, all surfaces should be repaired and prepped. An epoxy-based paint should be utilized in wet areas for durability.
