DEPARTMENT OF ADMINISTRATION  
STATE PUBLIC WORKS DIVISION  
FACILITY CONDITION ASSESSMENT

### PROPERTY PORTFOLIO REVIEW PROJECT ADDENDUM

9930 - SPRING MOUNTAIN RANCH STATE PARK SITE  
6375 HWY 159  
BLUE DIAMOND, NV 89004-  
CLARK COUNTY

SURVEY DATE: 03/19/2024

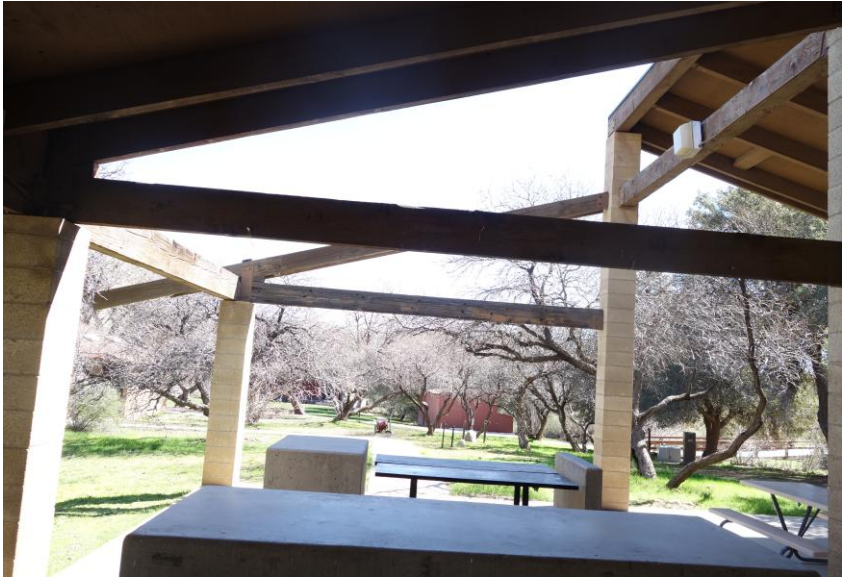
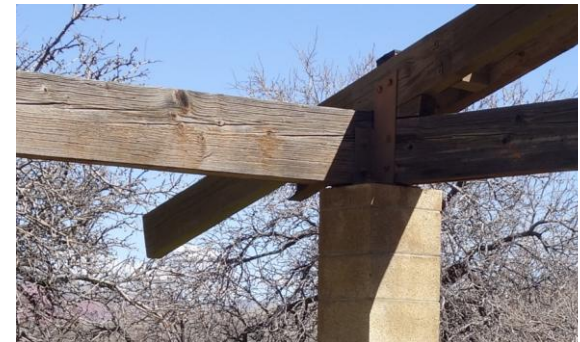
### **NEW STRUCTURAL - 2/25/2026** **1156-STR-1: RAFTER REPLACEMENT**

The rafters exposed to the elements in the section without roofing are cracked, broken and in need of replacement. It is recommended that new rafters and cross beams be installed in this area. This estimate includes removal and disposal of all structurally compromised rafters.

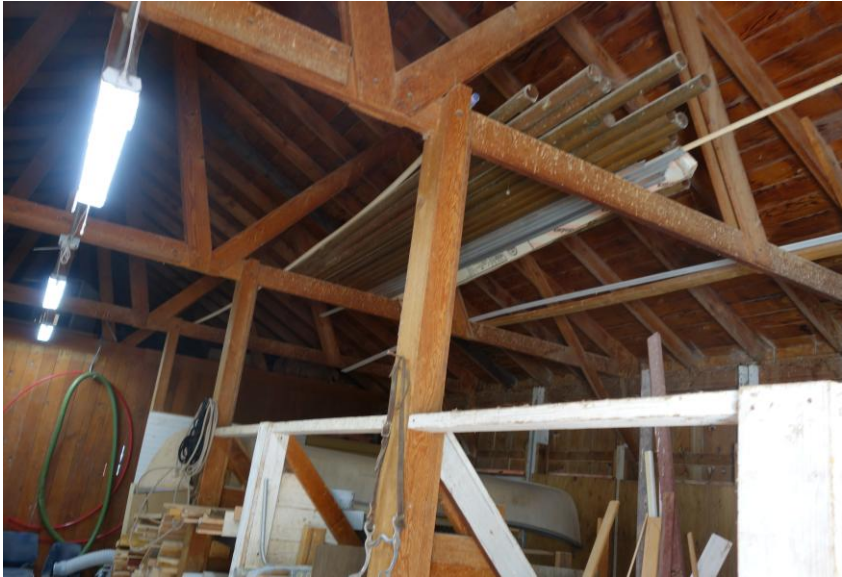
#### 1157-STR-1: STRUCTURAL REINFORCEMENT

Based on the findings of structural assessment CIP 19-P10, the building has been deemed structurally deficient and requires corrective measures to ensure safety and longevity. Per the assessment recommendations, additional framing members be added to existing load bearing walls and roof framing members. This improvement will address critical deficiencies, enhance structural integrity, and mitigate potential hazards, aligning

with the assessment's recommendations. Please reference 19-P10 project documentation for specific details.

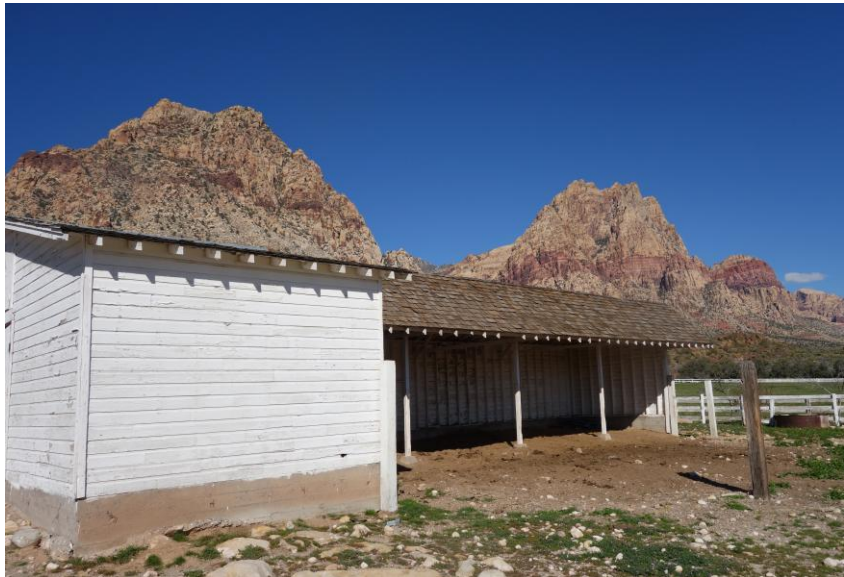
## 1159-STR-1: STRUCTURAL REINFORCEMENT

Based on the findings of structural assessment CIP 19-P10, the building has been deemed structurally deficient and requires corrective measures to ensure safety and longevity. Per the assessment recommendations, additional lateral resisting framing elements be added to existing load bearing walls and roof framing members. This improvement will address critical deficiencies, enhance structural integrity, and mitigate

potential hazards, aligning with the assessment's recommendations. Please reference 19-P10 project documentation for specific details. This project should be done prior to the ROOF REPLACEMENT project.

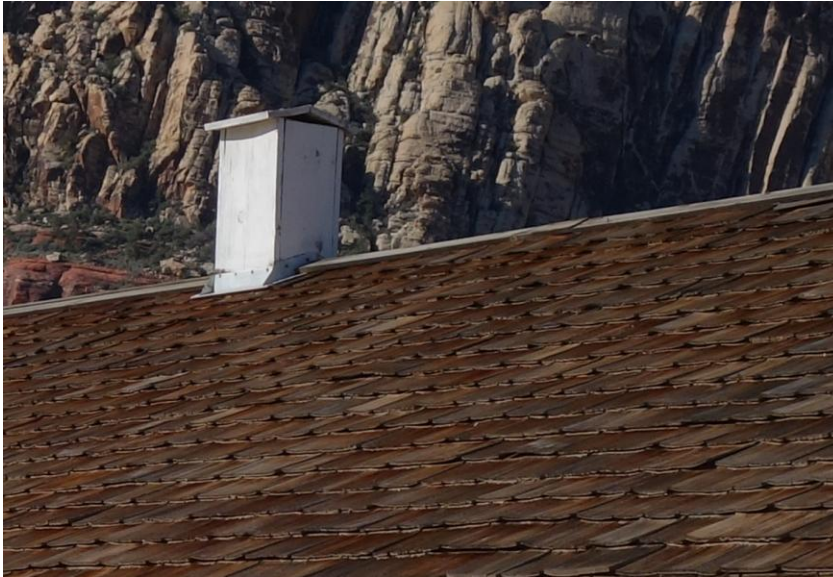
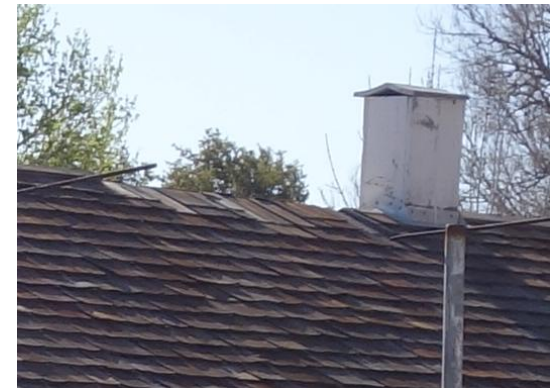
#### 1149-EXT-3: ROOF REPLACEMENT

will fund replacement of the wood shingle roofing system and installation of rain gutters. This estimate includes removal and disposal of the old roof. Please note this building was structurally assessed under 19-P10 and evaluated to be structurally sound; therefore, improvements can be made without URM reinforcement.

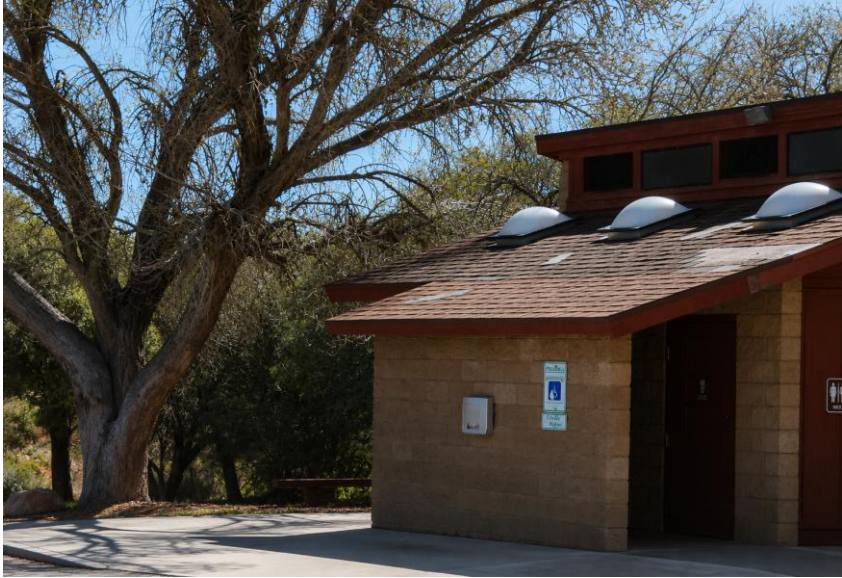
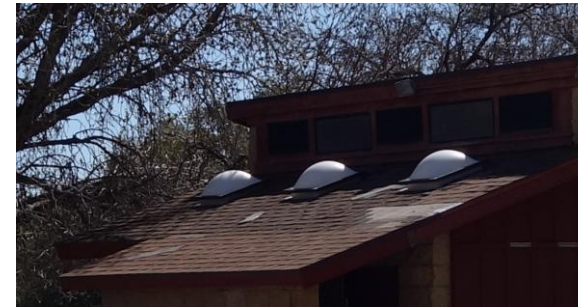
#### 1151-EXT-3: ROOF REPLACEMENT

At the time of the survey, the building's roof was found to be in poor condition. Harsh environmental conditions—such as temperature fluctuations, windborne sand and debris, and prolonged sun exposure—have accelerated deterioration. Re-roofing is recommended within the next 2 – 3 years to align with the statewide roofing program and address the aging system.

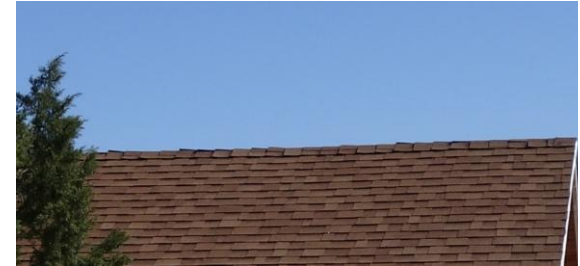
### 1153-EXT-2: ROOF REPLACEMENT

The asphalt composition shingle roof on this building was in poor condition at the time of the survey. It is recommended that this building be re-roofed in the next 2 - 3 years with a new 50 year asphalt composition shingle roof and new underlayment. This estimate includes removal and disposal of the old roof.

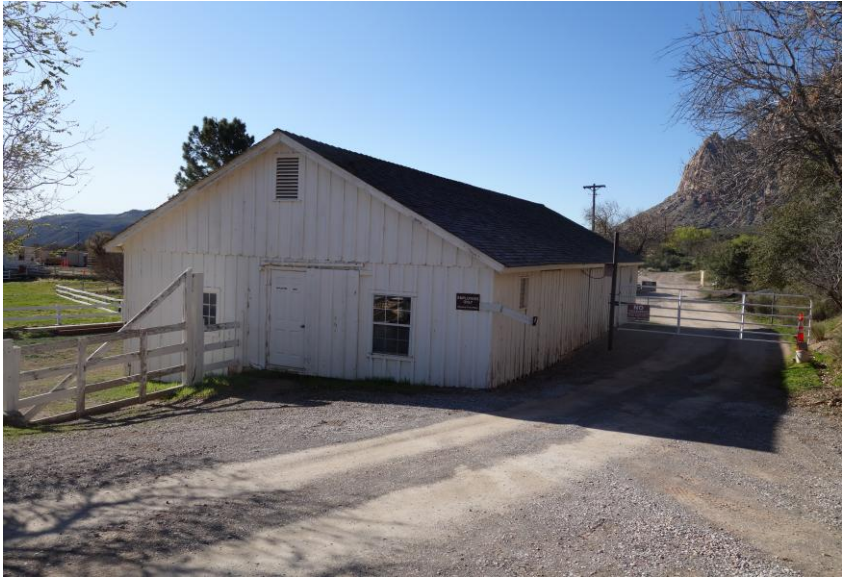
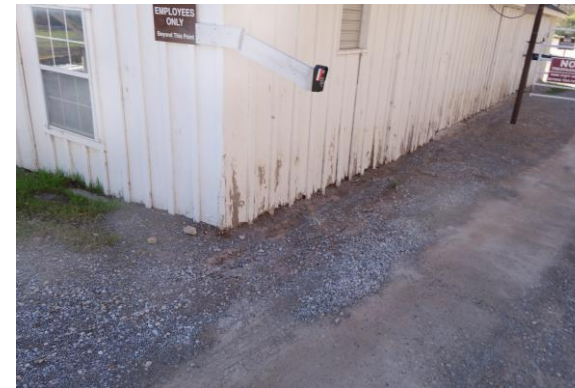
#### 1157-EXT-2: BUILDING WEST SIDE REPAIRS

The board and batten siding on the west side of the building is severely degraded where soil is in direct contact. Soil grades in this area are too high causing the siding degradation. This project recommends regrading the road profile on the west side is such a way to prevent water from sheet flowing toward the building. Once grading is complete, replace the existing damaged siding, re-paint to complete the repairs.

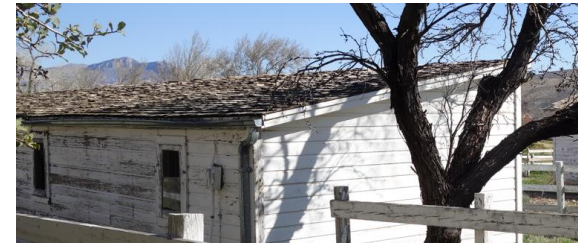
### 1162-EXT-2: ROOF REPLACEMENT

The wood shingle roof on this building was in poor condition at the time of the survey. It is recommended that this building be re-roofed in the next 2 - 3 years with a new wood shingle roof and new underlayment. Due to the historical nature of the building, this project is subject to review and approval from the State Historical Preservation Office. This estimate includes removal and disposal of the old roof.

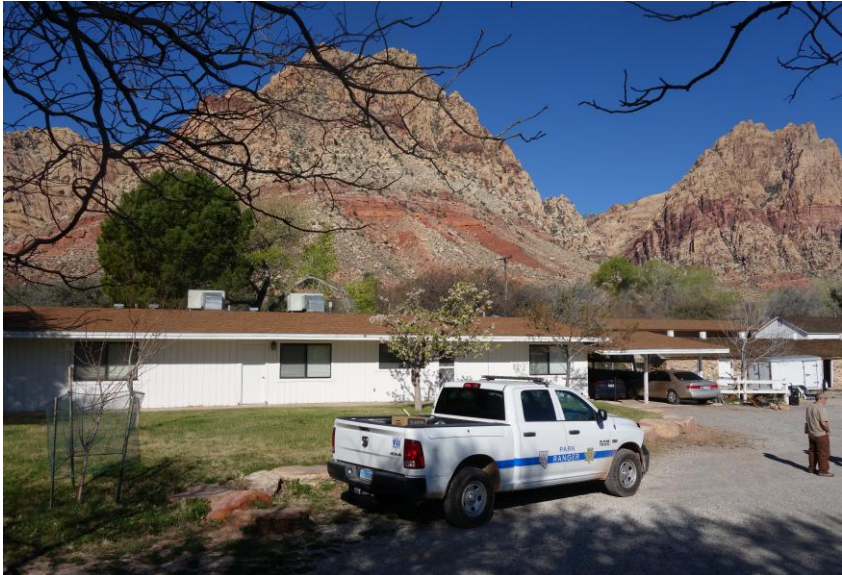
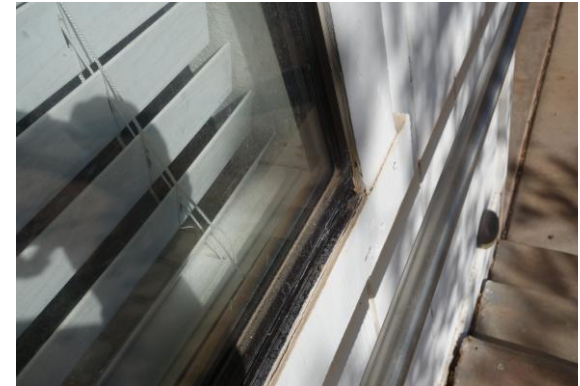
#### 1168-EXT-4: EXTERIOR BUILDING ENVELOPE REPLACEMENT

The exterior building envelope—including siding, doors, windows, and the rooftop air-conditioning unit—is in poor condition and no longer functioning as intended. Due to the extent of deterioration, this project recommends complete removal and replacement of these components to restore the building's performance, energy efficiency, and protection from weather.
