State of Nevada
Department of Conservation & Natural Resources
Division of State Parks

SPRING MOUNTAIN RANCH STATE PARK

Site Number: 9930
STATE OF NEVADA PUBLIC WORKS DIVISION
FACILITY CONDITION ANALYSIS

Report distributed in February 2021

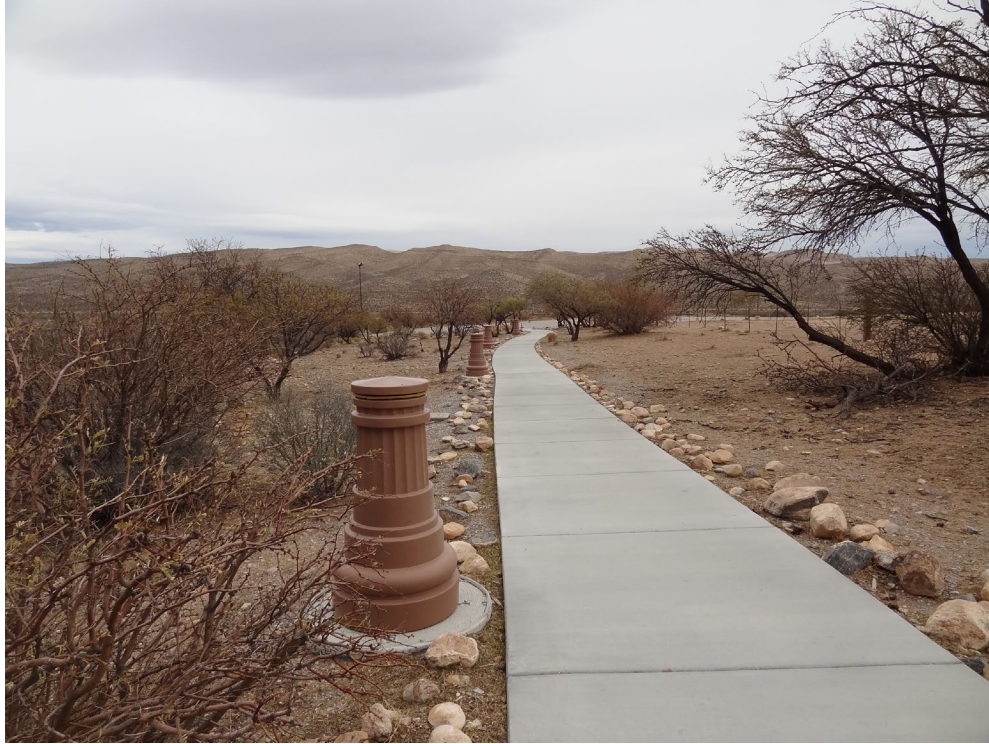
Spring Mountain Ranch State Park - Site #9930
Description: Sidewalk access to Group Use from Main Parking Area.

It is important to maintain the asphalt concrete paving on the site. This project would provide for minor crack filling and slurry sealing of the paving at the main parking lot near the Picnic Area. Striping is included in this estimate. This project should be scheduled on a 5 year cyclical basis to maintain the integrity of the paving and prevent premature failure. 50,000 square feet of asphalt area was used to generate this estimate. This project or a portion thereof was previously recommended in the FCA report dated 05/13/2010. It has been amended accordingly to reflect conditions observed during the most recent survey date of 12/15/2016.

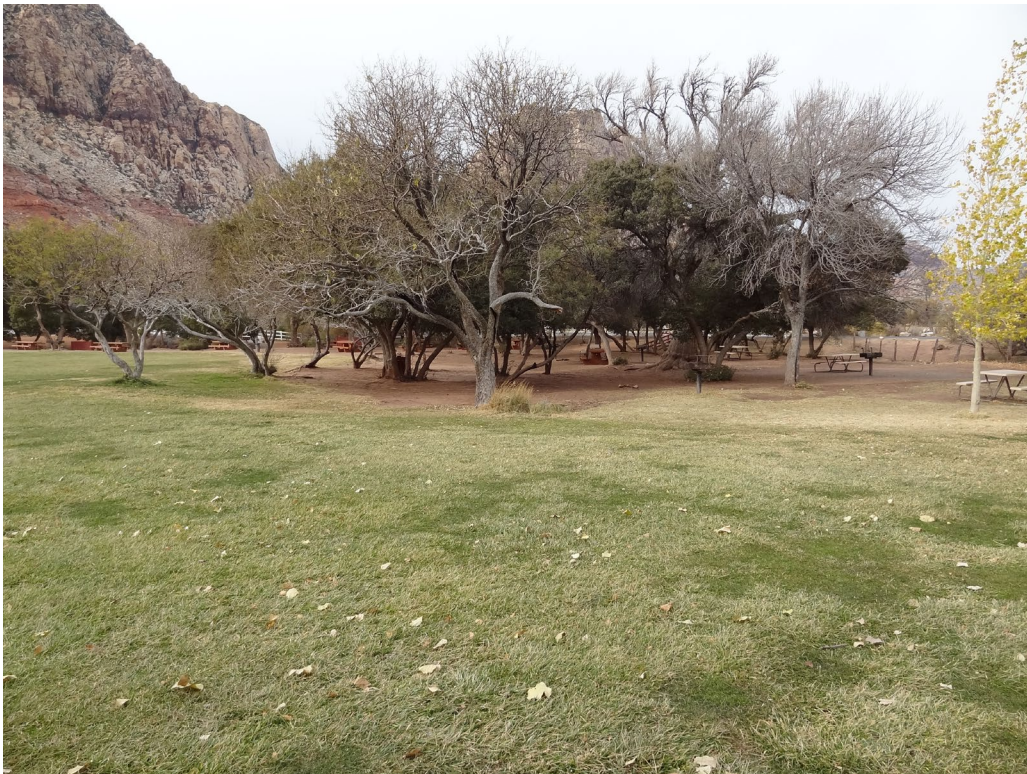
Spring Mountain Ranch State Park - Site #9930
Description: View of Group Use Area near Theater Pavilion.

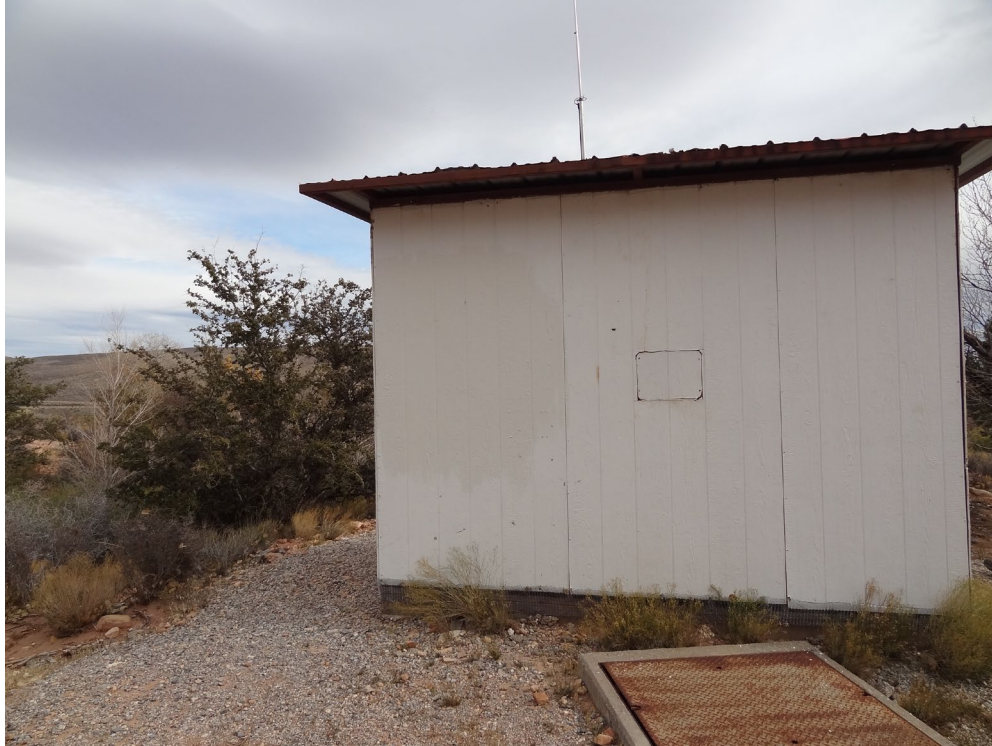
Domestic Well / Pump House - Building #3043
Description: Exterior of the Building.

It is important to maintain the finish, weather resistance, and appearance of the building. This project would provide funding to protect the exterior of the building excluding the roof. Included in the cost is sanding, priming and painting, and caulking of the flashing, fixtures and all other penetrations. It is recommended that the building be painted in the next 2-3 years and that this project be scheduled on a cyclical basis to maintain the integrity of the structure.

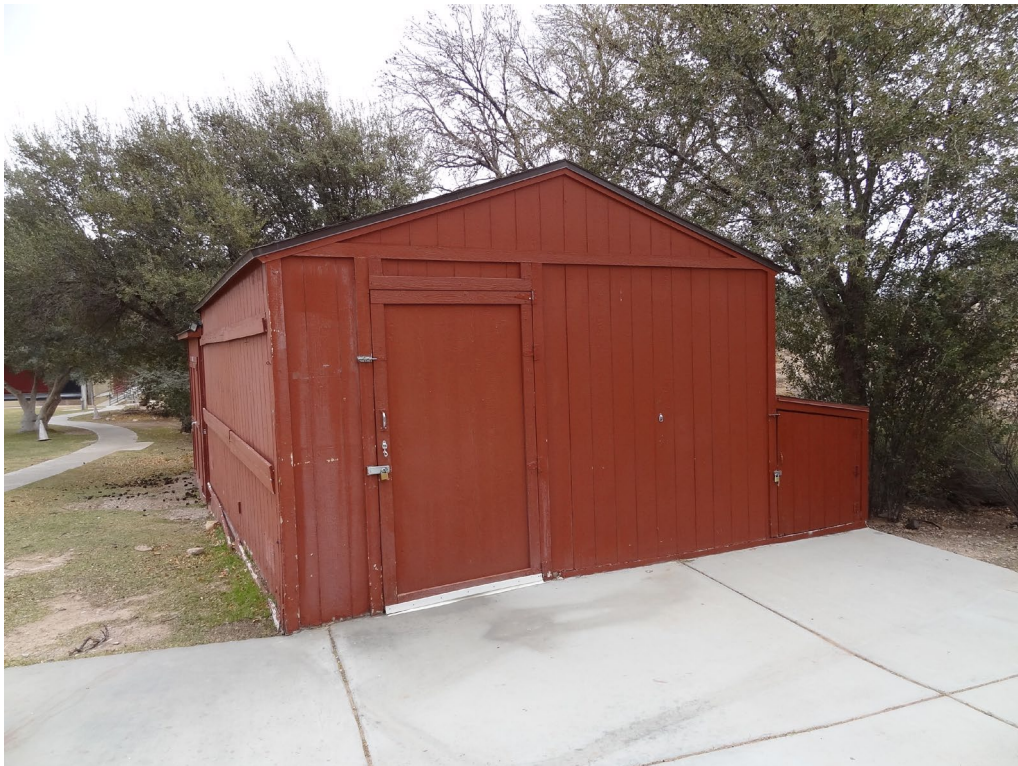
Theatre Storage - Building #2410
Description: Exterior Finishes of the Building.

It is important to maintain the finish, weather resistance and appearance of the building. This project would provide funding to protect the exterior of the building excluding the roof. Included in the cost is sanding, priming, painting and caulking of the flashing, fixtures and all other penetrations. It is recommended that the building be painted in the next 4-5 years and that this project be scheduled on a cyclical basis to maintain the integrity of the structure.

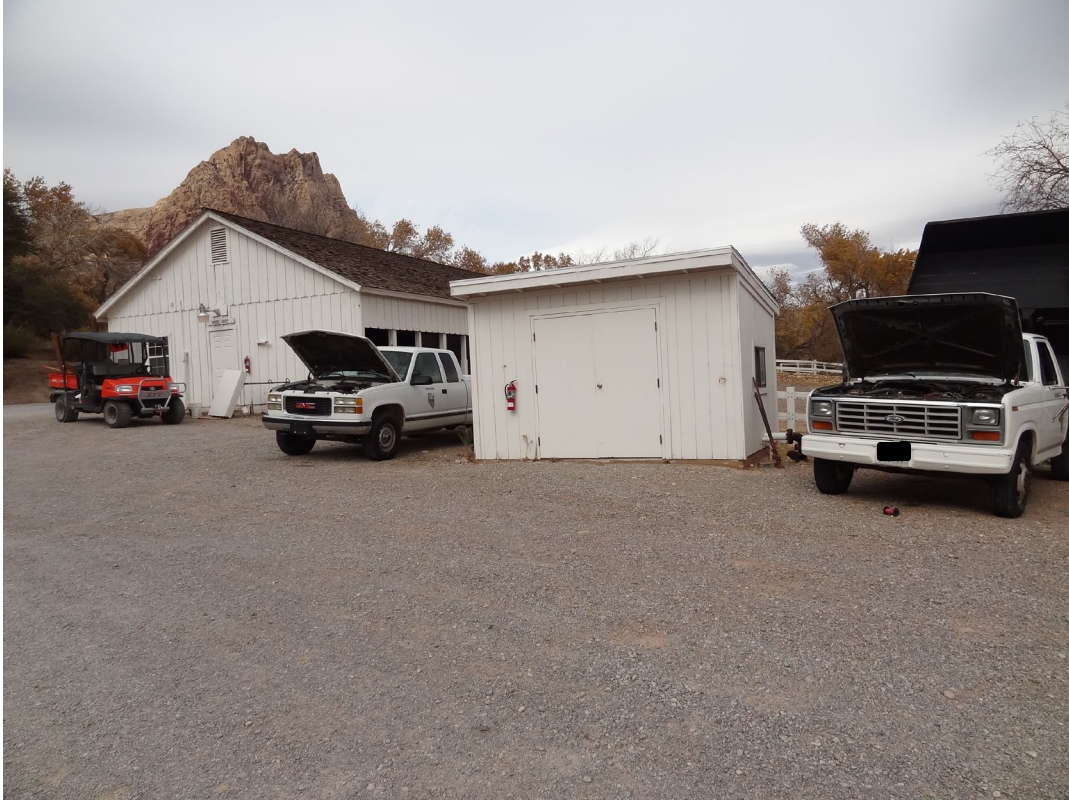
Irrigation Pump House - Building #1636
Description: Exterior of the Building.

It is important to maintain the finish, weather resistance and appearance of the building. This project would provide funding to protect the exterior of the building excluding the roof. Included in the cost is sanding, priming and painting and caulking of the flashing, fixtures and all other penetrations. It is recommended that the building be painted in the next 2-3 years and that this project be scheduled on a cyclical basis to maintain the integrity of the structure.

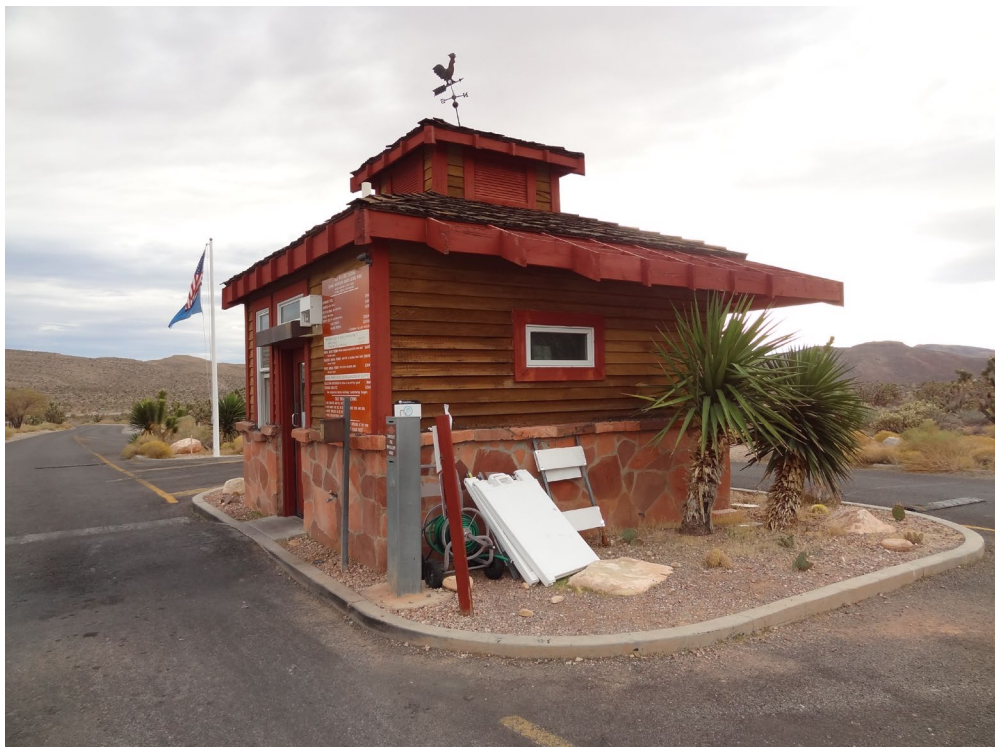
Entrance Station - Building #1635
Description: Exterior of the Building.

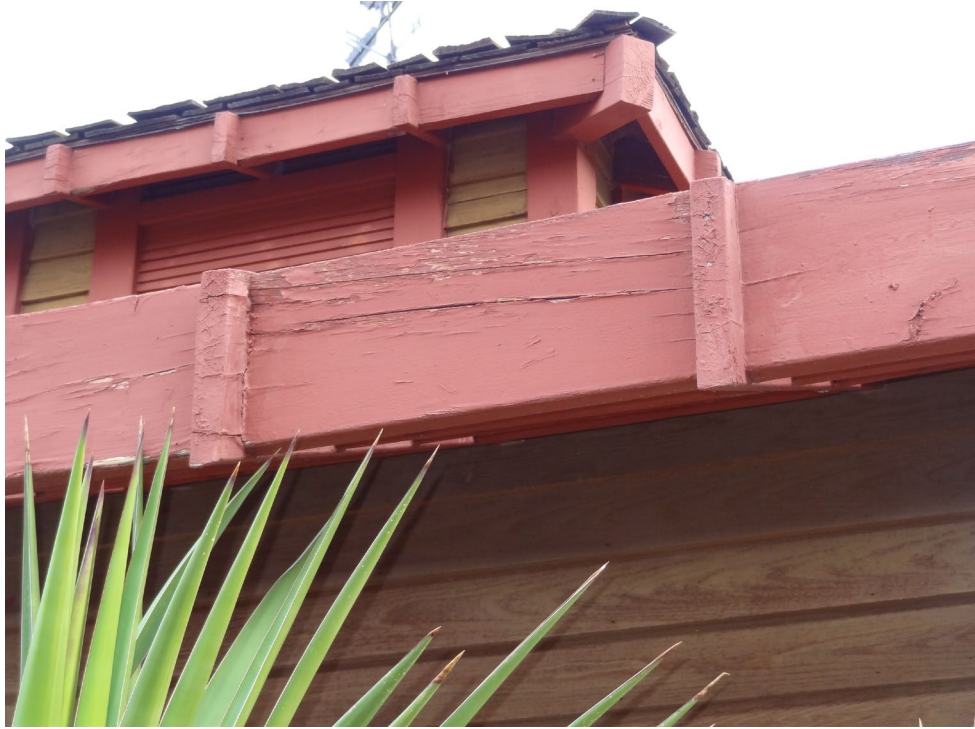
Entrance Station - Building #1635
Description: Exterior Finishes of the Building.

It is important to maintain the finish, weather resistance and appearance of the building. This project would provide funding to protect the exterior of the building excluding the roof. Included in the cost is sanding, priming and painting, cleaning and sealing the stone and caulking of the windows, flashing, fixtures and all other penetrations. It is recommended that the building be painted in the next 2-3 years and that this project be scheduled on a cyclical basis to maintain the integrity of the structure.

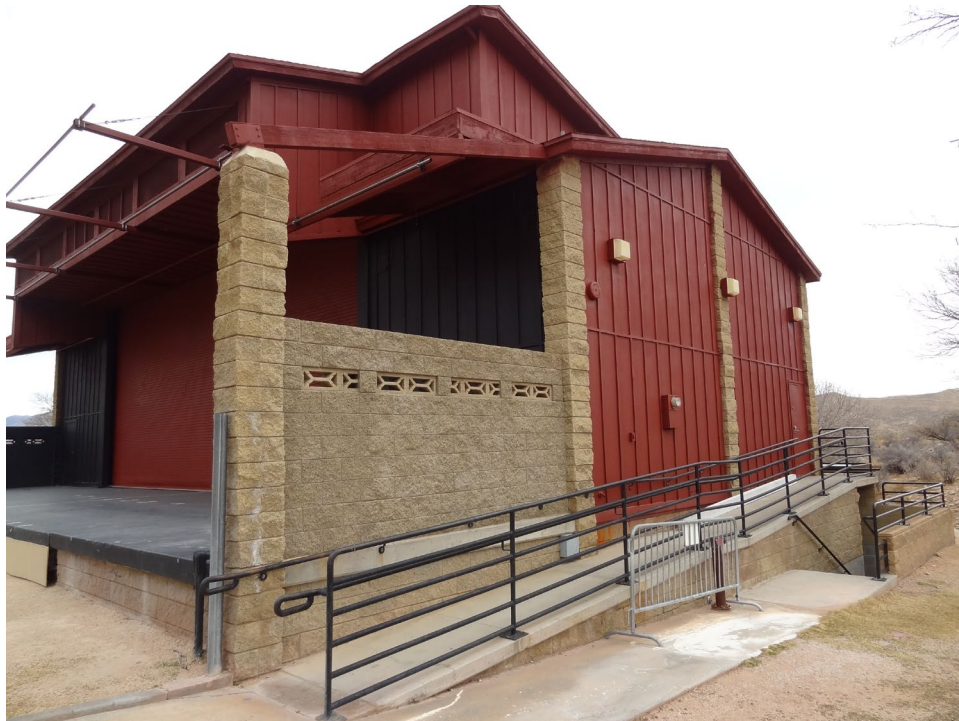
Theatre / Pavilion - Building #1634
Description: Exterior of Building and ADA Accessible Ramp to Basement Needed.

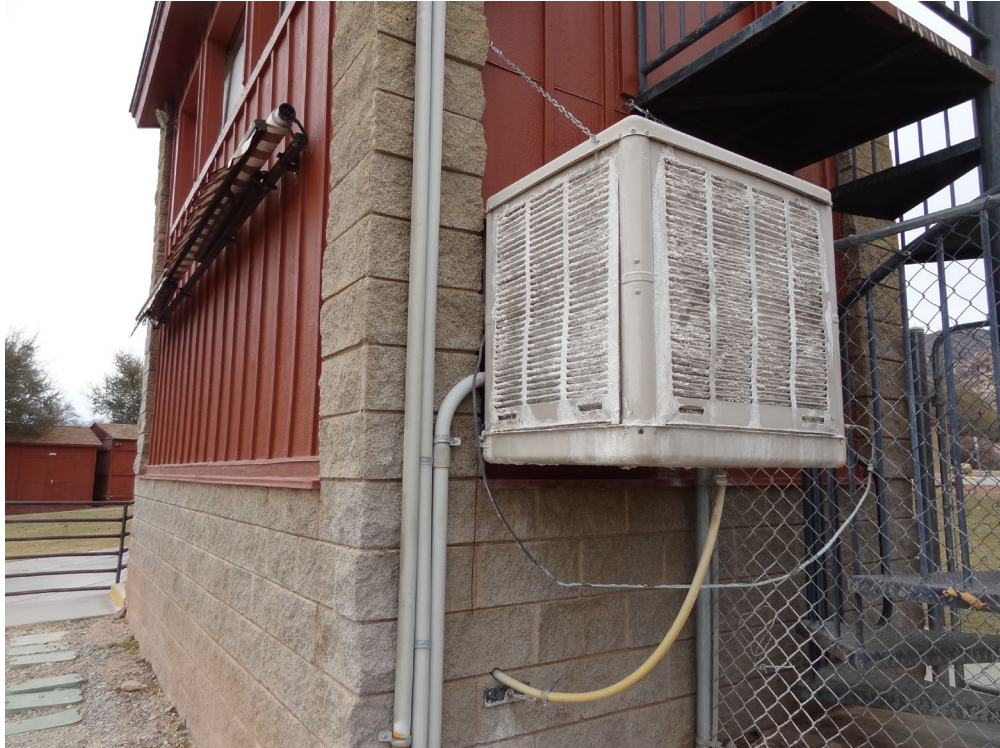
Theatre Concession - Building #1633
Description: Exterior of Building and Evaporative Cooler Replacement.

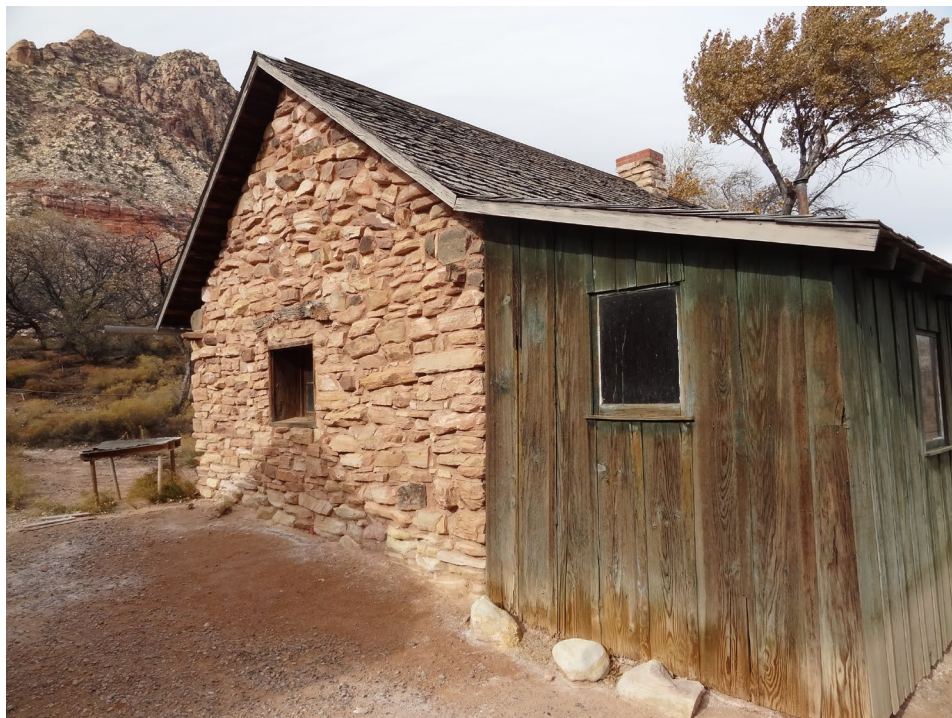
The structure is made of unreinforced stone masonry. It is over 100 years old and there are numerous areas where the mortar is failing, missing and not sealed properly. This is also an exhibit for the park and requires maintenance time to display the artifacts and maintain the signage. This project would provide for the cleaning, repair and re-pointing of the stone work and maintaining the exhibit. This project should be coordinated with the Nevada State Historical Preservation Office for possible restrictions or requirements which are not included in this estimate. It is recommended that the work be done in the next 1-2 years and that this project be scheduled on a cyclical basis to maintain the integrity of the structure.

Wilson Residence / Sandstone Cabin - Building #1174
Description: Exterior of the Building.

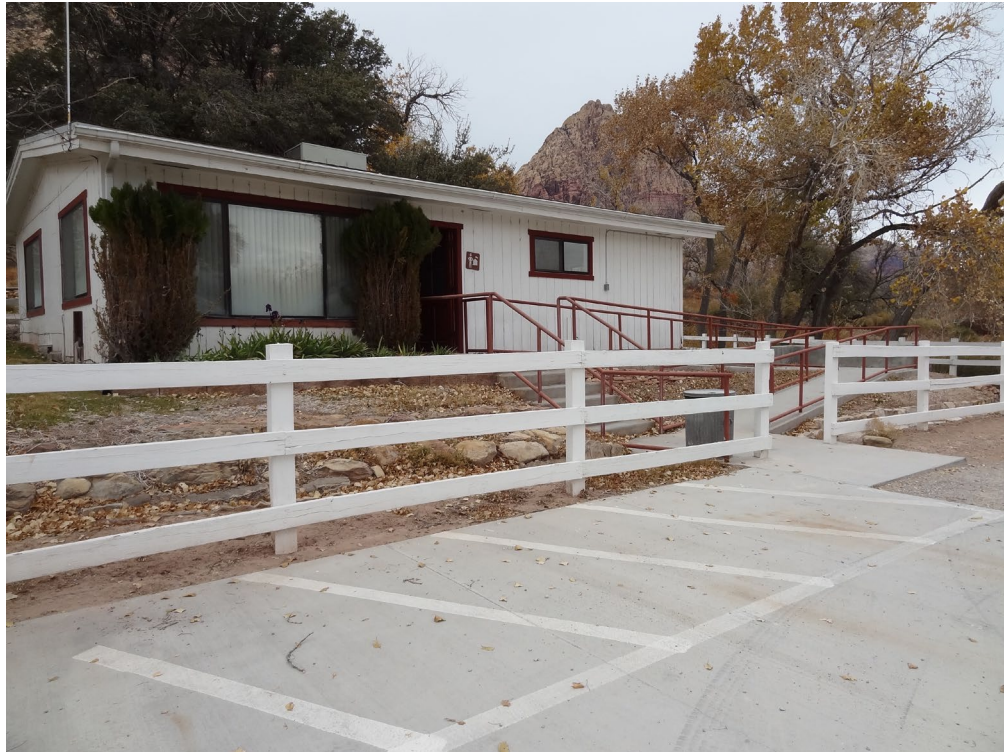
Ranger's Office / Guest House - Building #1173
Description: Exterior of the Building.

It is important to maintain the finish, weather resistance and appearance of the building. This project would provide funding to protect the exterior of the building excluding the roof. Included in the cost is sanding, priming and painting and caulking of the windows, flashing, fixtures and all other penetrations. It is recommended that the building be painted in the next 2-3 years and that this project be scheduled on a cyclical basis to maintain the integrity of the structure. This project or a portion thereof was previously recommended in the FCA report dated 05/13/2010. It has been amended accordingly to reflect conditions observed during the most recent survey date of 12/15/2016.

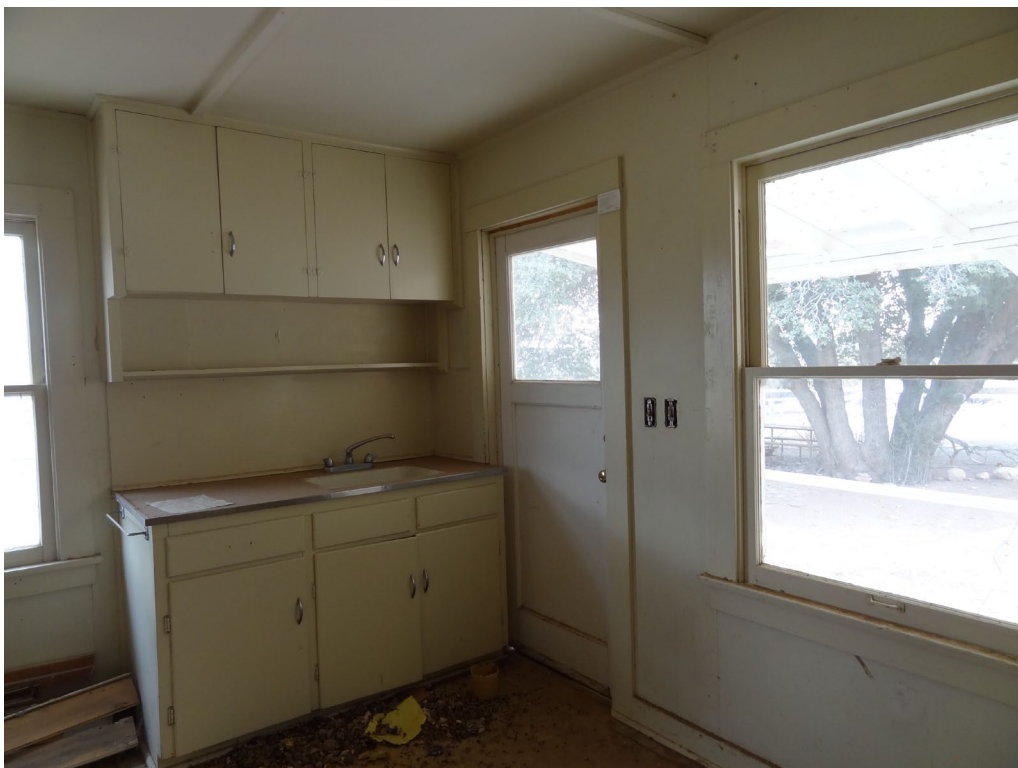
Residence #5 – Spring House - Building #1169
Description: Interior Remodel.

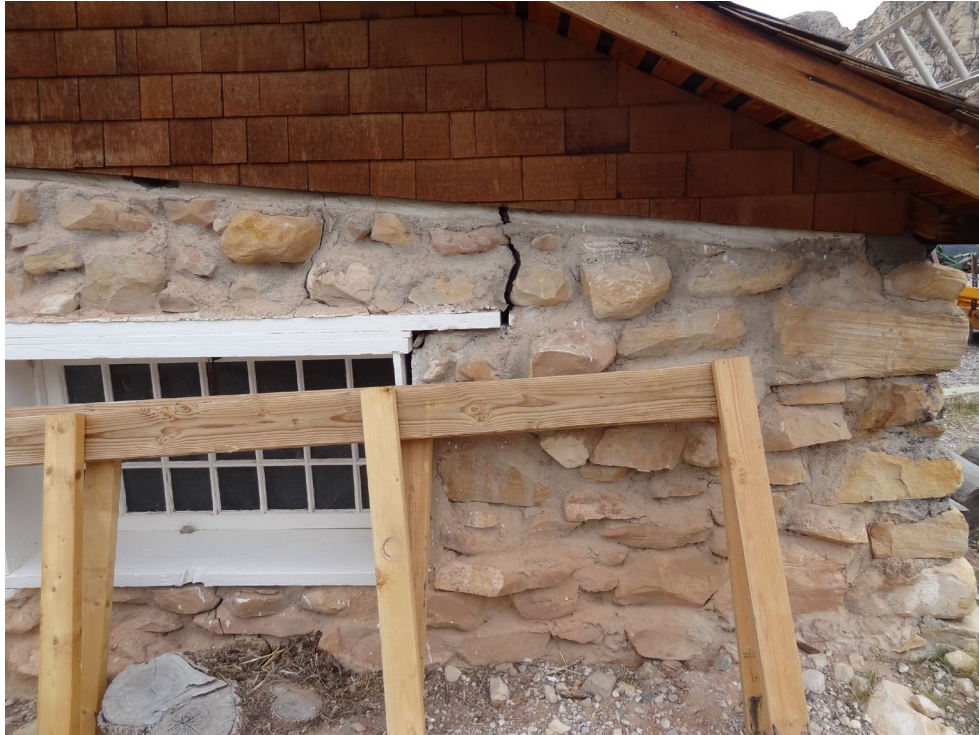
Chinchilla Shed - Building #1149
Description: Structural Repairs.
