BIG BEND OF THE COLORADO STATE RECREATION AREA

Site Number: 9931
STATE OF NEVADA PUBLIC WORKS DIVISION
FACILITY CONDITION ANALYSIS

Report distributed in October 2021

Survey Date: 12/13/2017

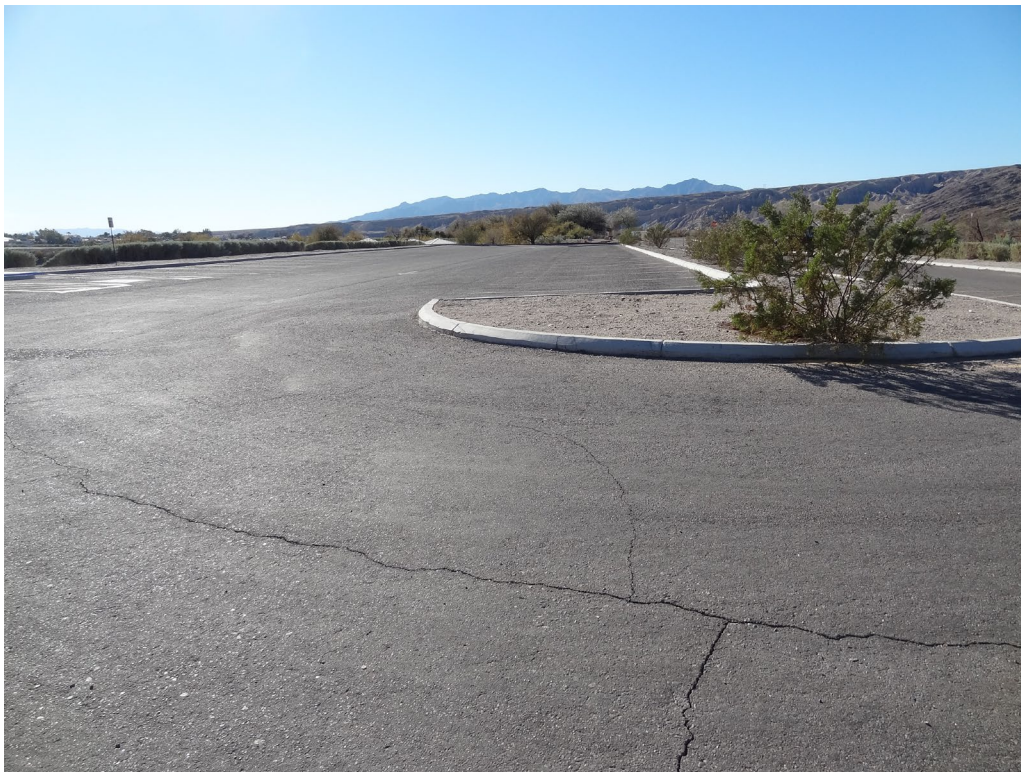
It is important to maintain the asphalt concrete paving on the site. This project would provide for minor crack filling and sealing of the paving site wide including access roads, parking areas and the maintenance yard. Striping is included in this estimate. This project should be scheduled on a 5 year cyclical basis to maintain the integrity of the paving and prevent premature failure. 100,000 square feet of asphalt area was used to generate this estimate.

Big Bend State Recreation Area - Site #9931
Description: Seal Asphalt Paving.

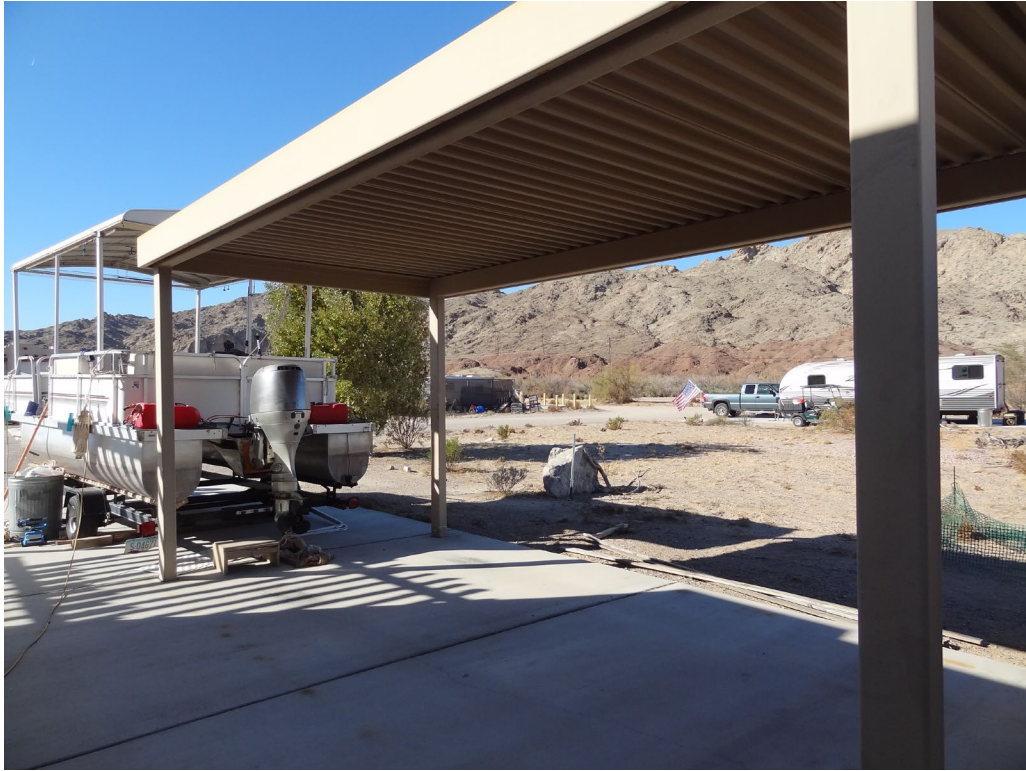
The exterior finishes are in fair condition. It is important to maintain the finish, weather resistance and appearance of the structure. This project would provide for painting of the structure in the next 5 - 6 years and it is recommended that this project be scheduled on a cyclical basis to maintain the integrity of the structure.

Ranger Residence #2 Carport - Building #2862
Description: View of the Building.

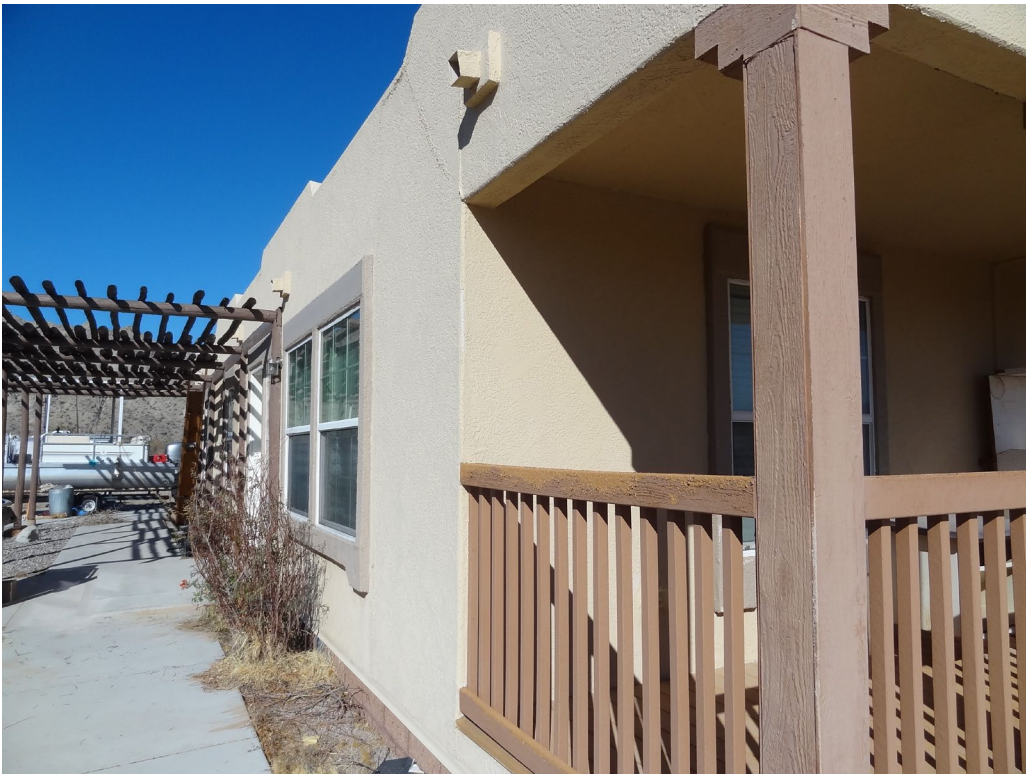
Ranger Residence #2 is a modular home which has been retrofitted with an exterior insulation and finish system (EIFS). It has a single-ply roofing system and is on a permanent concrete foundation. It contains bedrooms, bathrooms, and kitchen, living and dining areas. The HVAC system is a split system with a forced air unit in the interior and the condenser on the north side of the residence. The building is located in the northern portion of the park.

Ranger Residence #2 - Building #2861
Description: Exterior of the Building.

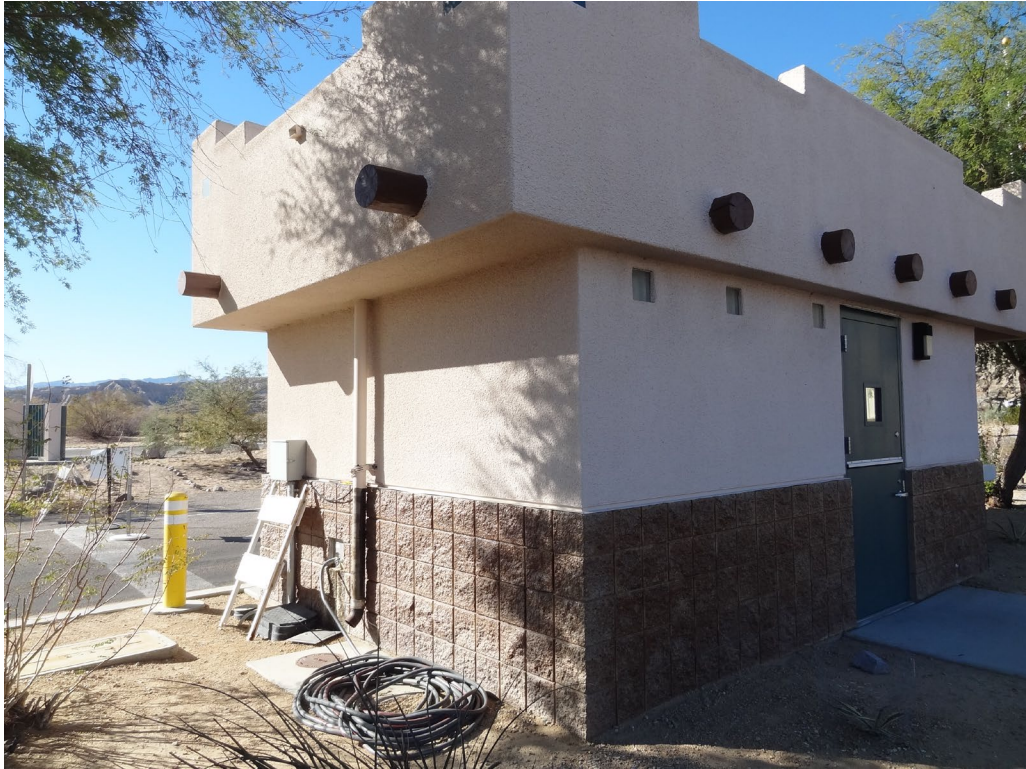
The Entrance Station is a concrete masonry unit and wood framed structure with a single-ply roofing system on a concrete foundation. The building has a small unisex restroom and office space for fee collection and other park related informational handouts. There is a small wall mounted heat pump with a condenser mounted on the roof for heating and cooling needs.

Entrance Station - Building #2860
Description: Exterior of the Building.

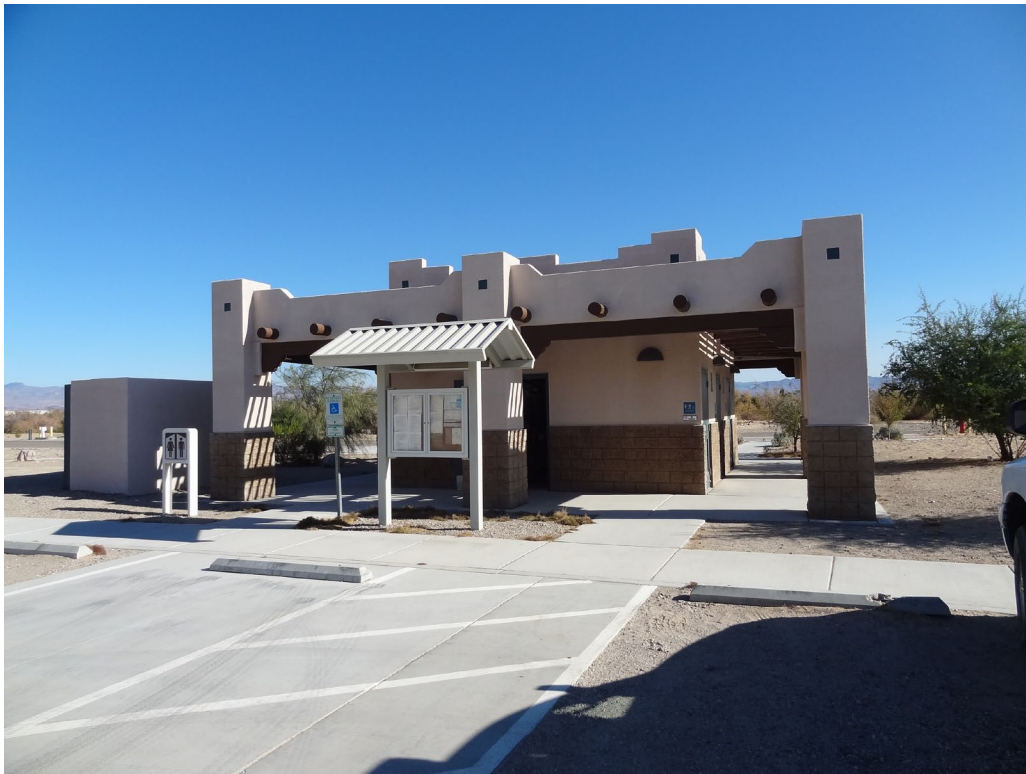
Comfort Station #2C - Campground is a concrete masonry unit and wood framed structure with a single-ply roofing system on a concrete foundation. It contains Men's and Women's ADA compliant restrooms and showers including an ADA route of travel from the parking spaces to the building.

Comfort Station #2C - Building #2859
Description: Exterior of the Building.

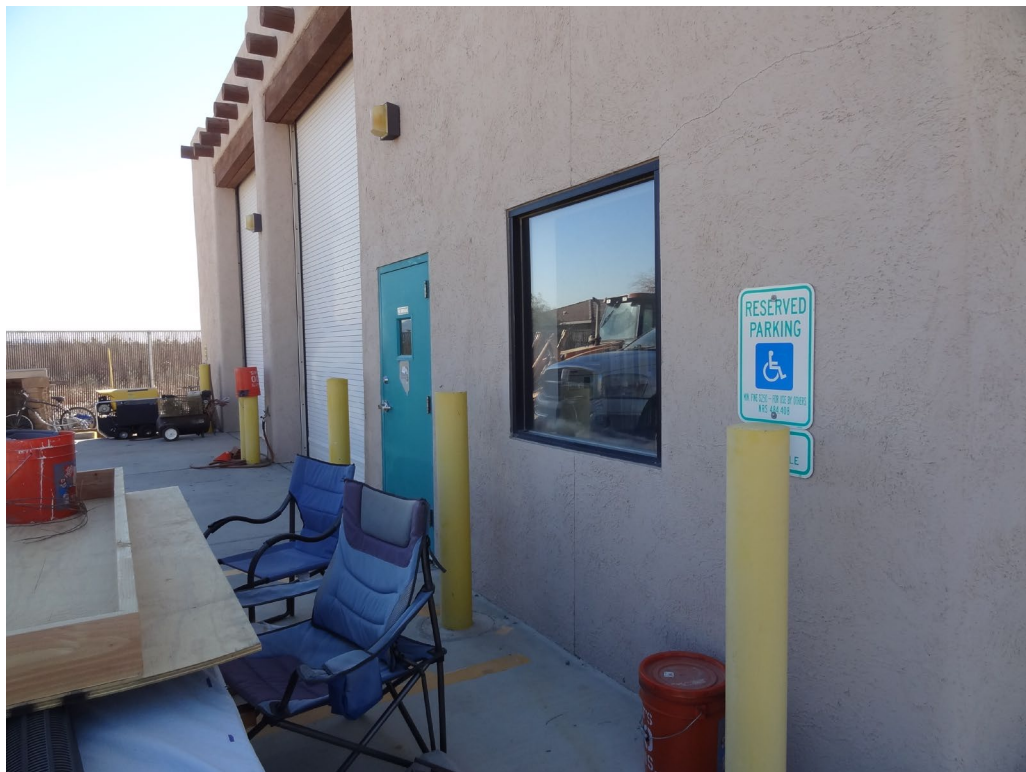
The Shop/Maintenance Building is an insulated engineered steel structure with a standing seam metal roofing system on a concrete foundation. The exterior has an exterior insulation and finish system (EIFS) and the interior consists of a large shop area and a small office with a restroom. There is evaporative cooling and a packaged HVAC unit also for the shop and a small wall mounted heat pump for the office area. There are no fire alarms or sprinklers located in the structure and there is an ADA accessible parking stall located adjacent to the entrance to the office.

Shop / Maintenance Building - Building #2349
Description: Exterior of the Building.

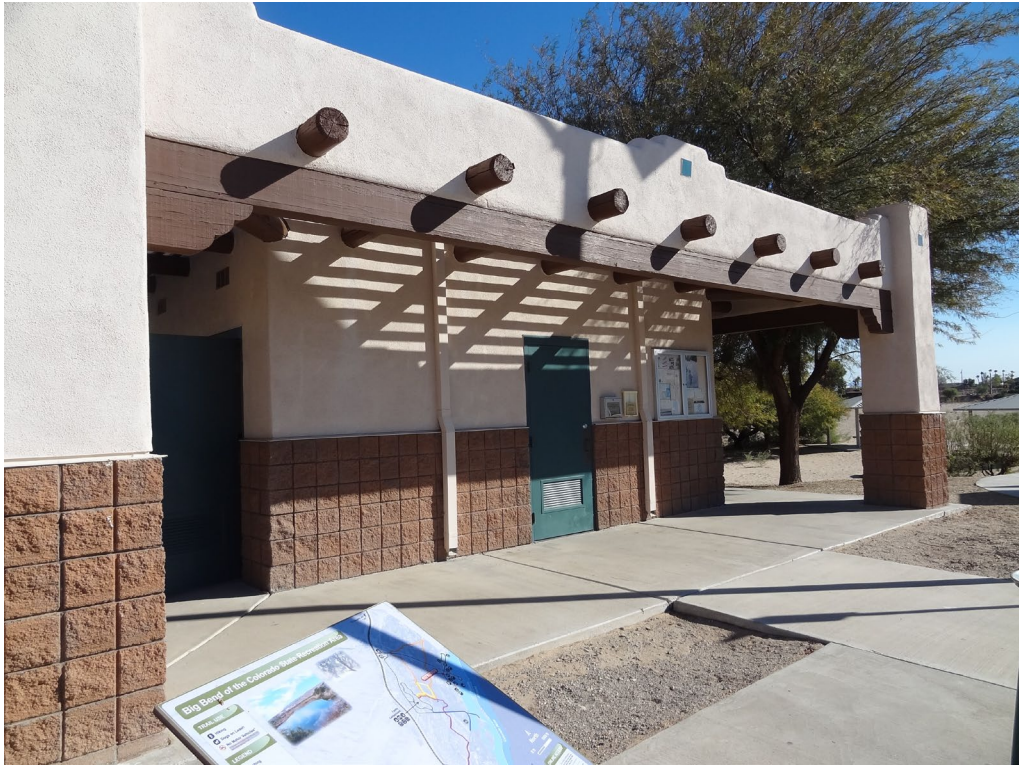
Comfort Station #1 - Day Use is a concrete masonry unit and wood framed structure with a single-ply roofing system on a concrete foundation. It contains Men's and Women's ADA restrooms including an ADA route of travel from the parking spaces to the building which is mostly compliant. Some minor ADA improvements will be recommended in the report. The facility is in good shape and well maintained.

The concrete slab is settling especially at the corners and has extensive cracking. The grade is shifting away from the building, pulling the concrete with it. The settling and shifting will continue and cause extensive damage to the concrete slab and eventually to the buildings footings. This project would provide for regrading and compacting next to and underneath the slab and replacing the concrete as needed.

Comfort Station #1 - Building #1908
Description: Exterior of the Building.

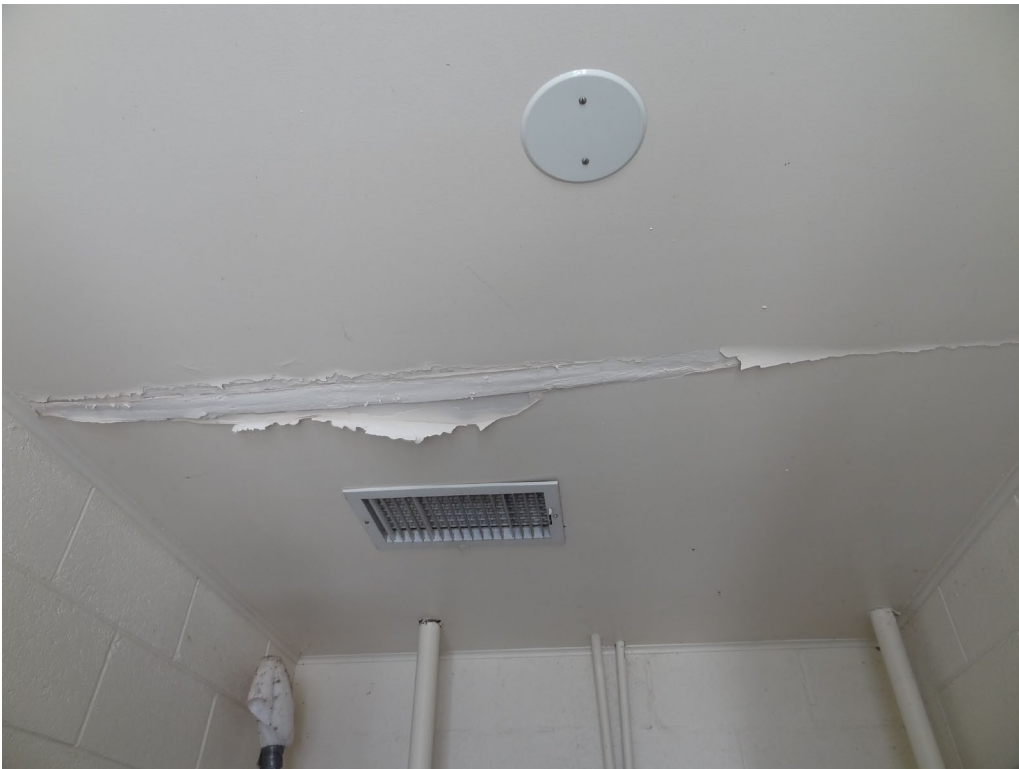
Water leaks and moisture have damaged the gypsum board in the utility room. If the gypsum board is not removed and replaced, the moisture potentially could cause mold and dry-rot. The source of the leak must be identified and repaired. This project recommends removing the gypsum board, repairing the leak and replacing it with green board and installing Fiberglass Reinforced plastic (FRP). Per IBC 2018 Section 1210 was used as a reference for this project.

Comfort Station #1 - Building #1908
Description: Gypsum Board Repair.
